Technical Report SL-97-9  
September 1997

# Durability of Posttensioned Concrete After 33 Years of Marine Exposure

by *Morris Schupack, Schupack Suarez Engineers, Inc.*  
*Edward F. O'Neil, WES*

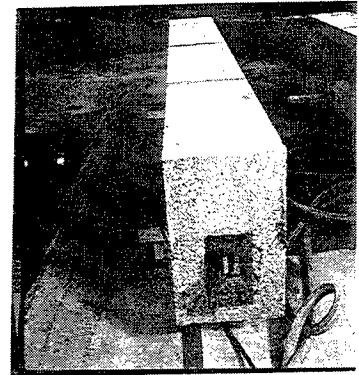
Fig. 4C

Exterior  
No reinforcement  
Bush hammered  
(Prescon tendon)

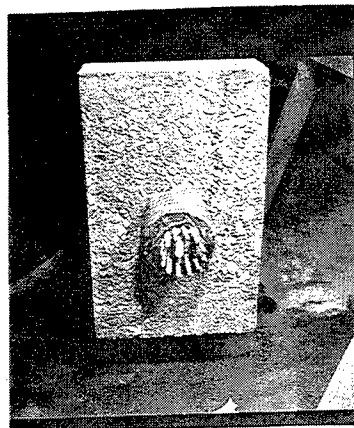
Fig. 4E

Exterior  
No reinforcement  
Bush hammered prep.  
(Freyssinet tendon)

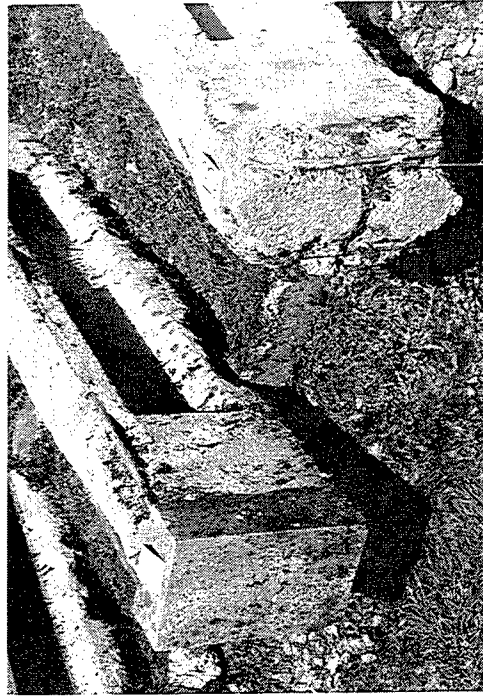
Beam 16 - Seaward end - 1988  
Fig. 8-1C

Although the epoxy-resin itself behaved very well for 33 years, the interaction between the epoxy-resin and the concrete manifested deterioration of the concrete interface and corrosion of the reinforcing steel that extended from the portland-cement concrete into the epoxy-resin concrete (Fig. 8-1, 8-2, and 8-3I). The concrete deterioration first appeared in 1972 in beam ends 16L and 20S. (Table 2-3). Prior to 1972 it appeared that the epoxy-resin concrete was a superior detail. The concrete deterioration was probably affected by the following conditions:
