DOT/FAA/AR-96/21

# Composite Failure Analysis Handbook Update 1

WL-TR-93-4004

August 1997

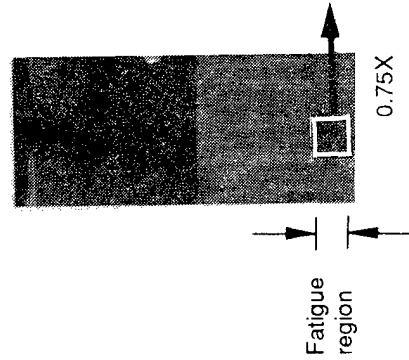
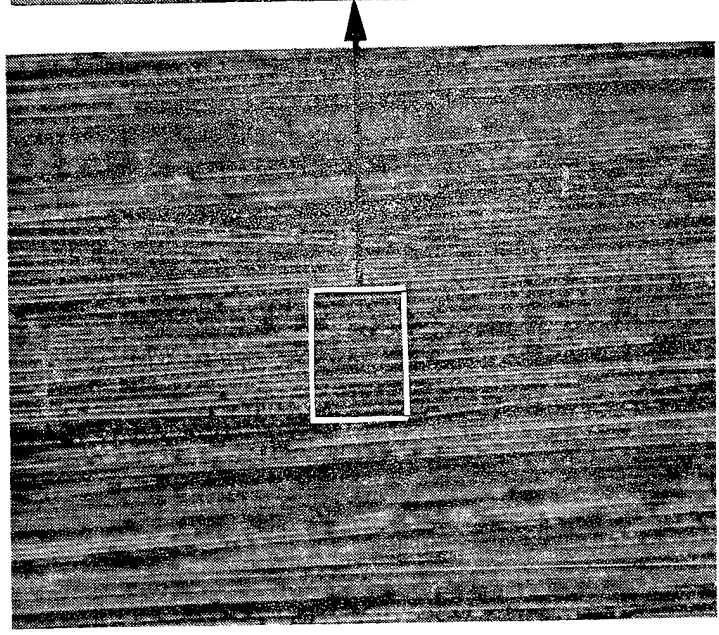
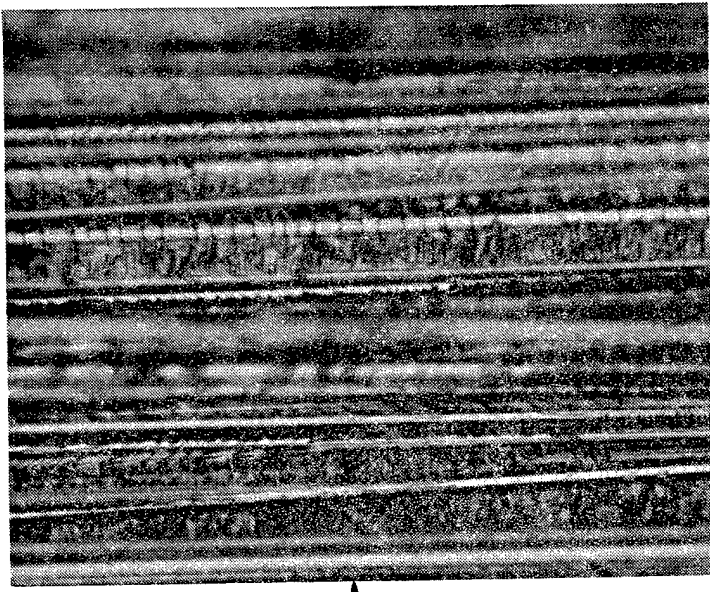
The typical mode II crack propagation features were easily identified on the surfaces of both specimens. In addition, indications of fatigue loading, in the form of fatigue crack growth increments or striations, were visible on the low-stressed specimen. They were observed only on the exposed fibers at the high optical and SEM magnifications. Even though the high-stressed fracture surface was thoroughly examined, no striations were found. Figures 3.1-1 through 3.1-4 show optical and SEM fractographs of interlaminar mode II fatigue at high and low stress levels.

Figure 3.1-1. Optical Fractographs of 3501-6/AS4 Interlaminar Mode II (Shear) Fatigue, Low Stress Loading, 270°F

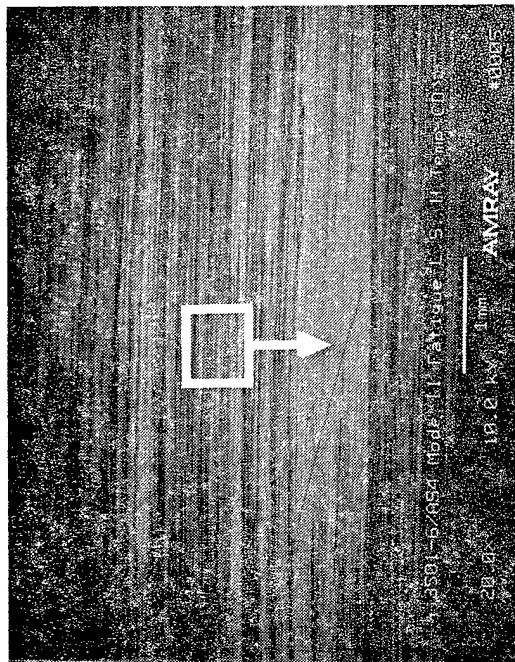
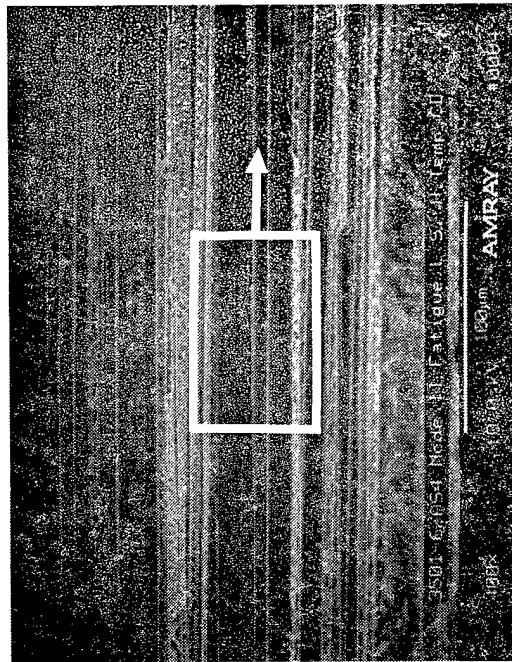
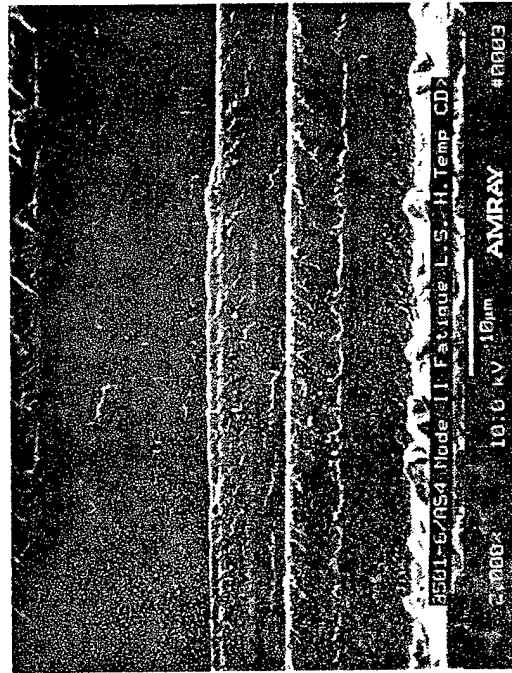
Figure 3.1-2. SEM Fractographs of a 3501-6/AS4 Interlaminar Mode II (Shear) Fatigue Fracture Surface, Low Stress, 270°F

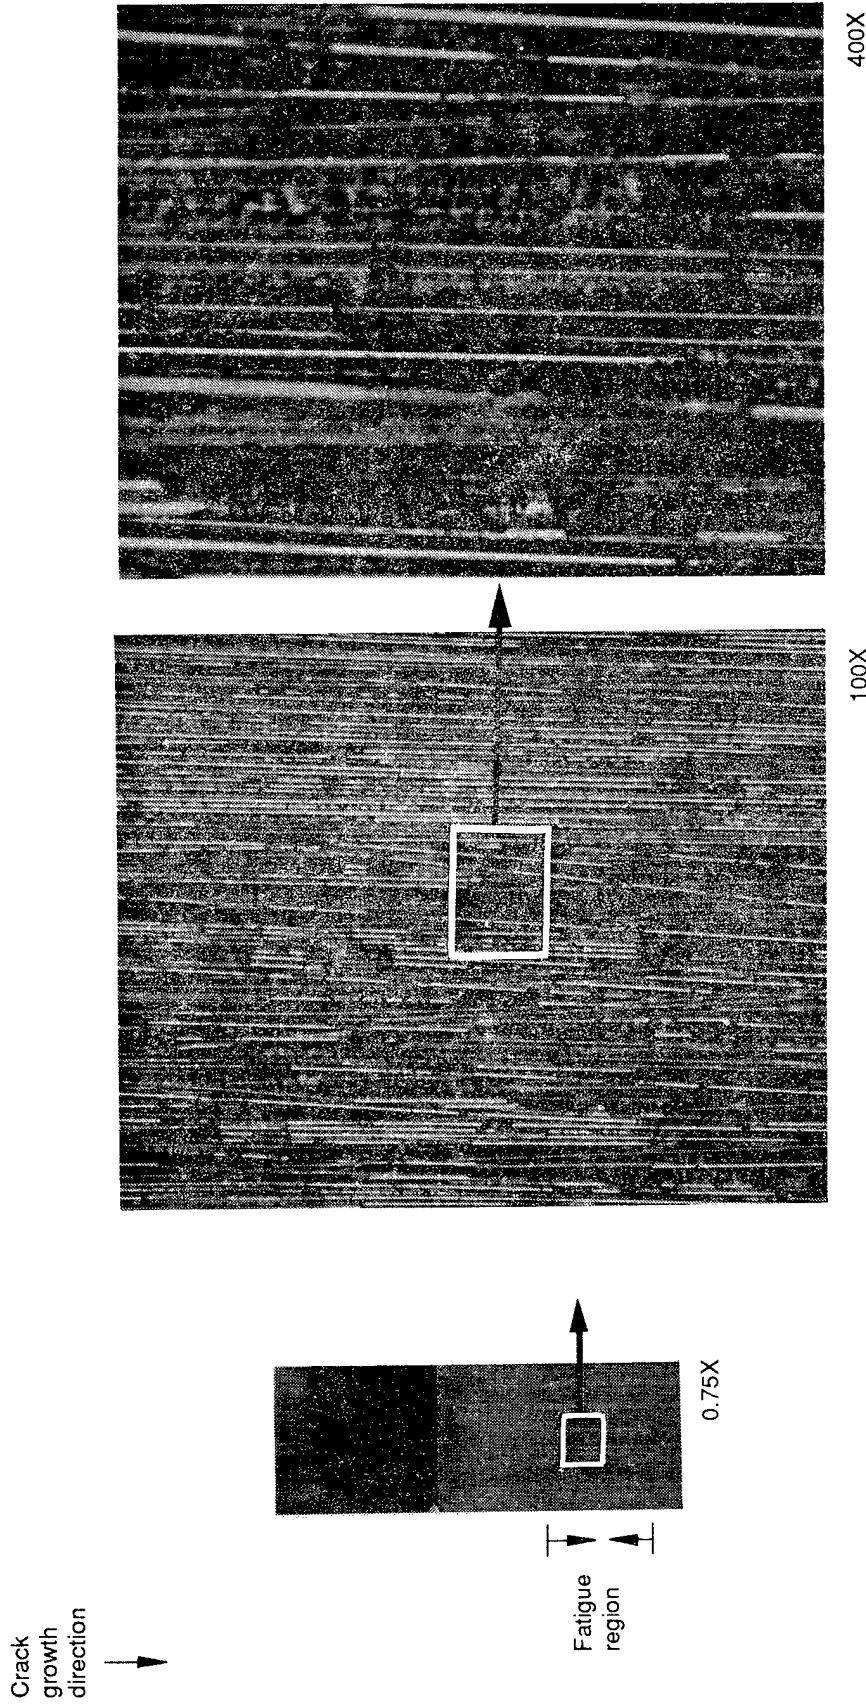
Figure 3.1-3. Optical Fractographs of 3501-6/AS4 Interlaminar Mode II (Shear) Fatigue, High-Stress Loading, 270°F

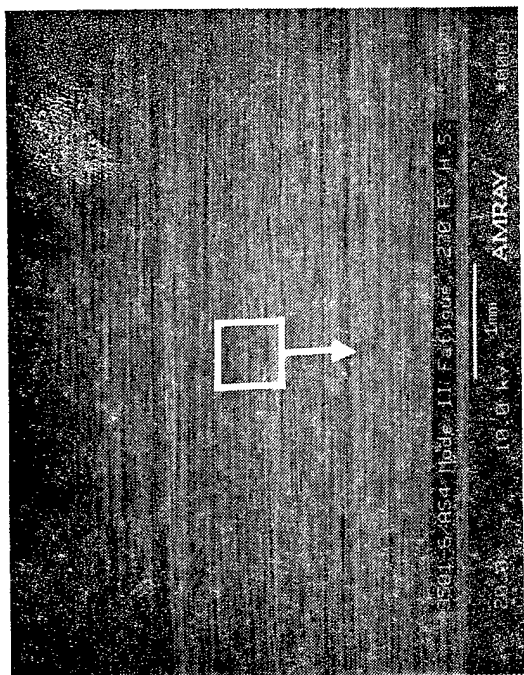
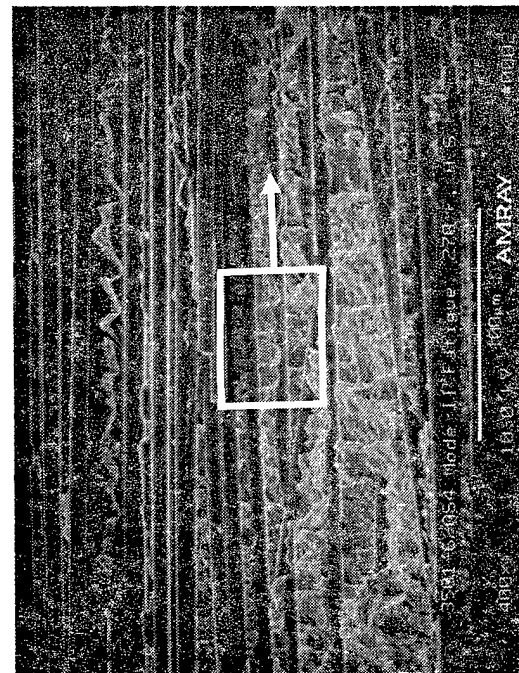
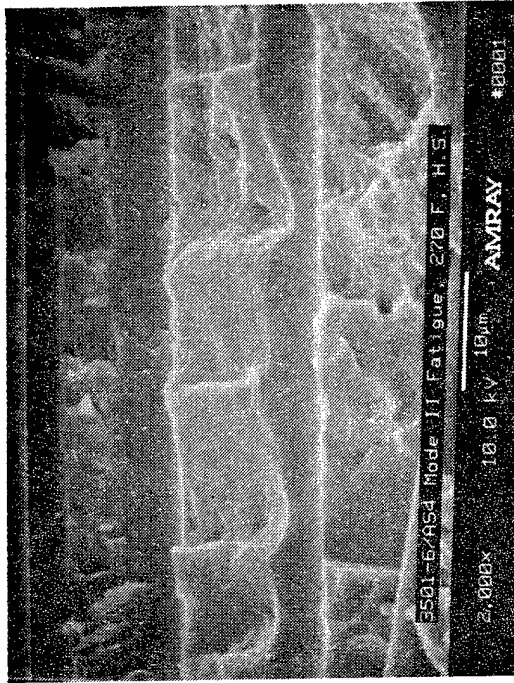
Figure 3.1-4. SEM Fractographs of a 3501-6/AS4 Interlaminar Mode II Fatigue Fracture Surface, High Stress, 270°F

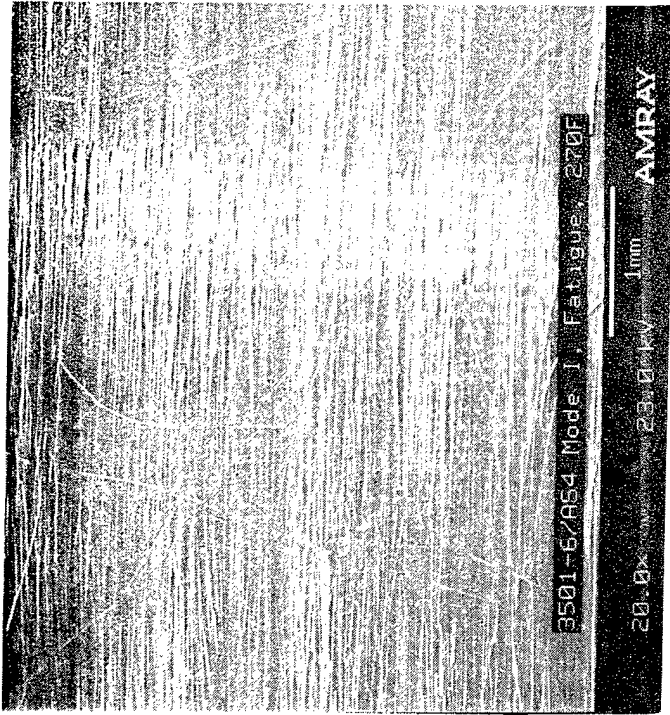
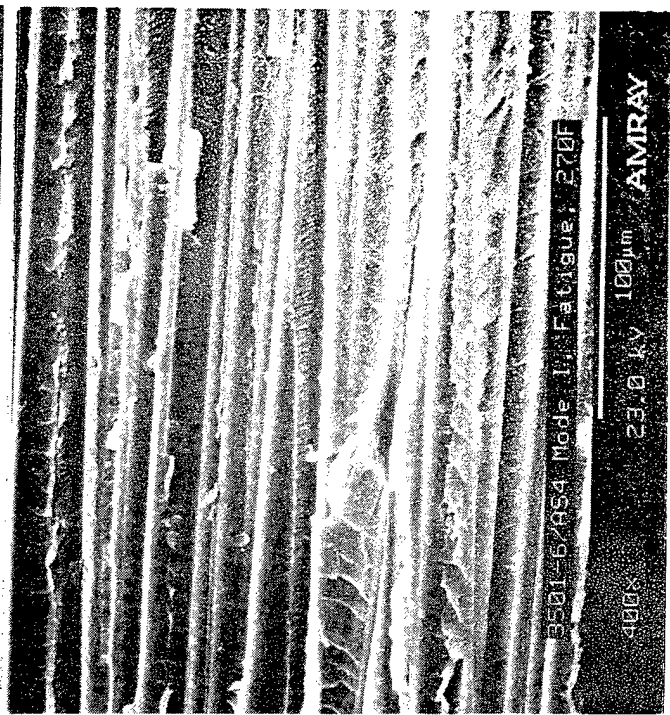
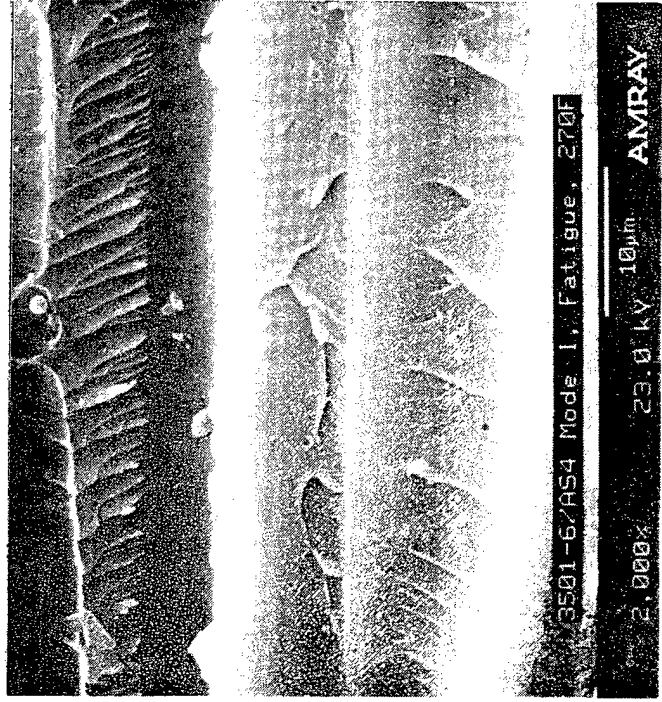
The mode I crack propagation features were not easily seen on the fracture surfaces (Figures 3.1-5 & 3.1-6) unlike a typical static load fracture surface. There were more features indicative of mode II (shear), such as hackles, throughout the surfaces. But these corresponded to the fiber pullout fractures than the overall crack propagation. Neither did these features generally indicate the overall crack propagation direction.

Figure 3.1-6. SEM Fractographs of a 3501/AS4 Interlaminar Mode I (Tensile) Fatigue Fracture Surface, 270° F

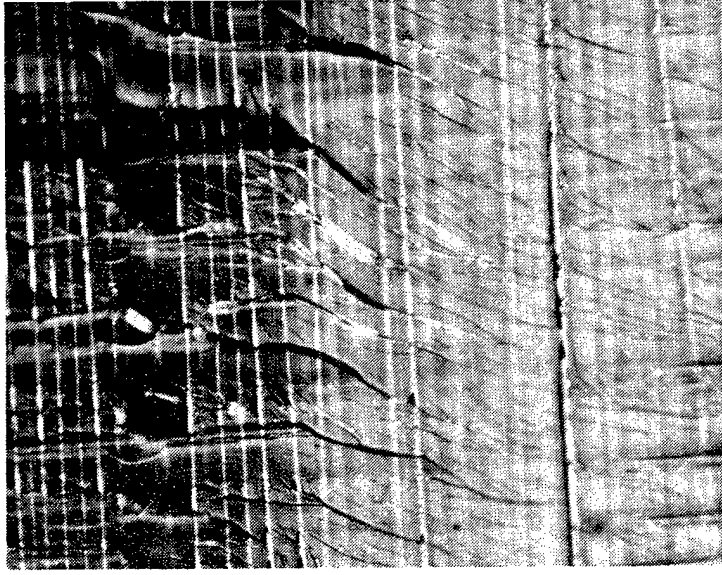
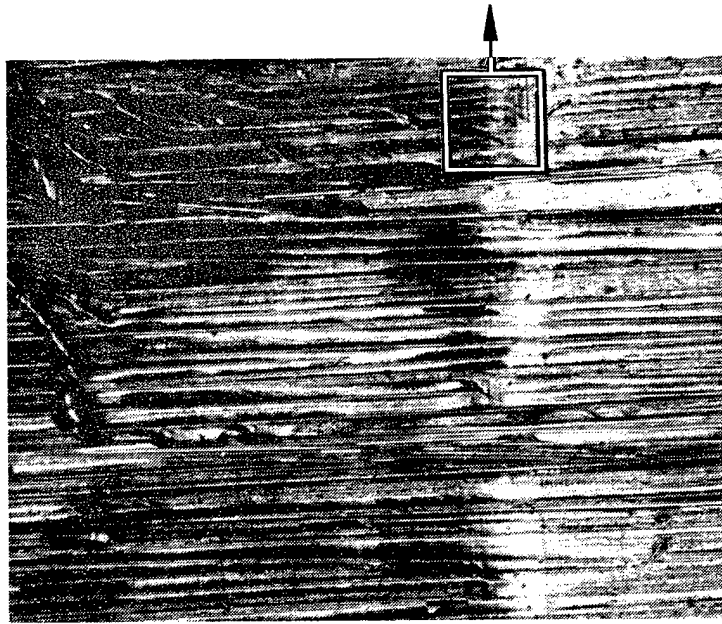
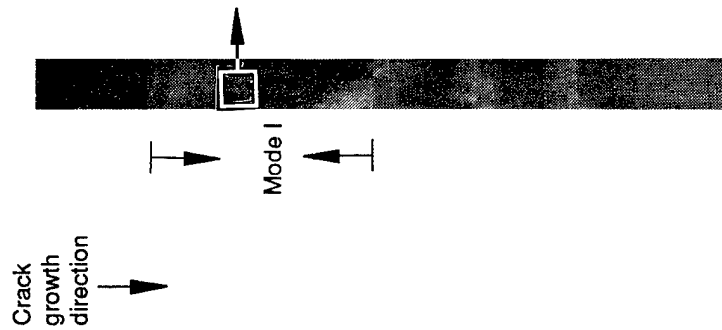
Following the exposures, the specimens were then tested and examined. Fractographic analysis of the surface morphologies revealed no abnormal or unusual surface features on any of the specimens.

Figure 3.1-7. Optical Fractographs of 3501-6/AS4 Interlaminar Mode I Tension, Specimen Exposed to Deicing Fluid

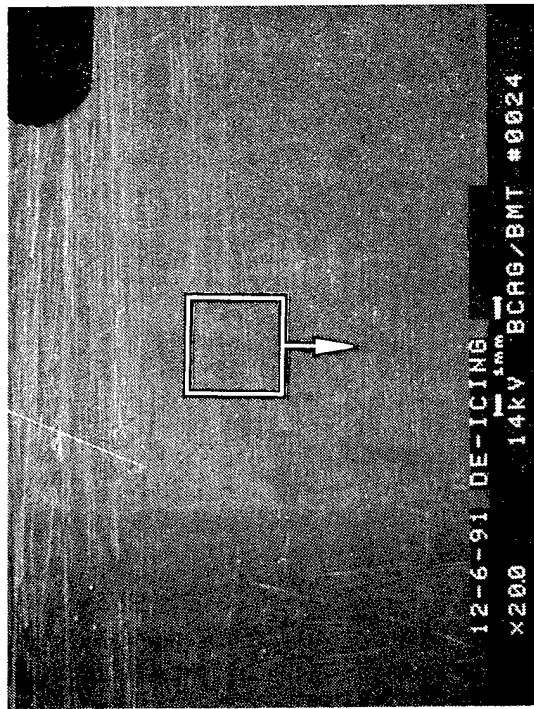
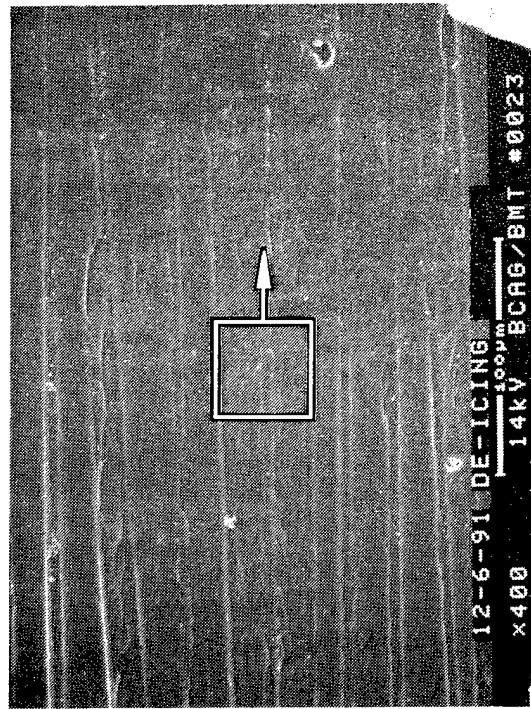
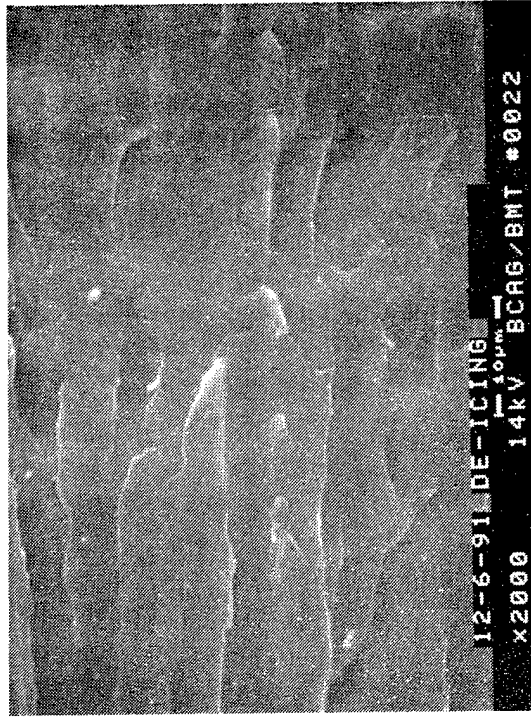
Figure 3.1-8. SEM Fractographs of 3501-6/AS4 Interlaminar Mode I Tension, Specimen Exposed to Deicing Fluid

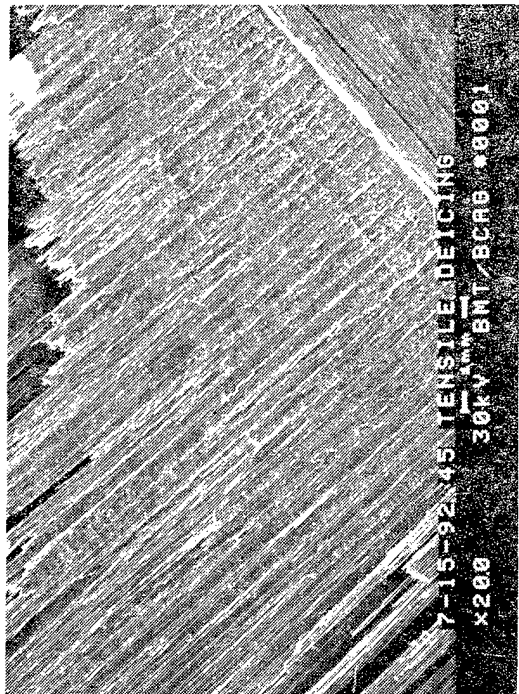
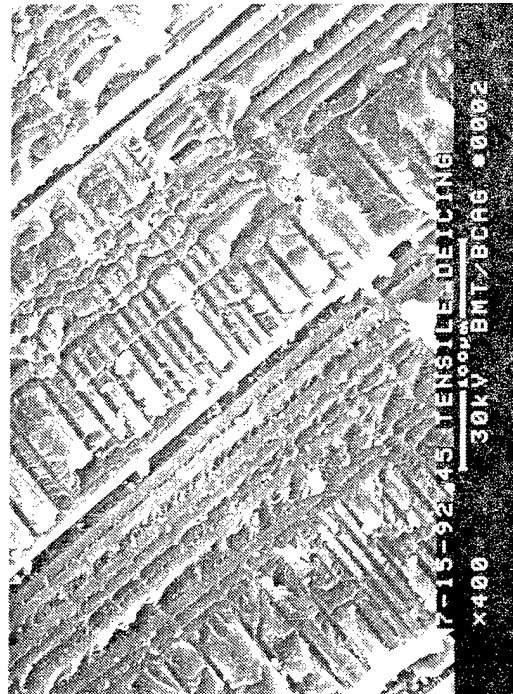
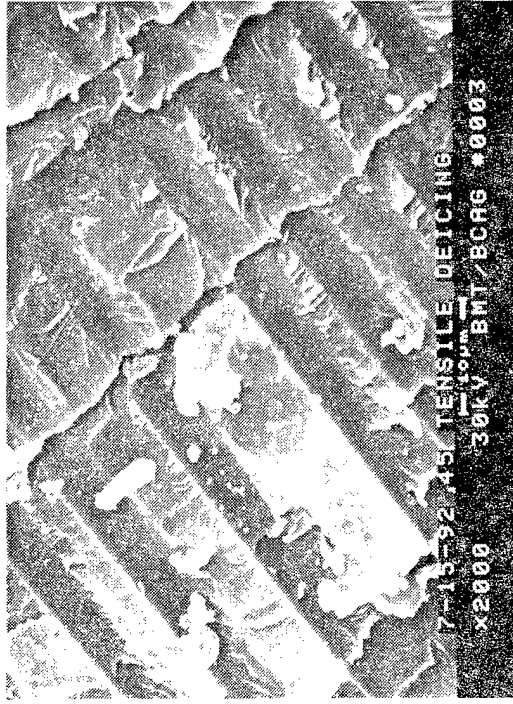
Figure 3.1-9. SEM Fractographs of a 3501-6/AS4 ± 45 Tensile Specimen Exposed to Deicing Fluid, Interlaminar Surface

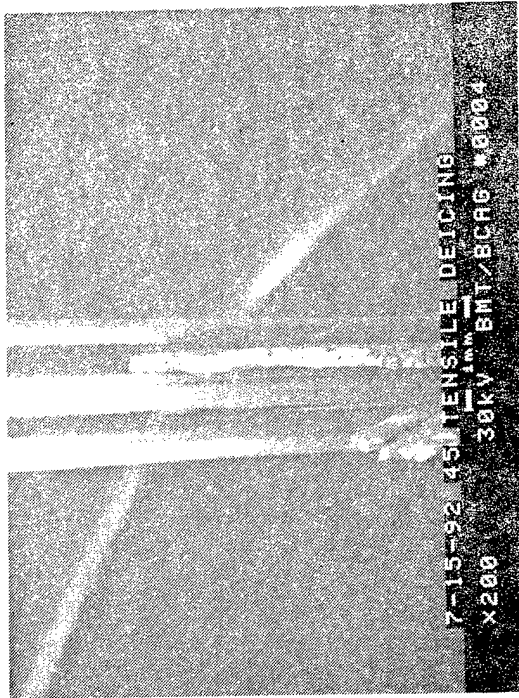
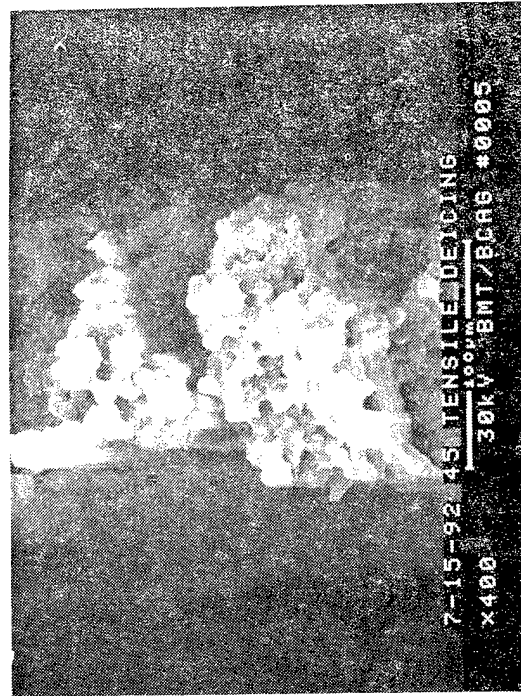
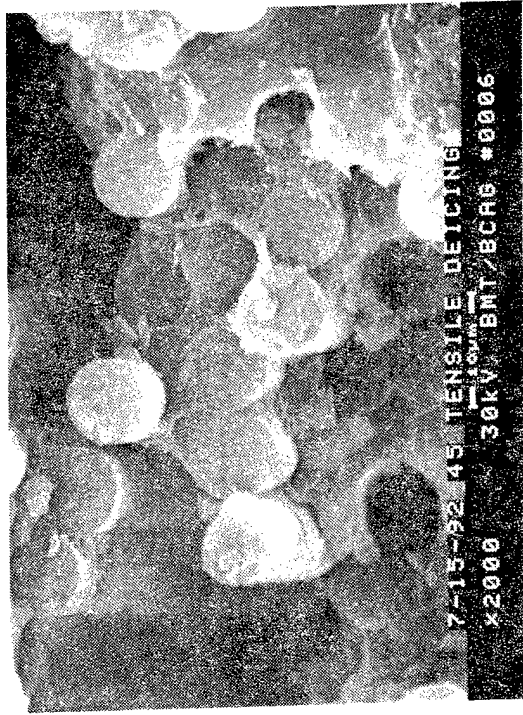
Figure 3.1-10. SEM Fractographs of a 3501-6/AS4 ± 45 Tensile Specimen Exposed to Deicing Fluid, Translaminar Surface

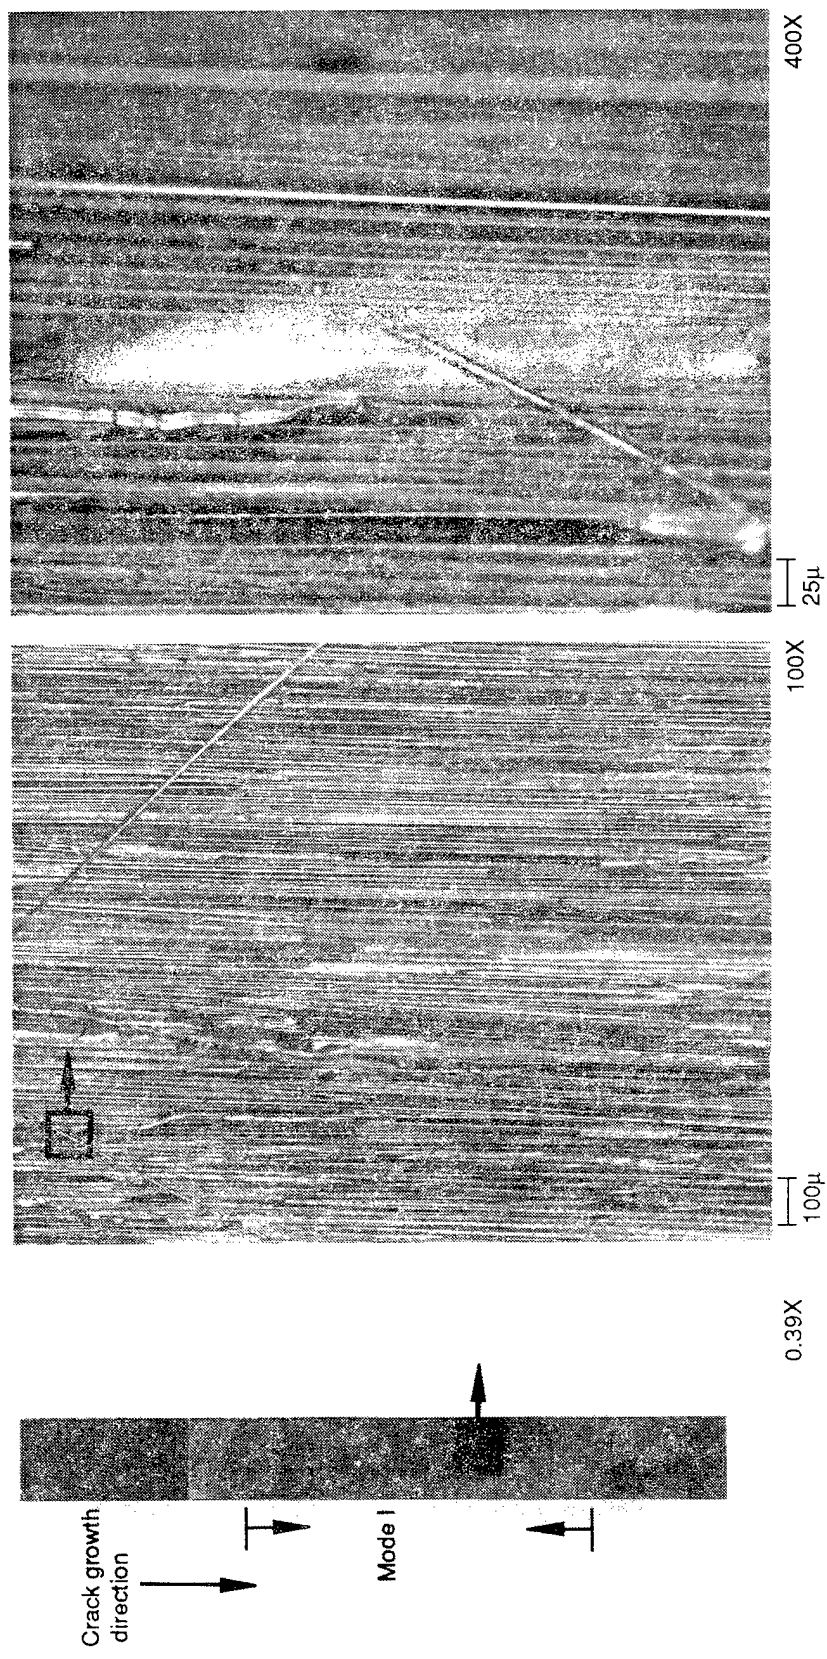
Figure 3.1-11. Optical Fractographs of 3501-6/AS4 Interlaminar Mode I Tension Specimen Tested at -20°F (Freezing Condition)

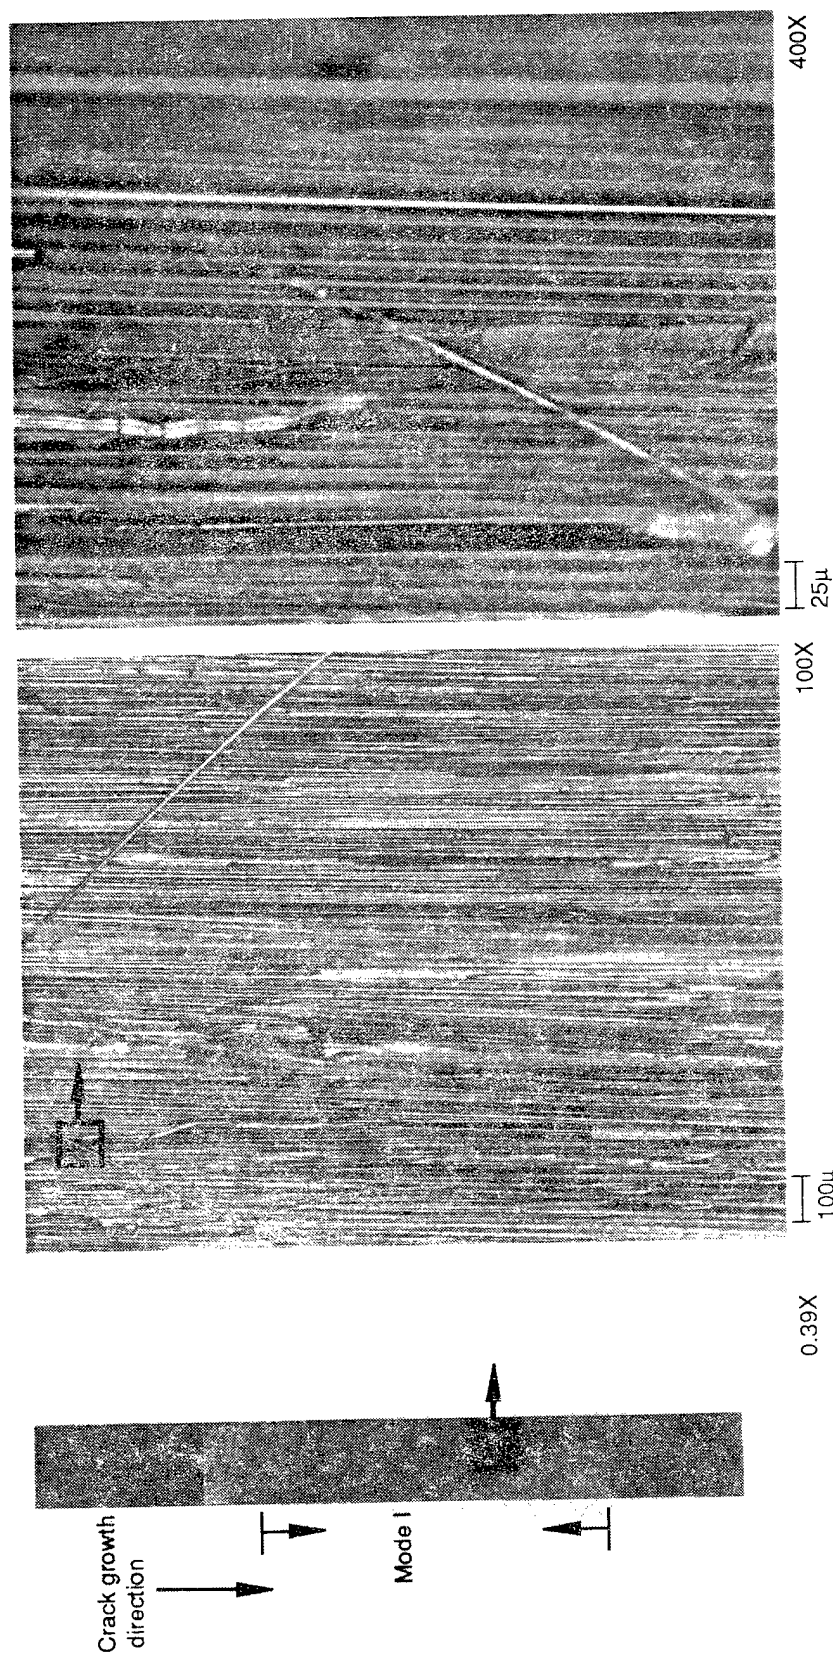
Figure 3.1-12. Optical Fractographs of 3501-6/AS4 Interlaminar Mode I Tension Specimen Tested at -20°F (Freezing Condition)

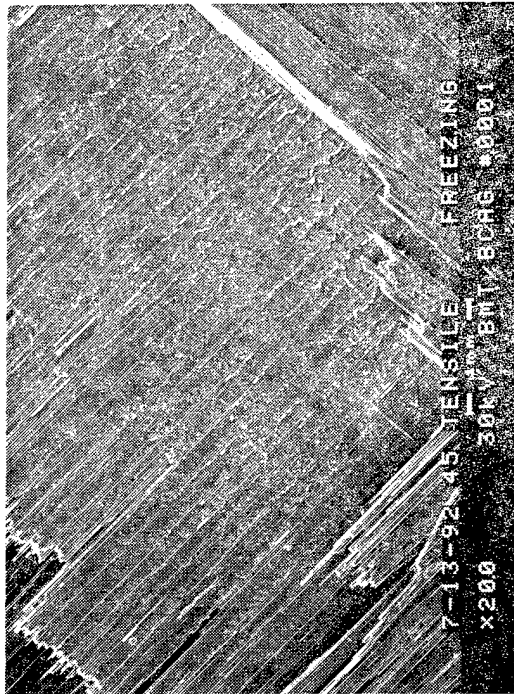
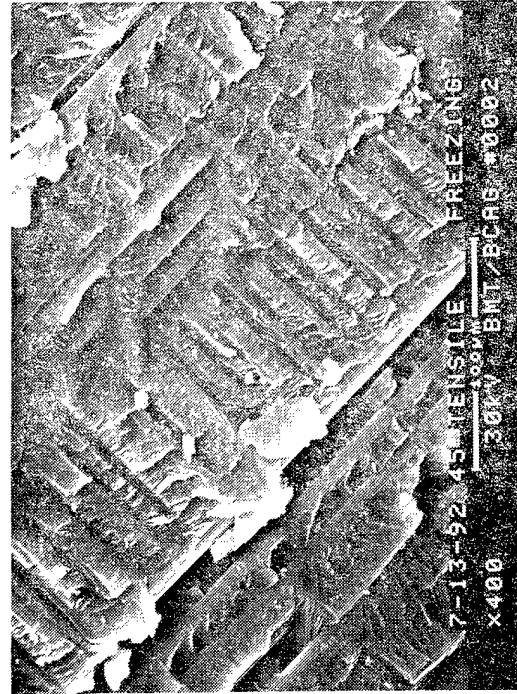
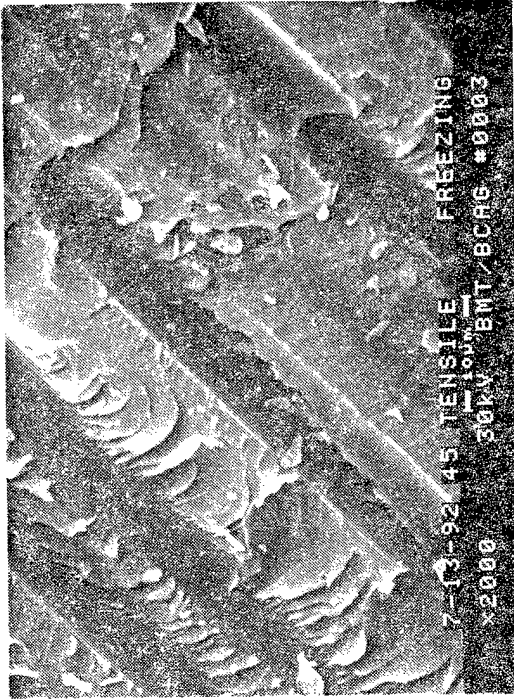
Figure 3.1-13. SEM Fractographs of a 3501-6/AS4 ± 45 Tensile Specimen Tested at -20° F, Interlaminar Surface

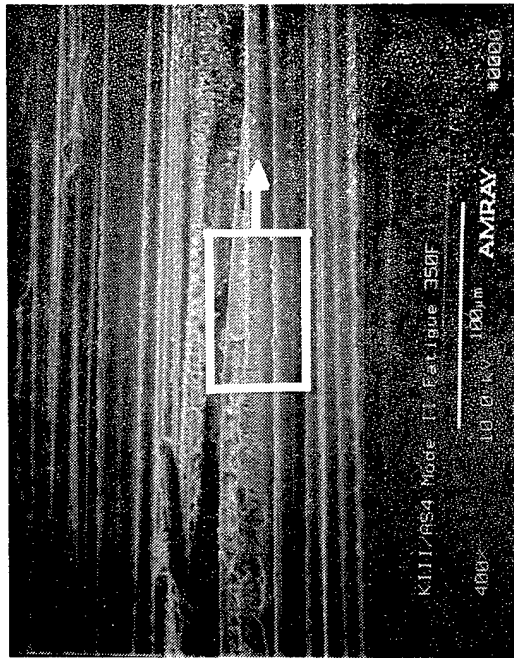
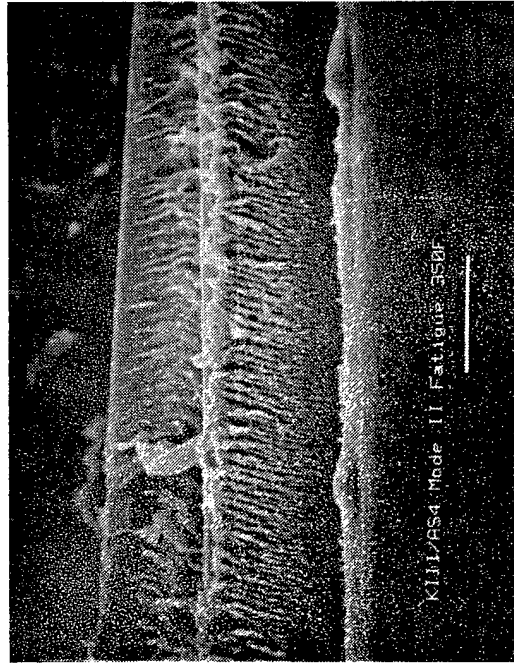
Figure 3.2-18. SEM Fractographs of a K111/RS4 Interlaminar Mode II (Shear) Fatigue Fracture Surface, 350° F

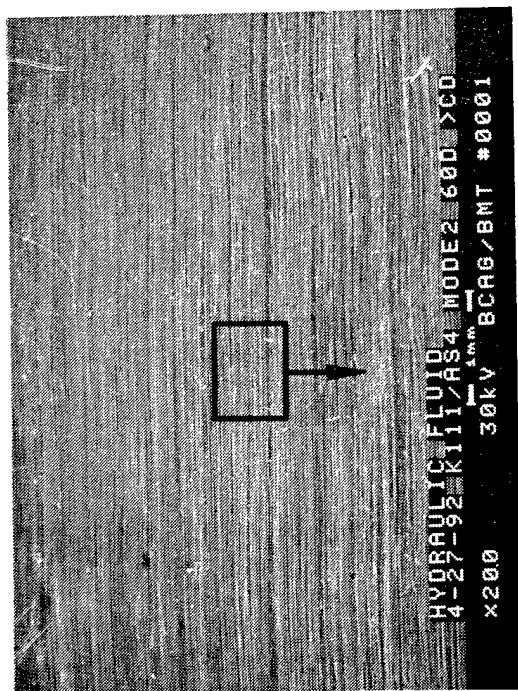
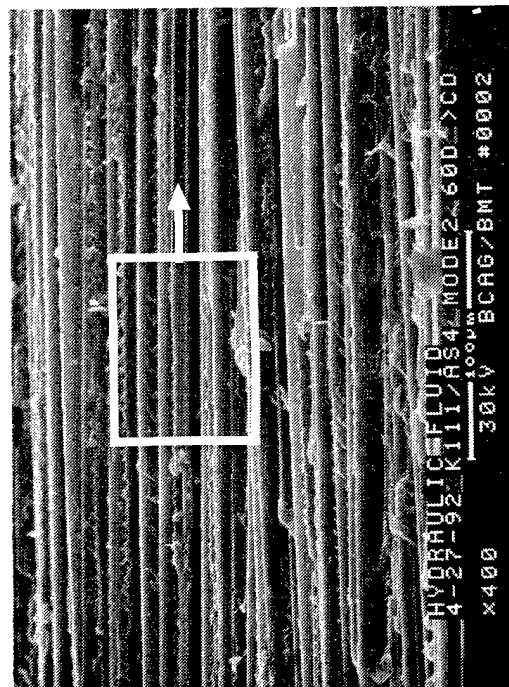
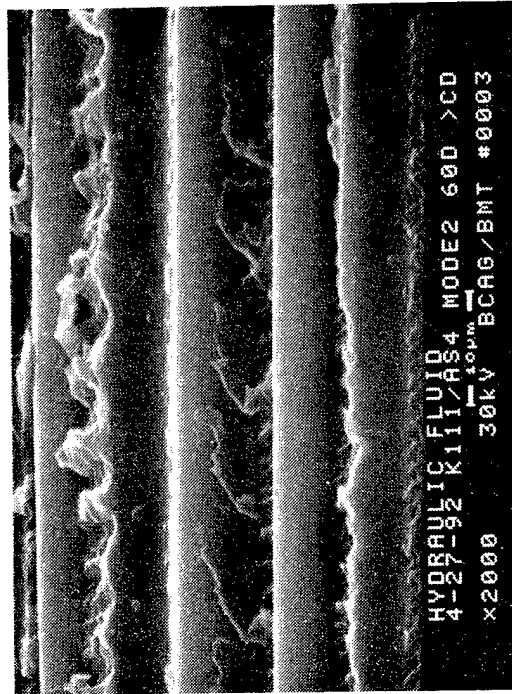
Figure 3.2-19. SEM Fractographs of a K111/AS4 Interlaminar Mode II Shear Fracture Surface Exposed to Hydraulic Fluid for 7 Days

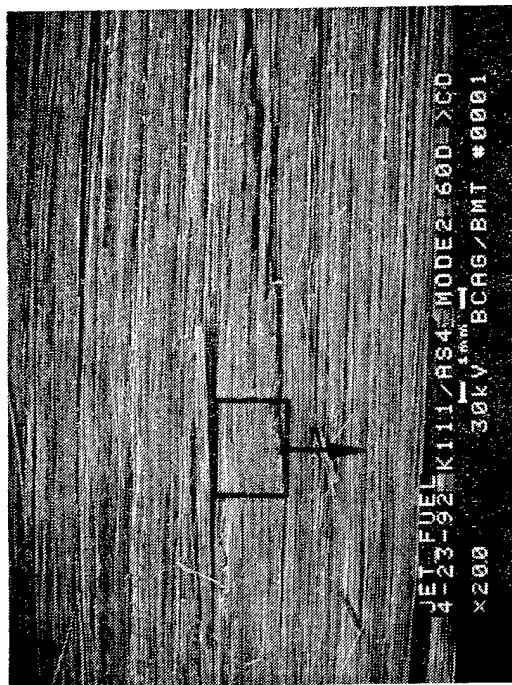
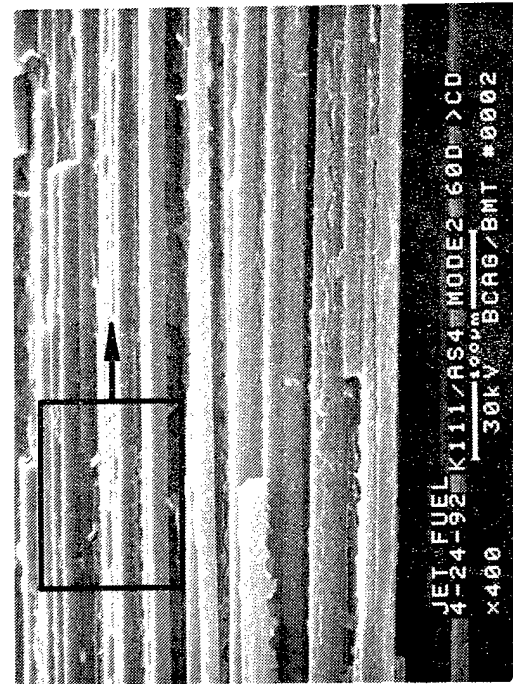
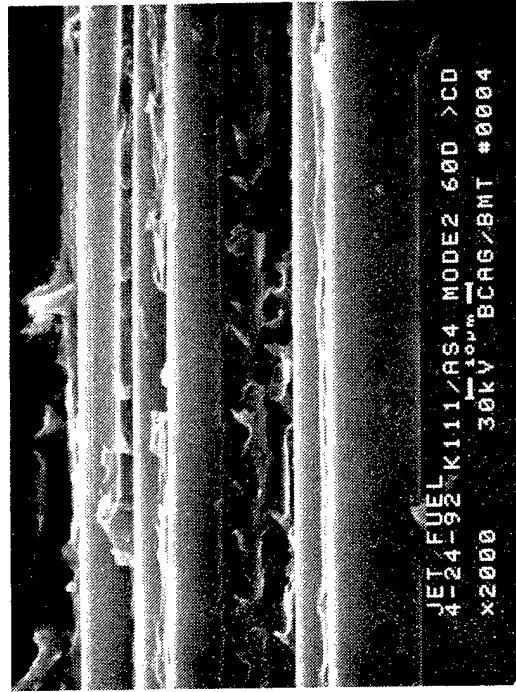
Figure 3.2-20. SEM Fractographs of a K111/AS4 Interlaminar Mode II Shear Fracture Surface Exposed to JP4 Jet Fuel for 7 Days

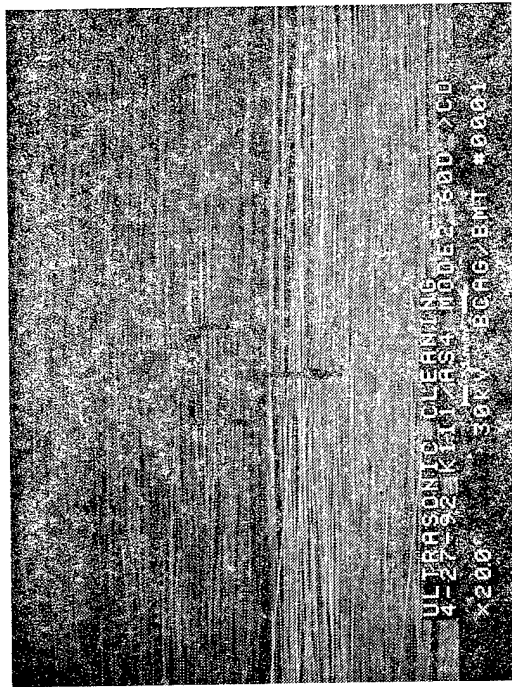
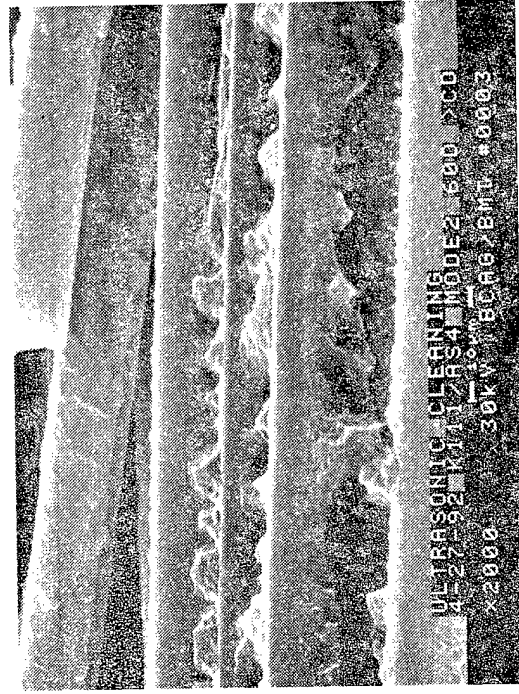
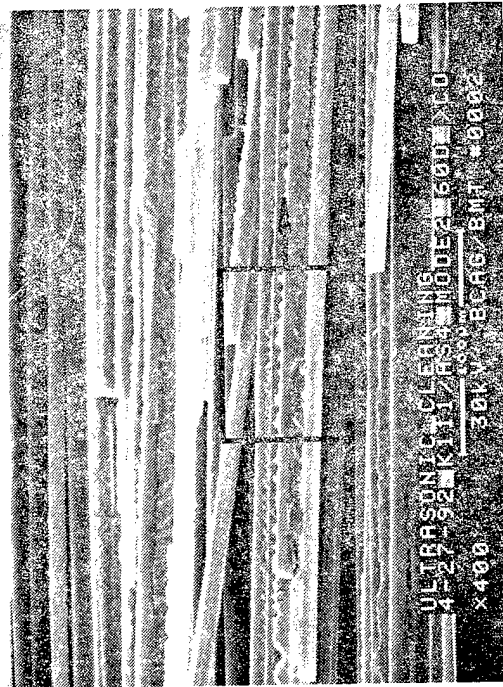
Figure 3.2-21. SEM Fractographs of a K1117/AS4 Interlaminar Mode II Shear Fracture Surface Exposed to Ultrasonic Agitation in Distilled Water for 24 Hours  
2405.01 9-5576 D1ai

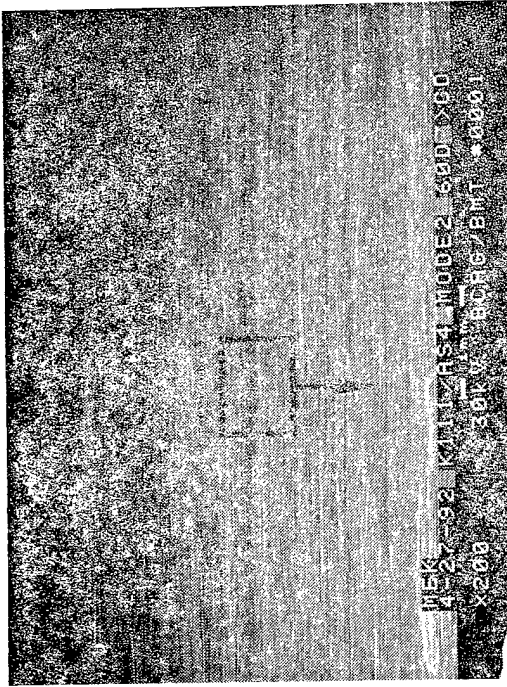
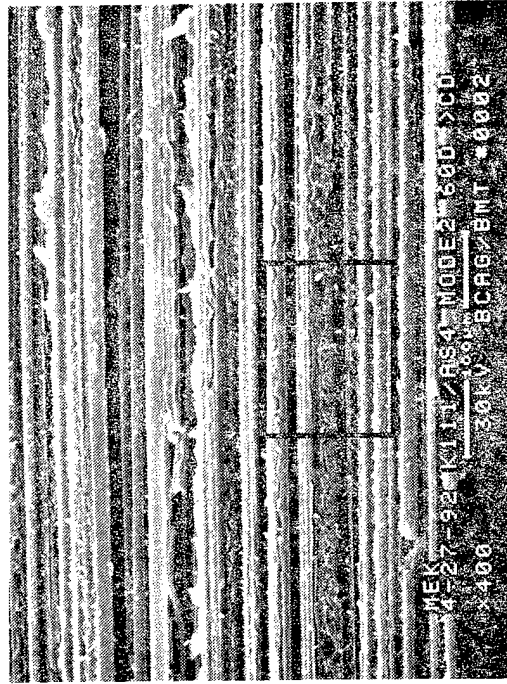
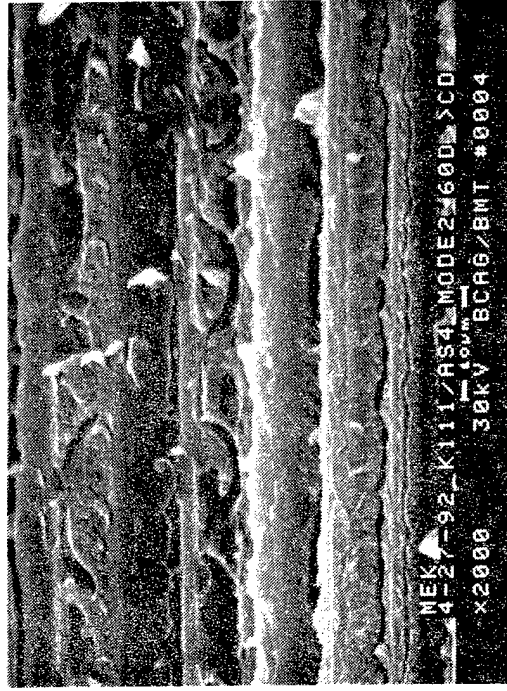
Figure 3.2-22. SEM Fractographs of a K111/AS4 Interlaminar Mode II Shear Fracture Surface Exposed to MEK for 24 Hours

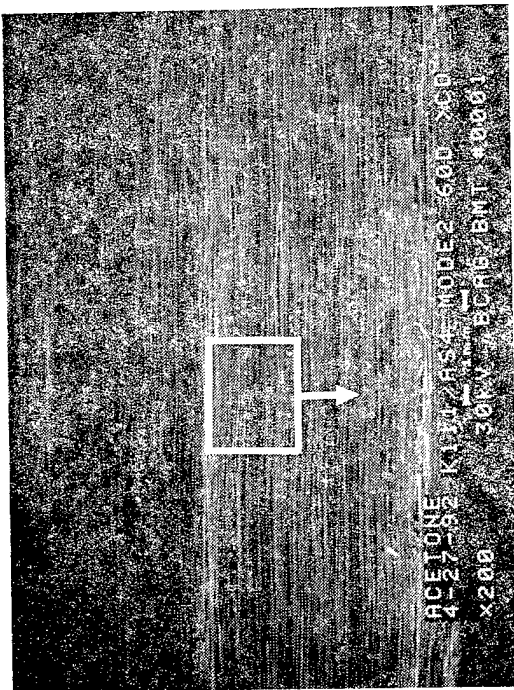
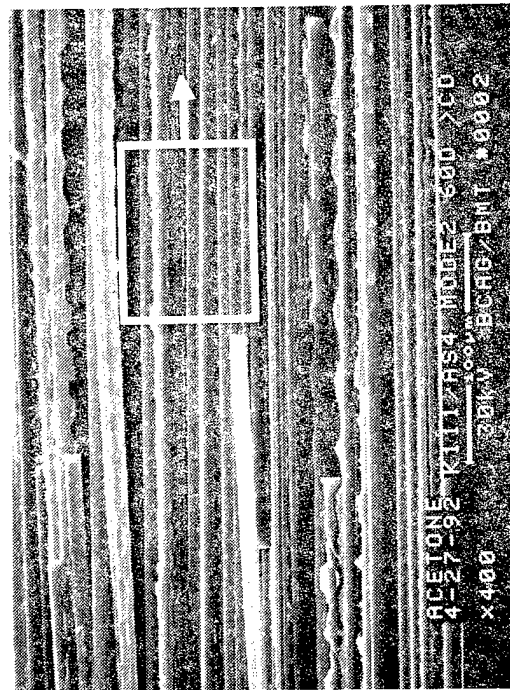
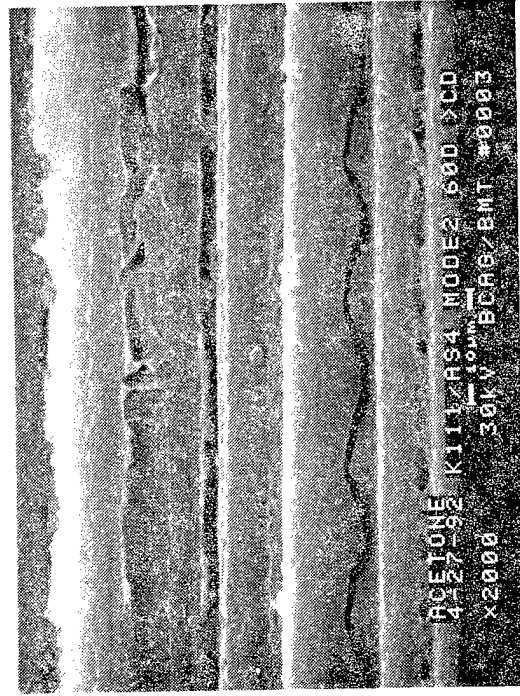
Figure 3.2-23. SEM Fractographs of a K111/AS4 Interlaminar Mode II Shear Fracture Surface Exposed to Acetone for 24 Hours

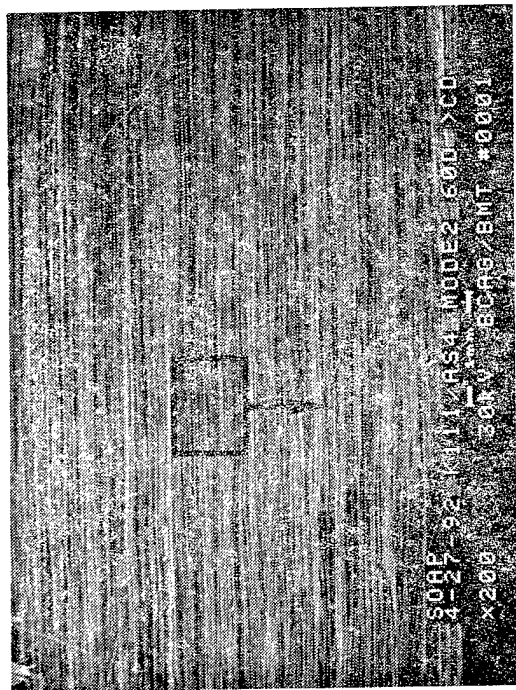
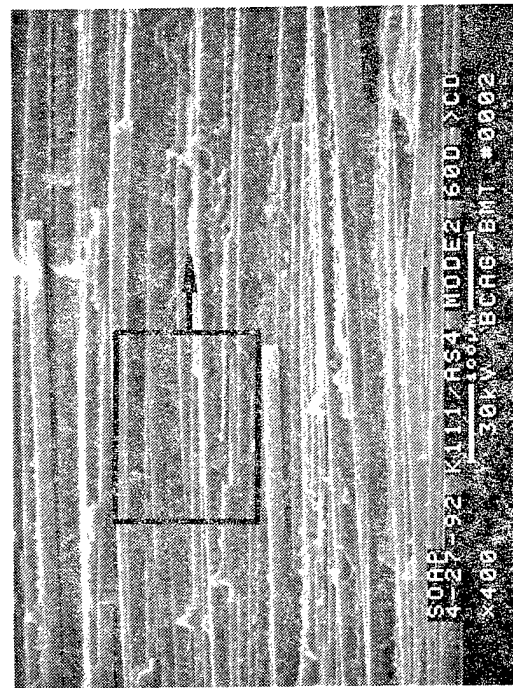
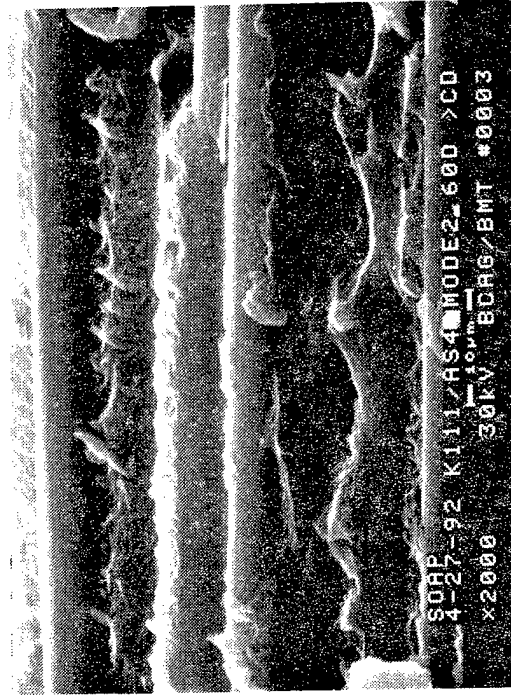
Figure 3.2-24. SEM Fractographs of a K111/AS4 Interlaminar Mode II Shear Fracture Surface Exposed to Soap Solution for 24 Hours
