DOT/FAA/AR-96/21

# Composite Failure Analysis Handbook Update 1

WL-TR-93-4004

August 1997

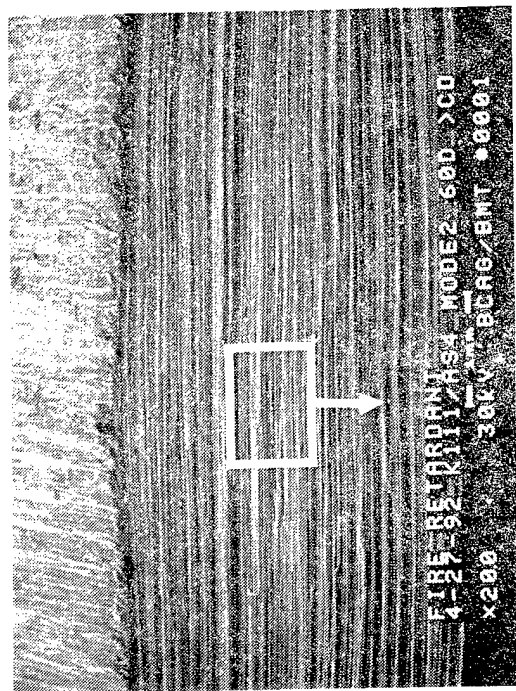
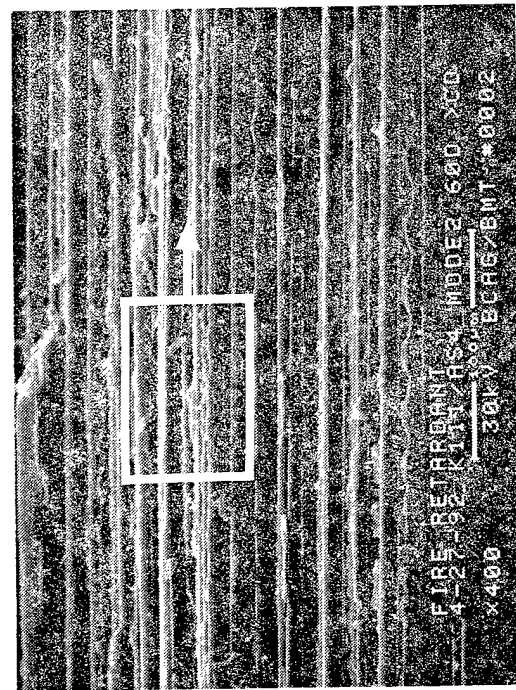
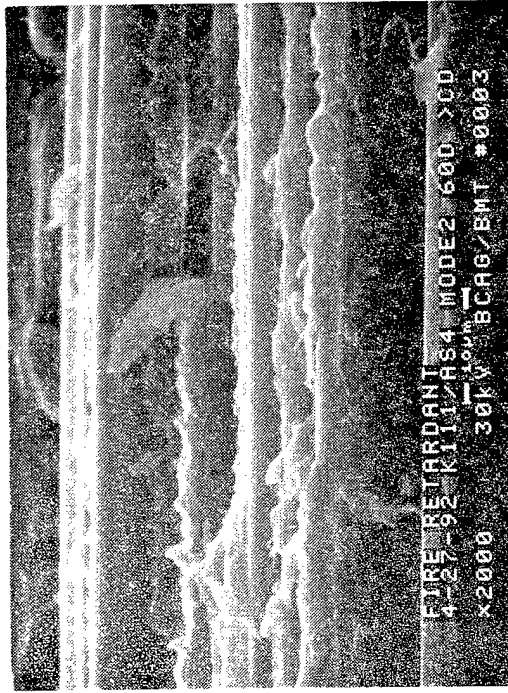
Figure 3.2-25. SEM Fractographs of a K111/ASA4 Interlaminar Mode II Shear Fracture Surface Exposed to Fire Retardant Foam for 7 Days

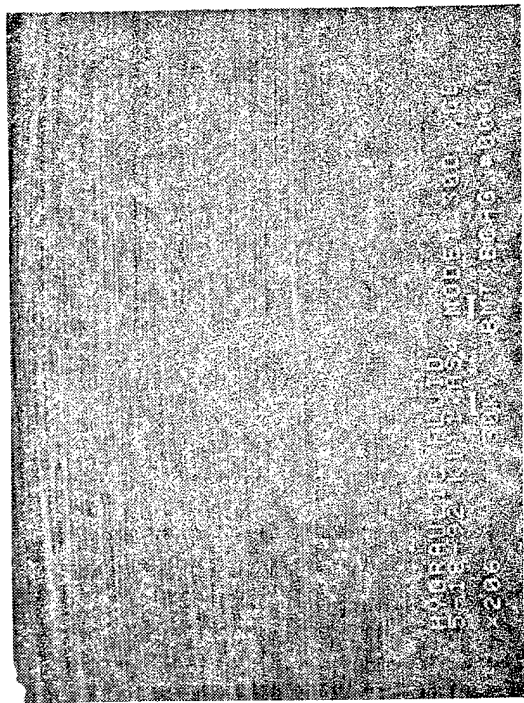
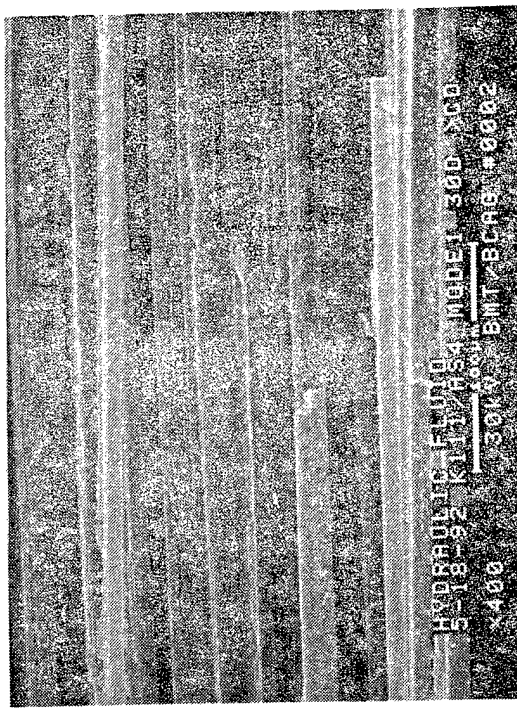
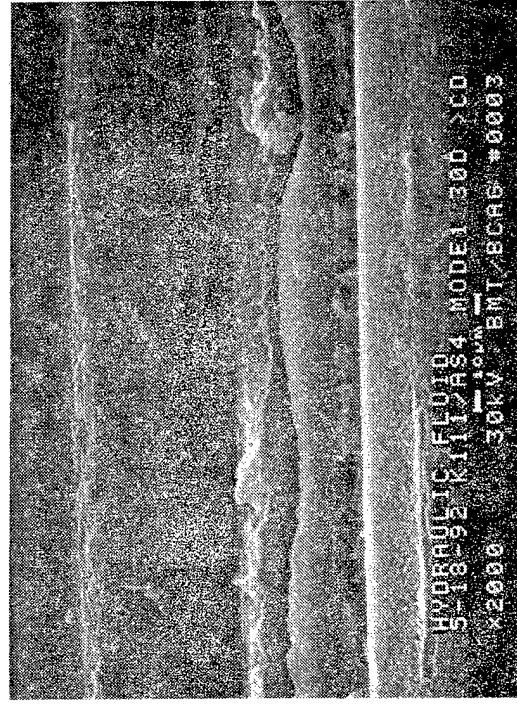
None of the exposure conditions appeared to have degraded the fracture features (Figure 3.2-26 through Figure 3.2-32).

Figure 3.2-26. SEM Fractographs of a Kill/AS4 Interlaminar Mode I Tension Fracture Surface Exposed to Hydraulic Fluid for 7 Days

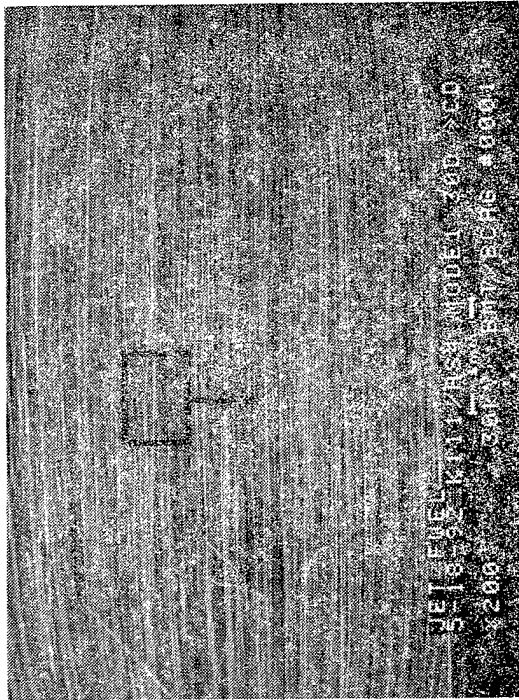
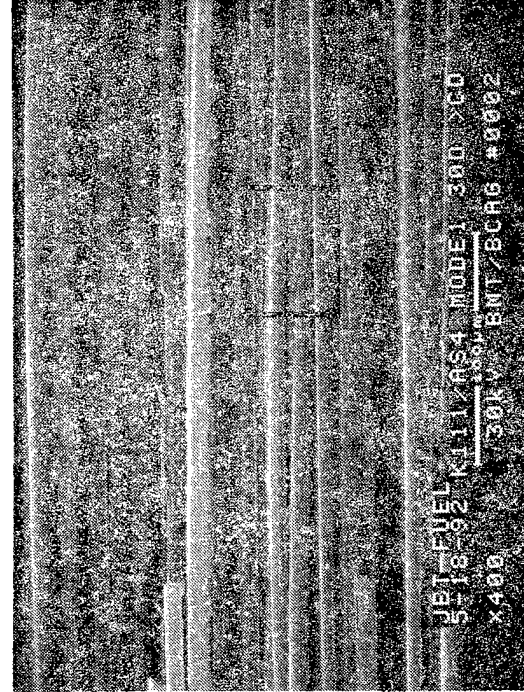
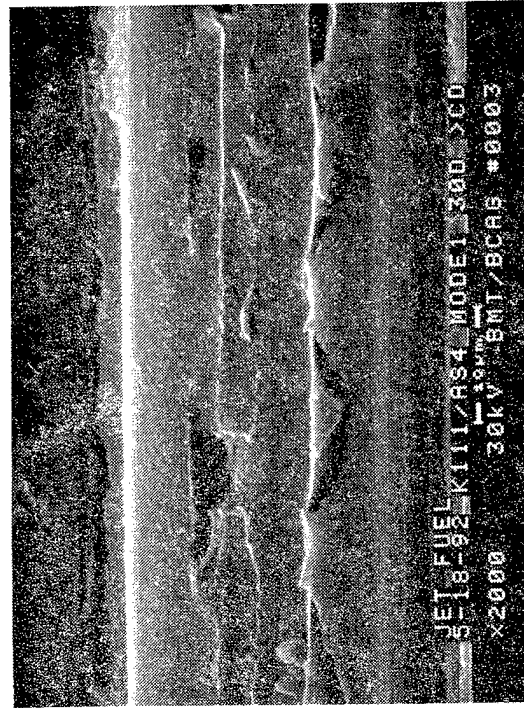
Figure 3.2-27. SEM Fractographs of a K111AS4 Interlaminar Mode I Tension Fracture Surface Exposed to JP4 Jet Fuel for 7 Days

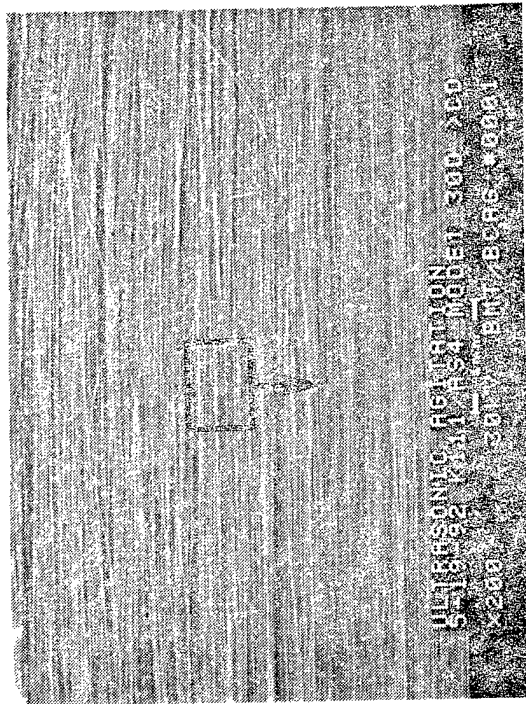
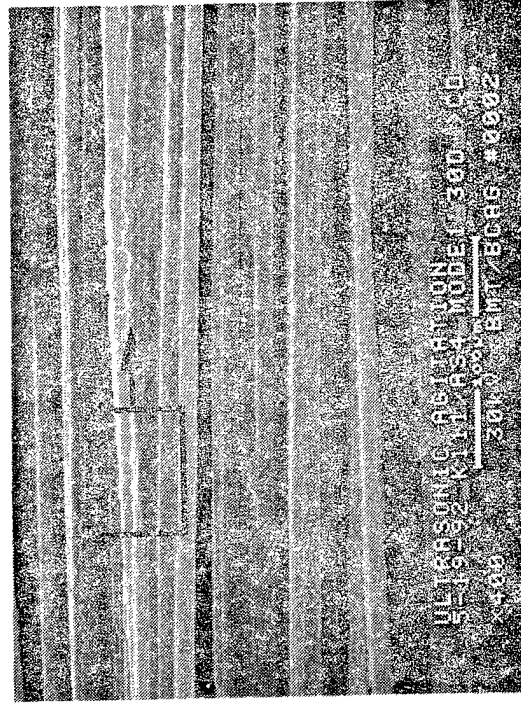
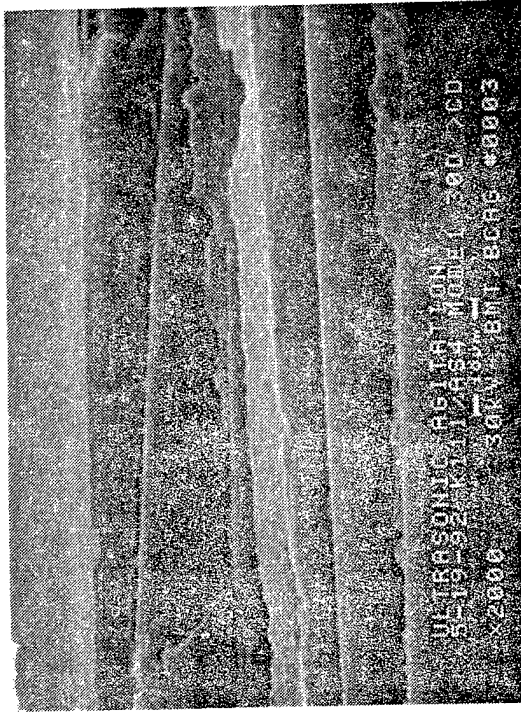
**Figure 3.2-28. SEM Fractographs of a KIII /AS4 Interlaminar Mode I Tension Fracture Surface Exposed to Ultrasonic Agitation in Distilled Water for 24 hours**

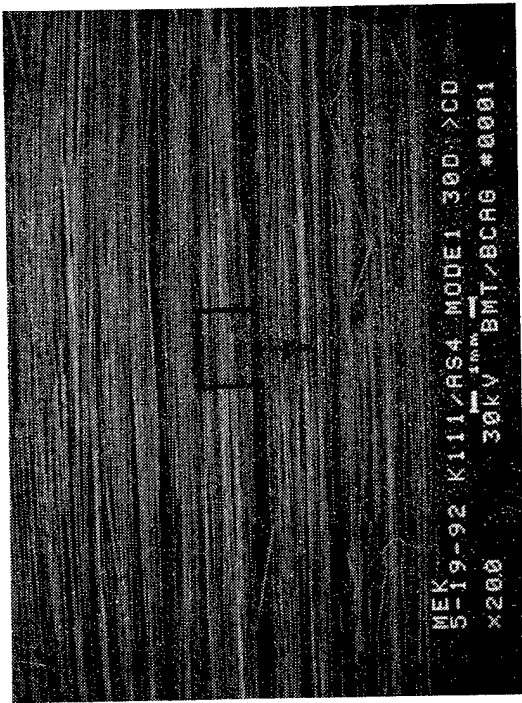
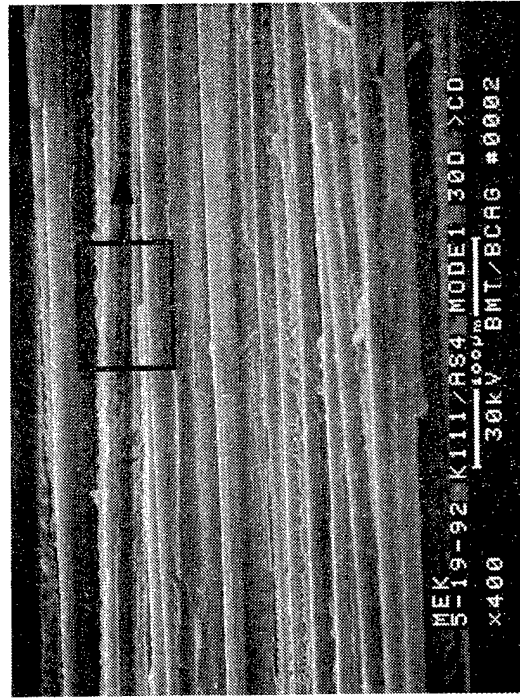
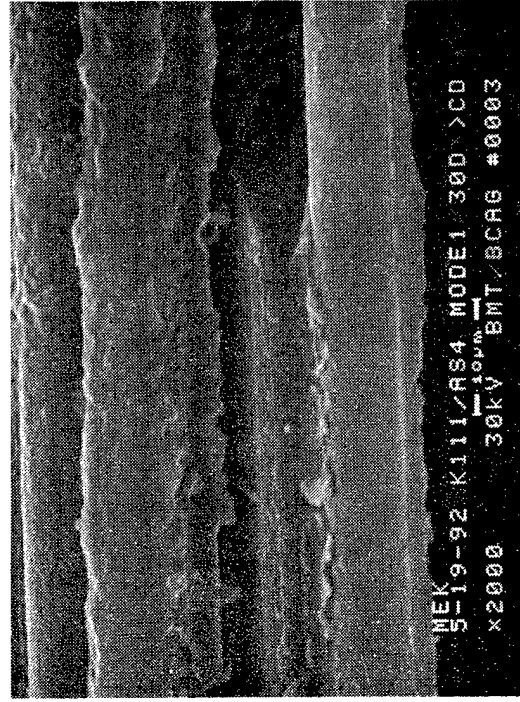
Figure 3.2-29. SEM Fractographs of a K111/AS4 Interlaminar Mode I Tension Fracture Surface Exposed to MEK for 24 Hours

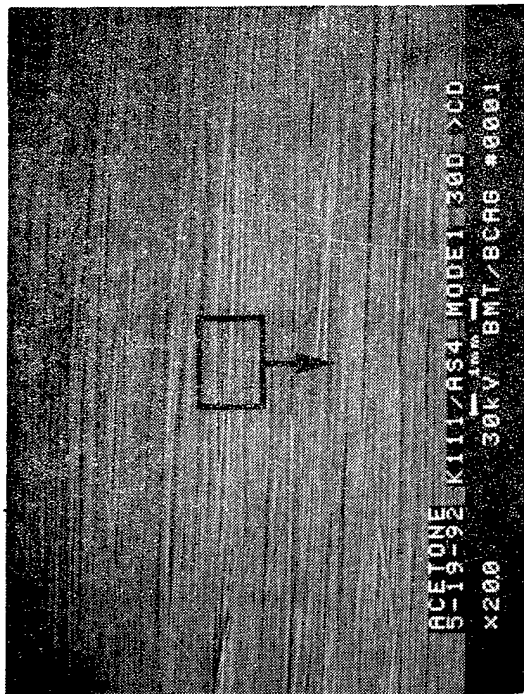
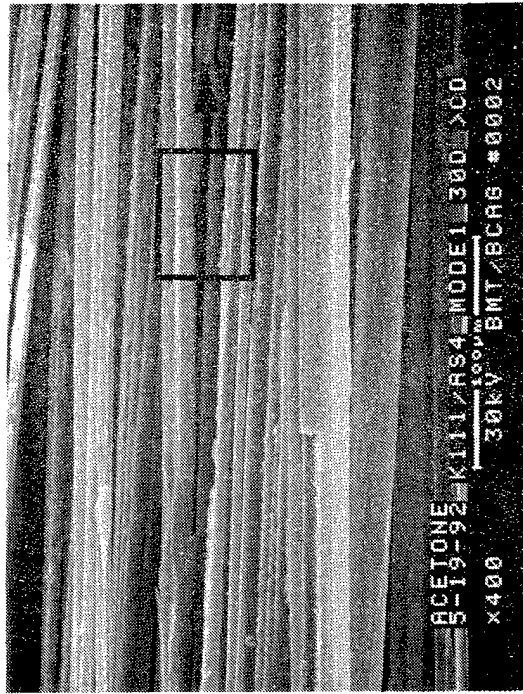
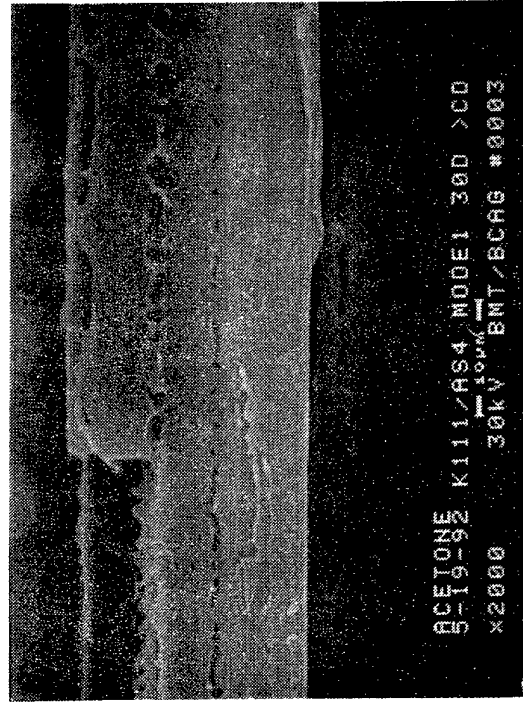
Figure 3.2-30. SEM Fractographs of a K111/AS4 Interlaminar Mode I Tension Fracture Surface Exposed to Acetone for 24 hours

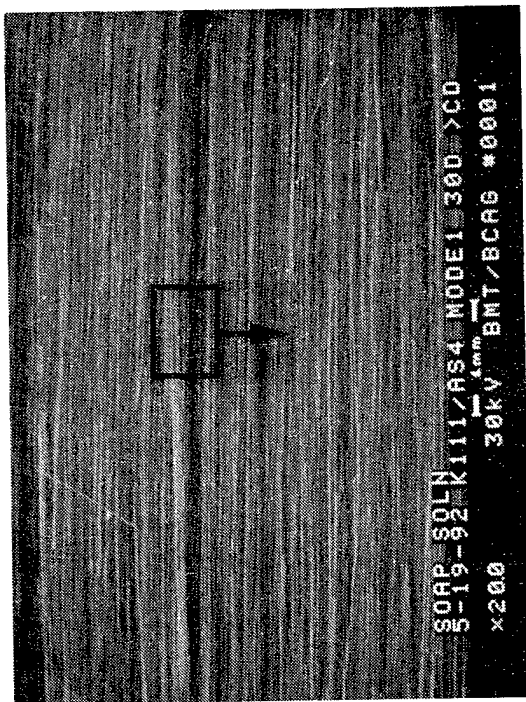
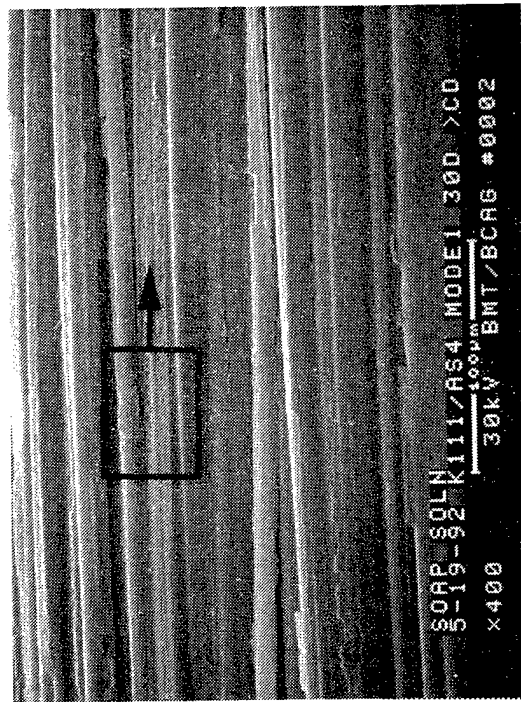
Figure 3.2-31. SEM Fractographs of a K111/AS4 Interlaminar Mode I Tension Fracture Surface Exposed to Soap Solution for 24 hours

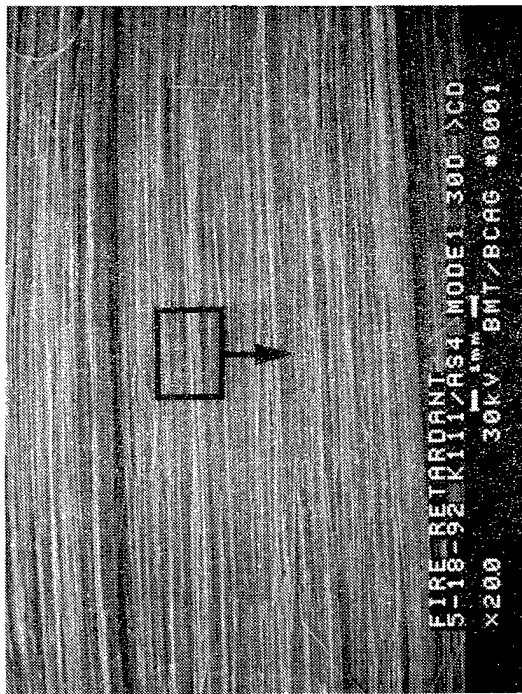
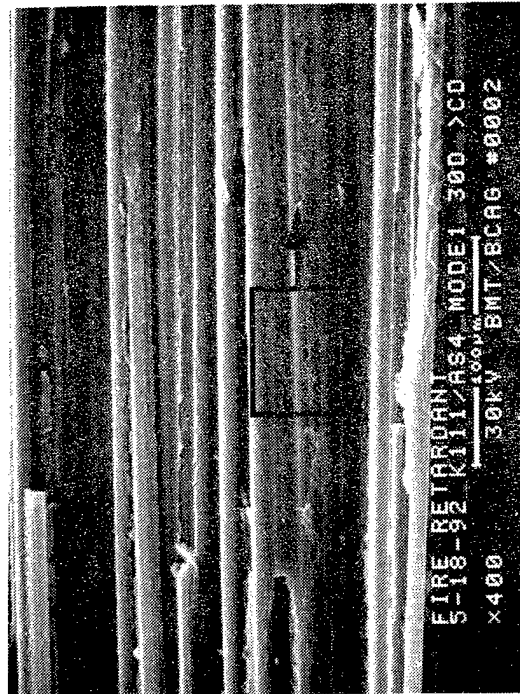
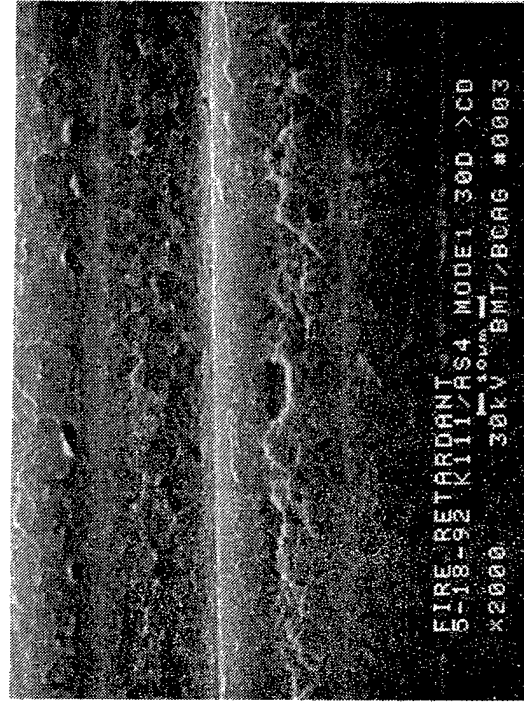
Figure 3.2-32. SEM Fractographs of a KIII/AS4 Interlaminar Mode I Tension Fracture Surface Exposed to Fire Retardant Foam for 7 Days

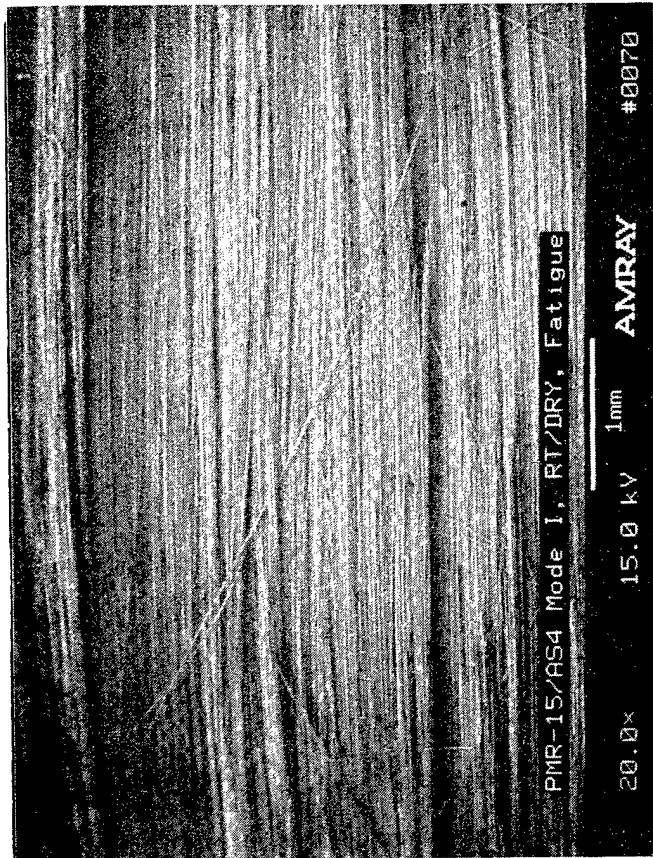
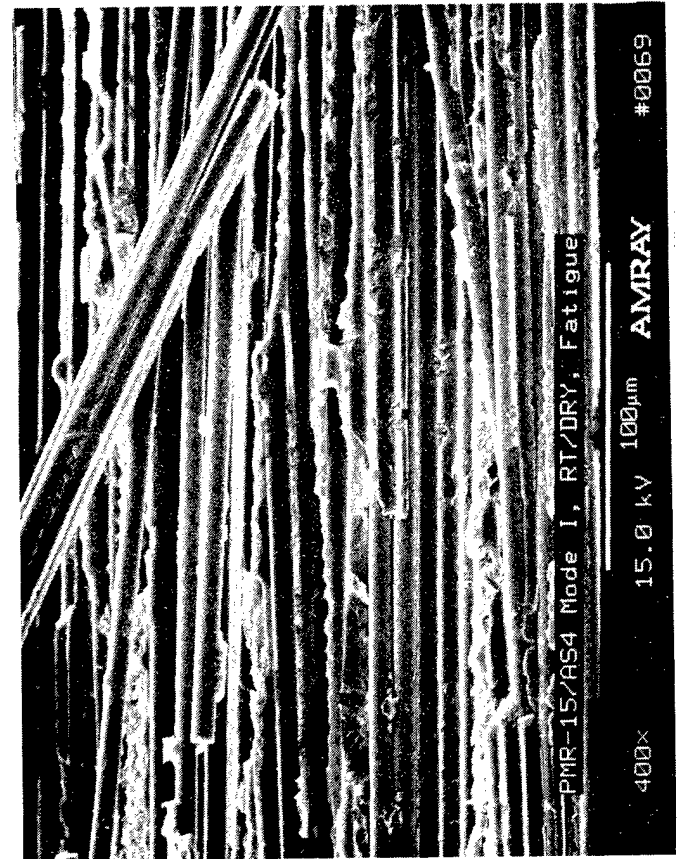
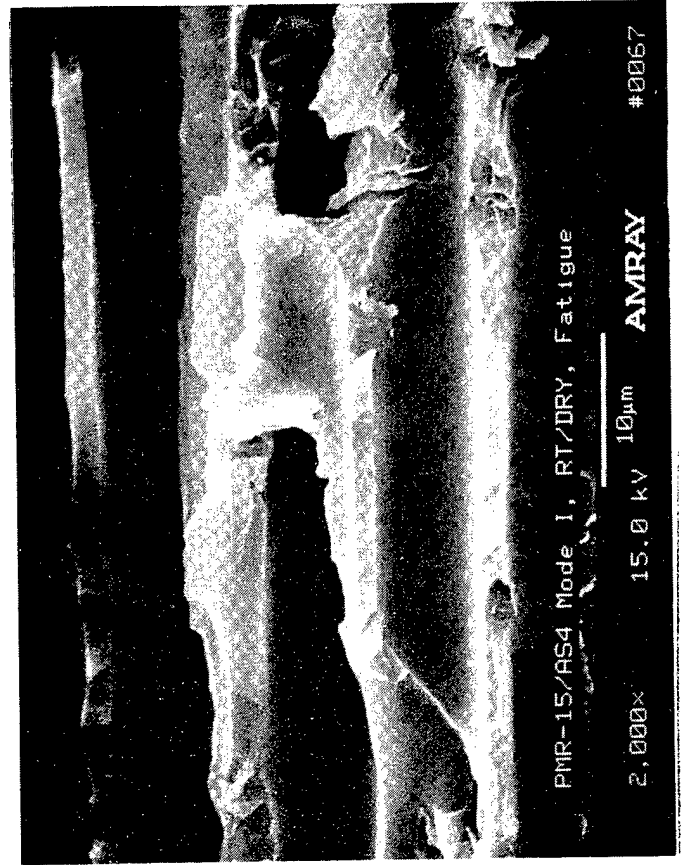
The overall surface morphology exhibited similar features as the fracture surface of a statically loaded specimen (Figure 3.3-1). Rivermarks and hackles were observed including fatigue striations. However, the striation features, which were usually located in fiber pull out troughs, were very difficult to identify even at very high magnifications (Figure 3.3-2a). These striations were also observed in resin rich regions, which resembled typical "beach marks" in fatigued metals (Figure 3.3-2b).

Figure 3.3-1. SEM Fractographs of a PMR-15/AS4 Interlaminar Mode I Tension Fatigue Fracture Surface, RT/Dry

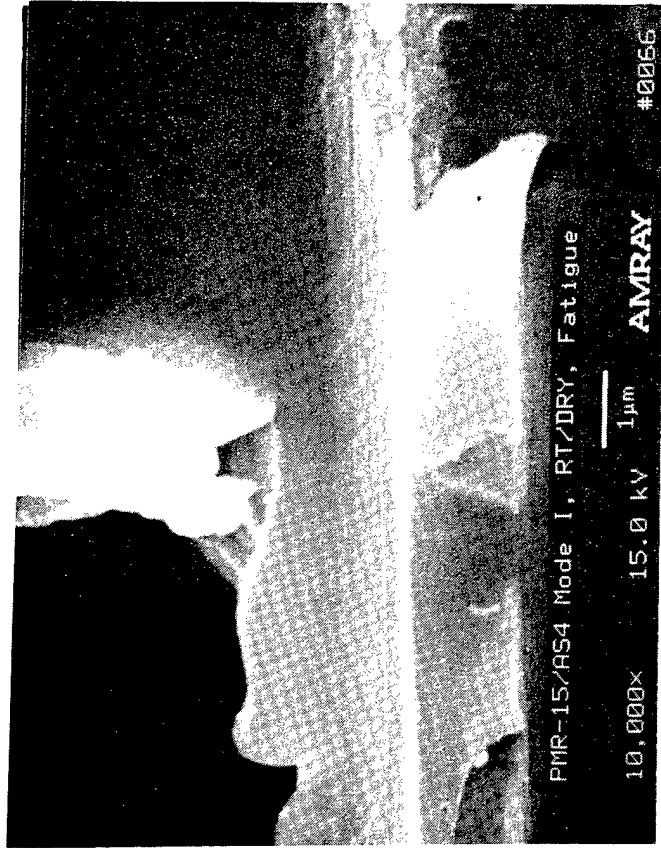
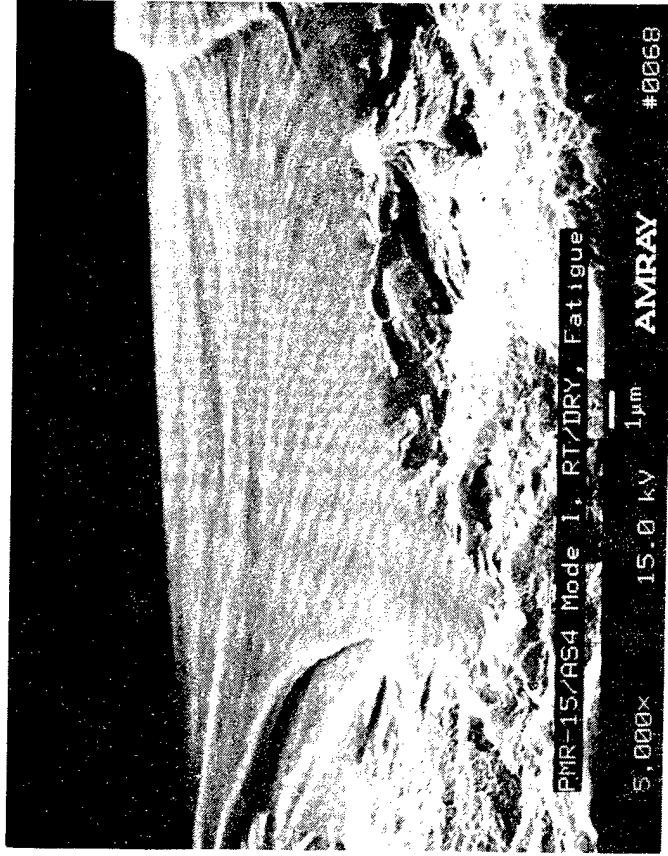
Figure 3.3-2. High-Magnification SEM Fractographs of a PMR-15/AS4 Interlaminar Mode I Tension Fatigue Fracture Surface, RT/Dry

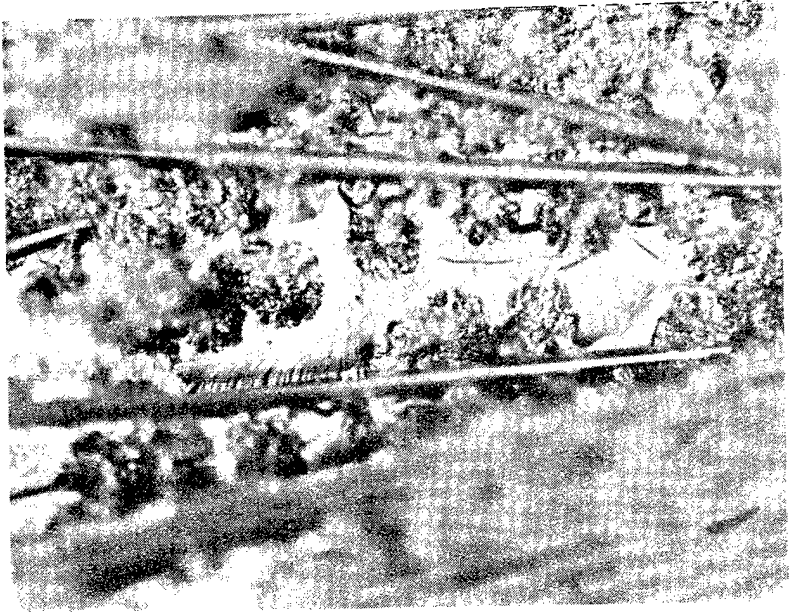
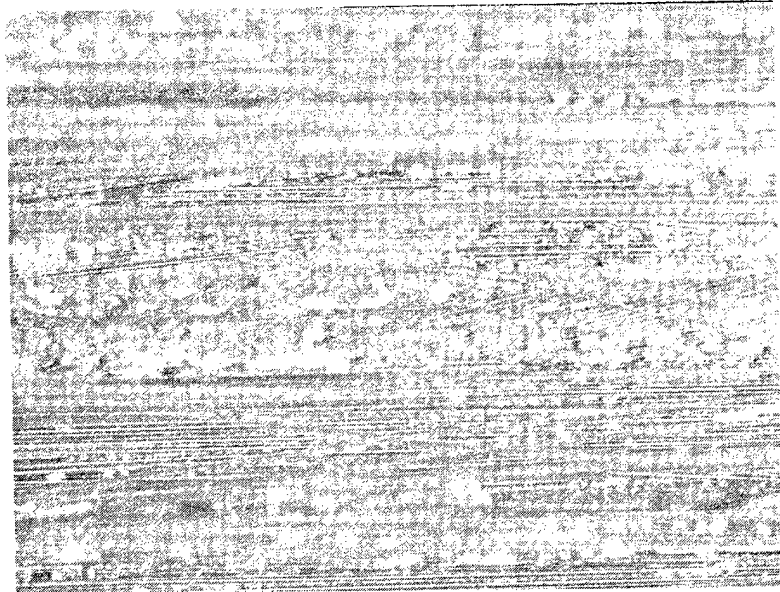
However the 350°F specimen fracture surface did not exhibit the typical mode I (tension) features. The fracture features were not distinct enough to determine the overall crack propagation direction

Figure 3.3-3. Optical Fractographs of a PMR-15/AS4 Interlaminar Mode I (Tensile) Fatigue Fracture Surface, 350° F

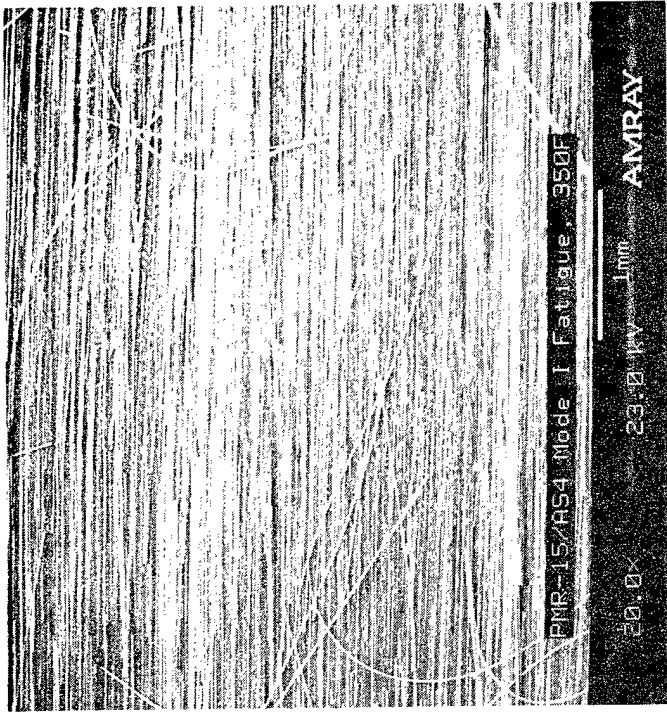
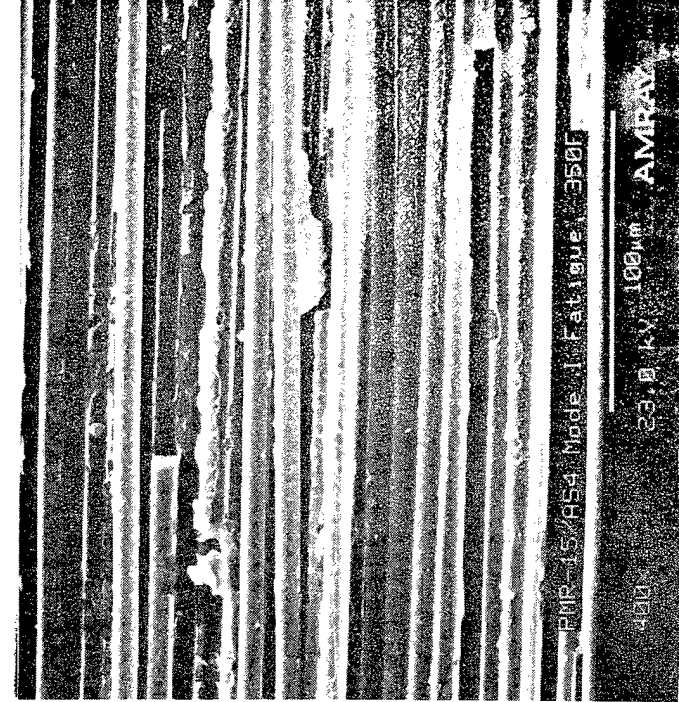
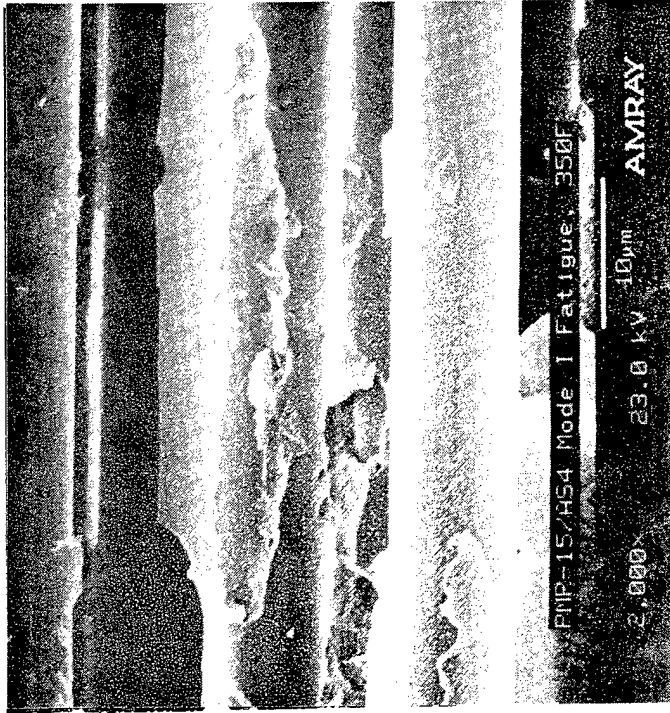
Figure 3.3-4. SEM Fractographs of a PMR-15/AS4 Interlaminar Mode I (Tensile) Fatigue Fracture Surface, 350° F

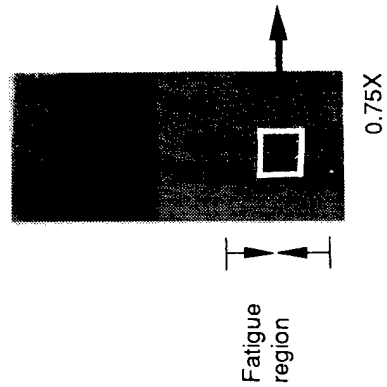
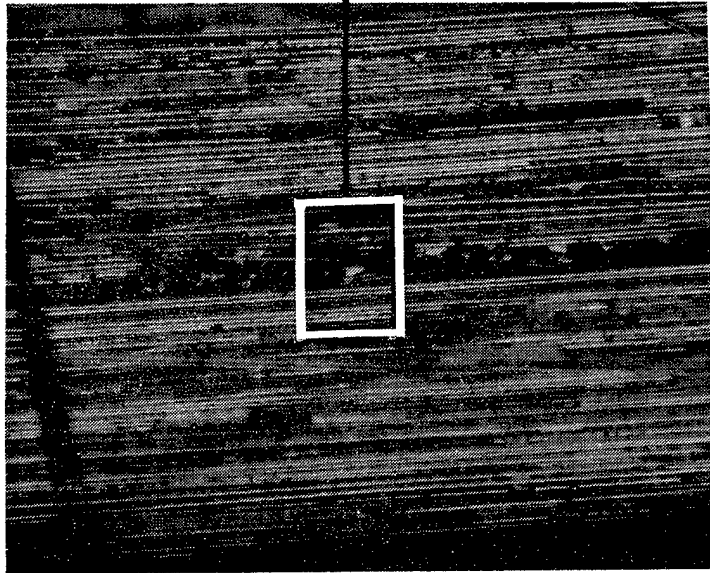
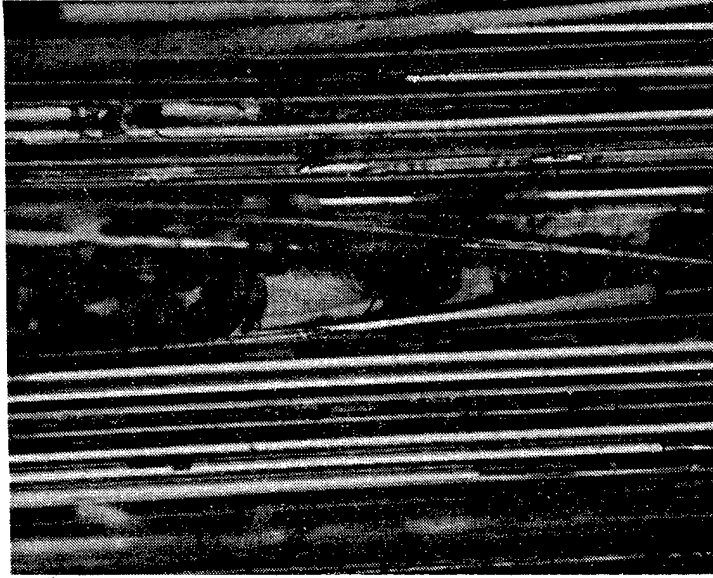
Figure 3.3-5. Optical Fractographs of PMR-15/AS4 Interlaminar Mode II (Shear) Fatigue, Room Temperature, High Stress

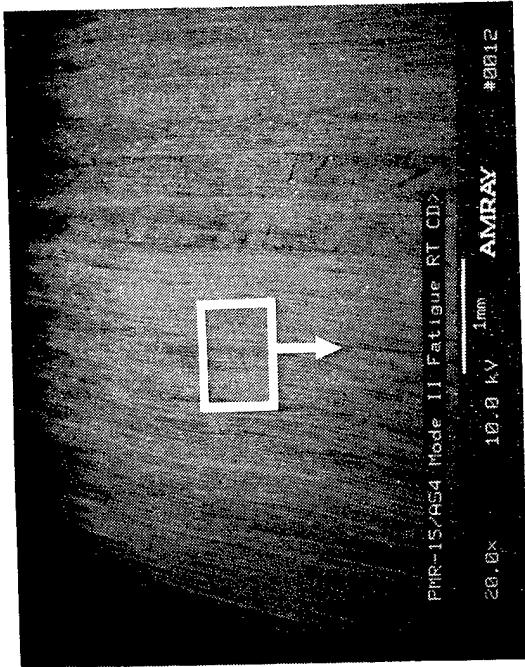
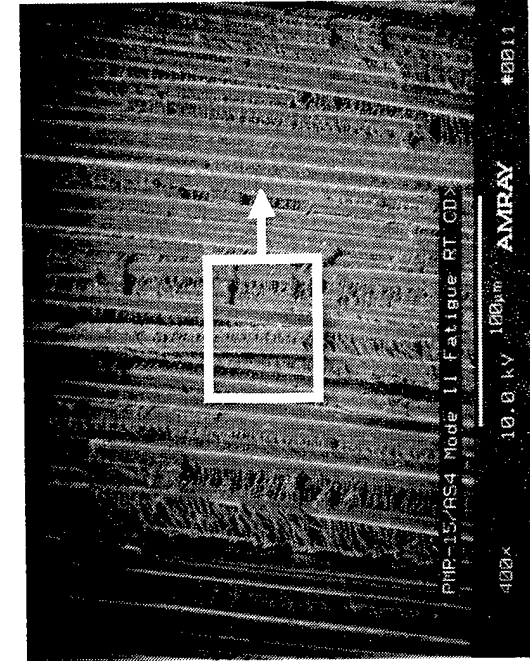
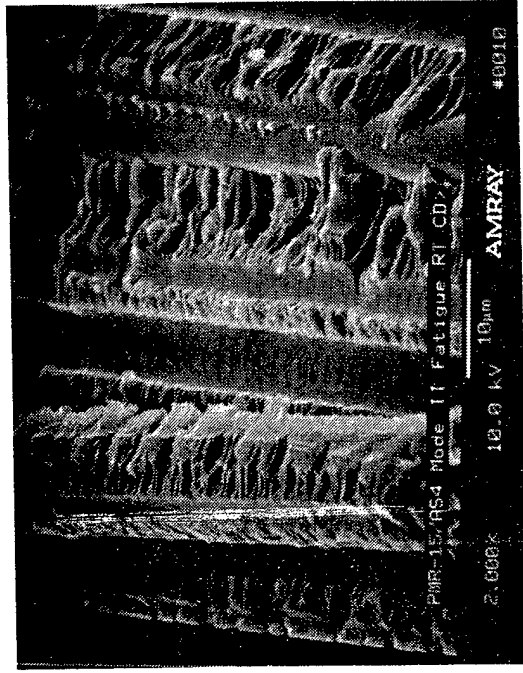
Figure 3.3-6. SEM Fractographs of a PMR-15/AS4 Interlaminar Mode II (Shear) Fatigue Fracture Surface, Room Temperature

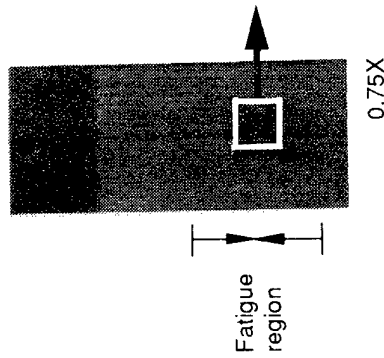
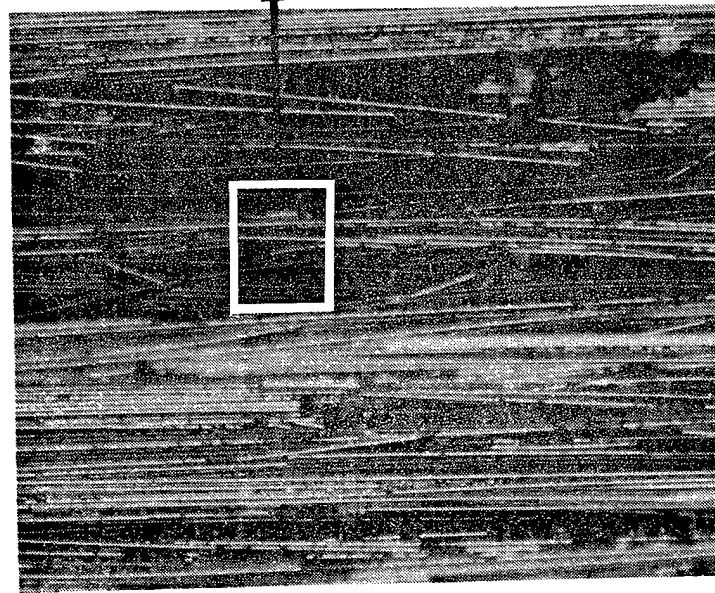
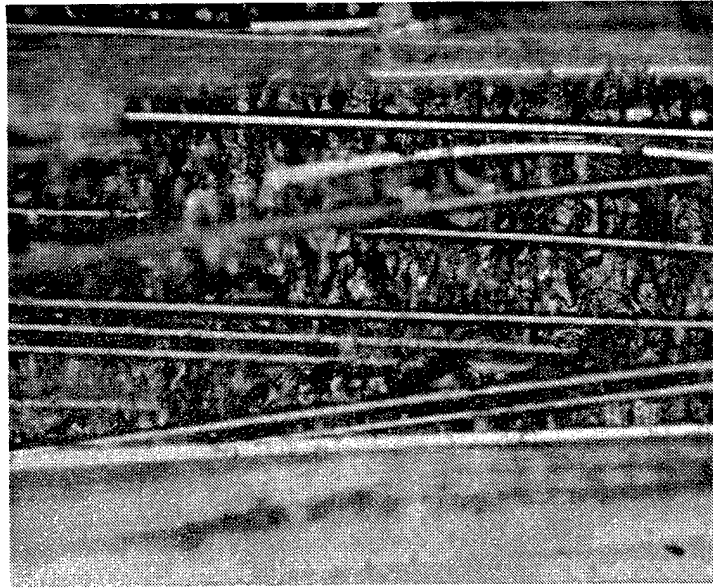
Figure 3.3-7. Optical Fractographs of PMR-15/AS4 Interlaminar Mode II (Shear) Fatigue, 350° F, High Stress

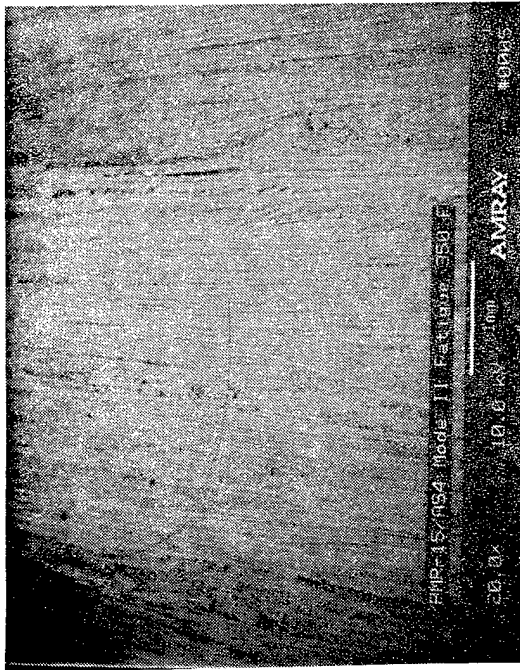
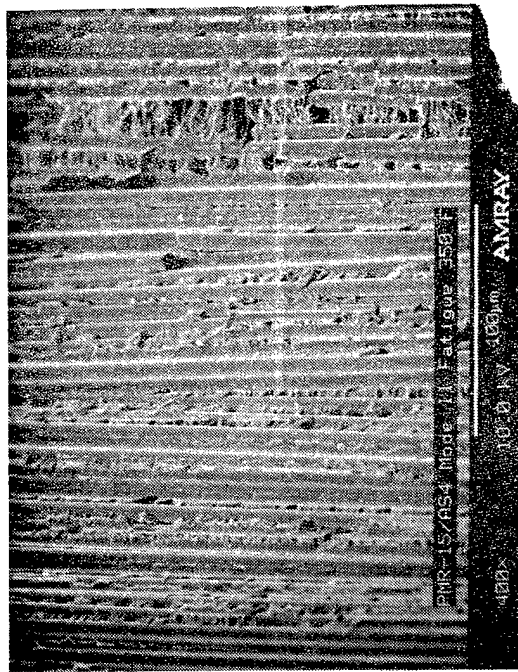
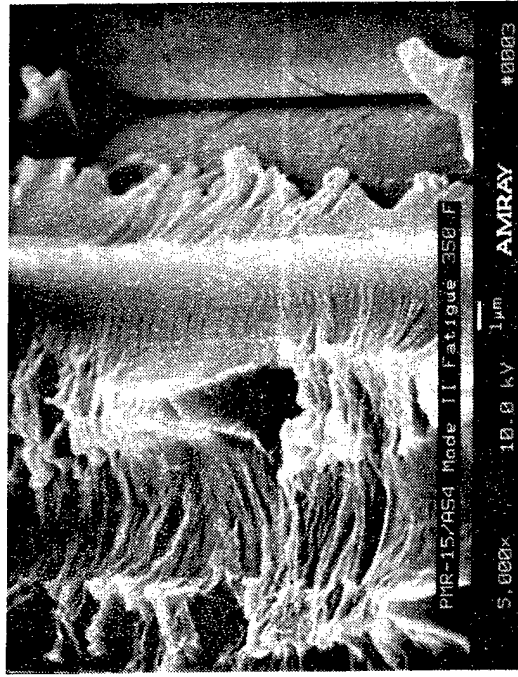
Figure 3.3-8. SEM Fractographs of a PMR-15/AS4 Interlaminar Mode II (Shear) Fatigue Fracture Surface, 350°F

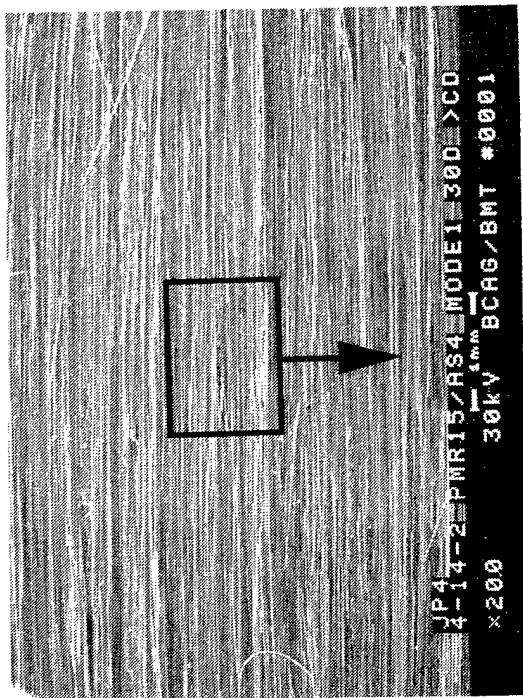
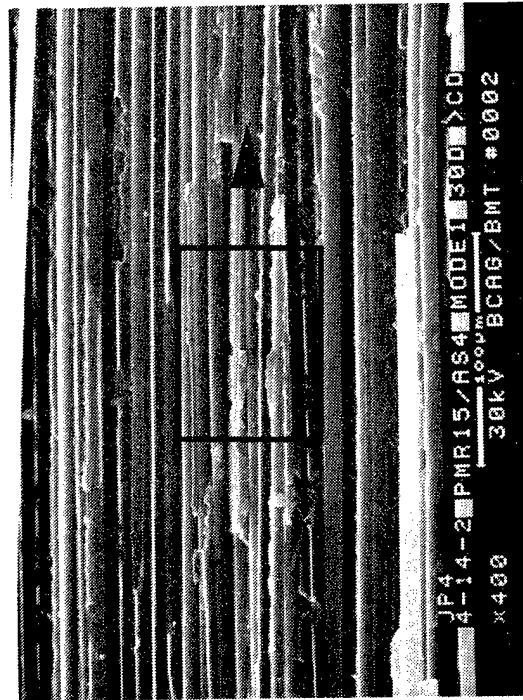
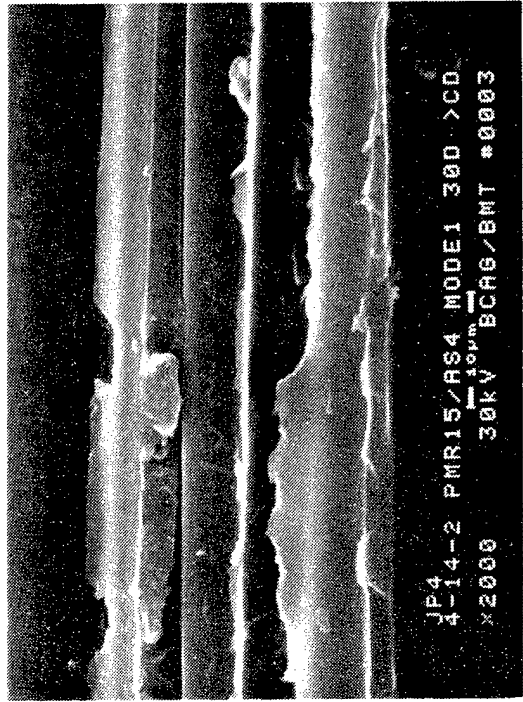
The effects of the exposure did not affect the fracture morphology to any noticeable degree. All of the characteristic mode I surface features were easily identified (Figure 3.3-9 through 3.3-15).

Figure 3.3-9. SEM Fractographs of a PMR-15/AS4 Interlaminar Mode I Tension Fracture Surface Exposed to JP4 Jet Fuel for 7 Days

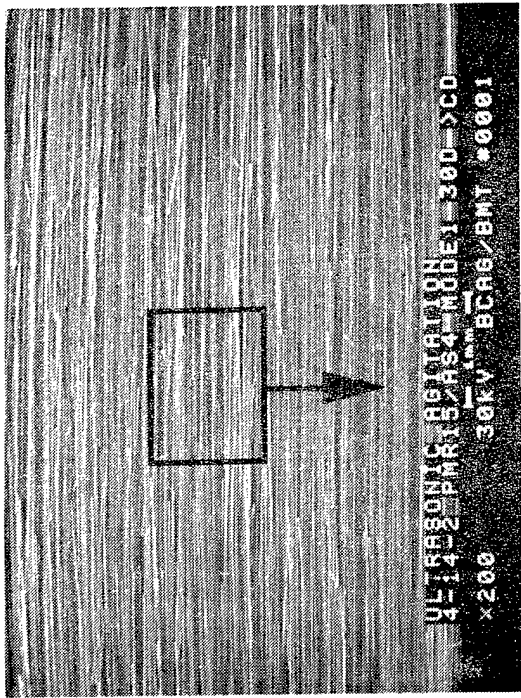
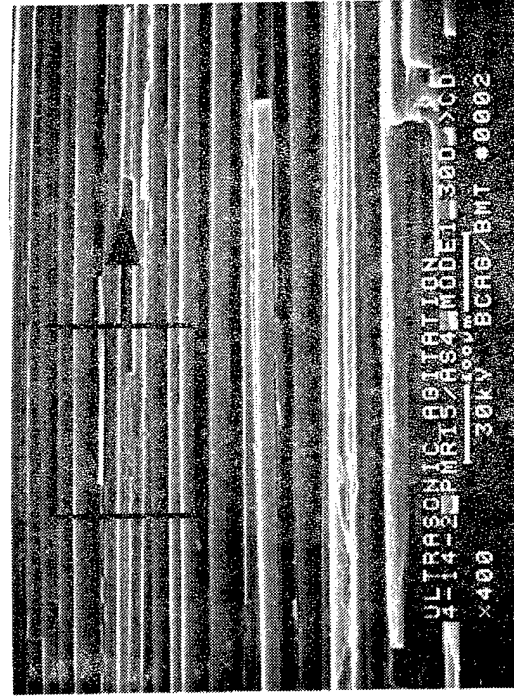
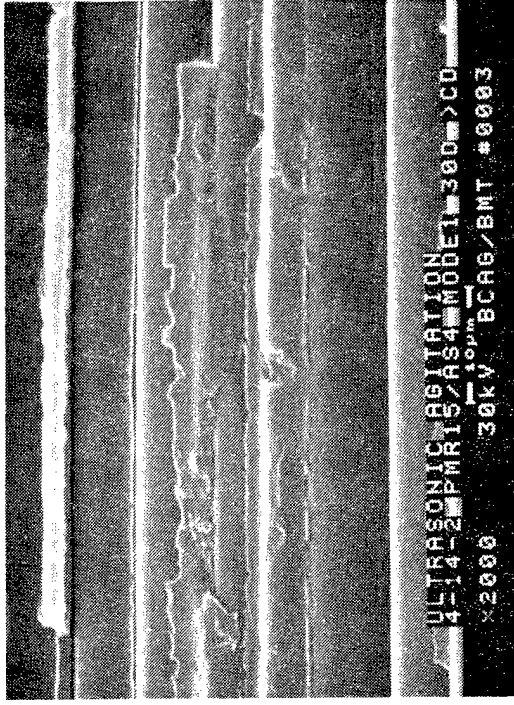
Figure 3.3-10. SEM Fractographs of a PMR-15/AS4 Interlaminar Mode I Tension Fracture Surface Exposed to Ultrasonic Agitation in Distilled Water for 24 hours

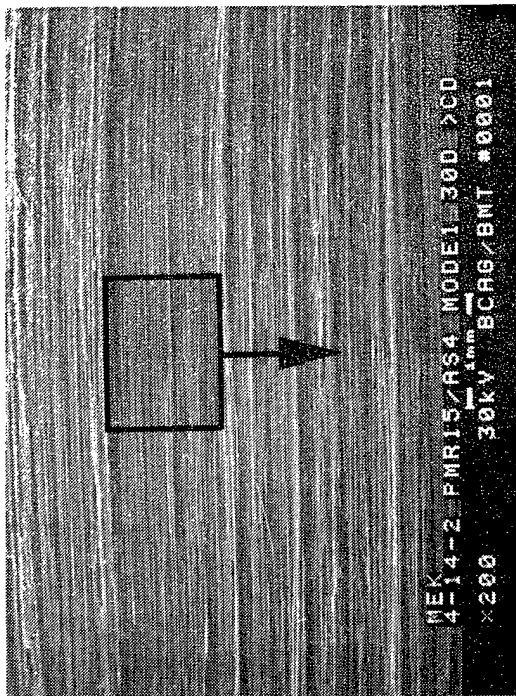
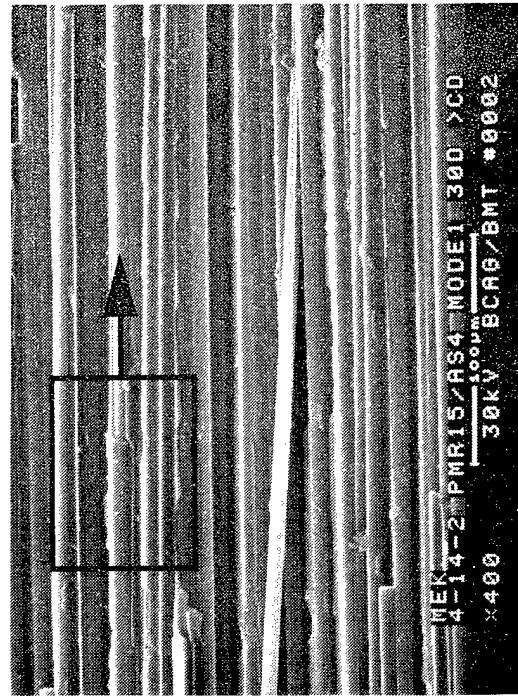
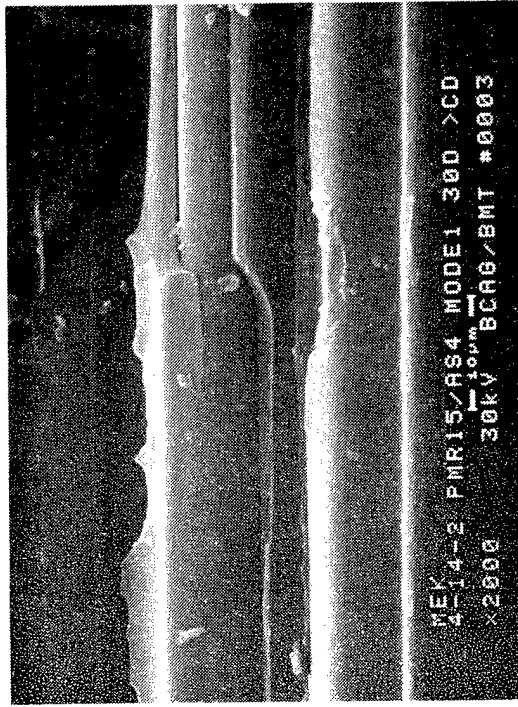
Figure 3.3-11. SEM Fractographs of a PMR-15/AS4 Interlaminar Mode I Tension Fracture Surface Exposed to MEK for 24 hours

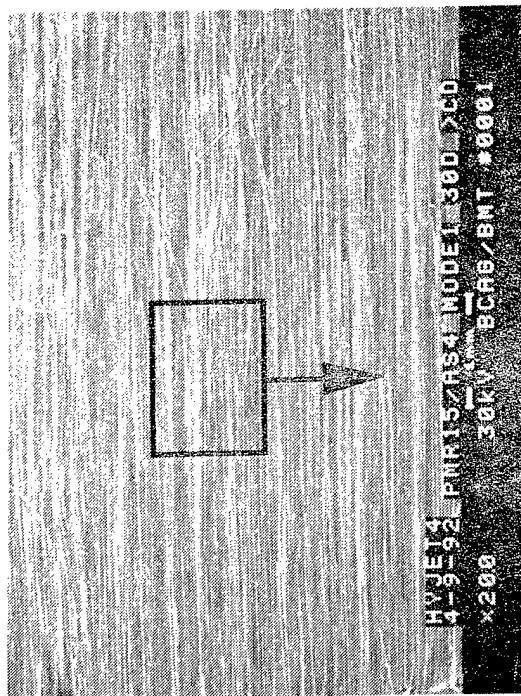
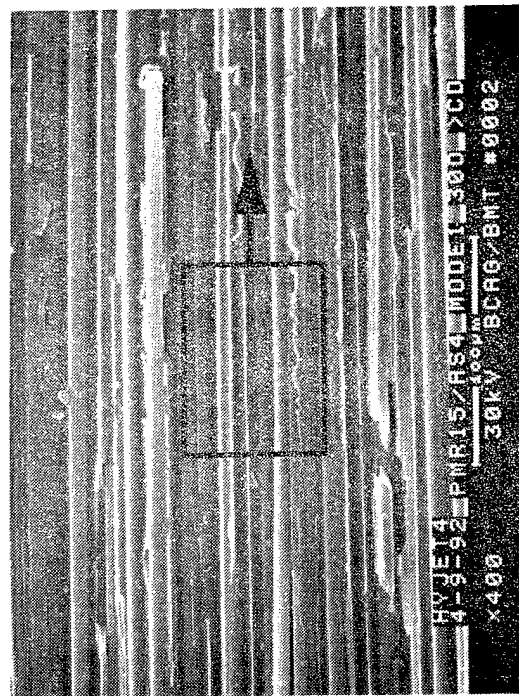
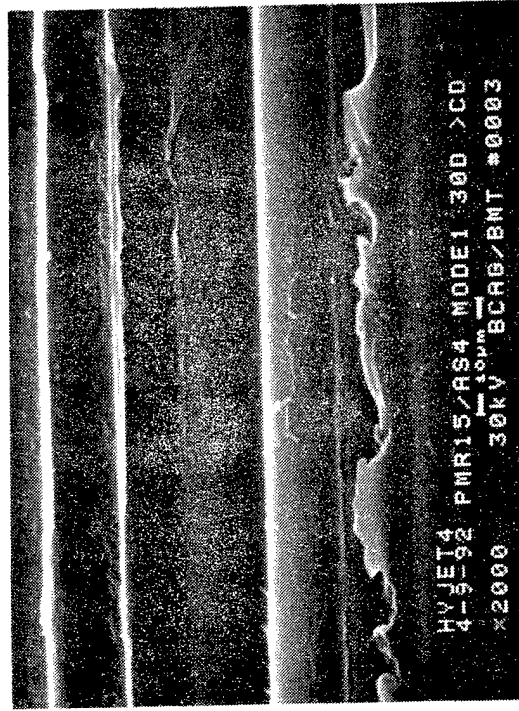
Figure 3.3-12. SEM Fractographs of a PMR-15/AS4 Interlaminar Mode I Tension Fracture Surface Exposed to Hydraulic Fluid for 7 Days
