DOT/FAA/AR-96/21

# Composite Failure Analysis Handbook Update 1

WL-TR-93-4004

August 1997

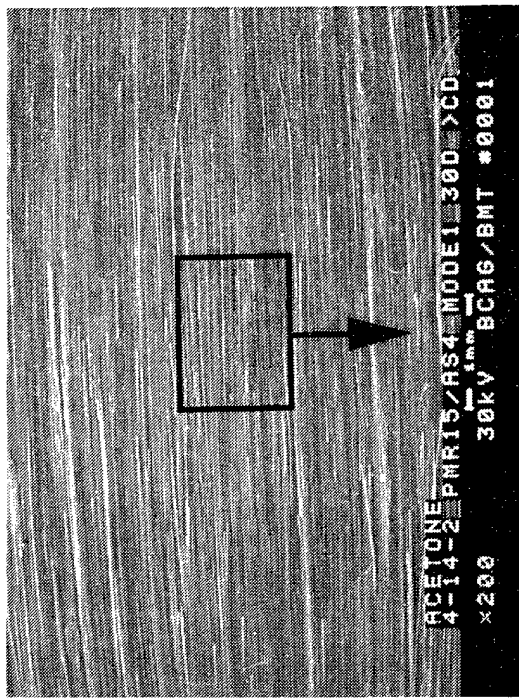
The effects of the exposure did not affect the fracture morphology to any noticeable degree. All of the characteristic mode I surface features were easily identified (Figure 3.3-9 through 3.3-15).

Figure 3.3-13. SEM Fractographs of a PMR-15/AS4 Interlaminar Mode I Tension Fracture Surface Exposed to Acetone for 24 hours

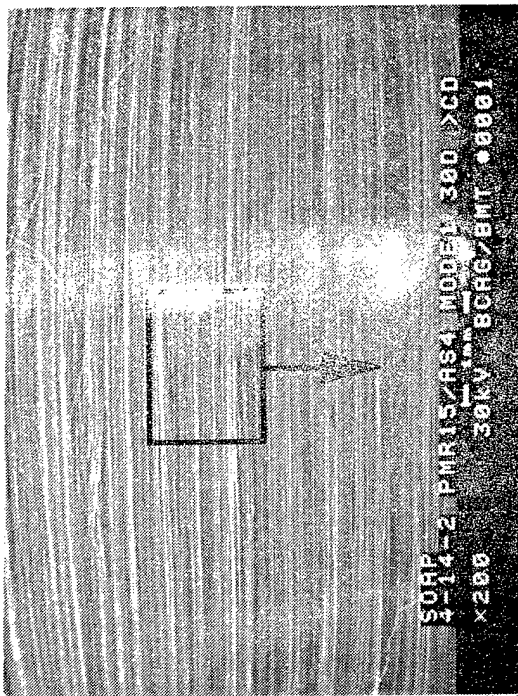
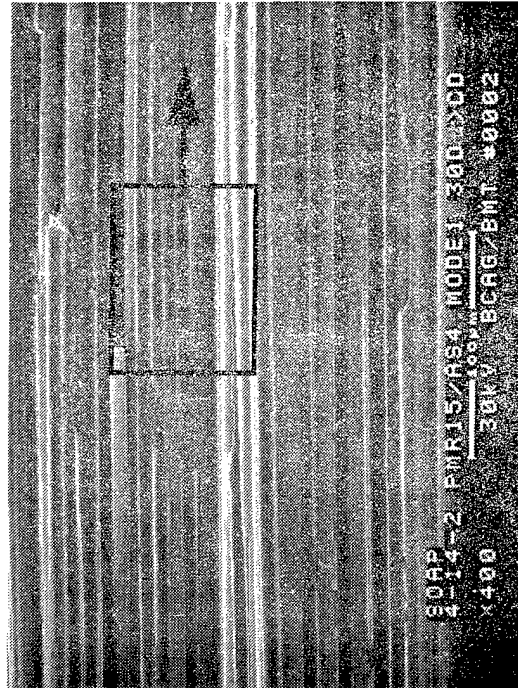
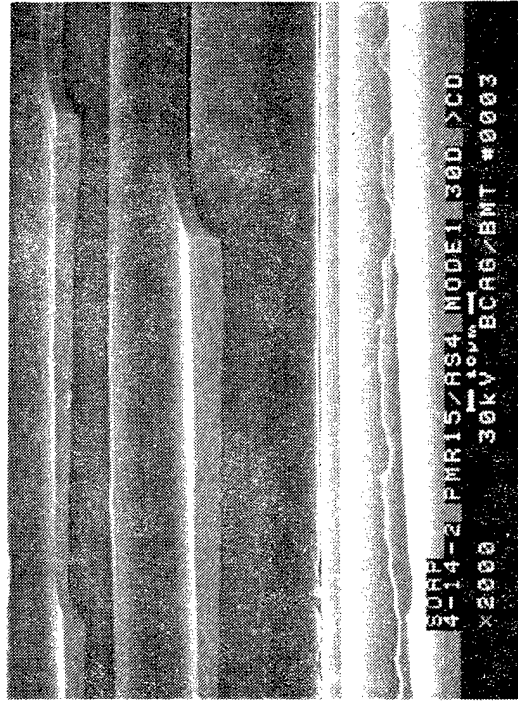
Figure 3.3-14. SEM Fractographs of a PMR-15/AS4 Interlaminar Mode I Tension Fracture Surface Exposed to Soap Solution for 24 hours

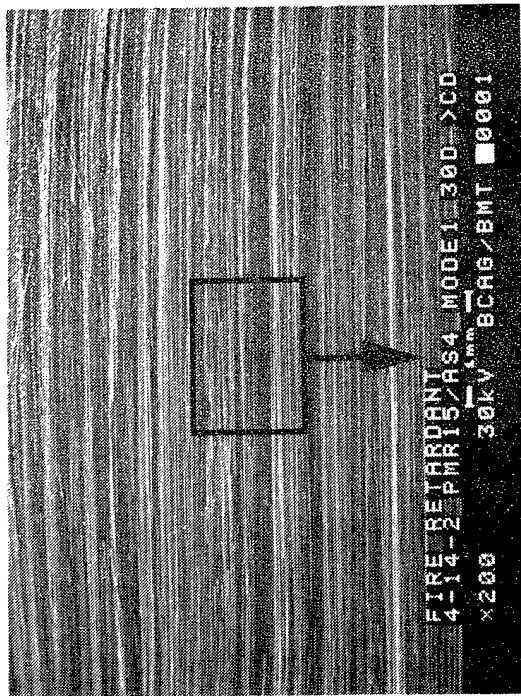
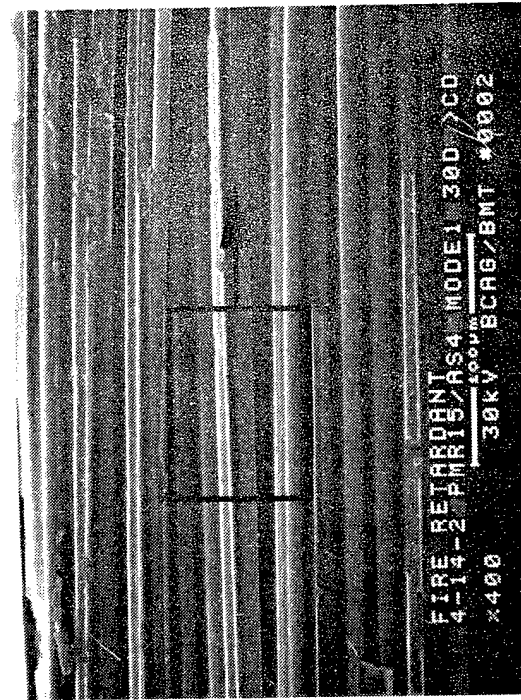
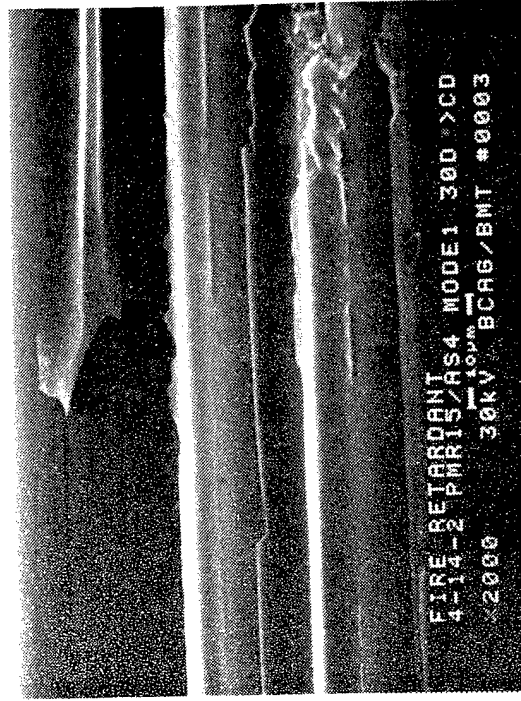
Figure 3.3-15. SEM Fractographs of a PMR-15/AS4 Interlaminar Mode I Tension Fracture Surface Exposed to Fire Retardant Foam for 7 Days

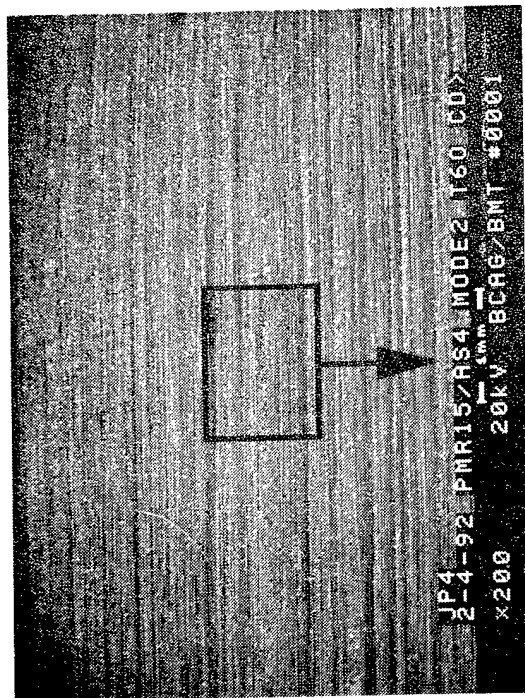
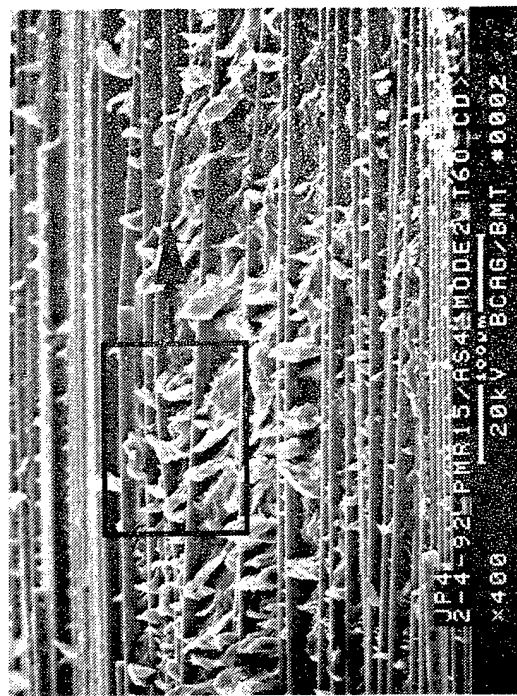
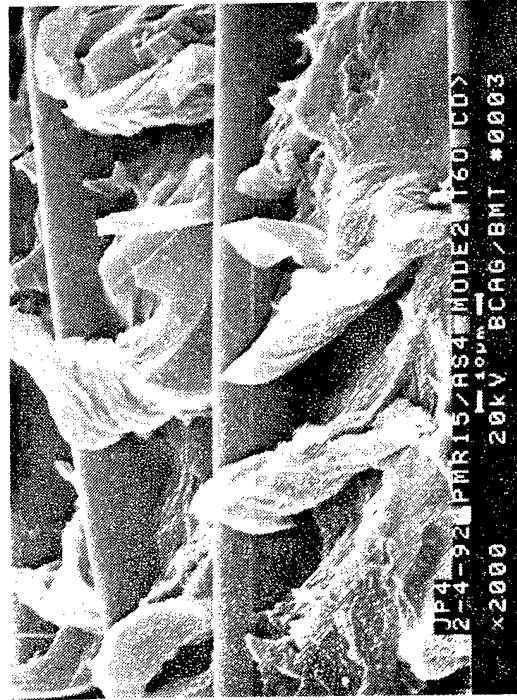
Figure 3.3-16. SEM Fractographs of a PMR-15/AS4 Interlaminar Mode II Shear Fracture Surface Exposed to JP4 Jet Fuel for 7 Days

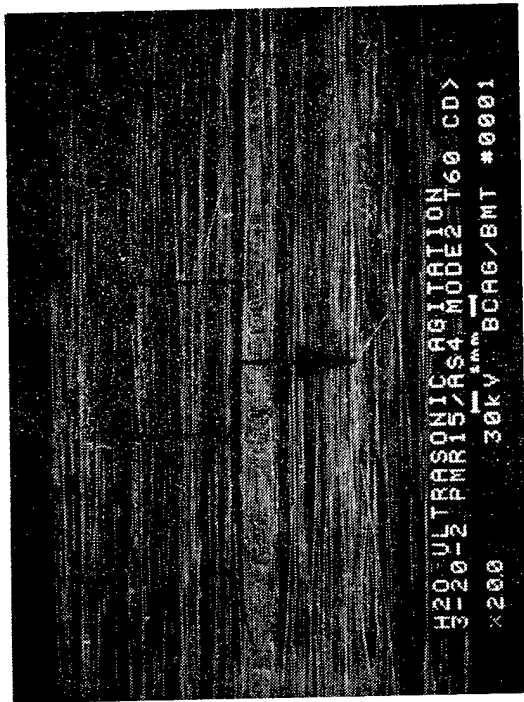
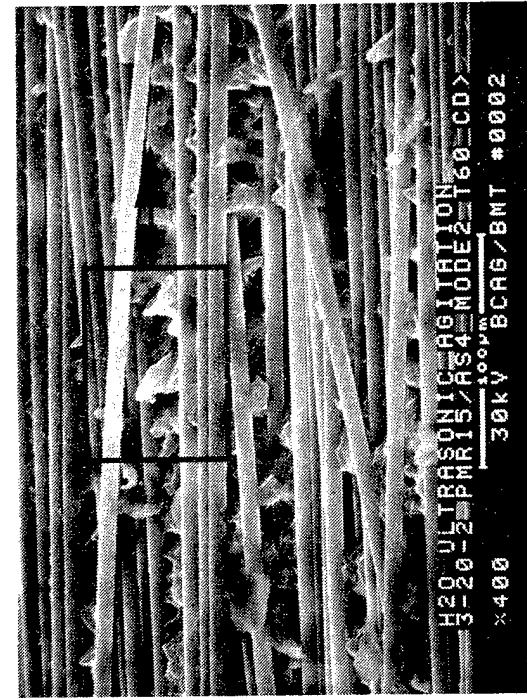
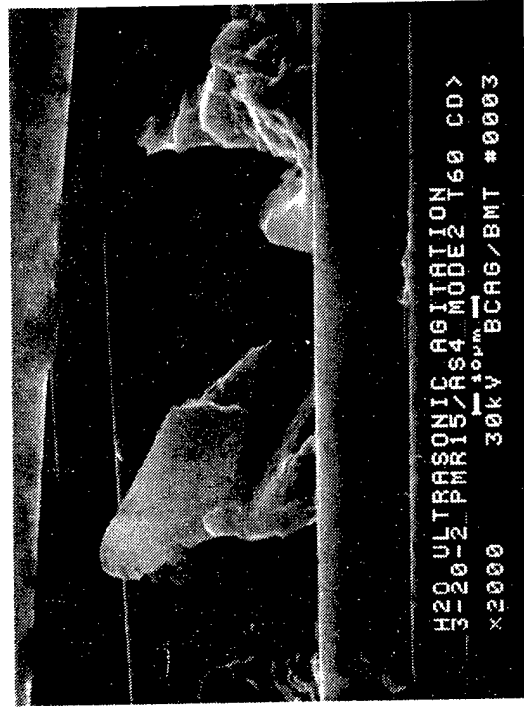
Figure 3.3-17. SEM Fractographs of a PMR-15/AS4 Interlaminar Mode II Shear Fracture Surface Exposed to Ultrasonic Agitation in Distilled Water for 24 hours

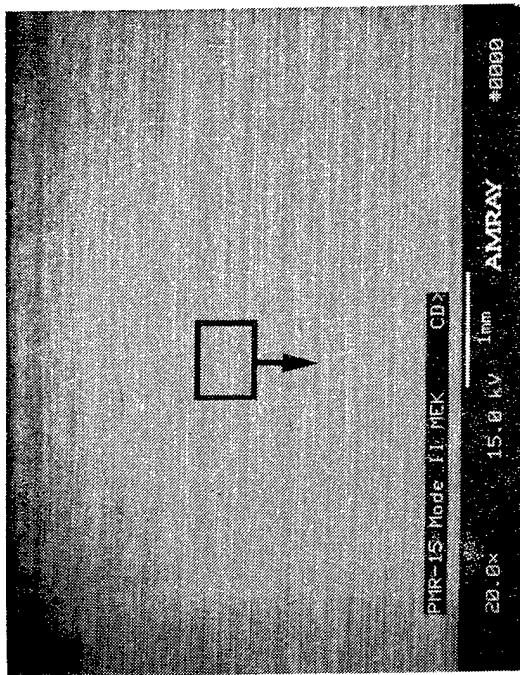
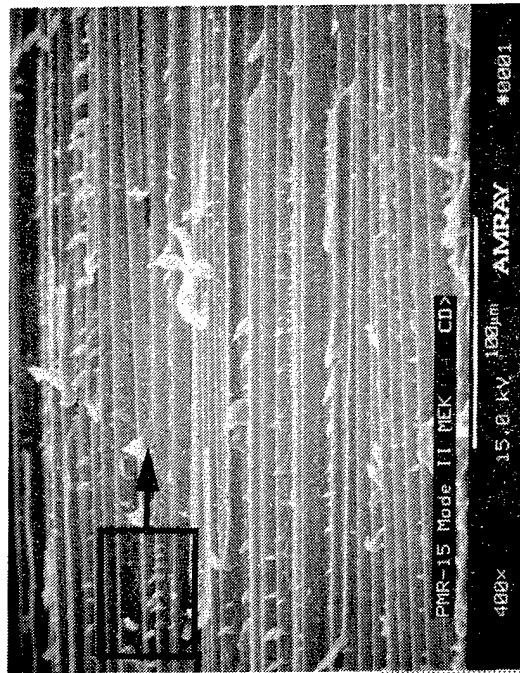
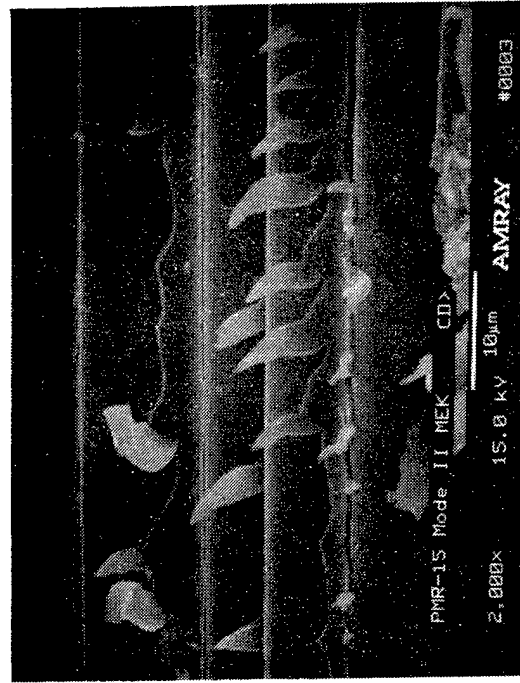
Figure 3.3-18. SEM Fractographs of a PMR-15/AS4 Interlaminar Mode II Shear Fracture Surface Exposed to MEK for 24 Hours

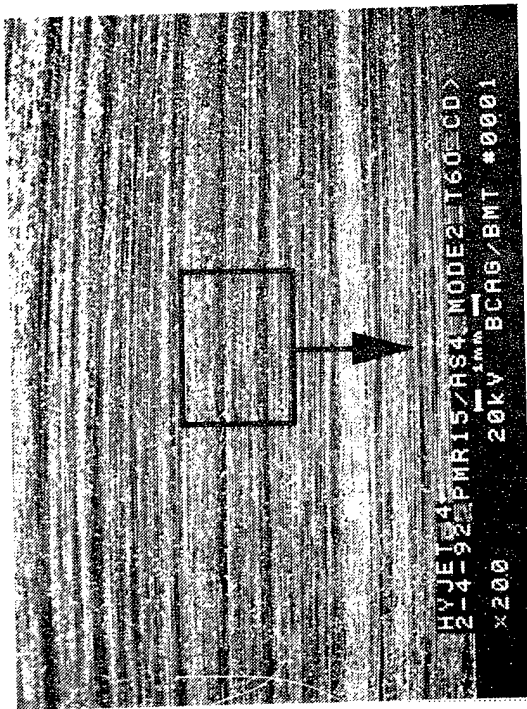
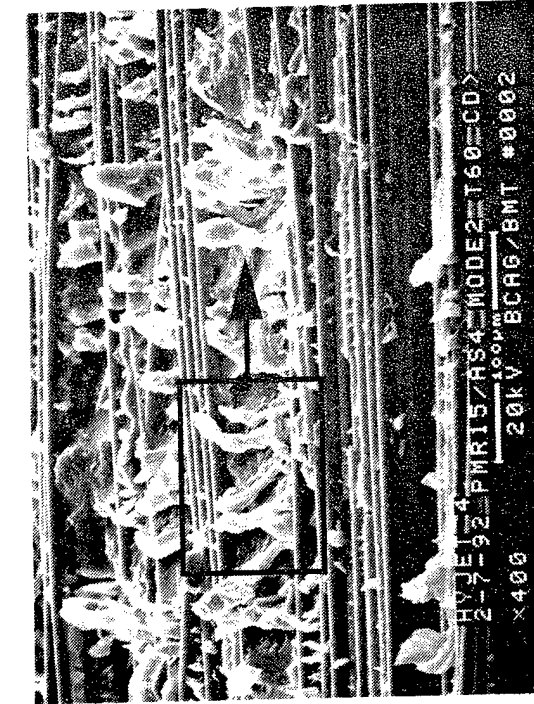
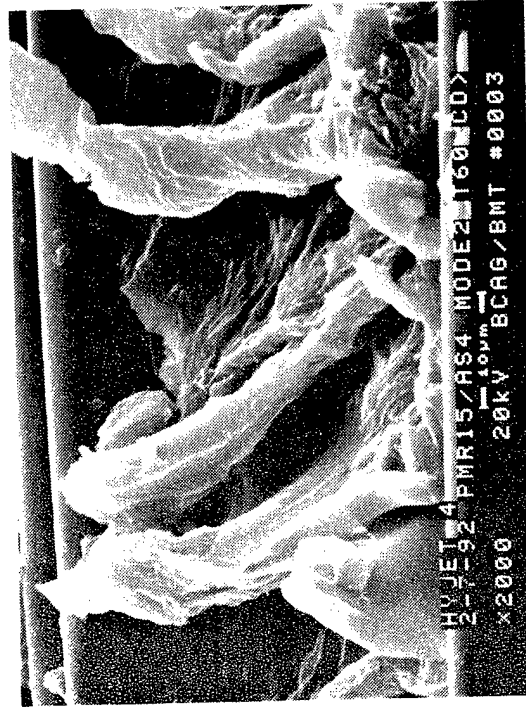
Figure 3.3-19. SEM Fractographs of a PMR-15/AS4 Interlaminar Mode II Shear Fracture Surface Exposed to Hydraulic Fluid for 7 Days

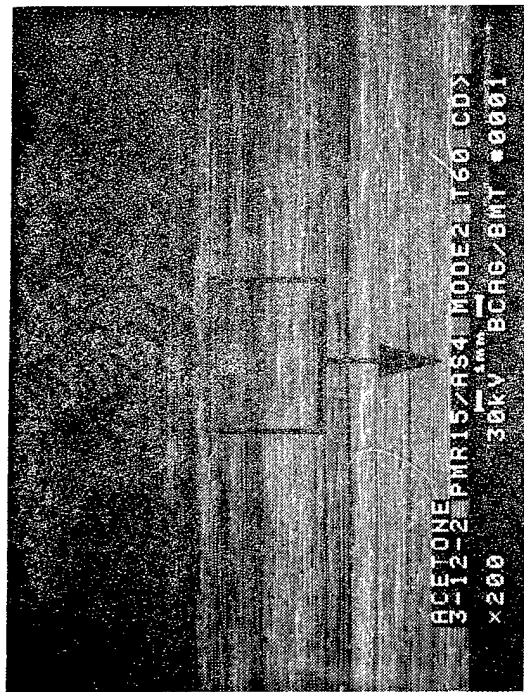
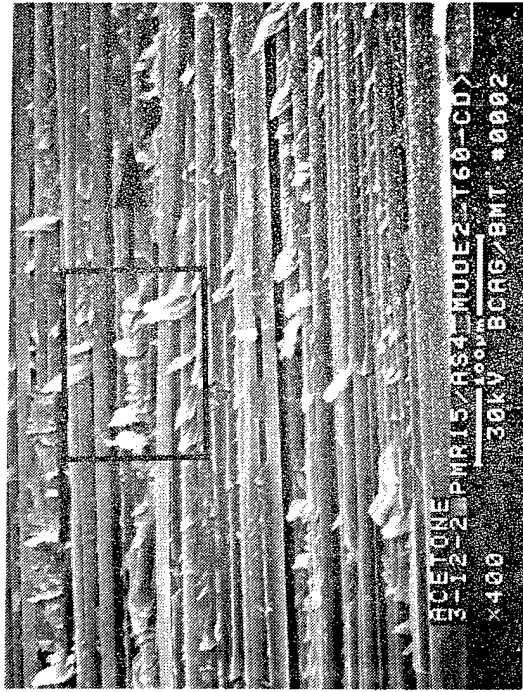
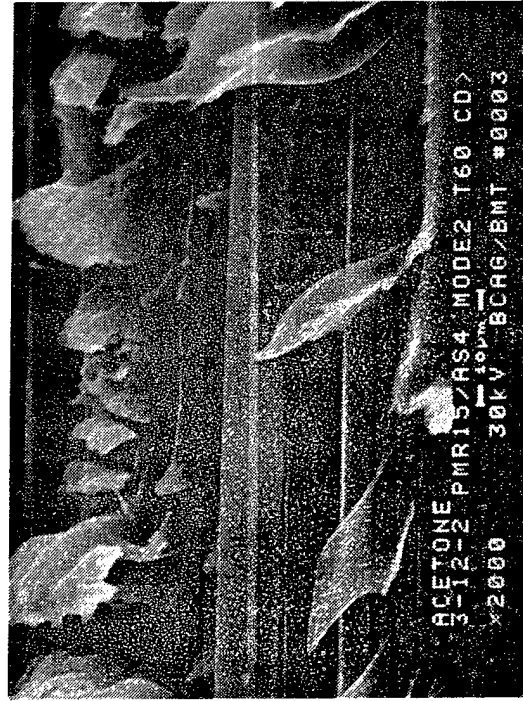
Figure 3.3-20. SEM Fractographs of a PMR-15/AS4 Interlaminar Mode II Shear Fracture Surface Exposed to Acetone for 24 hours

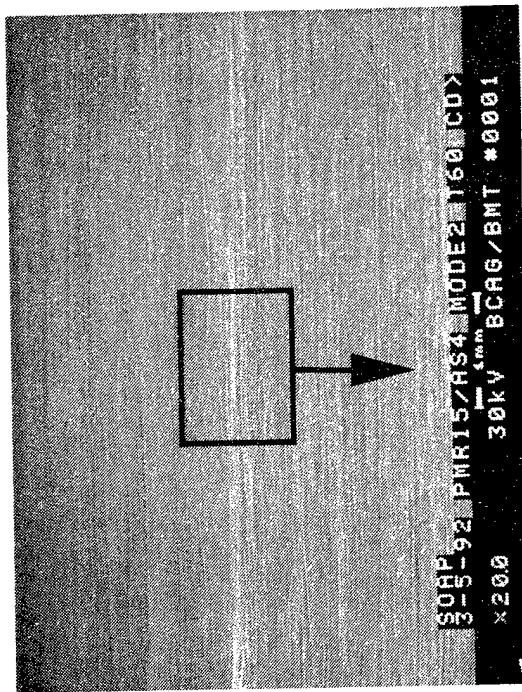
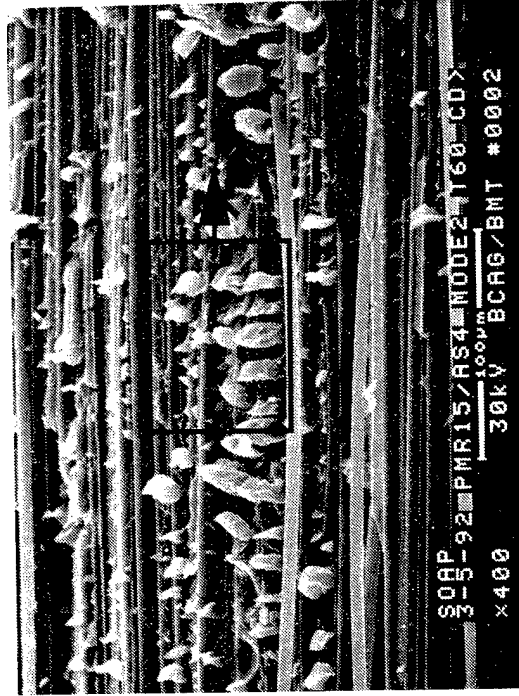
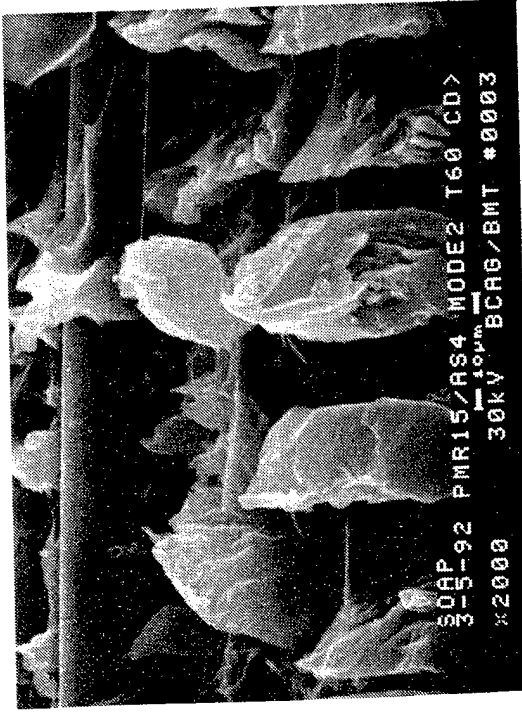
Figure 3.3-21. SEM Fractographs of a PMR-15/AS4 Interlaminar Mode II Shear Fracture Surface Exposed to Soap Solution for 24 hours

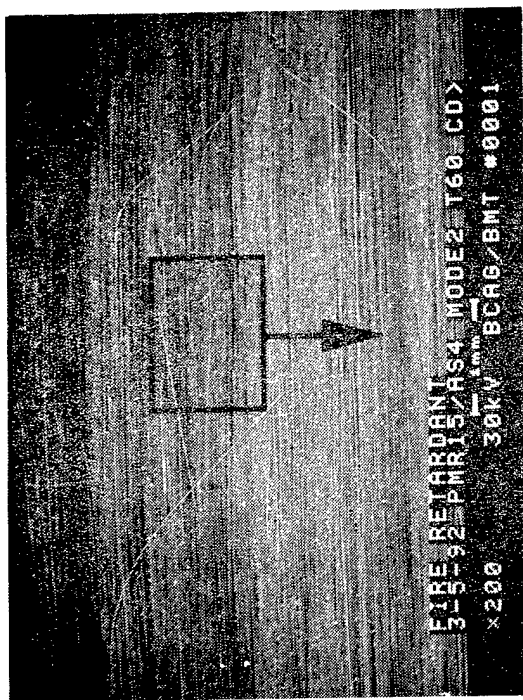
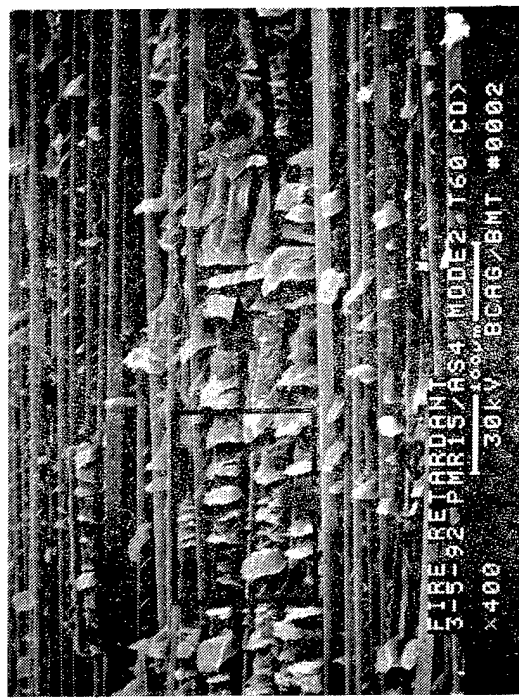
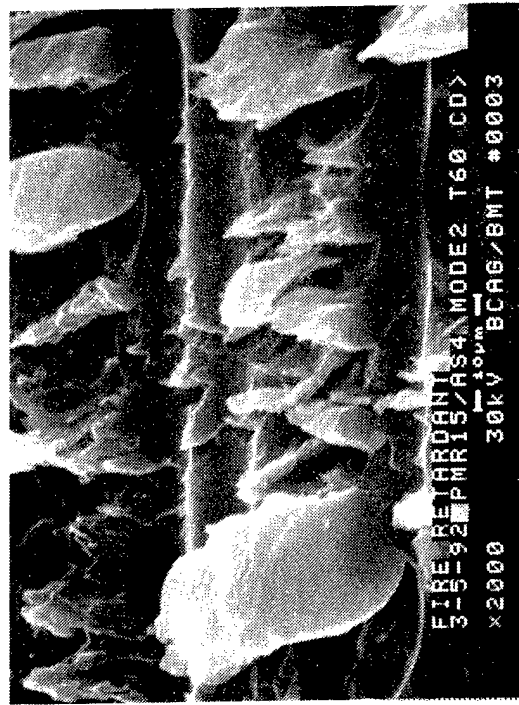
Figure 3.3-22. SEM Fractographs of a PMR-15/AS4 Interlaminar Mode II Shear Fracture Surface Exposed to Fire Retardant Foam for 7 Days

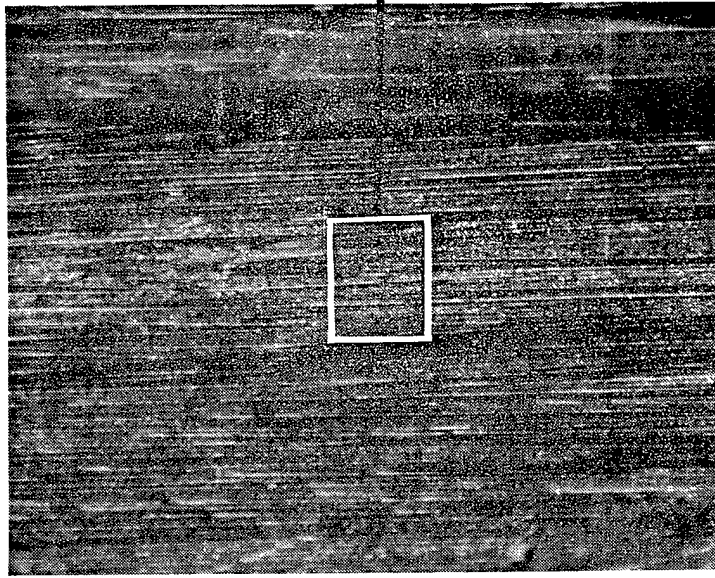
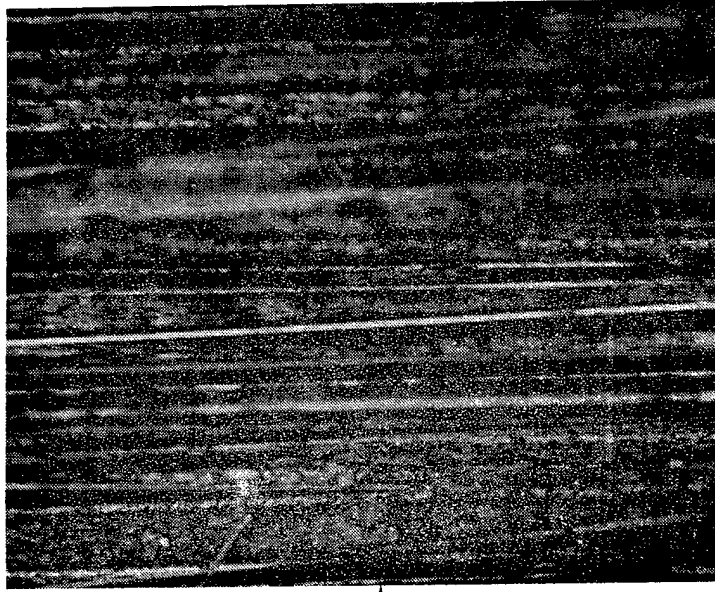
As shown in Figures 3.4-1 and 3.4-2, the fracture surface morphology of the RT specimen appeared typical for the mode II (shear) Gr/PEEK fracture surface. However, the hackle feature on this surface was considerably smaller than the statically loaded specimen and was probably unique to the cyclic loading.

Figure 3.4-1. Optical Fractographs of PEEK/AS4 Interlaminar Mode II (Shear) Fatigue, Room Temperature, High Stress

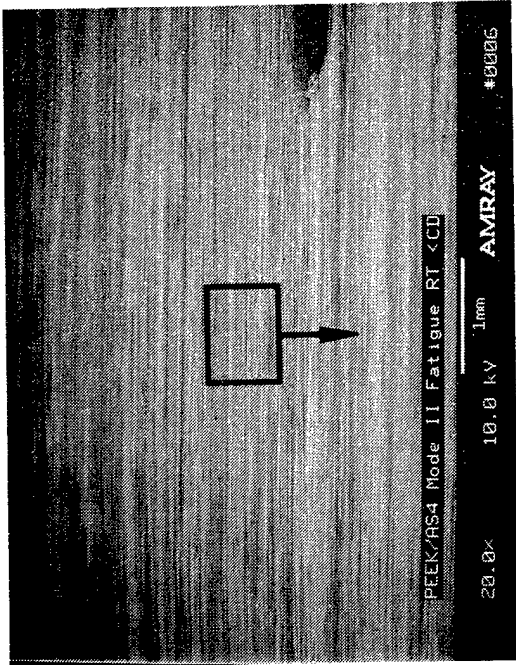
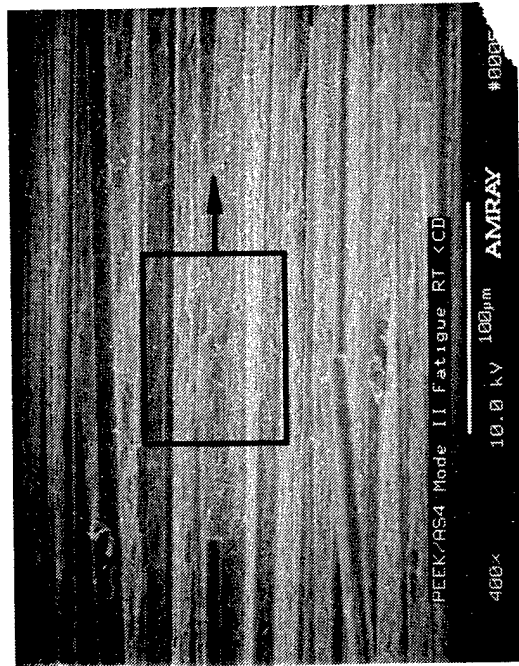
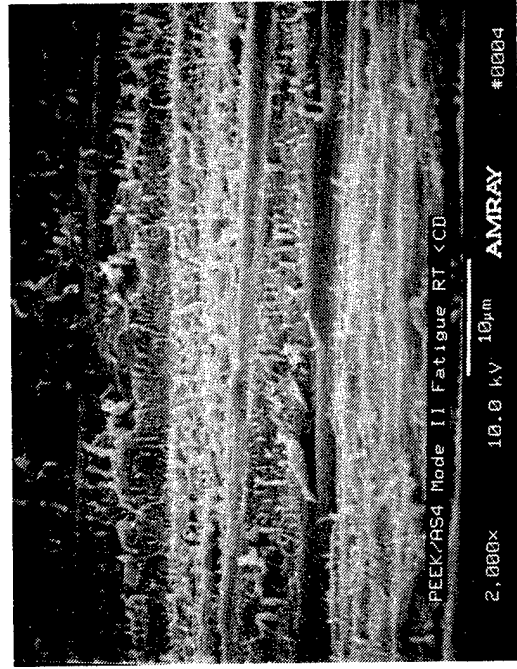
Figure 3.4-2. SEM Fractographs of a PEEK/AS4 Interlaminar Mode II (Shear) Fatigue Fracture Surface, Room Temperature

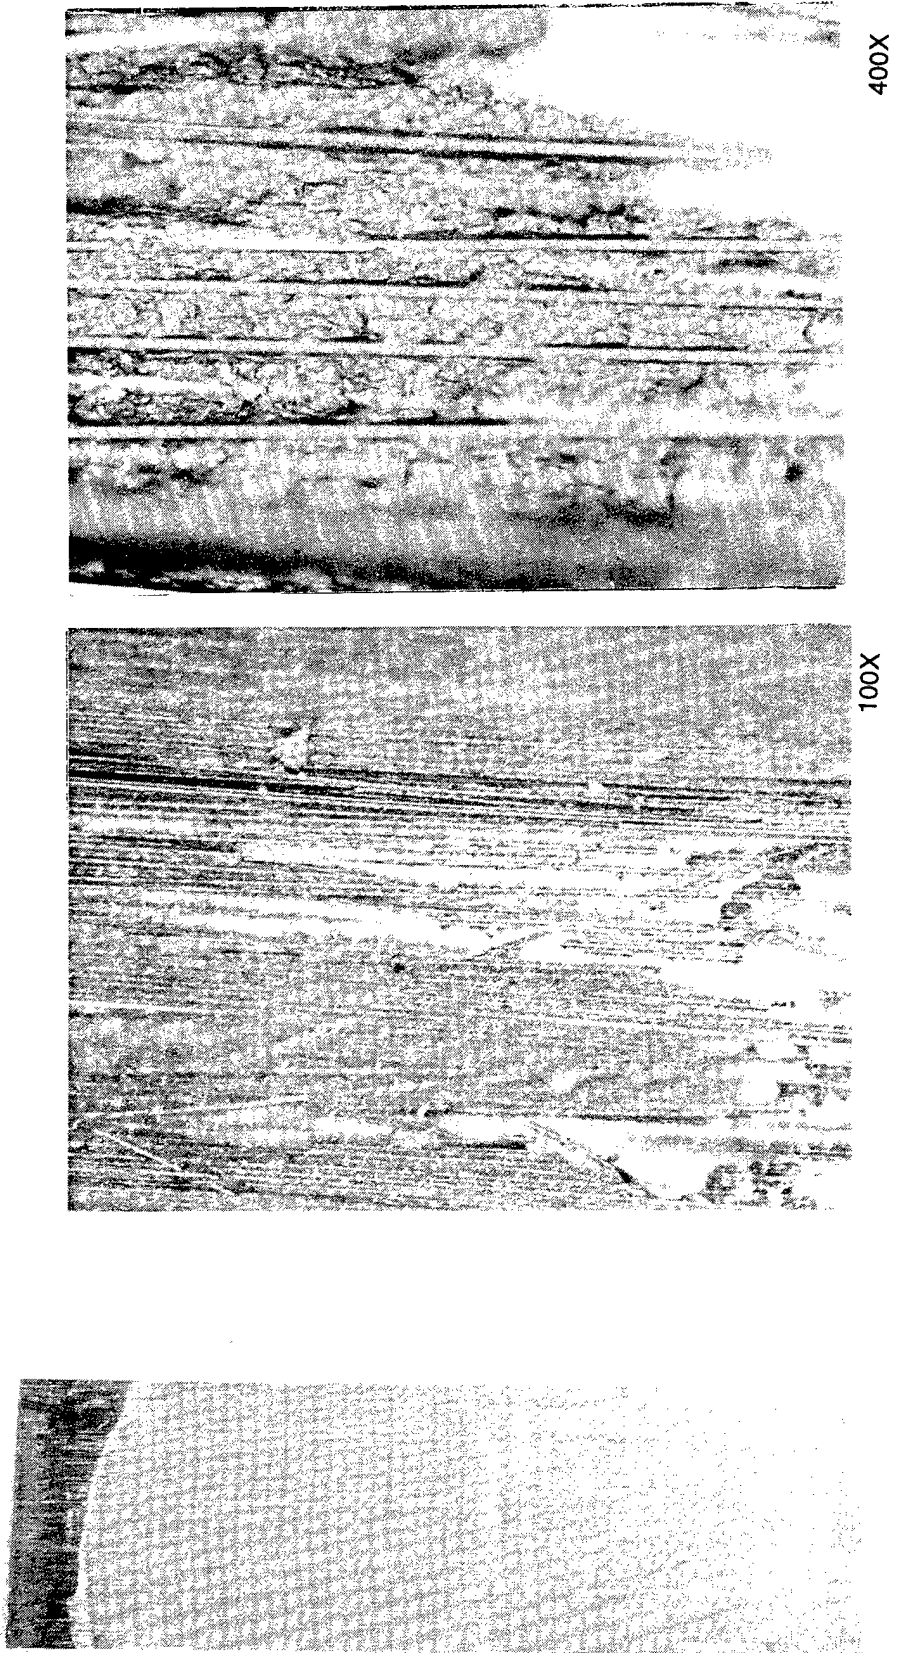
The fracture morphology was very different on the specimen tested at 250°F (Figures 3.4-3 and 3.4-4). The resin was pulled out in "ribbons" which did not indicate the overall crack propagation direction.

Figure 3.4-3. Optical Fractographs of a APC-2/AS4 Interlaminar Mode II (Shear) Fatigue Fracture Surface, 250° F

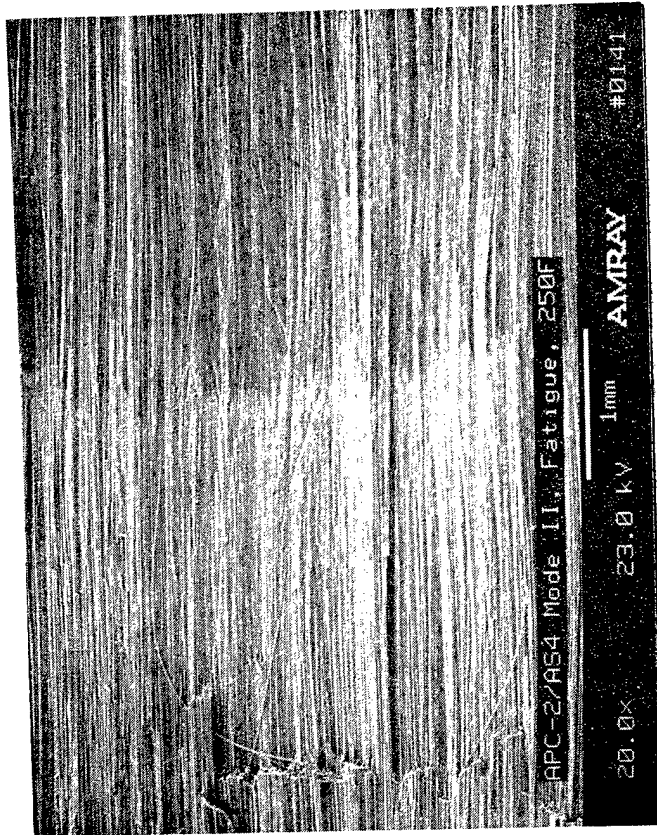
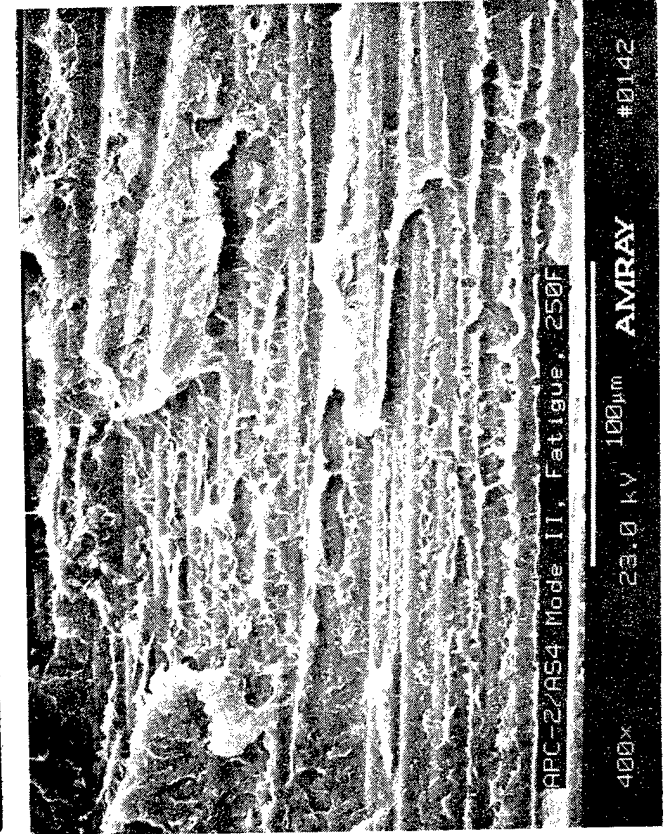
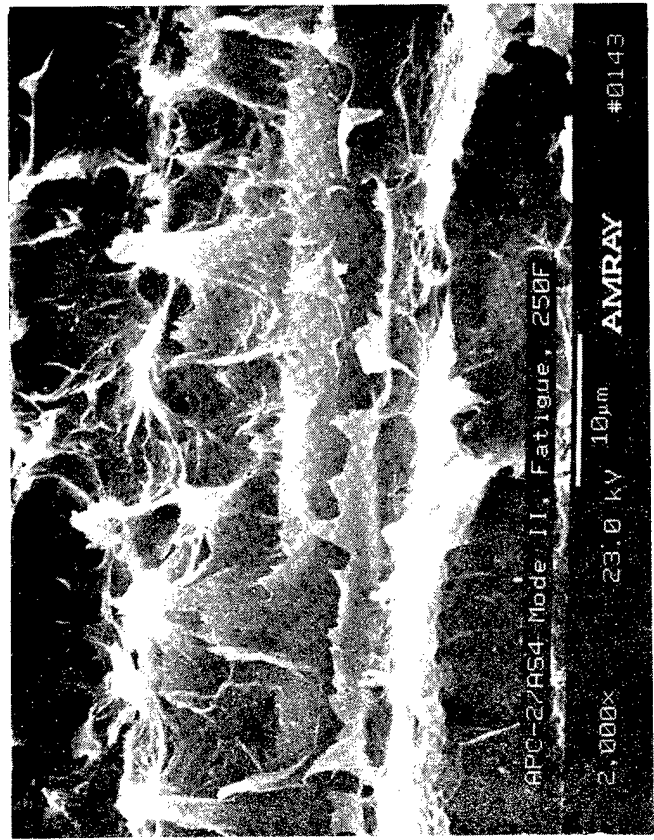
Figure 3.4-4. SEM Fractographs of a APC-2/AS4 Interlaminar Mode II (Shear) Fatigue Fracture Surface, 250° F

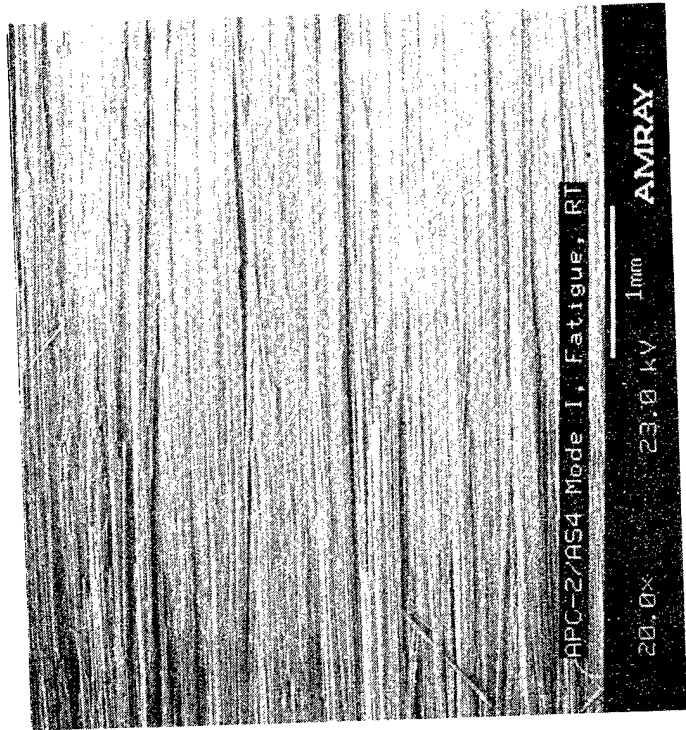
Figure 3.4-5. Optical Fractographs of a APC-2/AS4 Interlaminar Mode I (Tensile) Fatigue Fracture Surface, RT

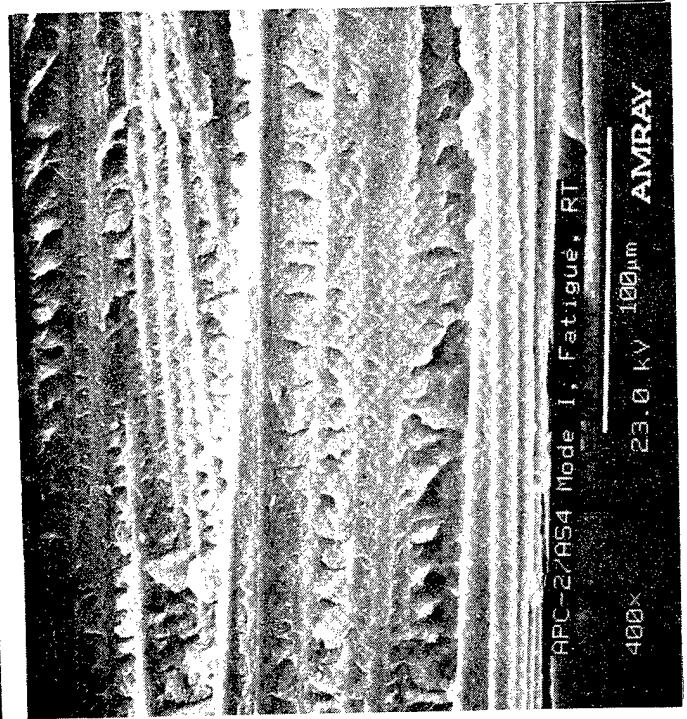
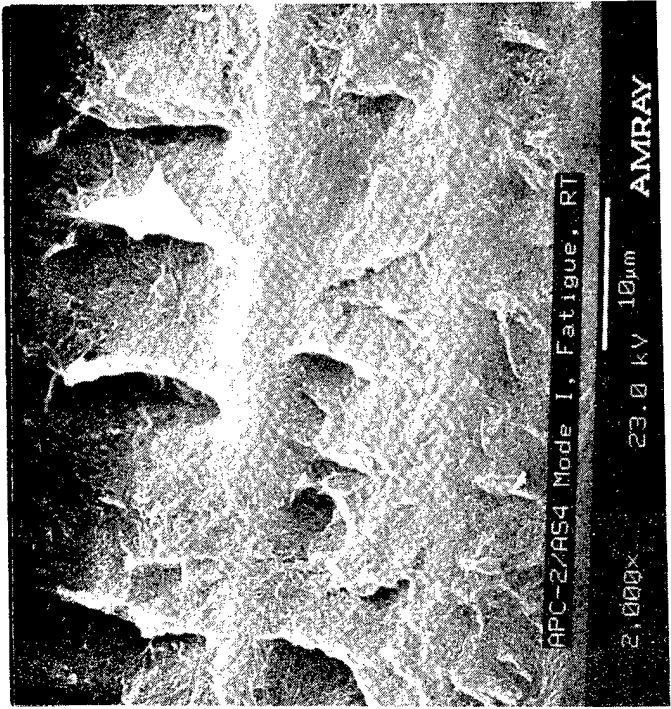
Figure 3.4-6. SEM Fractographs of a APC-2/AS4 Interlaminar Mode I (Tensile) Fatigue Fracture Surface, RT

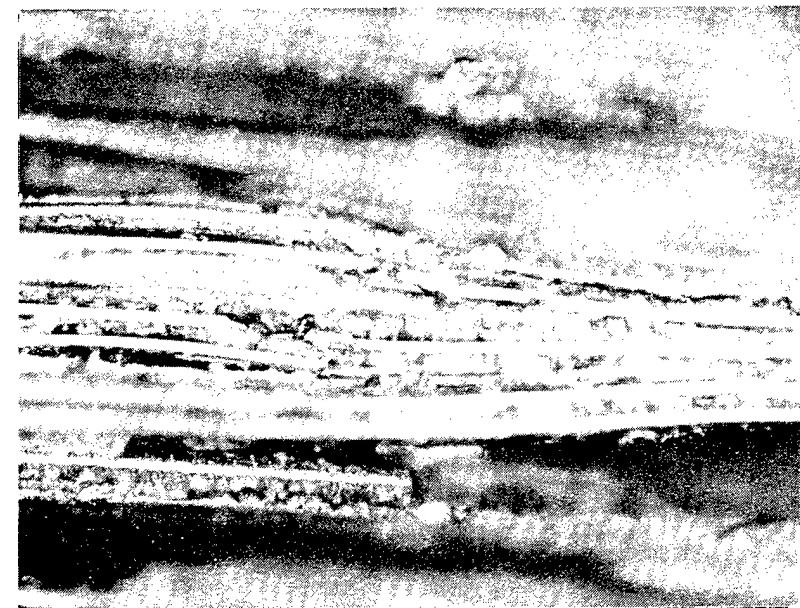
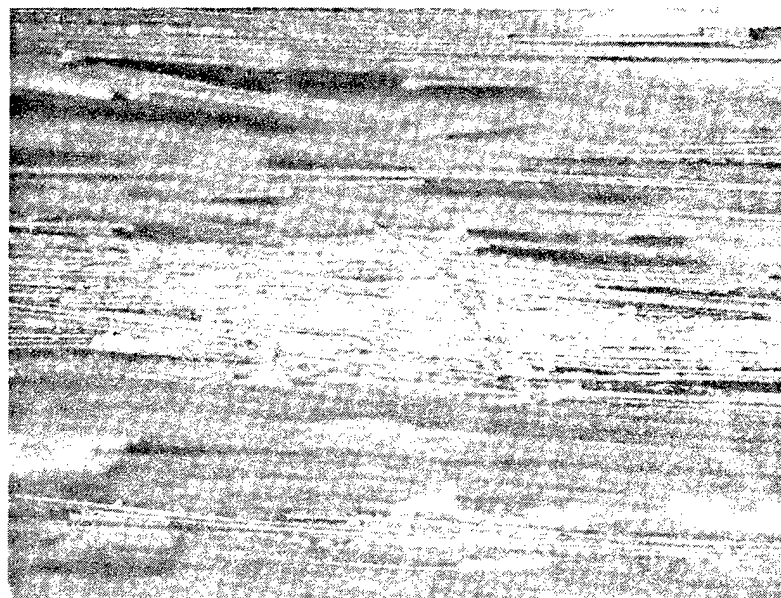
Figure 3.4-7. Optical Fractographs of a APC-2/AS4 Interlaminar Mode I (Tensile) Fatigue Fracture Surface, 250° F

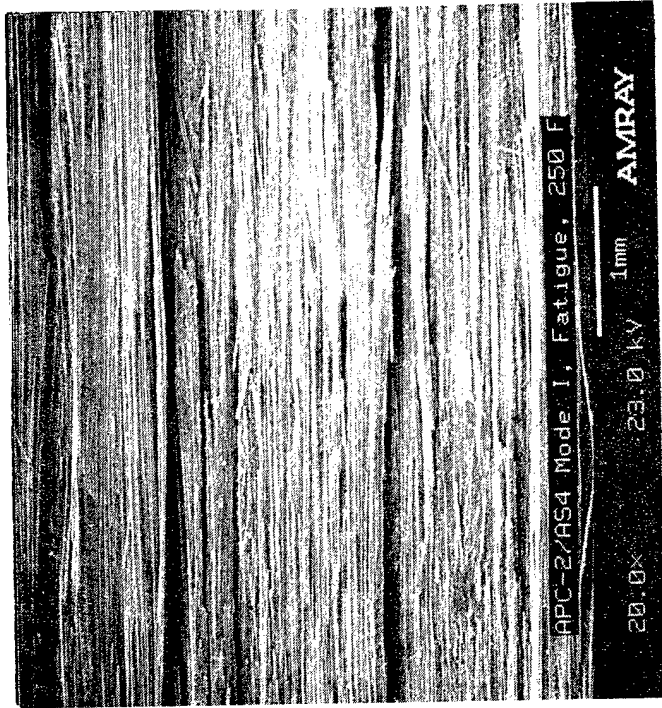
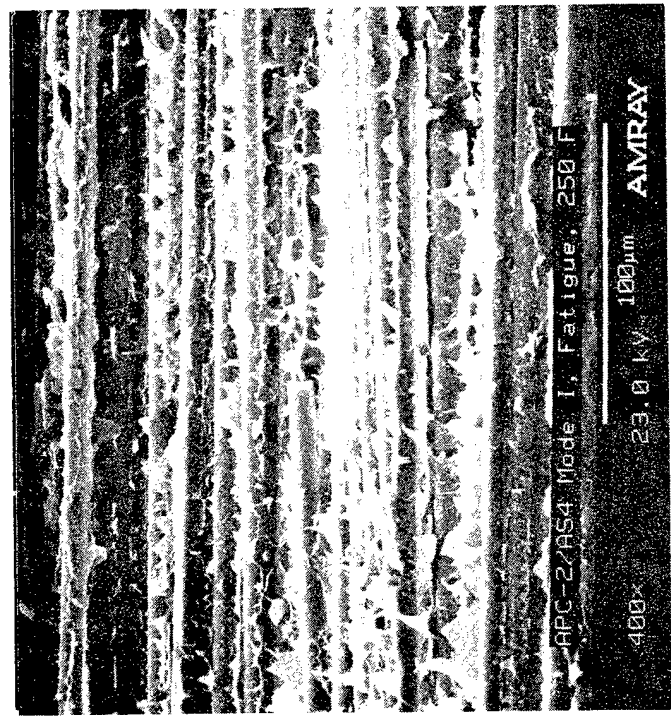
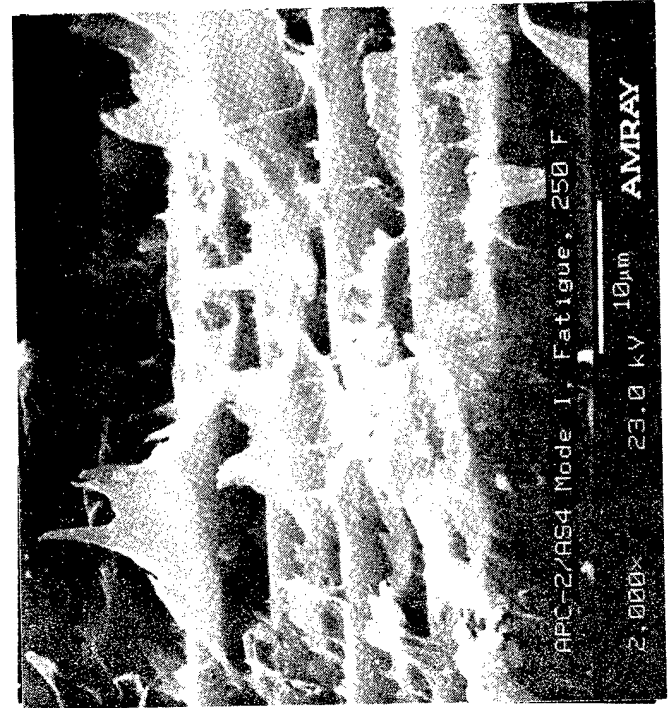
Figure 3.4-8. SEM Fractographs of a APC-2/AS4 Interlaminar Mode I (Tensile) Fatigue Fracture Surface, 250° F

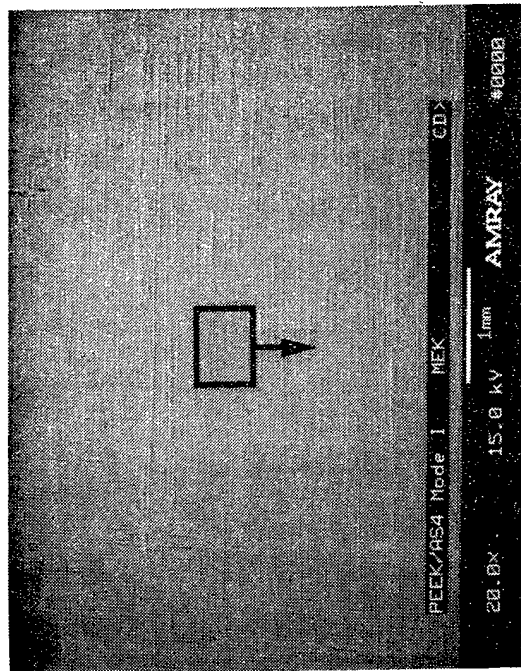
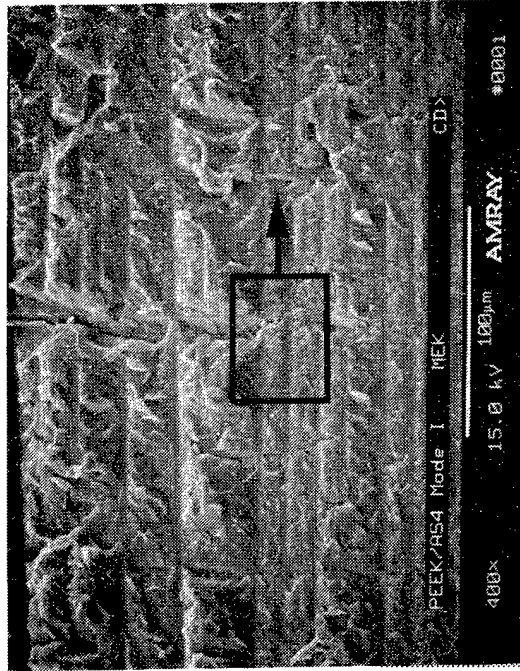
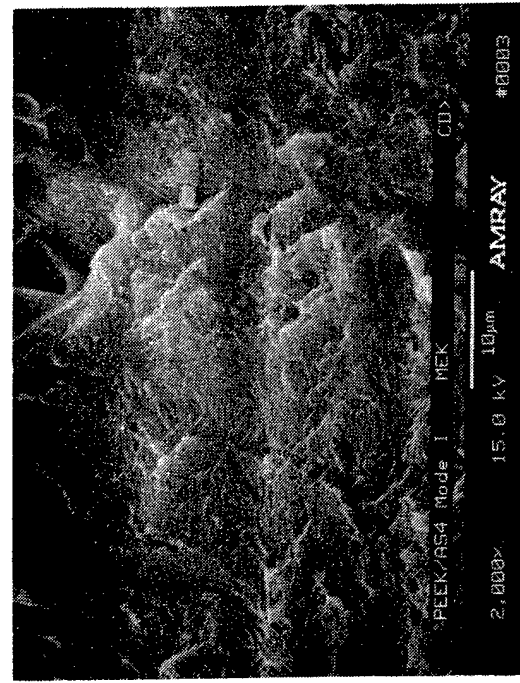
Figure 3.4-9. SEM Fractographs of a PEEK/AS4 Interlaminar Mode I Tension Fracture Surface Exposed to MEK for 24 Hours

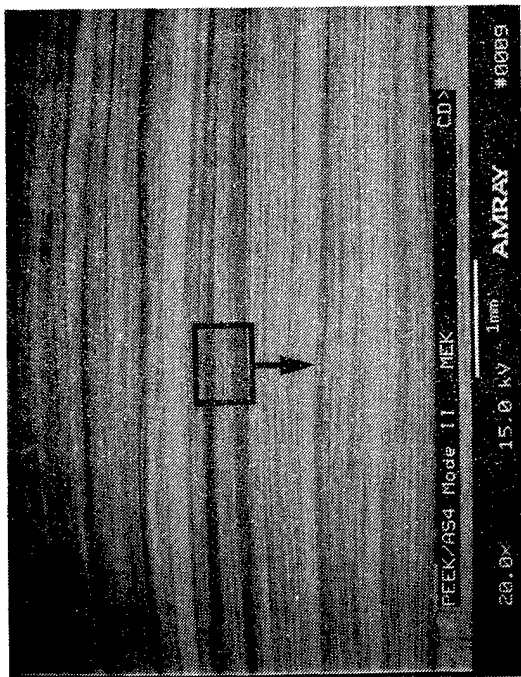
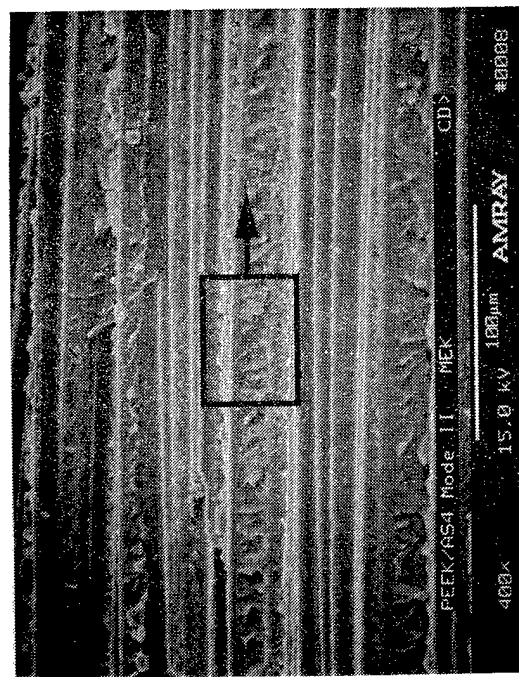
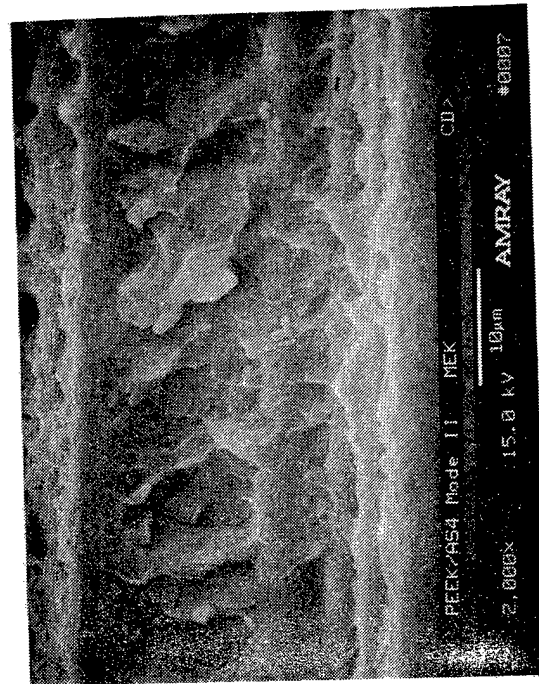
Figure 3.4-10. SEM Fractographs of a PEEK/AS4 Interlaminar Mode II Shear Fracture Surface Exposed to MEK for 24 Hours
