DOT/FAA/AR-96/21

# Composite Failure Analysis Handbook Update 1

WL-TR-93-4004

August 1997

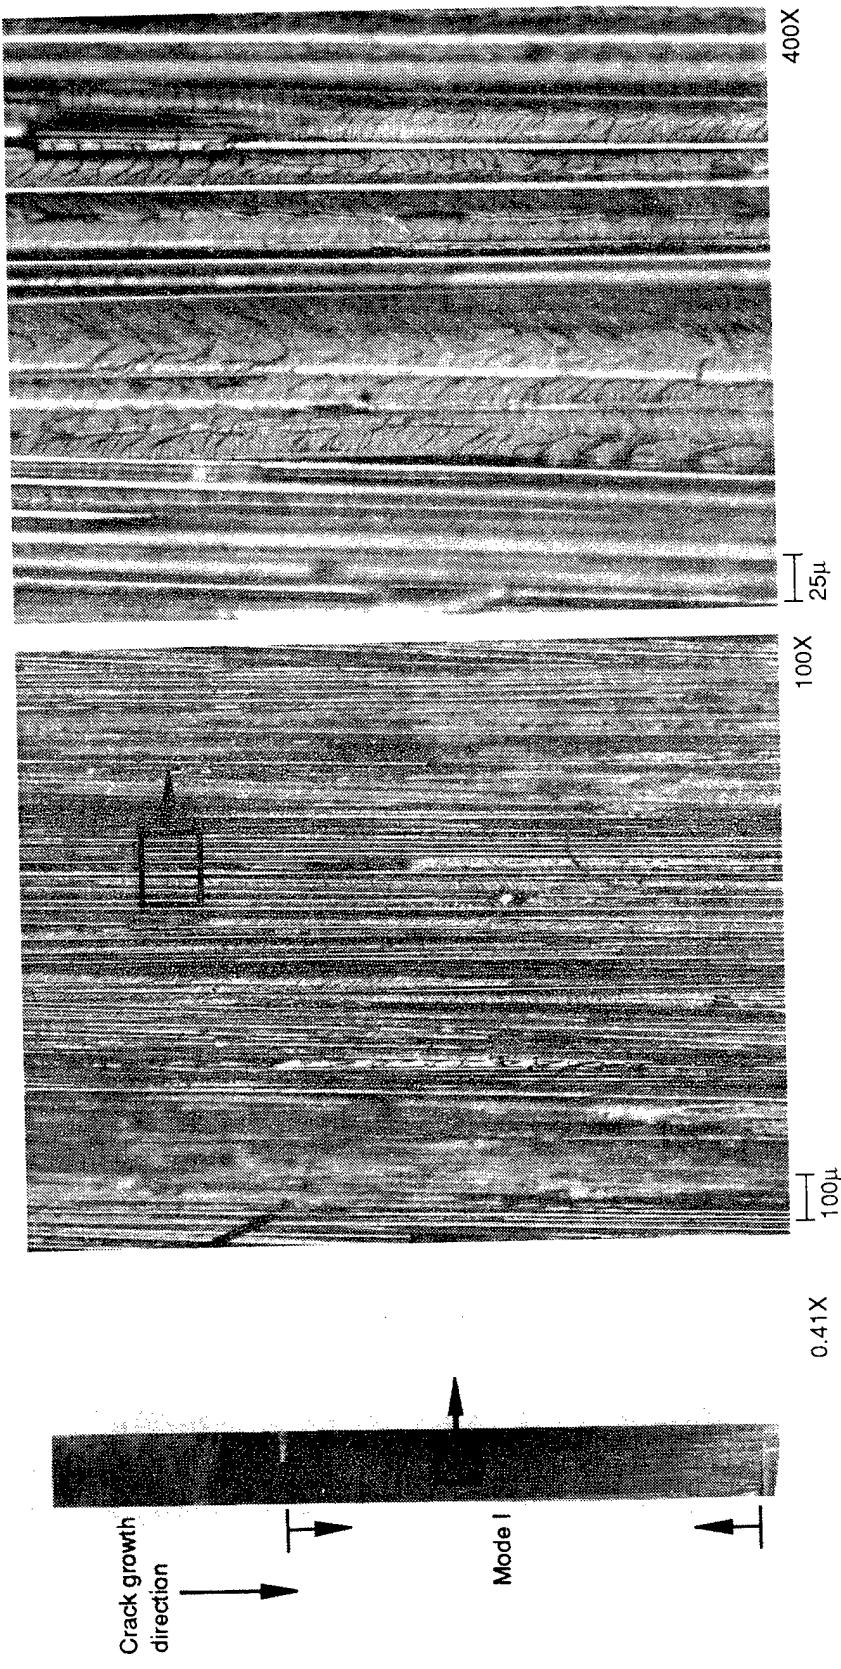
Visual observation revealed a smooth, glassy surface typical of an interlaminar mode I tension fracture. However, fragments of loose fibers were apparent on the fracture surface. These fibers were separated from the matrix (possibly due to weak fiber/matrix adhesion). Under the optical microscope, fine rivermarks were observed, indicating the overall crack propagation direction (Figure 3.5-1). As shown in Figure 3.5-2, SEM examination revealed rivermarks between the carbon fibers. These rivermarks indicated the crack growth is consistent with the mechanically induced crack direction.

Figure 3.5-1. Optical Fractographs of BM//AS4 Interlaminar Mode I Tension Specimen Tested at RT/Dry

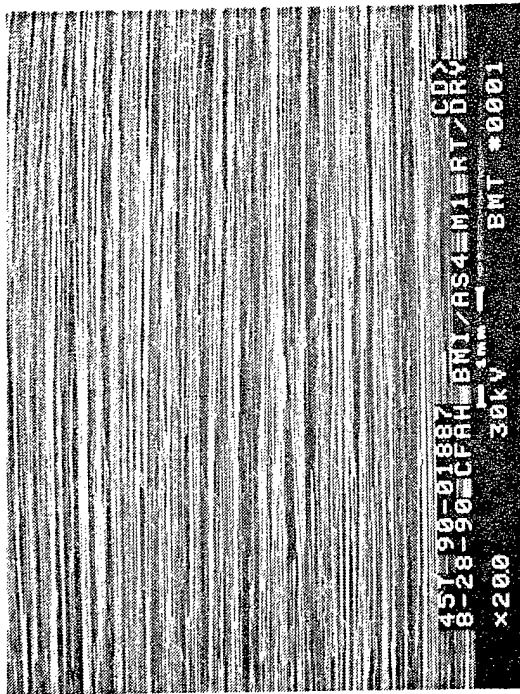
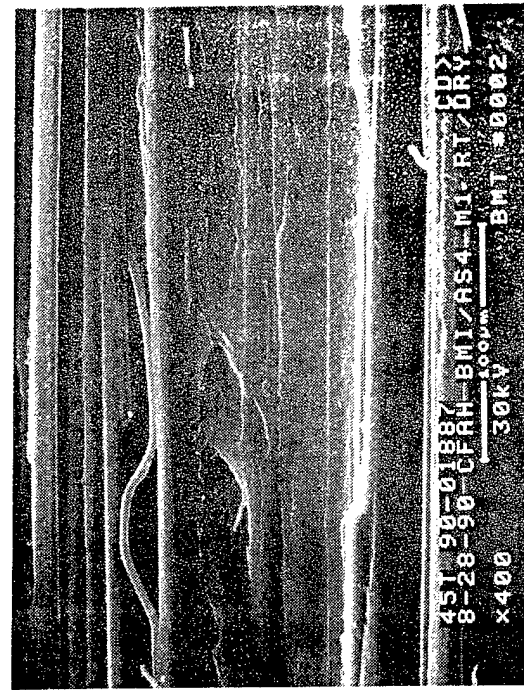
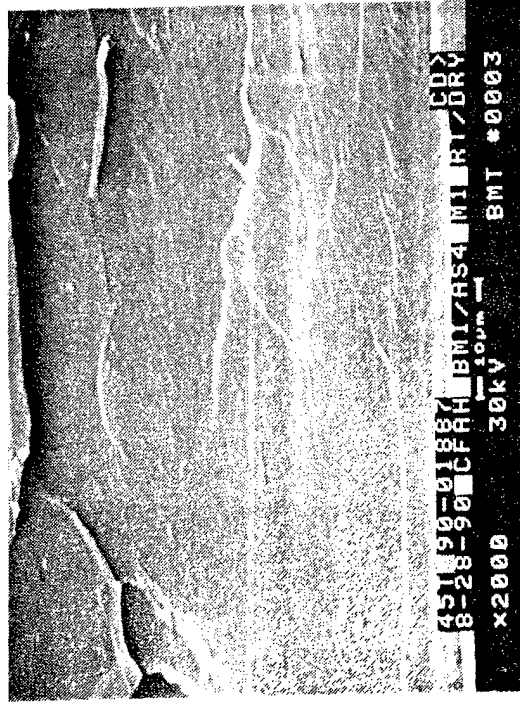
Figure 3.5-2. SEM Fractographs of an AS4/EMI Interlaminar Mode I Tension Specimen Tested at RT/Dry

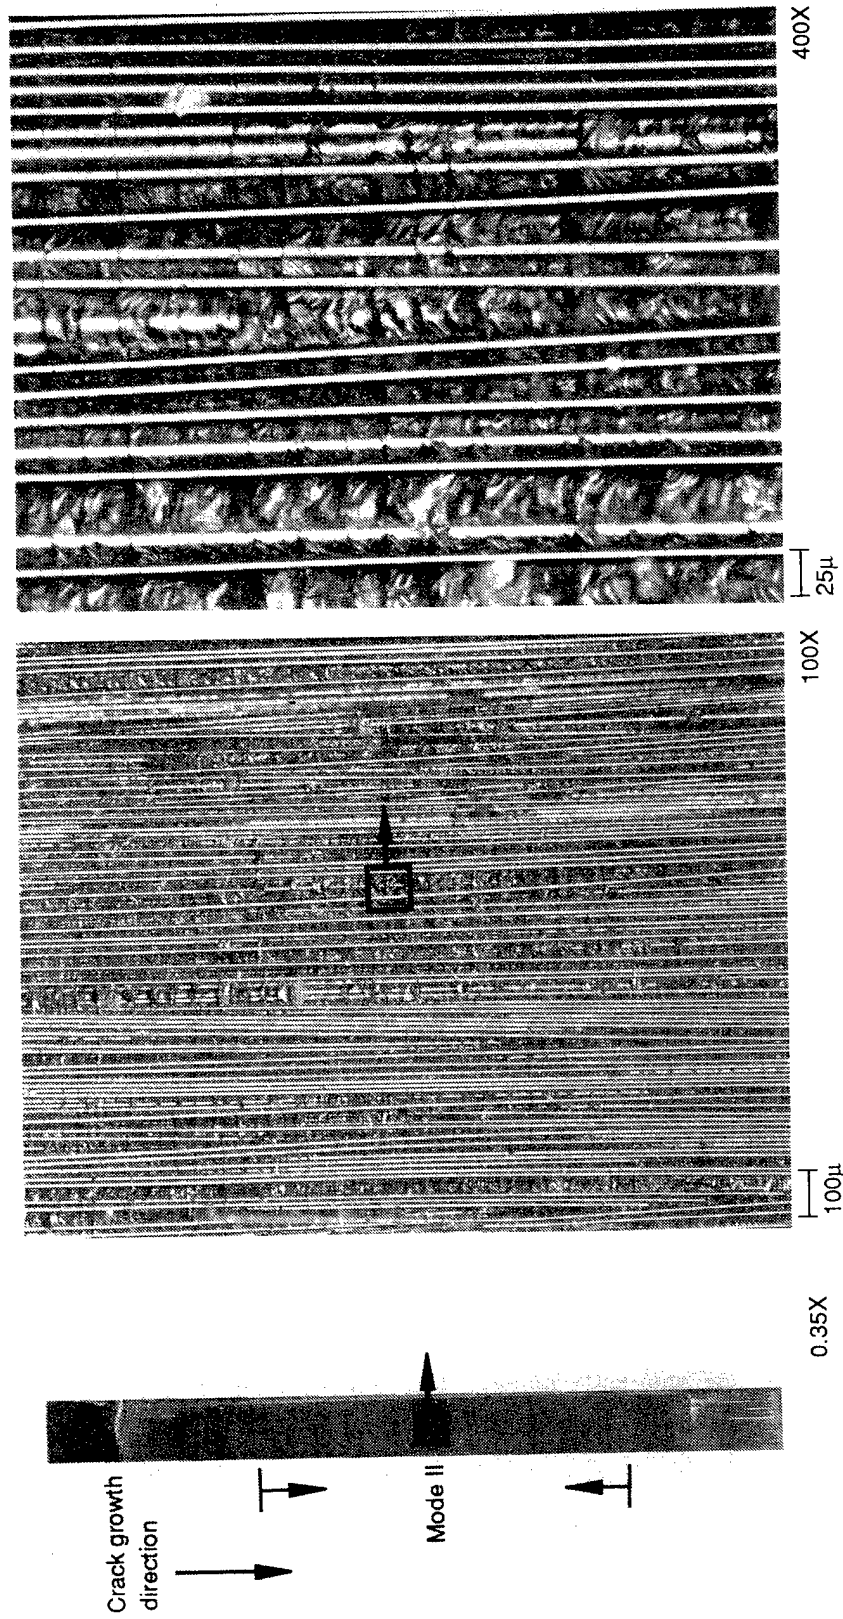
Visual observation of the fracture surface revealed a flat but milky appearance when held at an angle to the light. The milky appearance is due to the hackle formation created by shear loading, which was observed at higher magnification under the optical microscope (Figure 3.5-3). SEM examination revealed hackles of different sizes, shapes, and tilt angles located between the carbon fibers (Figure 3.5-4).

Figure 3.5-3. Optical Fractographs of BMI/AS4 Interlaminar Mode II Shear Specimen Tested at RT/Dry

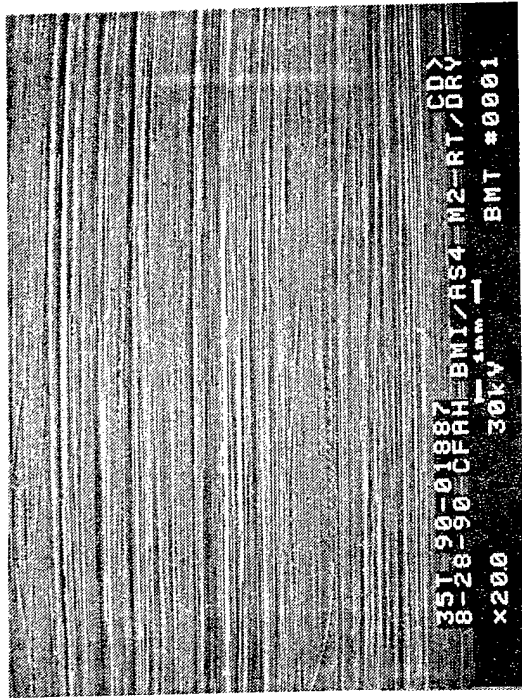
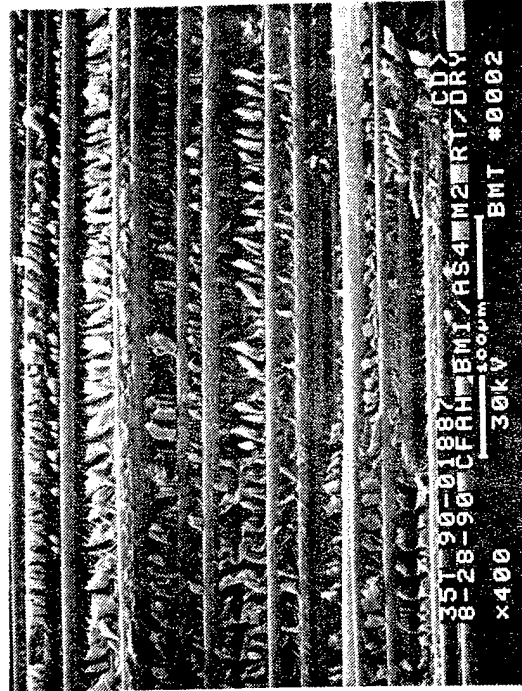
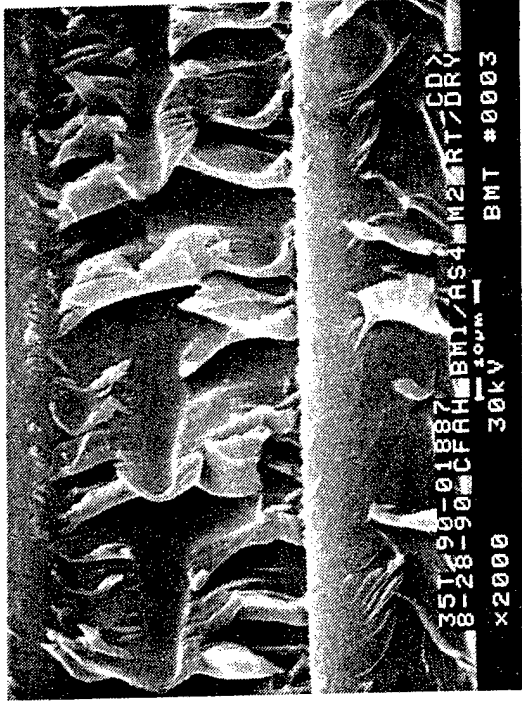
Figure 3.5-4. SEM Fractographs of an AS4/BMI Interlaminar Mode II Shear Specimen Tested at RT/Dry

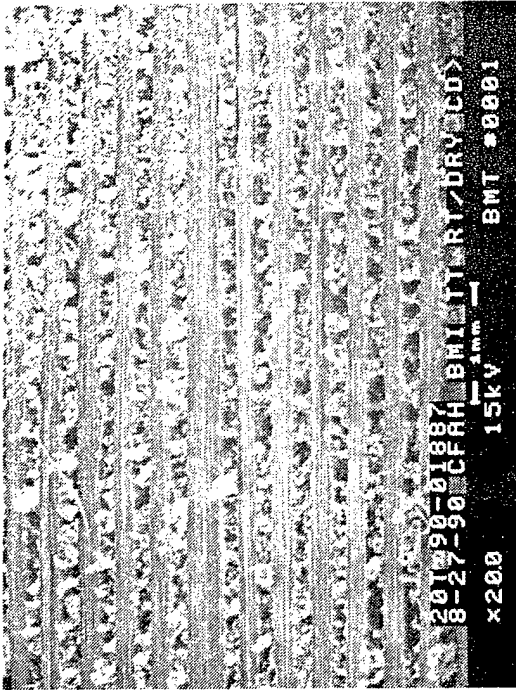
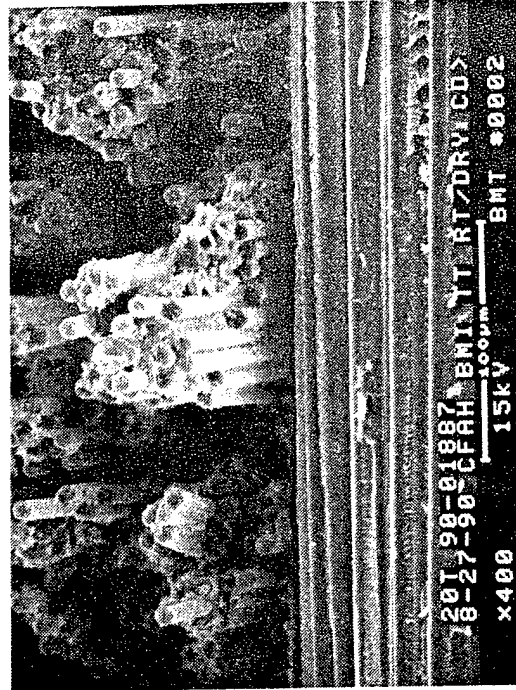
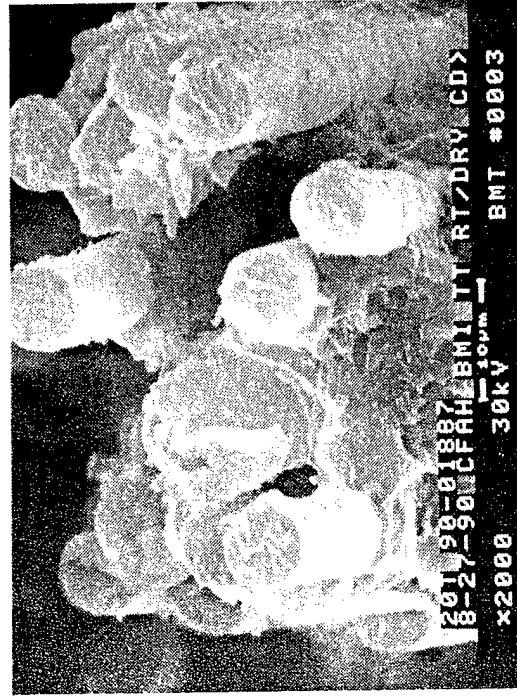
SEM fractography (Figure 3.5-5) revealed radial patterns on the fiber ends, indicating a resultant crack direction consistent with the mechanically induced direction. The specimen tested at 450° F did not fracture but only bent during the testing (Figure 3.5-6)

Figure 3.5-5. SEM Fractographs of an AS4/BMI Translaminar Tension RT/Dry Fracture

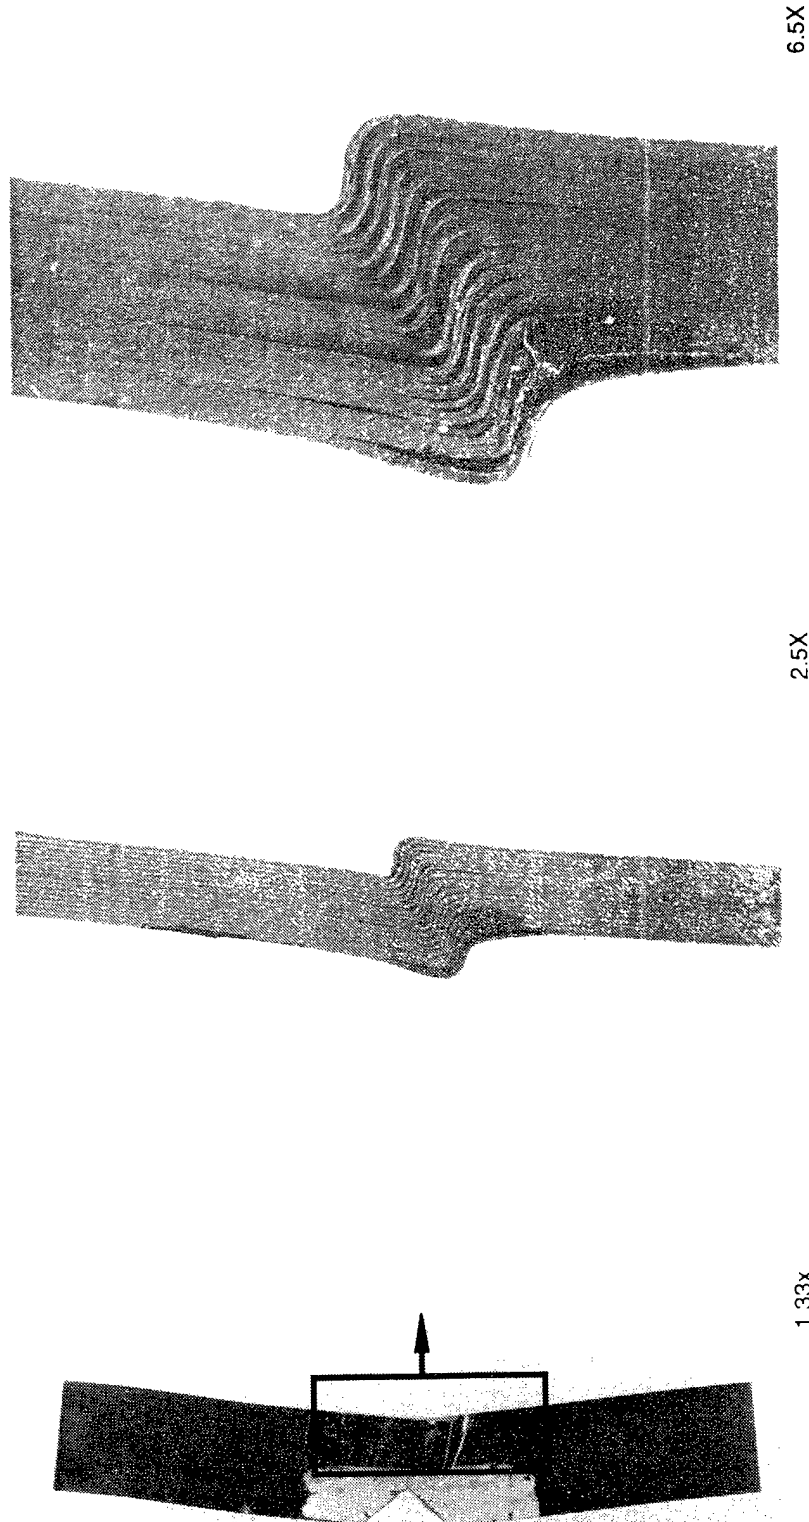
(a) Face View  
 (b) Cross-Section View  
 Figure 3.5-6. Macrophotographs of BMI/AS4 Translaminar Tension Specimen Tested at 450° F/Dry

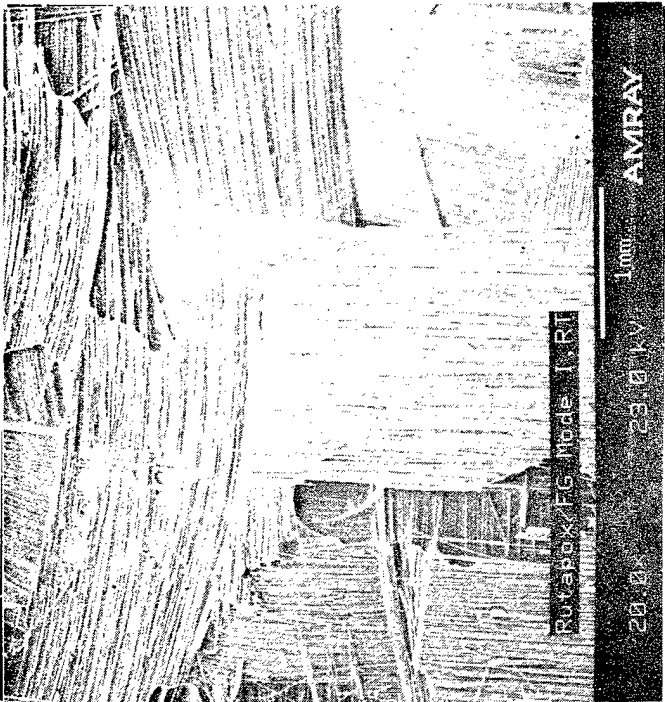
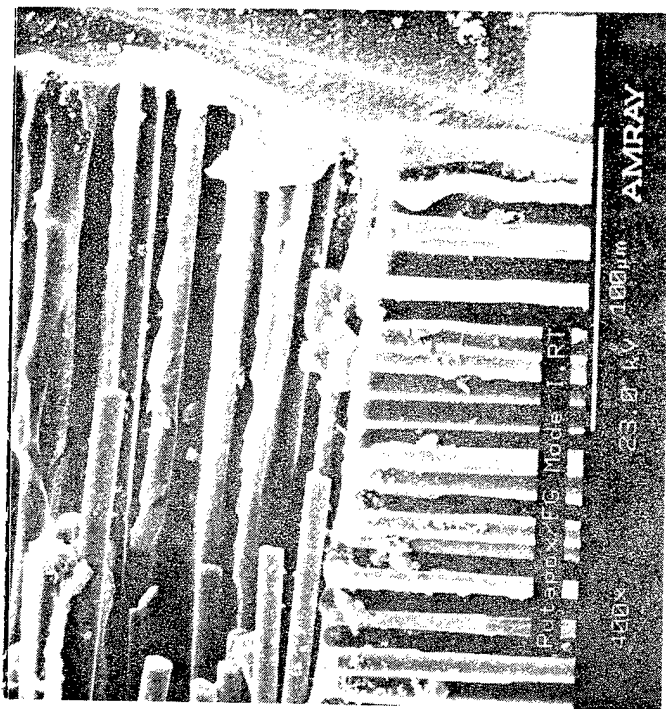
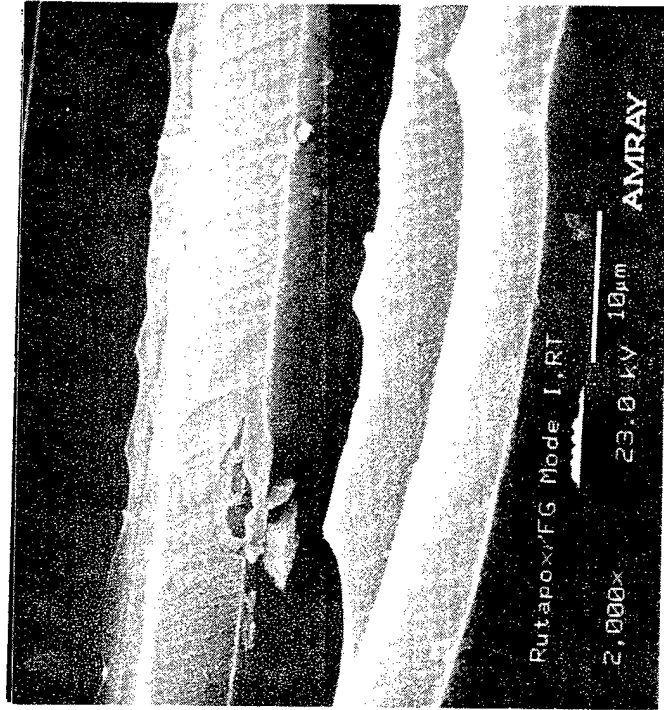
Visual examination revealed an opaque white fracture surface and an easily discernible fiber fabric weave. As shown in Figure 3.6-1 & 3.6-2, SEM examination revealed very few regions containing rivermarks, which would indicate the crack growth direction. In addition, there were numerous areas of matrix material cracking features that appear to be similar to hackles, which are usually indicative of a mode II shear loading than mode I tensile. The high strain rate test fracture surfaces Figure 3.6-3 & 3.6-4, exhibited a smaller region of fracture between the fabric plies. The "high" spots of the fabric weave were apparently the only areas that had fractured.

Figure 3.6-2. SEM Fractographs of a Rutapox/FG Fabric Interlaminar Mode I (Tensile) Fracture Surface, RT

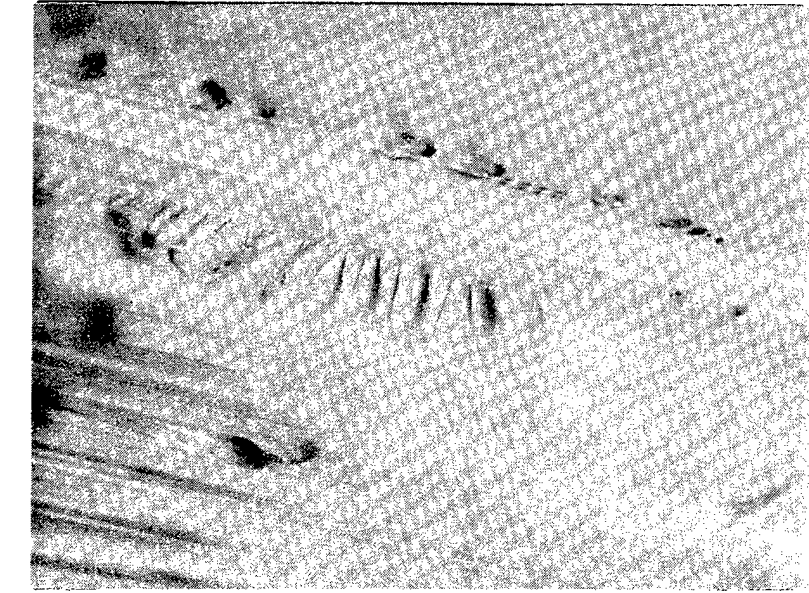
Figure 3.6-3. Optical Fractographs of a Rutapox/FG Fabric Interlaminar Mode I (Tensile) High-Rate Fracture Surface, RT

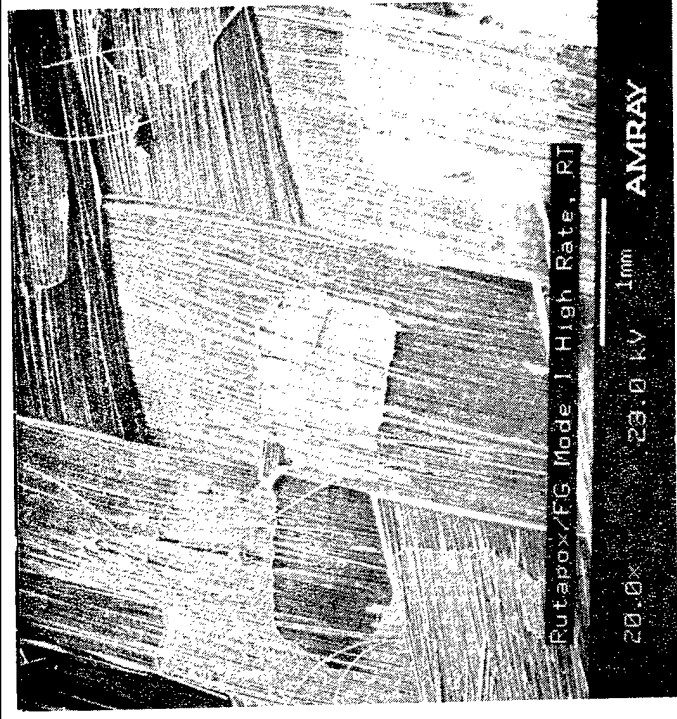
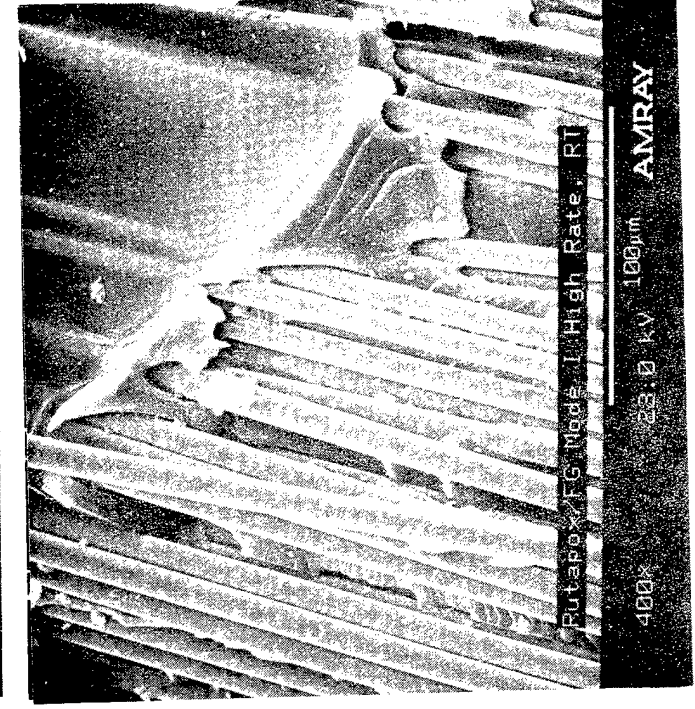
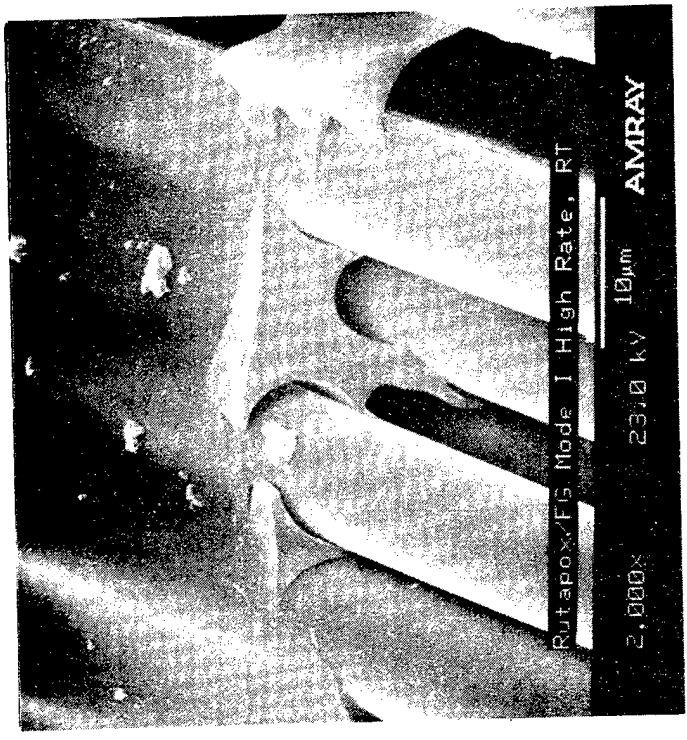
The fracture surfaces of both specimens exhibited similar features (Figure 3.6-4 & 3.6-5). The fabric tows parallel to the crack propagation orientation contained the hackles typical of a shear loading. Whereas the tows perpendicular to the crack direction exhibited ribbons of resin tearing from the fibers. The torn ends were generally bent towards the crack propagation direction.

Figure 3.6-4. SEM Fractographs of a Rutapox/FG Fabric Interlaminar Mode I (Tensile) High-Rate Fracture Surface, RT

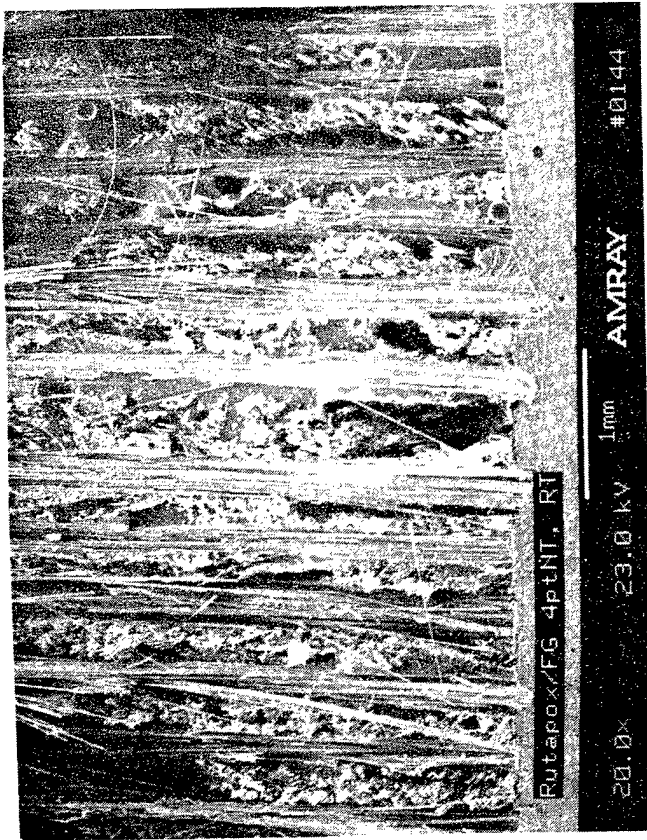
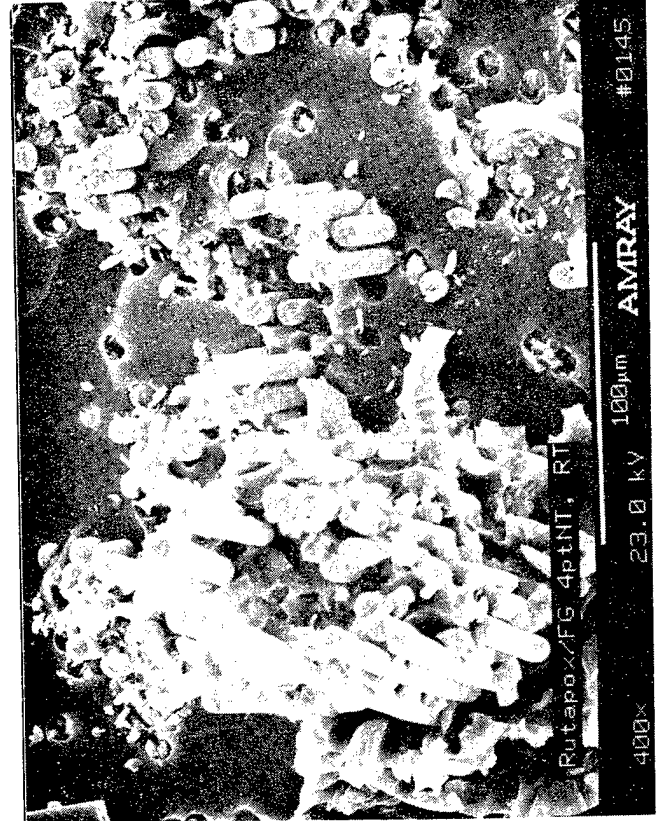
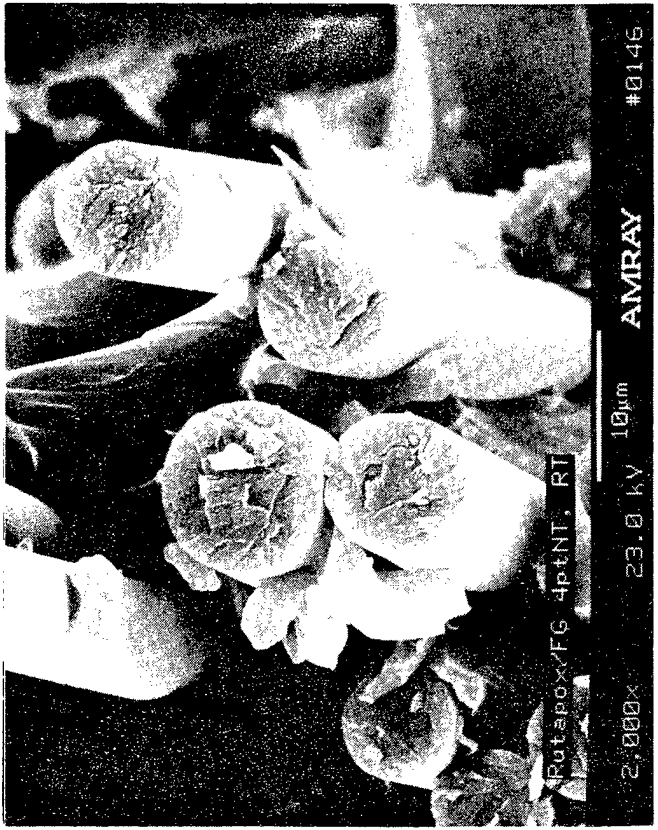
Figure 3.6-11. SEM Fractographs of a Rutapox/FG Roving 4ptNT Specimen Fracture Surface, RT

Large amounts of fiber pullout were present throughout the surfaces of both specimens (Figure 3.6-11 & 3.6-12). Fibers that pulled out from along the intralaminar surfaces (the 90° direction tows) were not wetted very thoroughly and the resin fracture surfaces on this fracture surface contained only a few fracture features. Unlike the other roving specimens, there didn't appear to be thorough fiber wet out in these roving specimens.

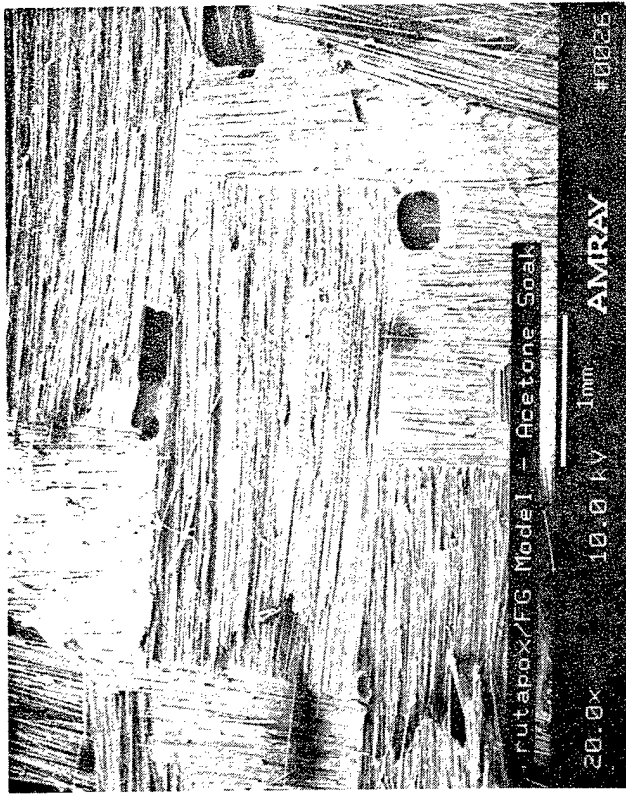
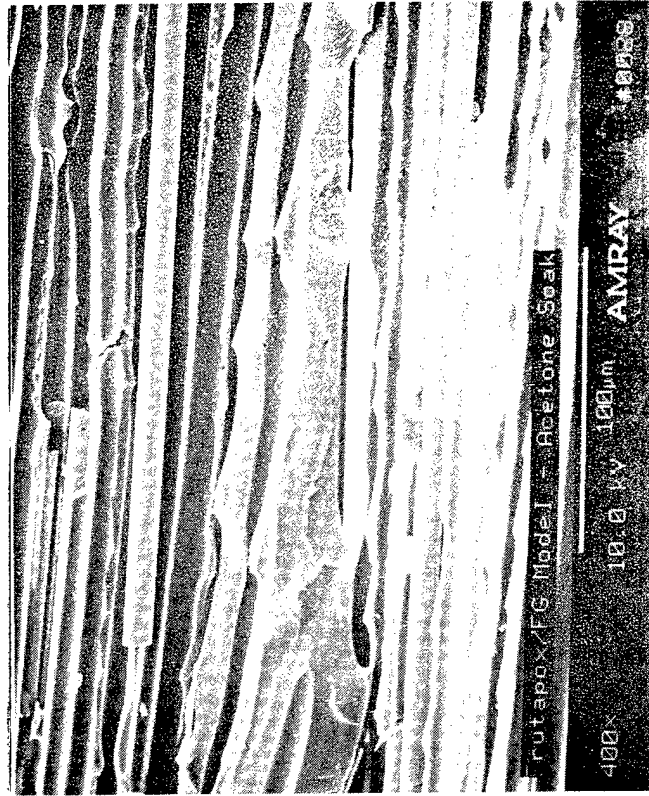
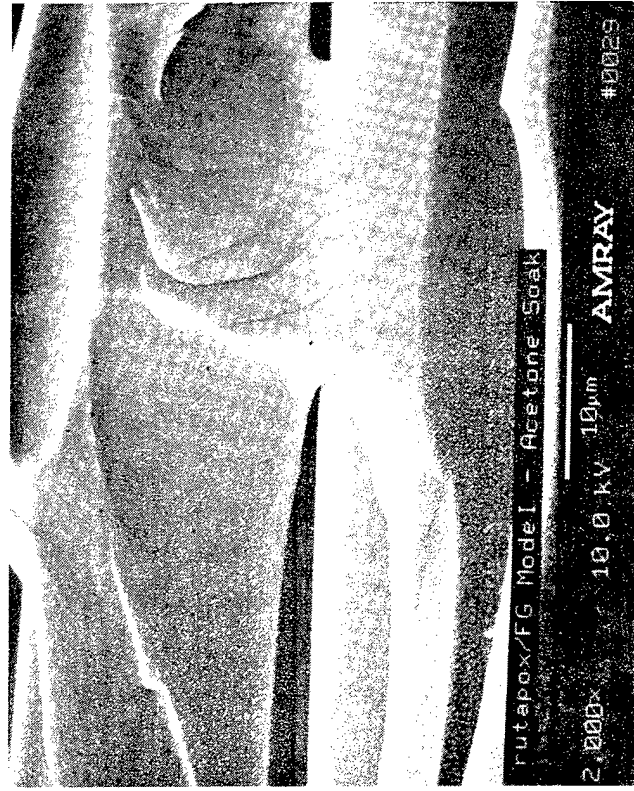
Figure 3.6-14. SEM Fractographs of a Rutapox/FG Fabric Interlaminar Mode I (Tensile) Fracture Surface Exposed to Acetone for 7 days

For the Rutapox epoxy resin system, only four specimens were examined that were of the most severe environments; JP4, Acetone, MEK, and Hydraulic Fluid (Figure 3.6-14 through 3.6-16). Examination of the fracture surfaces revealed no degradation of the fracture features regardless of the exposure conditions.

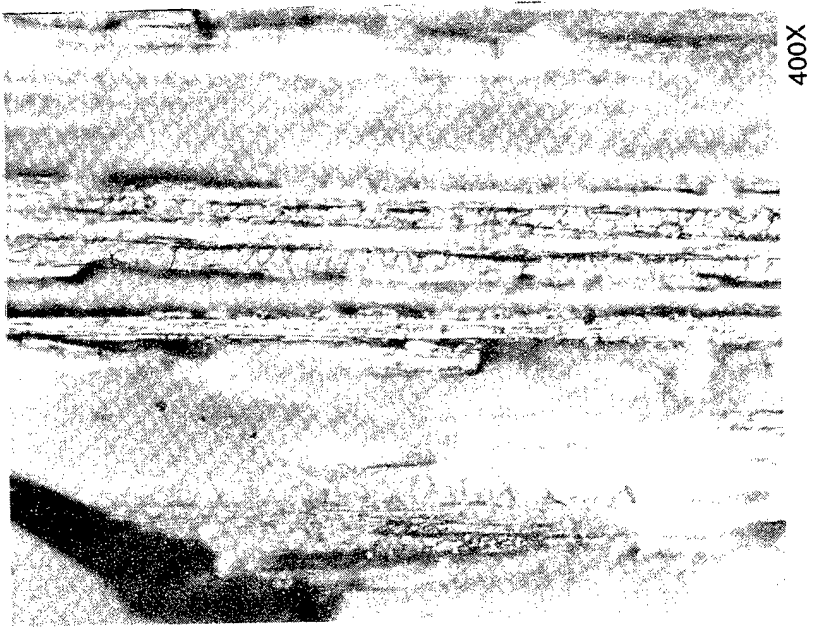
Figure 3.7-3. Optical Fractographs of a Rutapox/Graphite Fabric Interlaminar Mode I (Tensile) High-Rate Fracture Surface, RT

The high strain rate specimen fracture surfaces (Figure 3.7-3 & 3.7-4) were similar to the normal rate specimens, but the river patterns were more evident.

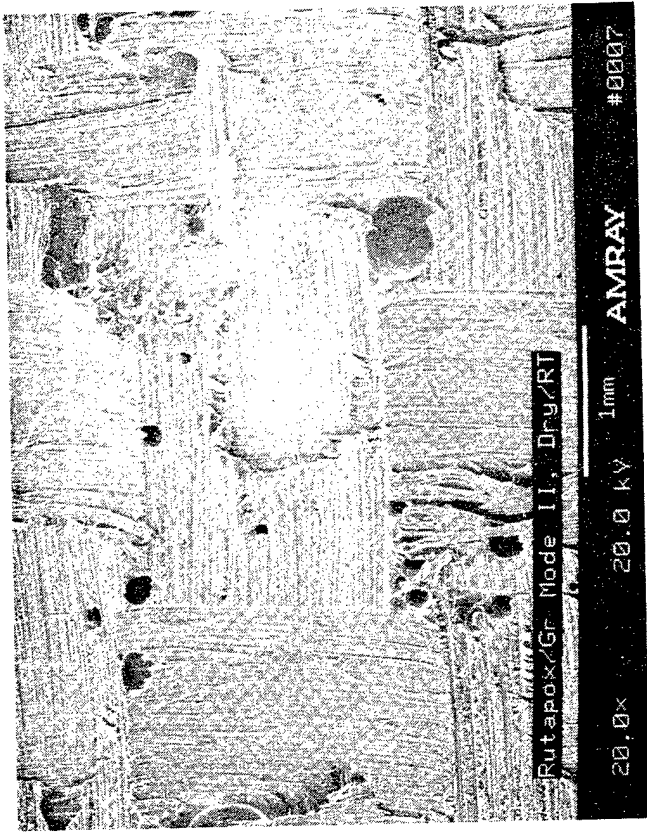
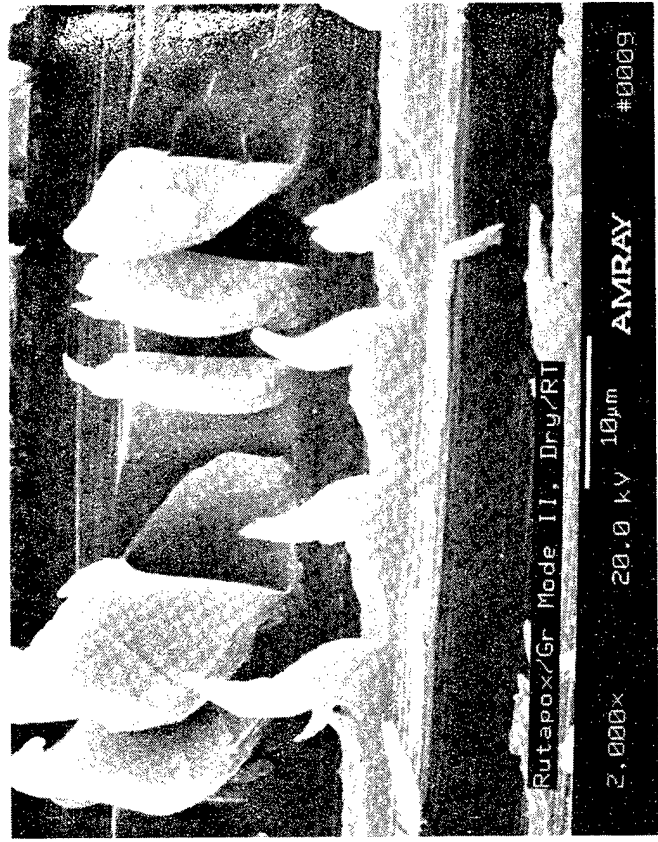
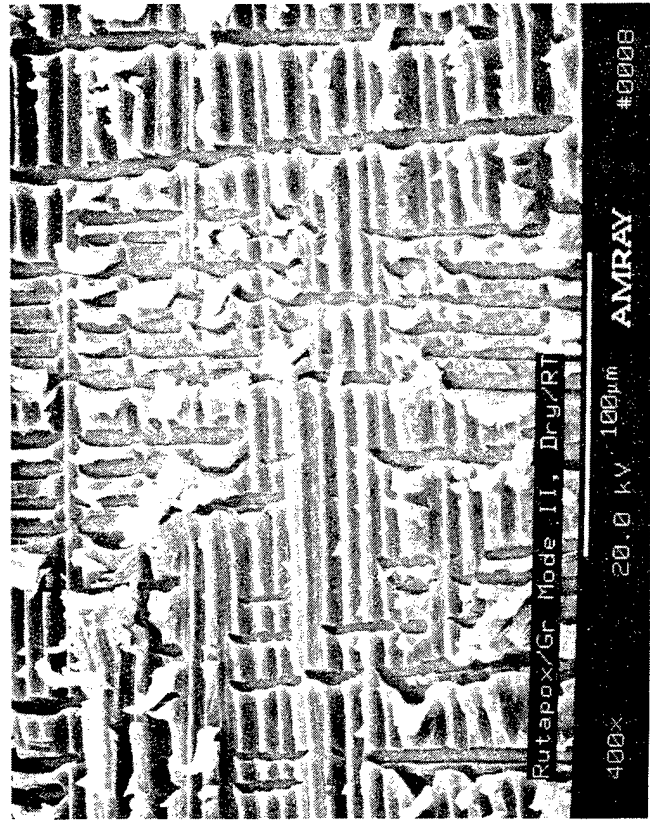
Figure 3.7-5. SEM Fractographs of a Rutapox/Graphite Fabric Interlaminar Mode II (Shear) Fracture Surface, RT

The visual appearance was generally rough similar to the mode I surfaces but with fewer shiny regions (Figure 3.7-5 & 3.7-6). The fracture surfaces were similar to the fiberglass specimens with the exception of the carbon fiber features as mentioned above. The fabric tows parallel to the crack propagation orientation contained the hackles typical of a shear loading and the tows perpendicular to the crack direction exhibited the ribbons of resin. The torn ends of the resin were generally bent towards the crack propagation direction.

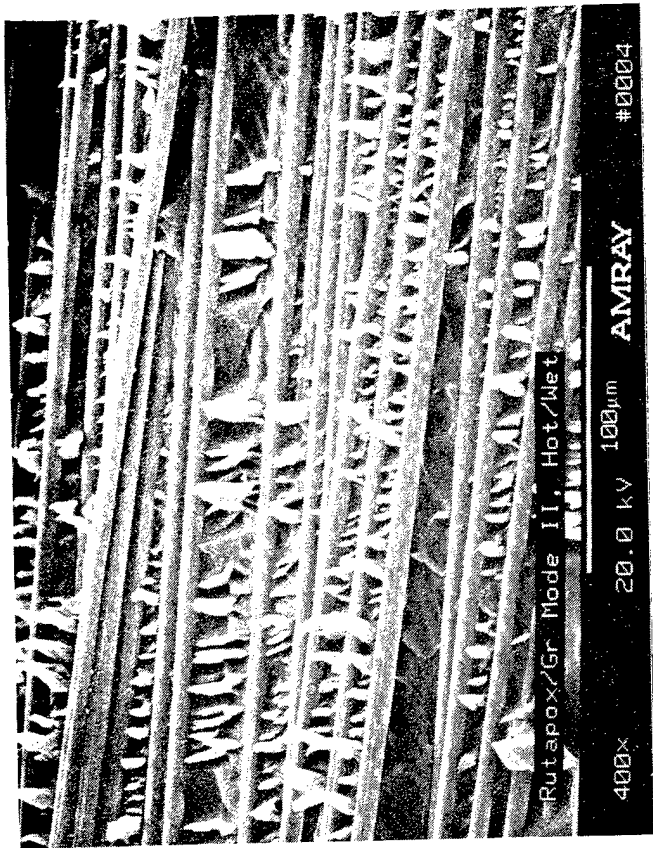
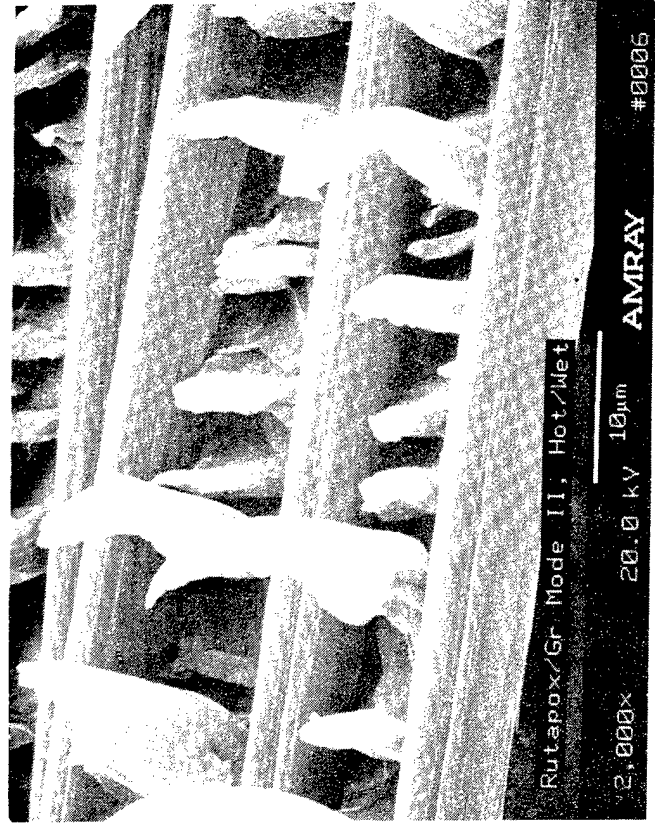
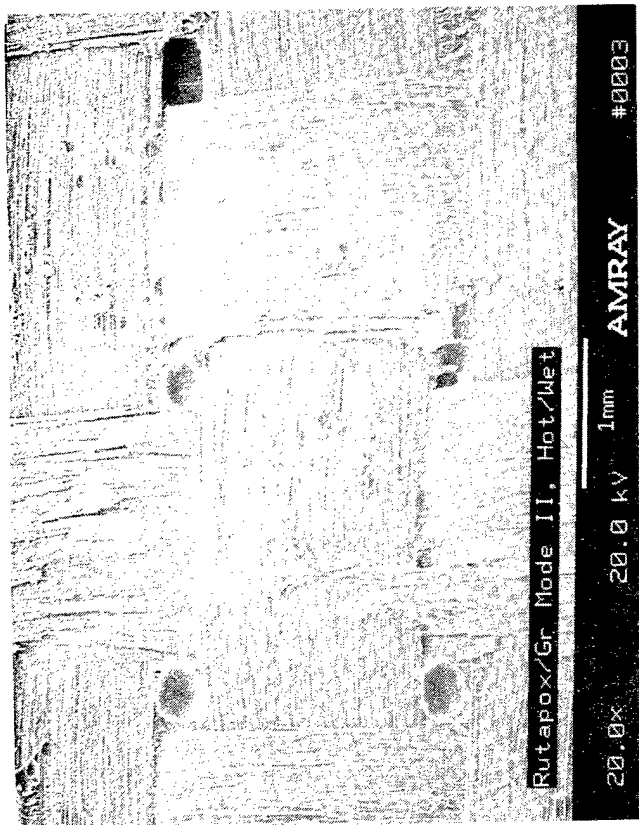
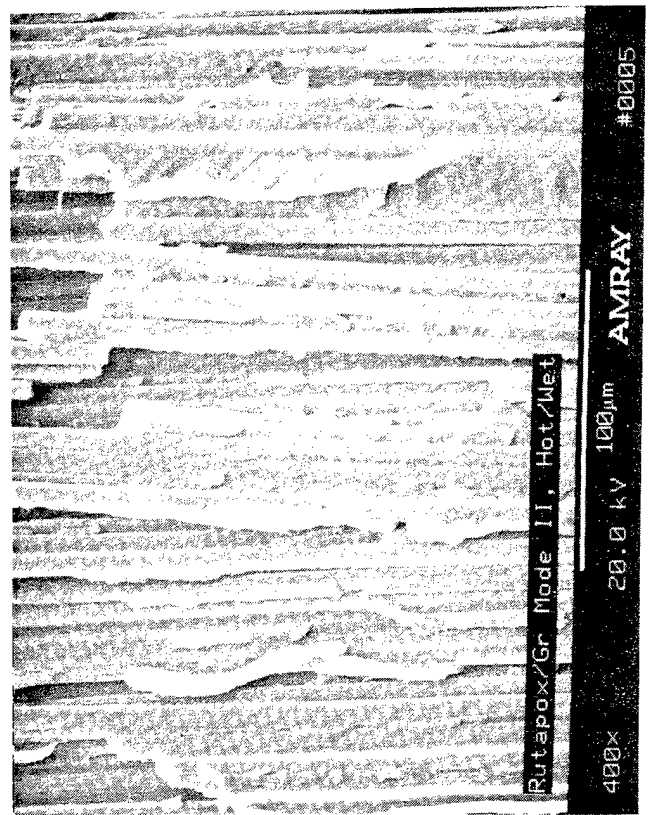
Figure 3.7-6. SEM Fractographs of a Rutapox/Graphite Fabric Interlaminar Mode II (Shear) Hot/Wet Fracture Surface, RT

The fracture surface of the RT/dry specimen was composed mainly of resin which indicates that the crack propagated through the interface between the fabric surface (as seen in the Hot/Wet fractographs) and

the resin. This resin fracture surface also contained translaminar cracks, perpendicular to the fibers, which are typical of shear cracked resin surfaces. In addition, voids were also present at the fabric tow intersections.

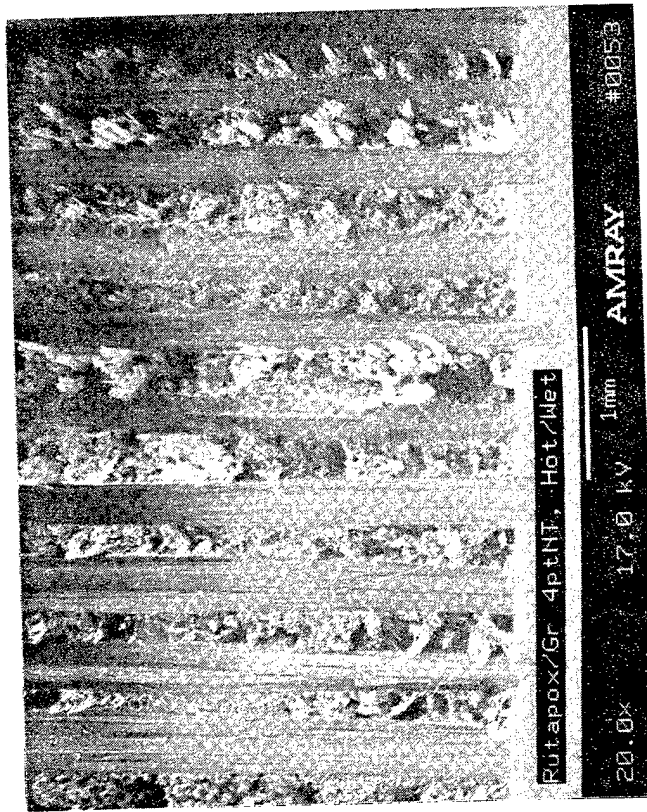
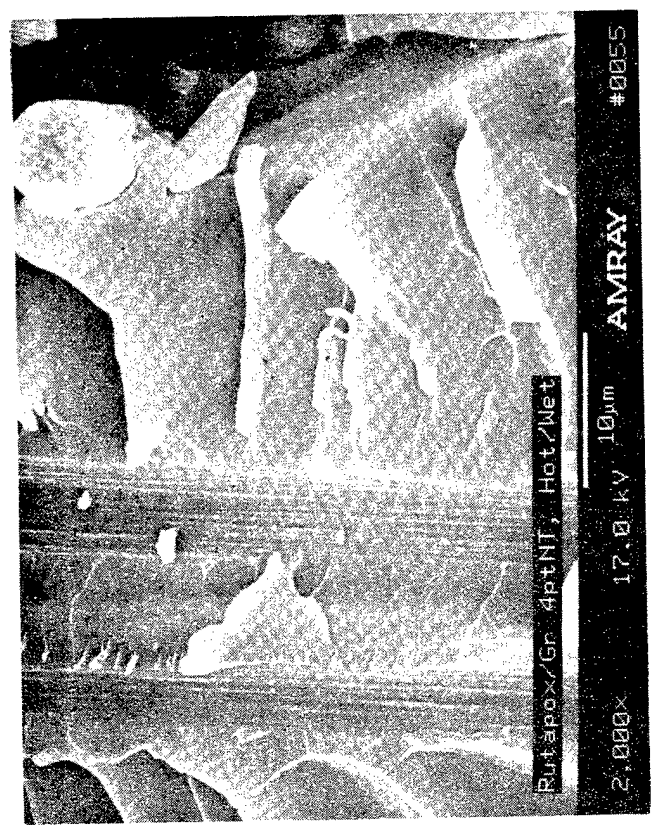
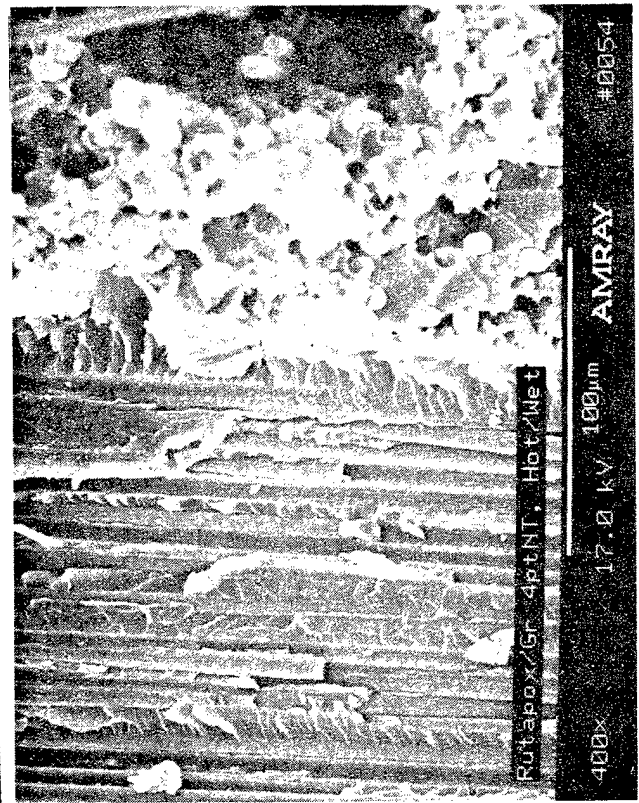
Figure 3.7-7. SEM Fractographs of a Rutapox/Graphite Roving 4ptNT Fracture Surface, Hot/Wet

Both fracture surfaces (Figures 3.7-7 & 3.7-8) were similar and both contained slightly oval fibers with longitudinal striations. There was little correlation between the fiber end fractures and the macroscopic fracture direction. In addition, even there was fairly good wetting of the fibers by the resin, it was difficult to determine the fracture direction on the ply surfaces parallel the fracture direction. Few fracture morphology features were evident on the these surfaces.

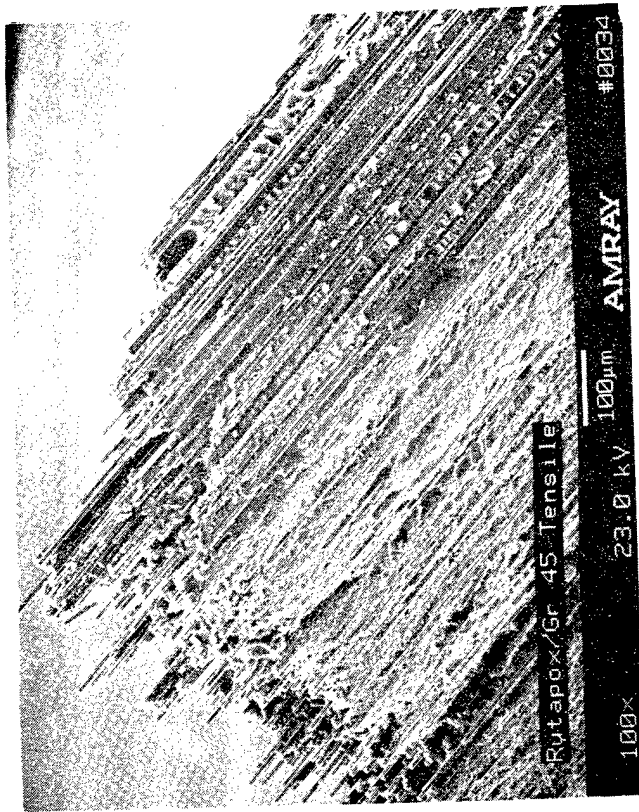
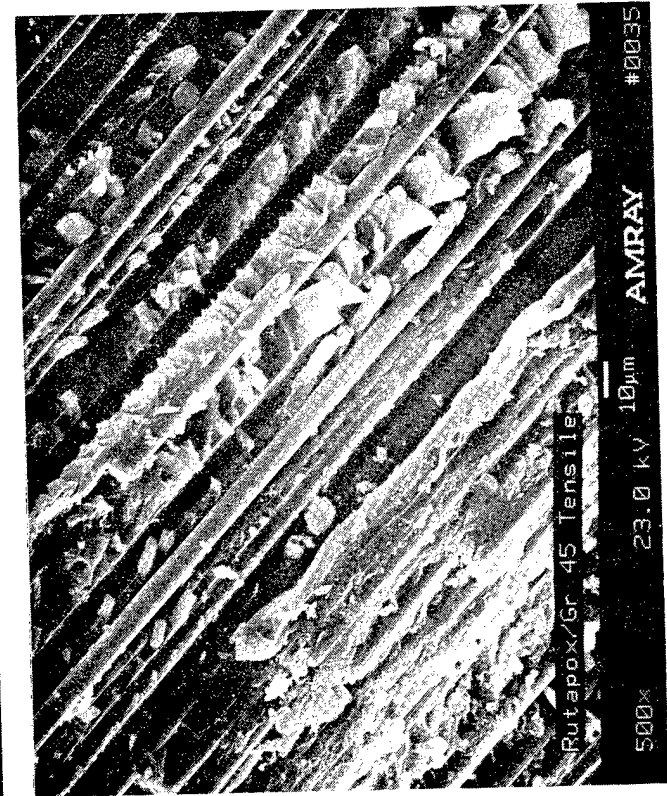
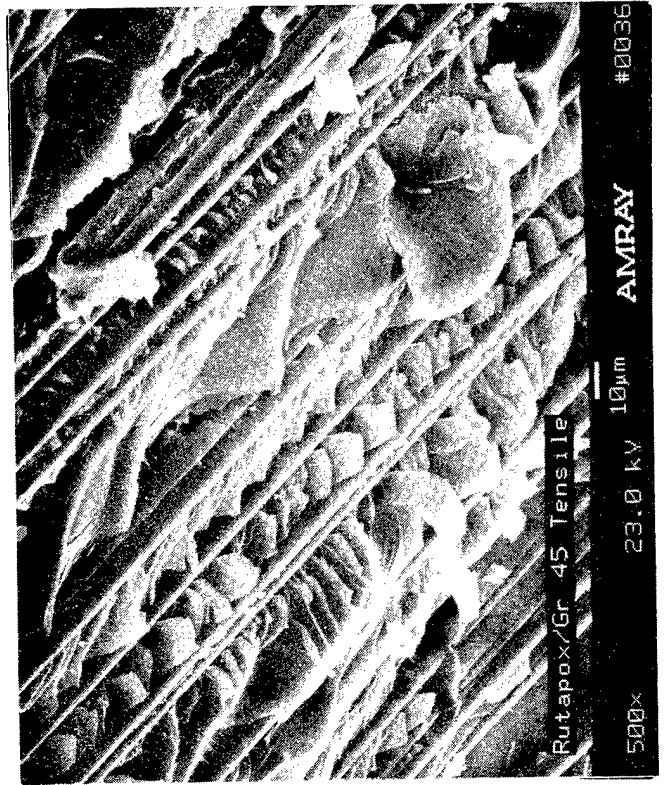
Figure 3.7-9. SEM Fractographs of a Rutapox/Graphite Fabric  $\pm 45^\circ$  Tensile Fracture Surface, RT

The overall appearance of the fabric surface exhibited both mode I and II fractures features (Figure 3.7-9). The orientation of the hackles did not give an obvious indication of the overall crack propagation direction.
