DOT/FAA/AR-96/21

# Composite Failure Analysis Handbook Update 1

WL-TR-93-4004

August 1997

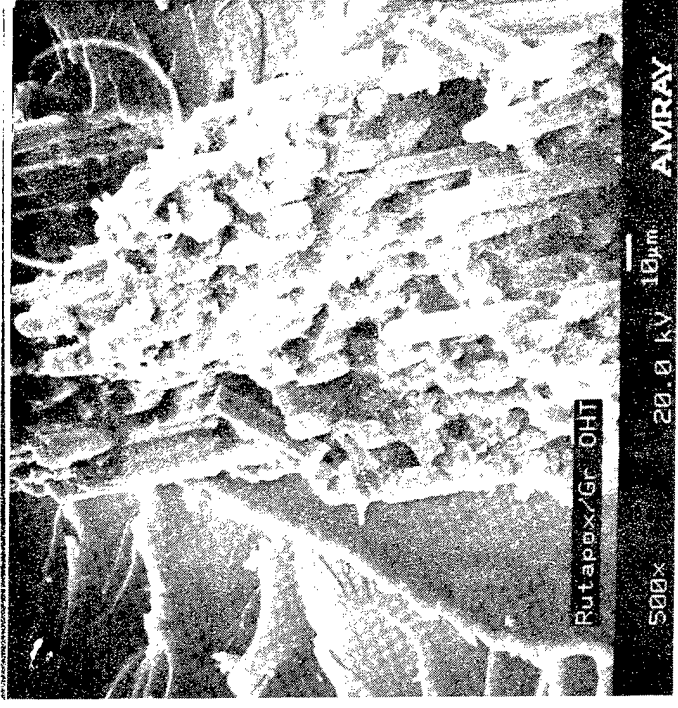
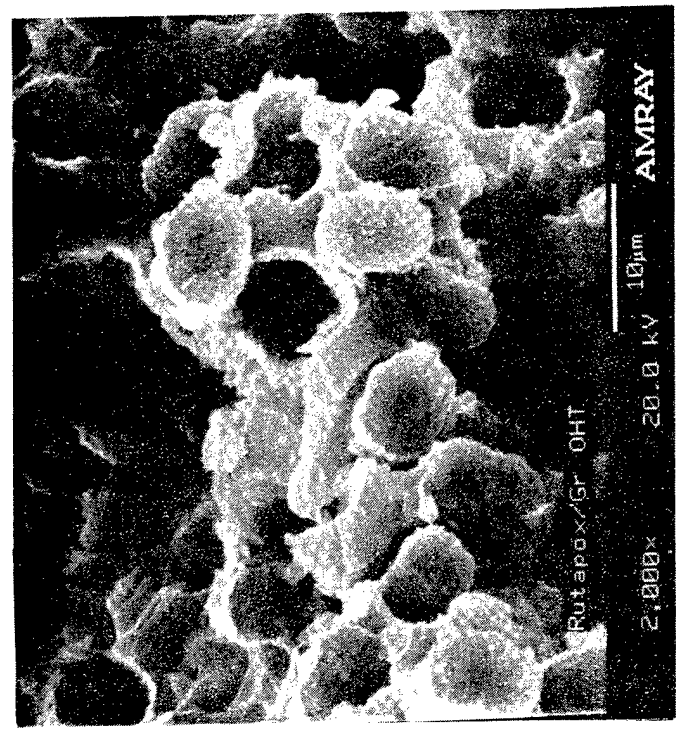
Figure 3.7-10. SEM Fractographs of a Rutapox/Graphite Fabric Open Hole Tension Fracture Surface, RT

The fiber ends did not clearly indicate the overall crack direction from examination of a small sample (Figure 3.7-10). The fibers were oval and contained distinct longitudinal ridges. Tracer yarns in the fabric were clearly visible and were initially confused with some type of fiber pull-out condition. The plies parallel to the crack direction had hackles on the surfaces, but it generally appeared that these tow regions were pulled apart in a mode I.

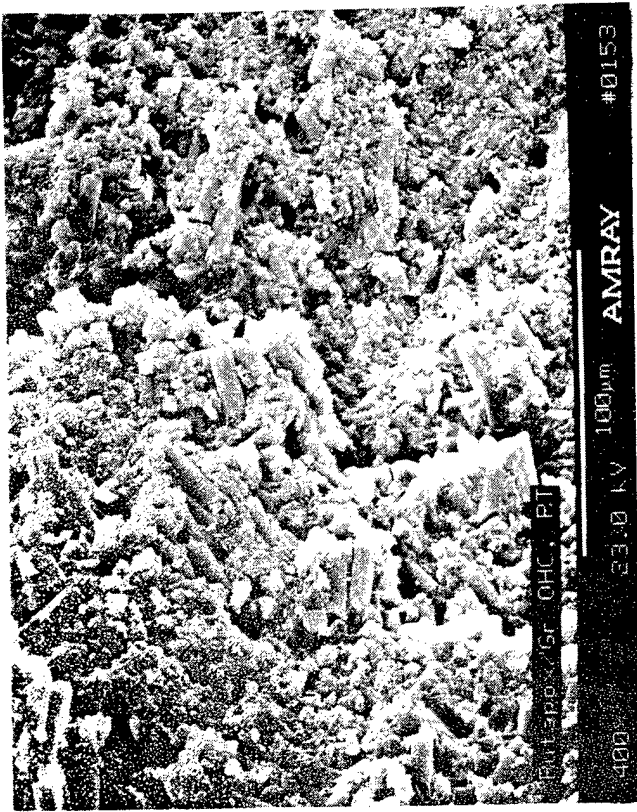
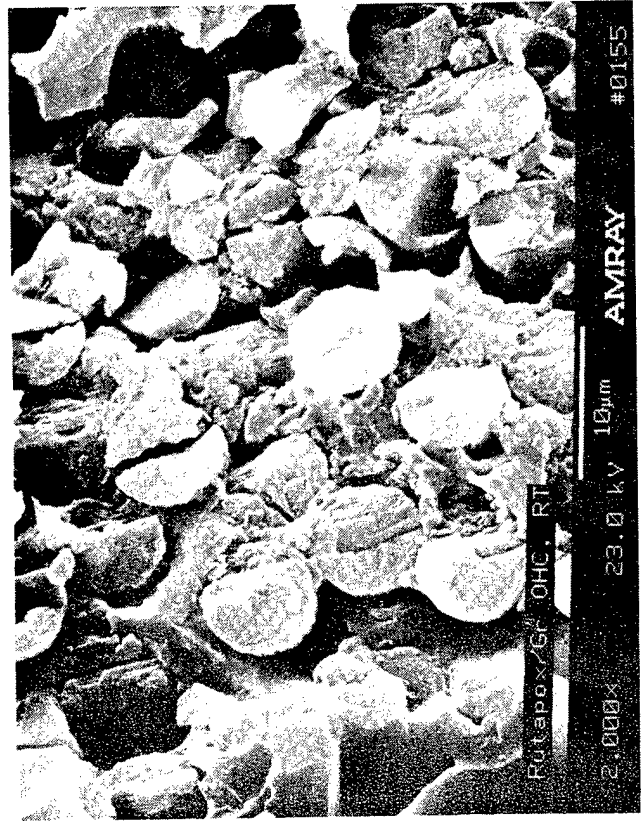
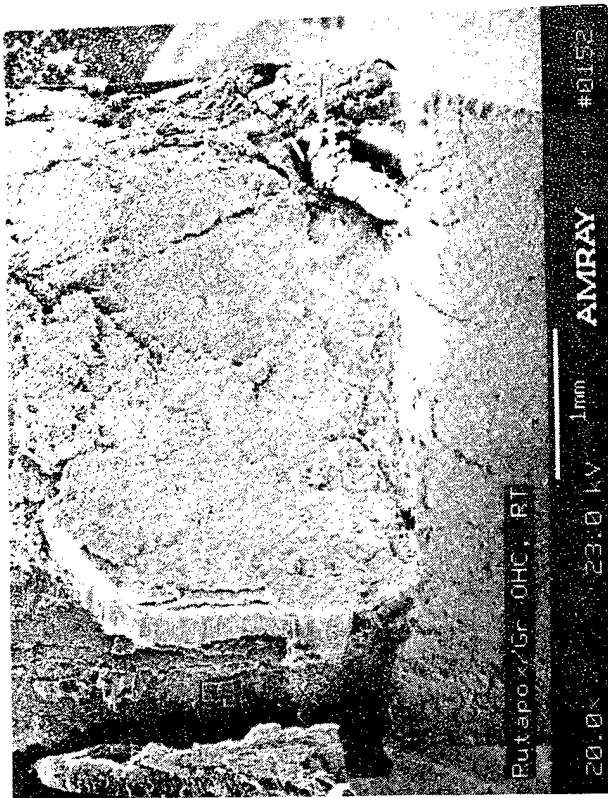
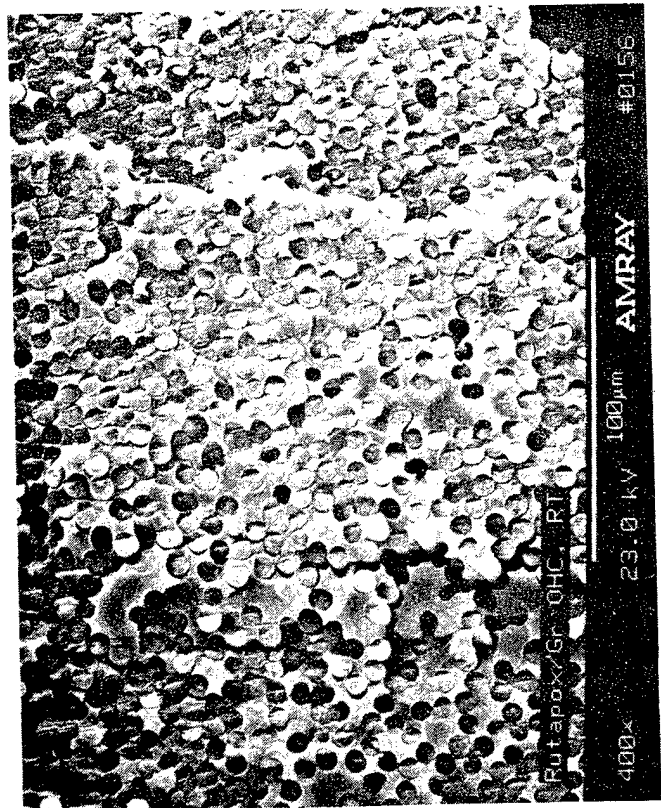
Figure 3.7-11. SEM Fractographs of a Rutapox/Graphite Rovings Open Hole Compression Fracture Surface, RT

Two distinct regions were present on the fracture surfaces (Figure 3.7-11). The region adjacent to the hole contained a great deal of rubble covered with small sections of fractured fibers. The regions further away from the hole exhibited the classic compression fracture morphology with the distinct centerline through the fibers. In addition, some of the fibers were actually split along their centerline to an unknown depth.

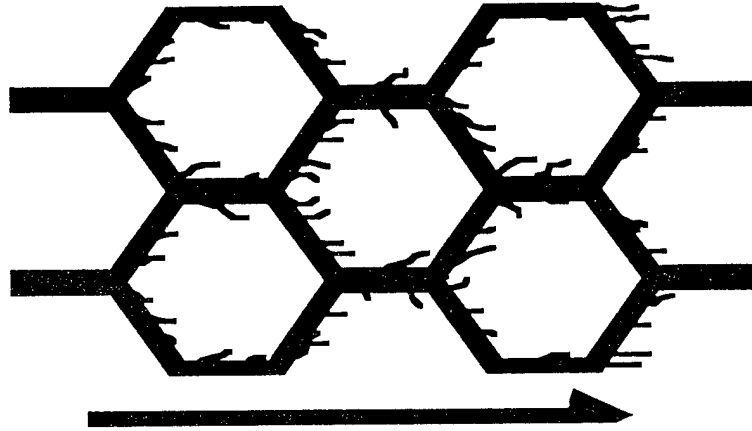
Failure propagation in honeycomb material is best determined by examination of the fiber pullout and by the direction in which the fiber is bent. As the honeycomb fails, the fiber and resin fail separately. The fiber is often freed from the resin by the failure and is drawn plastically in the direction of the displacement due to the propagation of the failure. For tensile failure this displacement is nearly normal to the direction of propagation, with a slight bias in the direction of propagation. The bias can result in plastic deformation of the side of the fiber away from the propagation direction or breakage of the fiber with the propagation direction of the crack in the fiber the same as that in the honeycomb. The result of these effects is that the propagation direction is indicated by the lay of the loose ends of fibers along the failed surface (see Figure 3.8-1). Studying the crack propagation directions in the resin meniscus where the honeycomb ribbons join is a more difficult method of determining the failure propagation direction.

Figure 3.8-1. *Fibers Torn and Bent in the Direction of the Propagation of the Failure*

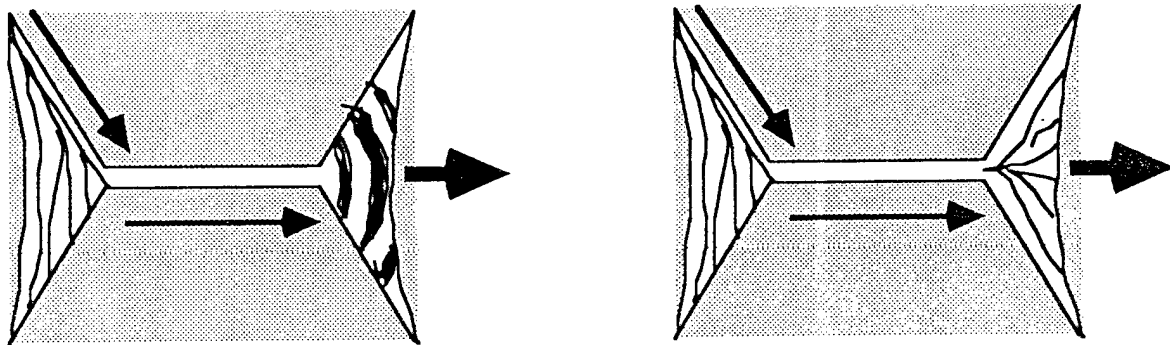
Figure 3.8-4. Failure Patterns in the Resin Menisci Indicating the Propagation Directions

The illustration on the left shows "Wallner" lines indicating the failure initiated at the apex of the upper arm of the meniscus. It then propagated across the joint and caused a conchoidal fracture in the trailing meniscus. The illustration on the right shows the same type of event but with a Wallner line failure pattern at the trailing meniscus.

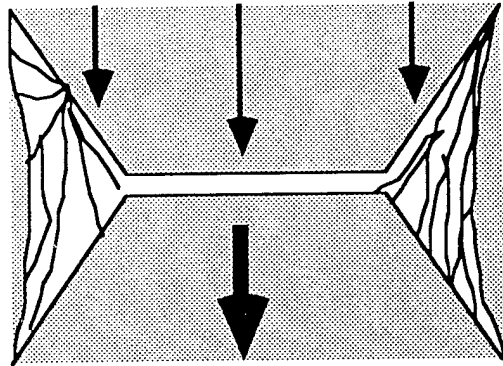
Figure 3.8-6. The Wallner Line Pattern for a Failure Propagating Normal to the Ribbon Direction

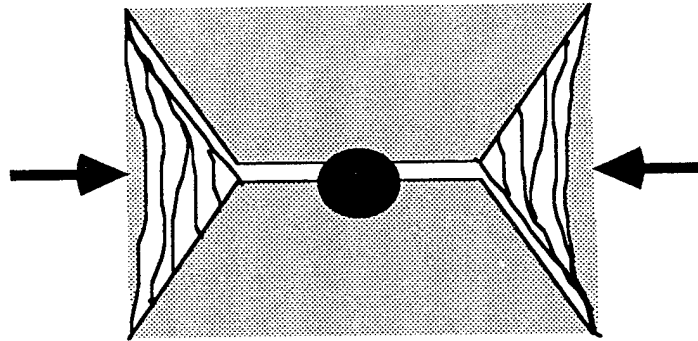
Figure 3.8-7. The Wallner Line Pattern for a Failure Propagating Inward From Both Sides Indicating a Vertical or Twisting Failure

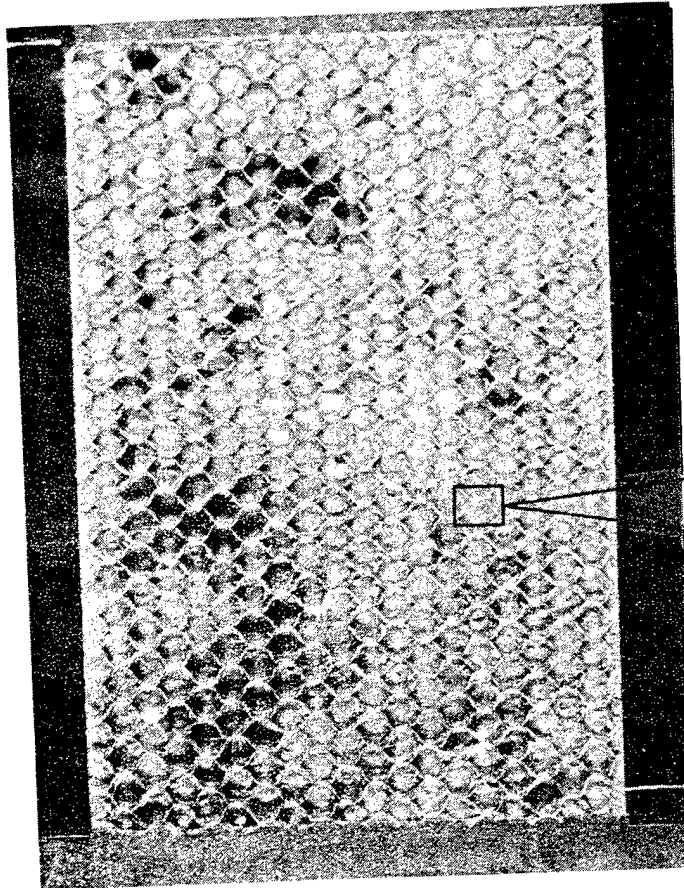
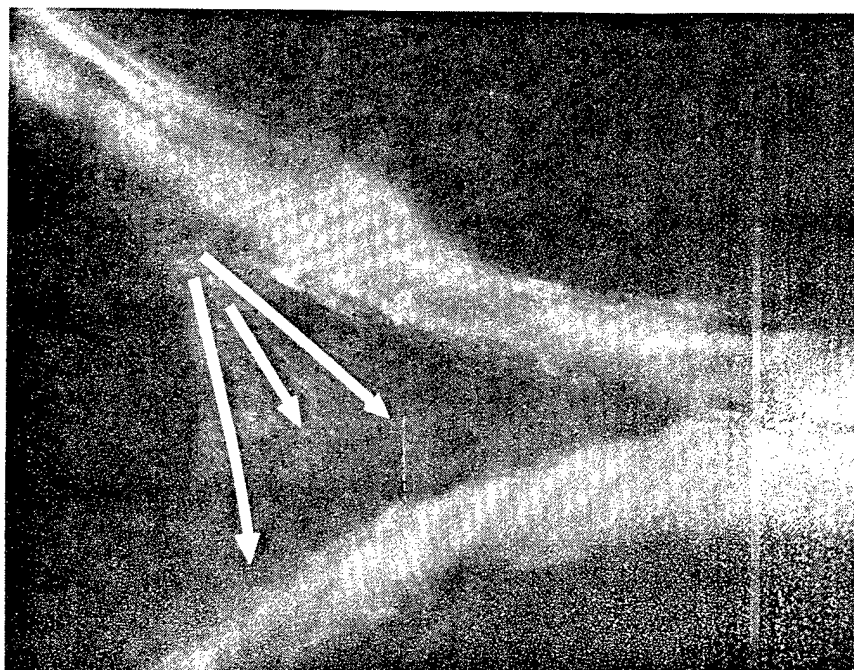
Figure 3.8-9. *Optical Fractographs of Mode I Sandwich, Control Specimen  
Sheet 1 of 2*

**Control Specimen.** No adhesive or cohesive failures were seen in these specimen types. As shown in Figure 3.8-9, 100% core failure was observed.

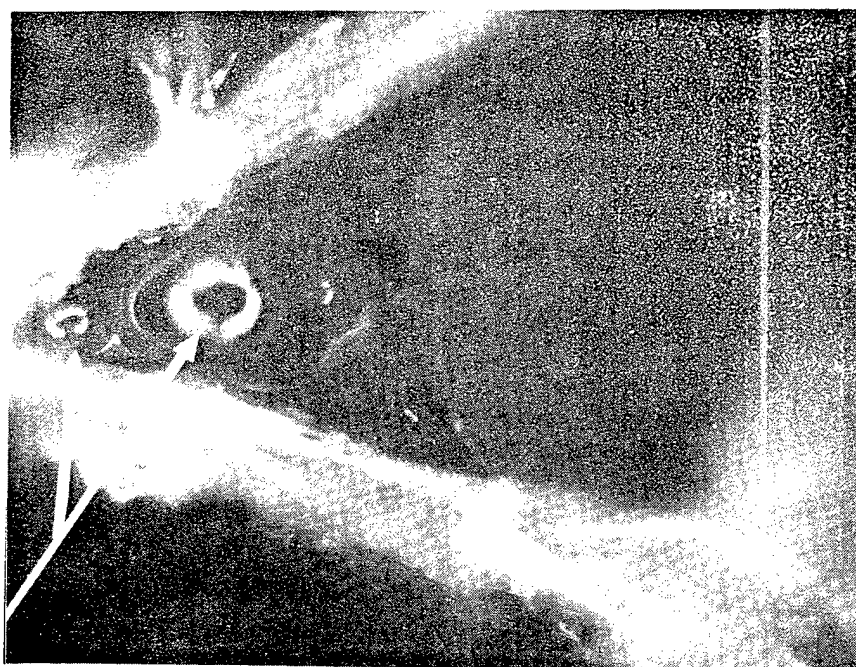
Sample 1A-1

Bubbles

Figure 3.8-9. *Optical Fractographs of Mode I Sandwich, Control Specimen*  
Sheet 2 of 2

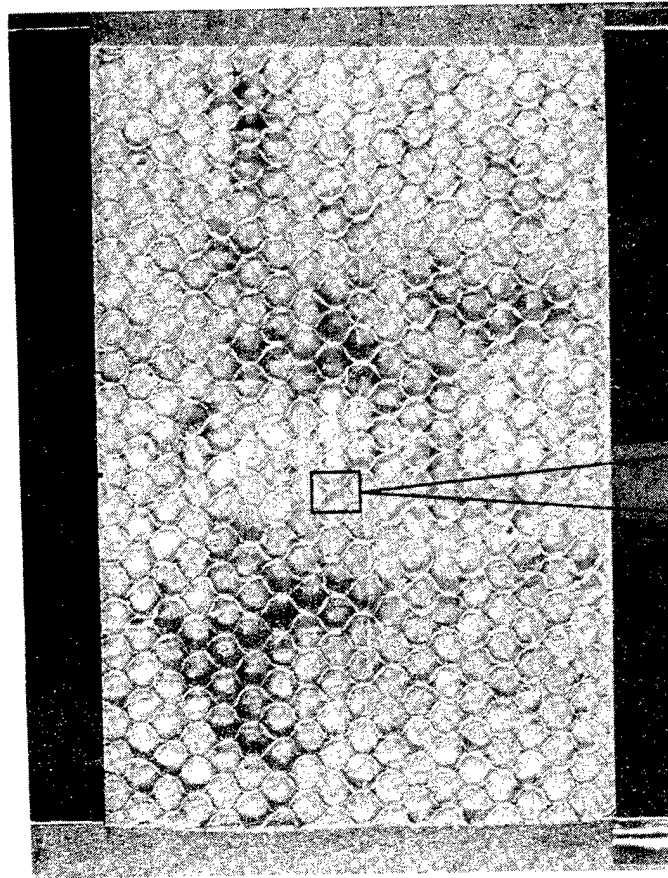
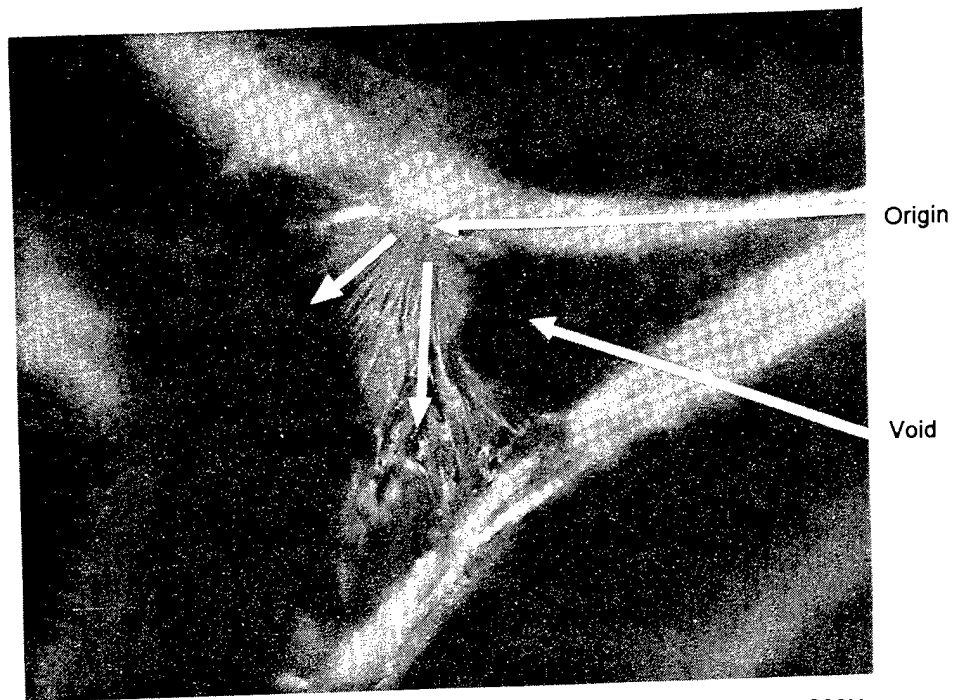
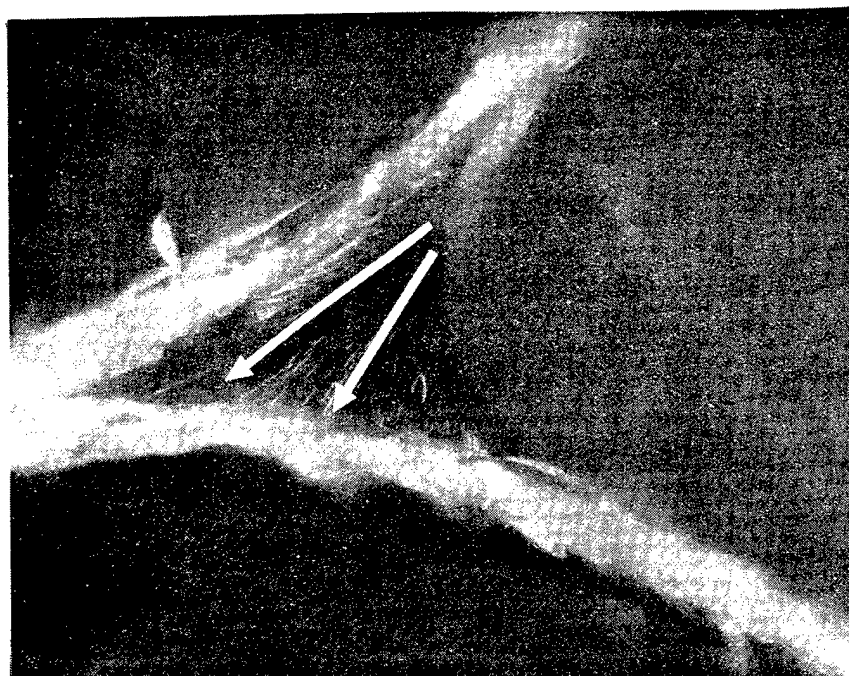
Sample 2B

**Aged Adhesive Specimen.** The honeycomb cells appeared to be more distorted in these specimens than in the others. It has not been determined if this is the result of processing or testing. The amount of burst fibers was less than that seen in the control specimen. As shown in Figure 3.8-10, the failure was in the honeycomb.

*Figure 3.8-10. Optical Fractographs of Mode I Sandwich, Aged Adhesive Specimen  
Sheet 1 of 2*

*Figure 3.8-10. Optical Fractographs of Mode I Sandwich, Aged Adhesive Specimen (Sheet 2 of 2)*

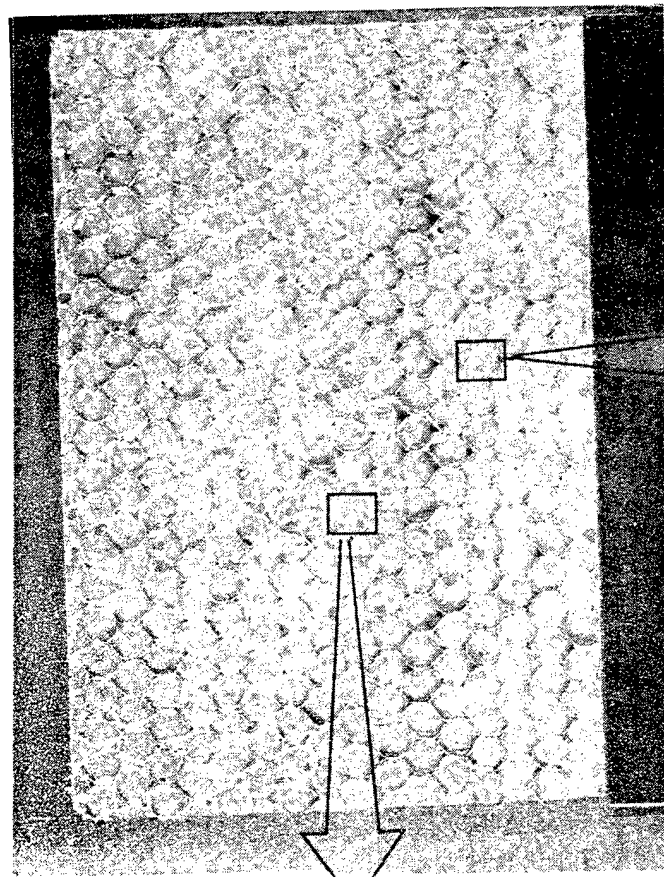
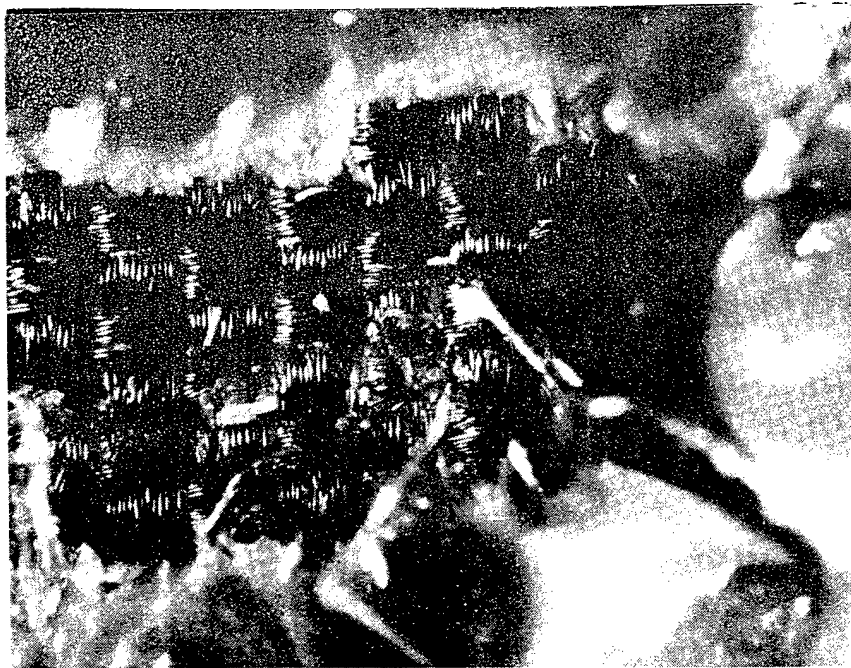
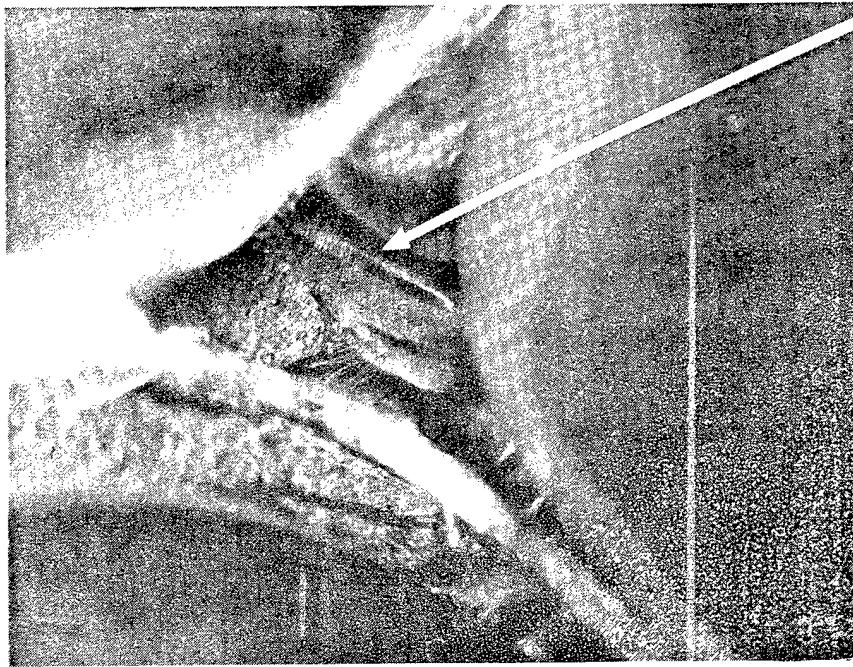
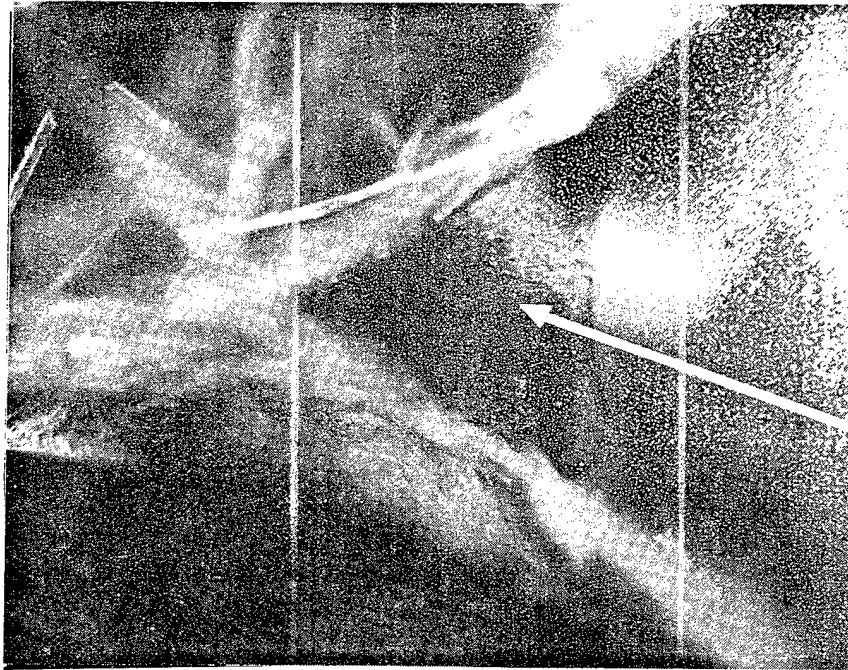
Sample 3A-2

**Eight-Pound Core Specimen.** The failure occurred primarily in the adhesive layer. Both adhesive and cohesive failure was evident. The adhesive failure, between the adhesive and the face sheet, occurred near the center of the specimen. Approximately 25% of the core failure was observed in these specimens. Optical fractographs taken at 200X showed a lower velocity fracture characteristic as evidenced by the mirror and mist fracture features shown in Figure 3.8-11.

Figure 3.8-11. *Optical Fractographs of Mode I Sandwich, Stronger Core Used (8-lb) Specimen Sheet 1 of 2*

Wallner  
lines

Mist

Figure 3.8-11. Optical Fractographs of Mode I Sandwich, Stronger Core Used (8-lb) Specimen  
Sheet 2 of 2

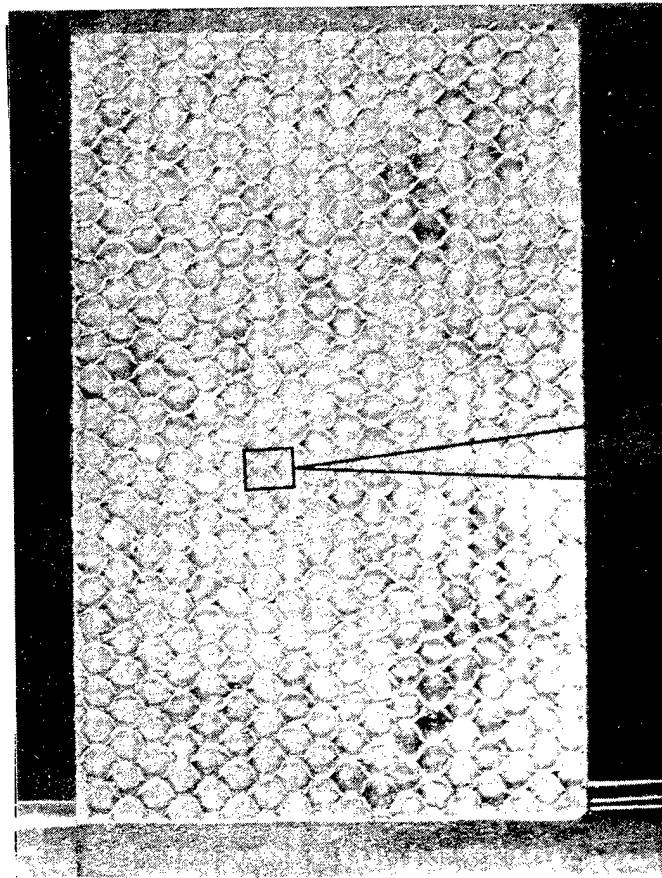
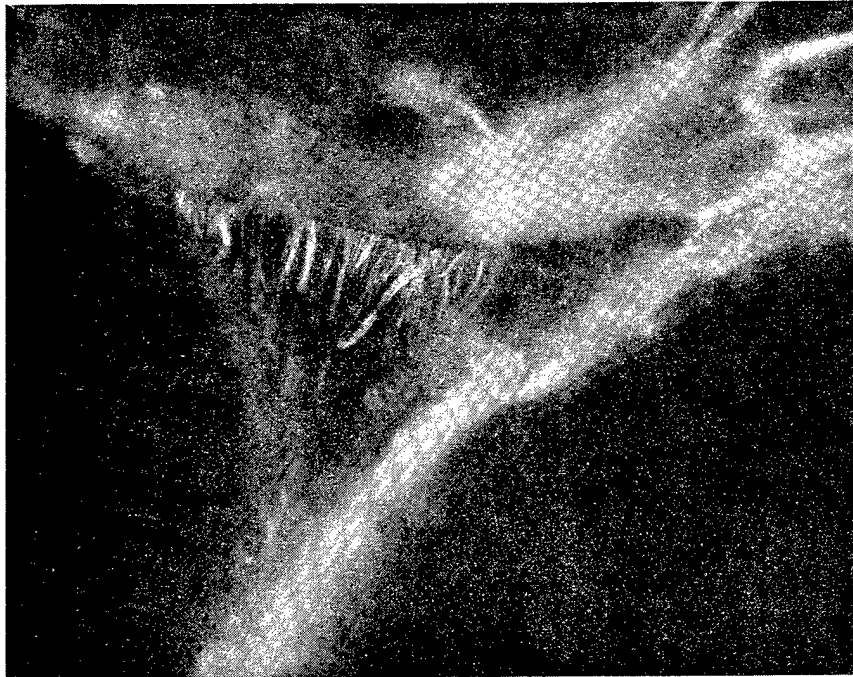
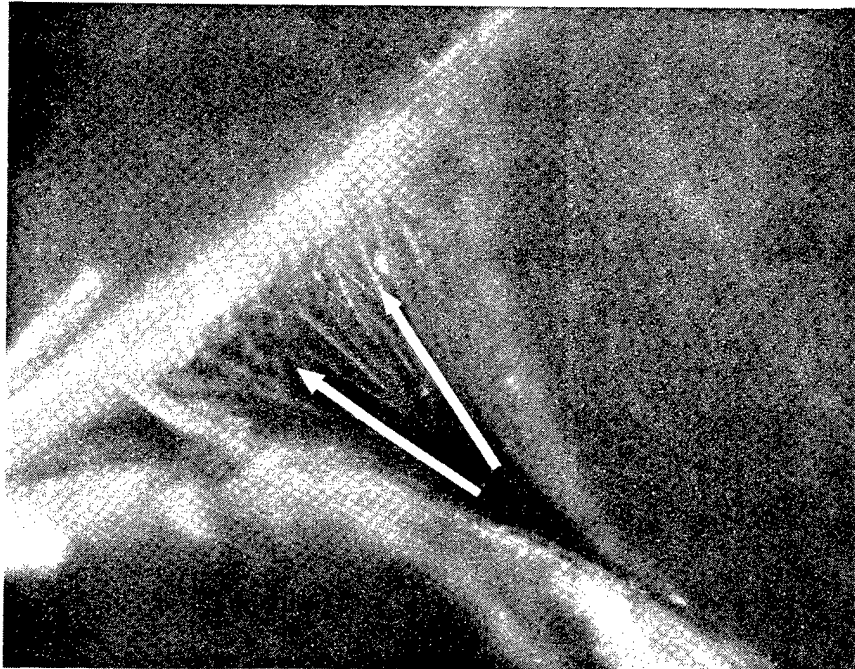
Sample 4B

**Undercured Adhesive Specimen.** There was more burst fiber on the failure surface in this sample than in most of the others, except the control specimens, (Figure 3.8-12).

Figure 3.8-12. *Optical Fractographs of Mode I Sandwich Specimen, Undercured Adhesive*  
Sheet 1 of 2

*Figure 3.8-12. Optical Fractographs of Mode I Sandwich Specimen, Undercured Adhesive*  
Sheet 2 of 2

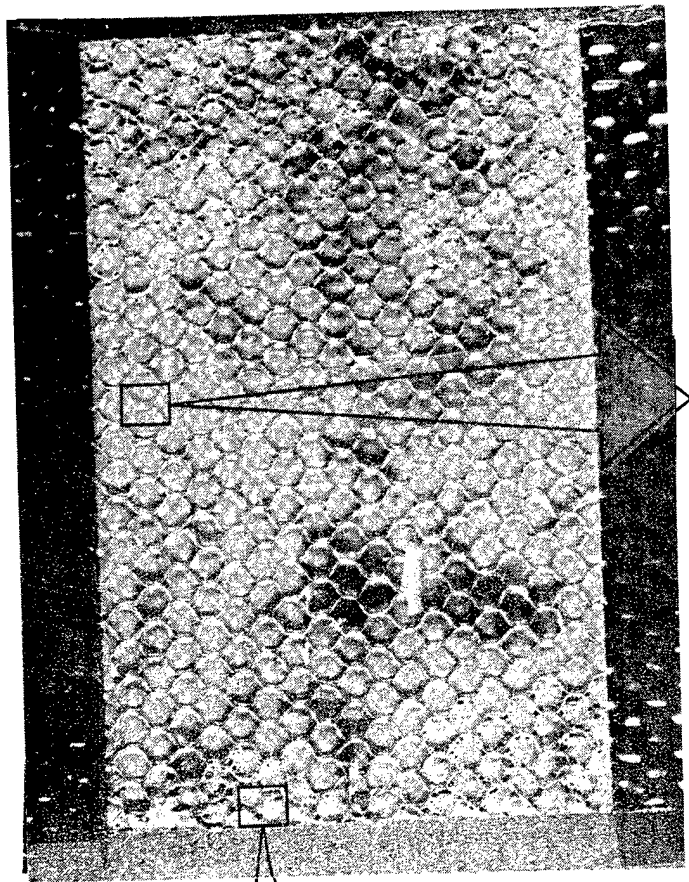
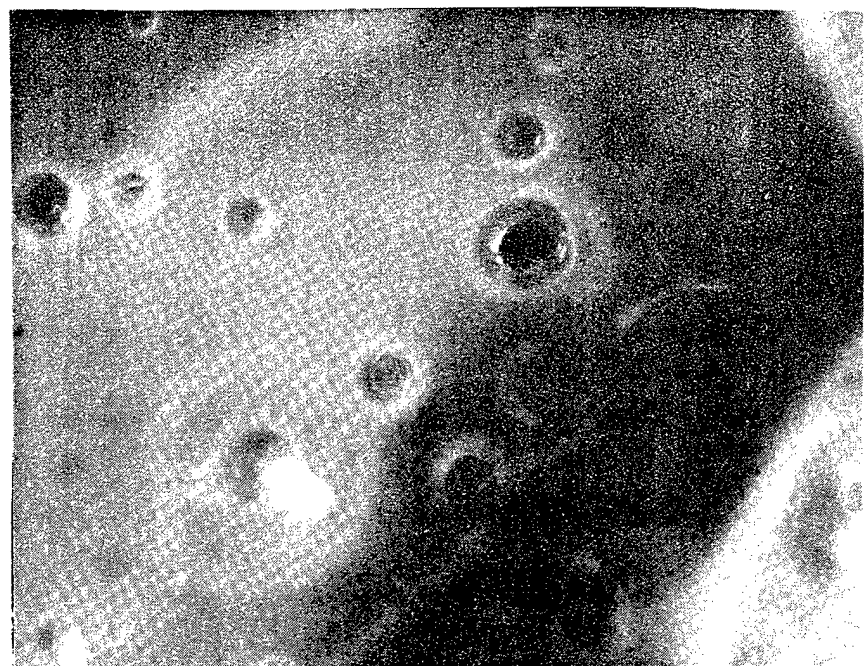
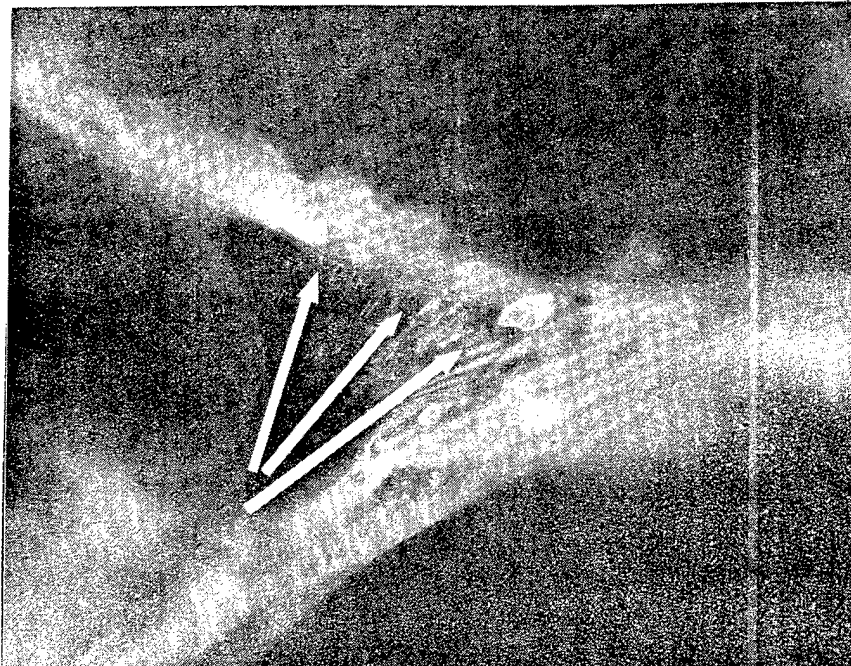
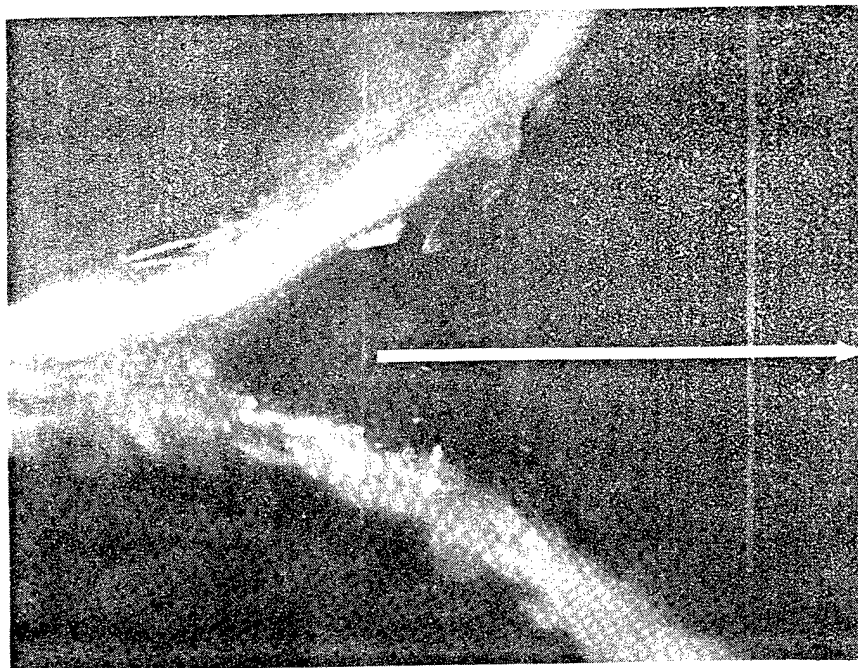
Sample 5A

Bubbles in adhesive layer

Figure 3.8-13. Optical Fractographs of Mode I Sandwich Specimen, Undercured Face Sheet Sheet 1 of 2

Mirror

Figure 3.8-13. Optical Fractographs of Mode I Sandwich Specimen, Undercured Face Sheet  
Sheet 2 of 2

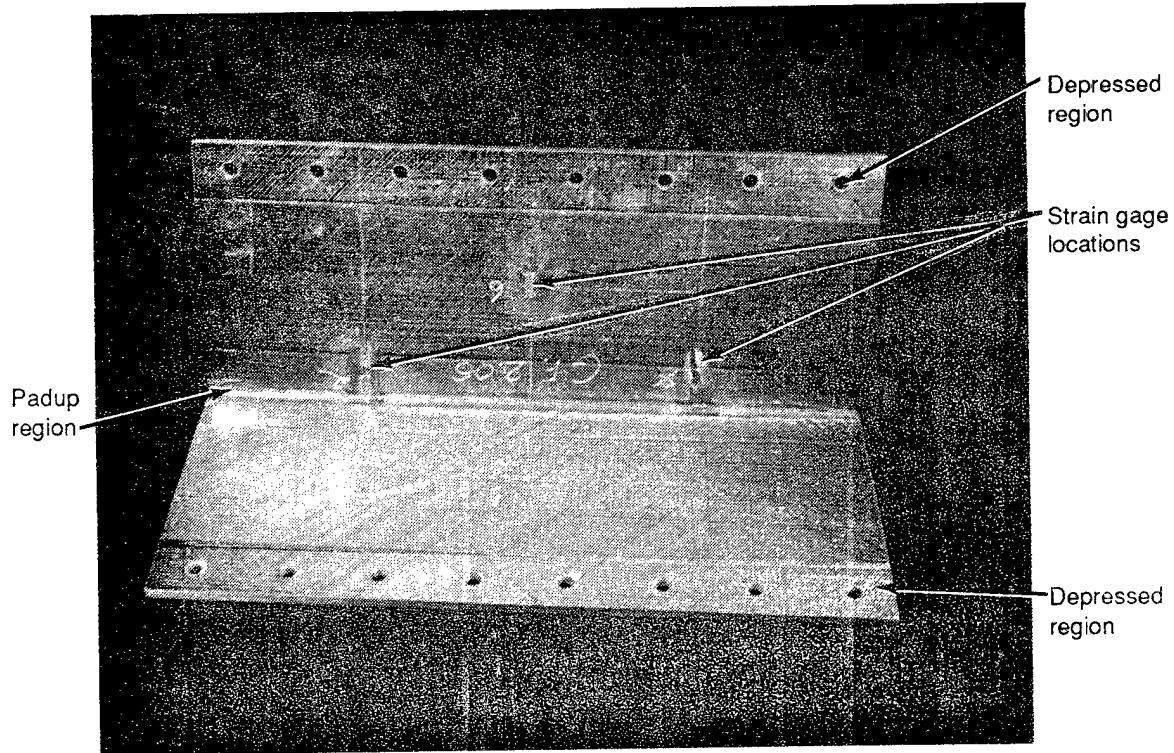
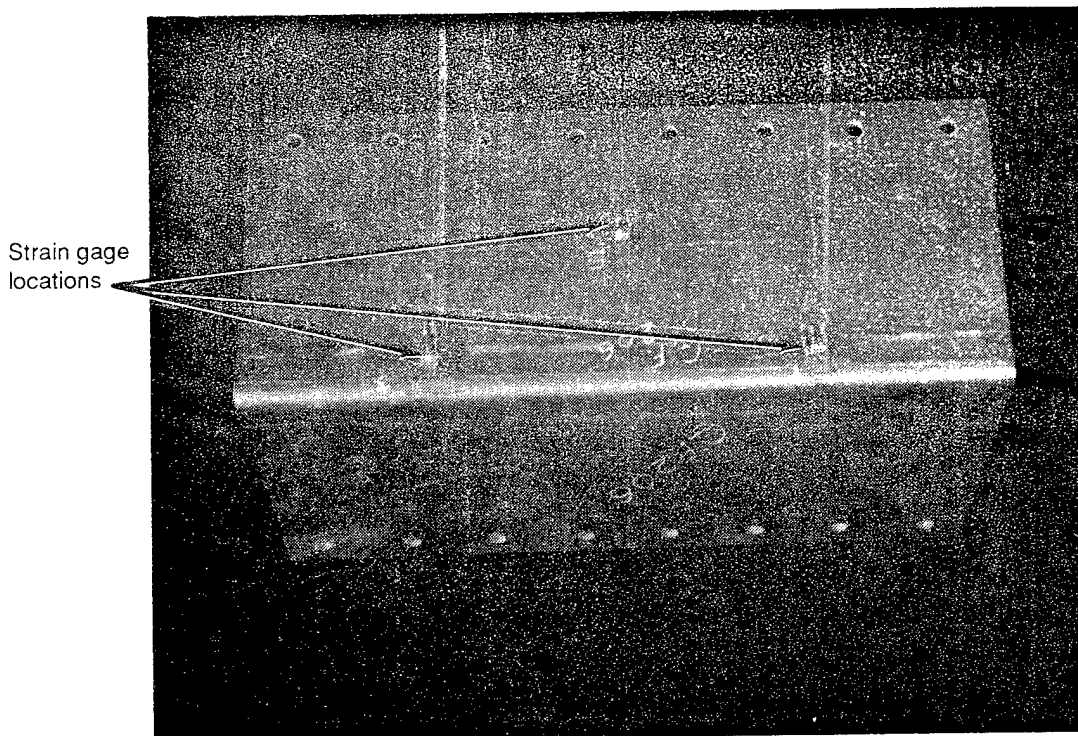
The submitted component (shown in fig. 2) was approximately 14 inches long with 5-inch wide flanges. The thickness was approximately 0.17 to 0.20 inch. The angle between the two flanges was approximately 95 to 100 degrees. The overall color and appearance was indicative of a carbon fiber-reinforced plastic system.

Figure 2. Photographs of the As-Received Component

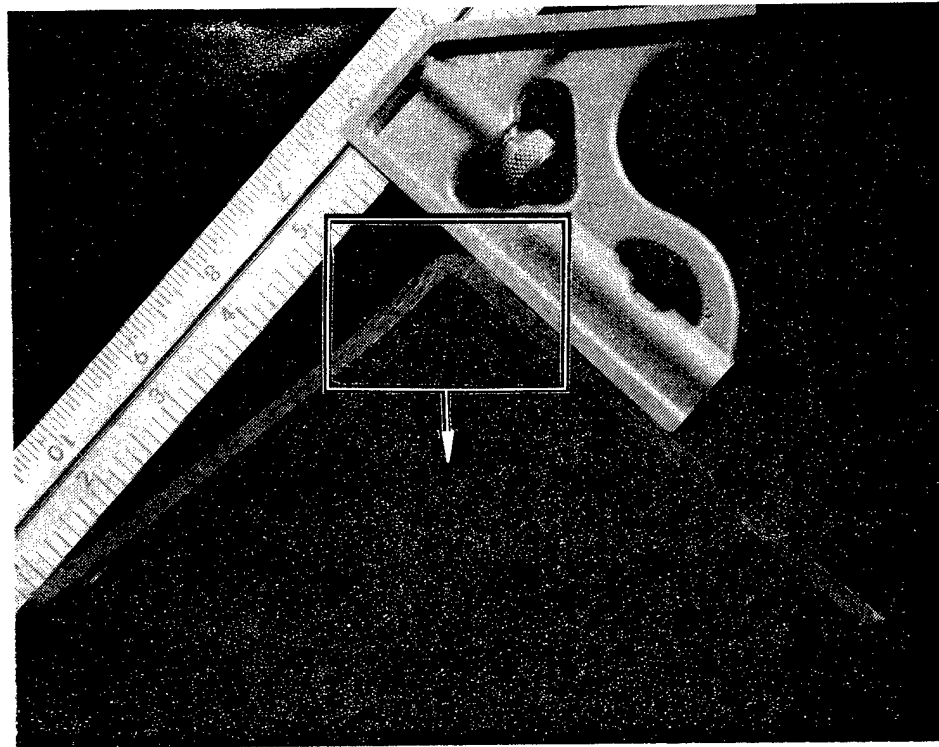
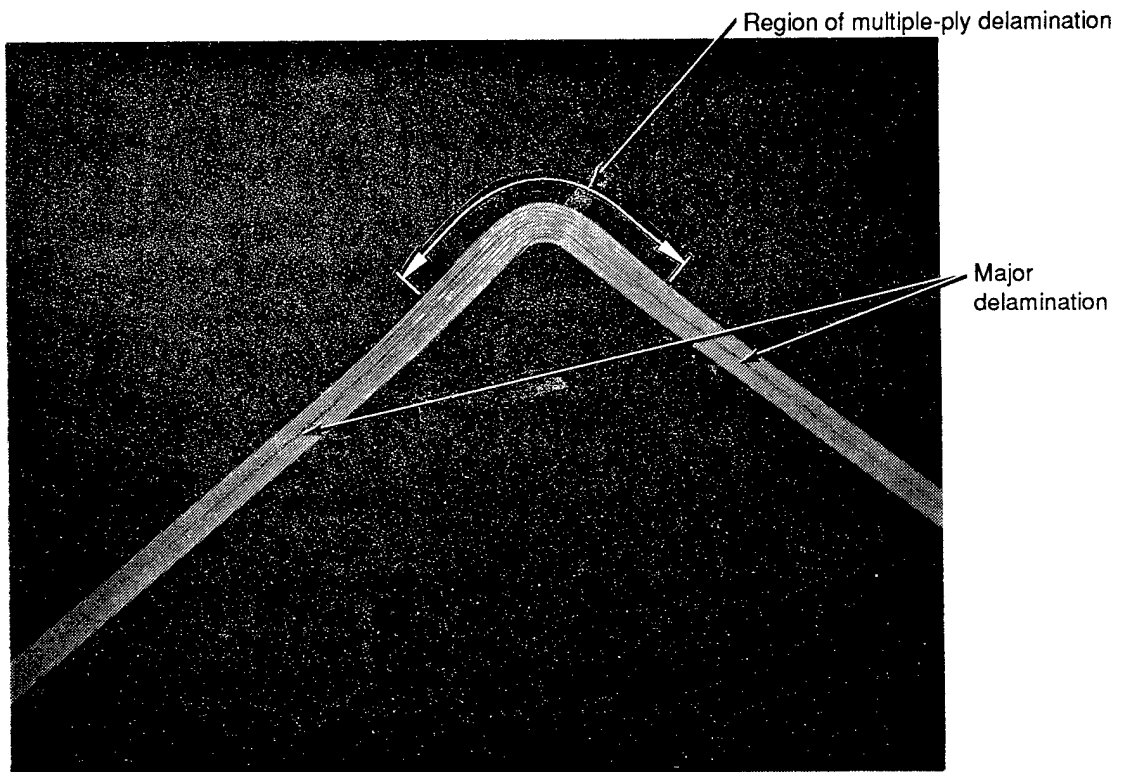
Internal delaminations, observe from both ends of the part, extended from the "knee" or angle region to the edges of the flanges (fig. 3). A 3-inch long delamination was located along the center plies. This delamination extended from an inserted ply placed within the center of the fiber plies at the knee region.

(a) Overall View of the Edge

(b) Close-Up View of the Delaminated Regions

Figure 3. Photographs of the Edge of the Component Showing the Extent of Delamination

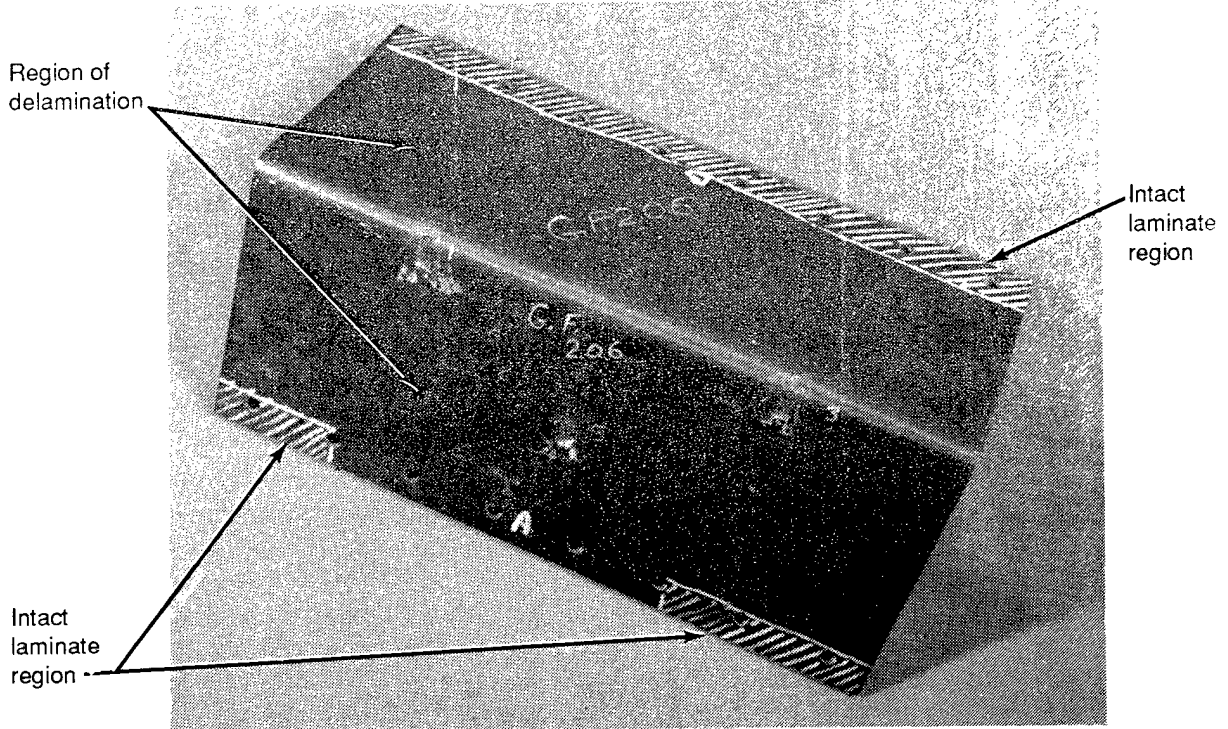
Examination using a handheld pulse-echo unit (C-scan) with a .25-inch transducer identified delaminations throughout the component (see fig. 7) except at certain locations along the region containing the fastener holes.

Figure 7. Photograph Showing the Regions of Intact Laminates Identified Using Pulse Echo

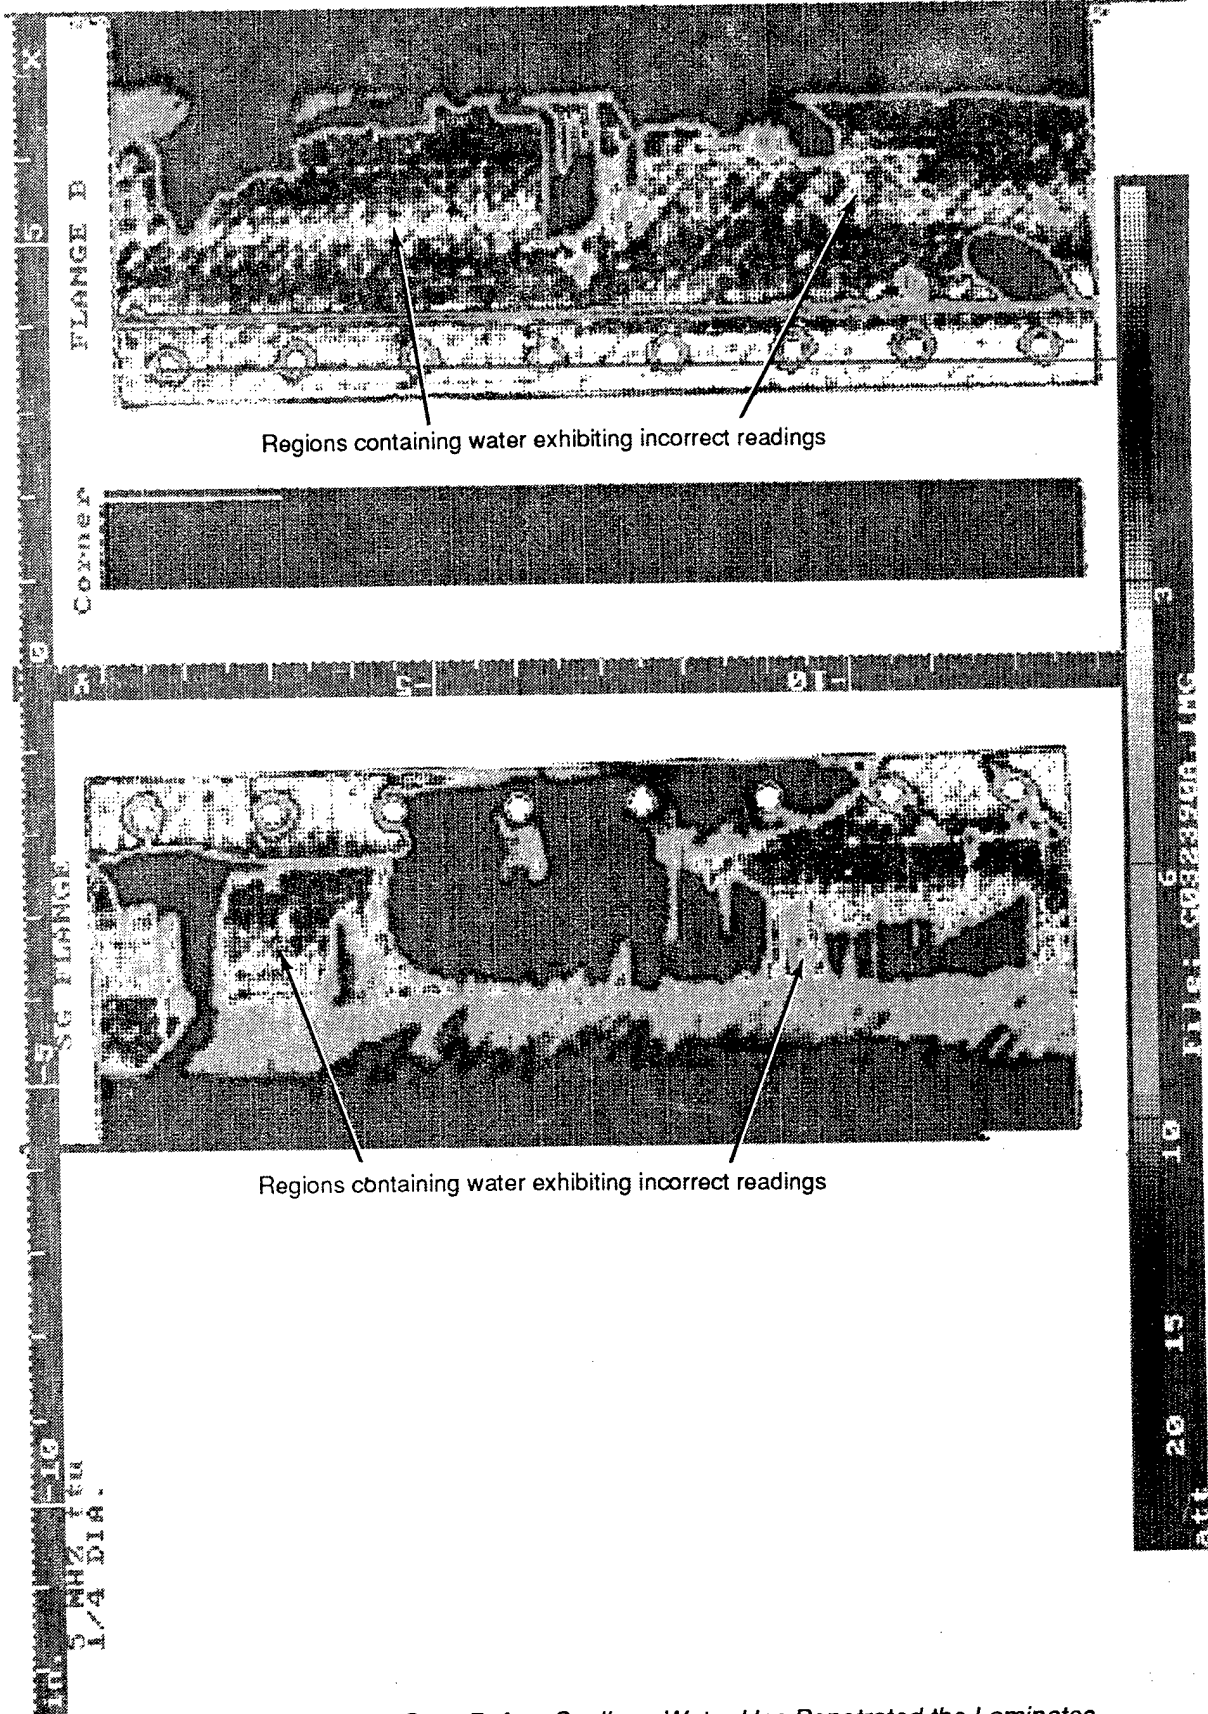
An attempt was made to further characterize the extent of delaminations using TTU (C-scan). However, since the part was exposed to water jets to perform the TTU analysis, large amounts of water entered the part through the edges and caused incorrect indications of delaminations and damage (fig. 8). These were grossly inconsistent with the pulse-echo analysis.

Figure 8. TTU Scan Before Sealing. Water Has Penetrated the Laminates From the Edges Causing Incorrect Readings
