DOT/FAA/AR-96/21

# Composite Failure Analysis Handbook Update 1

WL-TR-93-4004

August 1997

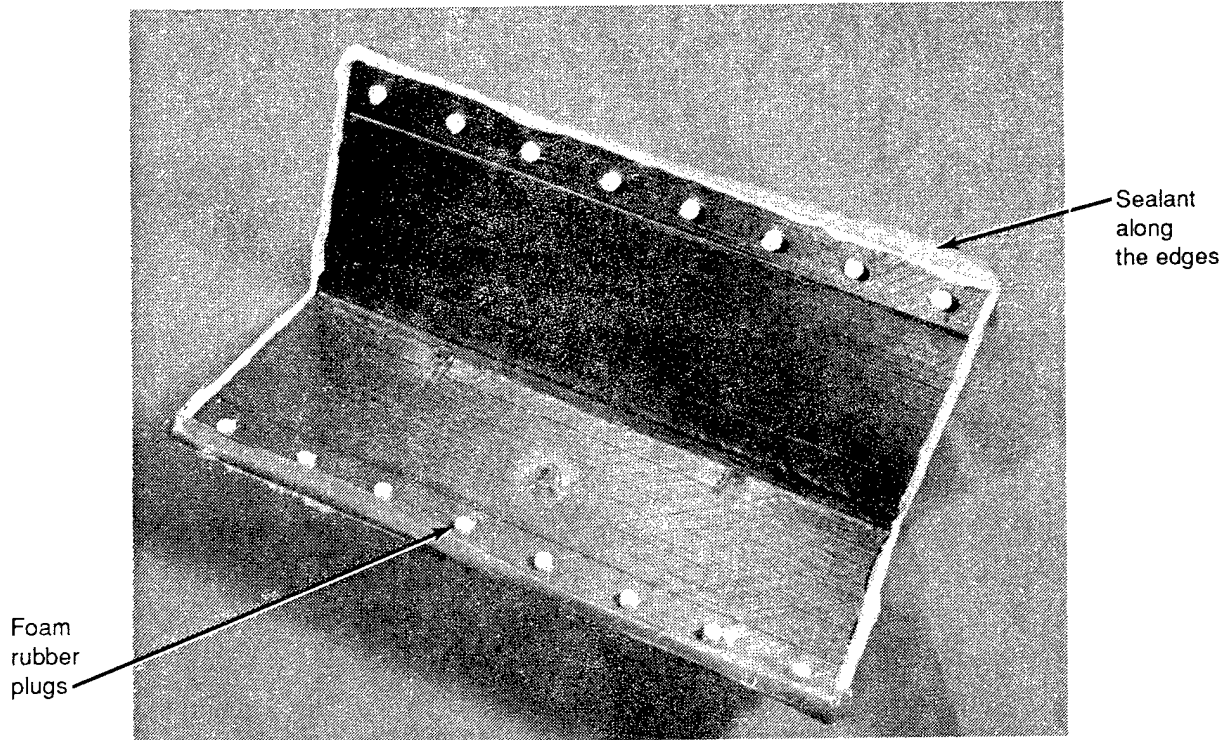
The part was subsequently dried in an oven at 90°F for 30 minutes before another set of scans was performed. This time the edges were sealed, the surface of the part was sprayed with a lacquer, and the fastener holes were plugged (fig 9). The part was then rescanned which revealed that it was almost completely delaminated (fig. 10). The grip areas were not delaminated as observed in the pulse-echo analysis.

*Figure 9. Photograph of the Part After the Edges and Fastener Holes Were Sealed Before the Second Series of TTU Scans*

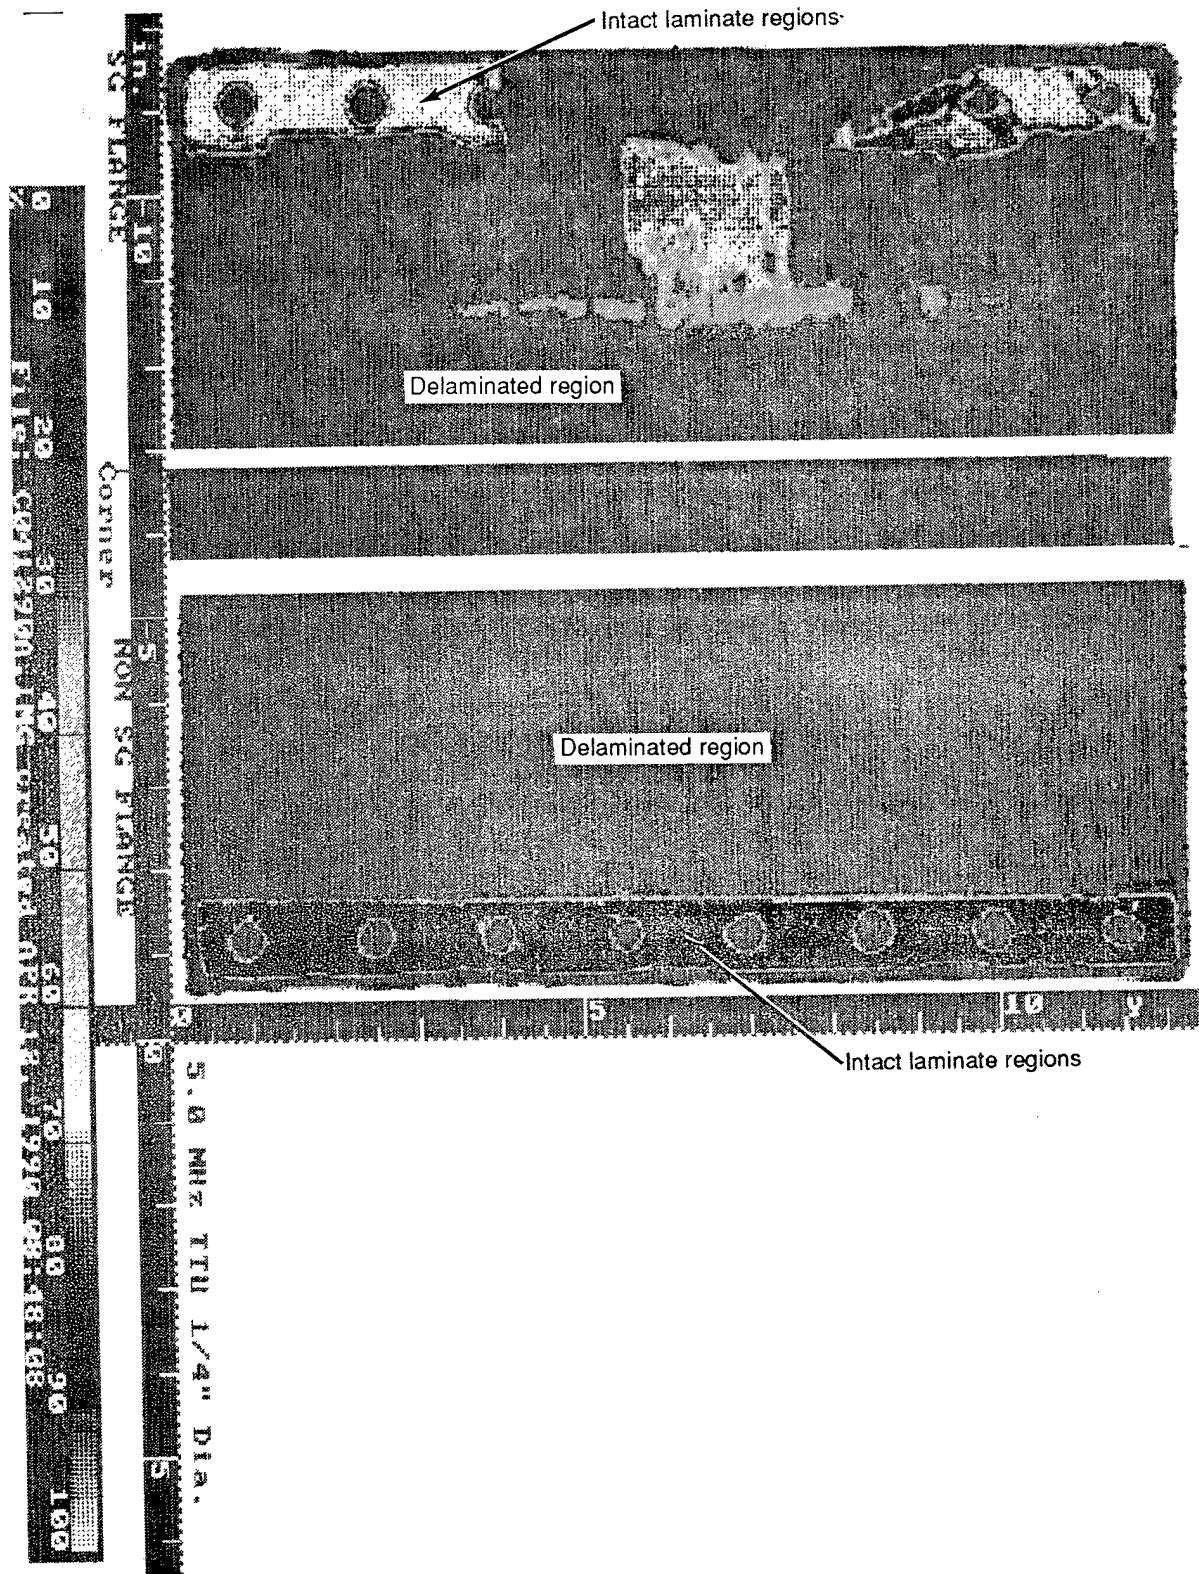
Figure 10. TTU Scan, After Drying and Sealing the Component, Exhibiting Delamination Regions Similar to the Pulse-Echo Examination

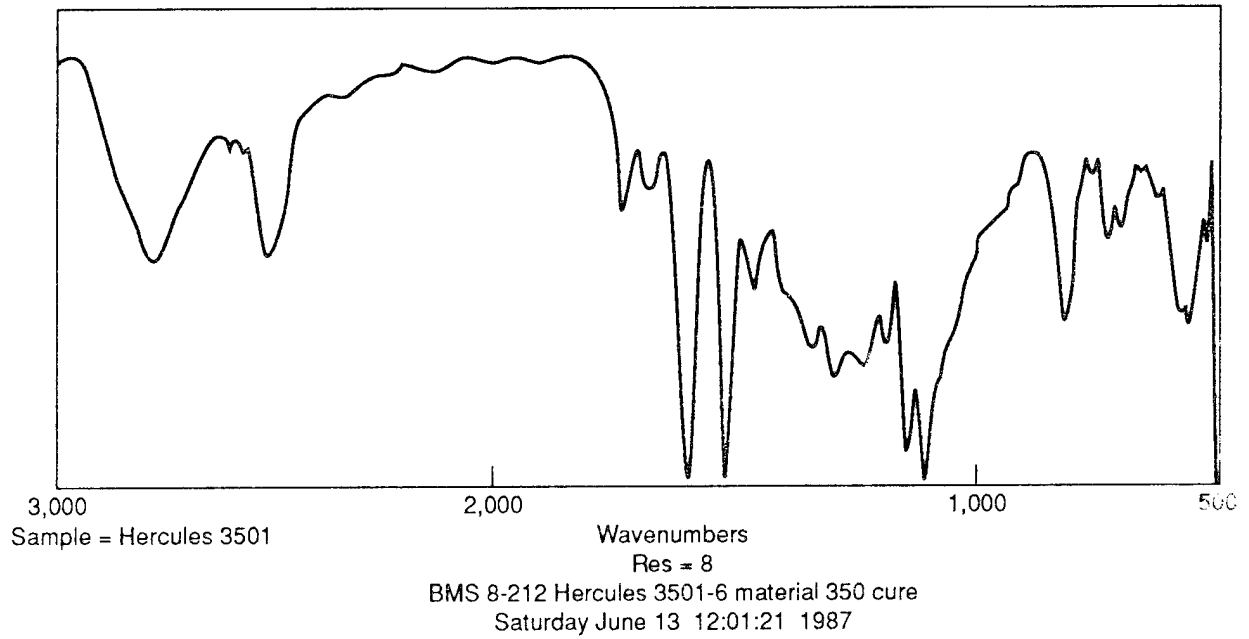
Figure 11. IR Spectrum From a Sample of Hercules 3501-6 350°F Cure Epoxy Resin

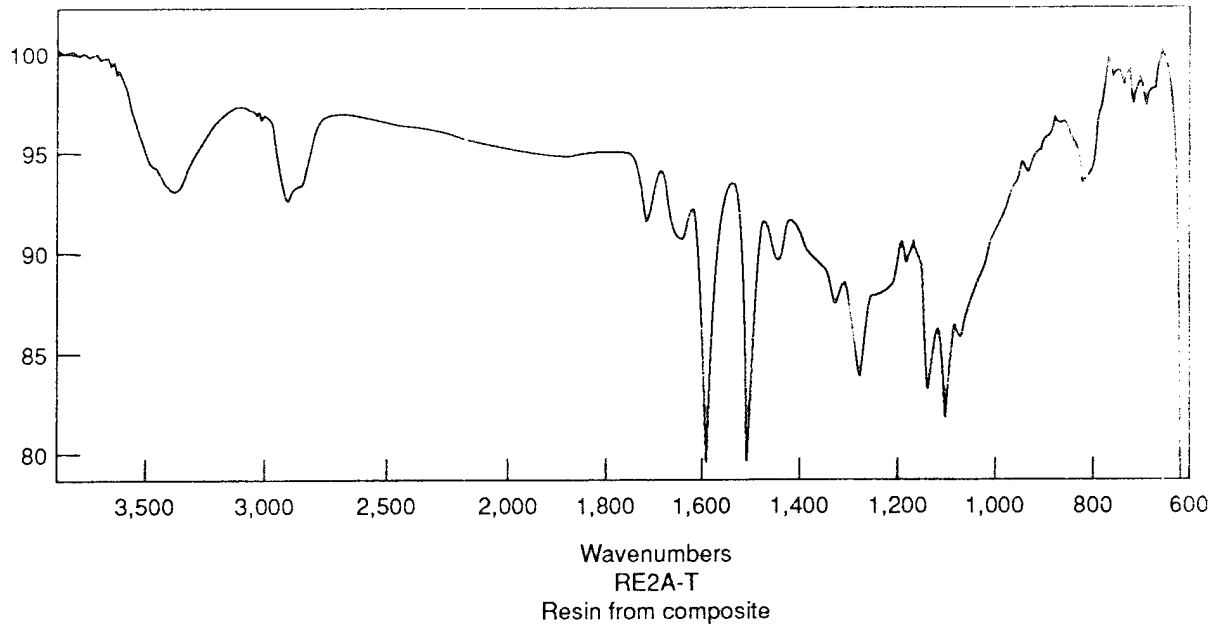
Figure 12. IR Spectrum From a Sample of the Resin From the Component

- b. Based on the infrared analysis, the material is a 350°F cure epoxy/graphite fiber composite which is similar to the Hercules 3501-6 resin. A Teflon peel ply was observed at the knee region extending approximately 1 inch into both flanges.

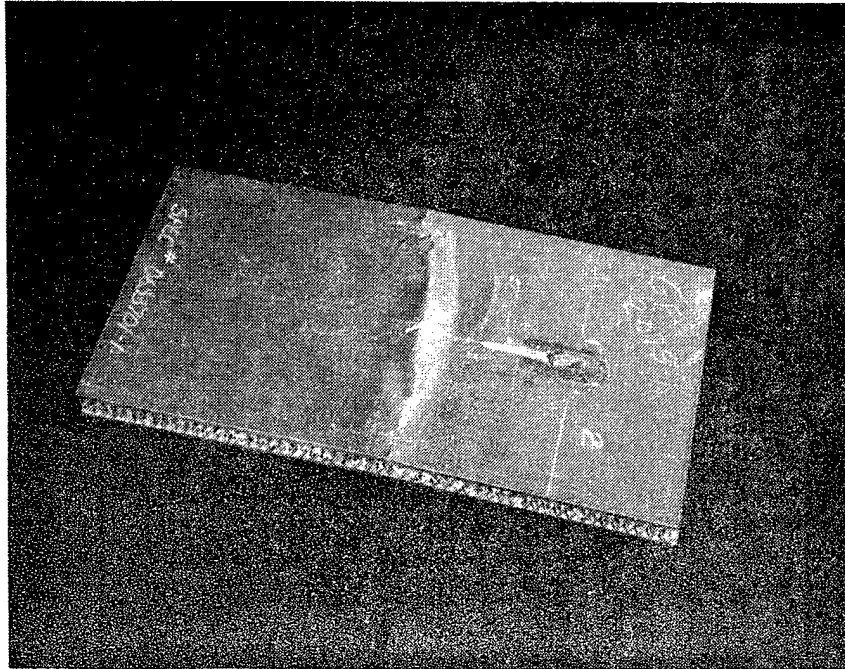
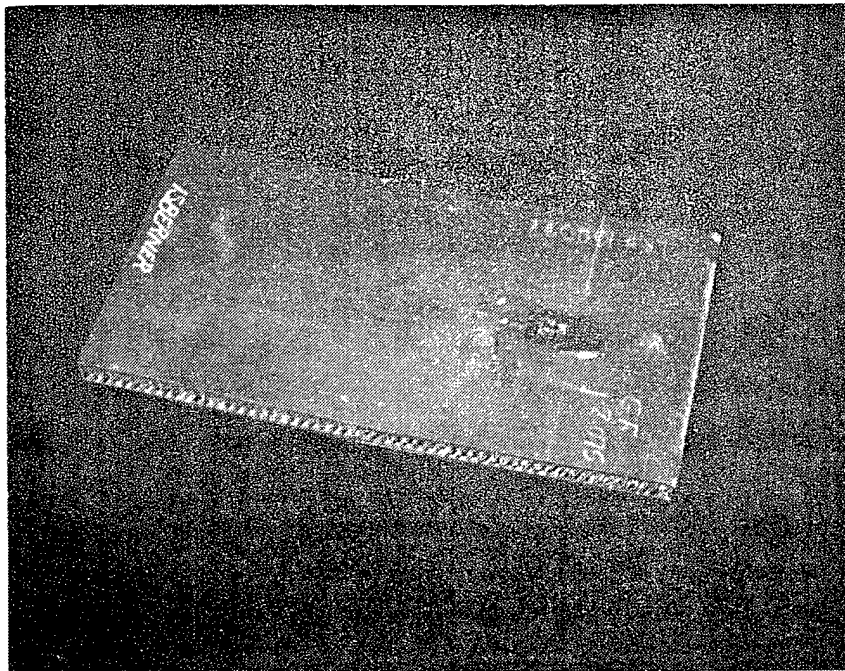
The component was a rectangle metal honeycomb sandwich panel with carbon fiber composite face sheets. It was approximately 0.6 inch thick, measuring 9.0 inches by 6.0 inches (see Figures 2 & 3). The top surface contained a transverse bulge located in the middle of the panel approximately 1 inch wide. The bottom surface was generally warped. Examination of the honeycomb core along the edges revealed that all of the honeycomb core was damaged (see Figure 3). However, no honeycomb/adhesive failures were observed, only the cell walls were deformed with the bonds to the facesheets being intact.

Figure 2. Photographs Showing the Top and Bottom Surfaces of the As-Received Component

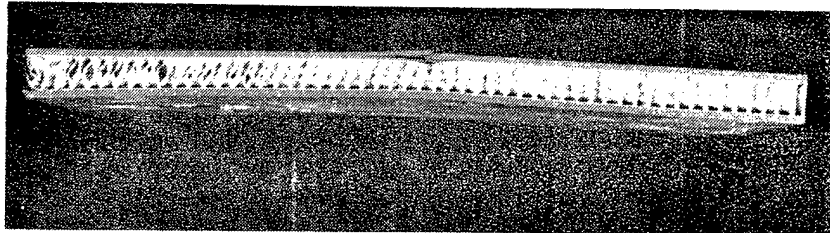
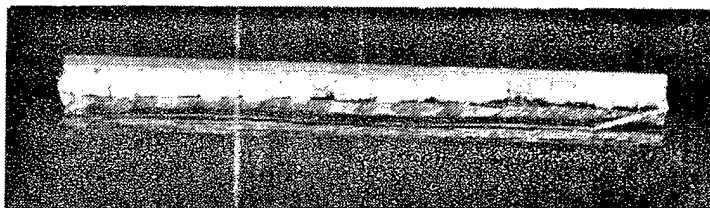
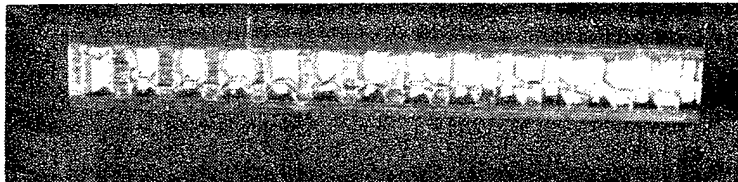
Figure 3. Photographs Showing the Front, Back and Sides of the Component

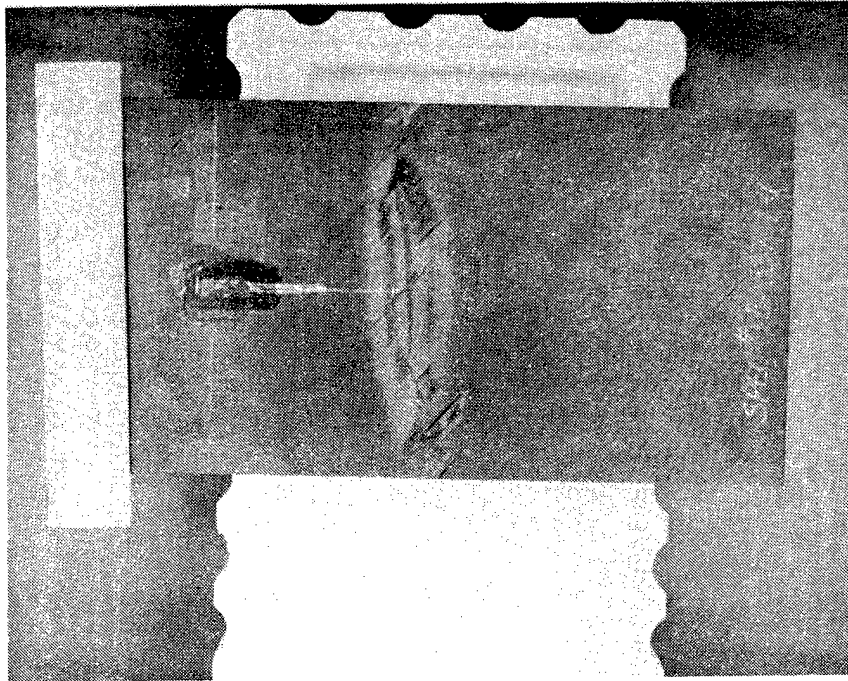
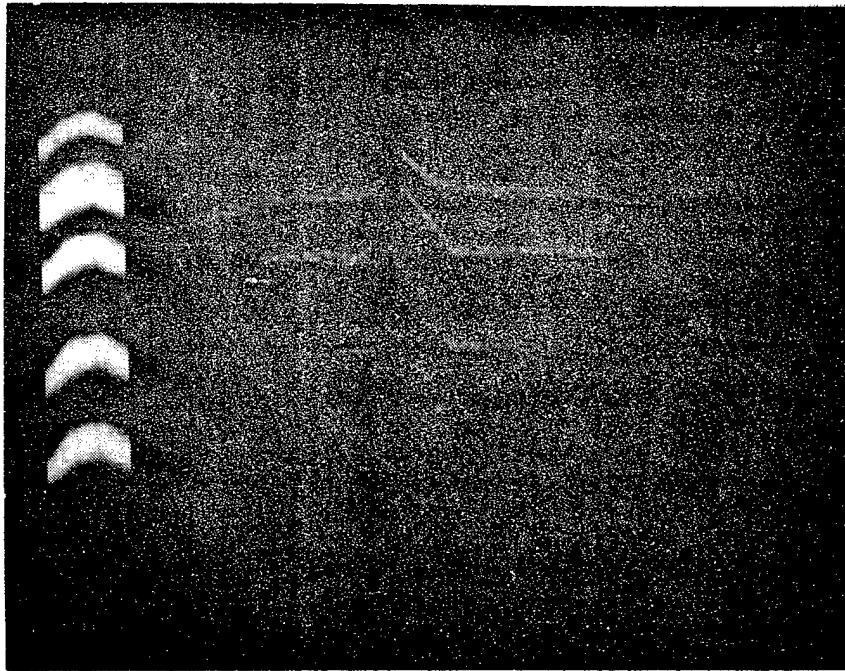
Following the visual examination, the surface of the component was analyzed using slit illumination photography. This technique involves photographing a series of beams of light projected at an angle onto the panel (Figures 4 & 5). Variations in the surface are seen as curvatures of the slit of light which have been calibrated to correspond to the variations in depth and height of the surface. This allows for quantitative documentation of the surface deformation as shown in Figure 6. Examination of the data reveals that the entire back side of the panel was warped. This is shown as both in a twisting and buckling type of deformation. It also indicates that no region of the panel was undamaged.

*Figure 4. Buckled Surface Showing the Angled Slit Lighting Contours*

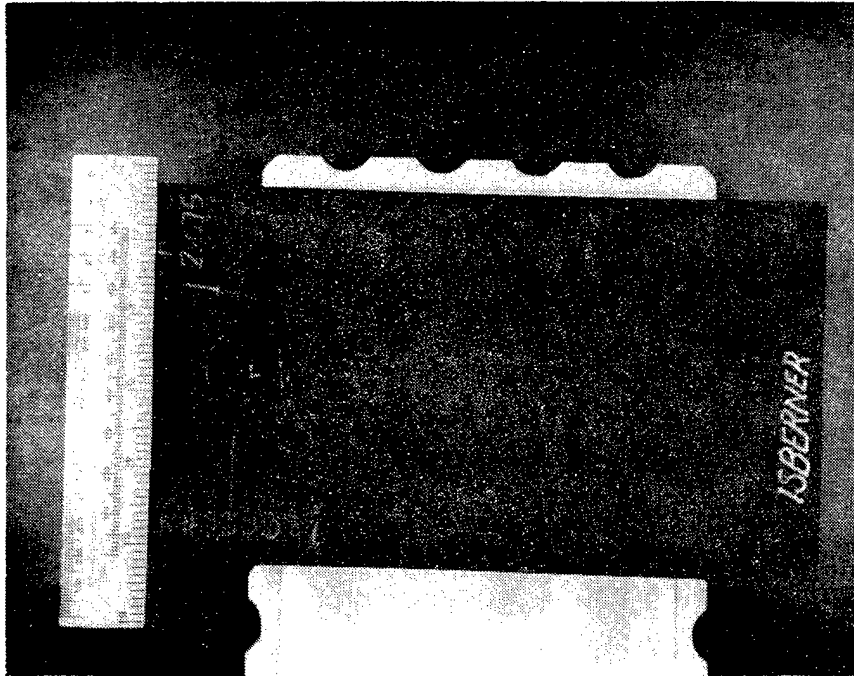
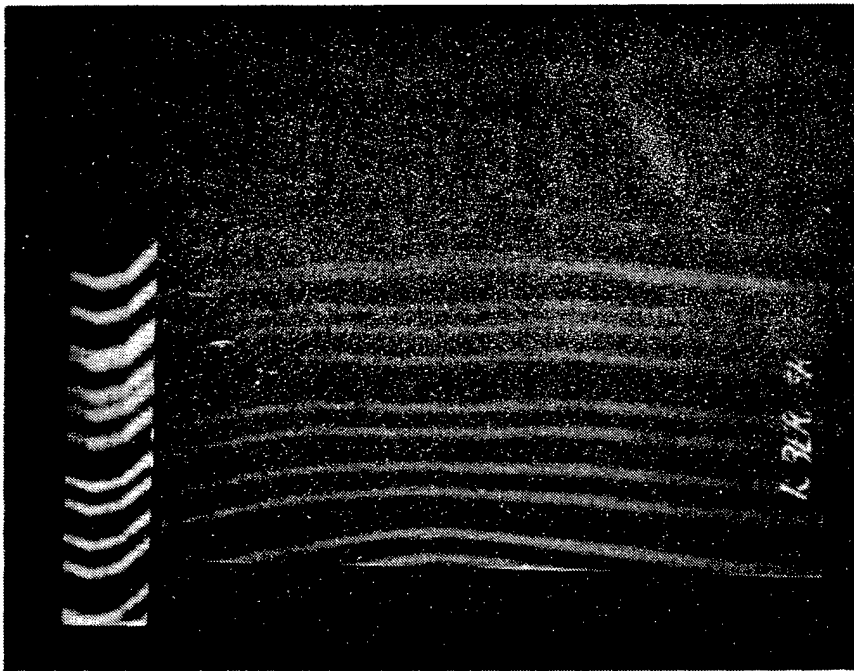
*Figure 5. Smooth Surface Showing the Angled Slit Lighting Contours*

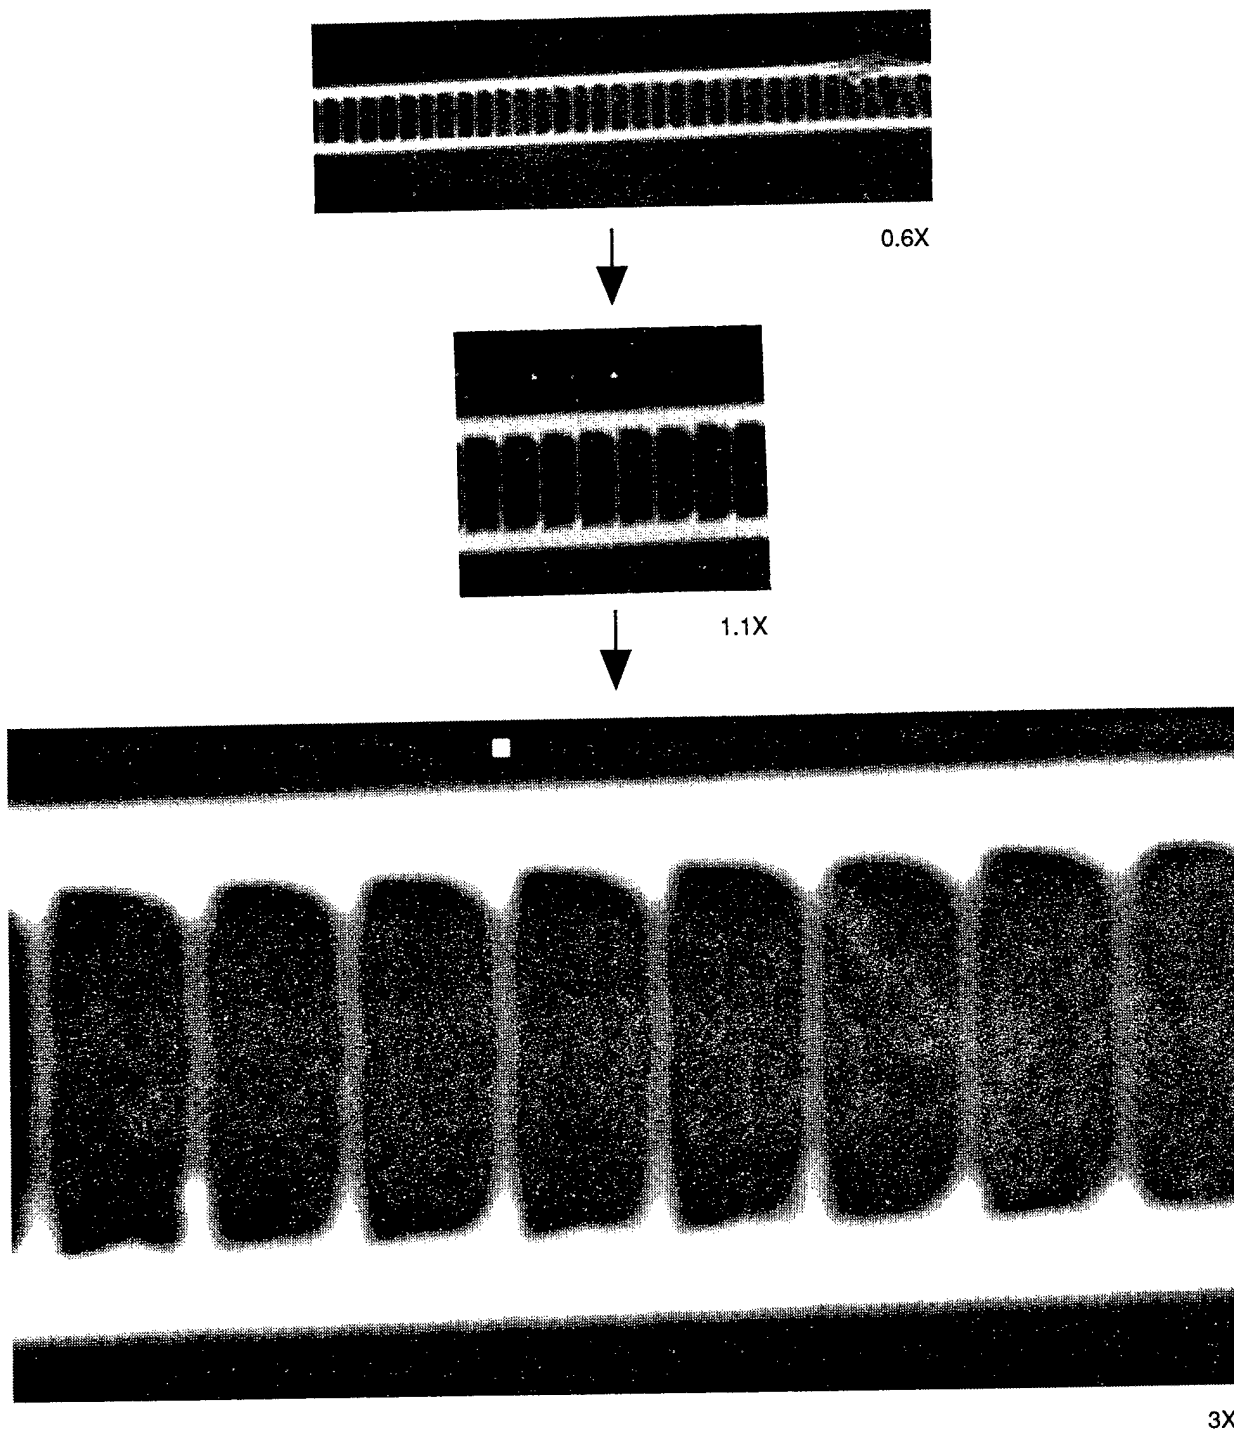
Figures 8 through 11 through show the various images of the slices through the component. The longitudinal slices 1, 2, & 3 show the damage present in the honeycomb regions in the center of the component. The front half of the panel appears to have been crushed by a macroscopic shearing of the upper front half of the facesheet. The back half exhibited little if no damage. However near the bulge, the core appeared to be crushed in the short transverse direction. There was no evidence showing any longitudinal buckling trends to either end (from one end to the other). This transverse damage was located all along the back half of the component.

Figure 9. CT Images of the First Longitudinal Scan

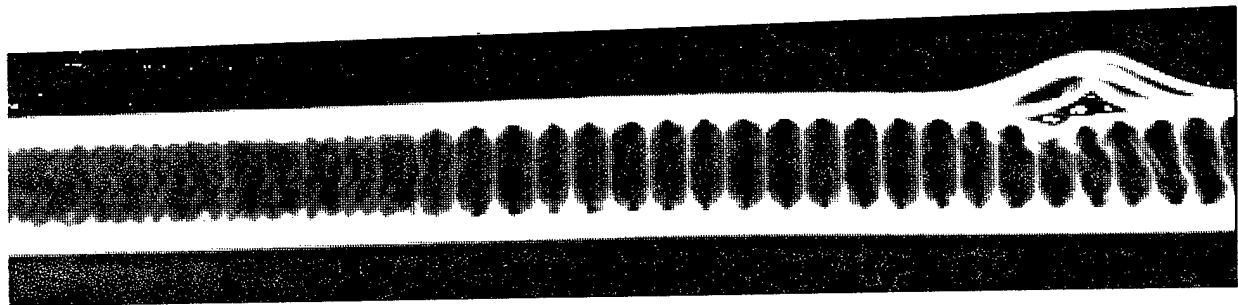
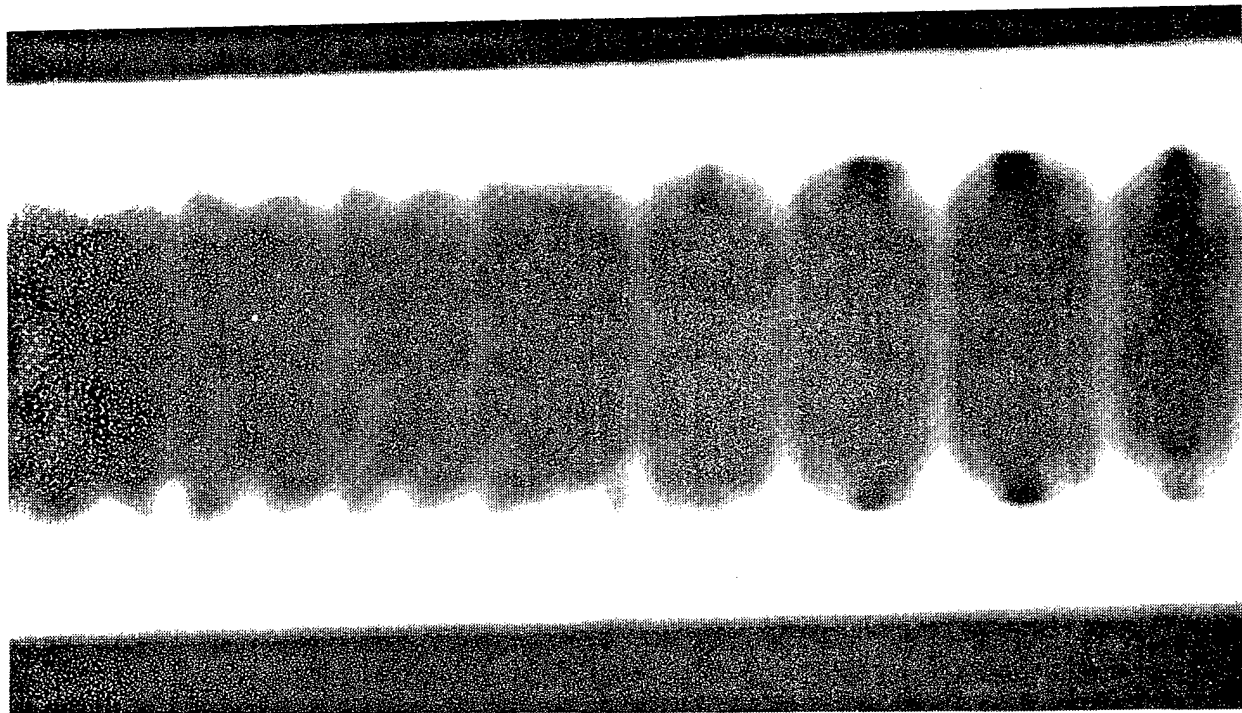
*Figure 10. CT Images of the Second Longitudinal Scan*

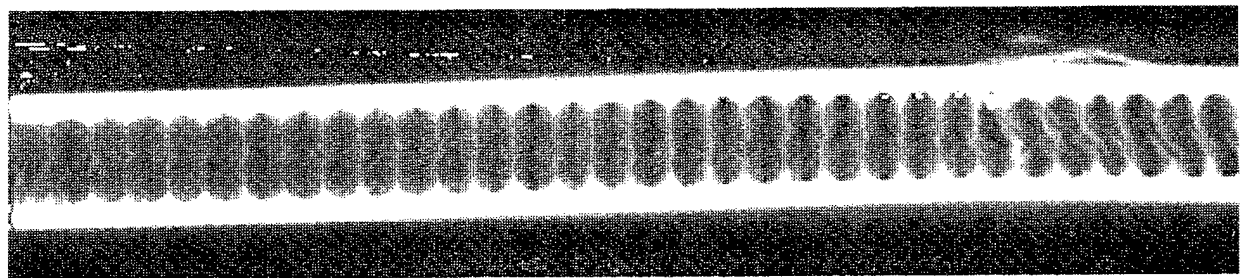
*Figure 11. CT Image of the Third Longitudinal Scan*

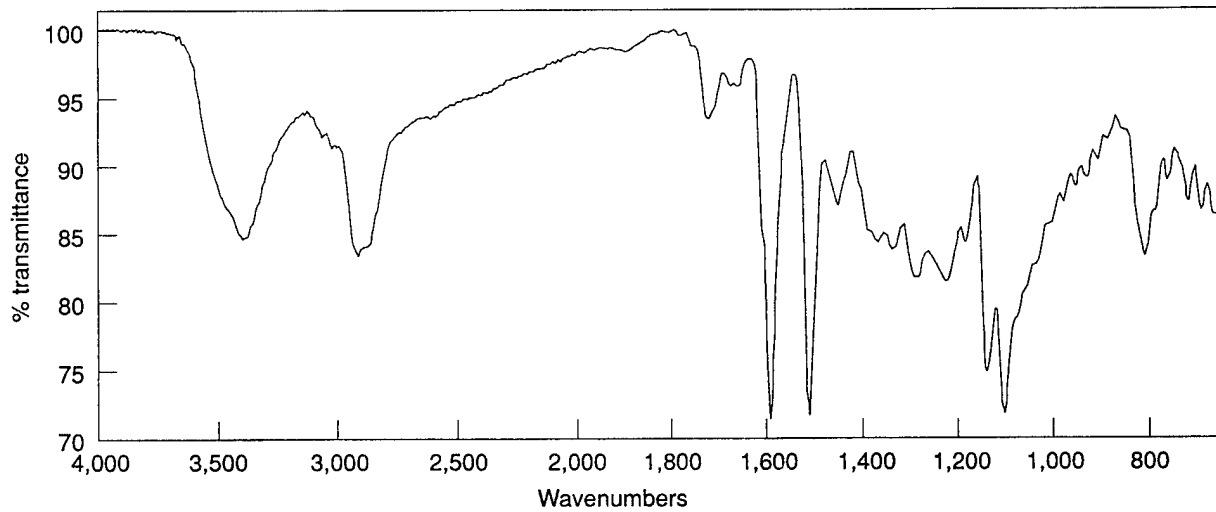
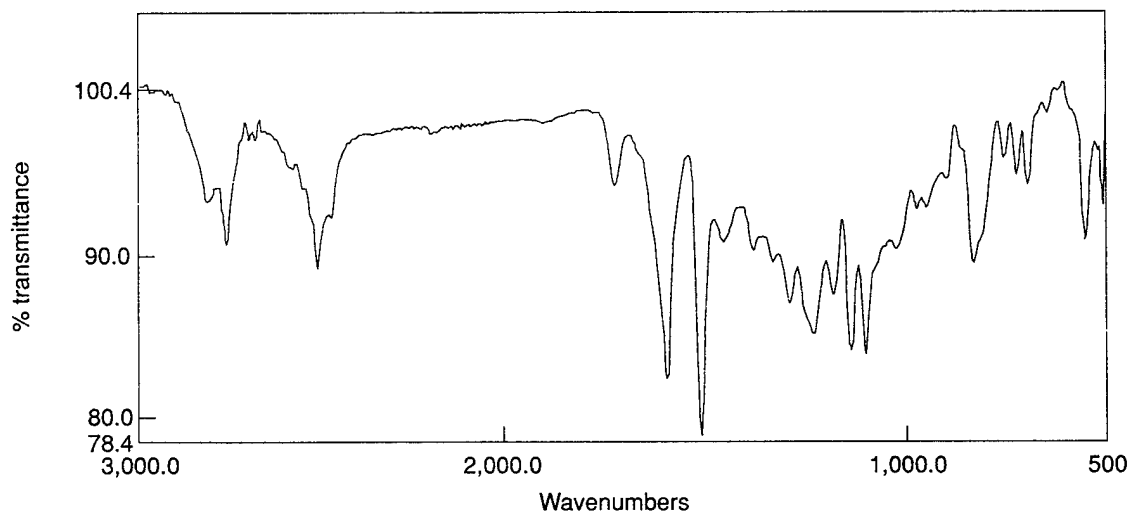
The facesheets were composed of carbon fibers in a 350° F cure epoxy resin system similar to the Hercules 3501-6 resin (see Figure 12 ). DSC analysis of the resin system revealed that the resin was fully cured (as shown in Figure 13a).

Figure 12. FTIR Plots of the, (a) Resin From the Honeycomb Panel, and (b) From a Data File of Hercules 3501-6

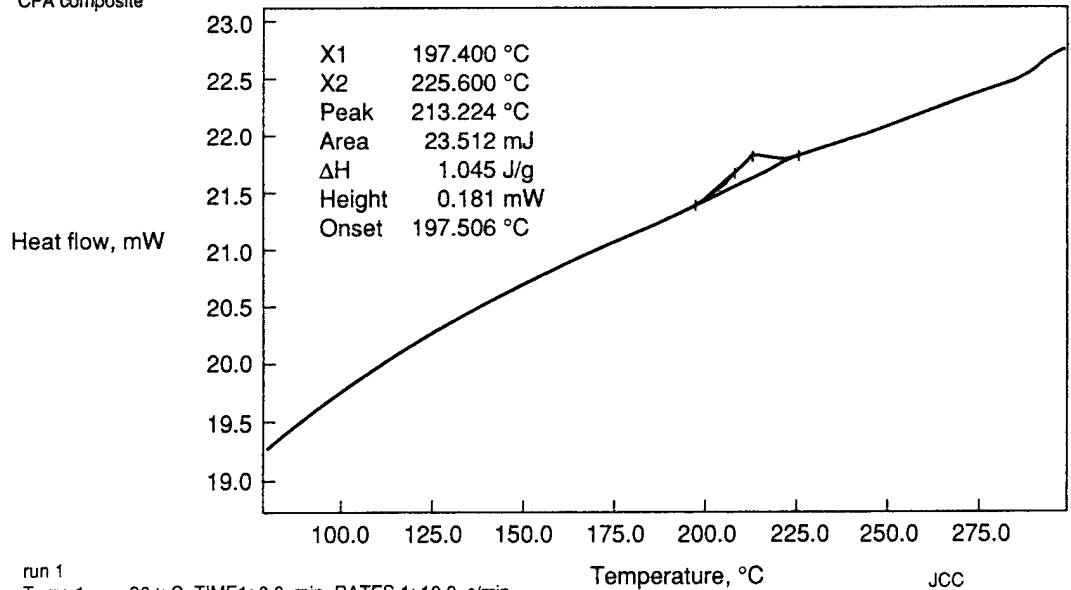
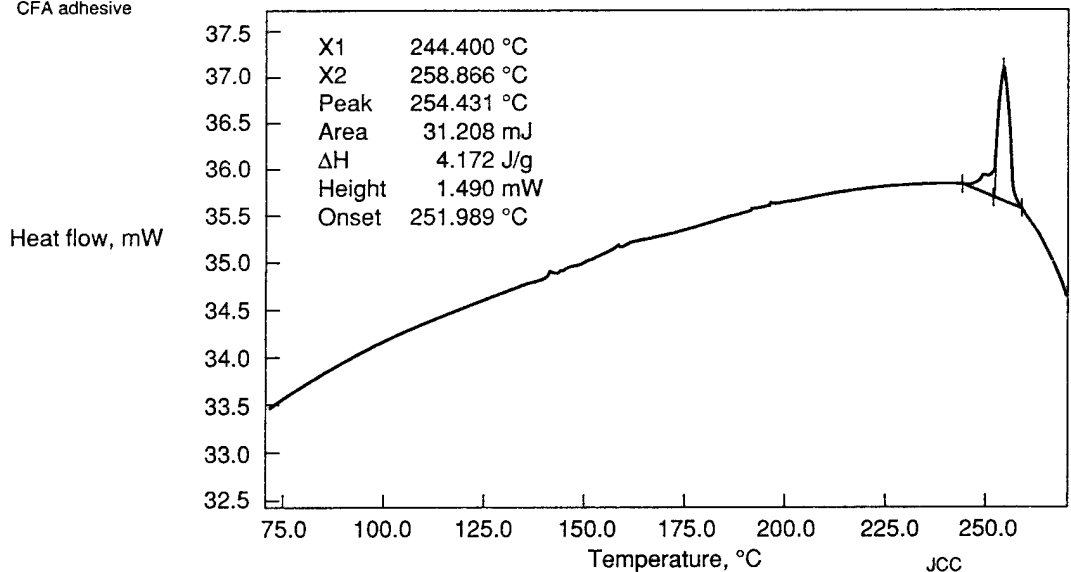
The adhesive was identified as an epoxy with additional compounds (Figure 13b). DSC plots revealed an endotherm peak which was determined to be the result of melting. Further analysis indicated that the adhesive was fully cured.

Figure 13. DSC Plots of the (a) Composite and (b) the Adhesive

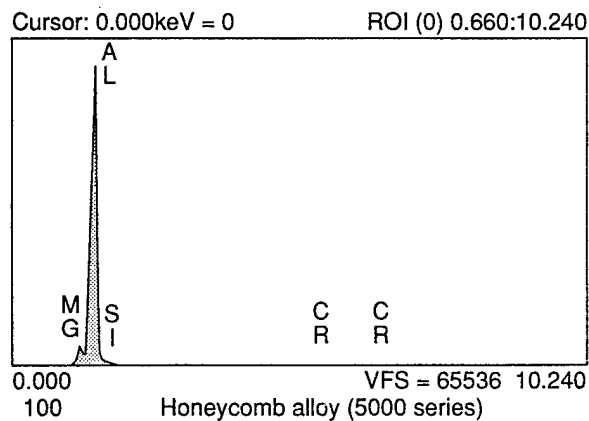
The honeycomb core was composed of a 5000 series aluminum as determined by the EDS analysis (Figure 14). Although aluminum honeycomb cores are usually made from 5000 type alloys, the EDS instrument is not accurate enough to identify the specific alloy in this series.

Figure 14. EDS Spectrum Showing the Major Elements That Have Been Detected and a Semi-quantitative Analysis of the Material

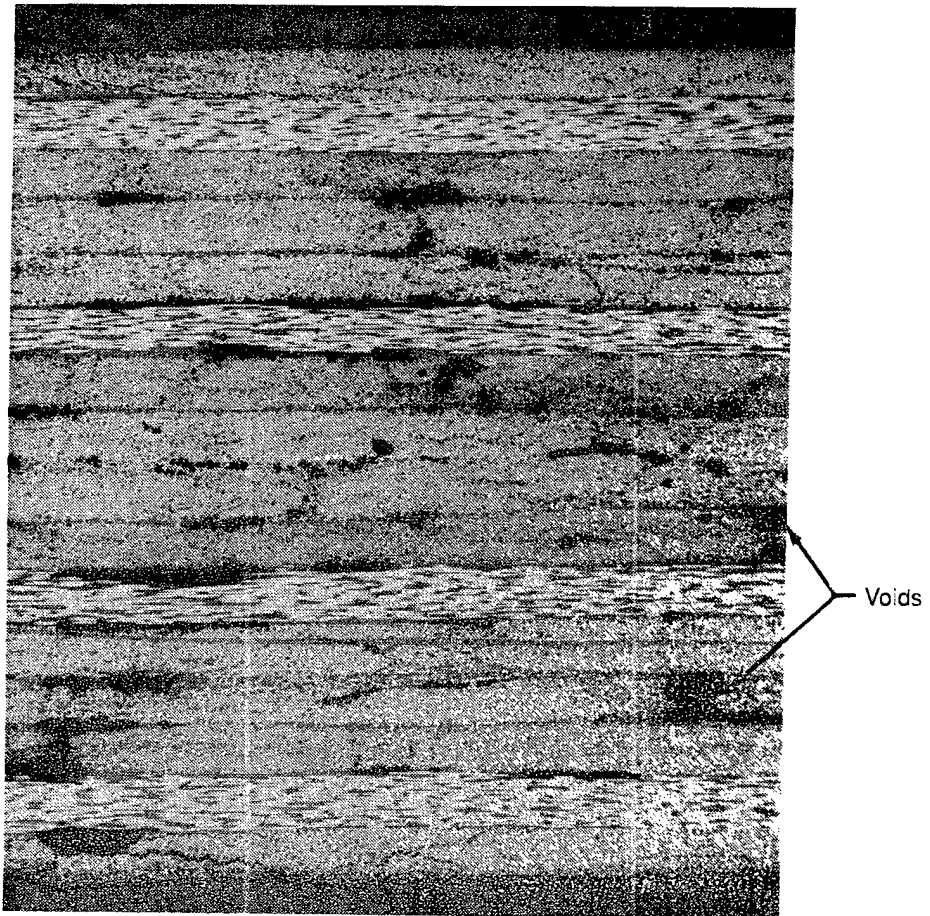
A small section of the panel was cut, mounted, ground and polished. The facesheet ply orientation sequence was:  $[(+45/90/0/-45)2]_s$ . Major voids were observed throughout the facesheet (see Figure 15). This could be the result of incorrect processing of the composite material prior to assembly of the entire component because the adhesive bond appeared to have been processed correctly.

*Figure 15. Cross-Sectional Micrograph of the CFRP Face Sheets Showing the Extent of Porosity and the Lay-Up Sequence*

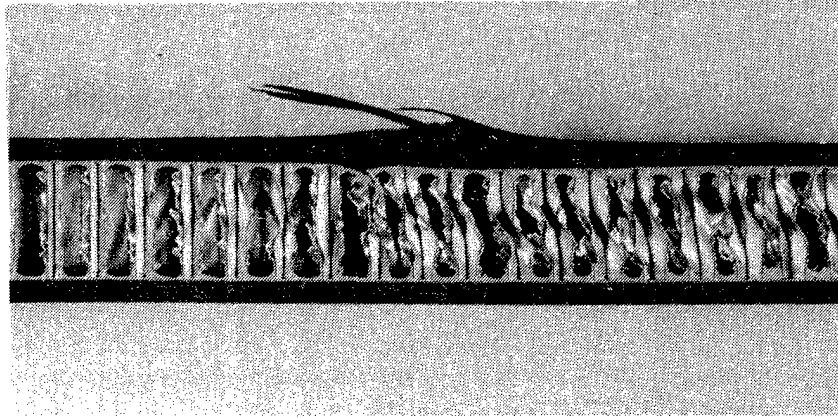
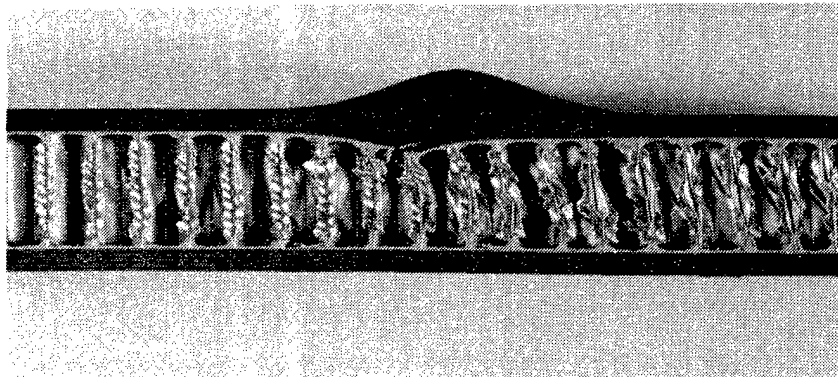
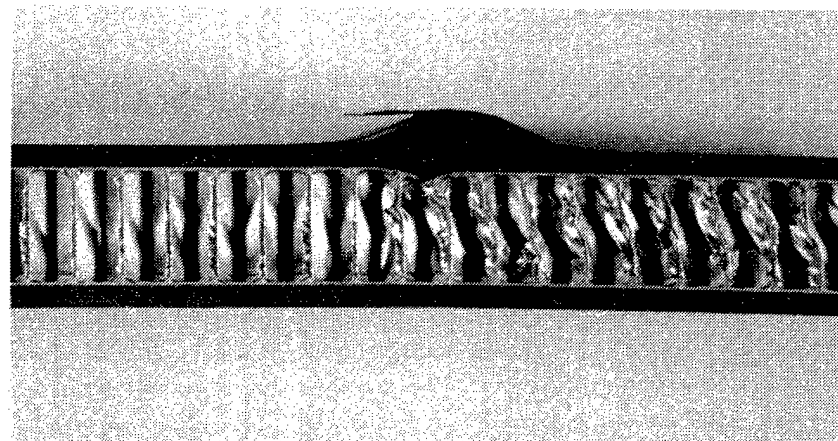
The component was sectioned longitudinally along the same three locations as the CT scan slices to obtain a more detailed examination of the damage within the panel. Figure 16 shows the cross-section at the right edges of each section which correspond to the CT images in Figures 9 to 11. Examination of the surfaces reveal damage similar to the CT images.

*Figure 16. Photographs of Cross Sections Through the Panel Corresponding to the CT Scans:  
(a) CT Slice 3  
(b) CT Slice 2  
(c) CT Slice 1*

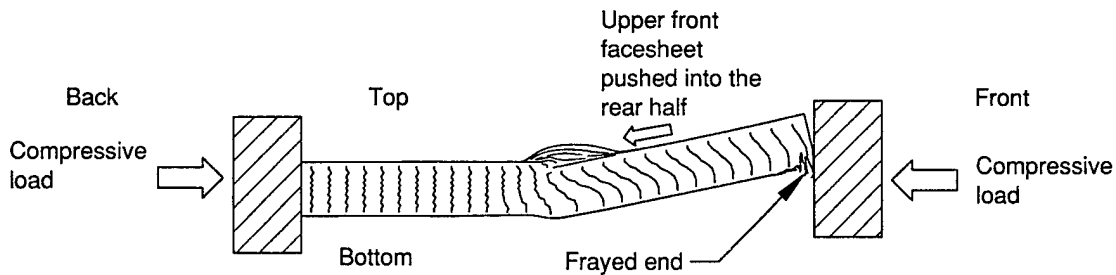
The transverse delamination region of the facesheets is indicative of compressive loading. There are two general ways in which the panel could have been loaded in order to cause a compressive loading; the first would be a three point loading configuration; the other would be a simple longitudinal compressive loading applied to the ends of the panel. If the component had been loaded in the three point loading configuration, the bottom side should exhibit tensile cracking and the honeycomb core on either side of the transverse delaminated region would not have been damaged or deformed. However, examination of the internal structure by both the CT scans and the sectioning revealed a non-uniform deformation. The longitudinal compressive loading configuration would most likely have produced this type of damage. Figure 17 shows a diagram of the panel illustrating a plausible loading sequence that could account for the damage to the panel. As the load was applied to both ends of the panel, the top facesheet began to delaminate and eventually buckle. Then the front half of the top facesheet shifted towards the back, deforming the honeycomb core in the process. This in turn caused the panel to bend with the back half of the panel remaining relatively straight while the front half twisted downward which resulted in the edge of the bottom facesheet being frayed. The downward twisting movement also deformed the bottom of the panel.

This description of the fracture sequence assumes that all of the damage to the panel was caused by the simple compressive loading. The porosity in the facesheets was the only anomaly discovered on the panel that wasn't the result of the loading. However these voids did not appear to have influenced the placement of the origins or crack propagation direction, they probably only effected the overall strength of the panel. If there was evidence of damage in the panel prior to the compression loading, it would have been destroyed by the subsequent loading.

Figure 17. Diagram Showing the Probable Loading Configuration and Subsequent Deformation of the Panel

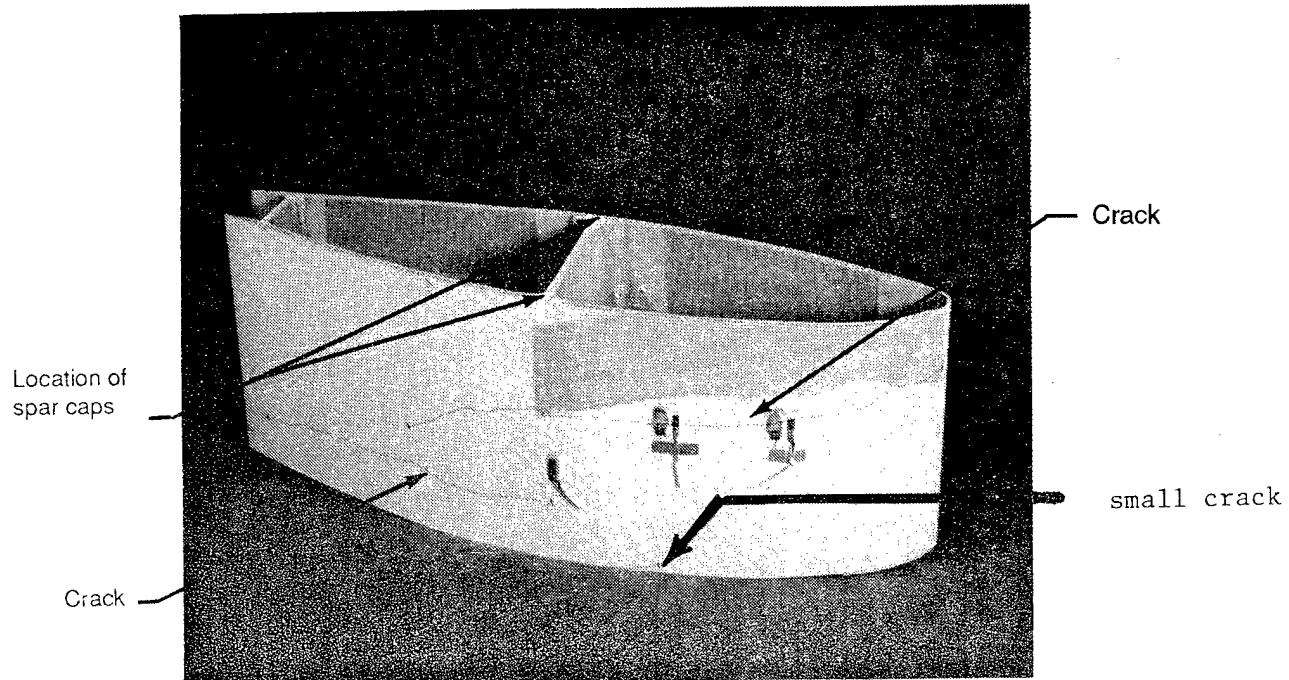
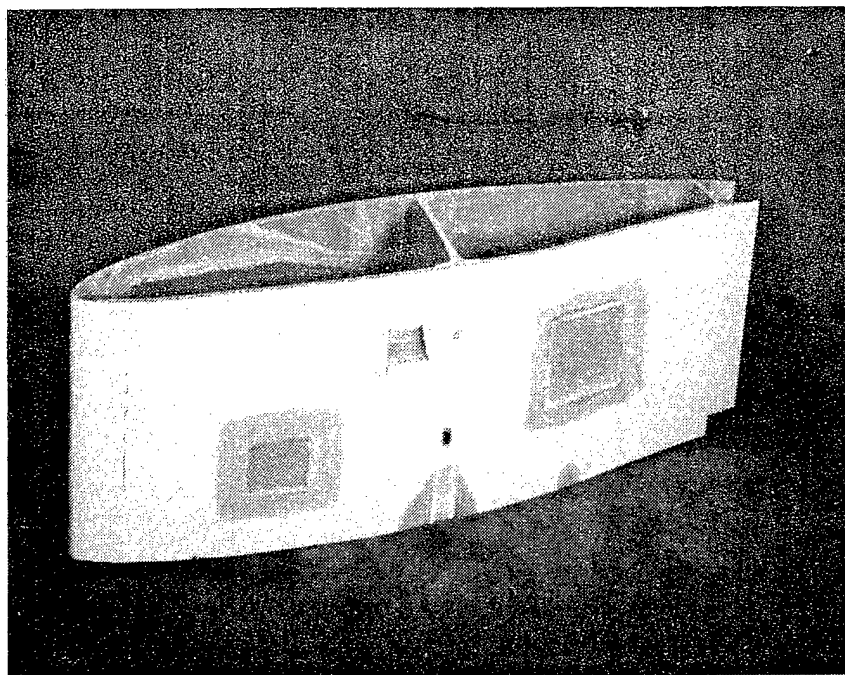
**Outer Wing Surface** - The upper wing skin was composed of a paper honeycomb core with layers of fiberglass plies on both sides. White Gelcoat was present on the outer surfaces. The upper skin contained two long cracks and one small crack. One long crack extended approximately three quarters of the way from the leading edge towards the aft. The other long crack was located between the mid spar and the aft spar. The small crack was located on the edge of the wing section near the middle of the wing section. In addition to the cracks; a large section of the surface, located adjacent to one edge and between the leading edge and the mid spar, had been sanded through the gelcoat.

The lower skin, fabricated identically to the upper skin, contained five regions which appeared to be in various stages of repair. Two of the regions (one ~5.5 and the other ~3.0 inch square) were located in the main section of the lower skin. Both contained exposed honeycomb and white potting compound along the perimeter of the exposed regions. In addition, the surfaces adjacent to these two regions were sanded. Another region (~2.0 inch square) simply had the honeycomb removed down to the inner surface skin. Finally, two sanded regions were located on the edge of the lower skin, one at the spar cap and the other aft of the mid-spar. Both of these regions were approximately 2 inch square and had also been sanded through the Gelcoat.

Figure 2. Photographs of the Outer Surfaces of the Wing Section  
a) Upper Surface  
b) Lower Surface

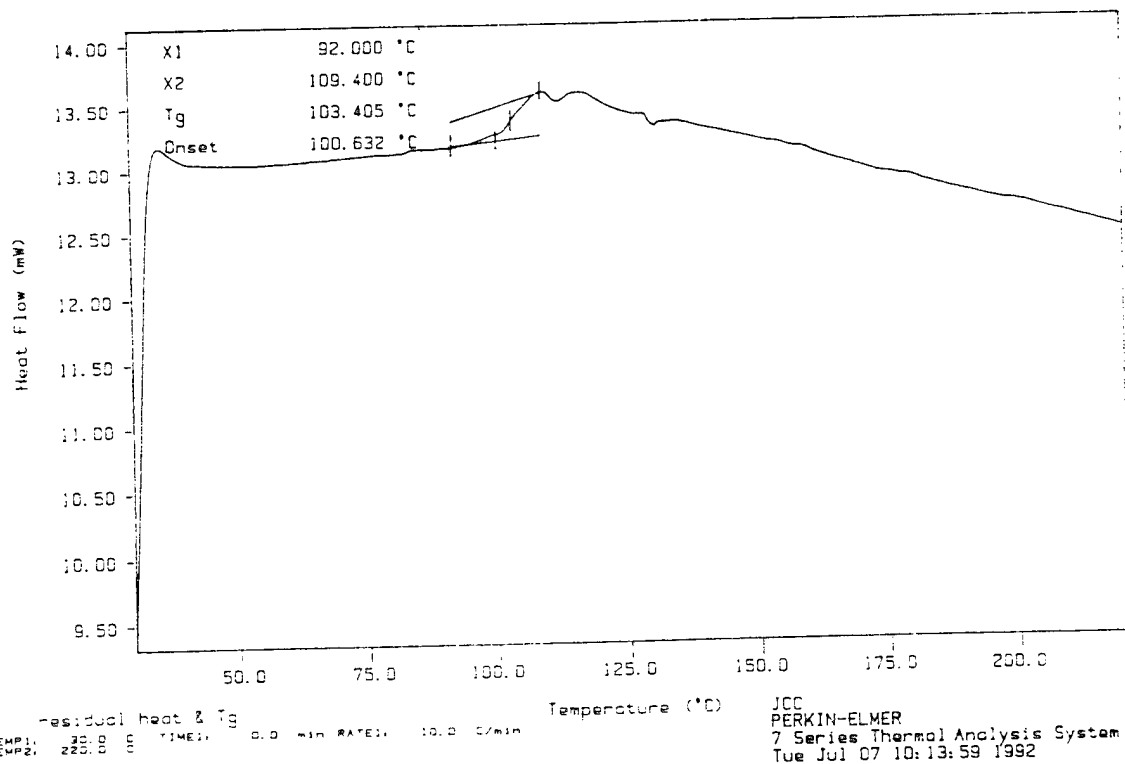
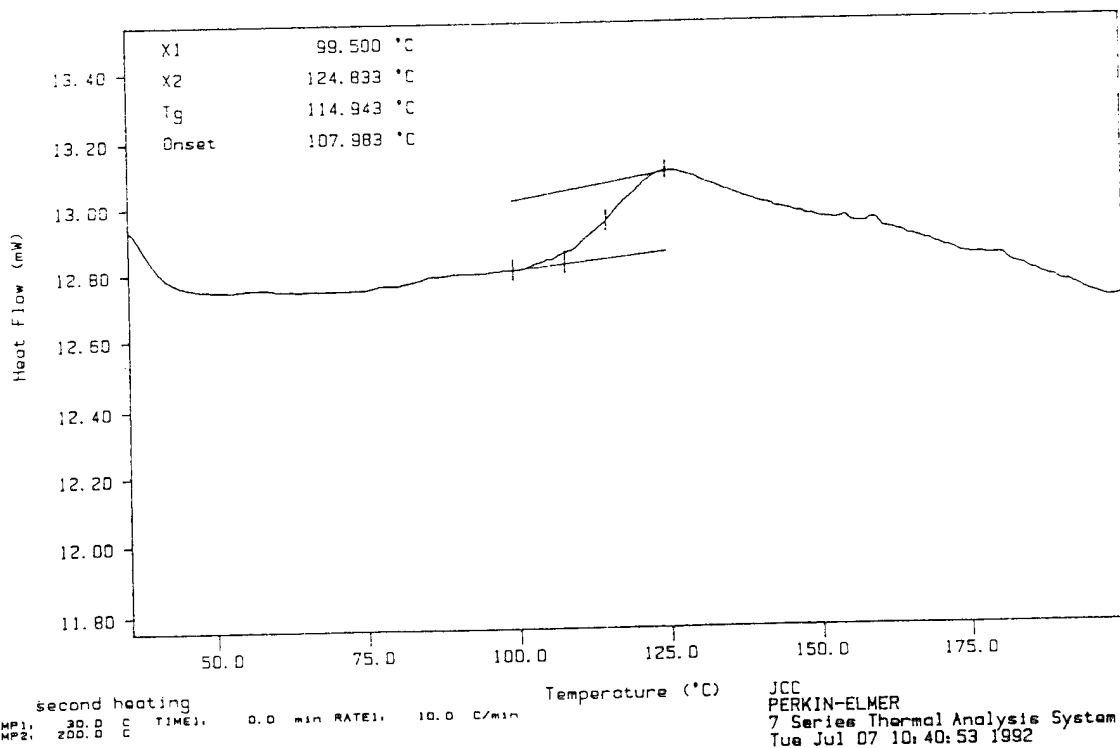
observed on either analyses and the Tg was 103° C and 115° C for the first and second tests respectively. This indicates that the resin in the wing section had been fully cured (Figure 6 & 7).

Figure 7. DSC Plots of the Wing Section Specimen
