DOT/FAA/AR-96/21

# Composite Failure Analysis Handbook Update 1

WL-TR-93-4004

August 1997

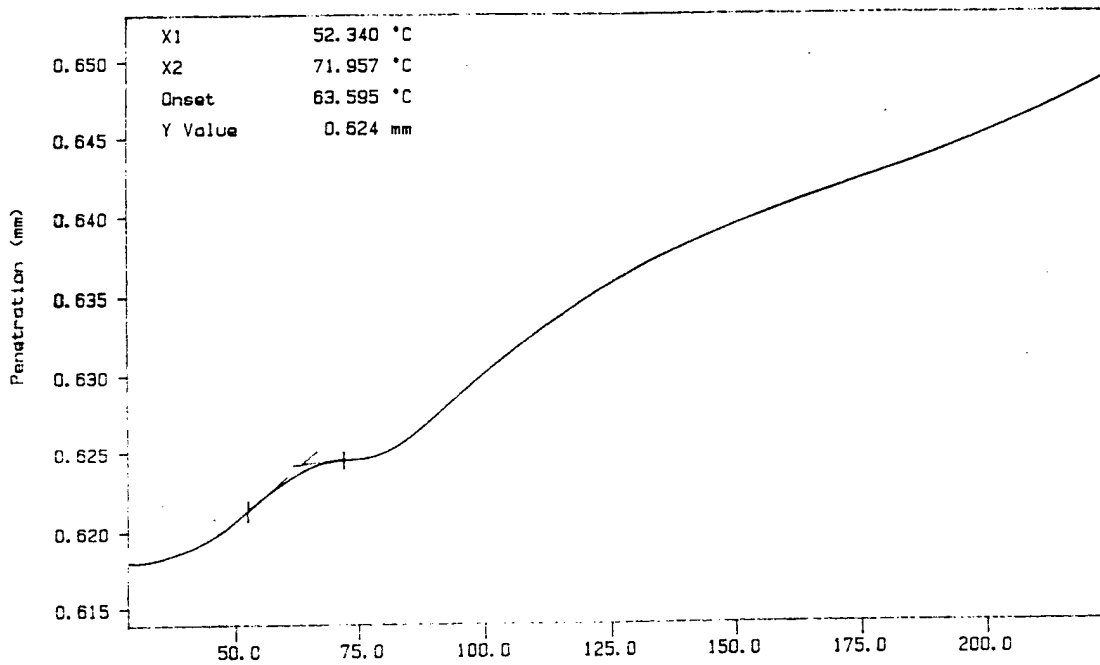
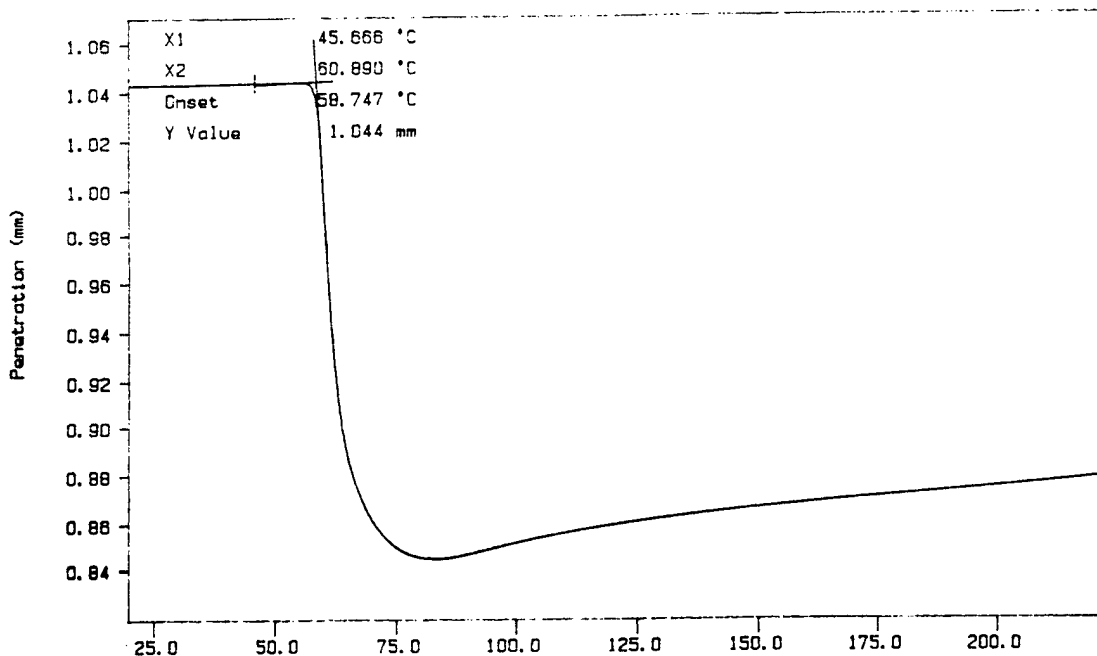
Figure 8. TMA Plots of the Non-Post-Cured Rutapox Sample

Thermo-mechanical Analysis (TMA) is another method to determine the Tg of a polymer. Again two specimens were tested; a non-post cured sample and a sample from the wing section. The first heat cycle of the non post-cured specimen revealed a definite Tg indication at 59°C. Testing of the resin from the wing revealed a Tg of 110°C and 107°C from the first and second runs, respectively. The difference between these two tests confirmed that the wing sample was fully cured because the Tg values were similar to the DSC analysis and that the uncured specimen exhibited a lower Tg and an exotherm. (Figure 8 & 9).

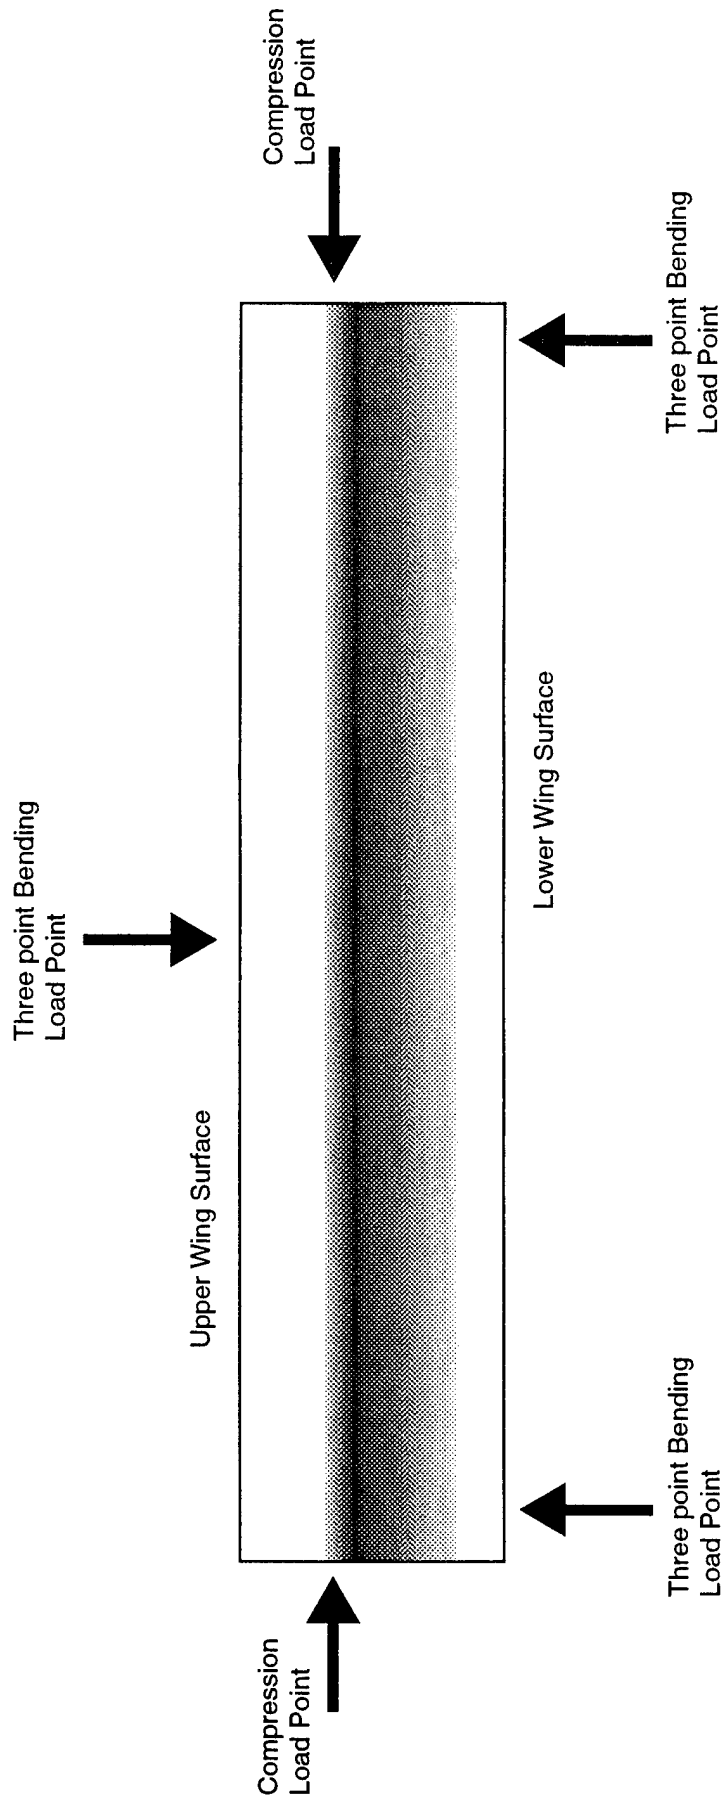
The fractures were most likely the result of a buckling of the upper skin that bent the edges upwards in relation the center of the wing section. This buckling was likely caused by either a general three point bending configuration or a longitudinal compression loading (Figure 13). In the case of the compression loading, it's assumed that the test grips or plates were removed prior to this investigation because no indication of crushed skin or honeycomb were seen on the edges.

1. The wing section contained two major cracks which extended from the leading edge of the wing to the aft edge. Another small crack was located at the edge, in the middle of the wing section. All of the cracks were on the upper wing skin.
2. Chemical analysis of the materials did not reveal any anomalies in the materials. No material or fabrication anomalies which could have contributed to crack initiation were found.
3. Cross-sectional and SEM analysis revealed the fractures were caused by buckling of the upper skin. The specific cause of the buckling could not be determined.

Figure 13. Diagram of the two Proposed Loading Configurations Which could Cause the Upper surface to Buckle
