TECHNICAL REPORT ARCCB-TR-97021

**HYDROGEN CRACKING DURING SERVICE OF
HIGH STRENGTH STEEL CANNON COMPONENTS**

**J. H. UNDERWOOD
E. TROIANO
G. N. VIGILANTE
A. A. KAPUSTA
S. TAUSCHER**

SEPTEMBER 1997

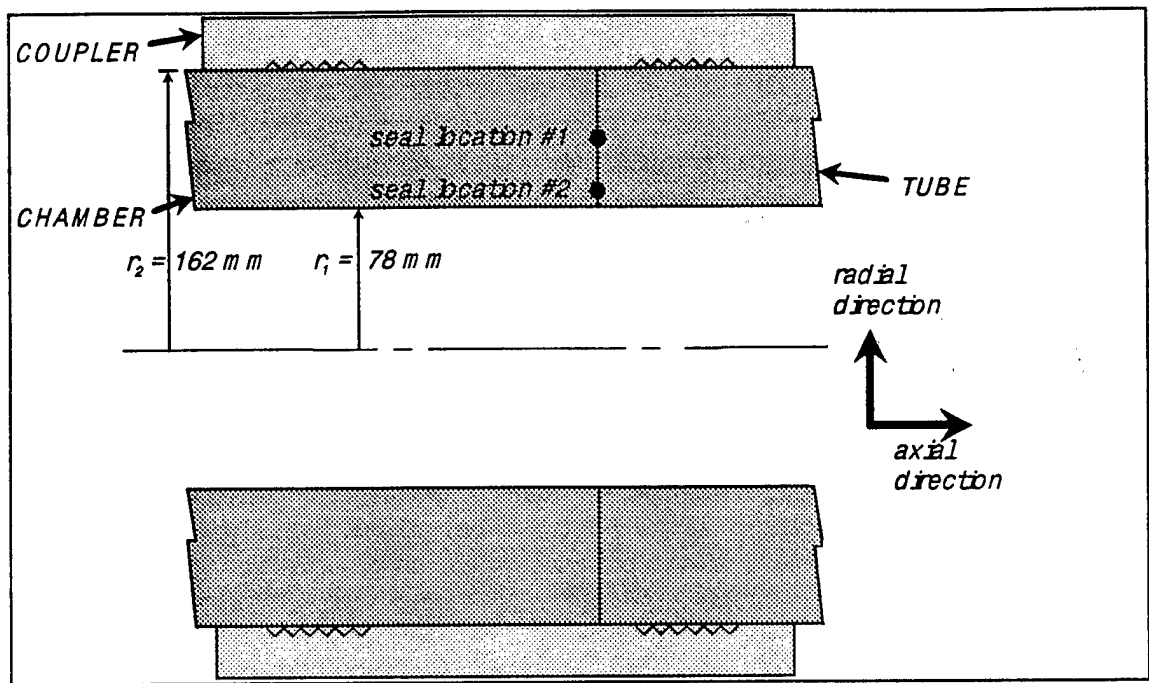
FIG. 1 - Sketch of Cannon Configuration and Nomenclature

The general configuration of the cannon components that sustained rapid cracking is shown in Figure 1. Cannon chamber and tube sections are connected using a cylindrical coupler with segmented threads on its inner surface. As the coupler draws the chamber and tube together, a preload is applied to the pressure seal between the two sections. Two seal locations that have experienced separate occurrences of rapid cracking are described here. Seal location #1, shown in Figure 2, is at a position about midway through the 84-mm wall thickness of chamber and tube. A triangular-shaped copper beryllium seal was used, along with a vented guard ring that allowed pressure on the seal while preventing a direct flow of cannon propellant combustion products onto the seal.

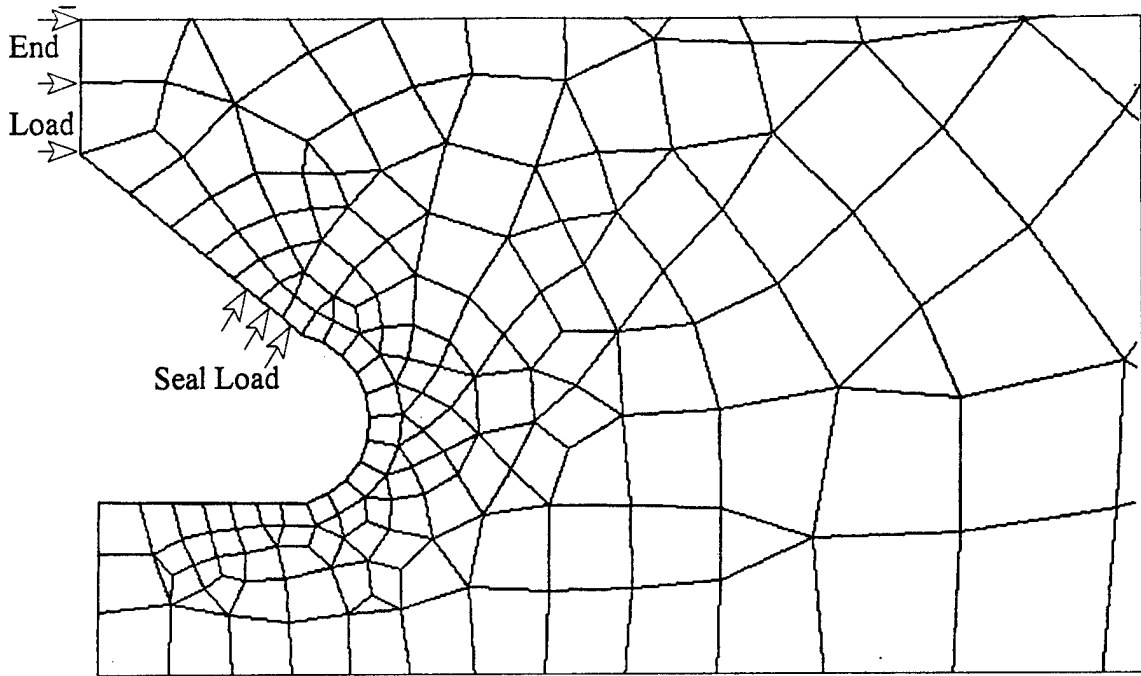
FIG. 7 - Finite Element Grid for Analysis of Cracking at Location #2

The important unanswered question at this point of the fracture case study was whether or not a significant sustained tensile stress could be accounted for at the location #2 failure location. A finite element analysis was performed to answer this question, using the ALGOR program. The portion of the grid in the area of the seal pocket is shown in Figure 7. The two types of sustained loads discussed previously were considered in the analysis and are shown schematically in Figure 7. The end load is caused by the contact between the chamber and tube sections of the cannon as they are drawn together by the coupler, see again Figure 1. An average end load of 156 MPa was determined from prior work (ref 2), based on typical loads on the coupler threads. The seal load, the other type of loading considered, was determined from the yield and ultimate strengths of the seal material given earlier and the significant values of triaxial stresses that are present in contact stress situations. Based on prior work (ref 7), the contact stresses are 2.97 times larger than the uniaxial yield strength of the material, the lower strength seal material in this case. Using this value of 2.97 and the average of the yield and ultimate strengths of the seal material, 1019 MPa, gives a seal load of 3023 MPa.
