**The Performance of Low-Rise Open Span Heavy Steel
Structures In Extreme Winds**

Joe R. Charlton, B.S., P.E.

A REPORT

CIVIL ENGINEERING

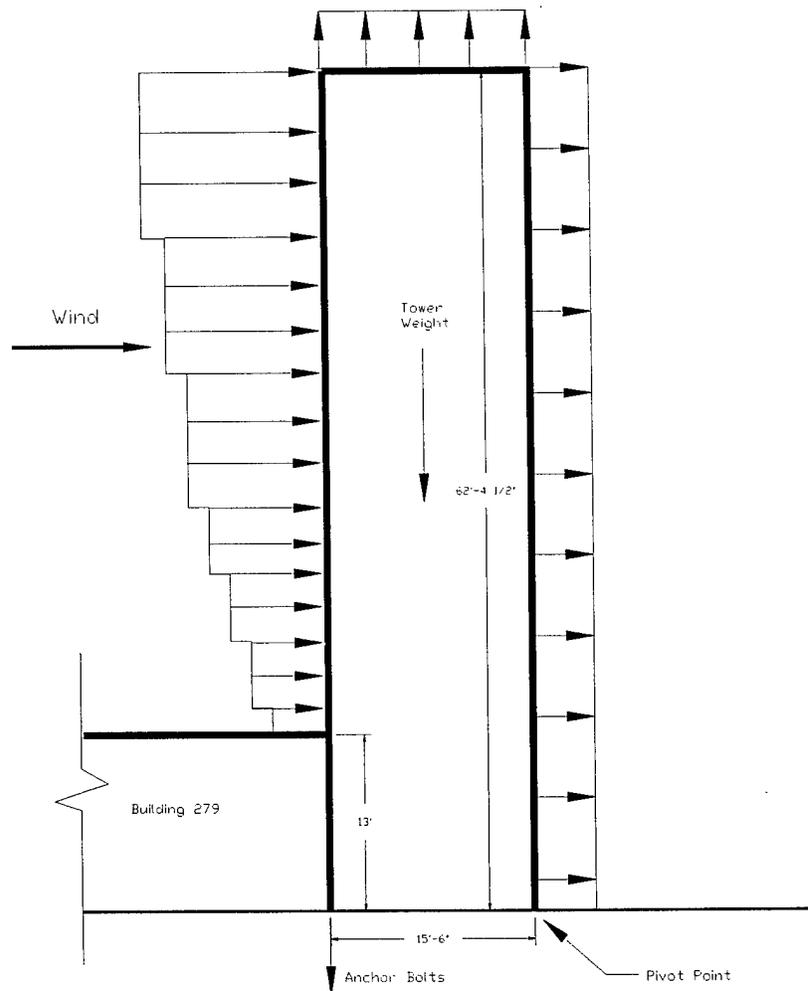
Figure 4.11 Forces Acting on Parachute Tower

The wind that caused the collapse of the parachute tower was generated by the Altus, Oklahoma tornado that was described earlier in Section 3.5. The wind caused the collapse of the parachute tower by generating enough force to cause failure of the column anchor bolts and also overcome the righting moment generated by the weight of the building. An illustration of the forces acting on the structure can be seen in Figure 4.11, below.

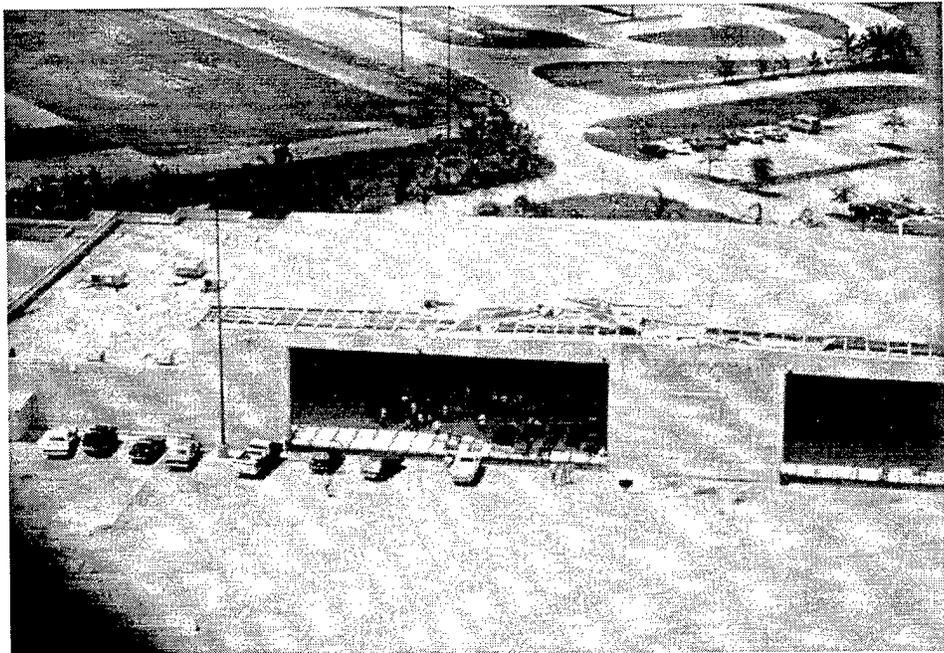
Figure 4.24 Elevation of Beechcraft Hangar

The Beechcraft hangar shown in Figures 4.23, 4.24, and 4.25 is approximately 200 feet long, 60 feet wide, and 40 feet tall. The structure has a gable roof with a very slight pitch (approximately 1/4" per foot). The exterior walls are covered with corrugated metal siding and the roof is covered with corrugated metal decking. The main structural system is made up of wide flange steel columns, large custom girders, and z shape roof purlins. The lateral loads are transferred to the foundation via steel cross bracing running between the columns. All of the main structural elements can be seen in Figure 4.25. The other two hangars that are shown in Figure 4.26 are very similar in size and construction to the Beechcraft hangar.

The main component that was damaged on all three hangars was the roof decking. The corrugated siding on the front of the Beechcraft hangar also received minor damage at the door pocket, see Figure 4.25.
