# Investigation of Concrete from I-20 Near Monroe, Louisiana

Miscellaneous Paper SL-98-1  
January 1998

Final report

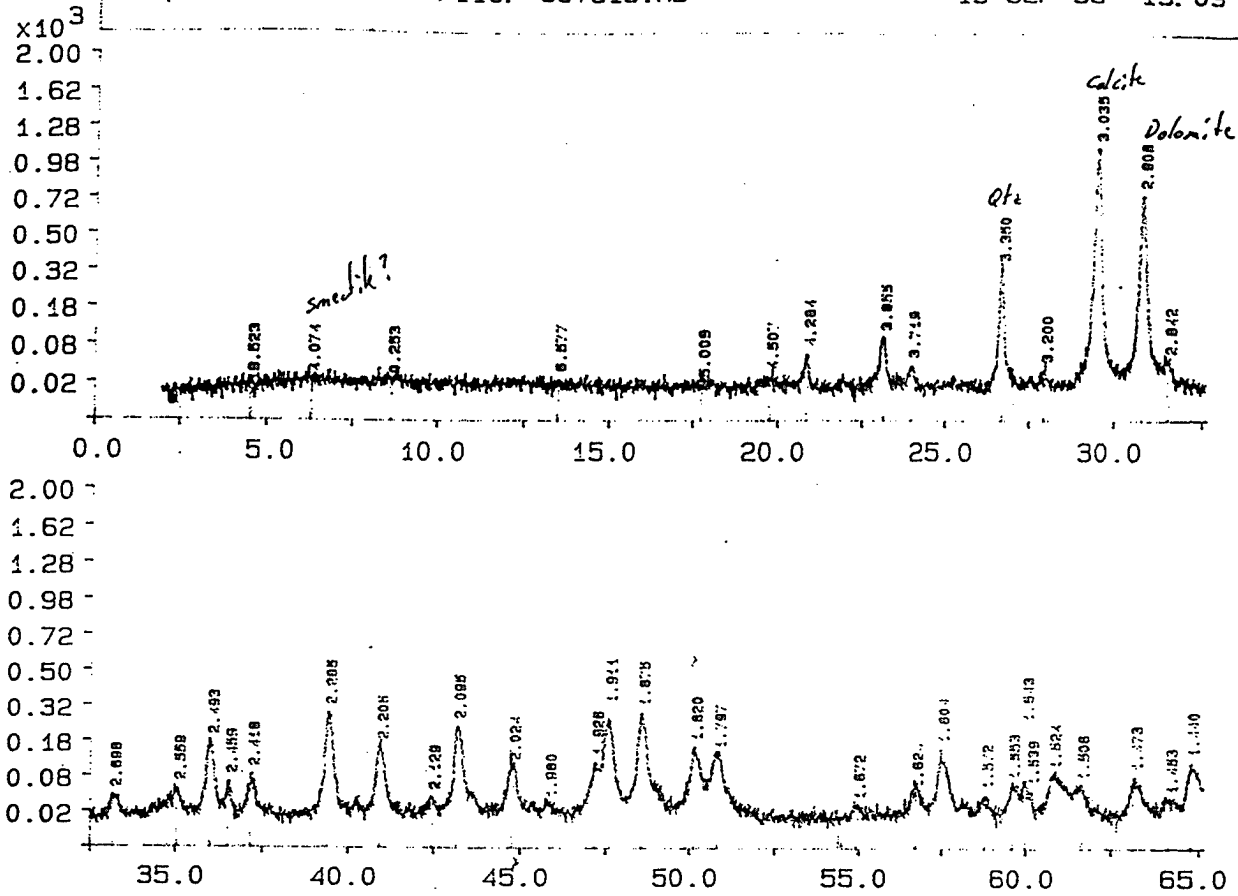
- a. 950623 - This core was cut along its entire length to expose the interior concrete. A near-surface vertical crack was associated with subsurface dark-gray coarse-aggregate particles with prominent reaction rims. These particles showed some interior cracks. X-ray diffraction examination of one particle indicated that the particle was composed of a fine-grained dolomitic limestone containing some quartz and clay, as shown in Figure 16. Some interior, randomly oriented incipient cracks were also observed associated with dark-gray coarse-aggregate particles with reaction rims, as illustrated in Figure A1, Appendix A. These cracks were located in the lower portion of the core.

Figure 16. X-ray diffraction pattern of reactive coarse-aggregate particle from core 950623

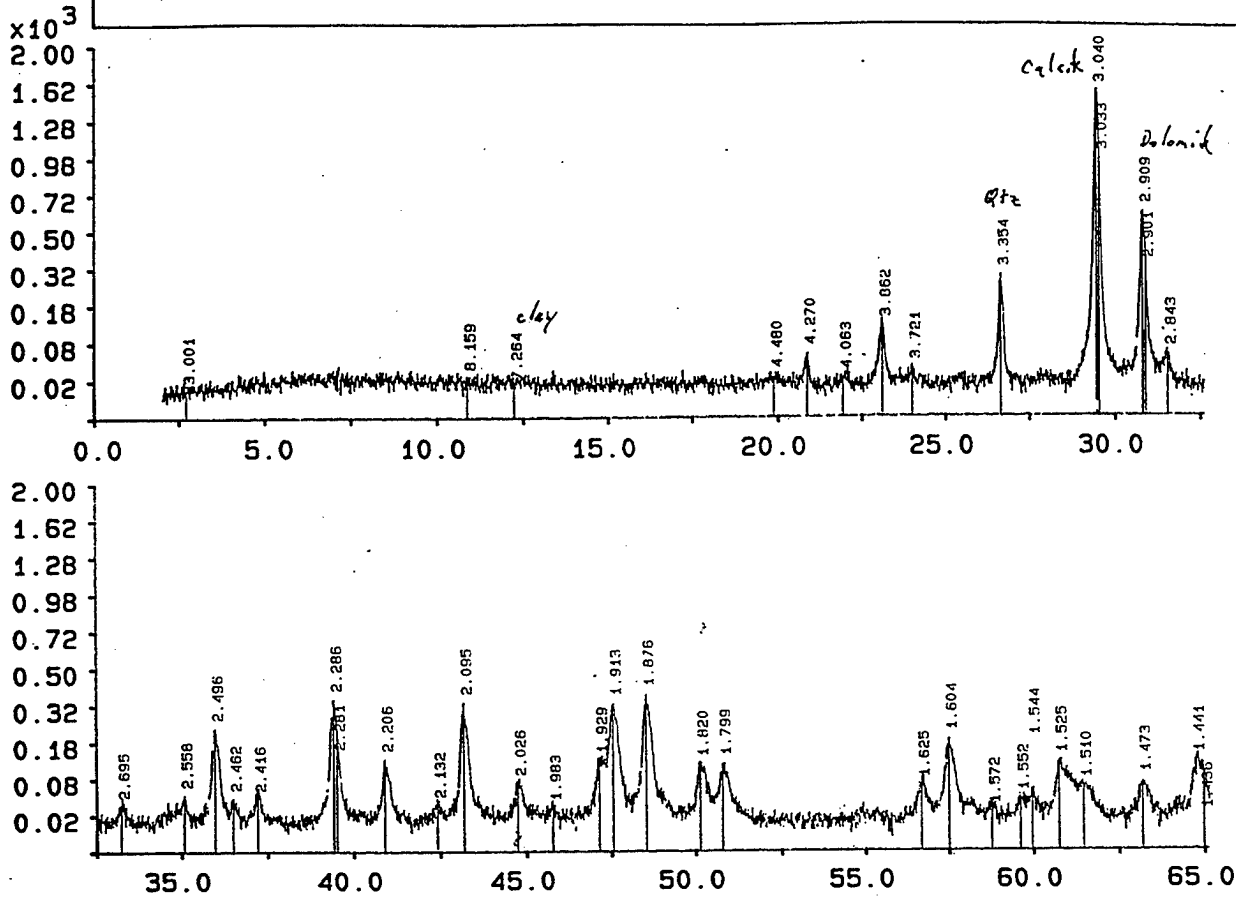
dark-gray fine-grained limestone coarse-aggregate particles in the concrete. Some of the pieces were large coarse-aggregate particles and some were small. Cracks were always associated with the larger pieces of aggregate of this nature and were less common with smaller pieces. Many of these pieces of aggregate showed open cracks in the interior of the particle. The X-ray diffraction pattern showed the coarse-aggregate particles to consist of a dolomitic limestone containing some quartz and clay (Figure 17).

Figure 17. X-ray diffraction pattern of reactive coarse-aggregate particle from core 950628

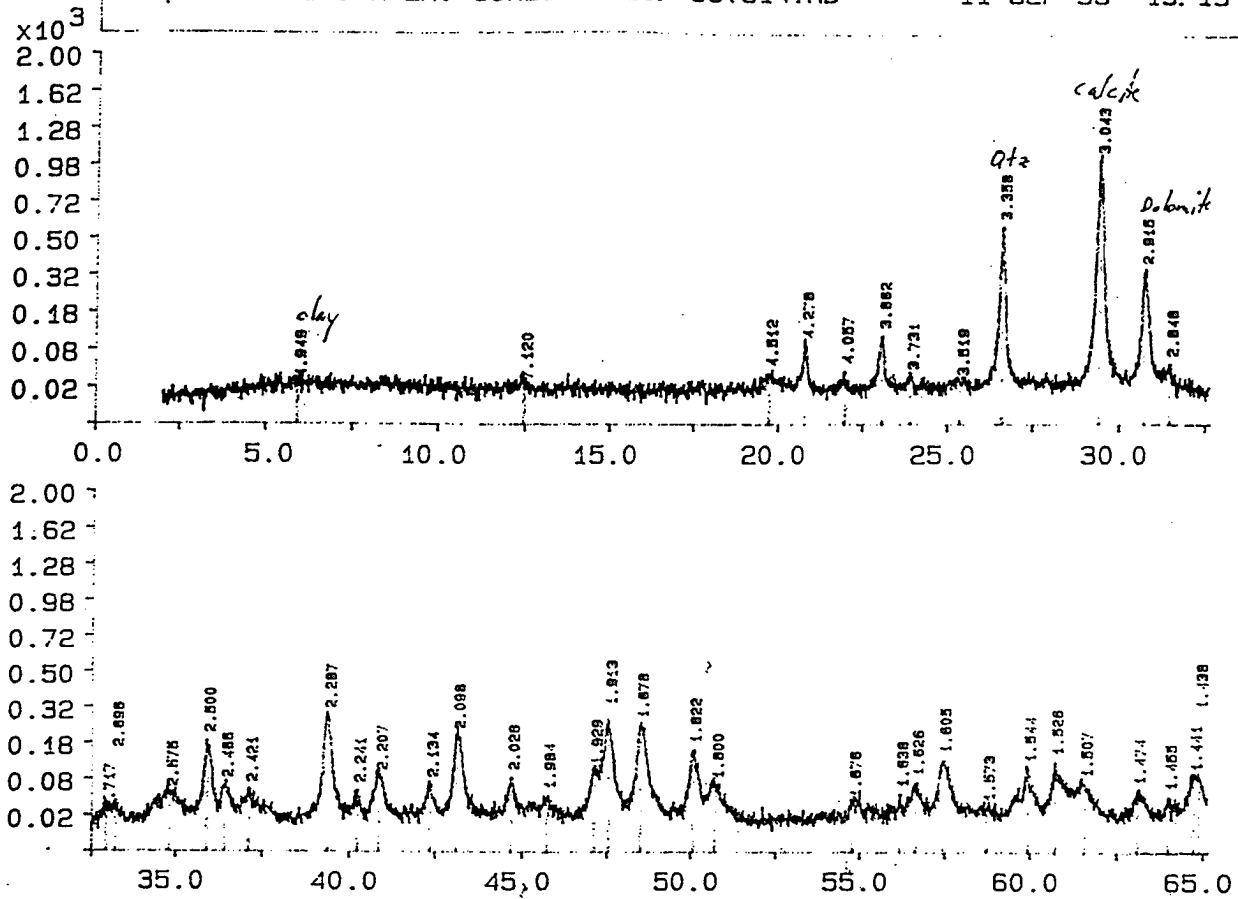
- f.* 950620 - The core was cracked throughout its length. The cracks were randomly oriented. There were numerous dark-gray limestone coarse-aggregate particles with dark reaction rims. The rims exhibited radial cracks that extended into the paste. Aggregate particles with these rims were dolomitic limestone containing quartz and clay. X-ray diffraction patterns are presented in Figures 18 and 19. Figure A6, Appendix A, shows the appearance of these aggregate particles.

Figure 18. X-ray diffraction pattern of reactive coarse-aggregate particle #A from core 950620

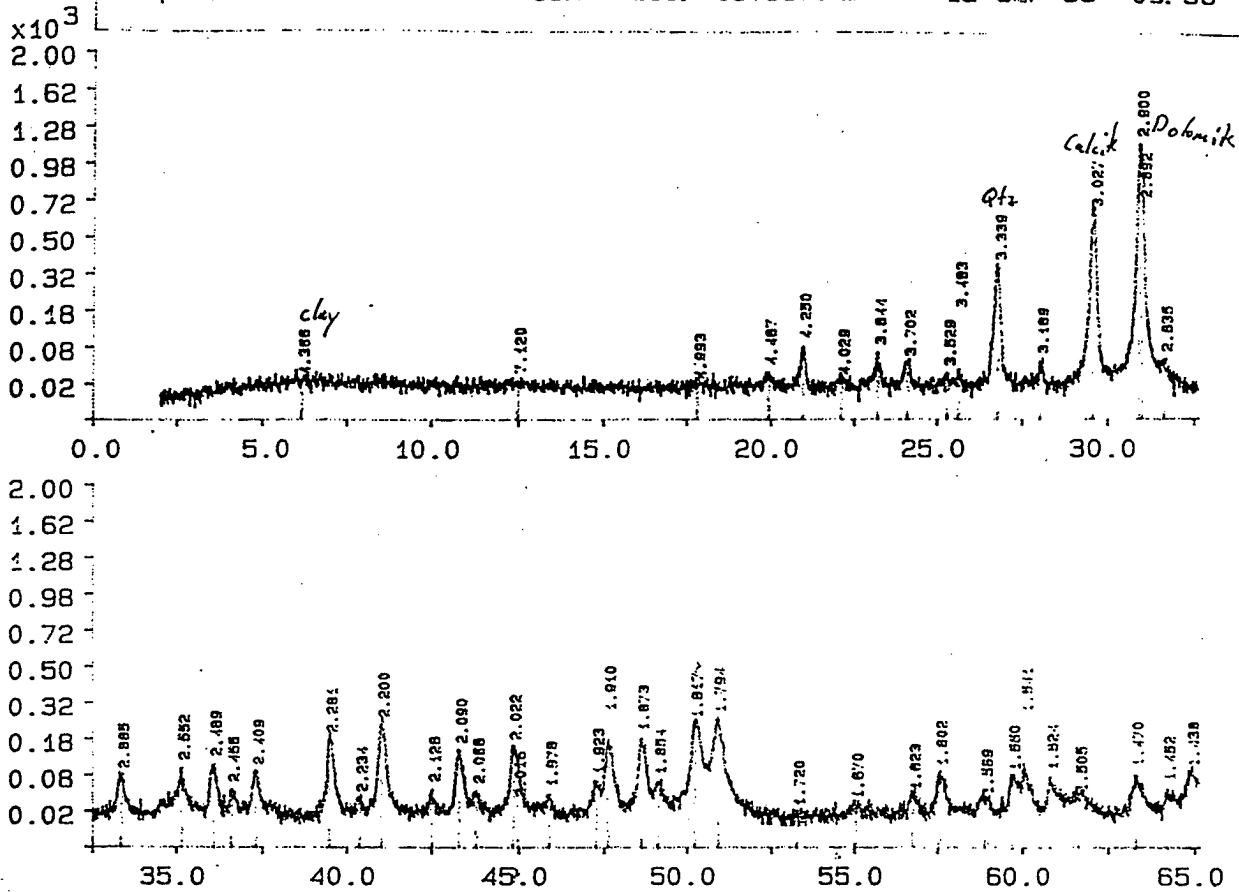
Figure 19. X-ray diffraction pattern of reactive coarse-aggregate particle #B from core 950620.

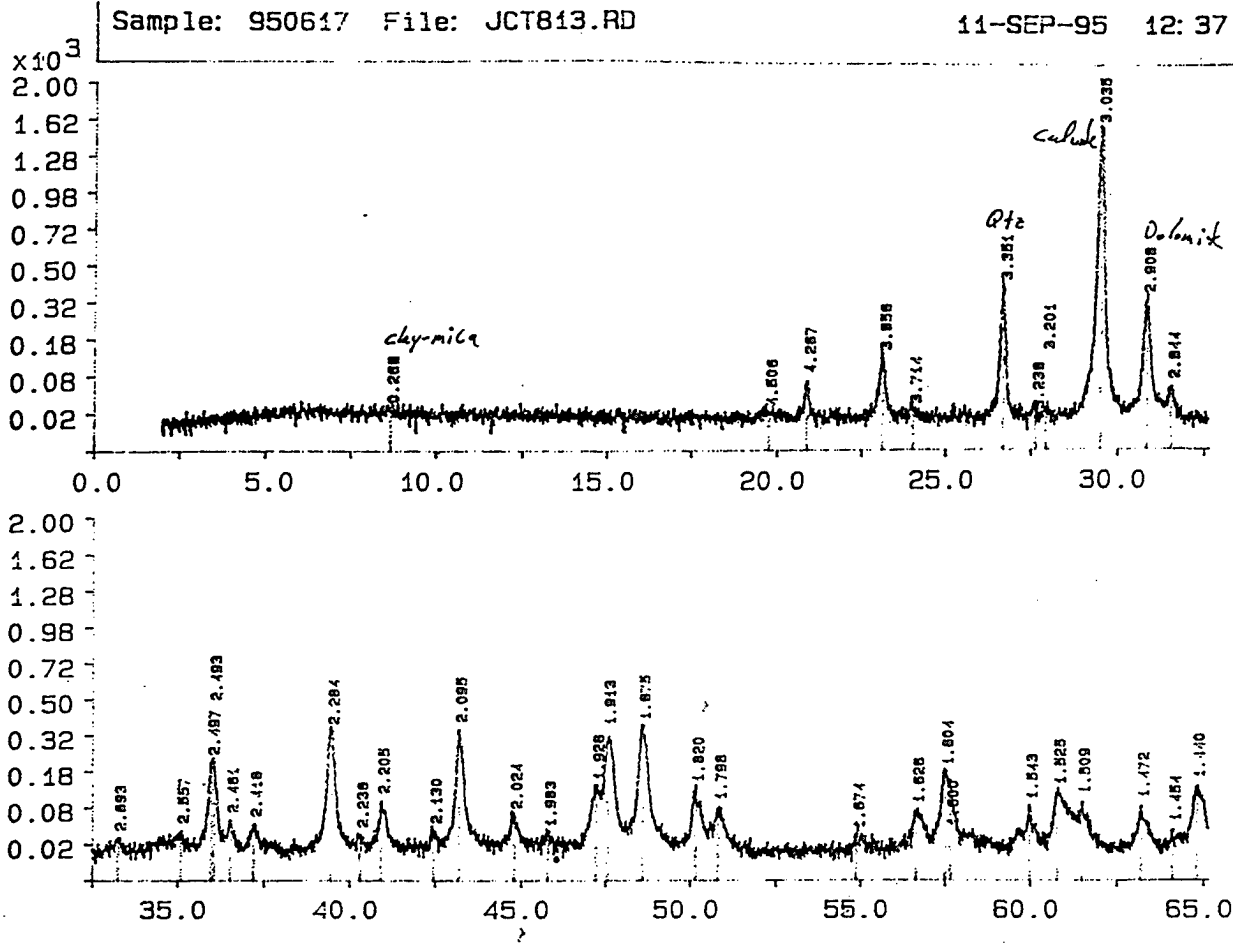
- h.* 950617 - This sample consisted of rubble. The core had broken into fragments during the coring process. One large piece was impregnated using an epoxy resin and then cut open for examination. The concrete was highly fractured (Figure A8, Appendix A). There were numerous dark-gray limestone coarse-aggregate particles. Cracks were mostly associated with the larger coarse-aggregate particles. The associated dark-gray coarse-aggregate particles were dolomitic limestone containing some quartz as well as illite (clay-mica). An X-ray diffraction chart showing the relative abundance of the calcite and dolomite is presented in Figure 20.

Figure 20. X-ray diffraction pattern of reactive coarse-aggregate particle from core 950617

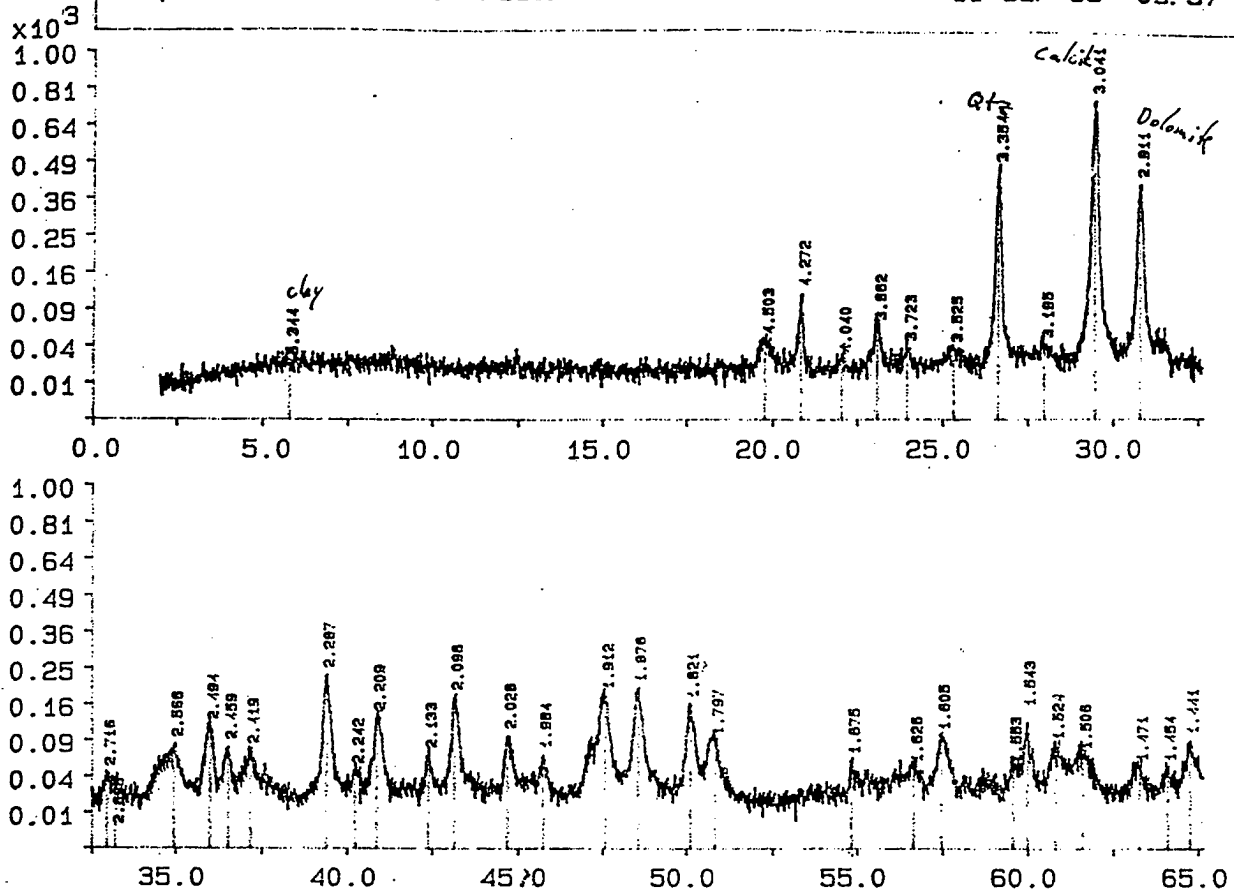
- j.* 950616 - The surface cracking was light. However, the interior concrete showed an extensive crack system. A vertical crack extended several inches into the interior concrete going through coarse-aggregate particles as well as around them. The vertical cracks intersected horizontal and diagonal cracks (Figures A9a and A9b, Appendix A). The majority of the cracks were associated with cracked dark-gray fine-grained limestone coarse-aggregate particles. Two particles examined by X-ray diffraction were dolomitic limestone with acid-insoluble materials consisting of quartz and clays. Figures 21 and 22 illustrate the relative abundance of the carbonate phases.

Figure 21. X-ray diffraction pattern of reactive coarse-aggregate particle #A from core 950616

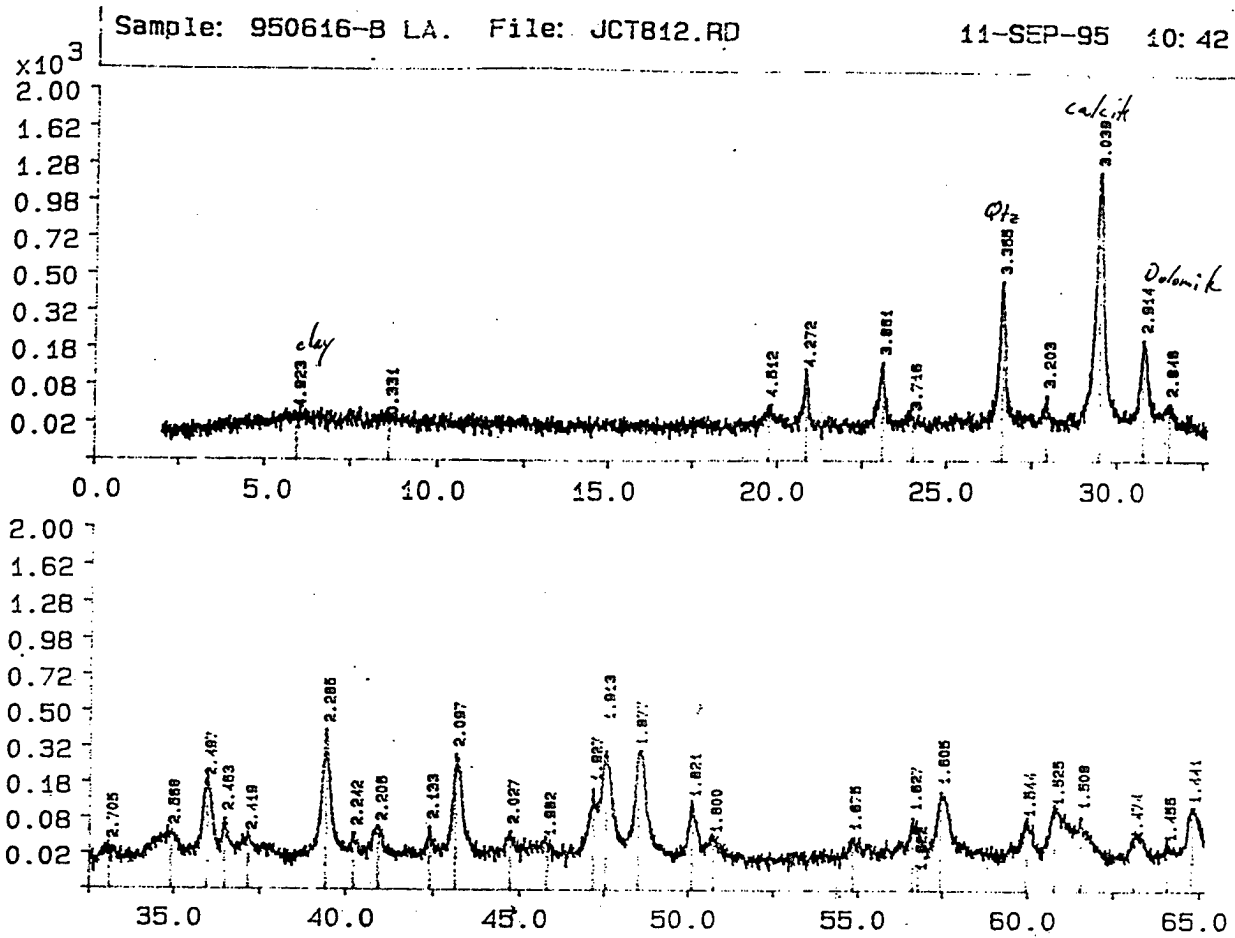
Figure 22. X-ray diffraction pattern of reactive coarse-aggregate particle #B from core 950616

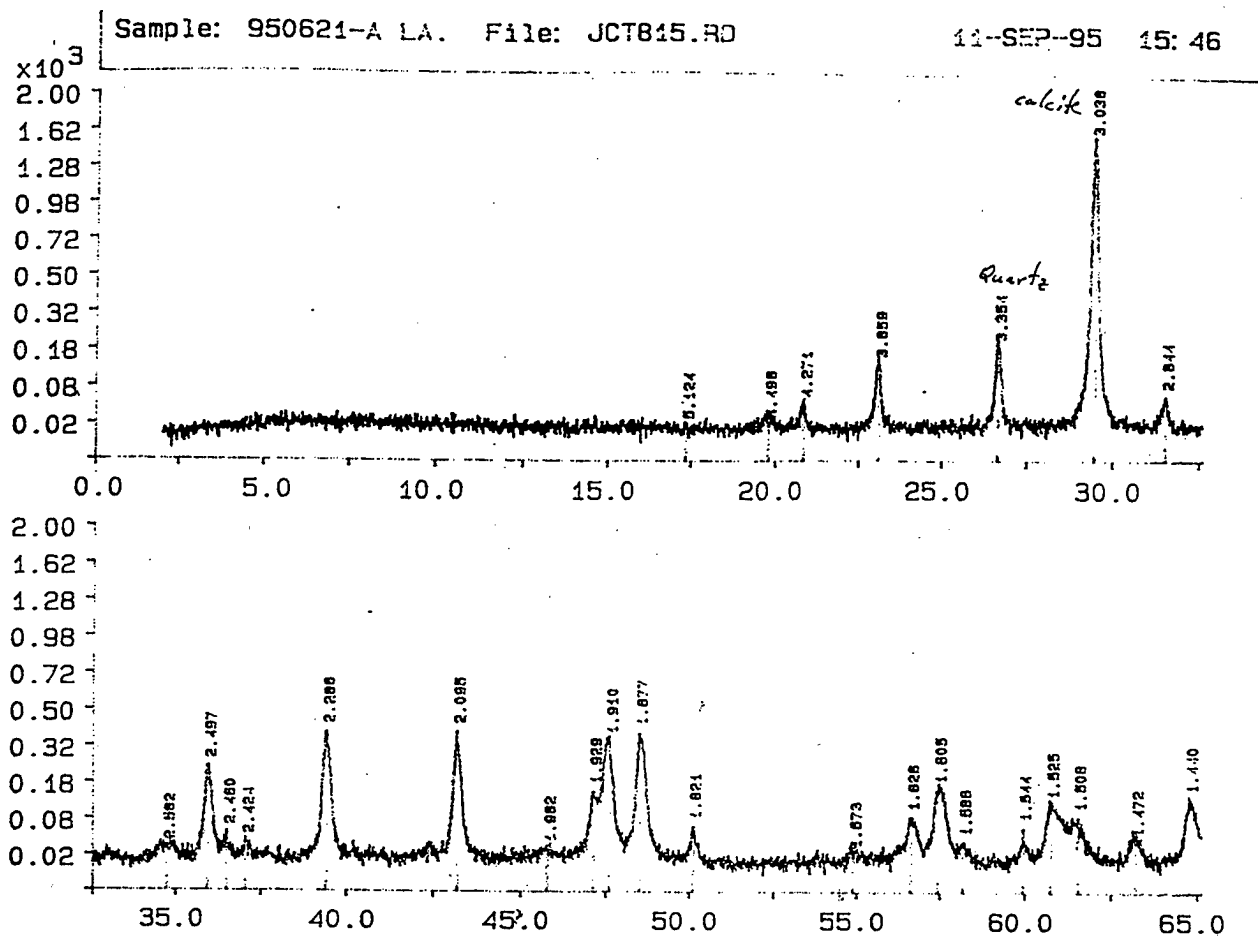
- m.* 950621 - This concrete had some hairline cracks at the surface. One crack penetrated into the interior concrete approximately 1 in. (25.4 mm) and terminated in the paste. The upper portion of the concrete consisted of lighter colored limestone coarse-aggregate particles. The lower portion of the core contained numerous dark-limestone coarse-aggregate particles with dark reaction rims. Some cracks associated with these limestone aggregate particles are shown in Figure A12, Appendix A. The X-ray diffraction pattern of aggregate particle #A, a dark-gray particle with a prominent dark reaction rim, showed it to be pure limestone, as shown in Figure 23. Light-colored brownish limestone with a reaction rim (particle #B) was pure limestone, as identified in Figure 24. The dark-gray particle

Figure 23. X-ray diffraction pattern of non-expansive reactive coarse-aggregate particle #A from core 950621

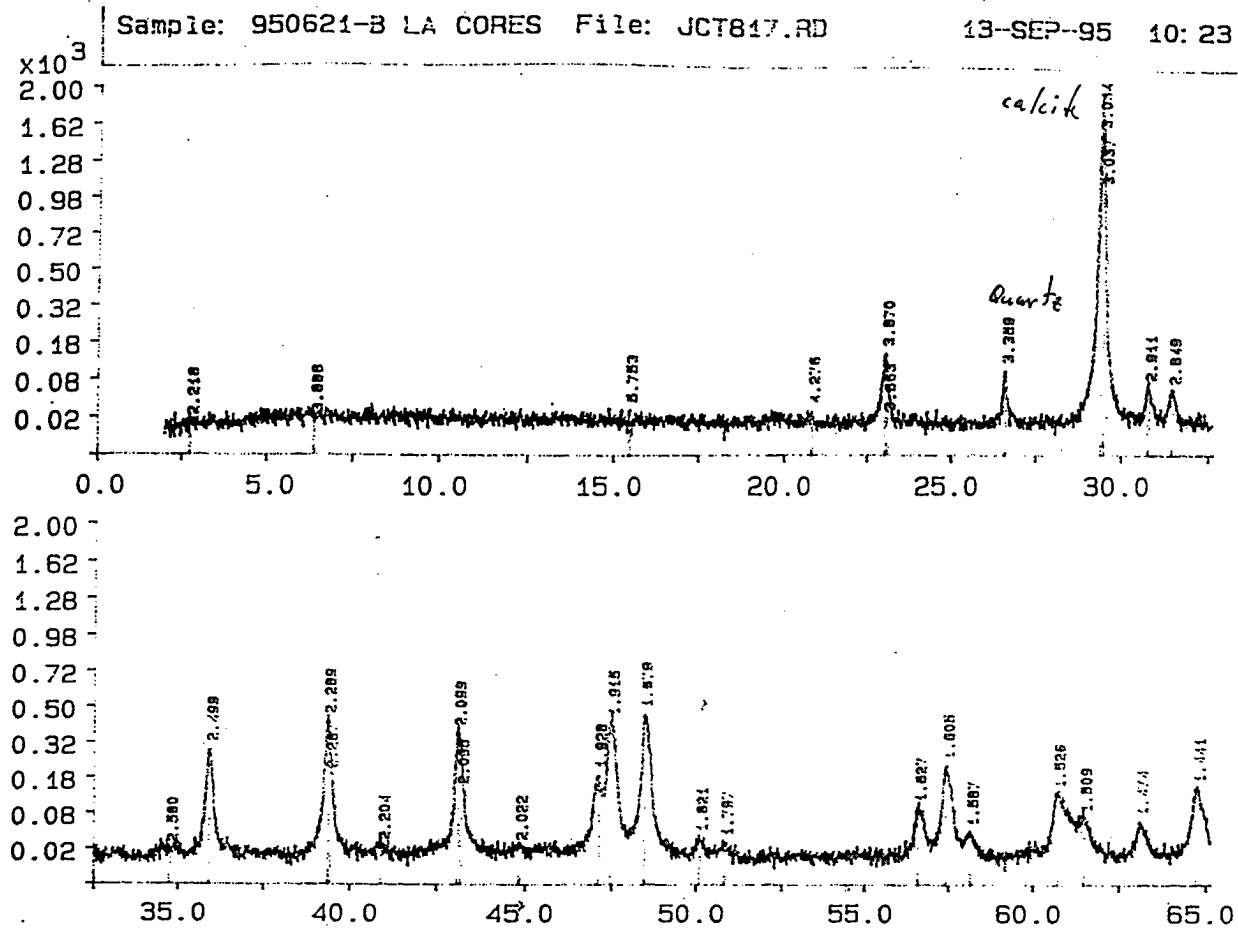
Figure 24. X-ray diffraction pattern of non-expansive reactive coarse-aggregate particle #B from core 950621

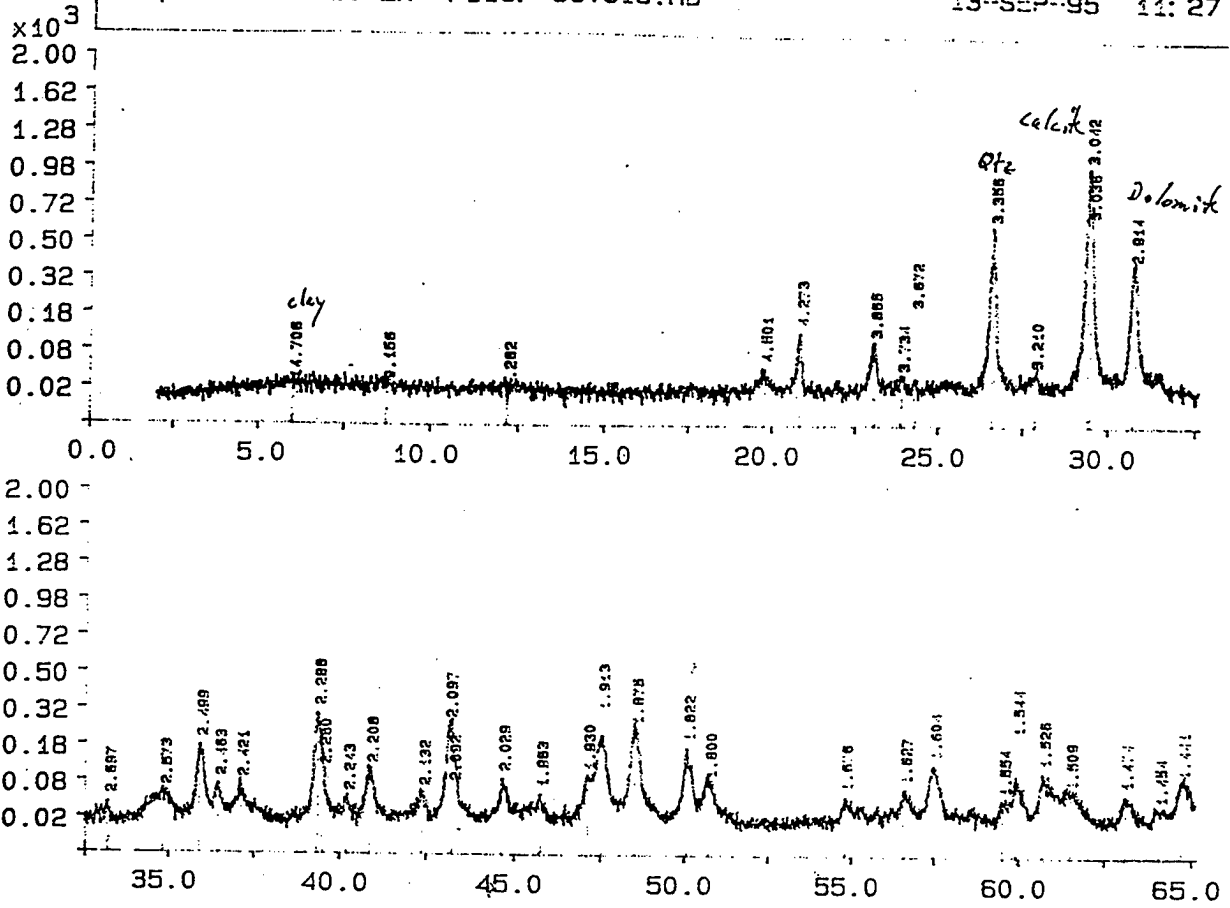
with a prominent reaction rim (Figure A12, Appendix A) (particle #C) was a fine-grained dolomitic limestone also containing insoluble material including clays and quartz (Figure 25). A thin section of a near-surface dark-gray fine-grained impure limestone coarse-aggregate particle showed a rim on this aggregate and micro cracks in the rim propagating into the paste. Etching of coarse-aggregate particle using dilute hydrochloric acid showed no relief in the rim area; i.e., the rim was neither more nor less acid soluble than the unaltered rock.

Figure 25. X-ray diffraction pattern of expansive reactive coarse-aggregate particle #C from core 950621

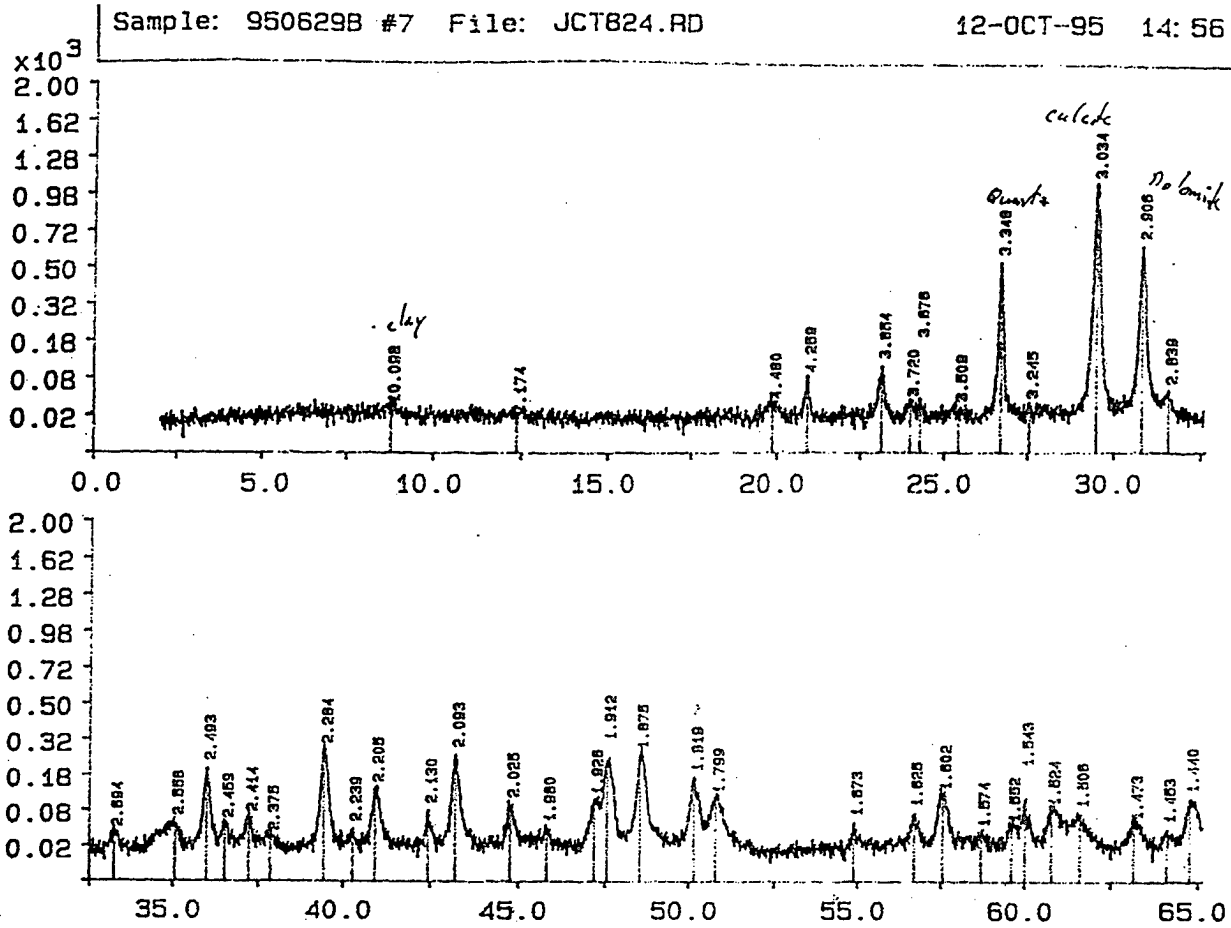
Rock-cylinder expansion measurements indicated that some of the aggregate particles were highly reactive when stored in sodium hydroxide in accordance with ASTM C 586. Figures 28 and 29 show expansion data up to 64 days. The specimens were immersed in water for 7 days and showed no change in length. Specimens from both limestone samples included aggregate materials that expanded significantly. Sample 950629 showed immediate expansion and rose to above 3 percent at 35 days; measurements were terminated for these particular specimens as they began to fall apart. Sample 950630 yielded specimens that expanded to above 0.4 percent in 64 days in sodium hydroxide. Analysis of a highly expansive particle in 950629 (particle B) indicated the sample to be composed of dolomitic limestone containing some quartz and clay. No reaction products were detected by X-ray diffraction analysis, as shown in Figure 26.

Figure 26. X-ray diffraction pattern of highly reactive coarse-aggregate particle #B from limestone sample 950629 after treatment in sodium hydroxide

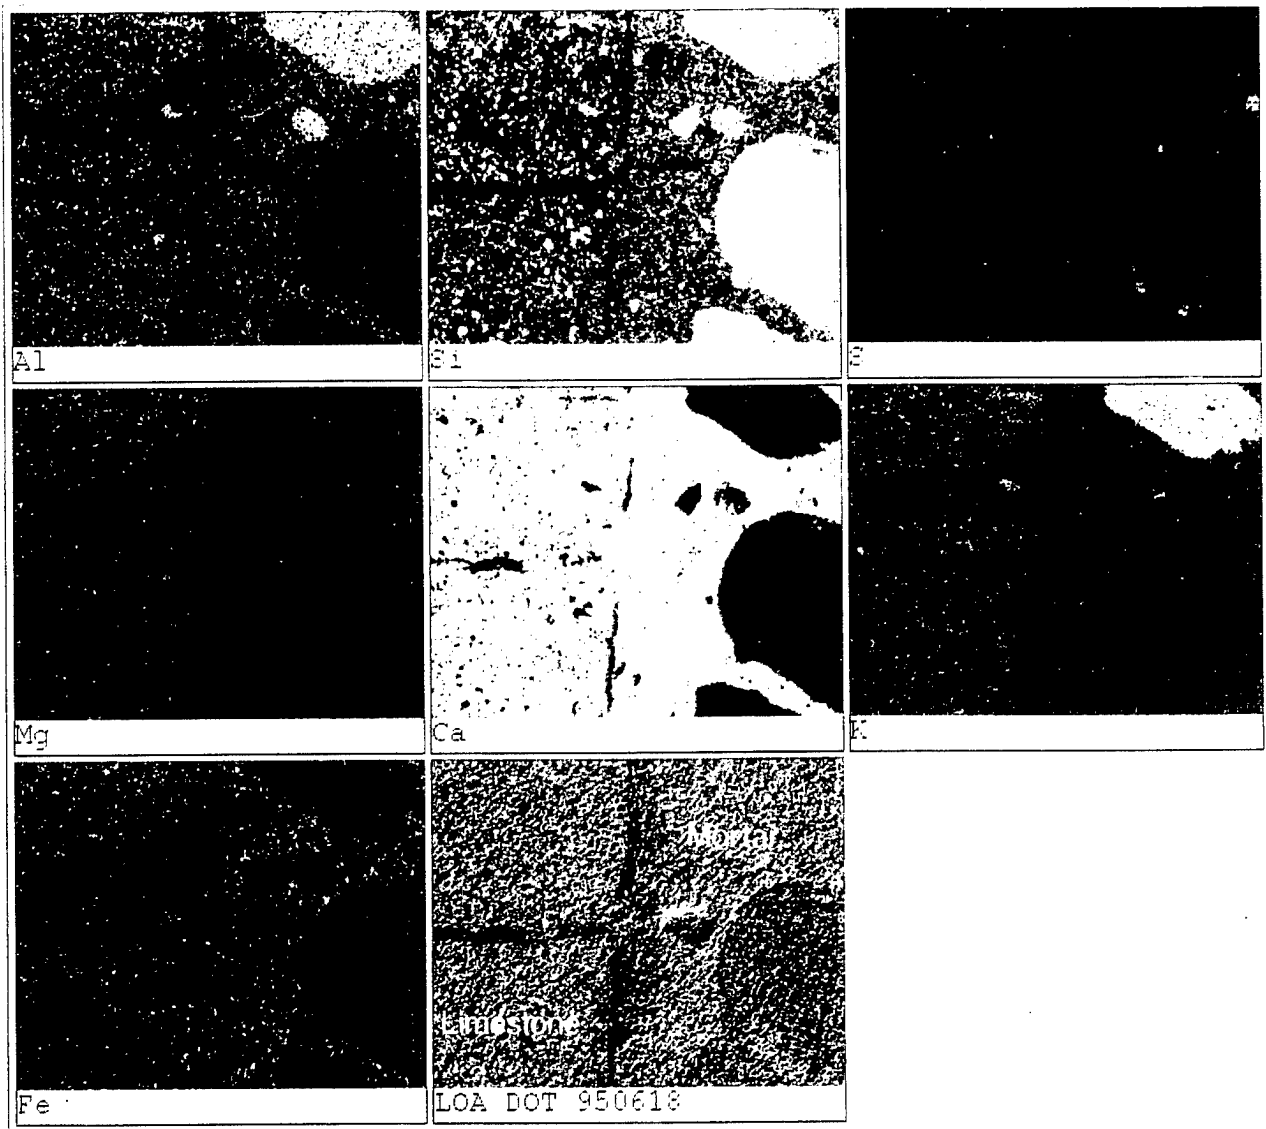
- l.* 950618 - This concrete was heavily cracked. Vertical, horizontal, and diagonal cracks were abundant throughout the length of core. The cracking was associated with a large dark-gray limestone coarse-aggregate particle (Figure A11, Appendix A). Fractures were observed in the central portion of the aggregate particle as well as in the rim area of the particle. A specimen of this aggregate particle was cored along the paste-to-aggregate interface and prepared for examination as a ground section. The specimen was impregnated using an epoxy resin to reinforce the sample and minimize possible additional cracking in the preparation process. The specimen showed the propagation of cracks through the interface zone. The cracks were not confined to the interface zone of the aggregate particle as they propagated into the interior of the aggregate particle. The interior portion of the aggregate particle was also cracked. High-resolution elemental analysis using the scanning electron microscope (SEM) and energy dispersive X-ray (EDX) showed no migration of elements in this particular aggregate particle, as illustrated in Figure 27.

Figure 27. High-resolution X-ray elemental map of reactive coarse aggregate interface with paste. No migration of elements is observed

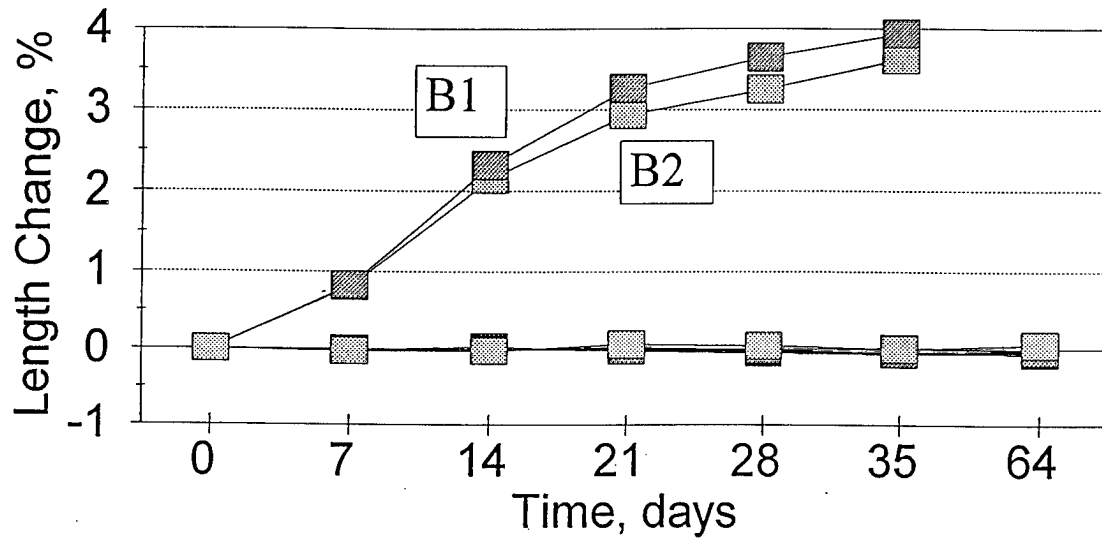
Figure 28. Rock cylinder test shows two specimens (B1 and B2) from sample 950629 expanding quickly while others did not expand. Cores were taken from five particles (A, B, C, D, and E) representing varieties of rock

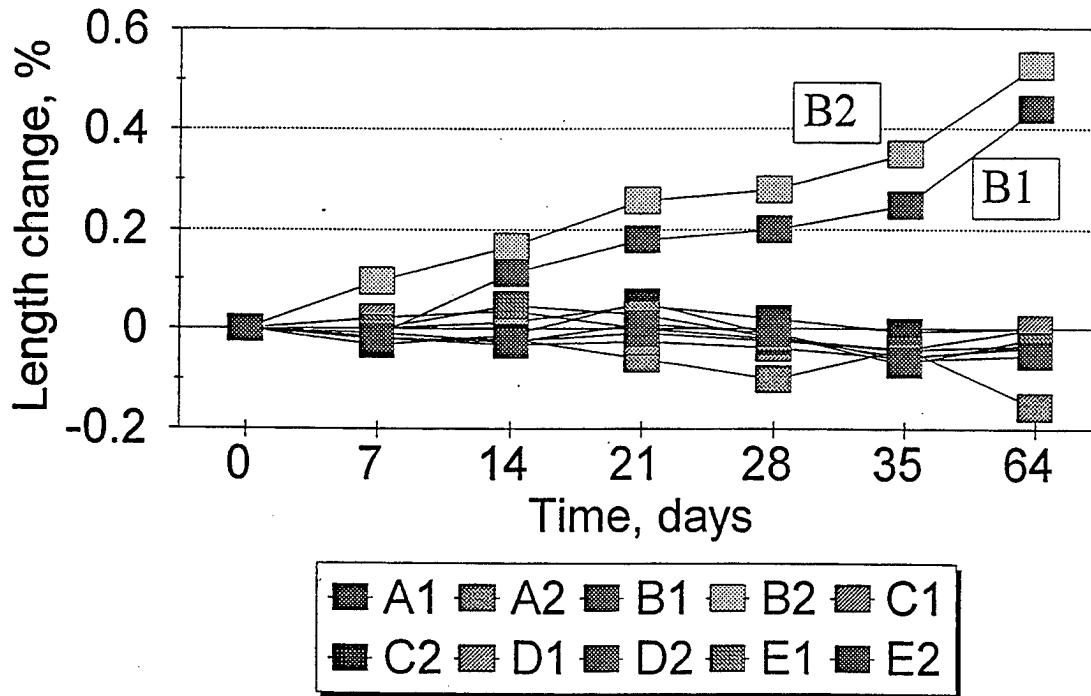
Figure 29. Rock cylinder test shows two specimens (B1 and B2) from sample 950630 expanding while others did not expand. Cores were taken from five particles (A, B, C, D, and E) representing varieties of rock
