AIRCRAFT ACCIDENT REPORT

UNCONTAINED ENGINE FAILURE
DELTA AIR LINES FLIGHT 1288
MCDONNELL DOUGLAS MD-88, N927DA
PENSACOLA, FLORIDA
JULY 6, 1996

**Adopted: January 13, 1998
Notation 6725C**

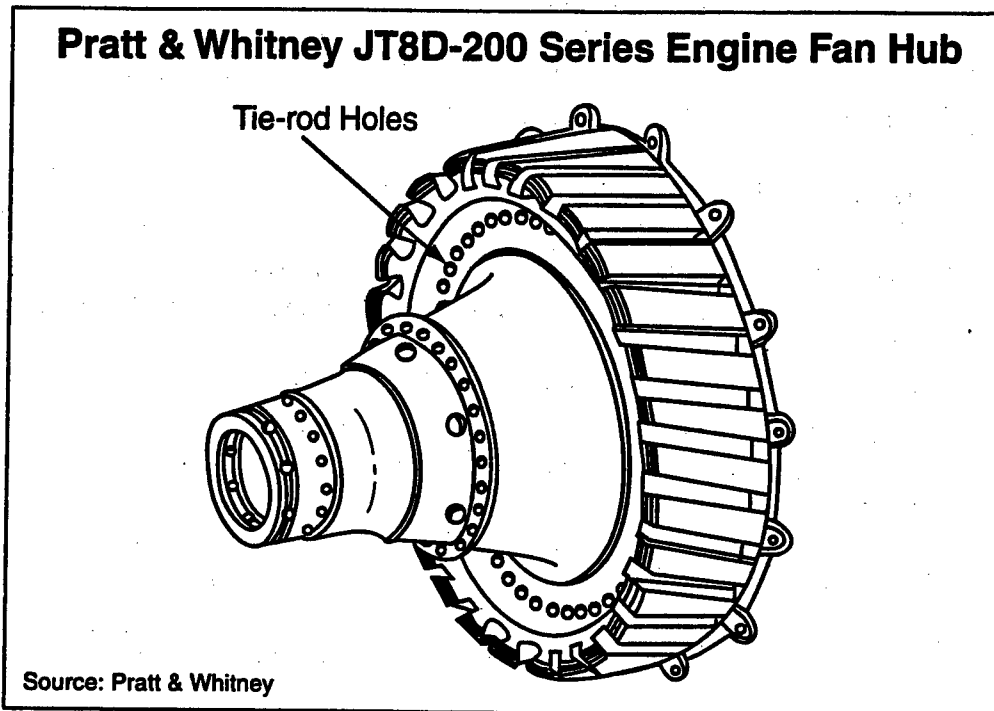
Figure 4.—Pratt & Whitney JT8D-200 series engine fan hub.

dovetail slots. The 2.91-inch deep tierod holes were located around the circumference of the hub bore and alternated with 24 smaller diameter stress redistribution (SR) holes (see figure 4).²¹ The fan hub was forged from a titanium-based alloy containing 6 percent aluminum and 4 percent vanadium.
