DOT/FAA/AR-98/22

FAA T53-L-13L Turbine Fragment Containment Test

June 1998

Final Report

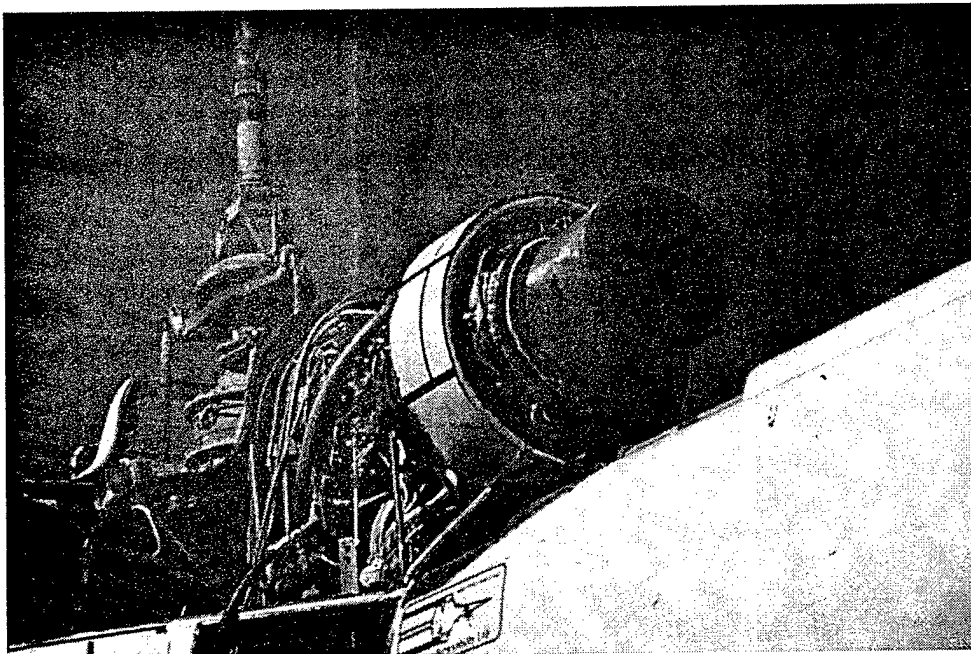
FIGURE 2. PRETEST INSTALLATION

The T53 engine was then installed in an UH-1 Huey helicopter (figure 2). The helicopter was mounted on two 2-foot-thick cement blocks and cabled down to three 1-foot-thick cement blocks (figure 3). The rotor head was removed to simplify the test setup and preparation. The engine was remotely started and operated. An emergency shutoff valve was located near the engine interface.

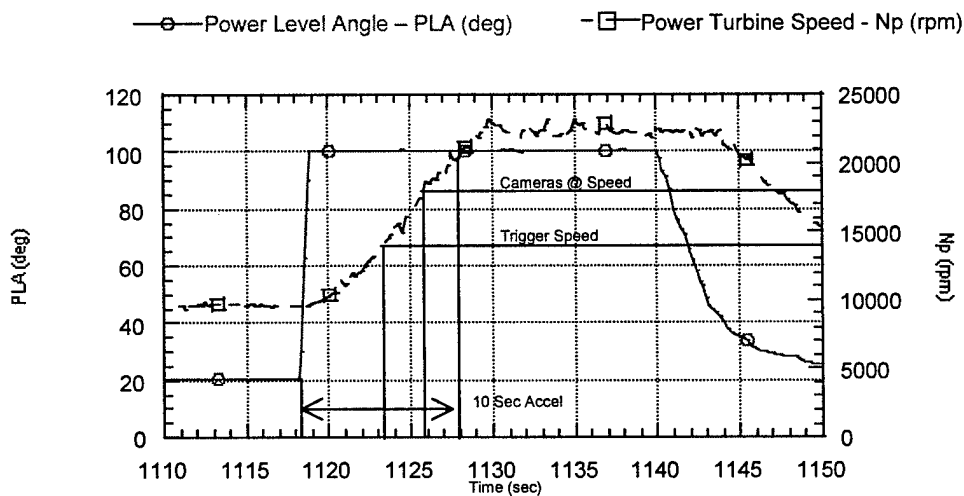
FIGURE 4. ENGINE ACCELERATION CALIBRATION

Even though the disk was notched, there was no way of determining exactly when or at what speed the disk would fail. To capture the event on high-speed film, a speed trigger circuit was used. There were approximately 8 seconds of film at a camera speed of 4000 pictures per second, 2.5 seconds of which were used as the cameras came up to speed. Prior to installing the test engine, a second engine was tested to determine the power turbine acceleration time from idle to maximum (figure 4). Multiple runs were conducted, and it was determined that the acceleration from idle to maximum was approximately 10 seconds. Idle speed was approximately 10,400 rpm and maximum was 22,500 rpm. Based on the engine acceleration times and the target rupture speed (20,400 rpm) and considering the camera time required to come to speed, a trigger speed of 14,000 rpm was chosen.

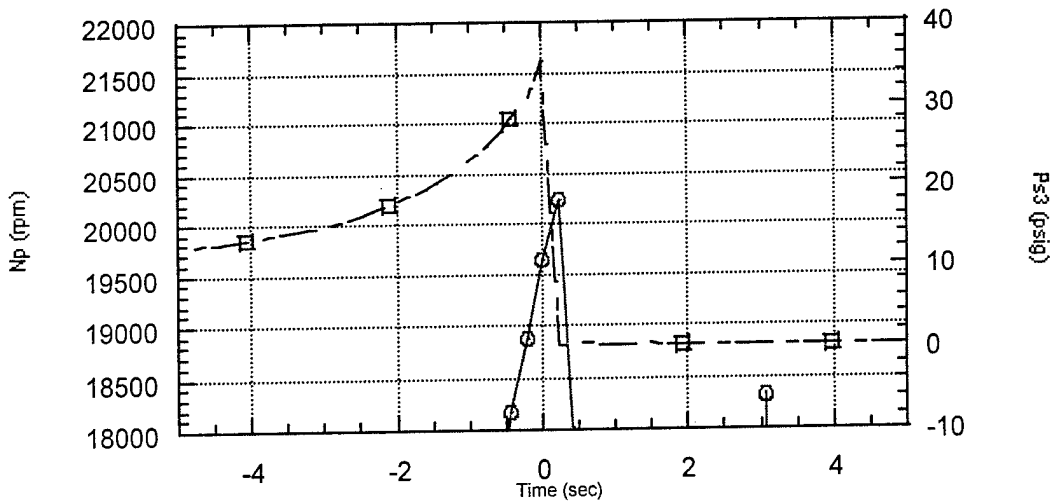
FIGURE 6. POWER TURBINE SPEED AND COMPRESSOR DISCHARGE PRESSURE VERSUS TIME TEST DATA

The test was completed as planned. The cameras were triggered as Np passed through 14,000 rpm. The disk released at 19,629 rpm. Test data are provided in figures 5 through 7. The disk ruptured into three nearly equal sections that were contained by the containment ring. The outer titanium shell split due to the tensile load resulting from the disk fragments pulling the Kevlar into a triangular shape. All three disk fragments penetrated the engine combustor case. The fuel lines located between the containment ring and combustor case were penetrated, resulting in a small fire. Secondary blade fragments exited the engine exhaust nozzle and a few fragments
