Modelling of the HMAS Westralia Fire

DSTO-TR-0698

MODELLING OF THE HMAS WESTRALIA FIRE

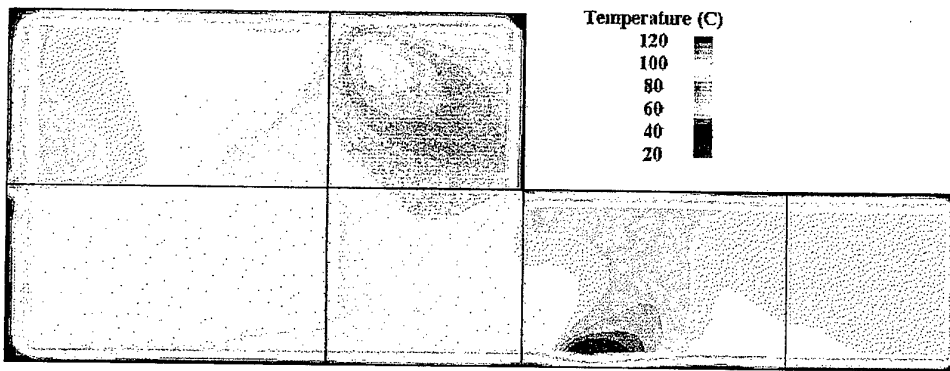
In the modelled scenario the fuel source is removed 1 minute into the event and the compartment is allowed to cool. A longitudinal compartment section through the origin of the fire is shown, in Figure 17, four minutes into the event. The temperature in the region of the cargo pumps and the diesel generators on the lower platform has reduced significantly over the temperature after one minute and become evenly heated at about 100°C. Cool air can be seen to be flowing down from the stack just aft of the MCR.

Figure 17. The predicted temperature distribution is shown for a section through the origin of the fire three minutes after the fuel supply is cut to the fire.

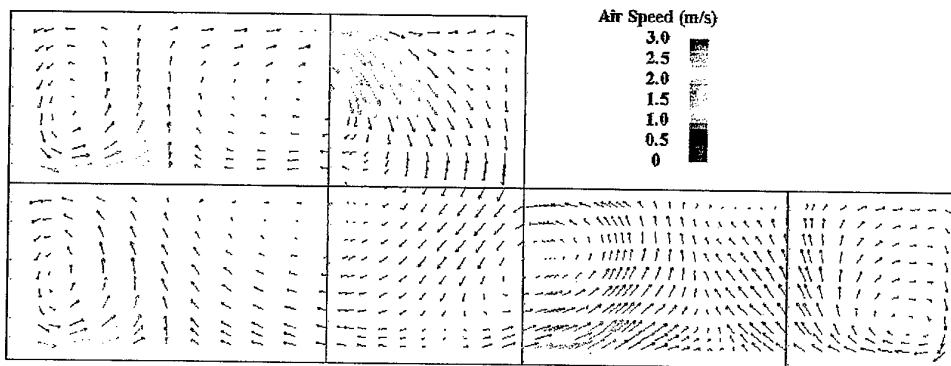
The predicted flow pattern depicted in Figure 18, shows a series of slowly swirling eddies supported by convective gas flows caused by heat losses to the compartment walls and to the atmosphere through the opening at the top of the stack.

Figure 18. The residual airflow for the simulated incident is shown for a section through the origin of the fire. The downward flow of cool air from the open stack and the associated circulations are clearly visible.

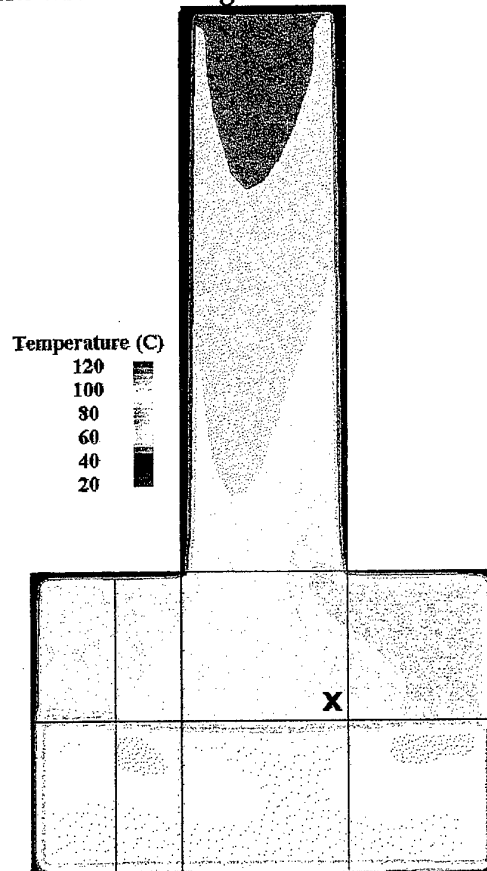
The stack provides the main flow of heat out of the compartment. The large surface area of the stack allows conduction to cool the air and the opening at the top of the stack allows warm air to leave compartment, which is replaced by a down flow of cool air into the compartment. Figure 19 shows the predicted temperature distribution for a cut just aft of the MCR four minutes into the event. Temperatures in the compartment at the level of the MCR and below remain at levels considered too high for firefighting above 80°C [9]. Cool air from the stack has penetrated to the region of the top of the port escape ladder, marked with an X in Figure 19.

Figure 19. The predicted temperature distribution is depicted for a section just aft of the MCR, facing aft, four minutes into the modelled incident. The blue area corresponds to a downdraft of cooler air flowing back down the stack. The x marks the location of the top of the port escape ladder.

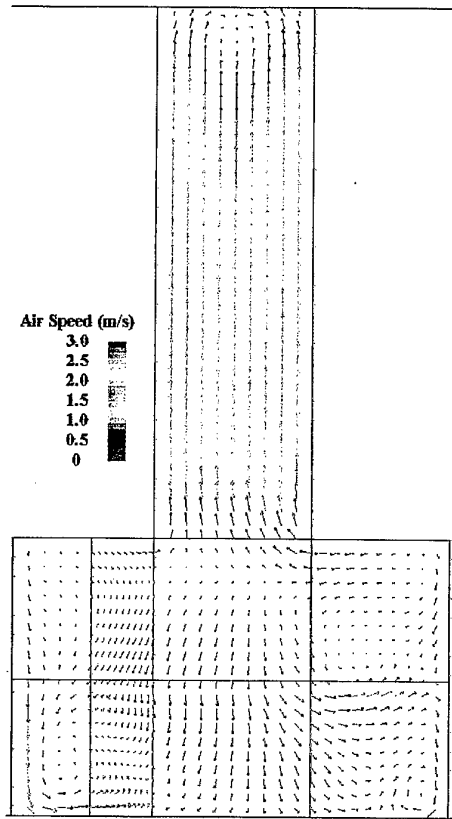
Four minutes into the event the airflow in the lower sections of the compartment is no longer driven by the heat of the spray fire but is driven by convective eddies created by the cool hull locally cooling the air. The upper section of the compartment is still subjected to convective cooling as warm air escapes up the stack. Figure 20 shows the predicted airflow at 4 minutes for a section just aft of the MCR looking aft. The flow up the stack is linear in this section and upward. However sections further aft reveal a complex flow of warm air rising and cool down drafts.

Figure 20. The air speed is show to the same section as in previous figure. The velocities are generally low less that 1.0 m/s except in the region of the stack. Convective eddies driven by the cool hull provide the main flow in the compartment below the level of the MCR.

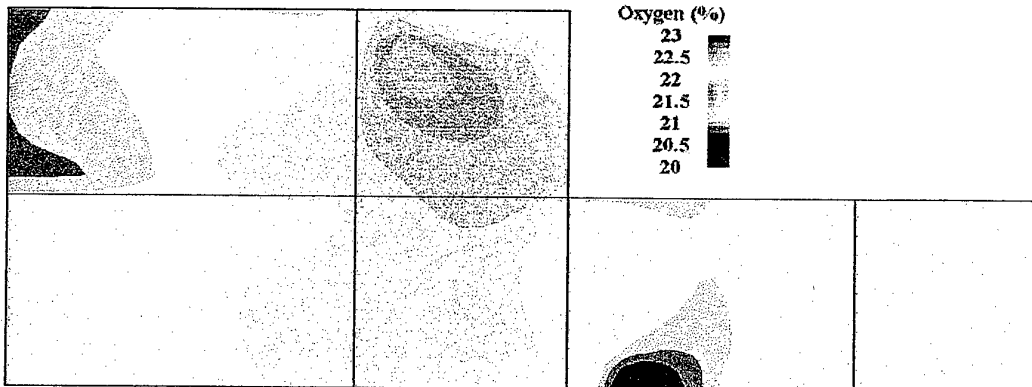
The oxygen level in the compartment four minutes into the modelled event show the levels to be only 10% less than normal. The levels being most depressed near the fire origin and at the fridge flat. Figure 21 shows the predicted oxygen levels at four minutes for a section though the fire origin.

Figure 21. The predicted oxygen levels for a section through the fire origin is shown.

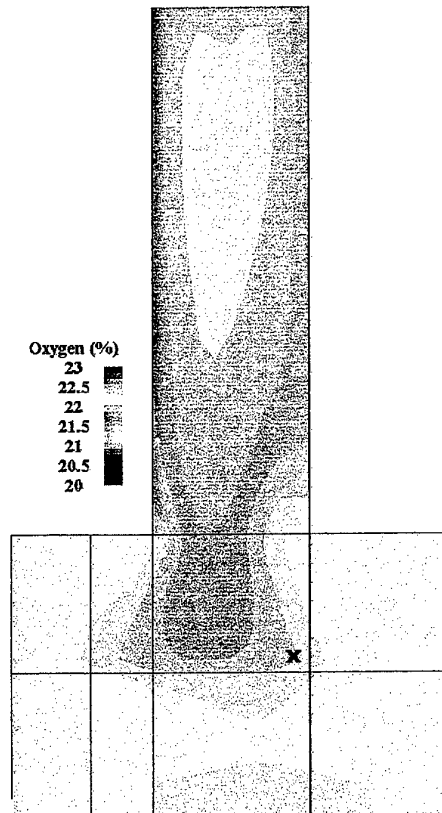
Figure 22 shows the oxygen content in the compartment for a section across the compartment just aft of the MCR looking aft. Clean air is seen to be flowing back into the compartment through the opening at the top. The overall oxygen level is near normal level throughout the compartment.

Figure 22. The predicted oxygen levels four minutes into the event for a section through the compartment just aft of the MCR, looking aft. The opening at the top of the stack has allowed the inflow of fresh air.

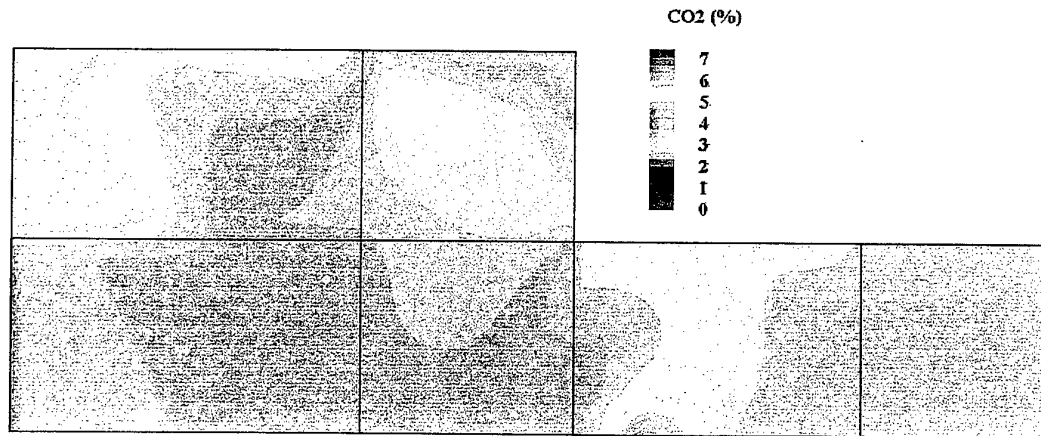
The level of CO_2 throughout the compartment is still high indicating mixing of the combustion products with the inflowing air. The levels are highest near the origin of the fire and at the fridge flat, see Figure 23. The effect of the down flow of fresh air from the stack can be seen in the area aft of the MCR as a reduced concentration of CO_2 .

Figure 23. The levels of CO₂ are shown for a forward-aft section through the fire origin. The effects of residual fuel can still be seen near the fire origin. The rest of the compartment shows an even level of CO₂ at about 4%. The effect of the inflow of clean air down the stack is evident.
