**US Army Corps
of Engineers**
Waterways Experiment
Station

Inspections of previously monitored coastal structures / by Robert R. Bottin, Jr., Larry R. Tolliver ; prepared for U.S. Army Corps of Engineers.

60 p. : ill. ; 28 cm. — (Technical report ; CHL-99-3)

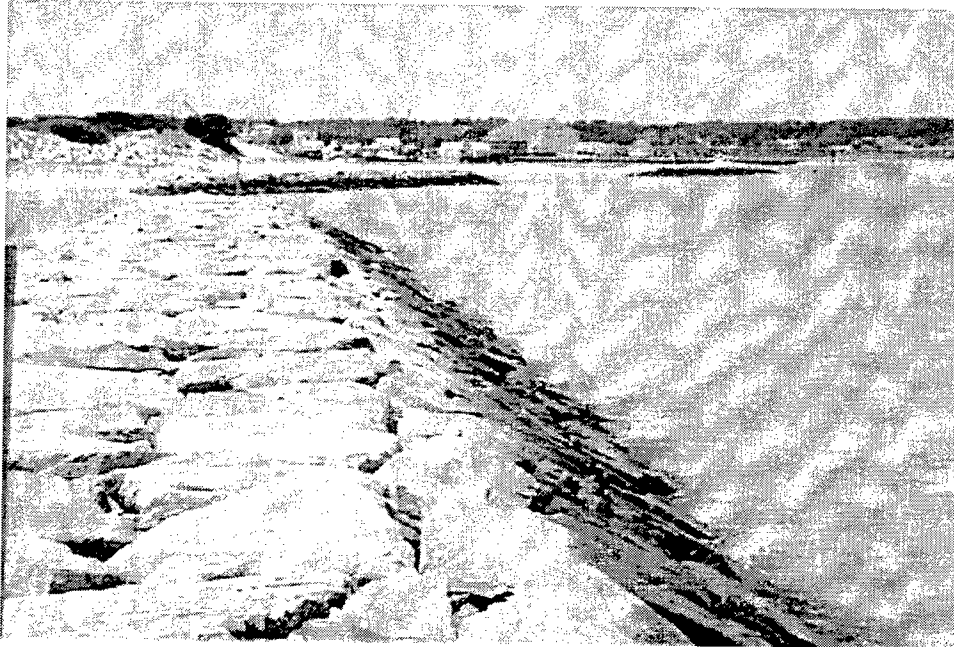
The rehabilitated south jetty and headland breakwaters at Ocean City Inlet were inspected on 11 June 1997. The rehabilitated south structure is shown in Figures 54 and 55, and the headland structures are shown in Figure 56. The inspection revealed these structures to be in excellent condition. No voids were noted, no armor stones were broken, and the cross sections of the structures appeared to be as built. It was noted that the seaward section of the old south jetty (that extending beyond sta 13+00) was in disarray. Armor stones were scattered, the crest height was inconsistent, and no definite cross section was apparent (Figure 57).

Figure 56. Headland breakwaters at Ocean City Inlet constructed to stabilize shoreline
