C-5 A FUSELAGE STRESS ANALYSIS

Report No. TR-92-7

June 1992

Operated for the Flight Dynamics Directorate by CSA Engineering, Inc.

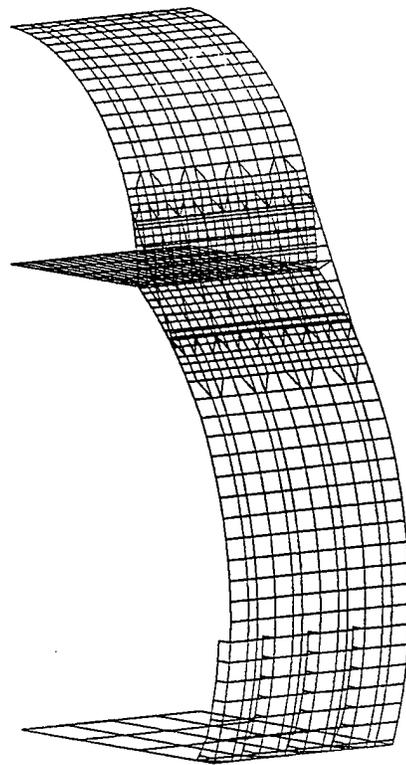
Finite Element Model: Since the fuselage section is symmetric, only half of the section was modeled. Furthermore, only the segment starting from fuselage station 604 (FS604) through FS684 was modeled. The model primarily consisted of beams and shell elements. The frames and stringers were modeled as beams and the fuselage skin panels were modeled with shell elements. The cargo floor, troop floor, and fairing panel were modeled with QUAD4 and BAR elements. In the model there are several ROD, SHEAR and RIGID elements which were included to replicate the Lockheed model. The FE model is shown in Figure 1.

Figure 1: Finite element model of the fuselage section
