Embrittlement of a Platinum-Iridium Screen

10 January 1999

G. L. STECKEL and N. MARQUEZ
Mechanics and Materials Technology Center
Technology Operations

6. AUTHOR(S) G. L. Steckel and N. Marquez					
7. PERFORMING ORGANIZATION NAME(S) AND ADDRESS(ES) The Aerospace Corporation Technology Operations El Segundo, CA 90245-4691				8. PERFORMING ORGANIZATION REPORT NUMBER TR-99(8565)-2

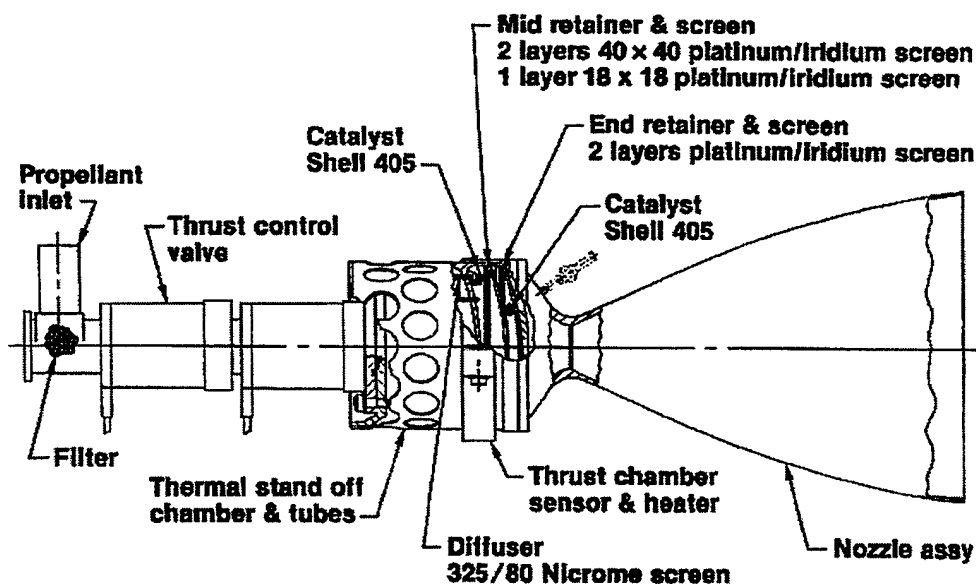
Figure 1. Spacecraft contractor drawing of rocket engine module.

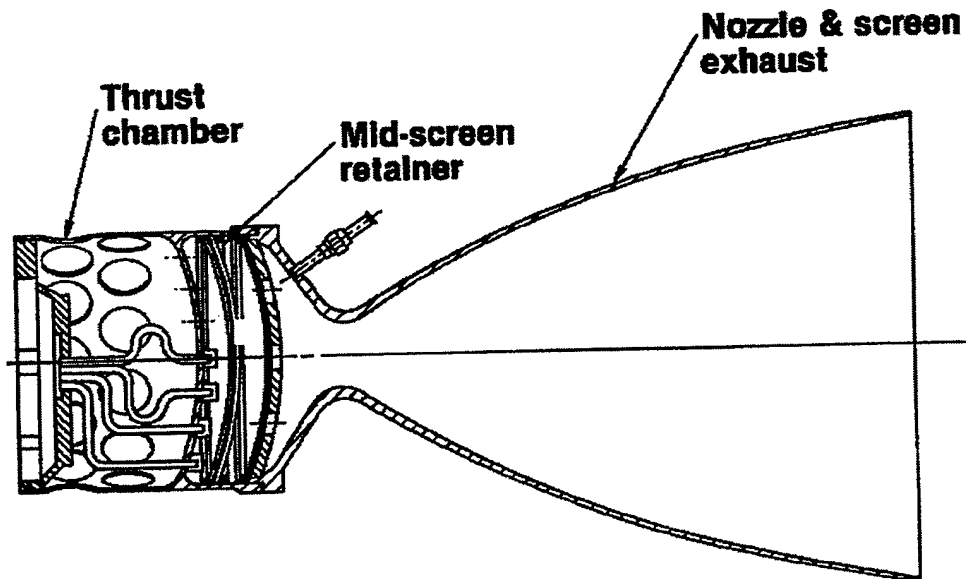
Figure 2. Spacecraft contractor drawing of thrust chamber and nozzle.

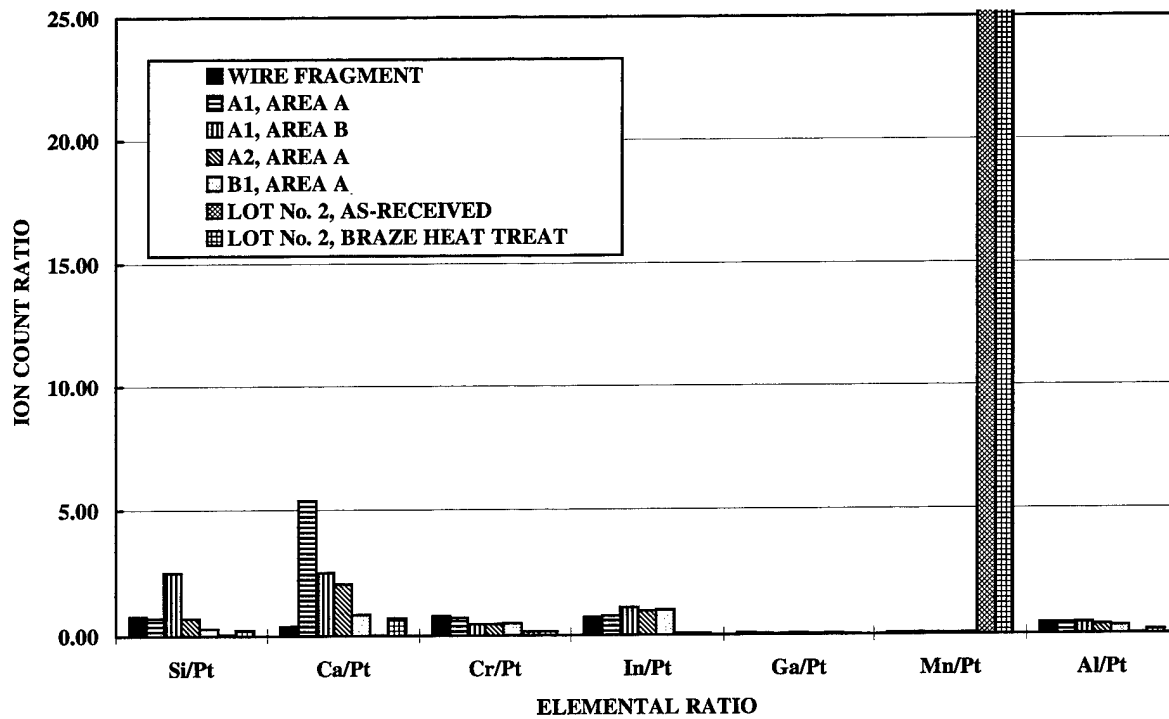
counts is indicated in parentheses for each element or compound. Spectral data are presented for two separate areas on Sample Nos. A1 and A2, and for one area on all other samples. Similar elemental spectra were obtained for the wire fragment, the two areas on Sample Nos. A1 and A2, and the one area on Sample No. B1. The primary impurities were Cr, Rh, Al, In, Si, and Ca. Rh was not included in Table 2 or Figure 13 since the presence of Rh is expected and is of no concern. Indium was the most surprising impurity and appeared to be present in significant levels, although not at concentrations sufficient to be detected by SEM/EDX. Cr, Rh, Si, and Ca were all detected in the bulk chemical analysis (Table 1), while Al was not detected, and In was not checked for in the bulk analysis. Elemental mapping indicated that the Cr, Rh, Al, and In were distributed uniformly throughout the cross section. The Ca and Si were associated with one another and appeared to be present as distinct particles, as shown by the elemental maps in Figure 14 for Sample No. A2, Area B.

Figure 13. Primary impurities detected in SIMS analysis of cross sections of Pt-Ir wire fragment and Mesh A, Mesh B, and Lot No. 2 screens.

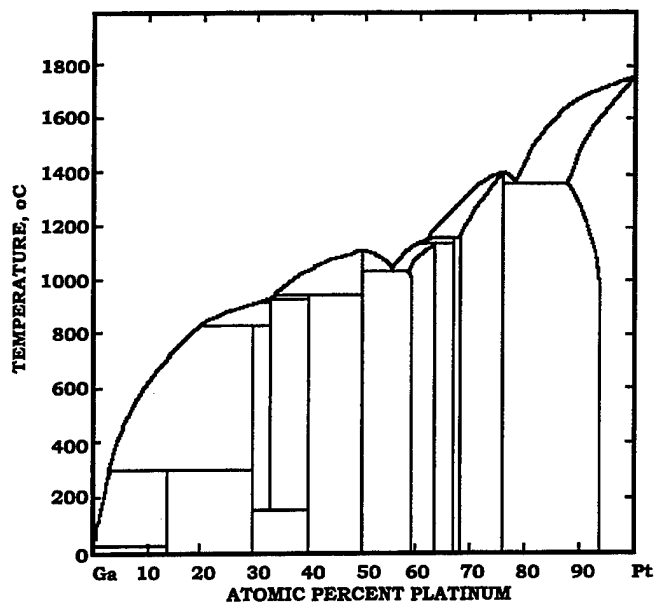
Liquid-metal embrittlement (LME) is the catastrophic brittle failure of a normally ductile metal when coated with a thin film of a liquid metal and subsequently stressed in tension.⁸ The fracture is usually brittle intergranular, with little indication of crack branching or striations to indicate slow crack growth. In general, LME fracture surfaces are completely covered by the liquid metal. However, in some cases very small quantities of liquid are required, making detection of the liquid metal on the fracture surface very difficult. LME is usually caused by low-melting-point metals. Liquid metals that have been reported to cause LME include lead, bismuth, cadmium, mercury, lithium, zinc, gallium, indium, and many others. The fact that Ga and In were identified on the Pt-Ir wire surfaces adjacent to brittle cracks is a strong indicator that the fractures were caused by LME by one of these elements or by a Ga-In alloy. No reports of LME of Pt or its alloys by In or Ga were found in the literature. However, Ga and In have been reported to cause LME in several other face-centered cubic metals, including Al and Cu. LME usually occurs at temperatures near the solidification temperature of the liquid. An increase in temperature usually decreases embrittlement, leading to a brittle-to-ductile transition. In the present case, the experimental results for tensile tests on extracted wires suggested that the Pt-Ir wire was ductile at low temperatures (23 and 300°C; 73 and 570°F), but brittle at 900°C (1650°F). The melting points for Ga and In are 30 and 156°C (86 and 313°F), respectively. Thus, LME would be expected to occur at lower temperatures. On the other hand, Mn and Cu were associated with the Ga and In on the wire surfaces. Thus, a more complex LME interaction may have occurred.

Figure 20. Platinum-gallium phase diagram.

Many aspects of the mid-screen failure on S/N KM004 are consistent with either liquid-metal embrittlement or the formation of a low melting phase at the grain boundaries. It is concluded that one of these mechanisms probably caused the failures. Ga and In are the most probable contaminants for causing the embrittlement. However, there may have been other factors that contributed to the failure. The partial fusion between wires at the crossover points of the weave along with the dissolution of grain boundaries, voids at grain boundaries, and dislodging of grains at the saddle points of the crossovers are indicators of abnormal behavior. The causes for this instability in the grain

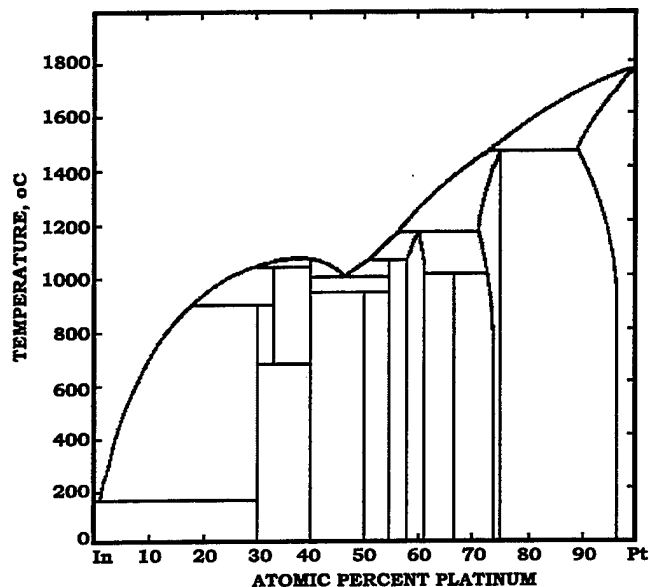
Figure 21. Platinum-indium phase diagram.
