# **National Transportation Safety Board**

### Safety Recommendation

Date: October 7, 1998

In reply refer to: A-98-87

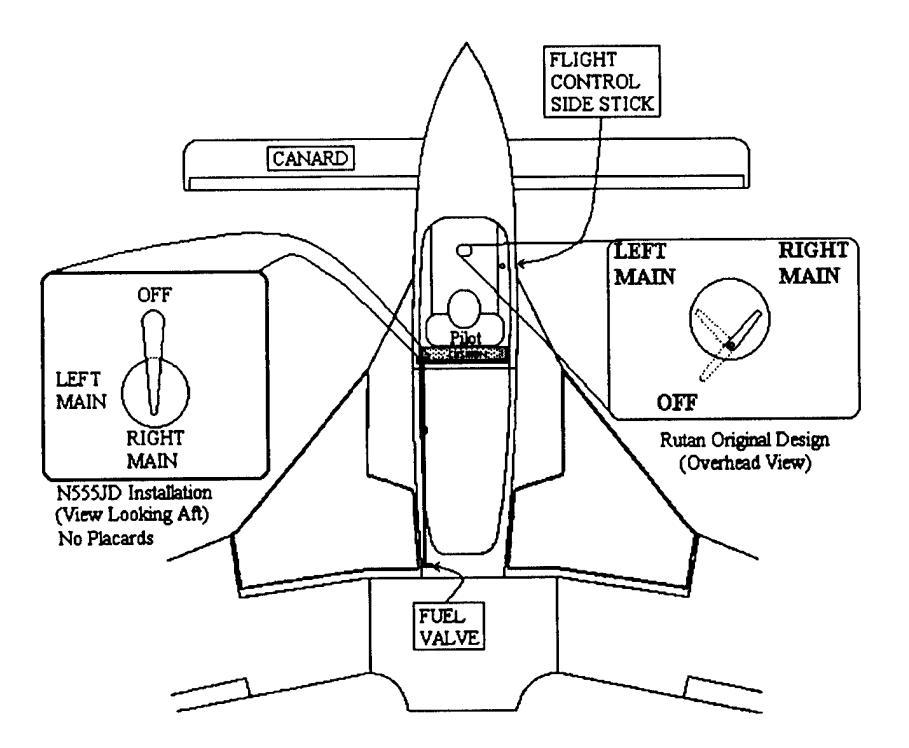
Figure 1-Comparison of fuel selector handle locations in Long-EZ

### N555JD vs. Original design

The flight control side sticks in both cockpits were installed in armrests on the right side of the cockpits, measured about 6 inches high, and were similar in function to a conventional control stick. During the postaccident investigation, simulation by Safety Board staff showed that the front-seat pilot in the accident airplane would have had to loosen his shoulder harness, completely release the flight control stick, turn in his seat, and stretch to his left when reaching over the left shoulder with his right hand to change the position of the fuel selector handle on the accident Long-EZ airplane. The Safety Board investigator, in every simulation, inadvertently applied right rudder when turning his body and reaching for the fuel selector handle. This finding concerned the Safety Board because the design change that moved the fuel selector handle introduced a safety hazard in N555JD. On the basis of the accident circumstances and witness accounts, the Board concluded that the accident pilot probably inadvertently applied right rudder while manipulating the fuel selector, precipitating the loss of control that preceded the accident.

The fuel selector valve assembly from the accident airplane was found in an intermediate position; the selector valve port from the right tank fuel supply line was about 33 percent open to the engine feed line and the left was about 2 to 4 percent open to the engine feed line. An engine test run in a test cell showed that full power could be attained (with fuel in both tanks) with the selector valve in the "as found" position. However, with fuel in only one tank and the other fuel

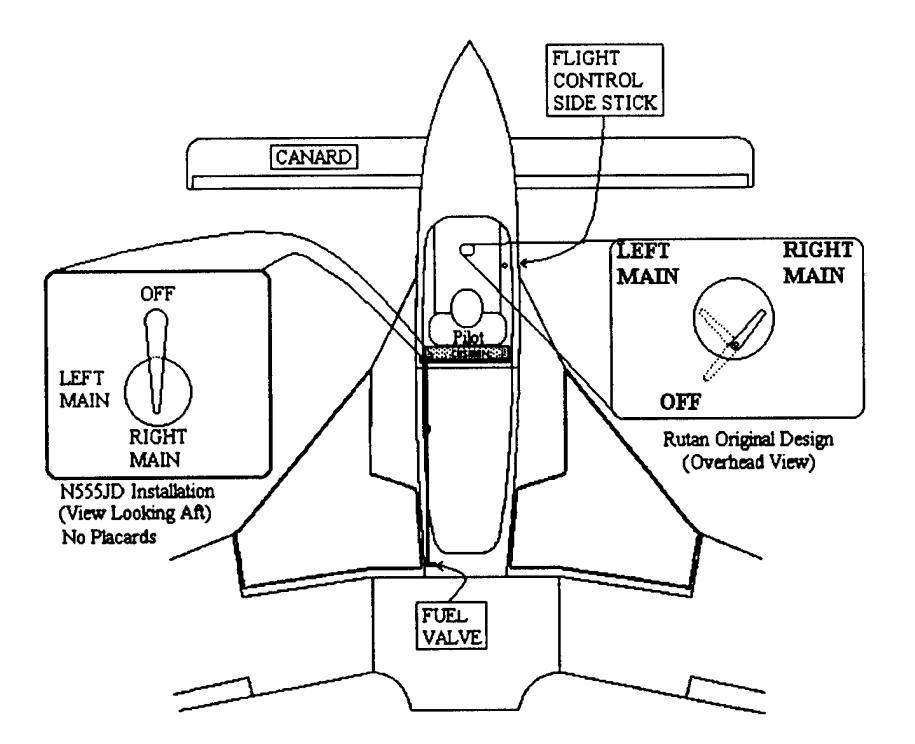
Figure 1-Comparison of fuel selector handle locations in Long-EZ

### N555JD vs. Original design
