TECHNICAL REPORT ARCCB-TR-99010

**ANALYSIS OF A PISTON EXPERIENCING
ENVIRONMENTALLY-ASSISTED CRACKING
AS A RESULT OF COMPRESSIVE OVERLOADING**

JUNE 1999

**US ARMY ARMAMENT RESEARCH,
DEVELOPMENT AND ENGINEERING CENTER
CLOSE COMBAT ARMAMENTS CENTER
BENÉT LABORATORIES
WATERVLIET, N.Y. 12189-4050**

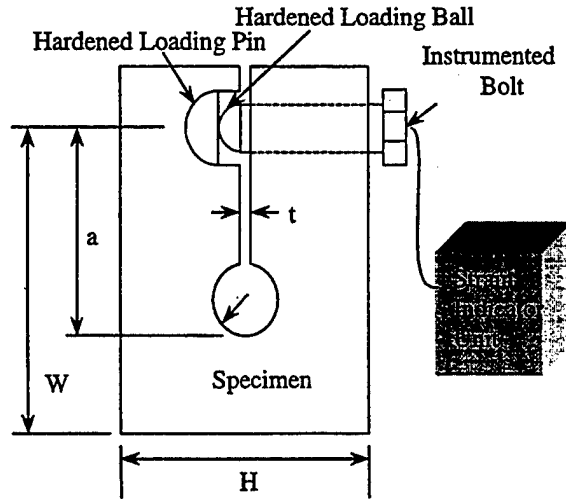
Our approach included modification of the bolt-loaded compact specimen currently being considered for addition to ASTM Standard 1681, "Determining a Threshold Stress Intensity Factor for Environment-Assisted Cracking of Metallic Materials Under Constant Load." Since the piston does not have any sharp stress risers, we felt that the inclusion of a sharp precrack into the specimen would not adequately model this geometry. Therefore, we opted for the inclusion of a 3/8-inch diameter through hole (Figure 3). The base materials chosen for the testing were Maraging 200 and an A723 Grade 2 pressure vessel quality steel, both heat treated to yield strength of 1300 MPa. These materials were chosen because of their unique combination of strength and toughness that was required for the component. Nickel-based alloys would have been the first choice for resistance to hydrogen, however none possessed the required strength. The hydrogen barrier coatings investigated and their thicknesses are included in Table 4.

Figure 3. Setup and configuration for the modified bolt-loaded compact testing.
