PB99-910401  
NTSB/AAR-99/01  
DCA94MA076

## AIRCRAFT ACCIDENT REPORT

UNCONTROLLED DESCENT AND COLLISION WITH TERRAIN  
USAIR FLIGHT 427  
BOEING 737-300, N513AU  
NEAR ALIQUIPPA, PENNSYLVANIA  
SEPTEMBER 8, 1994

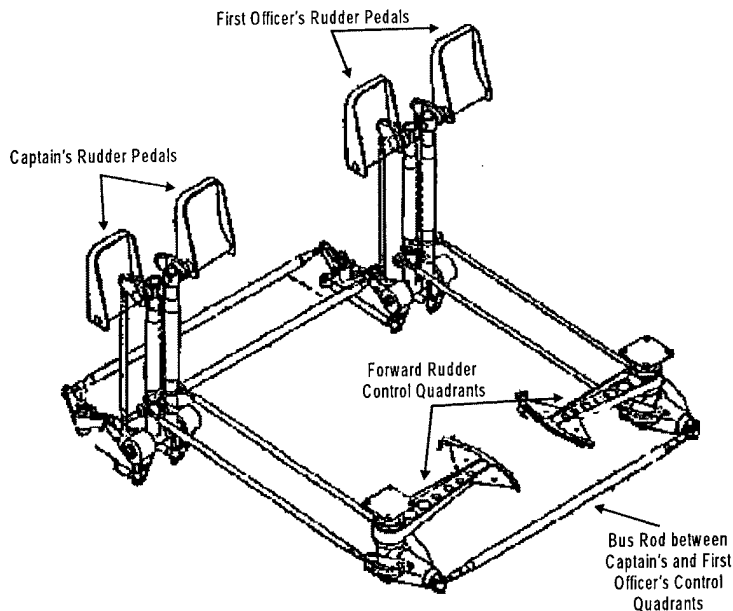
**Figure 12.** Rudder pedal assemblies as installed on the USAir flight 427 airplane.

The accident airplane's rudder pedal assemblies from both flight crew positions were removed from the wreckage. Both rudder pedal assemblies were fragmented and heavily distorted. The rudder pedal assembly from the first officer's position exhibited postimpact fire damage. The left rudder pedal pivot lugs on both rudder pedal assemblies were fractured near their respective support tubes.<sup>126</sup> Figure 12 shows a diagram of the rudder pedal assemblies as installed on the accident airplane.

direction. The right rudder pedal pivot lugs on both assemblies were bent but remained attached to their support tubes. With the support tubes positioned vertically, the right rudder pedal pivot lug at the captain's position was bent forward and downward, but the right rudder pedal pivot lug at the first officer's position was bent forward and upward.

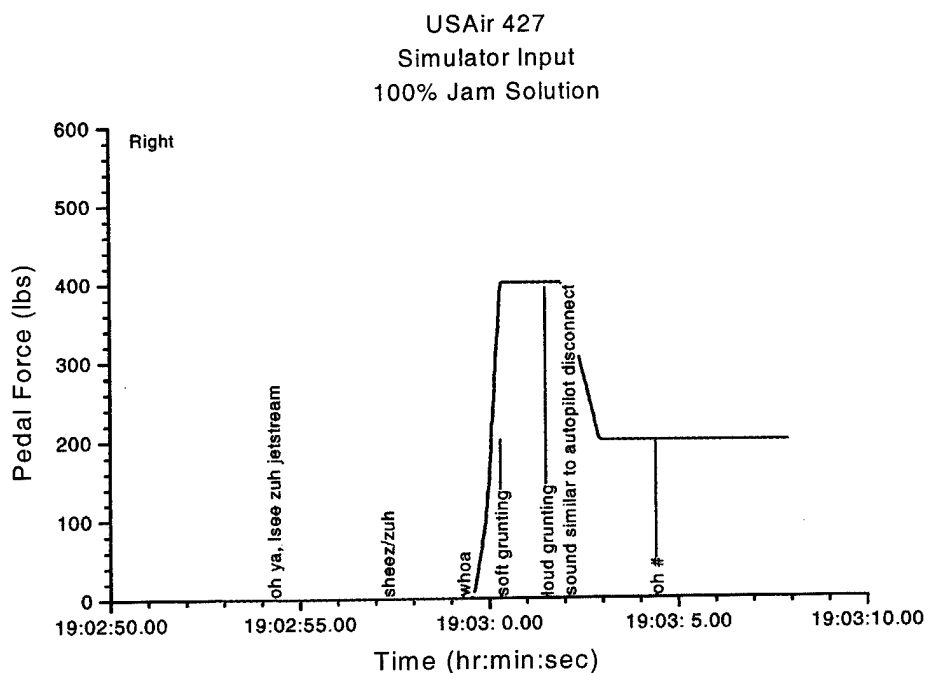
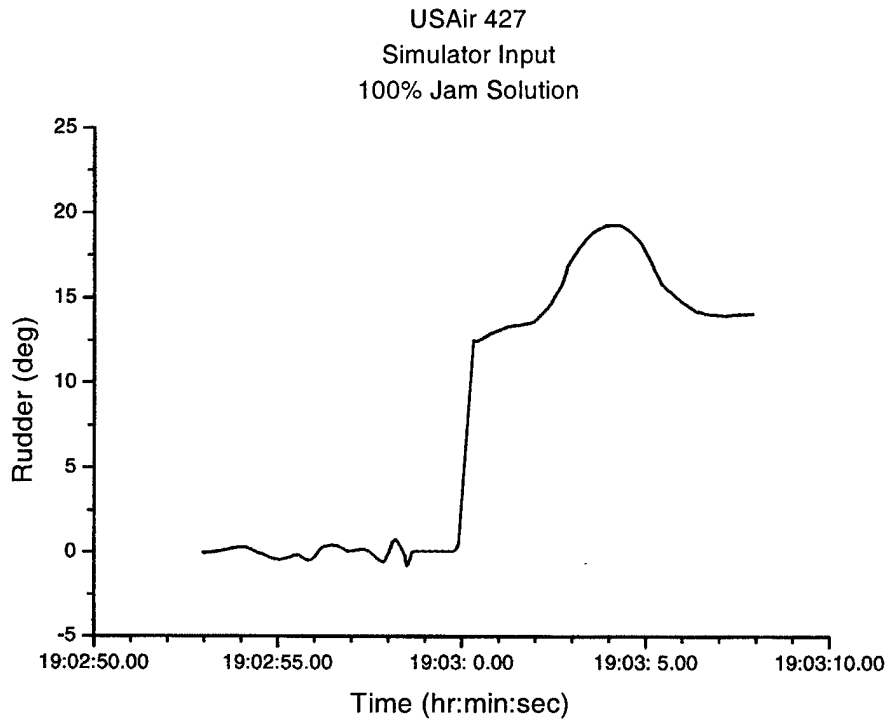
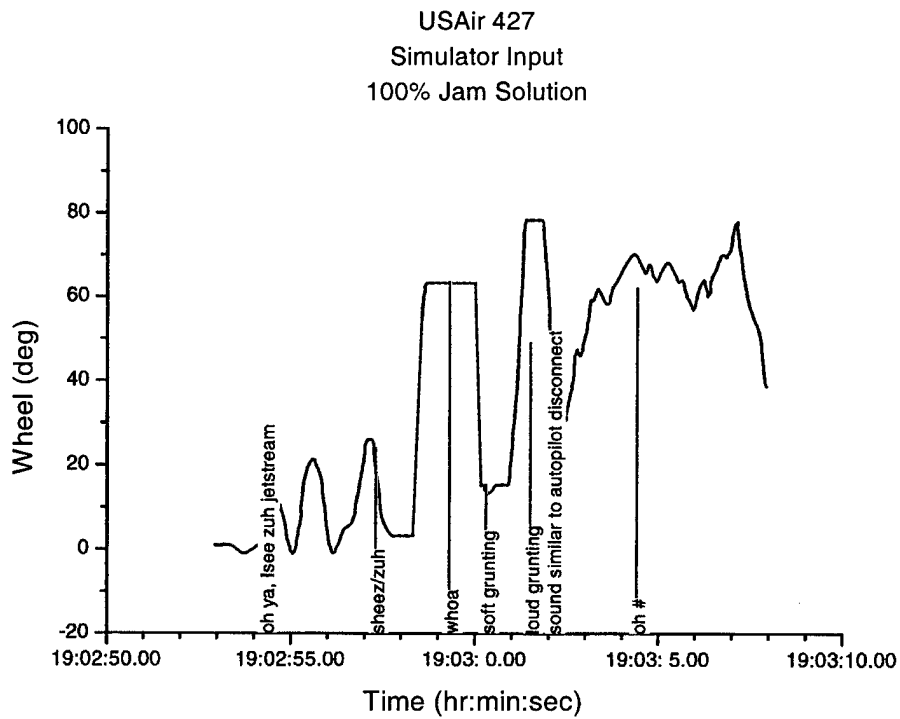
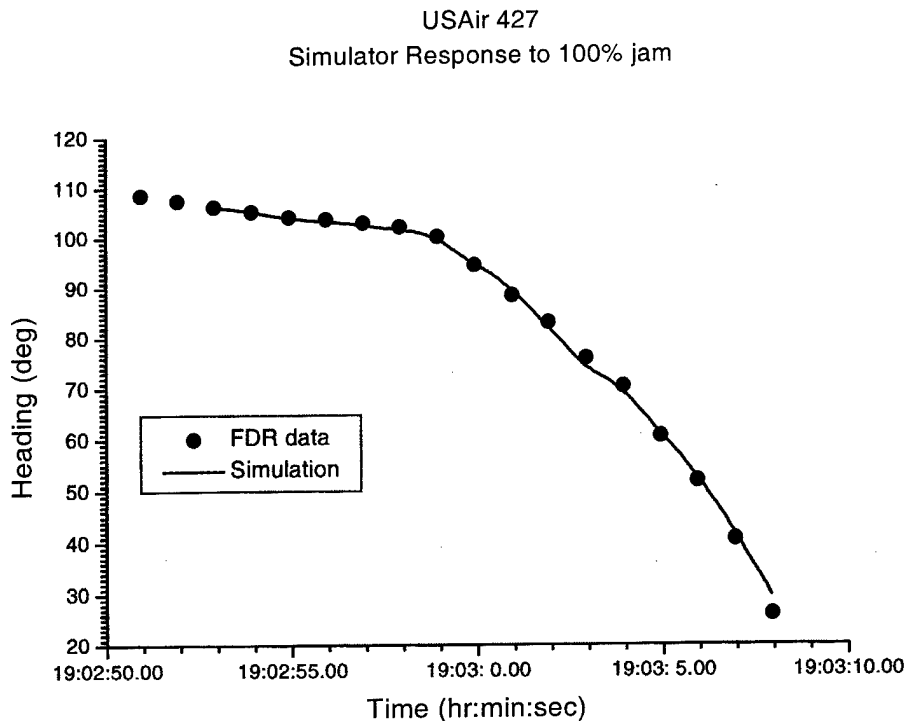
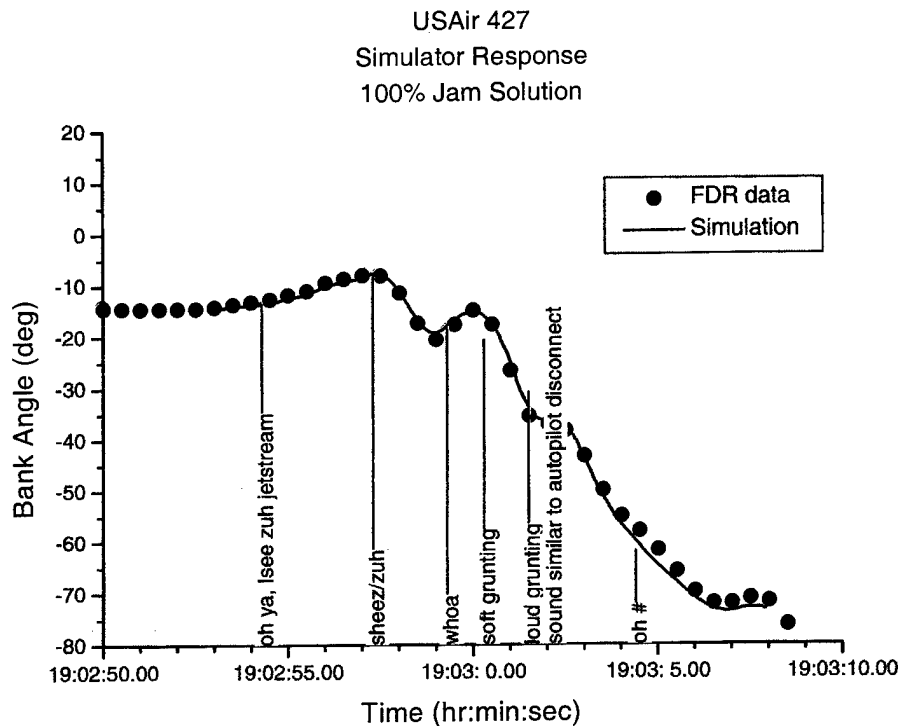
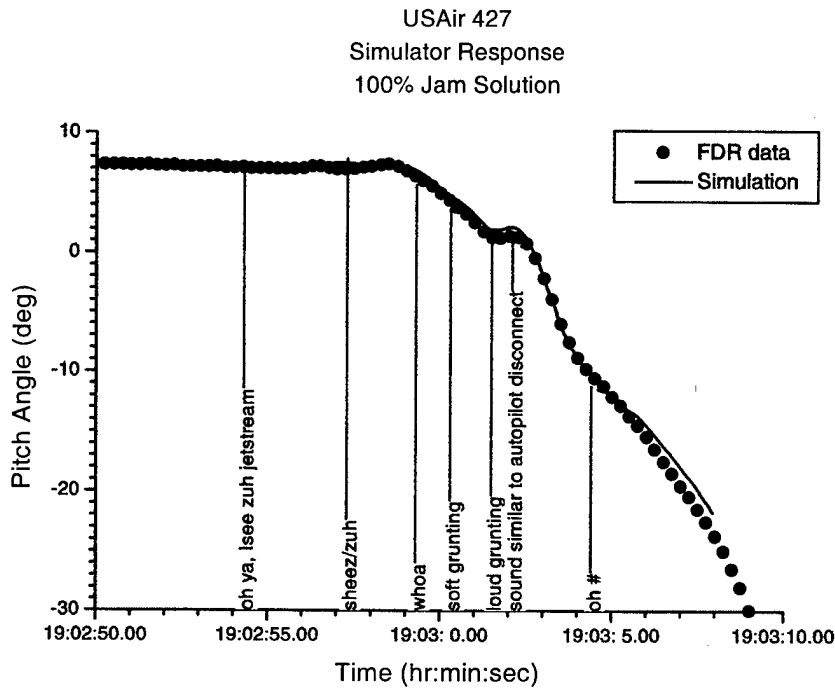
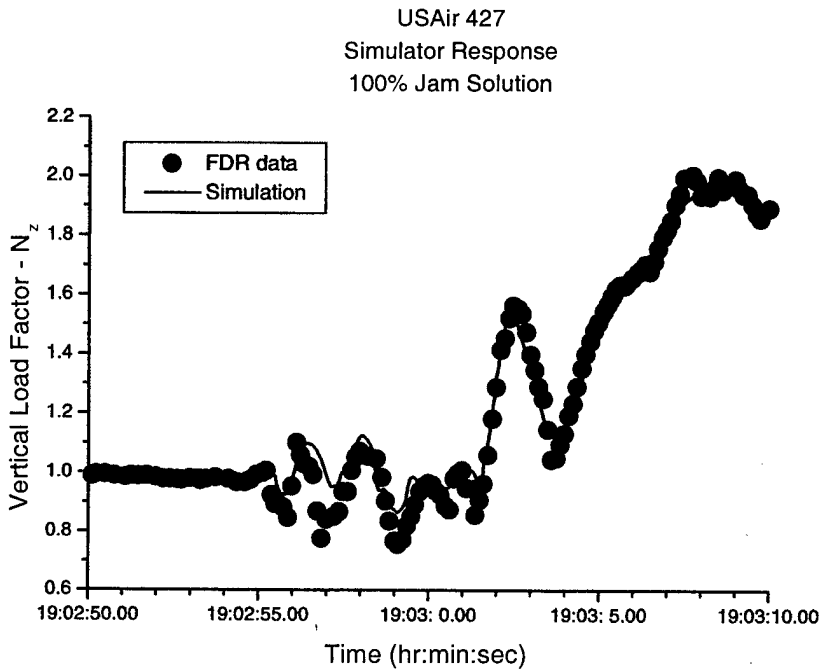
The heading data that resulted from the simulation with the secondary slide jammed to the servo valve housing at the 100-percent position matched the FDR heading data better than simulations with the secondary slide jammed at the other three positions. Control surface position data are presented for the 100-percent jam. The pilot rudder pedal force time history is shown in figure 18a.<sup>176</sup> The rudder surface and control wheel positions are shown in figures 18b and 18c, and the resultant heading, bank angle, pitch angle, and vertical acceleration data, compared with the FDR data, are shown in figures 18d through 18g, respectively.

<sup>176</sup> The Safety Board's best-match simulation used 400 pounds of rudder pedal force reducing to 200 pounds, based on ergonomic and other research data (see section 1.18.8). However, the Safety Board was also able to match the USAir flight 427 FDR data using only the minimum pedal force necessary to sustain full rudder authority (about 70 pounds).

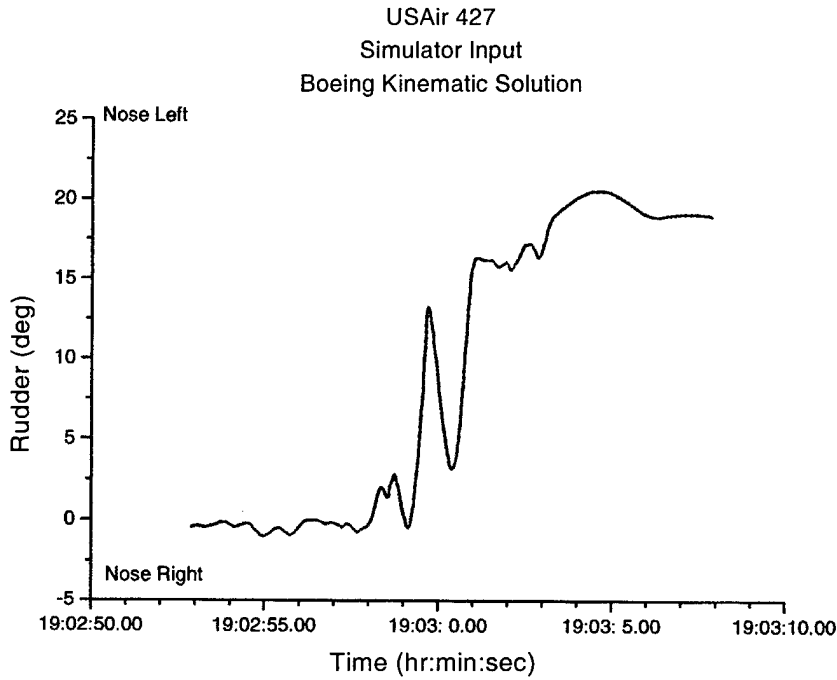
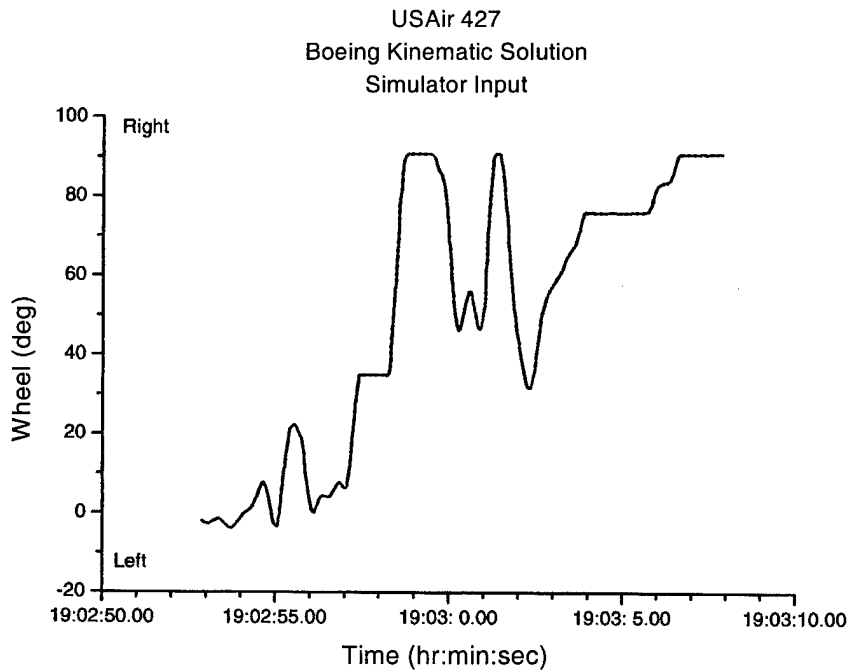
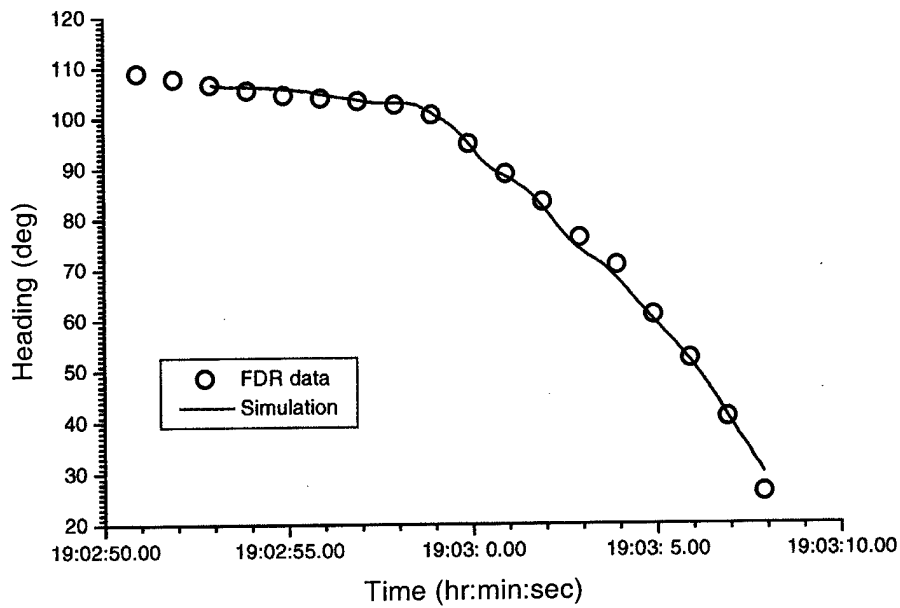
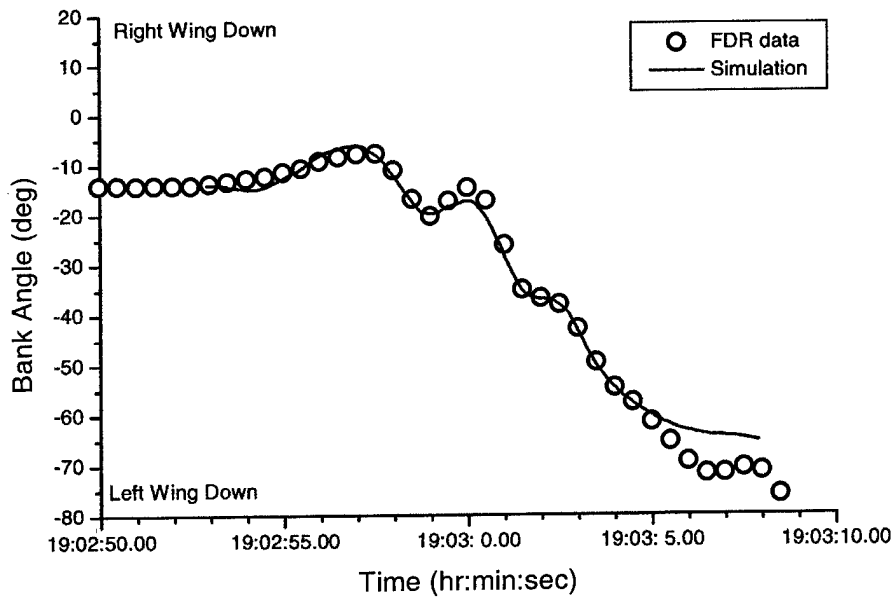
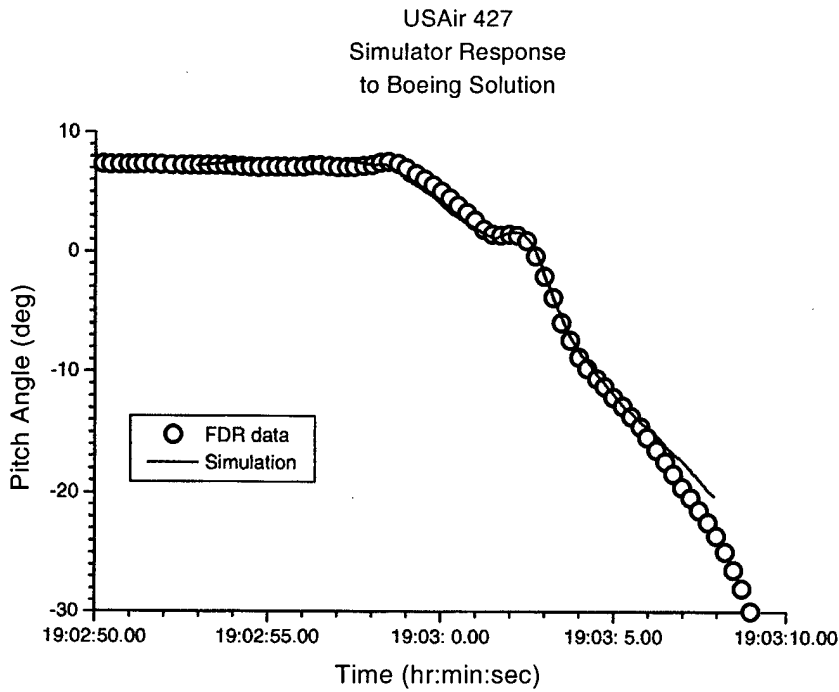
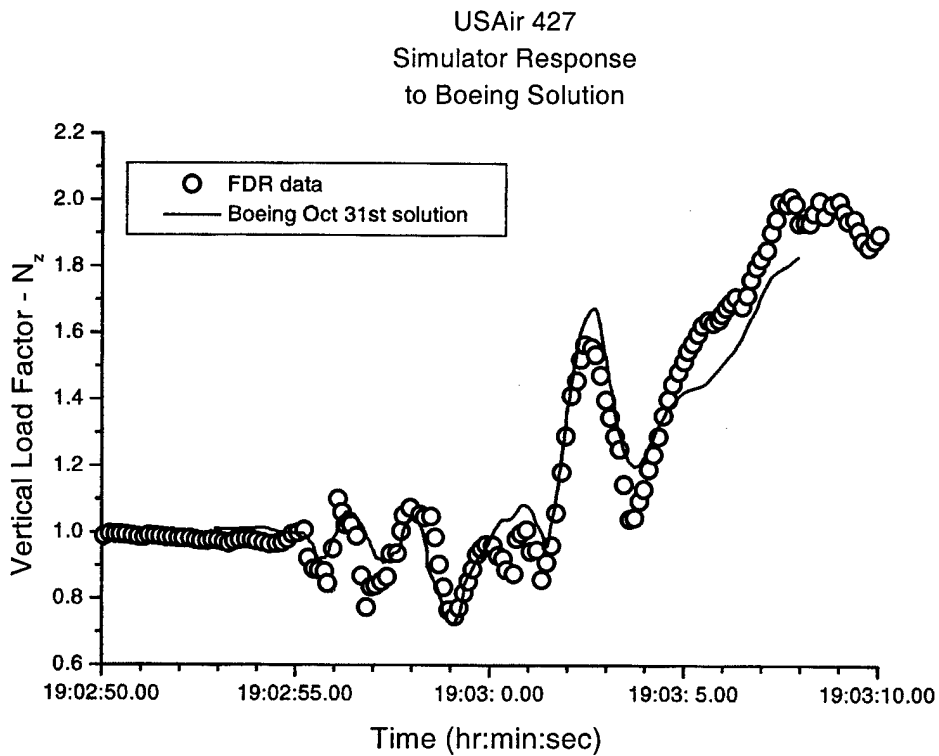
The rudder surface and control wheel position time histories resulting from Boeing's kinematic analysis for this scenario are presented in figures 19 and 20, respectively. Further, the Safety Board used Boeing's kinematically derived flight control position time histories as inputs in the Board's computer simulation to derive heading, bank angle, pitch angle, and vertical acceleration data and compared these results with the FDR data. These results are presented in figures 21a through 21d, respectively.

<sup>180</sup> Page 49 of Boeing's September 30, 1997, submission states that "from [just after stickshaker activation] until ground impact, the controls remained at full right wheel, full left rudder, and full aft column."

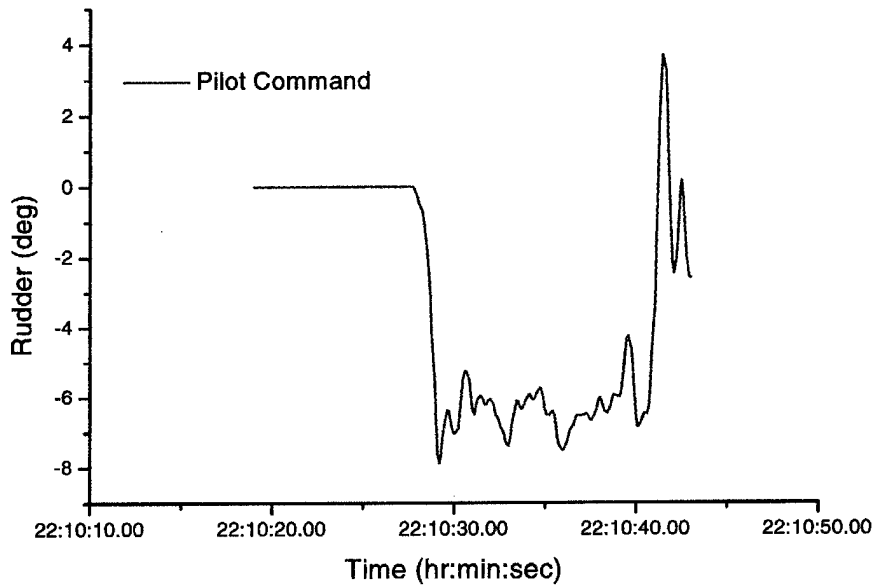
Figure 27b. Boeing's kinematic rudder for Eastwind flight 517 with pilot command and no yaw damper activity.

Boeing's submission supplement also stated that "the yaw damper hardover and recovery proposed in scenario 4 does match the flight data recorder information." According to Boeing's scenario 4, the yaw damper would have been active after the yaw damper hardover cleared at the beginning of the upset event. Boeing's estimated rudder, yaw damper response, and rudder command is shown in figures 27a, and Boeing's estimated rudder with pilot command and no yaw damper activity is shown in figure 27b.

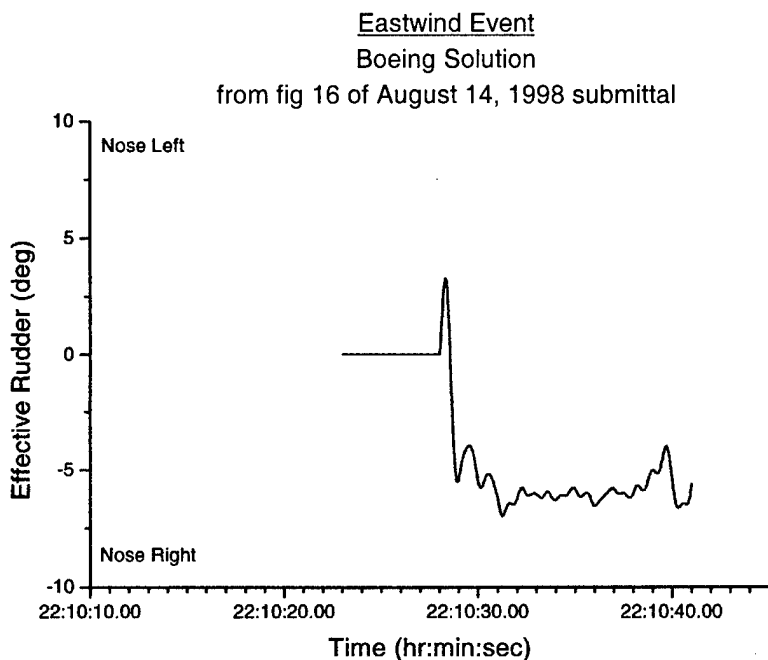
Figure 28a. Eastwind flight 517 rudder positions according to Boeing's scenario.

Figure 28a presents the rudder time history that resulted from Boeing's kinematic analysis of scenario 4. The heading time history that Boeing derived from its kinematically developed rudder (uncorrected for what Boeing has determined to be a simulator heading error) and used in its computer simulations is shown in figure 28b. Figure 28c shows the average flight test heading error, and 28d presents the "error corrected" heading time history compared with the FDR heading data.

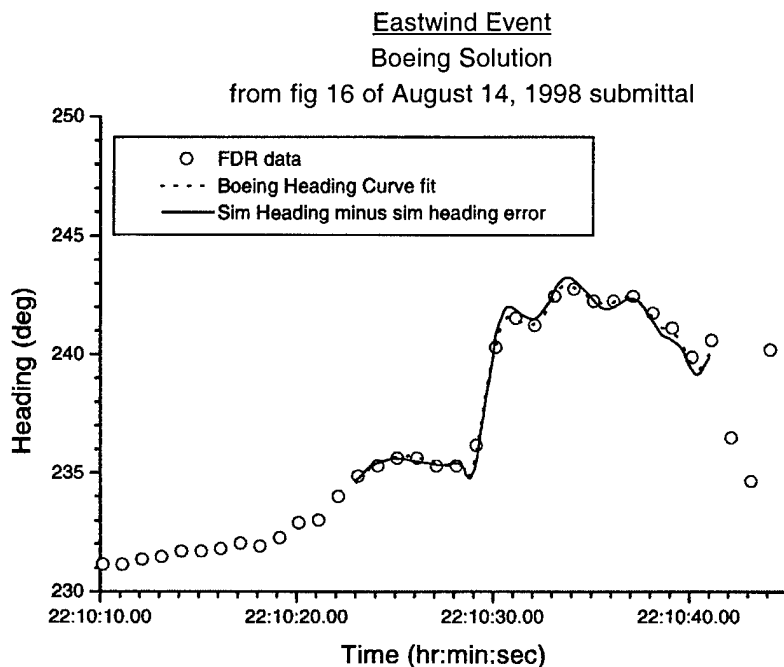
**Figure 28d.** Eastwind flight 517 corrected heading according to Boeing's scenario.

Boeing's submission supplement concluded that "multiple scenarios have been identified that match at least some of the data and crew reports from the Eastwind 517 event. None of the scenarios fully match all the data, kinematic analysis, and crew reports." The submission supplement also included Boeing's belief that, "...under the NTSB standard for identifying 'probable cause,' there is insufficient data to find a 'probable cause' for this event."

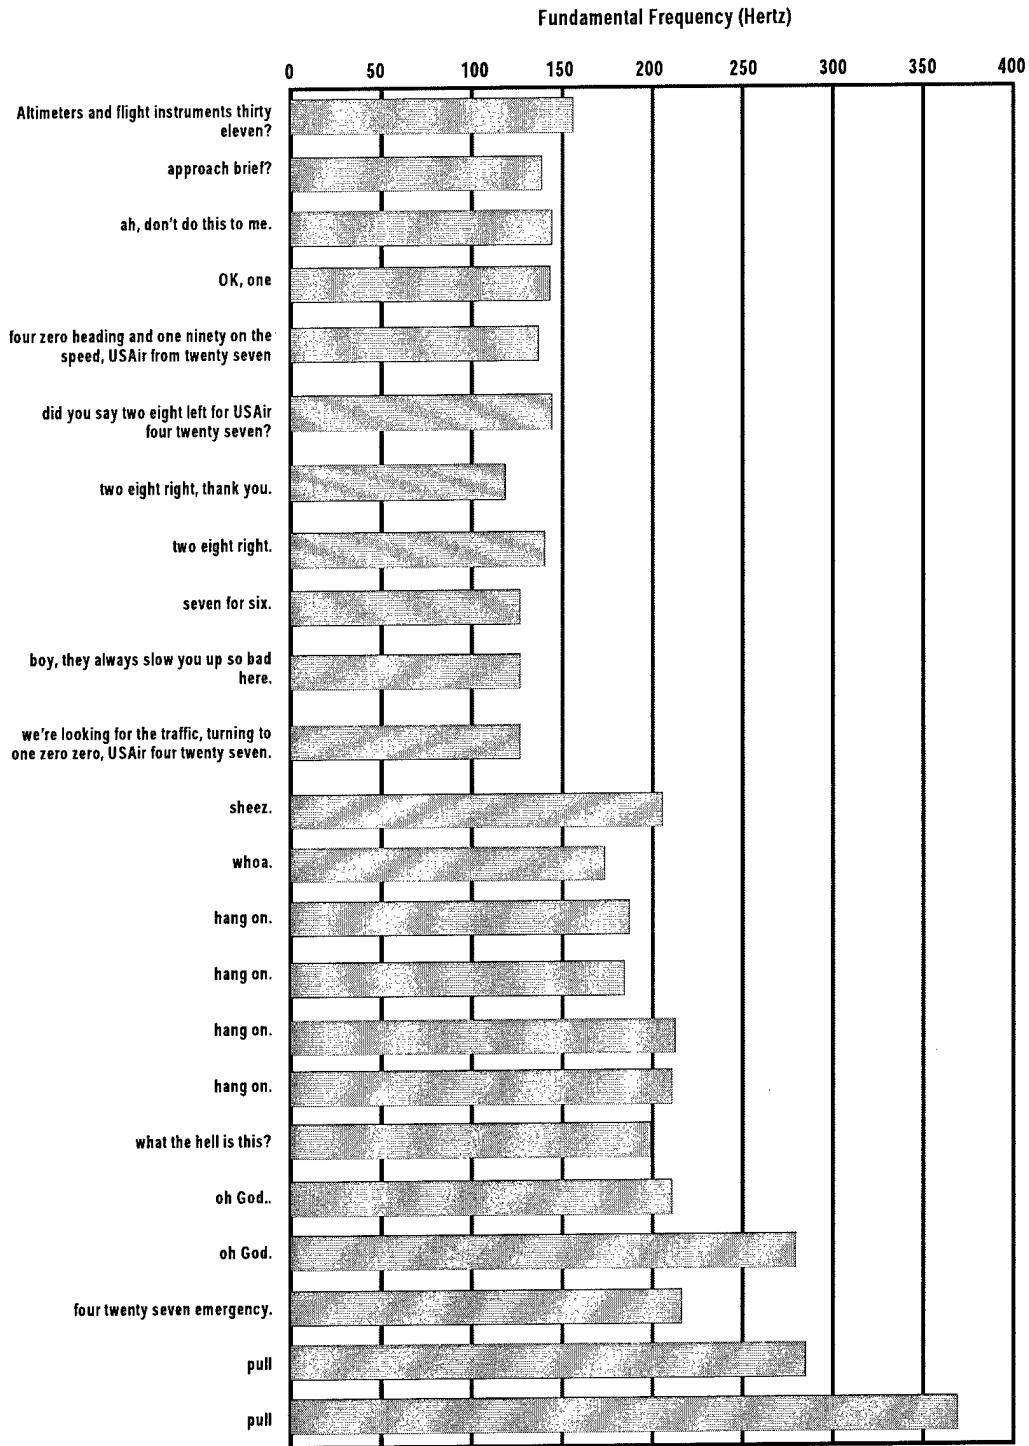
Figure 29. Fundamental frequency measures of the USAir flight 427 captain's speech.

The Safety Board reviewed the USAir flight 427 CVR for pilot speech samples appropriate for computer speech analysis. The Safety Board observed that the captain spoke the airplane's call sign, "four twenty seven," during routine and emergency radio transmissions, providing a basis for direct comparison using the same words. When the captain spoke the phrase "four twenty seven" during routine flight operations, the average fundamental frequency value was 144.6 Hz. However, when the captain stated four twenty seven about 1903:15 during the emergency descent, the speech fundamental frequency increased 47 percent, to 214 Hz. Figure 29 graphs the fundamental frequency measures obtained for the captain's statements before and during the upset period, showing changes in the fundamental frequency of his speech as the emergency situation developed.<sup>210</sup> Figure 30 graphs the amplitude measures obtained for the same statements. According to scientific literature,<sup>211</sup> fundamental frequency, amplitude, and speaking rate tend to increase in response to increased psychological stress.

<sup>210</sup> Only those statements that were free of artifacts caused by background conversation or other sounds appear on this graph and the one in figure 30. Of the three measured aspects of the captain's speech, fundamental frequency provided the most measurable data. Missing data precluded similar measurements of the captain's speech rate or amplitude.

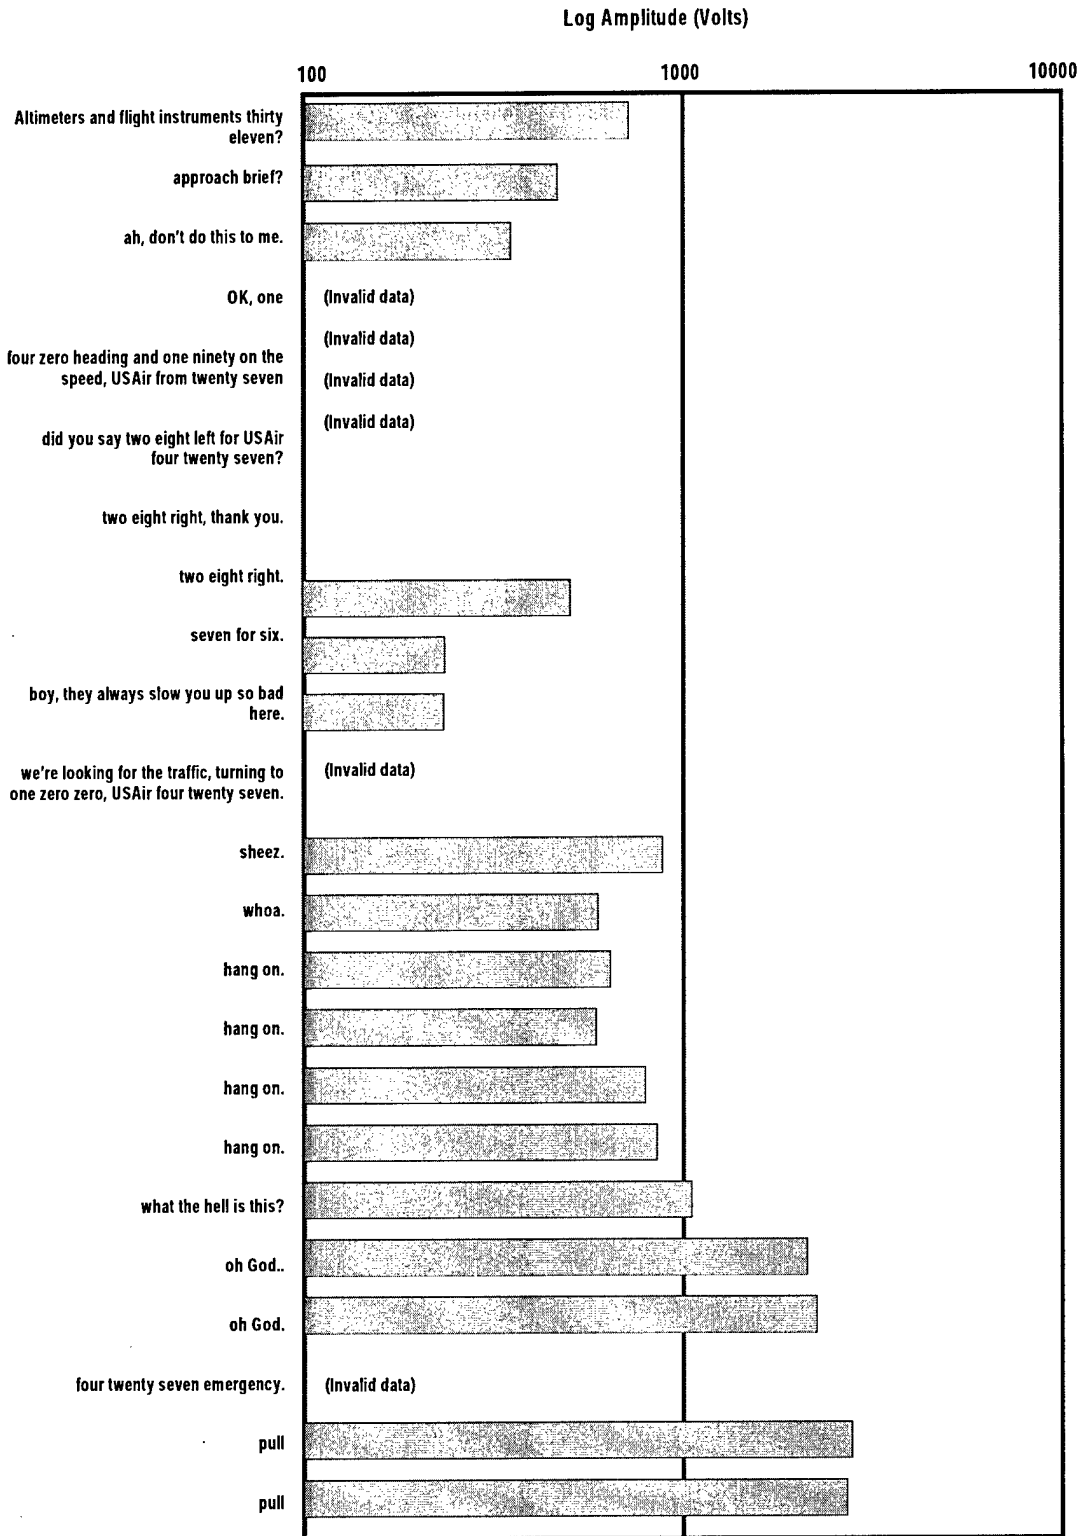
Figure 30. Amplitude measures for the USAir flight 427 captain's speech.

<sup>212</sup> Amplitude is often measured in decibels, a logarithmic scale determined relative to an internationally accepted calibration standard. Because no calibration standard was available in the CVR recording, amplitude was measured in volts (the direct measure of physical intensity) and plotted on a logarithmic scale for convenience.

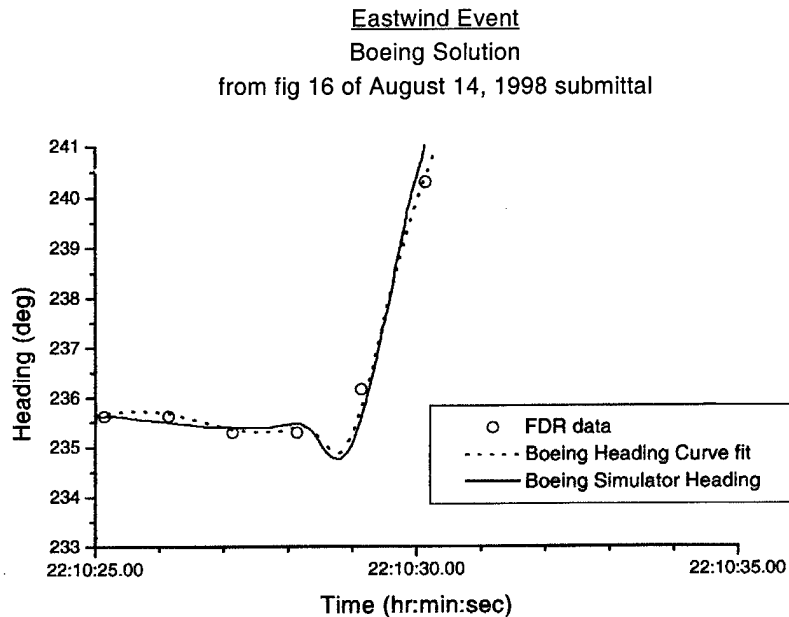
The specialist further stated that normal use of the cockpit controls should not produce these types of sounds. He said that the sounds emitted by the first officer during

Boeing used its kinematic analysis to derive flight control surface position time histories (particularly the rudder position time history). This effort required Boeing to curve fit the once-per-second FDR heading data, which Boeing accomplished with a manual, nonlinear fit of the heading data, as shown in figure 32. To justify a right rudder

input by the pilot about 2210:29, Boeing introduced a left heading change between 2210:28 and 2210:29 (in response to the postulated left rudder movement from the release of the yaw damper hardover about 2210:28) through its manual nonlinear curve fit of the FDR heading data, even though the FDR data did not reflect a left heading change. (Further, both the flight crew and the lead flight attendant recalled a yaw to the right as the initiating event.). When this manual curve fit of the heading data was used in Boeing's kinematic analysis, the results indicated a left rudder movement about 2210:28 that was consistent with Boeing's scenario of the release of the yaw damper hardover at that time. Boeing then used this rudder surface time history (and other control surface time histories) as input data in its computer simulation to produce airplane motion parameters, including heading.

Boeing asserted that its analysis demonstrated rudder activity during the event, which it considered evidence of the yaw damper activity during the event (and therefore evidence that the rudder was not jammed and did not reverse). However, the basis for this assertion that the yaw damper was active during the event is the rudder activity resulting from Boeing's kinematic analysis, which in turn resulted from Boeing's manual, nonlinear curve fit of the FDR heading data. Although the Safety Board cannot prove that the left heading change introduced into Boeing's curve fit about 2210:28 did not exist, no evidence indicates that it did. Further, the heading change does not match the character of the heading data between about 2210:27 and about 2210:30.
