155-mm Howitzer Malfunction Investigation: A Laboratory Study of the Igniter Train Operation

ARL-TR-2106

November 1999

Army Research Laboratory

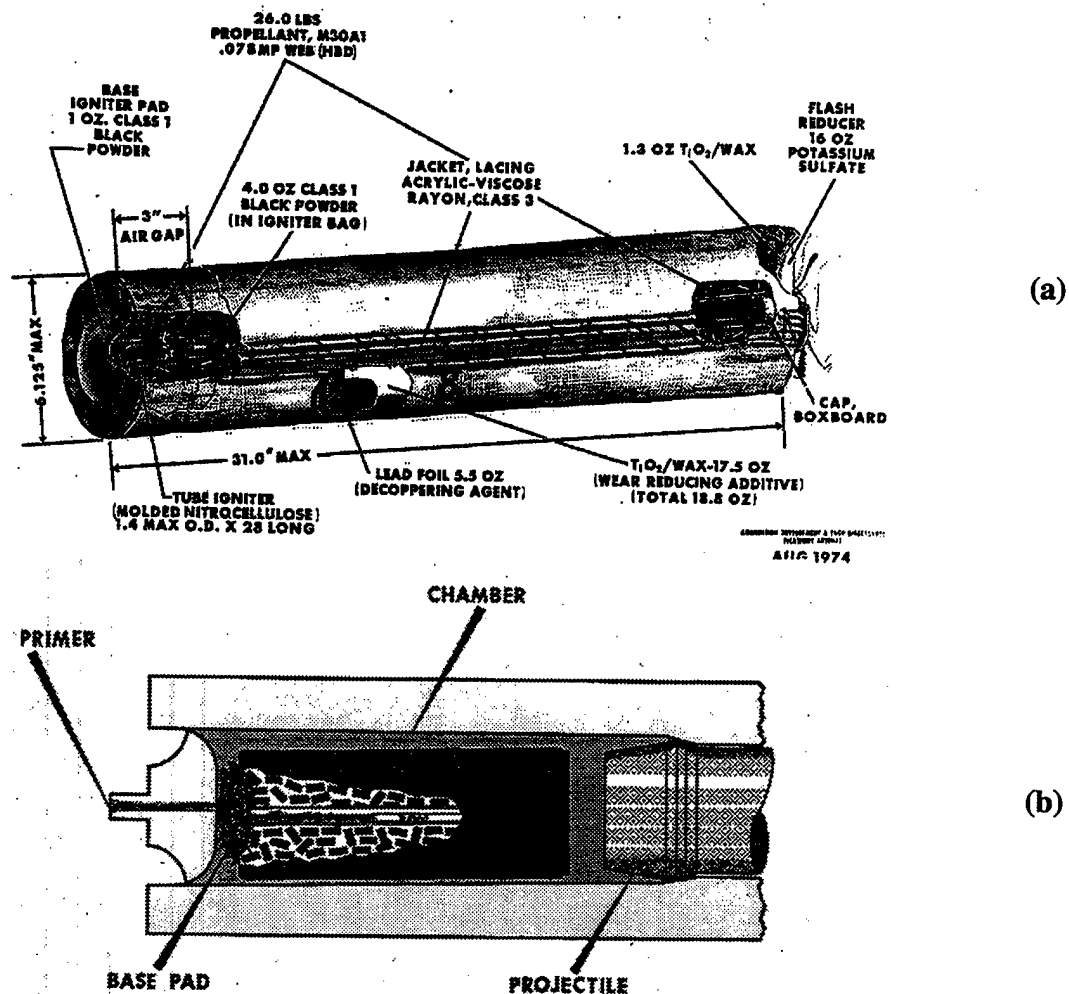
In the normal functioning of the igniter system, Figure 1(b), the firing pin initiates the M82 primer; the output of the primer ignites the base pad (containing black powder) located at the rear of the charge; the output of the base pad, in turn, ignites the central core tube of black powder (snake) located coaxially with the charge inside of a nitrocellulose (NC) tube; and the output of central core tube results in radial ignition of the propellant bed.

Figure 1. Illustrations of (a) Charge-Propelling 155-mm XM203E1 and (b) Igniter Functioning in Gun Chamber.

- (11) The igniter system was designed with a 7.5-cm (3 in) gap between the black powder base pad and center core snake (Figure 1). Does the confinement of the charge within the chamber have an effect on the ignition of the snake by the base pad?

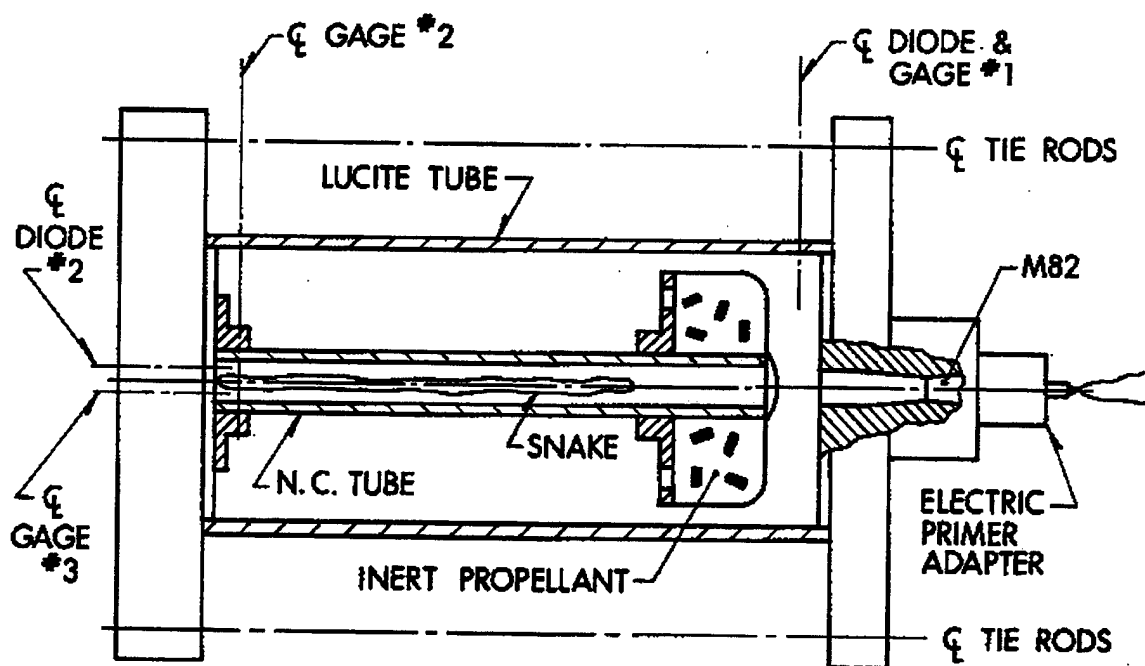
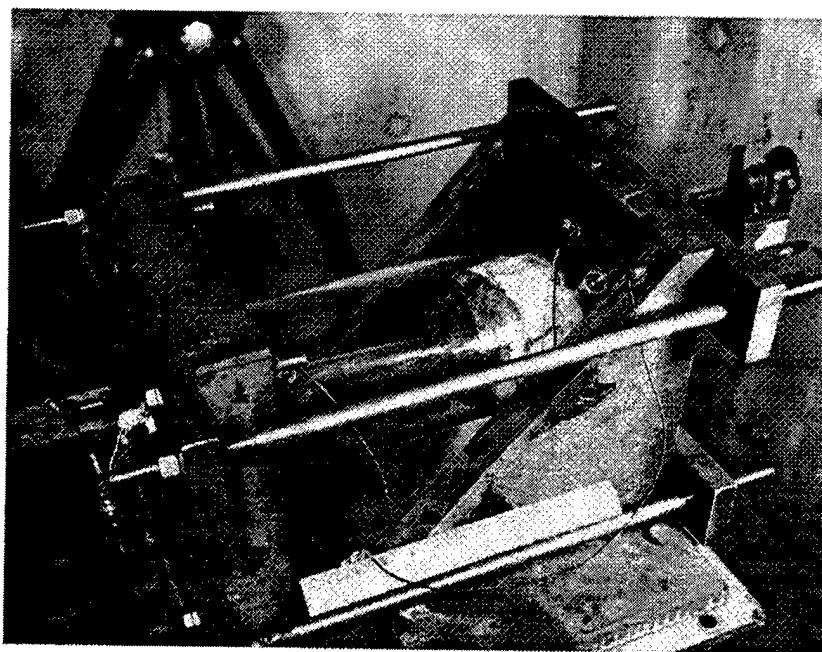
The actual igniter train used in the XM203E1 charge consisted of a base pad containing 28 g (1 oz) of Class 1 black powder; an igniter tube of molded NC, 71-cm (27.9 in) length \times 3.56-cm (1.4 in) outside diameter (OD); and a 63.5-cm-long (25 in) black powder snake located inside the igniter tube, 7.5 cm (3 in) from the base pad containing 113 g (4 oz) of Class 1 black powder (Figure 1). For convenience and speed of getting the study started, a laboratory simulator was used that would only accommodate an igniter train shorter than the actual igniter system was chosen. A diagram of the apparatus is shown in Figure 3(a). A picture of the setup is shown in Figure 3(b).

Figure 3. Laboratory Simulator for Ignition Train Studies:
(a) Schematic and (b) Photograph.

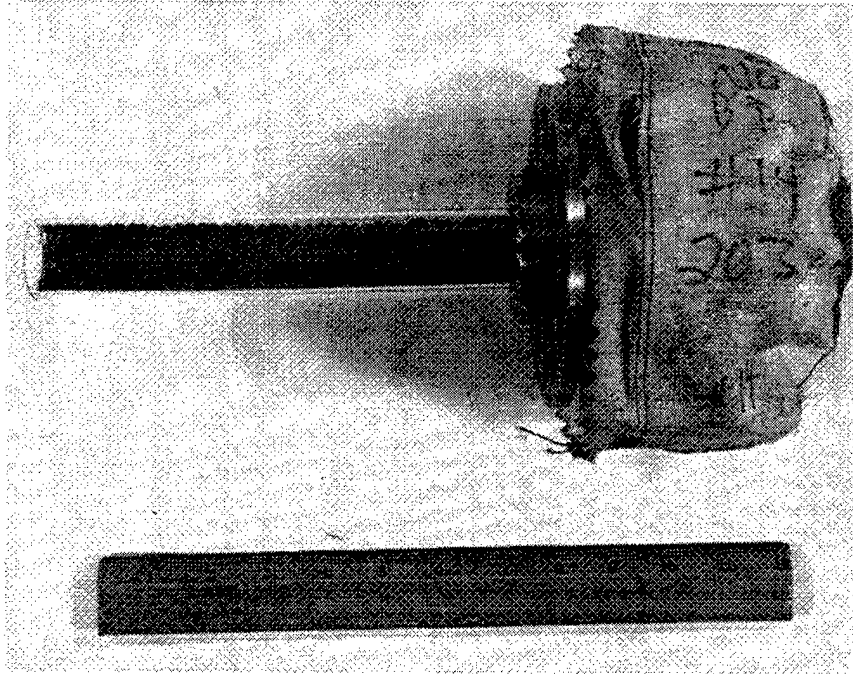
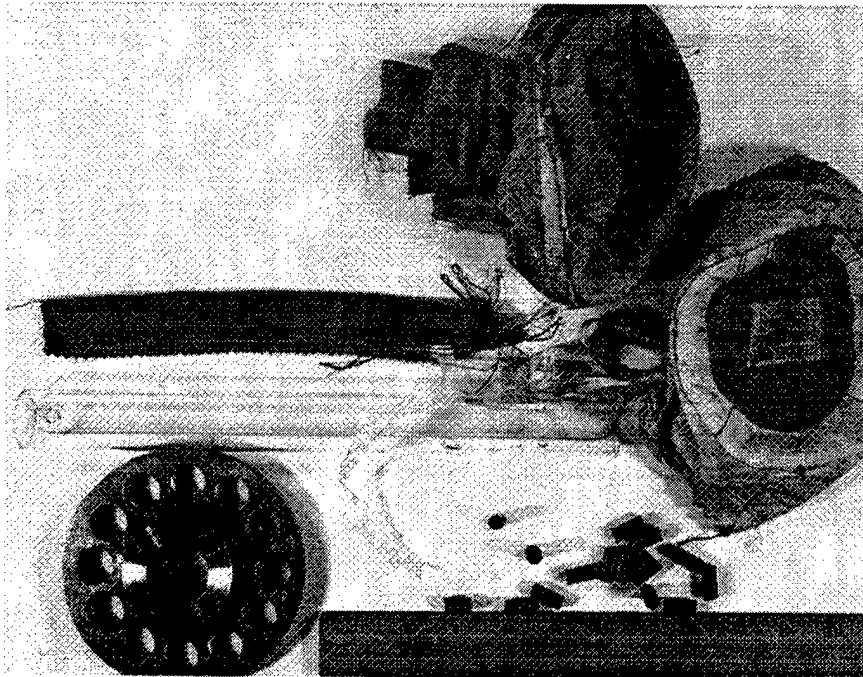
An exploded view of a typical charge can be seen in Figure 4(b), with a few representative grains of inert propellant. In this case, both the snake and the base pad are empty. An assembled view of this charge can be seen in Figure 4(a). It should be mentioned here that, for Runs 1-23, the center of the charge was carefully aligned with the primer output spit hole. Later runs were directed at testing the concept that misalignment of the charge could contribute to the hangfires.

**Figure 4. Fully Assembled Igniter Simulator Charge Views:
(a) Normal and (b) Disassembled.**

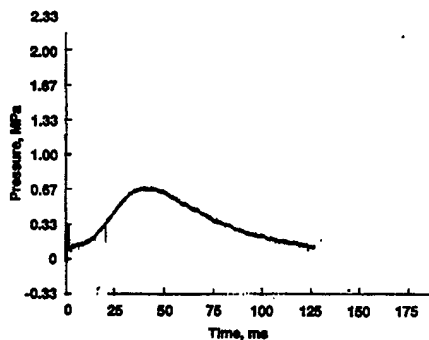
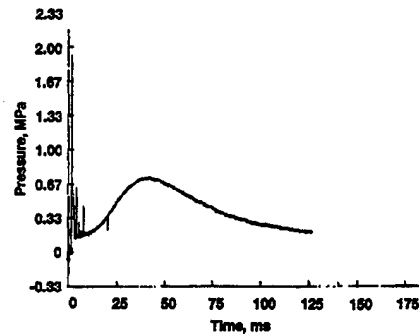
3.14.2 Run 42. Results of this test were essentially the same as Run 41. Figures 38 and 39 show the pressure-time curves. Figure 40 shows the signal from Diode 1. The light emission from the M82 primer can be clearly observed (1.5 ms) followed by light emission from the base pad (8 ms). This is also seen in Figure 41 for Diode 2. The pressure pulse transit time from one end of the chamber to the other can be found from Figure 42 ($2.8\text{ ms} - 1.5\text{ ms} = 1.3\text{ ms}$).

Figure 38. Pressure vs. Time for Run 42, Gauge 1. The 203 Base Pad With 28 g (1 oz) of Black Powder and a Conditioning Temperature of -54°C .

Figure 39. Pressure vs. Time for Run 42, Gauge 3.
