Technical Report REMR-CS-63  
September 1999

## **Repair and Rehabilitation of Dams: Case Studies**

*by James E. McDonald, Nancy F. Curtis*

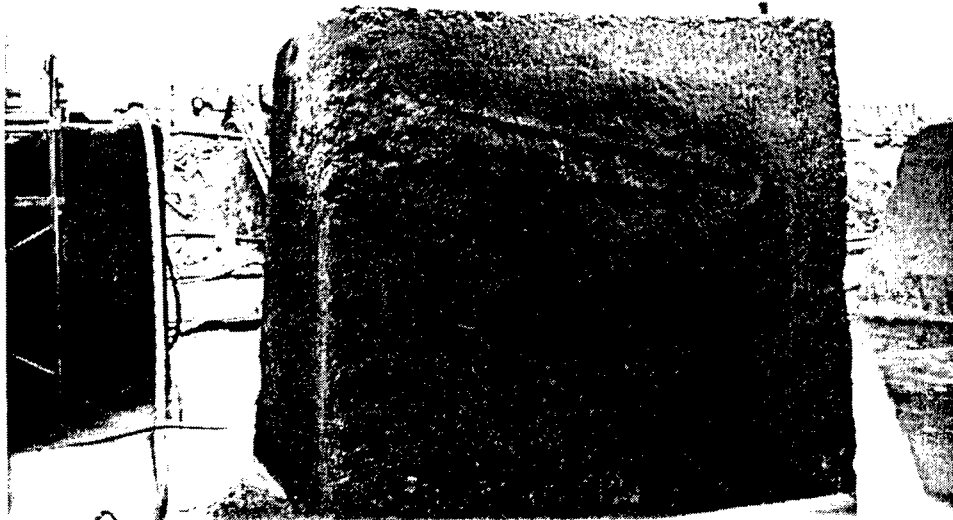
**Stilling basin repair.** After the inspection, workers began preparing the stilling basin slab for a 305-mm (12-in.) overlay of 34.5 MPa (5,000-psi) concrete with a low water-cement ratio (w/c). Over 10,000 hooked dowels were epoxied into the existing slab to anchor the overlay; then forms were erected, reinforcing steel was installed, piezometers installed in the slab were capped (two were left as permanent working piezometers), and over 1,529 cu m (2,000 cu yd) of concrete was placed. The overlay covered most of the damage to the baffle blocks. Damaged areas that extended above the overlay were repaired with shotcrete, a polymer improved cementitious mortar with aggregate that had a 28-day compressive strength over 48.3 MPa (7,000 psi) (Figure 7). It was also used to repair grout patches that had been damaged by erosion. Shotcrete was selected for these repairs because it is fast setting, has exceptional

Figure 7. Baffle Block repaired with shotcrete to restore original configuration and halt further erosion, Old River Control Structure (U.S. Army Engineer District, New Orleans 1988)

bonding properties, and has an abrasion resistance six times greater than that of conventional concrete. (Hassenboehler 1988).

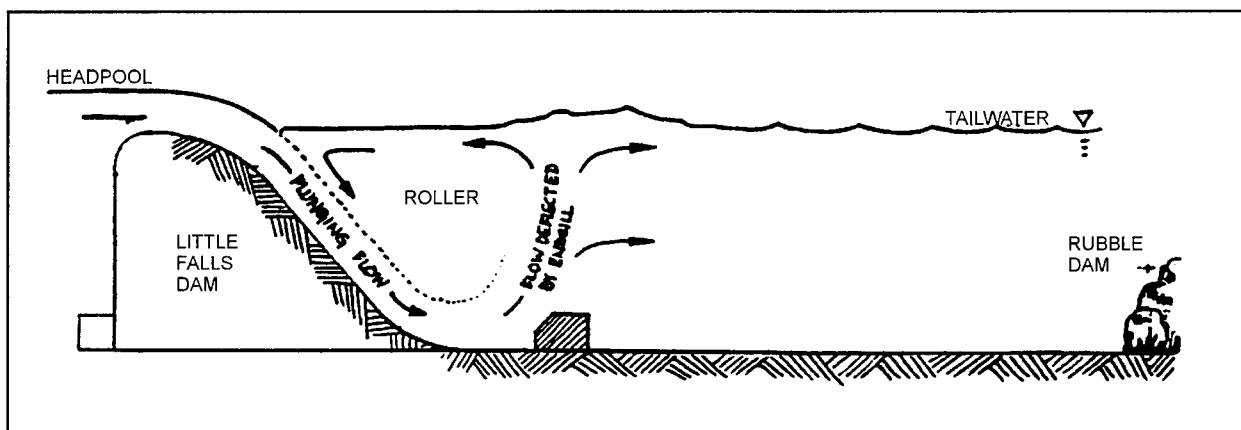
Little Falls Dam is located on the Potomac River between Virginia and Maryland just west of Washington, DC, in a section of the river that is a very popular recreational site. The dam was constructed to direct flow to the pumping station that supplies the nation's capital with water. It is a 426.7-m- (1,400-ft-) long low-impoundment dam with two pools. Depending on the season, the water level between the pools typically varies from 0.3 to 0.9 m (1 to 3 ft). It has an ogee downstream face and a 0.6-m- (2-ft-) high hydraulic jump at the toe of the apron. This configuration was designed to dissipate hydraulic energy and reduce erosion; however, remnants of a rock crib dam built in the 1830s blocks the free flow of tail-water below Little Falls, raising the elevation of the lower pool. In periods of very heavy flow, when 0.9 to 1.5 m (3 to 5 ft) of water crest the dam, a strong roller, or undertow, condition is created (Figure 9). Between 1975 and 1983, 17 people drowned in the vicinity of the dam. Rafting or canoeing near or over the dam, they were caught in the undertow and submerged. Seeking to prevent further loss of life, the USACE began looking for solutions for this problem (Davis and George 1985).

Figure 9. Cross section of Little Falls Dam, showing typical flow conditions below the dam (from Davis and George 1985)

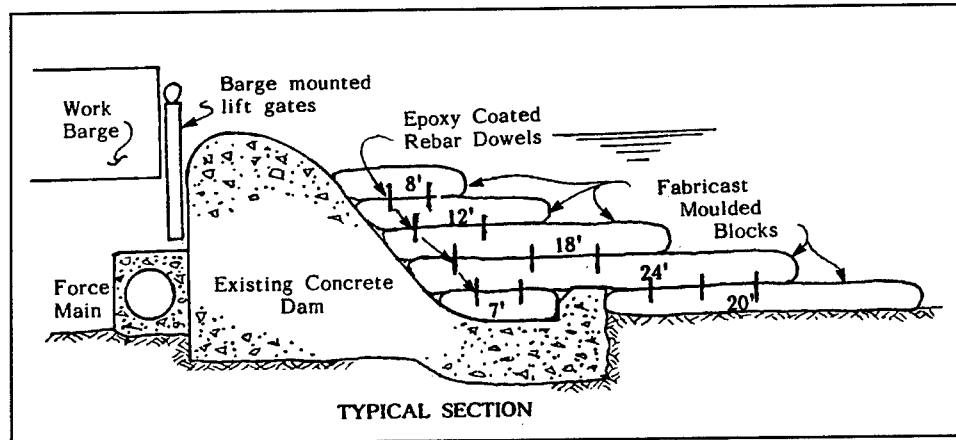
The most obvious solution was to remove the remnants of the rock crib dam, which was originally constructed to divert water into the Chesapeake and Ohio Canal, but the dam could not be removed because of its historic features. The USACE began model testing various alternatives for eliminating the roller. The alternative selected was to use grout-filled bags to create a 3:1 stepped slope that would extend about 6 m (20 ft) beyond the toe of the apron (Davis and George 1985). Figure 10 shows the alternative design.

Figure 10. Plan for placement of grout-filled bags to eliminate the roller at Little Falls Dam (from Intrusion-Prepakt, Inc. 1986)

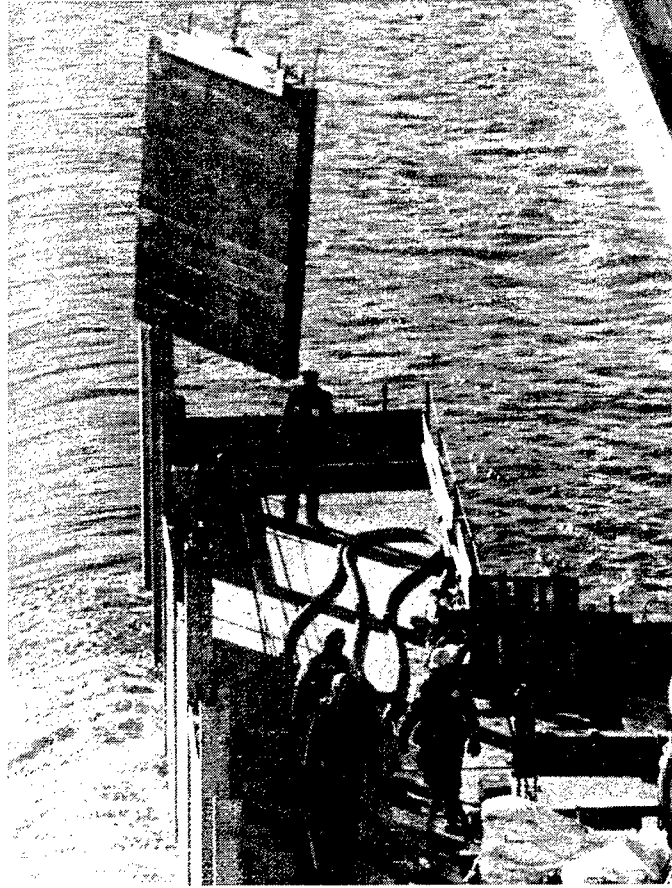
Barges were equipped to serve as floating work stations. To provide calm water for the divers, work barges were fitted with adjustable deflection gates. Once the barges were in place, a crane would lower the deflection gates into position to divert river flow around the work area (Figure 11).

Figure 11. Work barge with raised deflection gate, Little Falls Dam (from Intrusion-Prepakt, Inc. 1986)

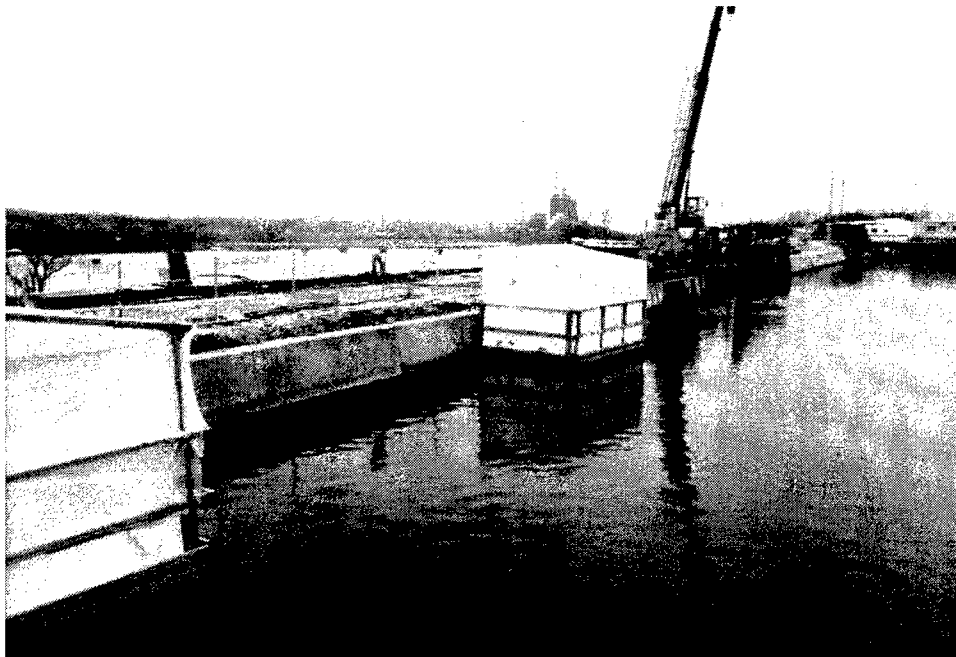
Figure 15. Head gate section on upstream face at Brandon Road Dam after rehabilitation

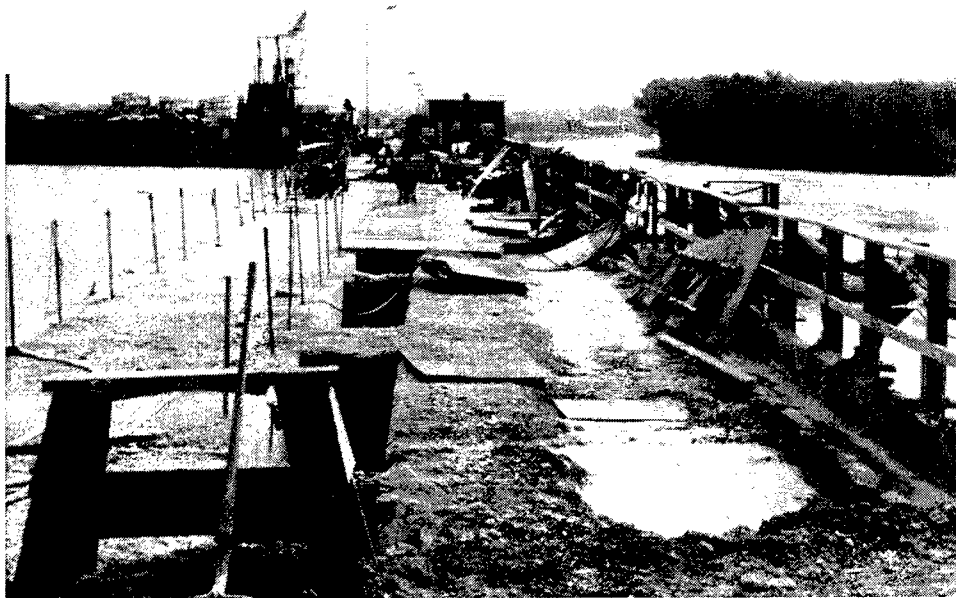
Figure 16. Repairs to the horizontal deck of the head gate section at Brandon Road Dam

Concrete was removed to a depth of 229 mm (9 in.) on the horizontal surfaces of the head gate section. No. 6 steel bars at 305-mm (12-in.) spacings each way provided reinforcing for the horizontal surfaces of the head gate section. Additional reinforcing was added across the openings in the existing concrete. An asphaltic bond breaker was applied to the existing concrete before the conventional air-entrained concrete overlay was placed (Figure 15). Repair to the horizontal deck of the head gate section was similar to that of the sides; a 229-mm- (9-in.-) thick, unbonded overlay was used to replace deteriorated concrete (Figure 16).

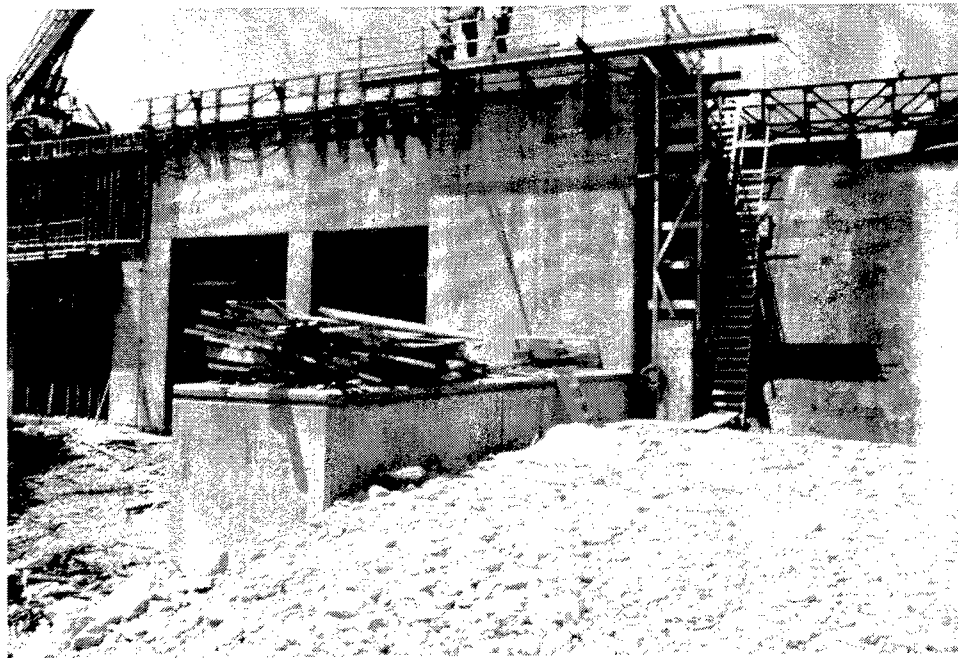
Figure 17. Boiler house after rehabilitation, Brandon Road Dam

The boiler house monolith was extensively modified. Rehabilitation included removal of a large portion of the downstream section, resurfacing vertical and horizontal surfaces, and filling existing openings. Conventional concrete was used, and a new metal maintenance building was erected on top of the rehabilitated monolith (Figure 17).

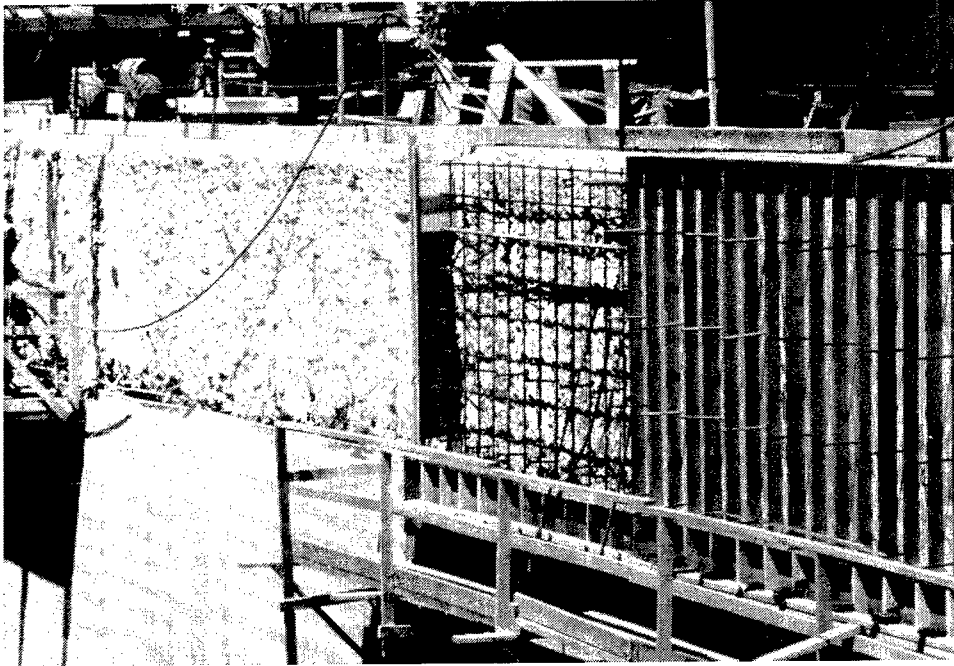
Figure 18. Reinforcing and forms for head gate closure panels at Dresden Island Lock and Dam

The head gate closure panels were installed on the downstream face of the structure. The panels, which were 4.6 m (13 ft 4 in. ) wide, 4.9 m (16 ft) high, and 1.2 m (4 ft) thick, were reinforced with No. 6 steel bars on 305-mm (12-in.) centers each way on both faces. No. 6 steel bars on 457-mm (18-in.) centers vertically were used to anchor the panels to the existing piers. Anchors were also installed at the bottom of the panels (Figure 18). The head gate section after rehabilitation is shown in Figure 19.

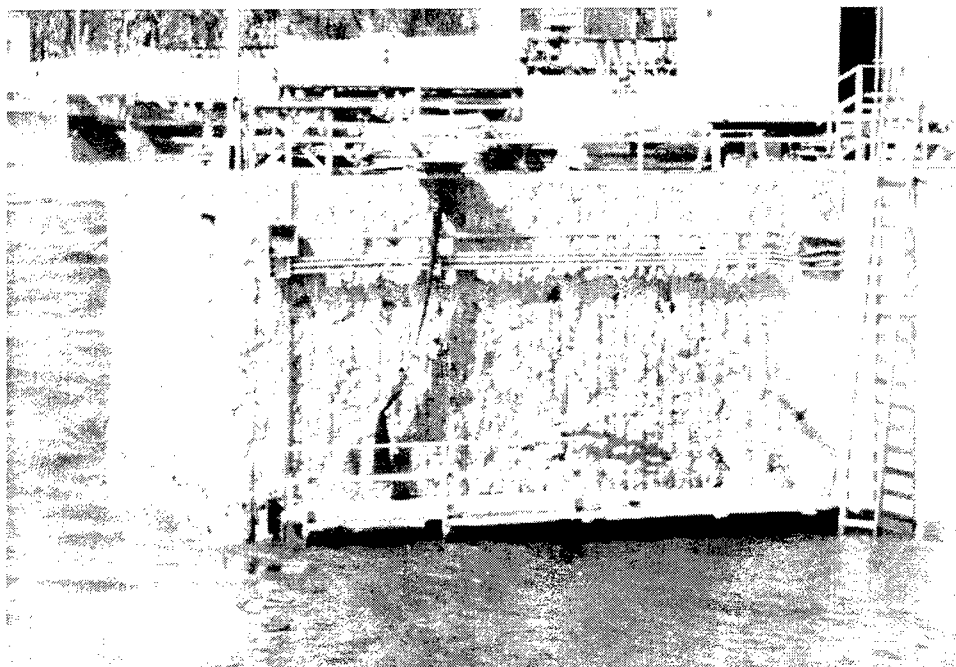
Figure 20. Concrete removal and anchors for the arch dam at Dresden Island Lock and Dam

The procedure for resurfacing the arch dam was similar to that used for the tainter gate section. Concrete removal on the arch section varied from 229 mm to 0.38 m (9 in. to 1 ft 3 in.). Line drilling, expansive grout, and chipping hammers were used to remove the deteriorated concrete (Figure 20). The arch dam after rehabilitation has been completed is shown in Figure 21.

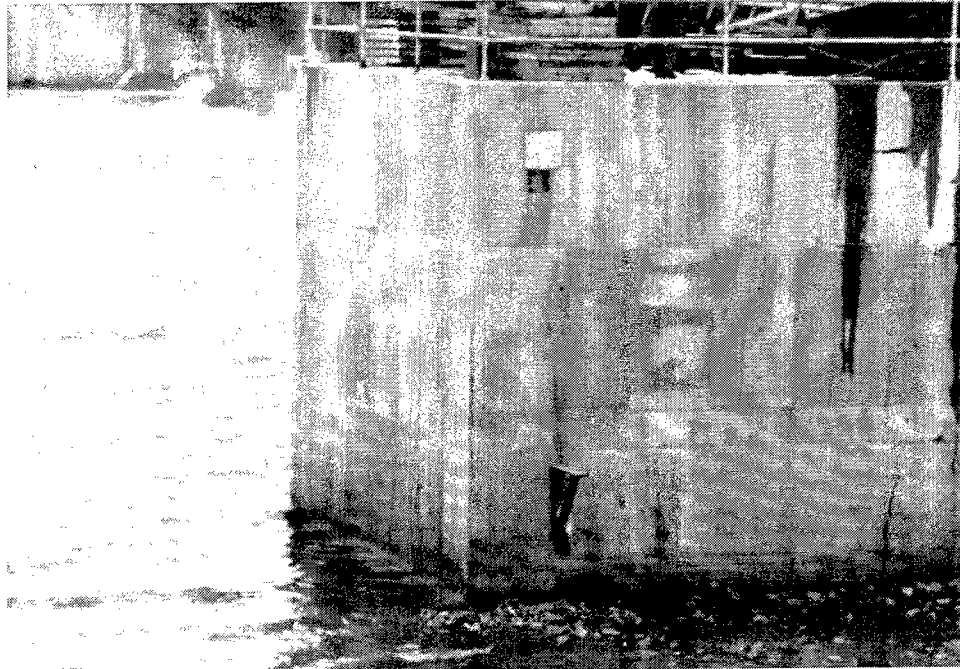
Figure 21. The south abutment of the arch dam after rehabilitation, Dresden Island Lock and Dam

The fifth periodic inspection (USAED, Rock Island 1990) noted only minor cracking in the rehabilitated structure. The inspection team for the sixth periodic inspection (USAED, Rock Island 1995) reported efflorescence on the bottom construction joint of the head gate bulkheads, but there was no indication of seepage. The arch dam also had efflorescence at some cracks and joints but, otherwise, was in good condition.

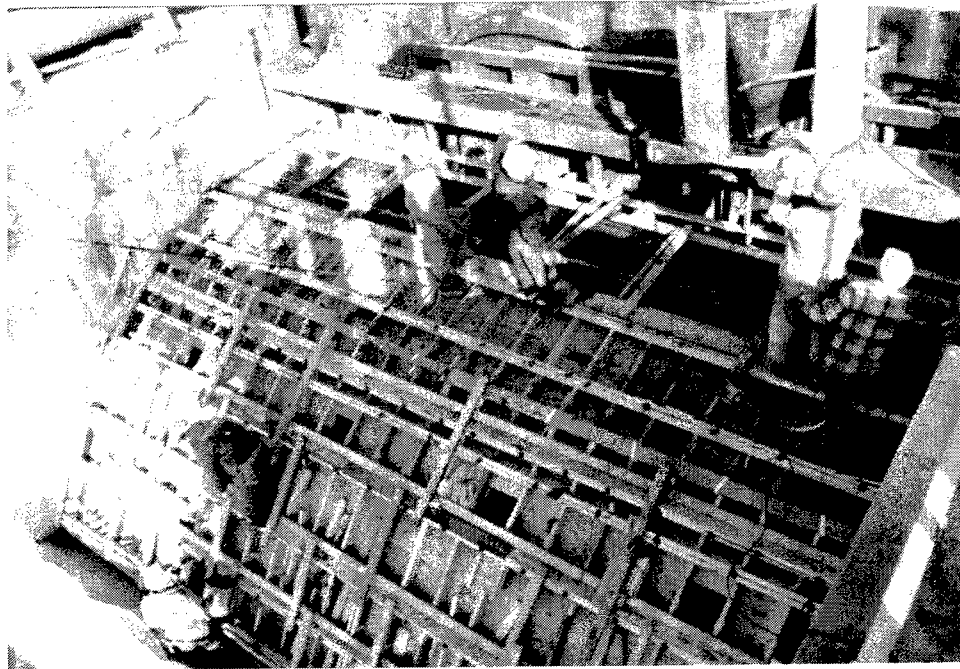
Figure 22. Concrete placed in the ice chute during conversion to ogee crest, Dresden Island Lock and Dam

The gated ice chute was converted to an uncontrolled ogee crest. Concrete was removed, forms were built, and the concrete replaced to obtain the ogee configuration (Figure 22). The converted ice chute is shown in Figure 23. The downstream face of the gate sill was resurfaced, and the gate recess in the sill was filled with concrete. The same methods were used to resurface this section as had been used on the arch dam.

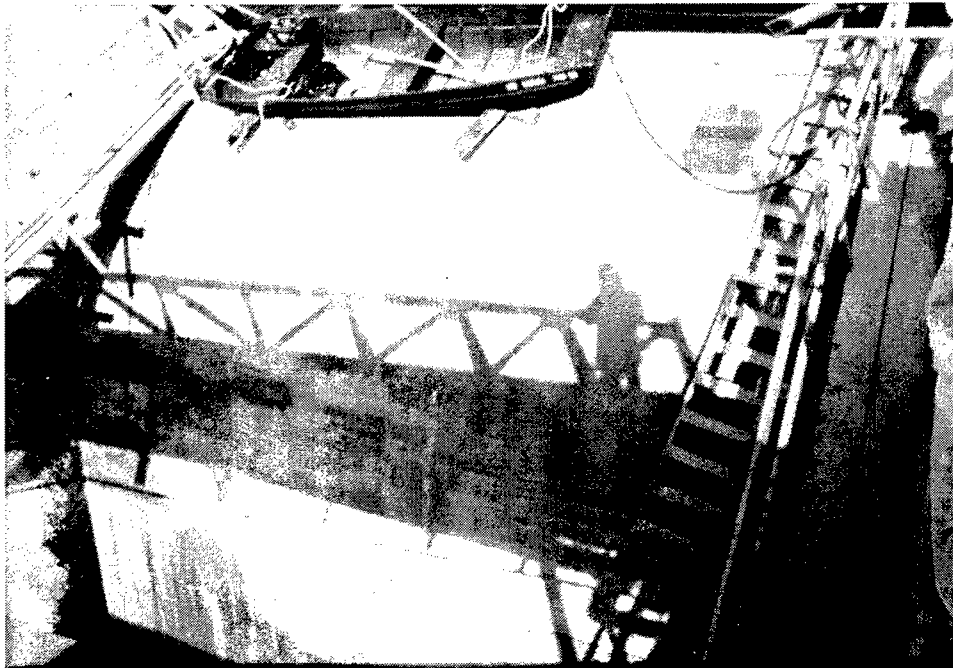
Figure 23. Completed ice chute, Dresden Island Lock and Dam

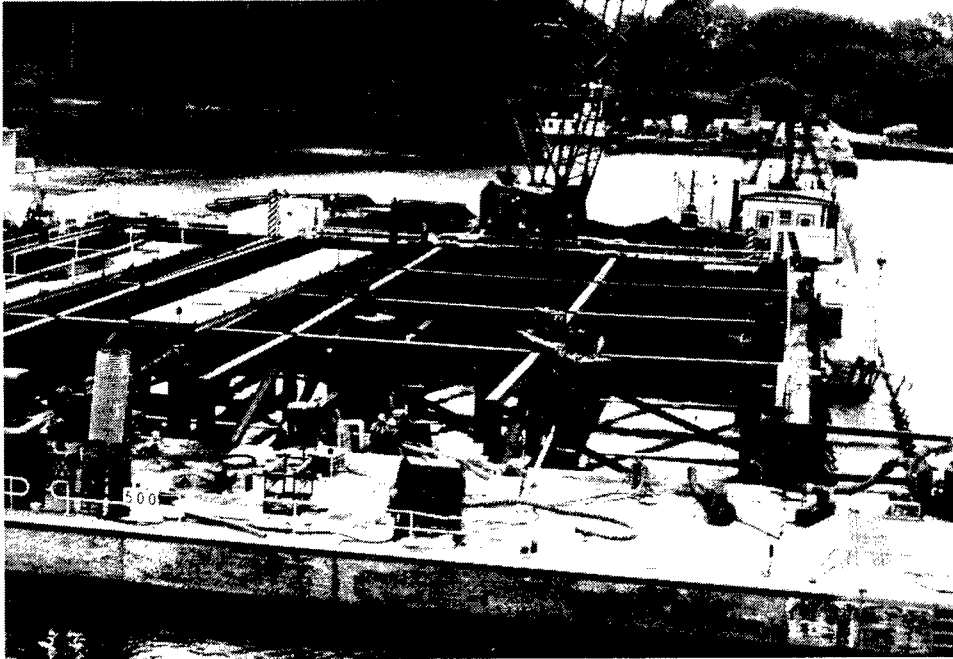
Figure 24. Braced steel sheet-pile cofferdam, LaGrange Lock and Dam

The contractor constructed a single-wall, internally braced sheet-pile cofferdam to dewater the work site. Three sides of the cofferdam were constructed of sheetpiling driven to an impervious layer. The fourth side consisted of the lock wall and its cutoff and a supplemental cutoff driven parallel to the lock wall. Tremie concrete placed between the supplemental cutoff and the lock wall formed a seal. The contractor assembled the cofferdam bracing above the sheet piles and lowered the 526 Mg (580 tons) of framing into the sheet piling with four hydraulic jacks. Bolted connections were designed to allow relocation of columns, struts, and cross bracing to accommodate construction activities (Figure 24).

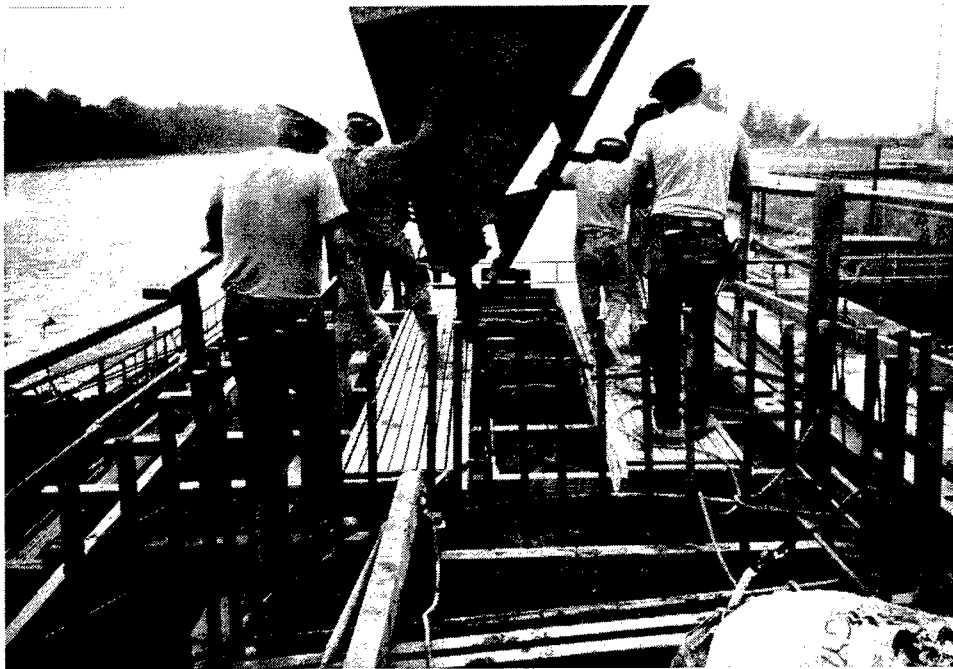
Figure 25. Concrete placement in riverward pier at LaGrange Lock and Dam

A concrete pier, 27.4 m (90 ft) long, 4.9 m (16 ft) wide, and 12.2 m (40 ft) high, a new gate sill, 35 m (115 ft) long, 26 m (85 ft) wide, and 3 m (10 ft) thick, and a half pier section were constructed to accommodate the submersible gate. Ready mix trucks were used to transport the concrete from a plant about 20 minutes from the dam. The trucks were loaded onto a barge; concrete was discharged into buckets and transferred by a crane to the forms (Figure 25). Lifts were restricted to 2.3 m (7-1/2 ft). Vibrators were used to consolidate the concrete, which was then moist-cured where possible; curing compound was used where necessary. A high-pressure water jet was used to clean lift joints. The last step was to place the gate between the new piers (Figure 26).

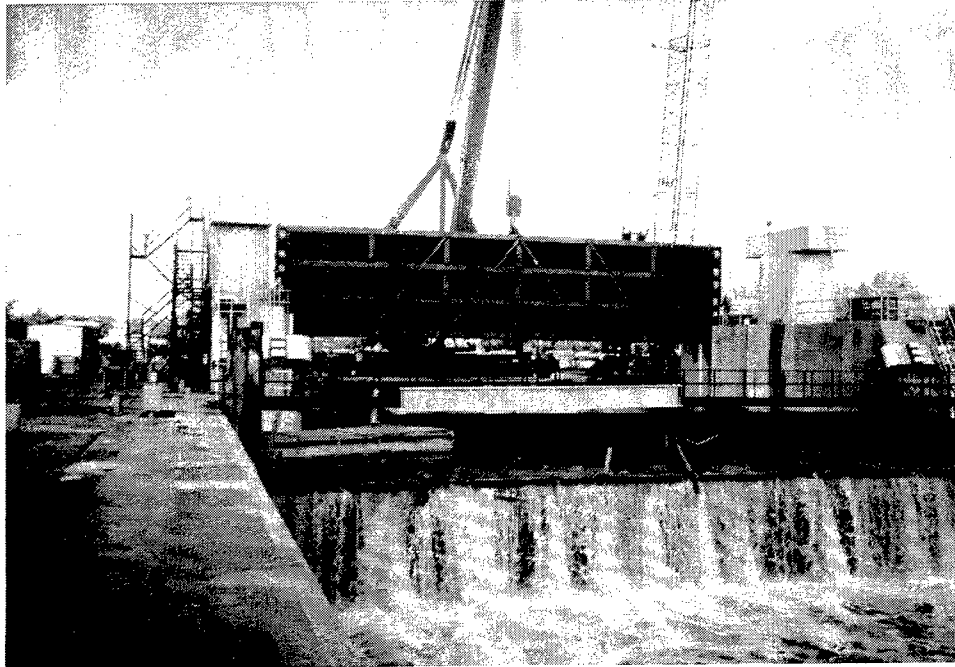
Figure 26. Placing of submersible gate, LaGrange Lock and Dam

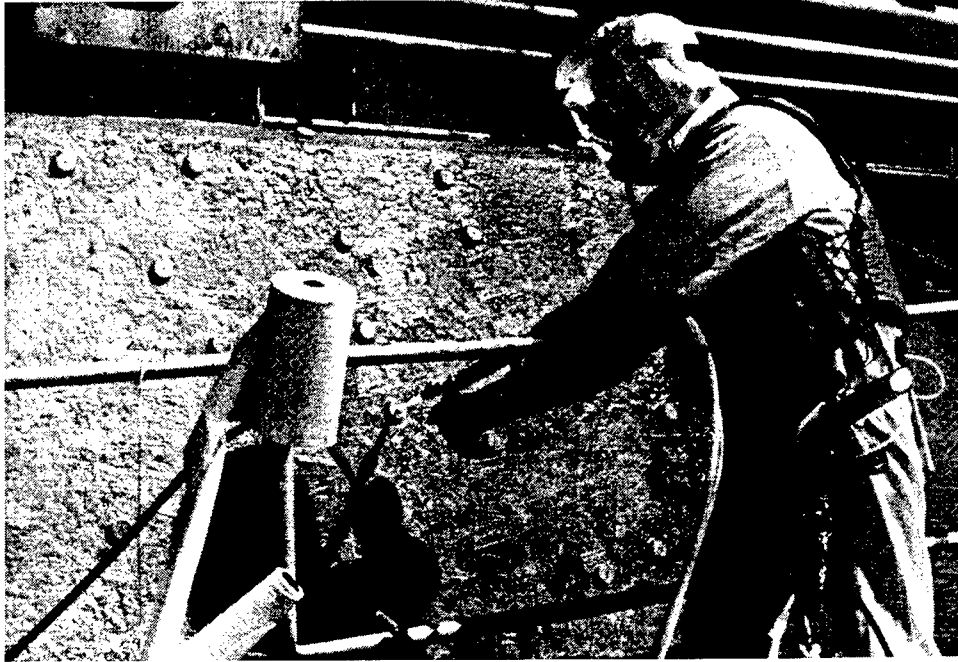
Ultrasonic velocity measurements were made before and after the injection, and, where practical, tests were run on core samples. One concern was that since the piers are integral with the submerged part of the dam, encapsulation could occur in the concrete behind the injected faces. If this encapsulation did occur, there would likely be rapid deterioration from cycles of freezing and thawing of the injected pier. Cores taken at intervals since 1982 and the Fifth Periodic Inspection (USAED, Rock Island 1991b) indicated no problem. The major problem was that the epoxy sealant used to waterproof the pier tops did not completely seal them, and seepage still occurred through unfilled cracks.

Figure 27. Epoxy injection of pier stem at Lock and Dam No. 20, Mississippi River

The petrographic examinations revealed that an average of 69 percent of the cracks in the upper zones of the cores were filled with epoxy. Piers that exhibited less cracking had a greater percentage of fractures filled than those that exhibited more cracking. Pier 42 was injected through 1,052 ports (approximately one port for every 0.07 sq m (0.75 sq ft)) of pier surface to be injected. Cores from this pier, which had more cracking, averaged 89 percent of the fractures in the upper zone filled. An average of 31 percent of the cores in the lower zone were filled.

The Sixth Periodic Inspection Report (USAED, Rock Island 1996) described the condition of the concrete in the dam good. The report also stated that the one concrete pier tested by epoxy injection during the last major rehabilitation was in satisfactory condition and the concrete surrounding the epoxy-treated area was in sound condition.

A further test of in situ repair was conducted on Pier 27 during August 1987 (Webster, Kukacka, and Elling 1989). For this test, an ultra-low-viscosity material was used, and injection was made through holes in wood dowels bonded directly to the concrete surface (Figure 27). This test demonstrated that pressure injection repair techniques can restore the integrity of cracked concrete hydraulic structures.

During the 1989 construction season, 13 pier stems were injected and cored. The first step in the epoxy injection procedure was to clean the surface of the pier with a power grinder. Port holes were then drilled and installed along the crack network. A water pressure test was performed, and the results indicated the need for additional ports. The surface was then sealed with an epoxy gel. The epoxy injected into the pier was an ultra-low viscosity, two-component, 100 percent solids epoxy resin, insensitive to the presence of water. Injection started at the lowest point of the area on the pier and moved up. Injection pressures were limited in the specifications to a maximum of 1.1 MPa (160 psi).

After analysis of the data and evaluation of epoxy injection program, USAED, Rock Island, decided to abandon the epoxy injection method and to modify the contract to remove and replace the remaining badly cracked and deteriorated pier stems. Seven pier stems were removed and replaced. Since all work had already been accomplished on the other piers and the contractor had already replaced the service bridge, no additional work was required for these piers.

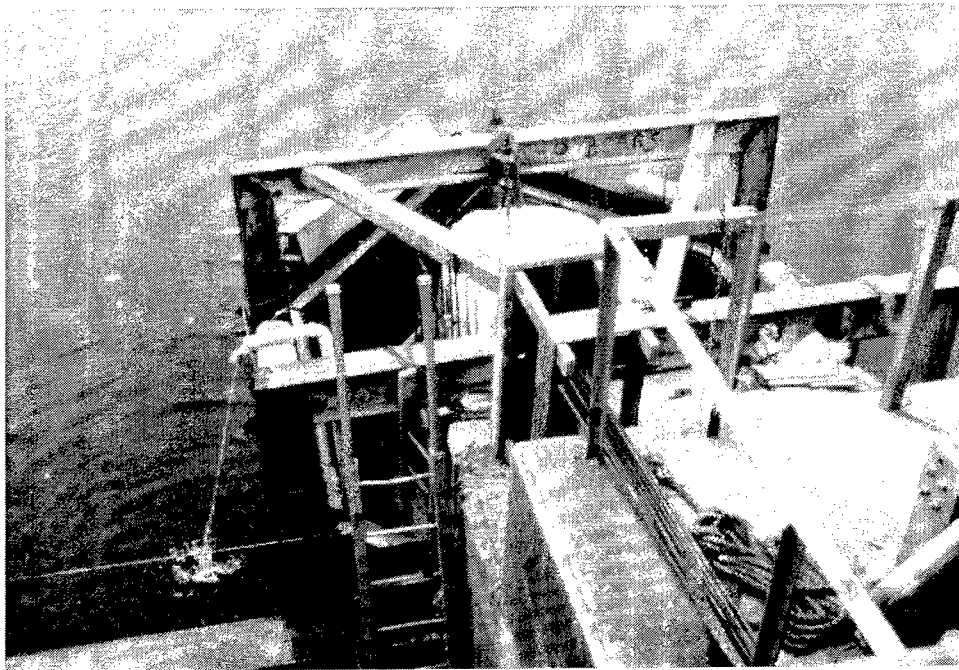
Figure 28. Local cofferdam used to dewater bullnose piers, Marseilles Dam

To replace the gates and complete repair work, it was necessary for the contractor to dewater each spillway sequentially. The contractor was faced with the challenge of constructing a reusable cofferdam that could withstand 6.1 m (20 ft) of water. Bedrock just below the bottom of the reservoir ruled out use of conventional sheetpiling. The solution was a local cofferdam that could be flooded to provide stability (Figure 28) (Stone and Webster).

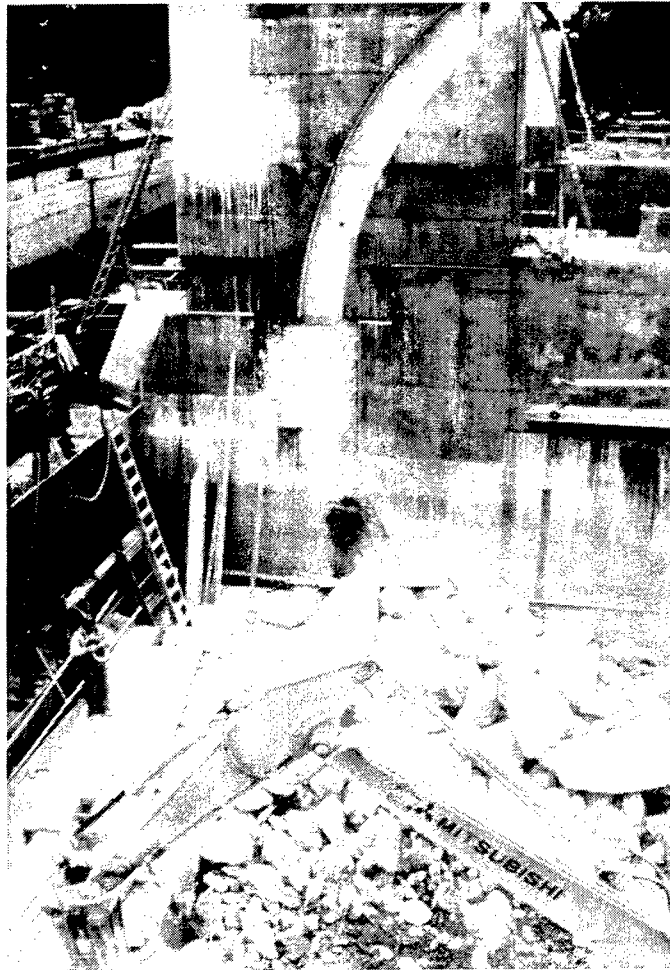
Figure 29. Concrete removal of ogee crest and side of pier to accommodate new gate, Marseilles Dam

from 102 to 254 mm (4 to 10 in.) deep and that the compressive strength of sound concrete was from 55 to 69 MPa (8,000 to 10,000 psi). Damaged concrete was removed to sound concrete, approximately 229 mm (9 in.). Deteriorated concrete was line drilled (Figure 30) and then removed with jackhammers and expansive grout. Diamond wire cutting was used to remove end blocks of concrete from the piers to allow for the installation of the new trunnion supports (Figure 31). With a cutting speed of 0.9 to 3.7 sq m/hr (10 to 40 sq ft/hr), the diamond wire was faster than conventional methods, and it required fewer workers. The pier sections were cut free in two work shifts.

Before the new submersible tainter gates could be installed, the piers had to be repaired and modified and the gate sills reconstructed. The ogee crest was removed and some concrete was removed from the side of the pier to accommodate the new gate (Figure 29). Concrete repair consisted of removing the deteriorated nonair-entrained concrete and replacing it with conventional reinforced mass concrete. In addition to visual inspection, concrete in the piers was further evaluated by coring. Concrete cores revealed that deterioration ranged

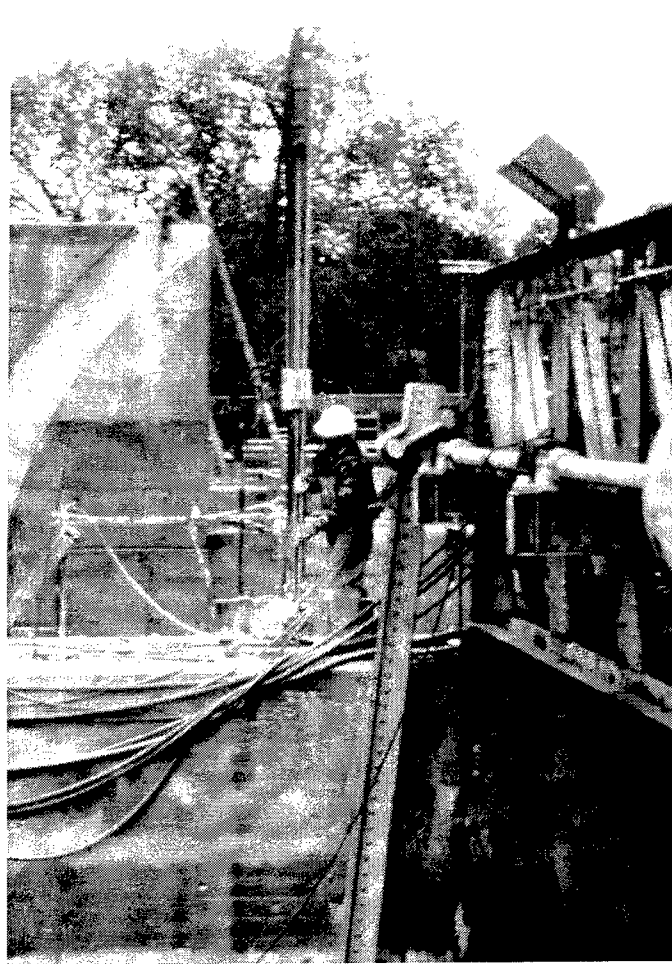
Figure 30. Line drilling for concrete removal at Marseilles Dam

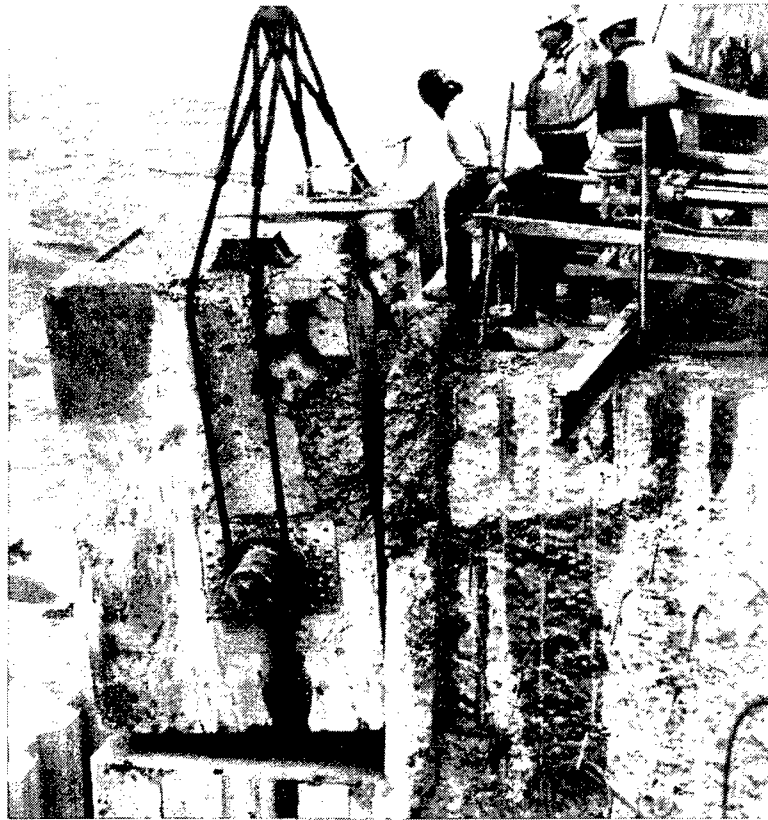
Figure 31. Twenty-nine thousand thirty and four-tenths-kilogram (32-ton) section cut from pier with diamond wire cutter, Marseilles Dam (from Cutting Technologies, Inc. 1990)

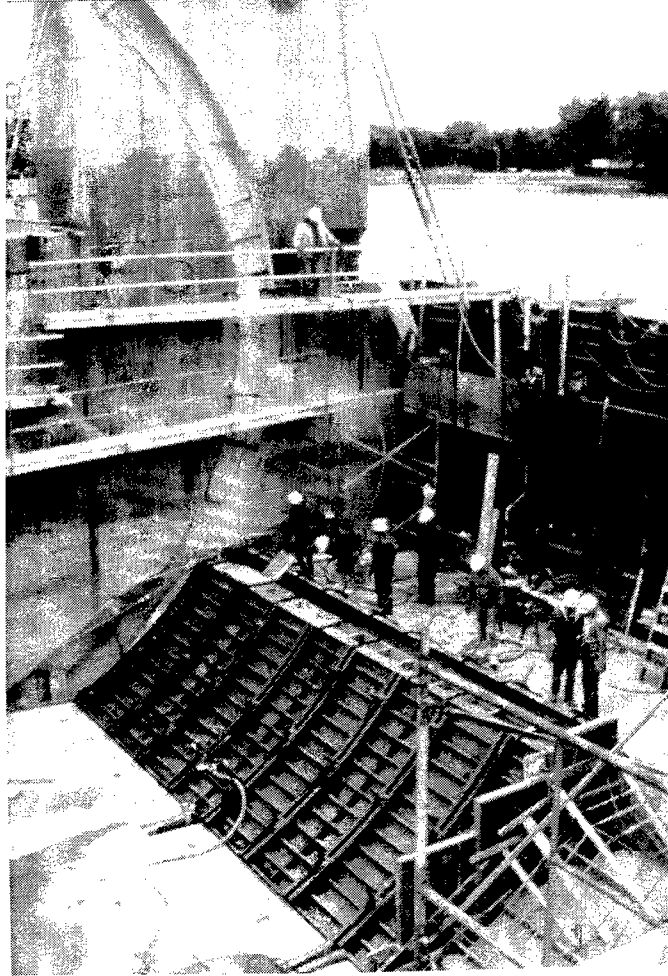
Figure 32. Concrete placement in new gate sill, Marseilles Dam

All horizontal surfaces were sloped slightly to prevent water ponding. A 0.5-m- (14-ft-) high extension was added to each pier so the gates could be raised to maximum elevation. Sills for the tainter gates were altered from an ogee shape to one that would allow the gates to be submerged (Figure 32). Post-tensioned tendons on the pier sides were used to support the trunnion anchor beam and resist trunnion loads. The tendon load was transferred into the parent

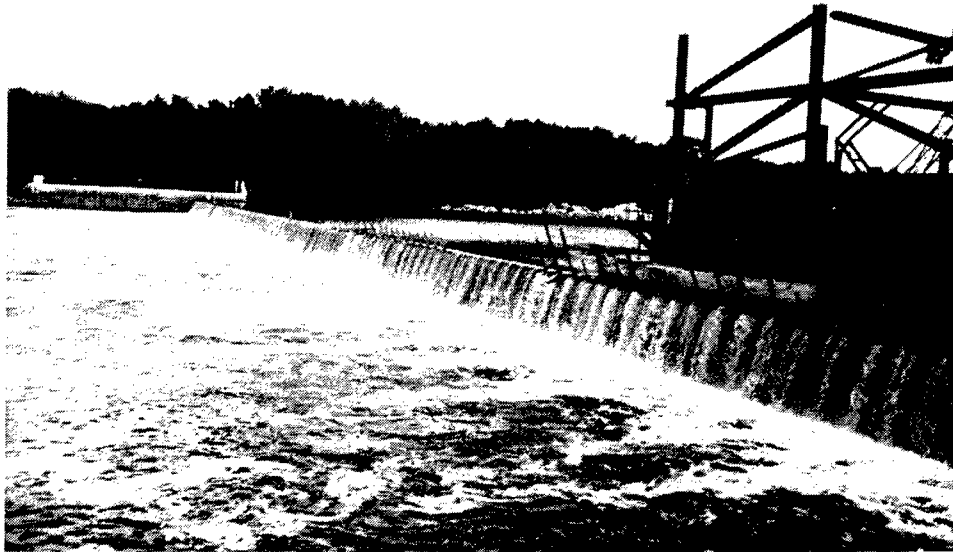
The wicket dam allows towboats to bypass the lock in open-pass navigation when flows are sufficient to lower all of the wickets. This condition occurs about 40 percent of the time during a year. There are, however, several problems with wicket dams, the biggest being that ice and debris cannot pass through the dam while the wickets are raised, which they must be during low river flows. Even the flip-top, hinged wickets, which can lower the top 0.9 m (3 ft), cannot sufficiently pass heavy ice flows. The dam had no other section for passing ice or debris. Backed up ice inhibits the movement of tows and slow lockages; ice lockages are frequently required to remove large quantities of ice while tows wait for a clear lock. Other problems with the wickets are that, in the lowered position, they pass a column of water that causes severe scouring action. Also, raising or lowering the wickets as flows change is a slow process.

Figure 33. Peoria Dam before a section of the wicket dam was replaced with a submersible gate

To alleviate some of the problems of the wicket dam and to provide ice passage capability and a safer means of regulating flow, a section of the wicket dam was replaced with a 25.6 m (84-ft) wide, submersible gate adjacent to the lock wall. Appurtenant piers, gate sills, an apron, and a service bridge were included in the modification plan.

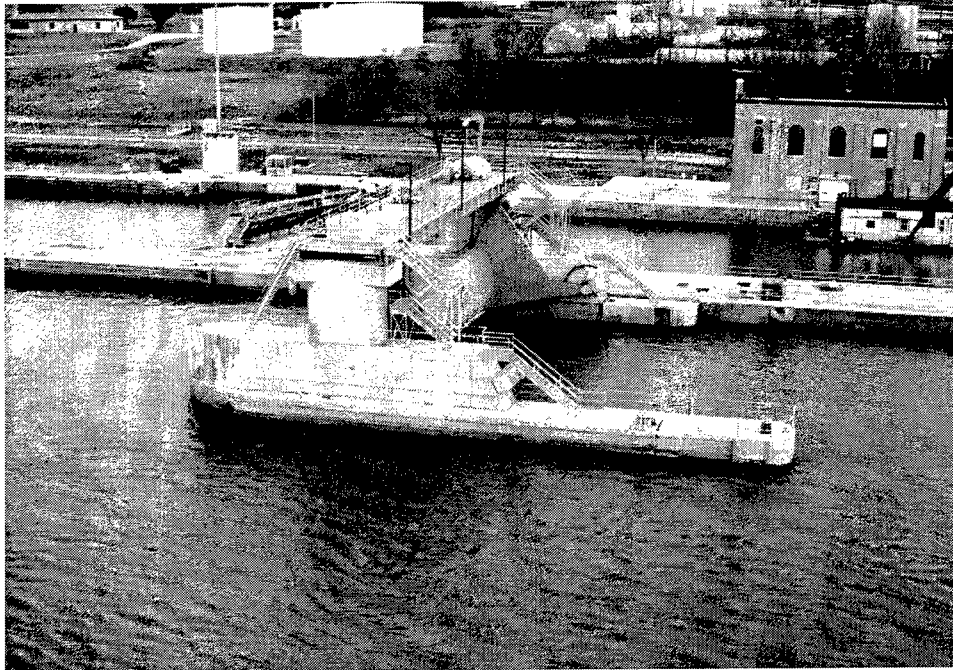
Figure 34. Completed piers and gate constructed at Peoria Dam

The report of the Fifth Periodic Inspection (USAED, Rock Island 1991c) noted a fine longitudinal crack in the riverward pier; otherwise, concrete in the dam was reported to be in excellent condition.

Ready-mix trucks were used to transport the concrete from a plant about 20 minutes from the dam. The trucks were loaded onto a barge; concrete was discharged into buckets and transferred by a crane to the forms. Lifts were restricted to 2.3 m (7-1/2 ft). Vibrators were used to consolidate the concrete, which was then moist-cured where possible; curing compound was used where necessary. A high-pressure water jet was used to clean lift joints. The completed piers and gate are shown in Figure 34.

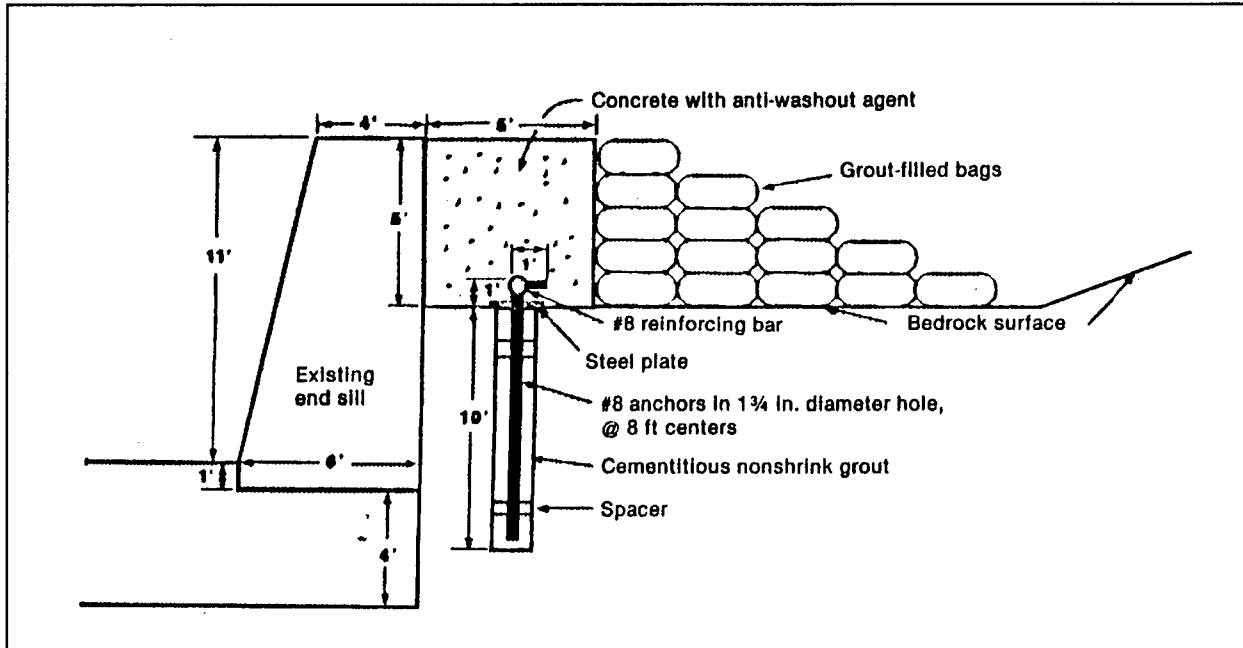
A final underwater inspection of the stilling basin was performed in August 1988, just before repair work was begun. The eroded areas, mostly in the bedrock, extended about 5.5 m (18 ft) downstream of the end sill; maximum depth of the eroded areas was approximately 1.5 m (5 ft). Prior to concrete placement, loose rock and debris were removed, and anchors and reinforcing were installed.

Figure 35. Anchor and concrete placement at the end sill, Red Rock Dam (from Neeley and Wickersham 1980)

Holes for the anchors were air-percussion drilled 3 m (10 ft) deep. Spacers were used to maintain an annular space to be filled with cementitious nonshrink grout. A 102- by 102-mm (4- by 4-in.) steel plate was placed over each anchor to minimize the washing away of the grout. A wall of grout-filled bags with a vertical upstream face and a sloping downstream face was constructed 1.5 m (5 ft) downstream from the end of the sill to help contain the concrete during placement (Figure 35).

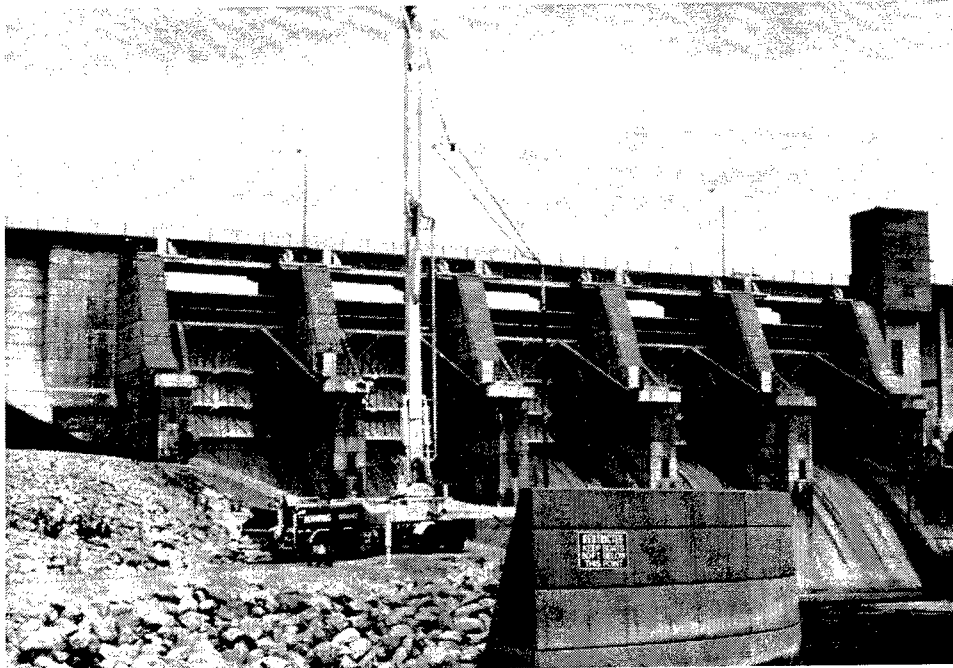
Figure 36. Concrete pump used for end sill repair at Red Rock Dam

Concrete mixture proportions for 1-cu m (1-cu yd) batch were 415 kg (700 lb) of Type 1 Portland cement, 729 kg (1,229 lb) of fine aggregate, 946 kg (1,594 lb) of coarse aggregate, 163 kg (275 lb) water, 0.19 ℓ (5 fl oz) of antiwashout admixture, 1.63 ℓ (42 fl oz) of water reducing admixture, and 0.80 ℓ (2 fl oz) of air-entraining admixture. The concrete was delivered to the job site by truck mixers, each arriving about 2 min after the previous truck had finished unloading. Haul time was approximately 15 min. A 102-mm- (4-in.-) diam pump line controlled by a diver was used to place the concrete approximately 7.6 m (25 ft) underwater (Figure 36). Placement began at the middle of the end sill and worked toward the north bank. During placement, water was discharged through the dam at a minimum 8.5 cms (300 cfs), and the river water temperature was about 26 °C (80 °F). The end of the pump line was kept embedded in the mass of concrete being discharged; the diver moved the line around to completely fill the repair area. Approximately 31 cu m (40 cu yd) of concrete was placed in the northern half of the end sill in about 1-1/2 hr.

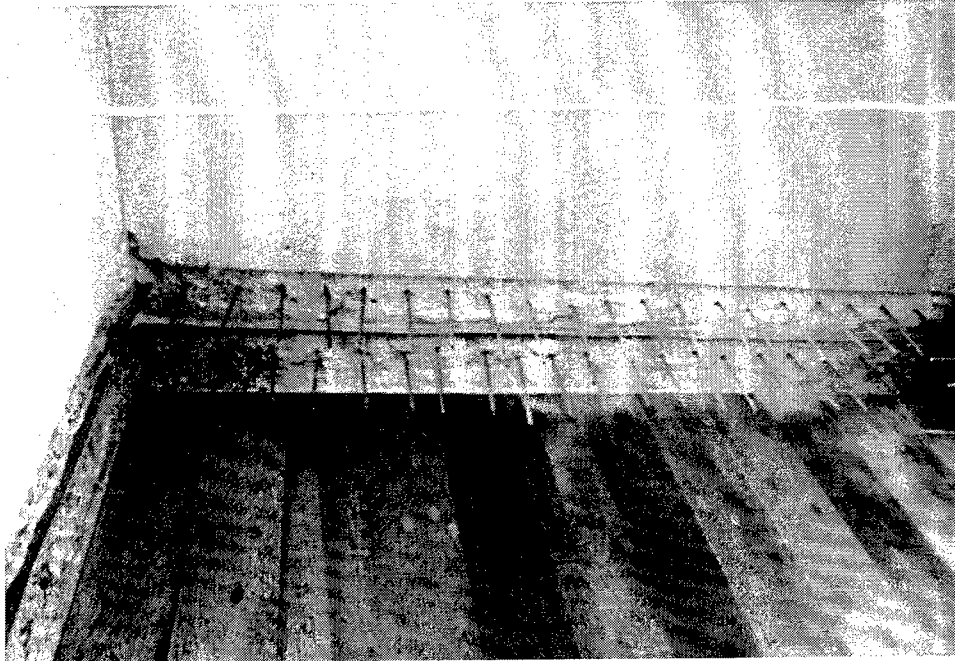
Figure 37. Anchors and waterstop installed in head gate section, Starved Rock Lock and Dam

The closure panels for the head gate section were 4.3 m (14 ft) wide, 4.9 m (16 ft) high, and 0.8 m (2 ft 6 in.) thick. Two rows of No. 6 steel bars on 229-mm (9-in.) centers were installed to anchor the panels (Figure 37). Deteriorated concrete was removed from the roof of the head gate opening, and a waterstop was installed along the perimeter of the opening. The concrete for the closure panel was pumped to just below the opening (Figure 38), and then the opening was filled with nonshrink grout. Vibrators were used to consolidate the concrete. A curing compound was used for curing.

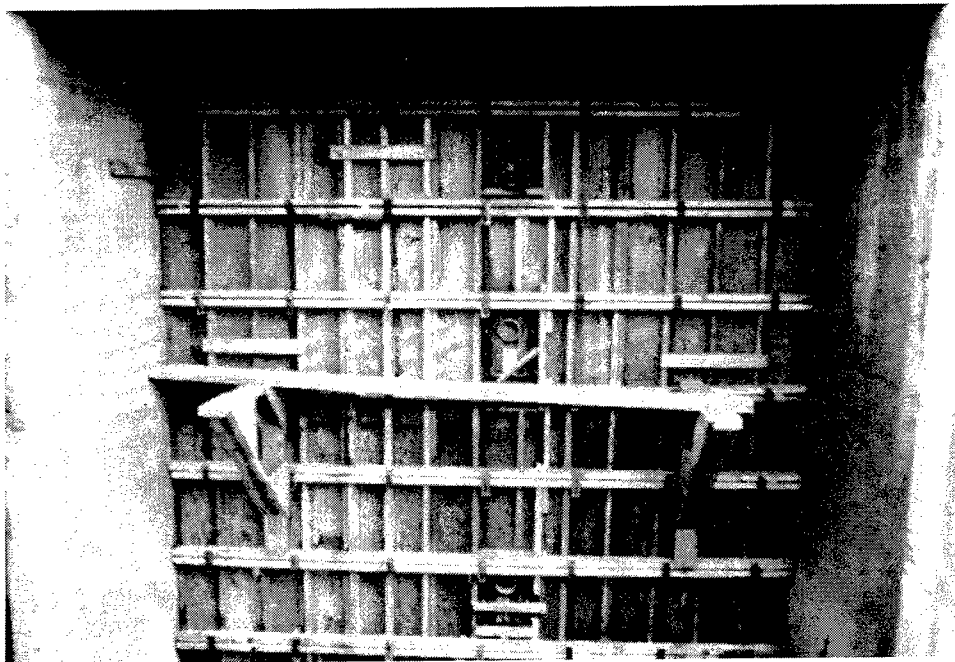
Figure 38. Forms and openings for pumping concrete for closure panels in head gate section, Starved Rock Lock and Dam
