Technical Report REMR-CS-63  
September 1999

## **Repair and Rehabilitation of Dams: Case Studies**

*by James E. McDonald, Nancy F. Curtis*

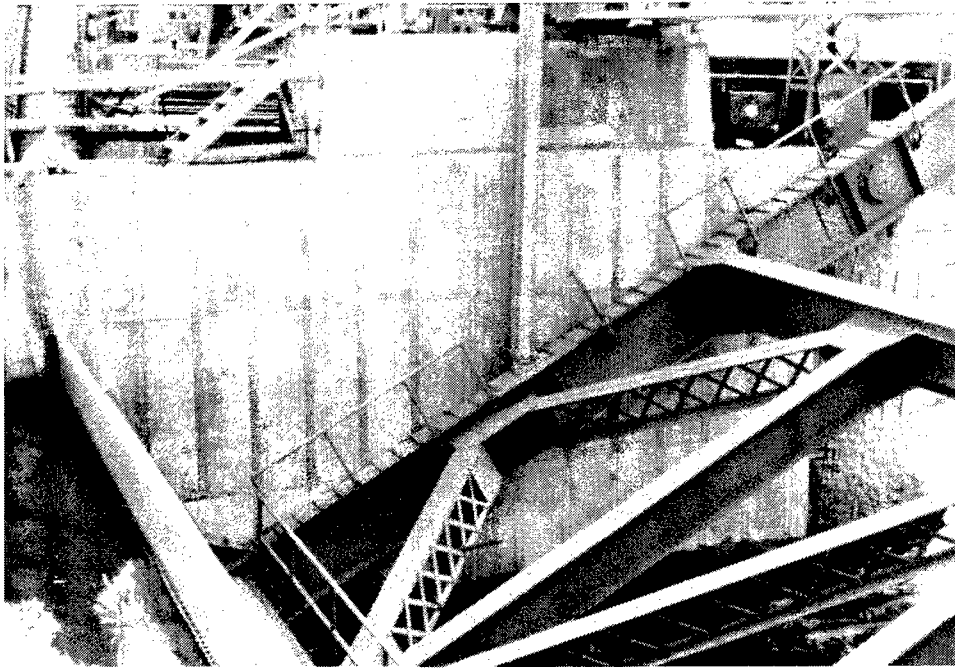
Figure 39. Tainter gate pier after rehabilitation, Starved Rock Dam

Concrete was removed to a depth of 152 mm (6 in.) for vertical and horizontal resurfacing. The replacement concrete was anchored to the piers with No. 6B steel bars on 0.6-m (2-ft) centers. Reinforcing consisted of welded wire fabric. A steel angle was embedded at the upstream bullnose of the piers. The contractor was concerned about being able to place the required 19-mm (3/4-in.) maximum concrete in the relatively narrow 152-mm (6-in.) section, which was congested with anchors, reinforcing, and other embedded items, so he requested permission to use a high range water reducer admixture (HRWRA) to increase workability of the concrete.

Ready-mix trucks carrying the concrete were transported by barge to the tainter gate section. A crane and bucket were used to place the concrete. A curing compound was used for curing the concrete. The rehabilitated tainter gate is shown in Figure 39.

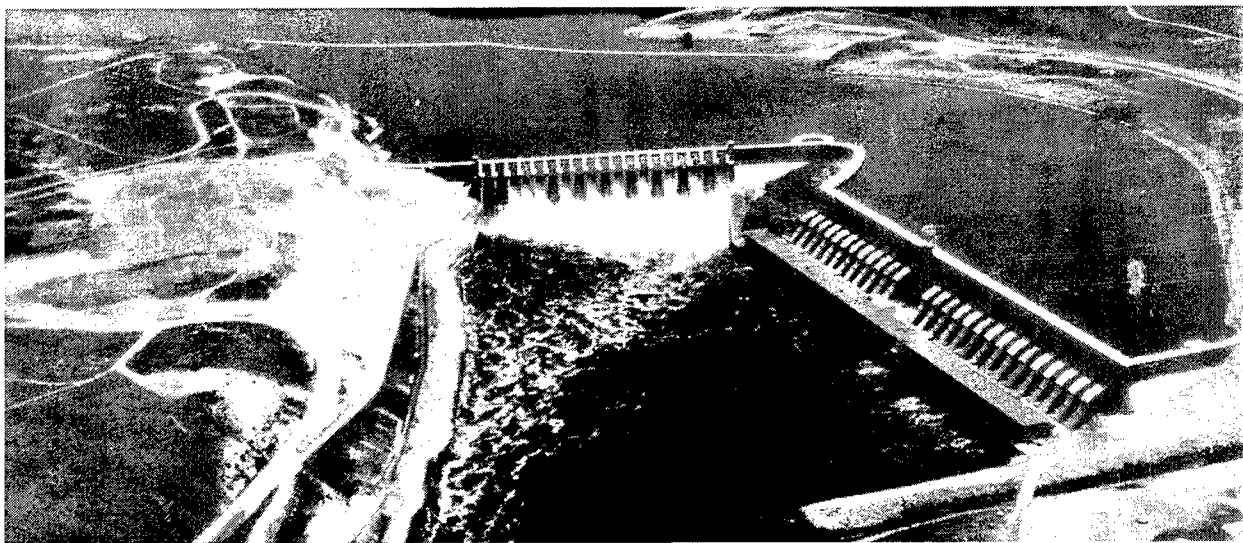
Chief Joseph Dam, which was built in the 1950s to provide hydropower, is located on the Columbia River in north-central Washington near Bridgeport; its pool extends 82 km (51 miles) to the tailrace of Grand Coulee Dam (Figure 41). The original dam stood 70 m (230 ft) above the riverbed. The spillway structure consisted of 19 tainter gates. The powerhouse was constructed for 27 generator units; however, when the dam was completed only 16 units were installed because they supplied all the power requirements at that time. However, rapid development in the Northwest significantly increased the demand for hydropower, so from the mid-1970's to 1981, the dam was modified to increase hydropower production.

Figure 41. Chief Joseph dam with completed 27-unit powerhouse and raised dam (from Sondergard 1991b)

Modifications included raising the height of the dam by 3 m (10 ft), and installing of 11 generating units in the powerhouse to bring the total to 27 as per the original plan. Raising the dam required increasing the height of the spillway piers from 18.3 to 21.3 m (60 to 70 ft) and their width from 2.7 to 4 m (9 to 13 ft). This work had to be done without interruption of power production or the flow of the Columbia River. To solve this problem, engineers decided to use floating cofferdams that would allow several spillway bays to be dewatered at one time without the reservoir having to be lowered.

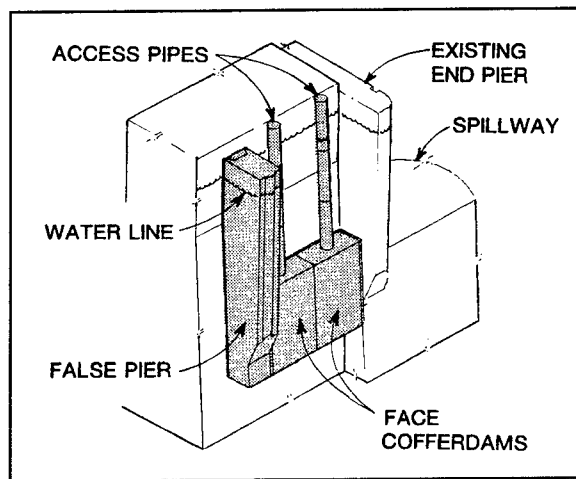
Before the floating cofferdams could be used, the contractors had to provide a way to lock them against the flat and recessed spillway abutment so they would overlap the first pier when they were first positioned. Two false piers were constructed for this purpose. They were floated to the site and lowered into place by hydraulic suspension units located on top of the dam. The false piers were permanently attached to the dam with anchors and tremie concrete. Mass concrete was used to fill the piers within 7.6 m (25 ft) of the top. The false piers were joined to a pair of boxes that made the spillway abutment and the piers even (Figure 42).

Figure 42. False pier with boxes that make spillway face and pier even, Chief Joseph Dam (from ENR 1978)

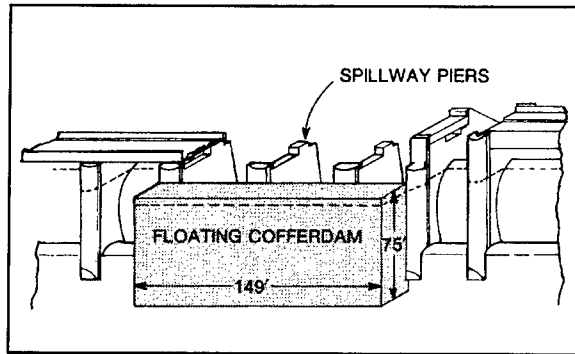
the sides and bottom of the cofferdam. When first placed, each cofferdam was locked on a false pier and the third pier down the spillway, closing two bays for work. Afterwards, each closed three bays, so two piers could be modified before the cofferdam must be moved. (Figure 43).

Figure 43. Floating cofferdam positioned for dewatering for pier modifications at Chief Joseph Dam (from ENR 1978)

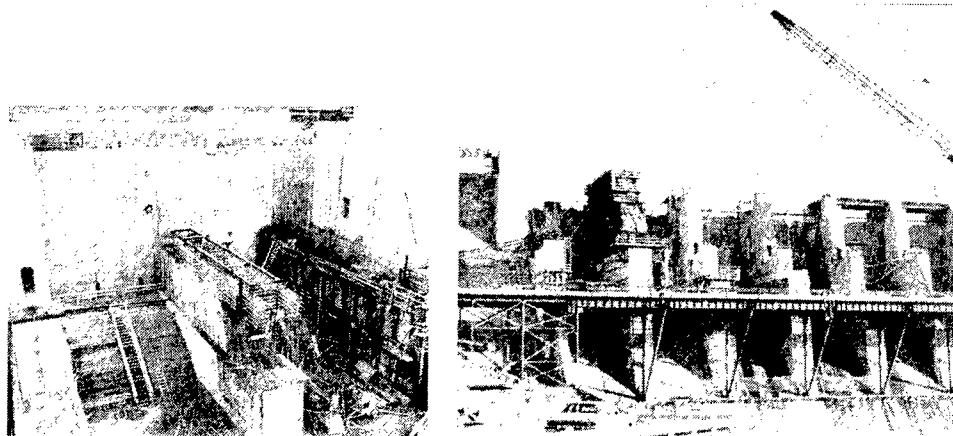
contractor developed a plan for concrete removal that included presplitting the pier noses with drills and then placing fractions of dynamite sticks in the holes and detonating them with blasting cord. With this method, a pier top could be removed in about 3 weeks. Installing dowels and rebuilding the piers took several months (Figure 44). When work on a pair of piers was completed, the crew placed stop logs in the bays and then moved the

Figure 44. Piers raised and widened to resist greater head at Chief Joseph Dam (from ENR 1978)

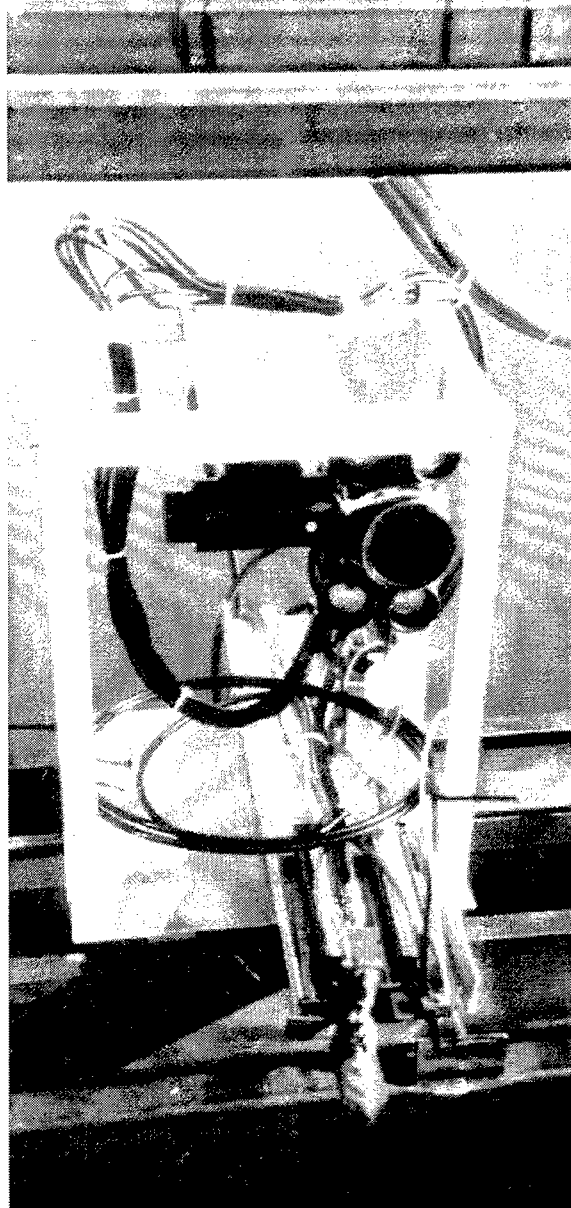
All repairs were performed underwater. A remote-controlled camera with a 360-deg pan, 360-deg tilt, and 8-power zoom was used to monitor the repair work. A pneumatic grout pump supplied grout to the application nozzle, and a pressure pot supplied dye to leak-detection equipment. The camera, cleaning equipment, dye injection hose, lights, and grout injection nozzle were mounted on an underwater frame supported by a crane. A pneumatic motor moved the cleaning-inspection-grouting equipment along the length of the frame, which was positioned over a lift joint (Figure 46). Controls for the camera, lights, and grouting equipment were on top of the spillway bridge. As each joint was sealed, the amount of leakage through drain outflows was measured and inspected visually. The leakage reduction in each instance was significant.

Figure 46. Frame-mounted remote-controlled camera and pneumatic equipment used for inspection and repair of monoliths at Chief Joseph Dam (from ENR 1978)

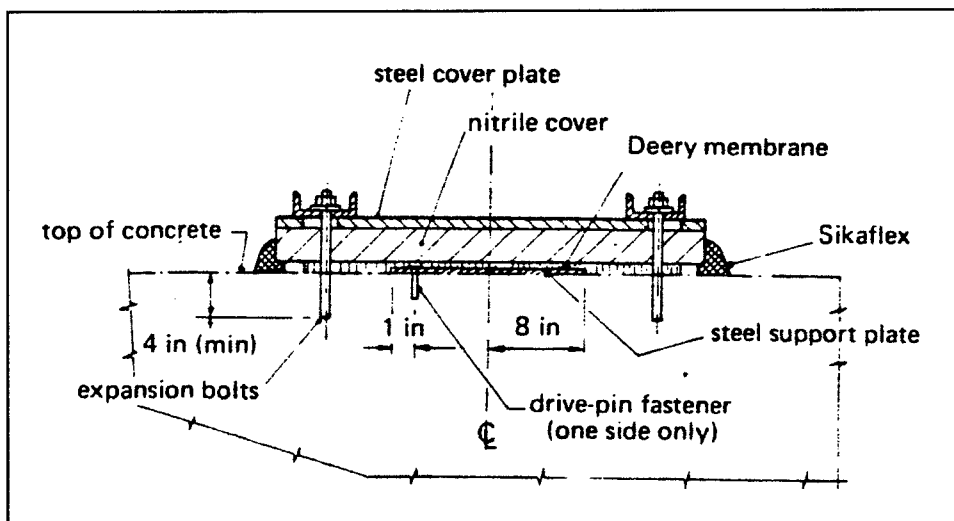
for anchor bolts and the bolts were installed and tightened with a torque wrench. A sealing compound was placed at the edges of the joint cover between the nitrile and the concrete face slab (Figure 48).

Figure 48. Details of joint covers used at New Exchequer Dam (from Brown and Kneitz 1987)

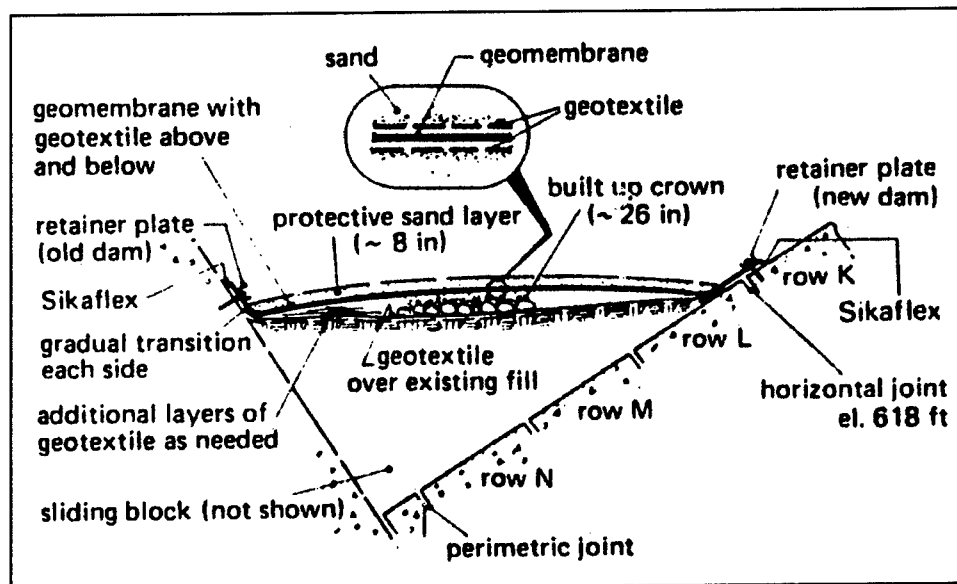
Although the toe fill was in good condition, with no sinkholes, the repairs planned for this area were completed (Figure 49). Two light bulldozers were used to remove extraneous material and grade the fill. Next, a layer of geotextile was placed over the fill, followed by imported material dumped from the crest of the old dam and spread by the dozers. This material was covered with a second layer of geotextile. A watertight geomembrane was placed over this layer of geotextile. The geomembrane had been precut and seamed in three large panels. An additional piece had to be added because of the difference between the expected and actual toe-fill geometry and to provide for adjustment of the membrane to the toe fill after the reservoir filled. A tented enclosure and heaters were used to maintain proper temperatures for making the field joints.

Figure 49. Details of installation of geomembrane over toe fill at New Exchequer Dam (from Brown and Kneitz 1987)

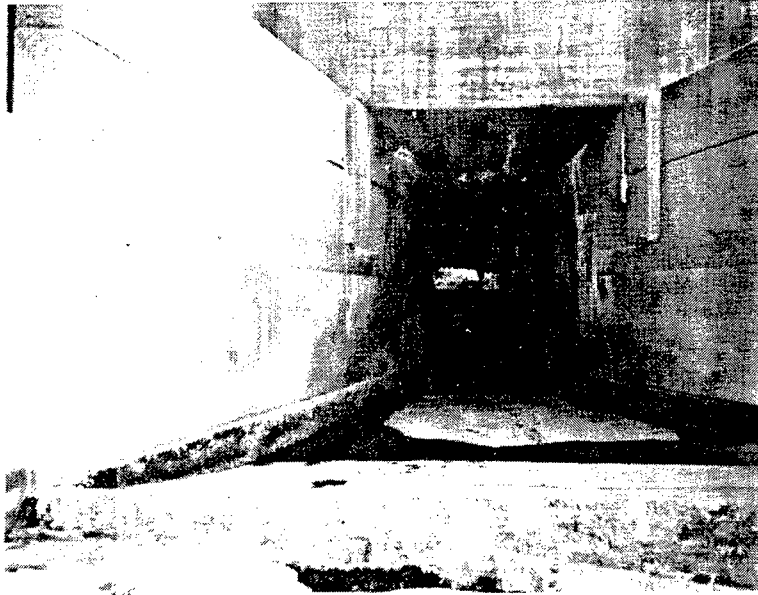
Figure 52. Outlet channel of flip bucket no. 4 with steel plates on the walls, Lucky Peak Dam (from U.S. Army Engineer District, Walla Walla 1983)

In 1974, a hydraulic study of the outlet was conducted. The study concluded that the major factors contributing to the erosion damage on the concrete aprons downstream of the modified flip buckets were the reduced flip angle of the affected flip buckets, the deterioration of the flip lip, normal air flow to the underside of the flow jet being blocked by the training walls, and high-velocity flows, in the range of 2.5 to 3.5 cu m/s (88 to 124 fps).

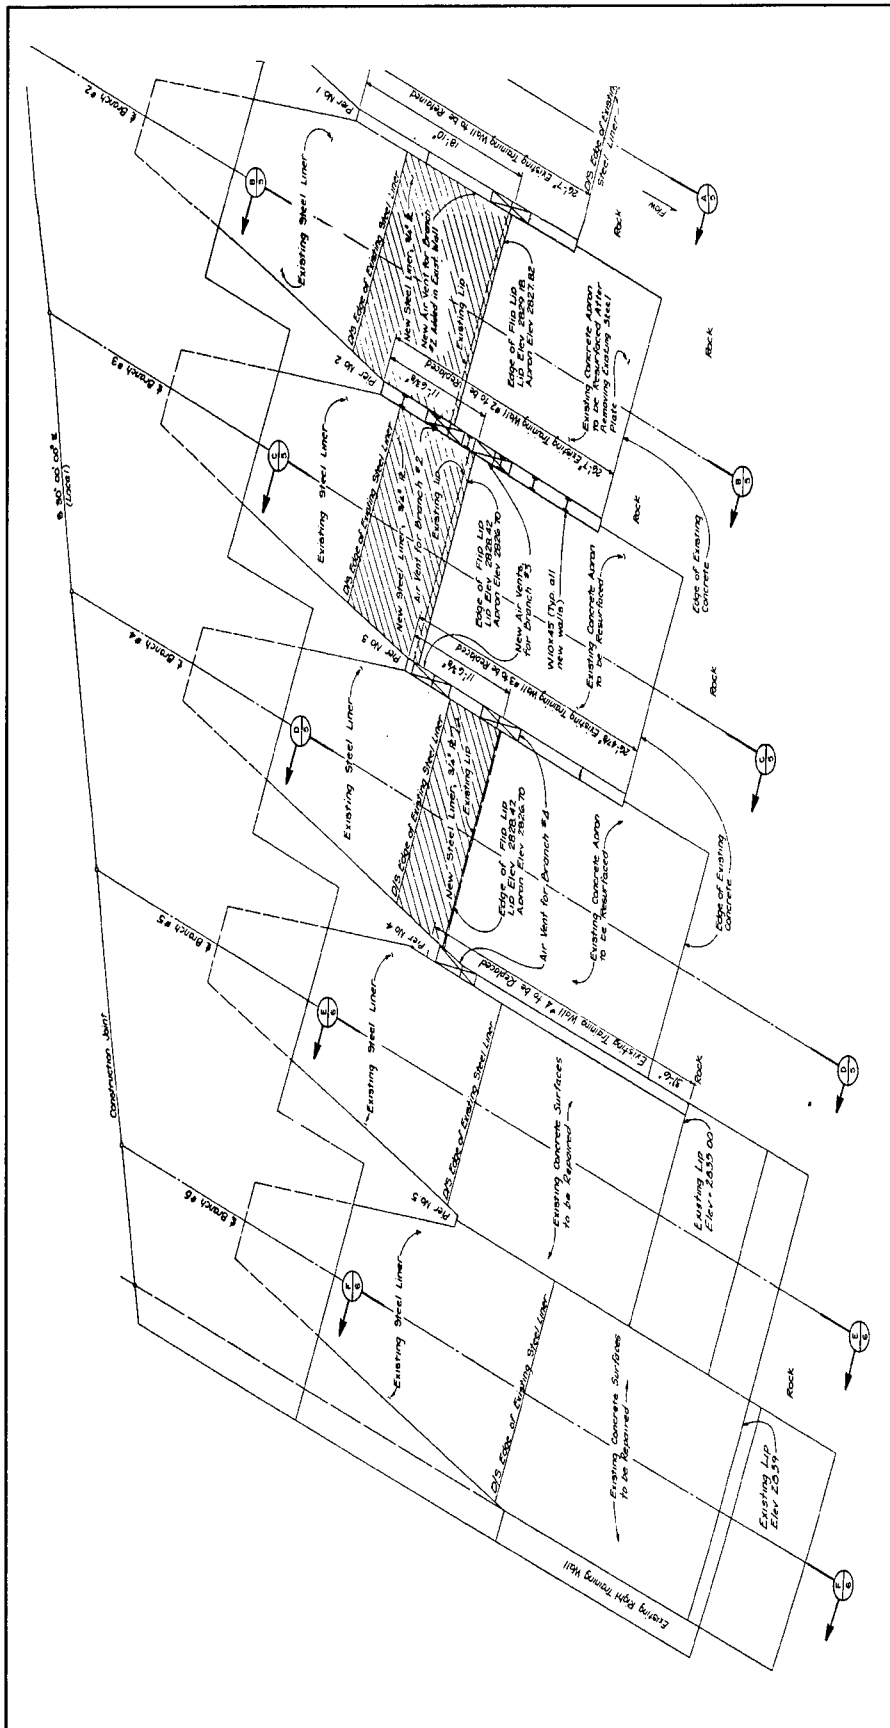
Figure 53. Plan for repairing outlet works, Lucky Peak Dam (from U.S. Army Engineer District, Walla Walla 1983)

invert plates. No further work was done because modifications to the powerhouse would nearly eliminate usage of the outlet. Following 1 year of greater-than-average usage of Bays 3 and 4, cavitation had worn through the protective steel plates on the side piers downstream of the gates and about 152.4 mm (6 in.) into the concrete; the invert plates, however, showed no signs of cavitation. - Since the completion of the powerhouse, the use of these gates has almost been discontinued.

In 1972, cavitation damage in the flip bucket channel floors were repaired with fibrous concrete. In 1984, a contract was let for repair of the outlet work. The alternative selected for these repairs was to: (a) fully cover the floors of each flip with 19-mm (3/4-in.) steel plate, including the vertical faces at the edge of the flip lip; (b) to restructure Channels 2, 3, and 4 with provisions for air vents in the training walls to supply air to the channel floors just downstream of the flip lips (wall heights in the area of the air vents would be raised by 1.5m (5 ft) to raise the air intakes above the level of the waterflow and prevent suction of water into the air vents); (c) fully line Channels 2, 3, and 4 with steel (Figure 53); (d) patch and repair the existing concrete surfaces of Channels 5 and 6; (e) cut back and resurface the concrete aprons of Channels 3 and 4 to provide a 10 percent downstream slope from the edge of the flip lip; (f) replace the severely damaged training walls 2, 3, and 4 with new 19-mm (3/4-in.) steel welded to W10 × 45 columns and filled with concrete; and (g) establish a mandatory operation schedule for flip buckets 5 and 6 to minimize road hazard, making sure the gate would be operational in an emergency.

In addition, the piers and invert were strengthened with 32-mm- (1-1/4-in-) thick steel plates, stiffened at 1.5-m (5 ft) intervals with steel rods. Concrete was placed between the pier plates and mortar backfill was pumped behind the

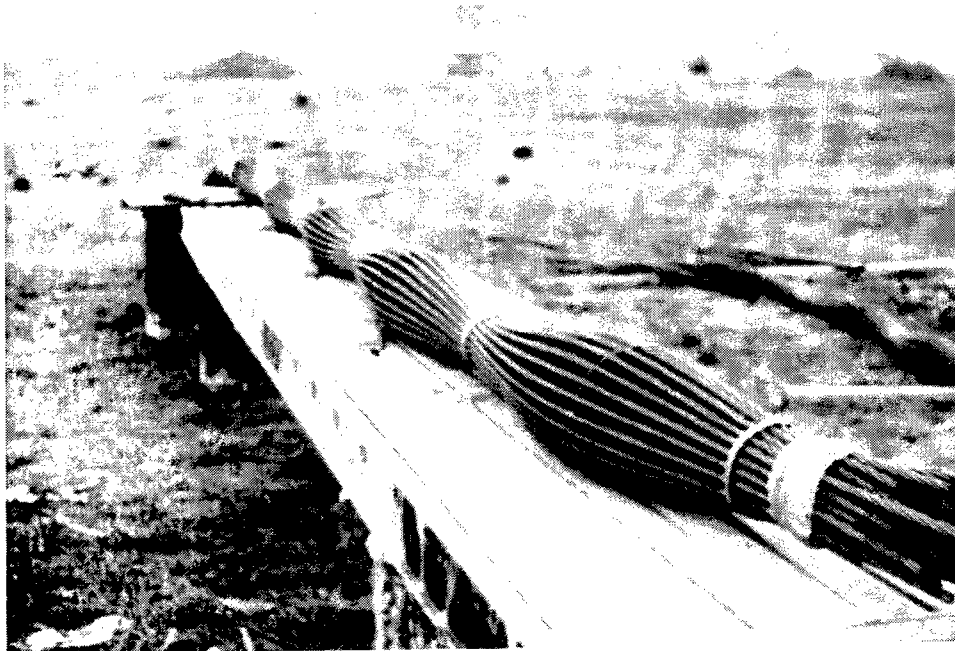
Another contract alteration allowed the contractor to use a 52-strand anchor with a minimum of 1,900 MPa (275 ksi) per strand instead of the designed 53-strand anchor with 1,700 MPa (250 ksi). The strands were cut and bound together (Figure 55) to form an anchor. A helicopter was used to install the anchors; each anchor unit weighed approximately 1,540 kg (3,400 lb). The operation was completed in 5 hr on 6 September 1977. The next 3 days were used to grout the anchors in place. The grout contained 19 ℓ (5 gal) of water per bag of cement and 1-percent Intraplast-N. Fifty one-millimeter- (2-in.-) cube specimens were taken and tested at both 7 and 21 days; they passed the contract specification of 27.6 MPa (4,000 psi) with compressive strengths of 29.1 and 42.7 MPa (4,220 and 6,200 psi), respectively.

Figure 55. Anchor strands, cut and bound, for Alum Creek Dam (from Barnes 1982a)

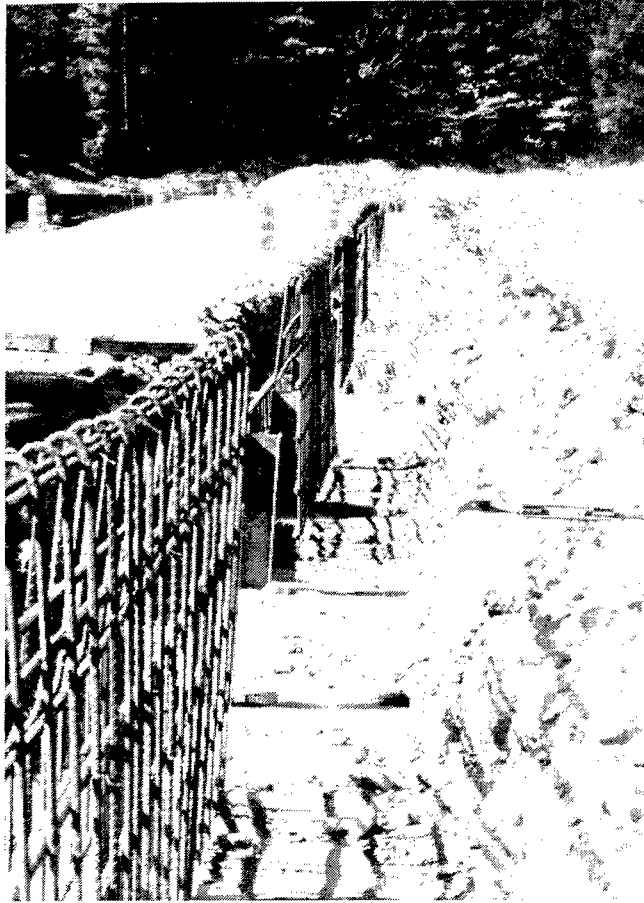
The procedure for raising the crest of the dam was to place a layer of random fill on the upstream face of the embankment and then cover it with a layer of random rock fill. The original upstream slope varied from 2 to 3:1. The rock fill and random rock blanket provide a 4:1 stability berm to el 840 where a 15.5-m- (50-ft-) wide bench was constructed. The 4:1 slope continues above the bench to el 891 where it transitions to 2.5:1 and continues from there to the crest. Because space near the intake structure was limited, it was not possible to maintain the 4:1 stability berm cross section. In this area, select fill was placed on a 2:1 slope to el 900 before transitioning to a 2.5:1 slope from that point onward to the crest. The crest of the dam was covered with impervious fill. After the embankment was raised, a 0.9-m- (3-ft-) high concrete parapet wall was installed to provide the minimum required freeboard (Figure 56).

Figure 56. Construction of a parapet wall on the upstream crest of Mohawk Dam (from U.S. Army Engineer District, Huntington 1990b)

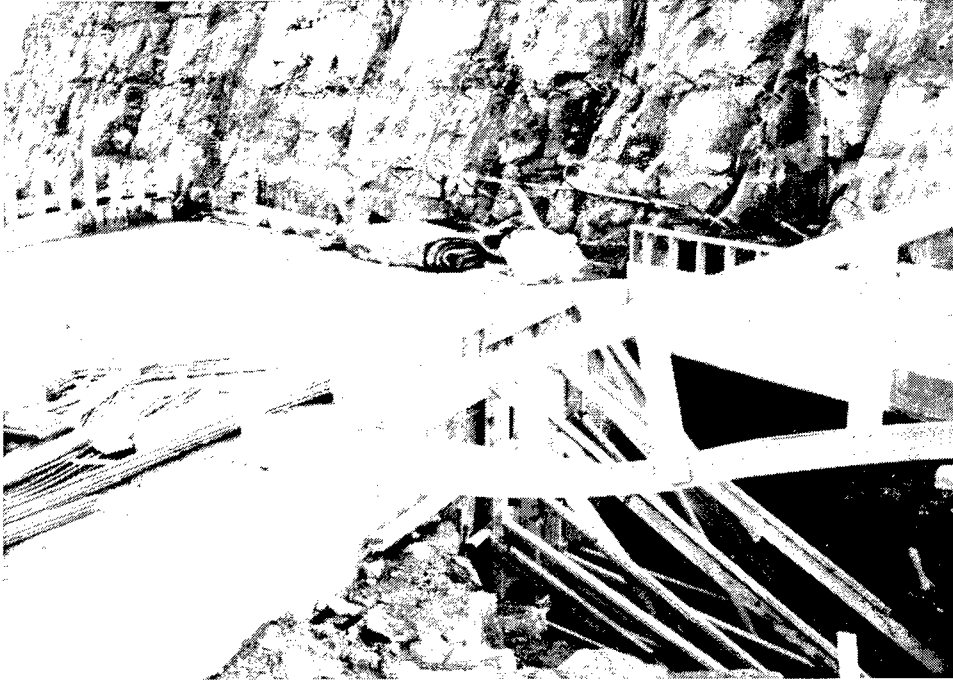
The spillway was widened from 195 to 200 m (640 to 657 ft) to improve entrance conditions and to provide a suitable foundation for the newly added spillway approach sidewalls. A monolith was added to each end of the curved concrete weir that protects the spillway crest in the event of spillway flow (Figure 57). Concrete hang-on walls for the spillway approach were constructed at the contacts between the weir and the excavated spillway sidewalls. A one-row grout curtain, 9 m (30 ft) deep, 3-m (10-ft) centers was also placed along the line of the concrete weir. Additionally, the concrete hang-on walls and the existing weir monoliths were anchored into the rock. No. 8 reinforcing bars were grouted into drill holes spaced on 3-m (10-ft) centers (Figure 58). The anchors were then posttensioned to 149 kN (33.5 kips).

Figure 57. Forming for construction of additional monolith on the right side of the spillway, Mohawk Dam (from U.S. Army Engineer District, Huntington 1990b)

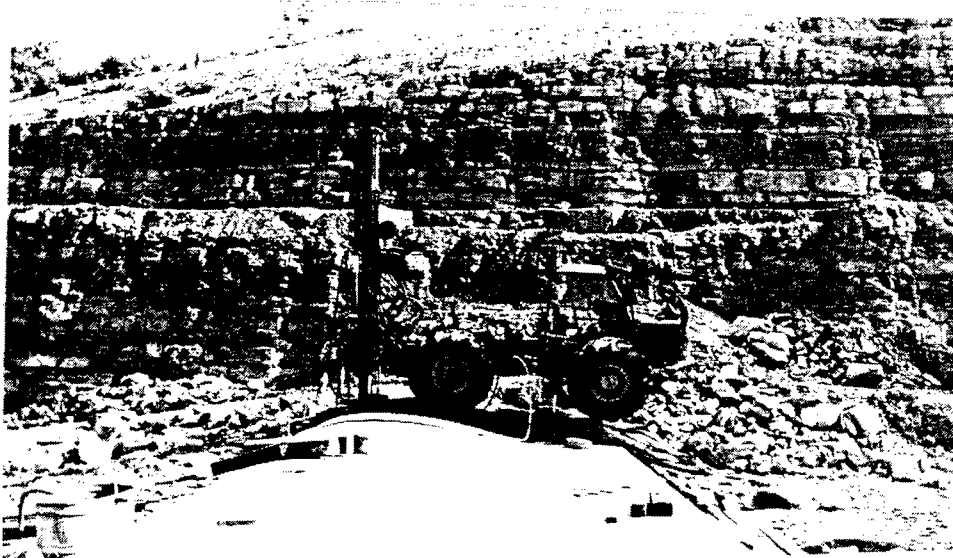
Figure 58. Holes drilled for installation of posttensioning anchors on spillway crest, Mohawk Dam (from U.S. Army Engineer District, Huntington 1990b)

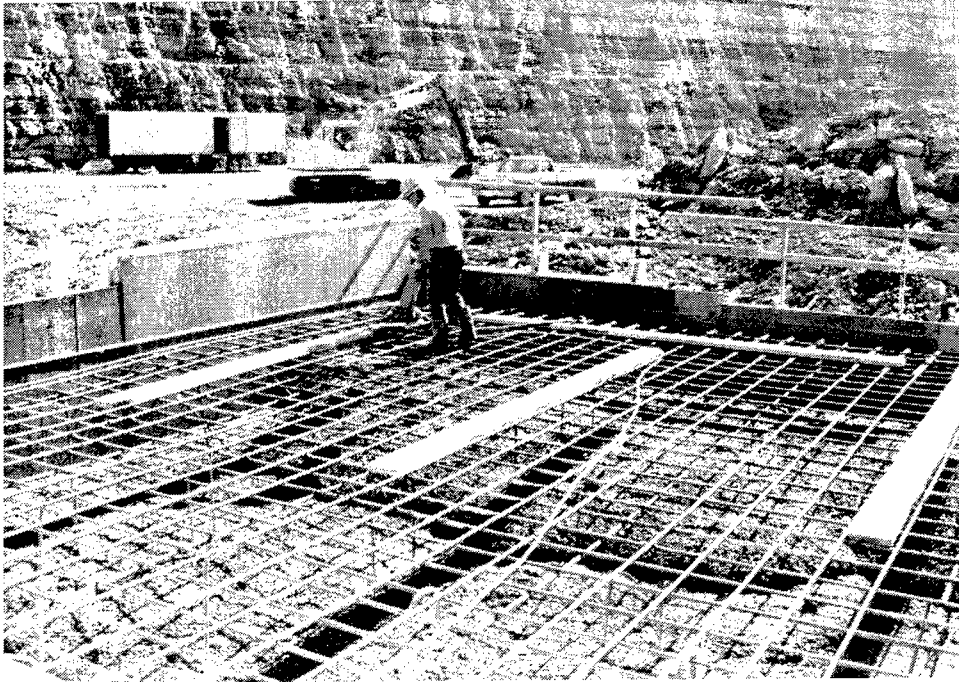
Figure 59. Forming and reinforcing for the top lift of concrete for the apron, Mowhak Dam (from U.S. Army Engineer District, Huntington 1990b)

An apron keyed into the rock was added to the existing weir cross section. Reinforcing bars anchored into the existing weir were used to secure the apron. Only the top lift of concrete for the apron was reinforced (Figure 59). The surfaces was screeded smooth (Figure 60).

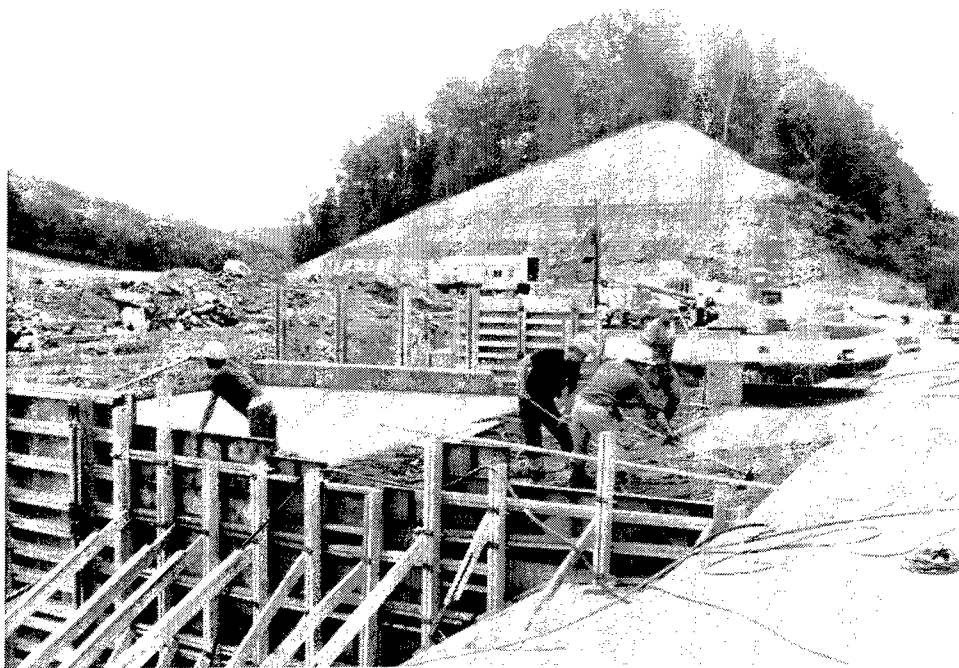
Figure 60. Placing and finishing concrete for the top of the spillway apron, Mohawk Dam (from U.S. Army Engineer District, Huntington 1990b)

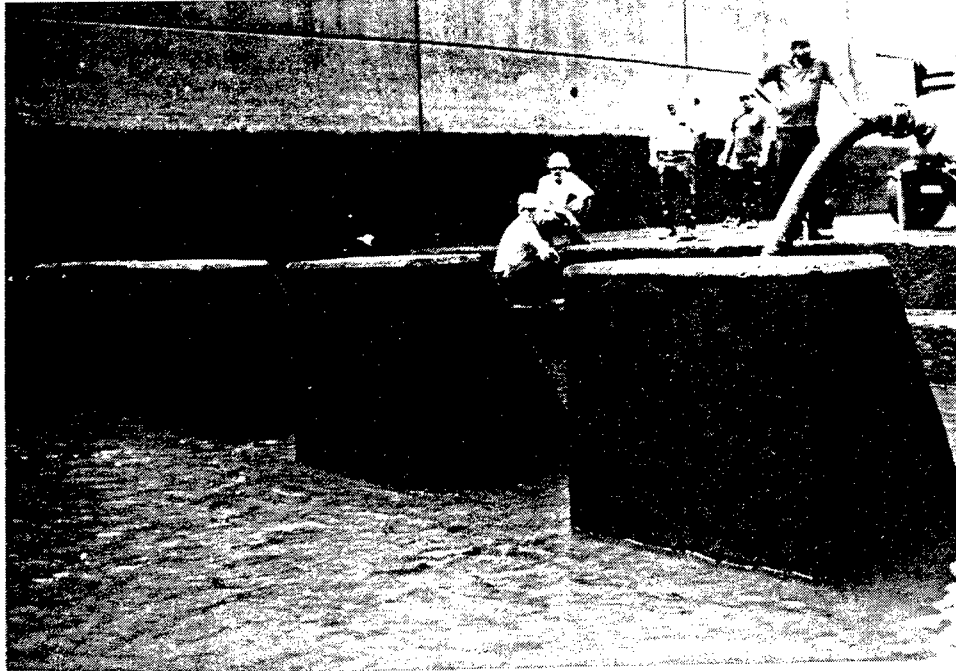
The stilling basin was dewatered in May 1977 during the final inspection of the outlet works. At that time, some damage to the baffles had occurred. During this inspection, erosional damage to both sides of the outlet channel was noted. No action was taken. The basin was again dewatered in 1980. Inspectors found no stones in the basin, but the damage to the baffles had worsened, and they noted an area of erosion downstream of the stilling basin. A study to determine the cause of the erosion and lack of stilling action in the basin was conducted. The conclusion was that the basin had been inadequately designed. To correct the design flaw, a concrete dam was constructed in the outlet channel to increase stilling action by raising the tailwater. The stilling baffles were rebuilt, and an anchored concrete slab was placed in the scour hole. A new 7.3-m- (24-ft-) wide bridge with walkway and parapet was placed on top of the new dam. The left side of the outlet channel was repaired with a semi-gravity, concrete hang-on wall, and stones were placed on both sides of the outlet channel to protect the slopes from erosion. Construction was completed in 1983. Dewatering and inspection in July 1993 revealed the general condition of the stilling basin to be very good. No chipping, spalling, or other damage was noted (Figure 61).

Figure 61. Upstream face and baffles in dewatered stilling basin, R. B. Bailey Dam (from U.S. Army Engineer District, Huntington 1993)

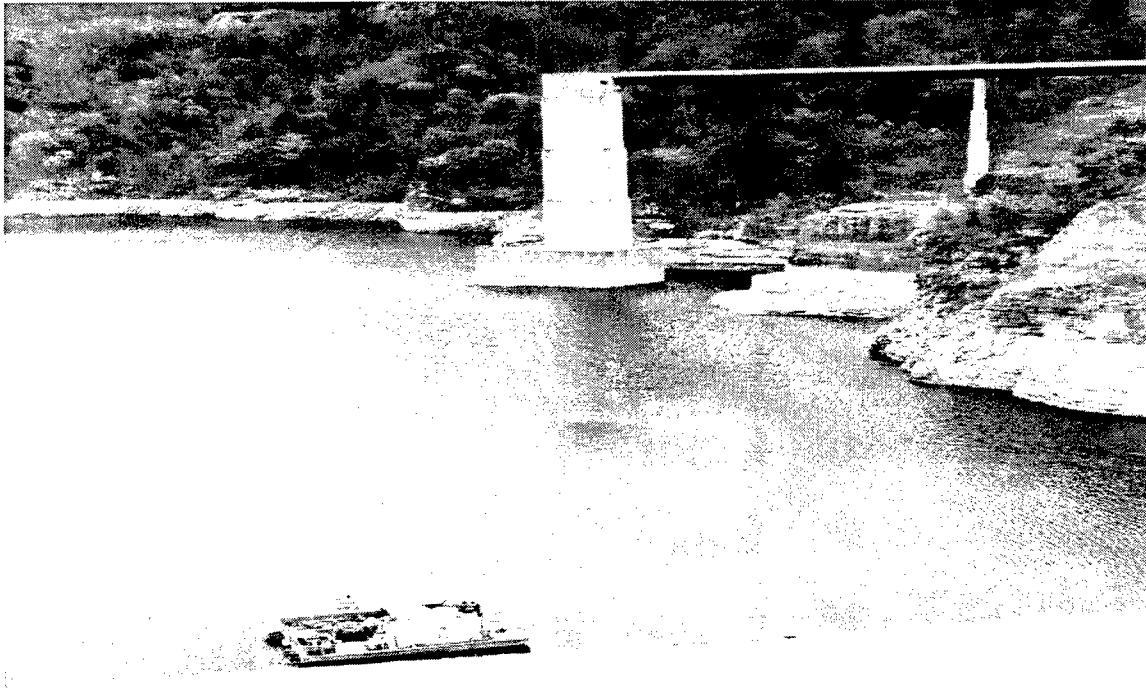
Moisture has been a problem in the intake structure since the dam became operable. During the first inspection in 1979, a number of cracks in the intake structure were noted in the walls and service platform. These cracks were not considered structurally harmful, but most did exhibit leakage when the pool was raised. Excess water (due to leakage) and high humidity levels caused problems with electrical equipment and created a safety hazard to those working with and around the equipment. Also, the excess moisture caused the paint on equipment to peel. In November 1984, a gutter was installed to channel seepage and condensation from the walls to the floor drain on the premise that if the gutter had solved or improved the problem, sealing the cracks would not have been necessary.

Figure 62. Intake structure and access bridge, R. D. Bailey Dam

the lower portion of the intake structure as a test of the repair method; if that repair was successful, the other cracks would be similarly repaired. The crack was sealed with an epoxy grout heated to approximately 38 °C (100 °F) and injected under pressure to about 0.7 MPa (100 psi). The work, completed in March 1987, was only partially successful. The relative coldness of the concrete, coupled with the narrow crack width and long crack path apparently caused the sealing to be incomplete.

In 1989, a plan to cover the outside of the intake structure (Figure 62) with an adhesive-mounted rubber membrane similar to roofing-type materials was considered. However, because of concern for loss of fish and other aquatic life and the impact upon recreational activities resulting from the proposed drawdown, a decision was made to make another attempt at sealing the cracks, this time from the inside.

In January 1990, plans and specifications for sealing the cracks from inside the intake structure were completed, and work was scheduled to begin in the spring of 1990. However, the specified materials were determined to be hazardous because of their low flashpoint. A recommendation was made that safer materials be used. Specifications were rewritten to use a polyurethane grout with a high flashpoint. The cracks were injected in 1991 with a single-component, moisture-reactive urethane liquid, which, upon curing, expands and forms a water-impermeable, elastomeric-polyurethane foam. The cracks injected ran vertically in a wall 4 m (3 ft) thick and then continued horizontally in a floor slab 2.4 m (8 ft) thick. The maximum external hydrostatic head on any crack

during sealing was 34 m (12 ft). The injection was done by contract. Although the sealing appeared to be successful at first, the 1993 inspection revealed continued problems with the elevator, other electrical items, and metal components caused by leakage through cracks and condensation. A decision to try to solve the moisture problem by dehumidification was made, and a request for bids for providing and installing a complete dehumidifier system was issued in November 1993. This decision was based on the success of this method at other district project intake structures with similar moisture problems.

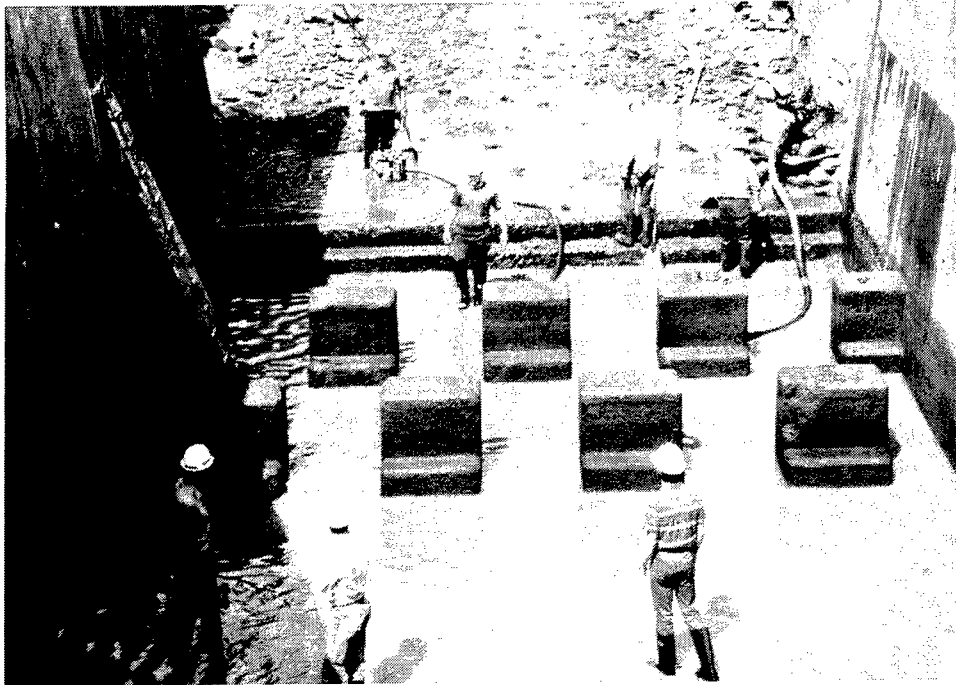
The stilling basin was dewatered for the Fifth Periodic Inspection (Figure 66). All components were in satisfactory condition. A depression from 25 to 51 mm (1 to 2 in.) was found in the center of the basin floor, but no remedial action was planned. Monolith joints in the training walls had slight damage, spalling, and popouts (Figure 67) but none that required repairing.

Figure 66. Stilling basin dewatered for fifth periodic inspection, Tom Jenkins Dam (from U.S. Army Engineer District, Huntington 1990c)

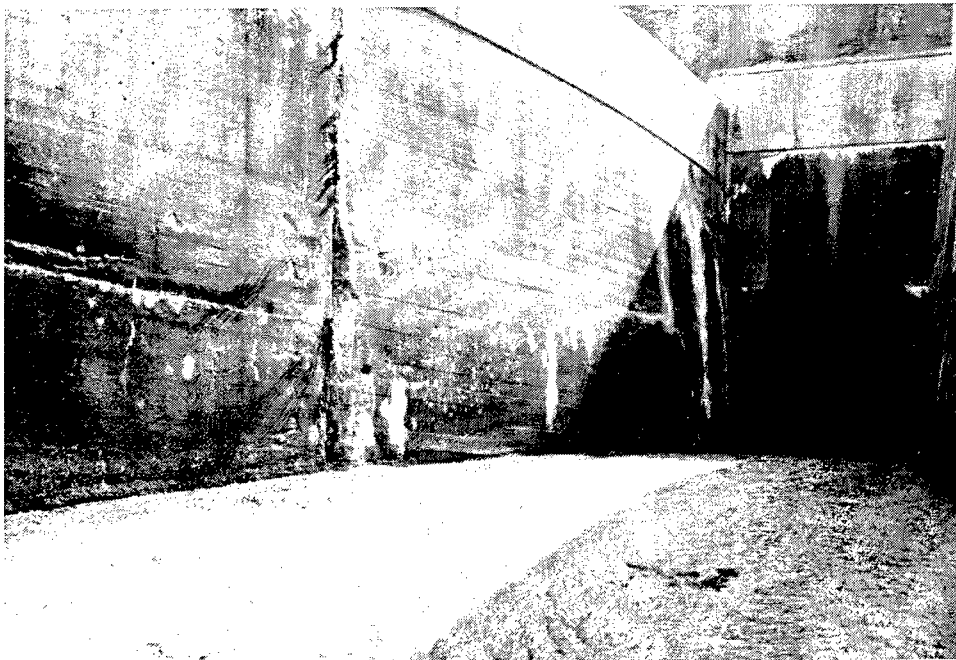
Figure 67. Spalled area in monolith joint on right basin wall, Tom Jenkins Dam (from U.S. Army Engineer District, Huntington 1990c)

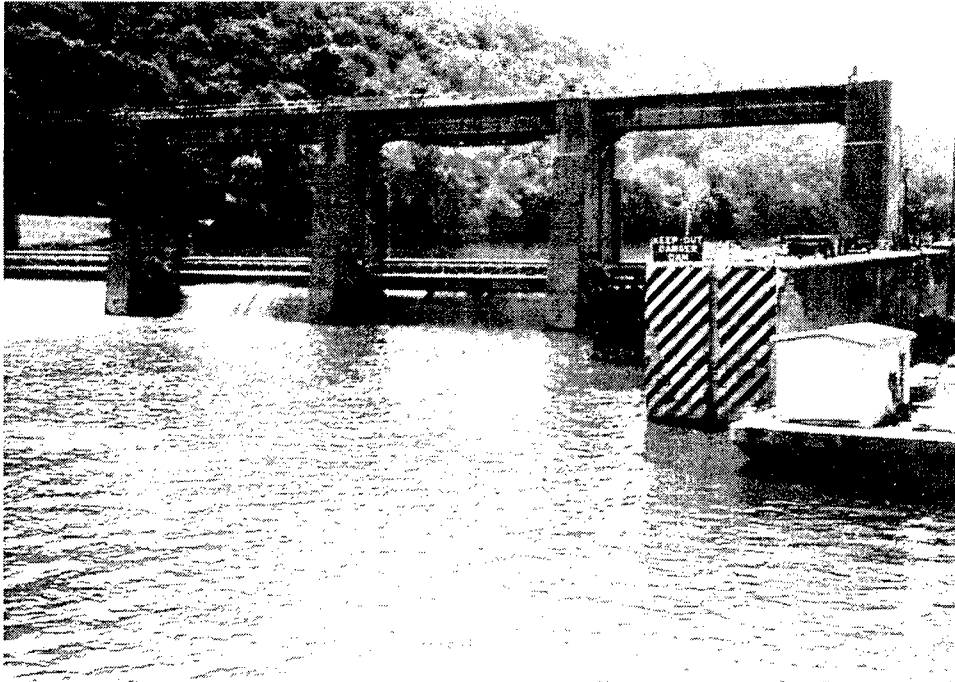
The Seventh Periodic Inspection (USAED, Pittsburgh 1994) found that the condition of the dam and appurtenances was good (Figure 72). Fine, random cracks in refaced areas below the upstream bridge bearings on Piers 5 and 7 have developed; these will be visually monitored by staff and will be sealed as time and funding are available. Corrosion on the top flange of the upstream bridge girder has caused cracking and spalling in the overlying concrete deck slab. The recommendation for these areas is to clean and reseal the expansion joints to eliminate leakage that is causing the corrosion.

Figure 72. Downstream face of Point Marion Dam; end of old land wall is at right (from U.S. Army Engineer District, Pittsburgh 1994)

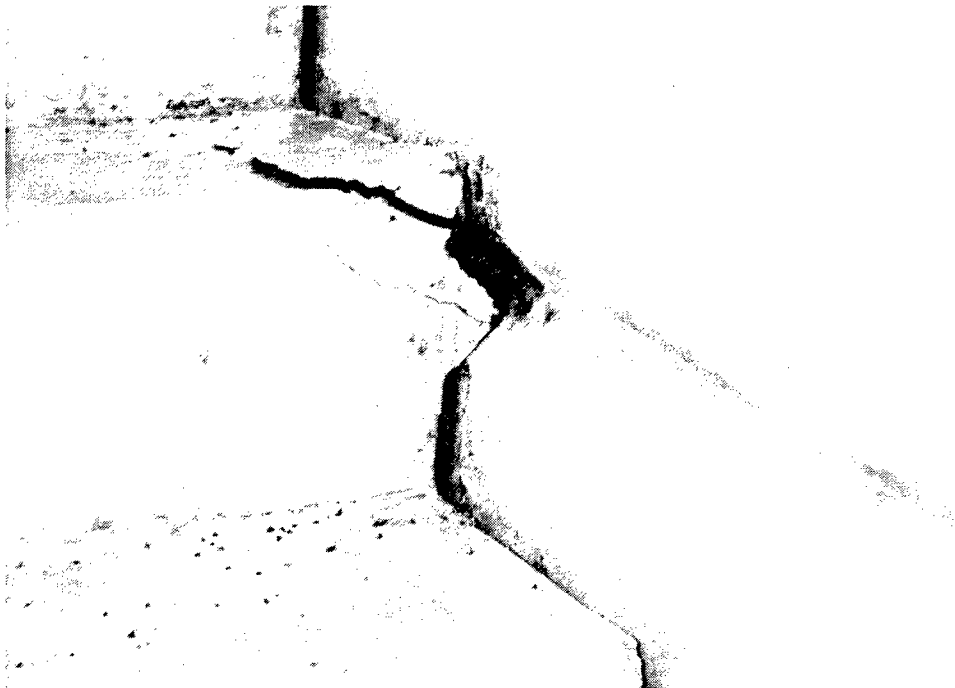
The access stairways for both water quality towers had separated from the face of the dam (Figure 76). Water quality tower No. 1 also had a crack about midway underneath the stairs. Water quality tower No. 2 had a spalled area approximately 13 mm (1/2 in.) deep on the bottom platform of the stairs (Figure 77). Minor deterioration was also noted around monolith joint drains.

Figure 76. Access stairway for tower no. 1 separated from dam face at Stonewall Jackson Dam (from U.S. Army Engineer District, Pittsburgh 1989b)

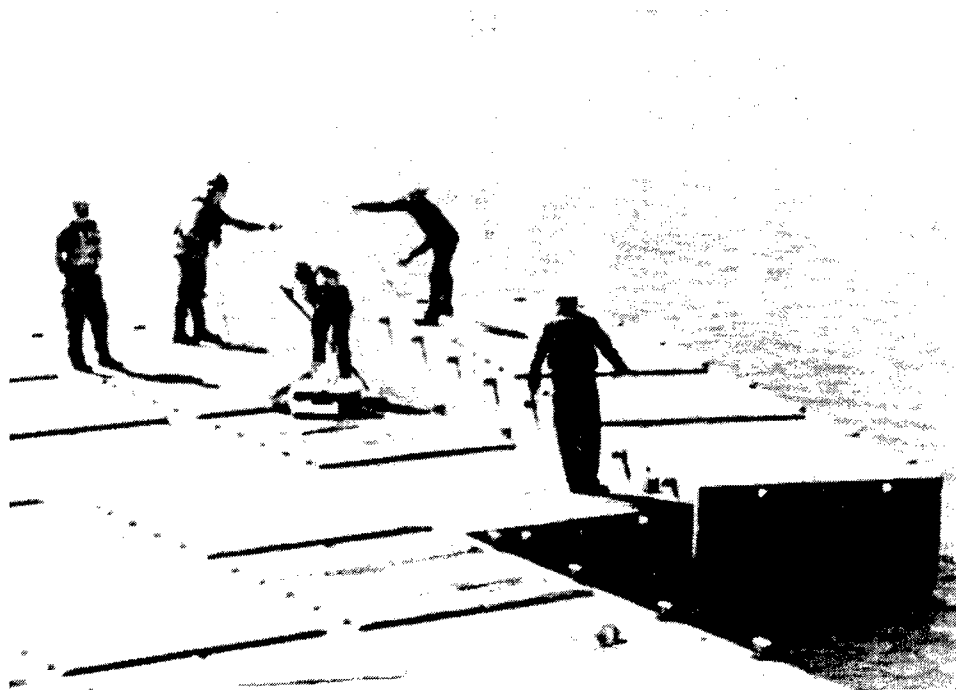
In March of 1991, the hydraulically operated service gates of Abiquiu Dam were inspected and repaired. To perform the repairs, workers had to retrieve two steel bulkhead gates from their underwater stored position and place them so that

they would seal the intake control structure of the dam. Because of shoreline and intake geometry, a crane operating from land could not be used to maneuver the 9,979-kN (11,000-lb) gates. Instead, a waterborne crane mounted on a Flexifloat barge and a team of divers were contracted from Oceaneering International, Inc., for the project. The 16- by 13.7 by 1.2-m (52.5- by 45- by 3.8-ft) "L"-shaped operations barge was assembled with seven 9.1 by 2.2 by 1.2-m (30- by 7.5-ft by 3.8-ft) Quadra-floats, four 4.6 by 2.3 by 1.2-m (15- by 7.5- by 3.8-ft) Duo-floats, and two 4.6 by 2.3-m (15- by 7.5-ft) loading ramps (Figure 82). The barge was powered to the work site by three Army MK-1 jet boats and anchored on location with cables and buoys.

Figure 82. Flexifloat barge assembly, Abiquiu Dam (from Oceaneering International, Inc. 1991)

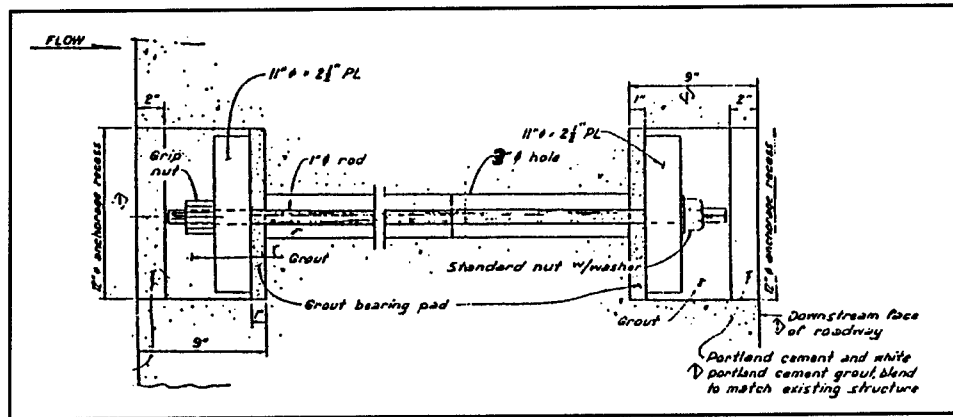
Figure 86. Steel rods used to reinforce cantilever portion of Norfolk Dam (multiply inches by 25.4 to obtain millimetres)

In 1982, the concrete in the roadway on top of the nonoverflow monoliths was reinforced by retrofitting and posttensioning 25-mm- (1-in.-) diam steel rods on 1.8-m (6-ft) centers, transverse to the roadway cracks, in each of 38 monoliths (Figure 86). After installation of stress rods, 76-mm (3-in.) holes were drilled through the top of the dam monoliths and then grouted. The cantilevered portion of the dam roadway was reinforced with special strength 581-mm (2-in.) reinforcing bars. A 152-mm (6-in.) hole was drilled through the 12.2-m (40-ft) roadway of the dam; the reinforcing bar with a threaded end was inserted through the hole and tensioned with 550 MPa (80,000 psi). Nuts on the end of the reinforcing bar were tightened down on steel washers. The hole was grouted with high-strength grout, and the cavity for the nut and washer on each end of the reinforcing bar was concreted over. These reinforcing bars were placed every 6 m (20 ft). In 1983, the roadway cracks were sealed with a nonflexible epoxy. Cost of the repair was \$525,600.

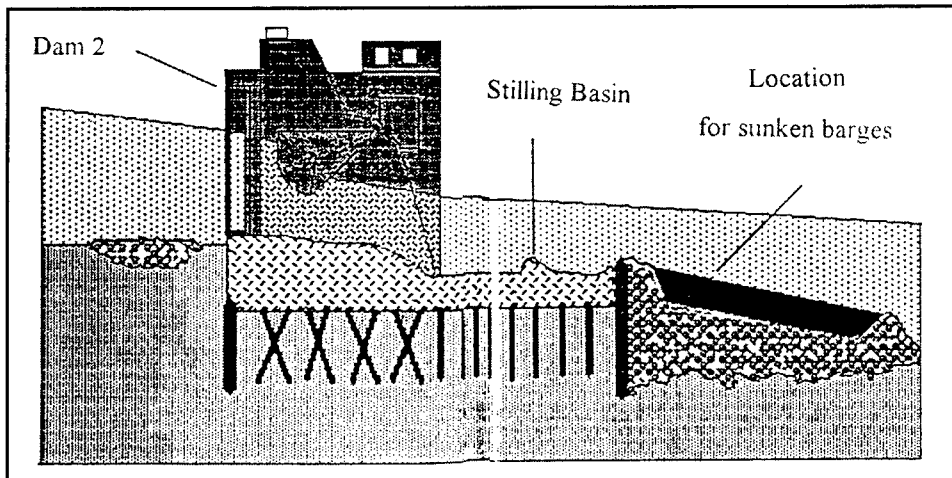
The Arkansas River flows into the Mississippi River. Flooding along the Arkansas River in December 1982, when the Mississippi River was low, created a situation of high water velocities in the Arkansas River and through the dam. The turbulent water caused 34 barges to break loose from a fleeting area 8 miles upstream of the dam. These loose barges caused the runaway of three others 8 km (5 miles) upstream of the dam. Fourteen of the barges struck the dam and sank wholly or partially and were wedged against the spillway gates; two passed through the open gate bays of the dam; the remaining twenty-one sank or grounded farther upstream (ASCE 1988).

Figure 87. Repair stilling basin at Wilbur D. Mills Dam (from *Construction News* 1992)

In October 1990, work began on a permanent repair to the scour problem downstream of the dam. This repair involved the use of a novel concept (sunken barges filled with riprap) to extend the stilling basin 64 m (210 ft) downstream (Figure 87) (*Construction News* 1992).

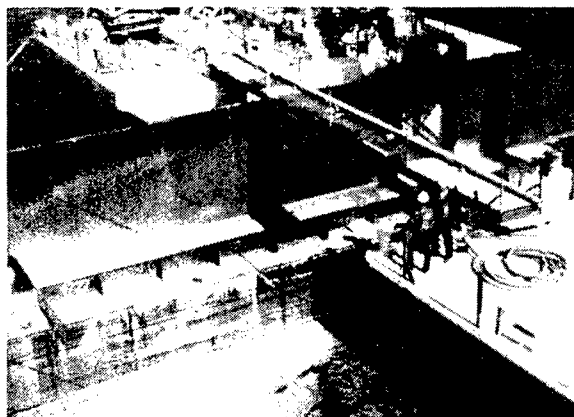
Figure 88. Lay barge with hopper barge positioned for sinking at Wilbur D. Mills Dam (from Spaul and Virden 1992)

Once the riverbed was ready, the lay barge was constructed (Figure 88). Two rake barges were connected with two huge plate girders to form a giant catamaran. Cross-bracing and walkways between the barges were added. The space between the "pontoons" was 13 m (43 ft) wide, to allow positioning of the hopper barge for sinking. The flotation chambers of the hopper barge were filled with 650 cu m (850 cy yd) of concrete for a total weight of 1,451 Mg (1,600 tons). A tow boat then pushed the lay barge
