Technical Report REMR-CS-63  
September 1999

## **Repair and Rehabilitation of Dams: Case Studies**

*by James E. McDonald, Nancy F. Curtis*

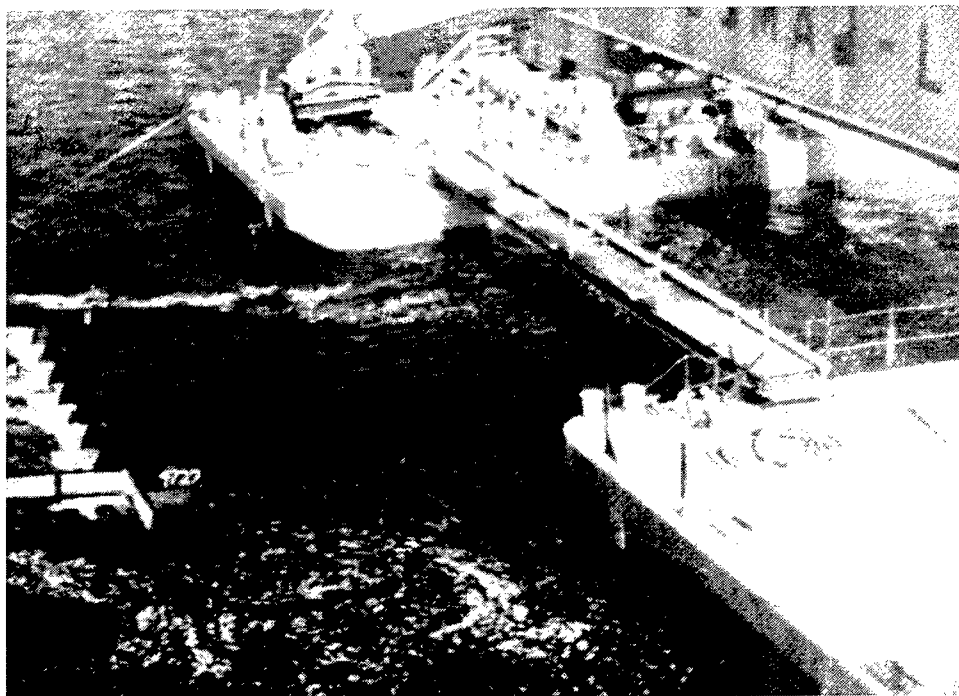
Figure 89. Lay barge with a flooded hopper barge being lowered to the river bed at Wilbur D. Mills Dam (from Spaul and Virden 1992)

into position below the dam. Anchor lines were moored to piles downstream of the dam and to the stern and bow of the lay barge. These lines were used to adjust the position of the hopper barge. When it was in the correct position, the hopper barge was sunk to the river bottom; the back of the barge was lowered so water could flood the cargo hole (Figure 89). The barge was then lowered to the bottom by four winches with 32-mm (1-1/4-in.) cables.

After each hopper barge was sunk, its cargo hold was filled with rock, and an underwater concrete mixture was used to fill the voids in the rock-filled barge. This same concrete mixture was used to fill the spaces between the existing stilling basin upstream and the sunken barges.

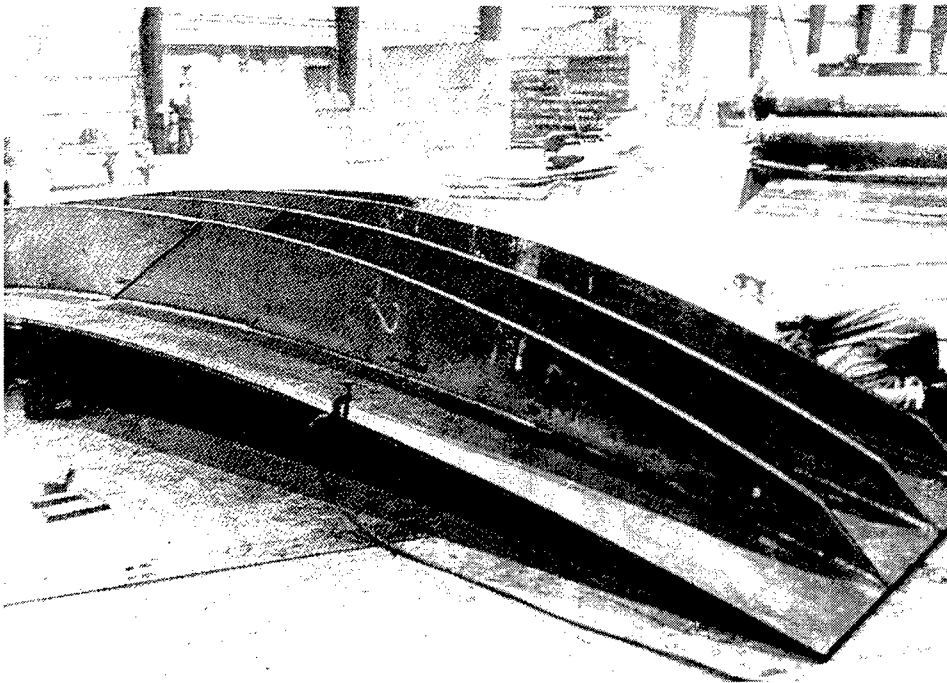
Figure 91. Fabrication of Obermeyer Pneumatic Spillway Gates for installation  
at Friant Dam (from *Hydro Power and Dam* 1997)

The Obermeyer Pneumatic Spillway Gate System planned for installation at Friant Dam was being designed to match the curvature of the existing lowered drum gates (Figure 91). The project was scheduled to be completed in February 1998.

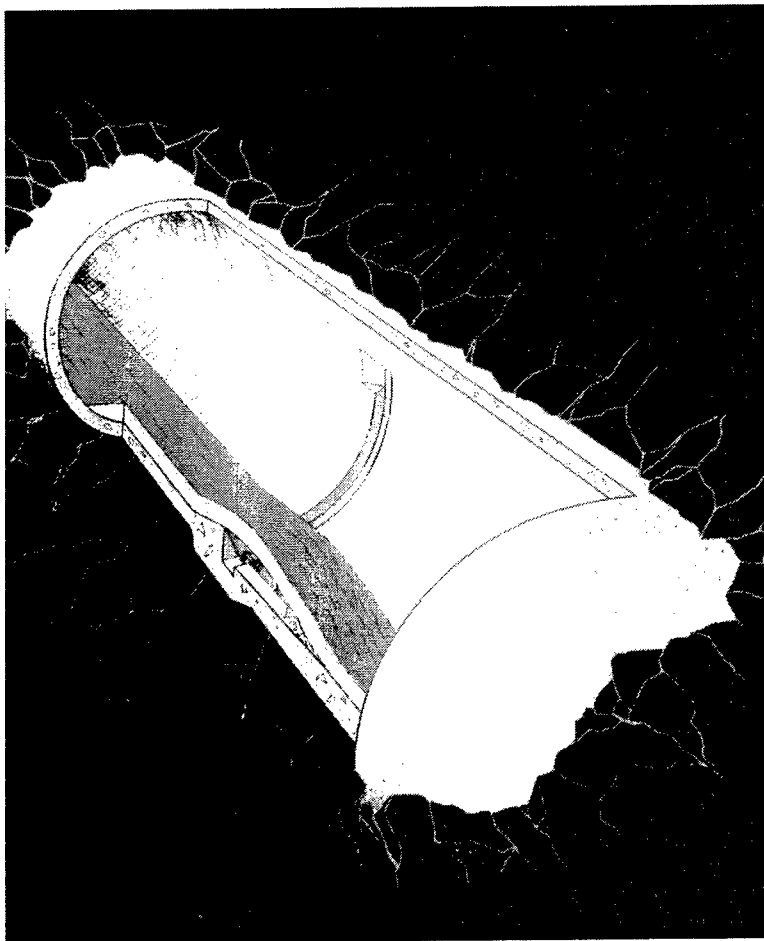
Figure 95. Aeration slot, Glen Canyon Dam (from Burgi and Eckley 1987)

The aeration-slot design for Glen Canyon Dam consists of a short length of ramp that lifts the flowing water over the air supply slot to prevent the slot from filling with water (Figure 95). The slot, which is 1.2 by 1.2 m (4 by 4 ft) in cross section, extends around the lower three-quarters of the tunnel. It is located on the 0.96 radians (55 deg) incline approximately 45.7 m (150 ft) above the start of the elbow and just below the 178-mm- (7-in.-) high ramp. The ramp is designed to create a low-pressure zone under the water jet which draws air into both sides of the slot from the tunnel above the water surface. The air drawn under the water jet is concentrated in the lower surface of the jet nappe and flows along the boundary through the elbow.

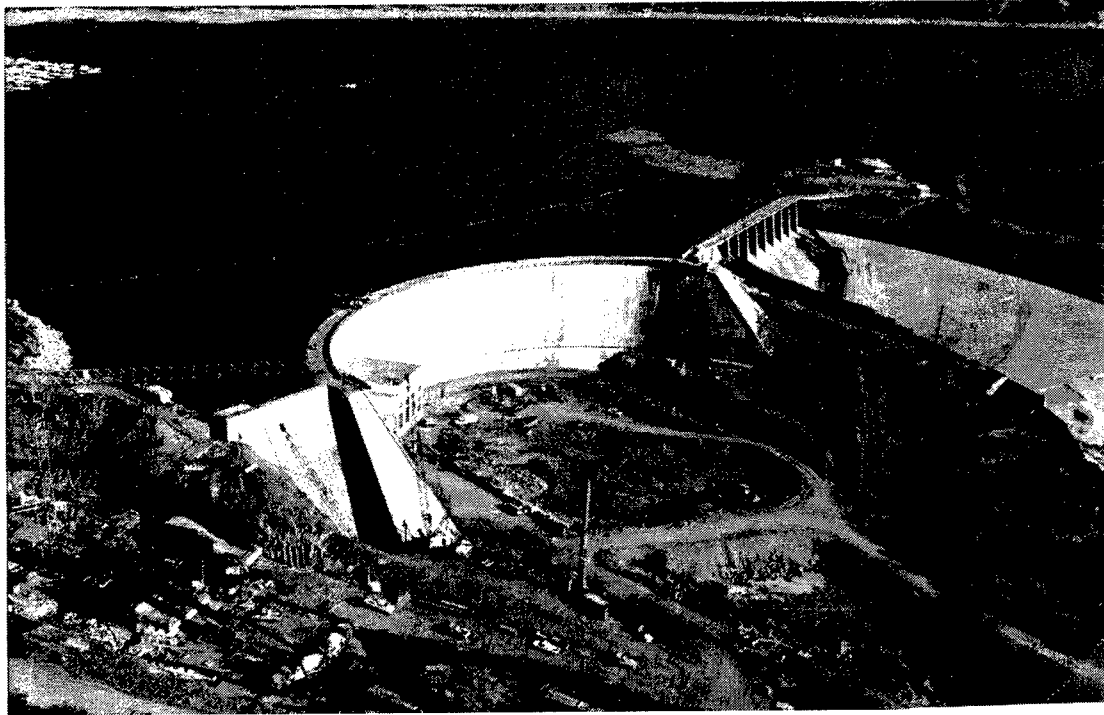
Structural stability investigations conducted by the BuRec in the late 1960s, indicated Stewart Mountain Dam was not stable enough to survive the revised maximum credible earthquake (MCE), Richter magnitude of 6.75 at 15 km (9.3 miles). The stability of the dam was questioned because of poor bond of the horizontal construction joints, deterioration of surface concrete, a 152-mm (6-in.) displacement of the arch crest, and revised PMF loads, which indicated the dam would be overtopped by 4.3 m (14 ft). The poor bond between the 1.5-m- (5-ft-) high concrete blocks of the dam was attributed to ineffective clean-up between placements during construction and the use of concrete with relatively high water content to combat high ambient temperatures at the time of construction. Alkali-silica reacted concrete caused the surface deterioration and the displacement of the arch crest. A three-dimensional finite element analysis of the dam under PME seismic loading conditions indicated there could be separation of lift joints which could cause failure of the dam (Nuss and Fielder 1988).

Figure 96. Overview of Stewart Mountain Dam (from Bruce, Fielder, and Triplett 1991)

After further study, BuRec decided to construct an auxiliary spillway to alleviate the PMF loading and to stabilize the dam against possible seismic loadings with posttensioned rock anchors. Posttensioned anchors had been used to stabilize concrete gravity dams, but this was believed to be the first time this method was used to stabilize a thin arch concrete dam (Nuss and Fielder 1988).

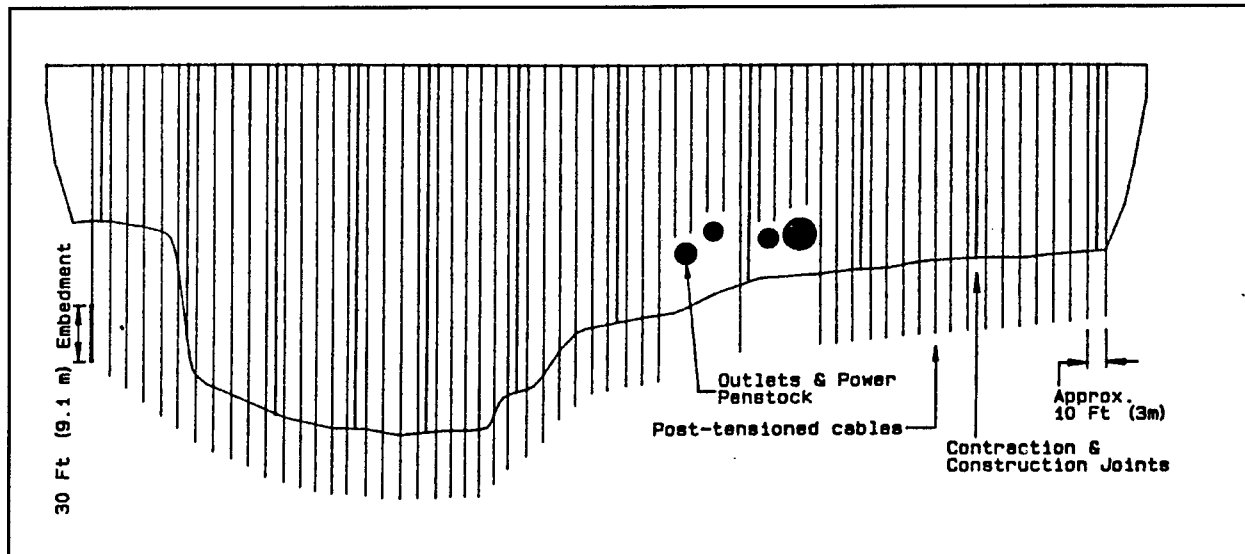
Figure 97. Profile Stewart Mountain Dam, showing locations of posttensioned tendons (from Nuss and Fielder 1988)

The installation of posttensioned cables was judged to be the least expensive, most viable solution for stabilizing the arch dam. Sixty-two tendons with free lengths ranging up to 65.8 m (216 ft) and bond lengths in the foundation from 9 to 13.7 m (30 to 45-ft) were installed on approximately 2.7-m (9-ft) centers (Figure 97). Each arched tendon was made up of 22 (152-mm- (0.6-in.-) diam)

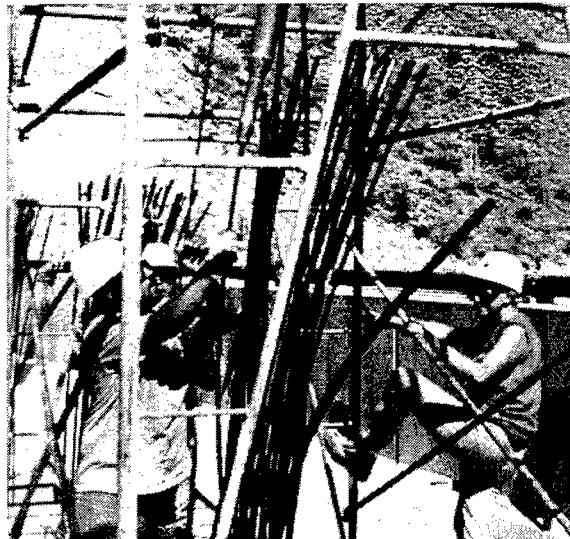
Figure 98. Arched tendons used to stabilize Stewart Mountain Dam (from Bruce, Fielder, and Triplett 1991)

epoxy-coated strands (Figure 98). Design working loads averaged approximately 2,958 kN (665 kips), the equivalent of about 50 percent guaranteed ultimate tensile strength (GUTS).

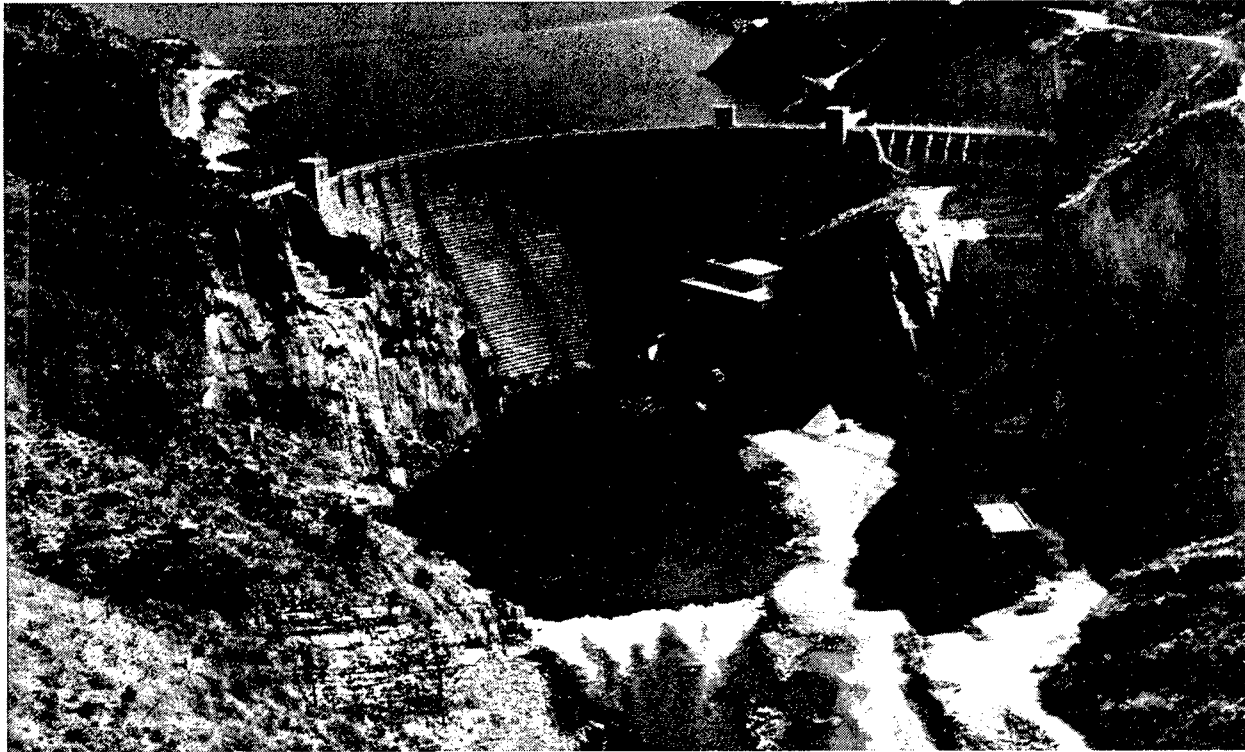
Figure 99. Theodore Roosevelt Dam prior to rehabilitation (from Quint and Fielder 1989)

In 1978, during investigations for the Federal Safety of Dams Act, Roosevelt Dam, which impounds Roosevelt Lake, was identified as a high-hazard dam in need of modifications. According to revised PMF figures (a peak inflow of 18,500 cms (654,000 cfs) and a volume of 7 billion cu m (3 million acre-ft) during a 16-day period), Roosevelt Dam would be overtopped, causing a loss of the spillways and the power plant and possibly causing failure of the three dams downstream. The loss of these dams would probably result in loss of life as well as extensive damage, including flooding in Phoenix. In addition, revised maximum credible earthquake (MCE) figures indicated Roosevelt Dam could fail in the event of an MCE. If the dam did not fail but suffered significant cracking, the low-level outlets were not adequate to empty the 1.6 billion-cu m (1.3 million-acre-ft) Roosevelt Lake in an emergency (Hepler and Drake 1995).

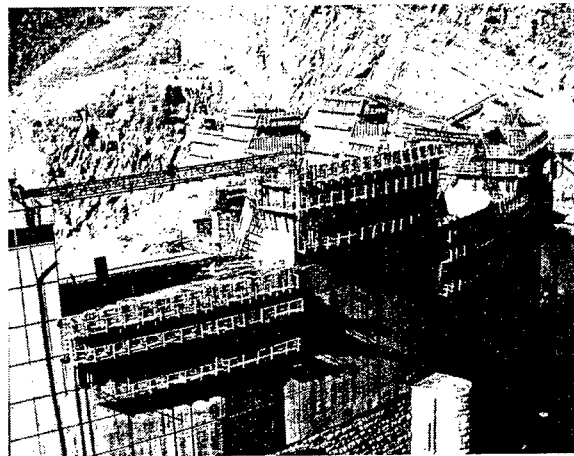
Figure 100. Alternating cantilevered placement of mass concrete blocks at Theodore Roosevelt Dam (from Balogh 1996)

Basing their decision on finite element and thermal analyses, BuRec engineers decided to use a single-curvature arch design and to use mass concrete placed in 3-m- (10-ft-) high, 21.3-m- (70-ft-) wide blocks that ranged in thickness from 13 to 15.2 m (10 to 50 ft) to raise and thicken Roosevelt Dam. The blocks were placed in alternating cantilevers (Figure 100). Also, mass concrete was used for the two large thrust blocks constructed on the right and left dam abutments to transfer arch loads from the dam into the foundation.

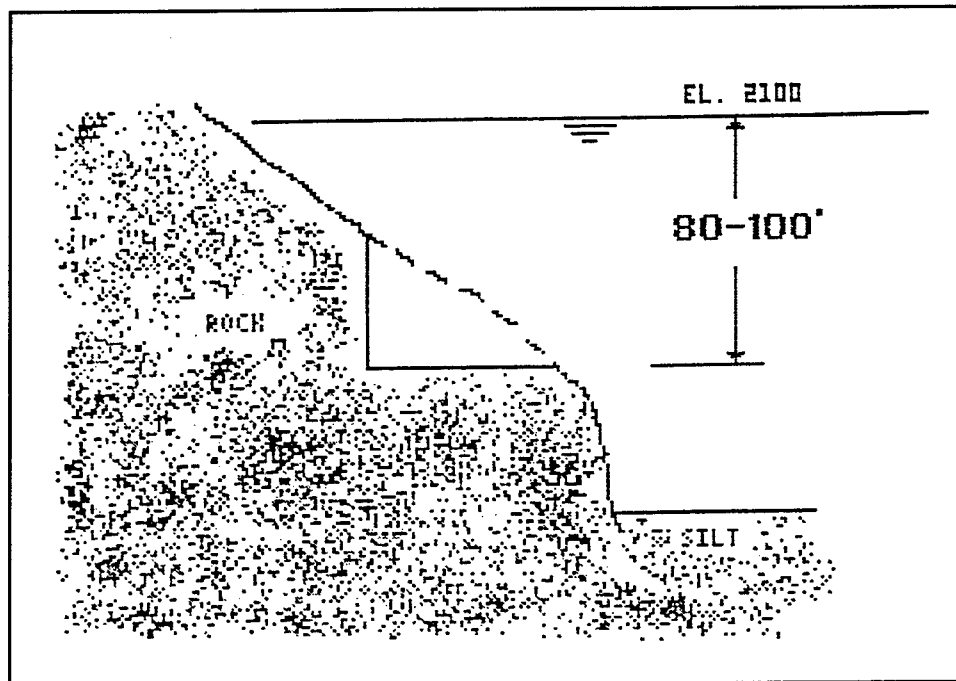
Figure 101. Bench excavation for Theodore Roosevelt Dam lake tap

To effect this construction, a lake tap was needed. Instead of a conventional uncontrolled lake tap, BuRec engineers designed a completely controlled tap for Roosevelt Dam. To construct the lake tap, workers excavated a horizontal bench (Figure 101) and a 6-m- (20-ft-) diam vertical shaft underwater. A drill mounted on a barge was used to drill the 18-m (60-ft) bench about 30 m (100 ft) underwater. A 22.6-m- (74-ft-) long template with a sonar mounted on it was used to position the drill. Information from the sonar was displayed on a cathode ray tube (CRT) with a gridded screen that showed the drill operator where to place the drill. Also, divers and a remote operated submarine with a camera monitored the work. Cuttings from the bench were sucked up an air lift, screened, and returned to the lake in a return pipe (Beall 1991).

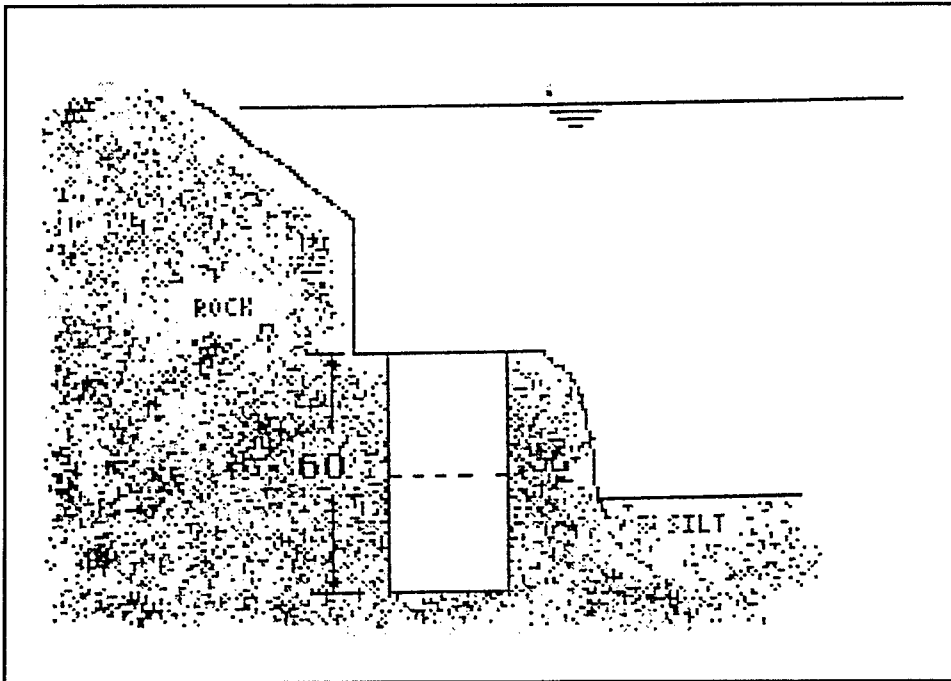
Figure 102. Inlet tube shaft at Theodore Roosevelt Dam

Once the bench was completed, the template was cut and reformed and used for the inlet tube shaft, which was excavated in a horseshoe shape to accommodate the 1.6-radian (90-deg) angle in the inlet tube (Figure 102). The steel inlet tube was floated out to the site and inserted in the completed shaft. The inlet tube was grouted into place with tremie concrete (Figure 103). Specifications for the tremie concrete called for a 27.6 MPa (4,000-psi) compressive strength. The mixture contained 25-mm (1-in.) aggregate and a plasticizer. The ROW tunnel is 200.6 m (658 ft) long with a 4.9-m (16-ft) finished diam. Reinforced concrete was used to line the section of the ROW upstream of the gate chamber, and the cross section downstream of the bifurcation structure is lined with steel and reinforced concrete. After the inlet tube was installed, capped with a bulkhead, and dewatered, the remainder of the ROW was mined along the pilot tunnel to the inlet and from the gate shaft to the outlet. Then the 108.2-m- (355-ft-) long, 3.8-m- (12.5-ft-) diam power penstock tunnel was constructed, the

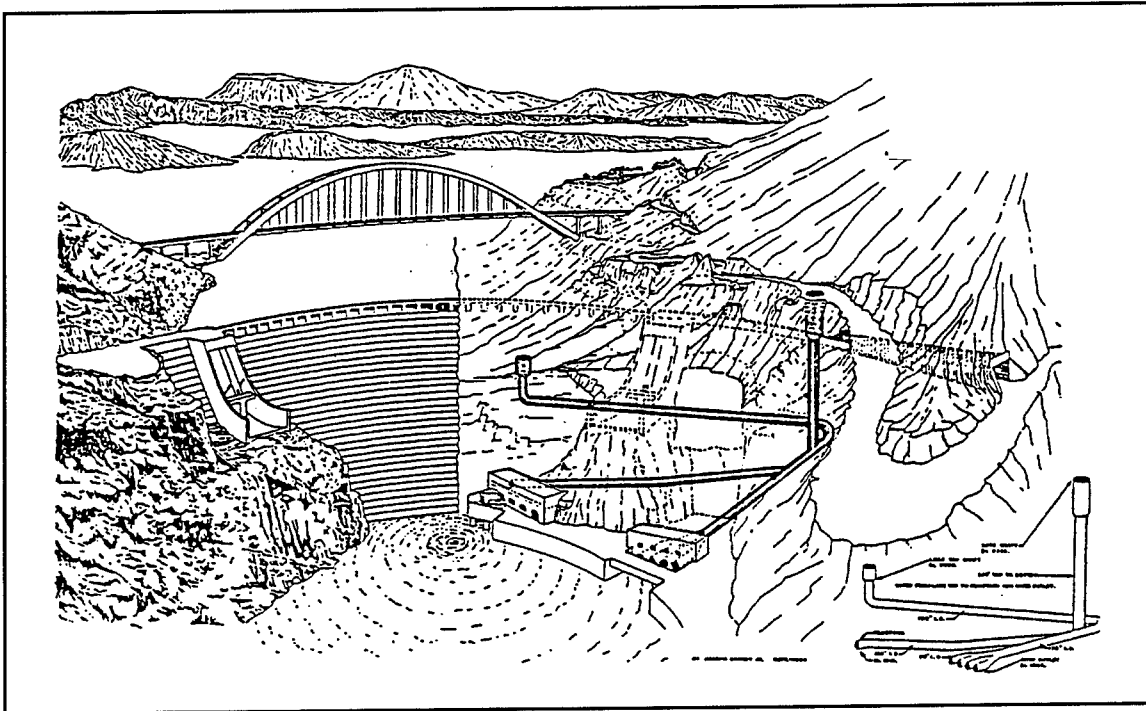
Figure 104. Penstock tunnel installed at Theodore Roosevelt Dam

gate was installed in the gate shaft, and alterations were made to the power plant (Figure 104). The original 49,500-horse-power (hp) turbine was replaced with a new, smaller turbine having the same capacity and capable of operating at the new higher reservoir heads (Beall 1991).

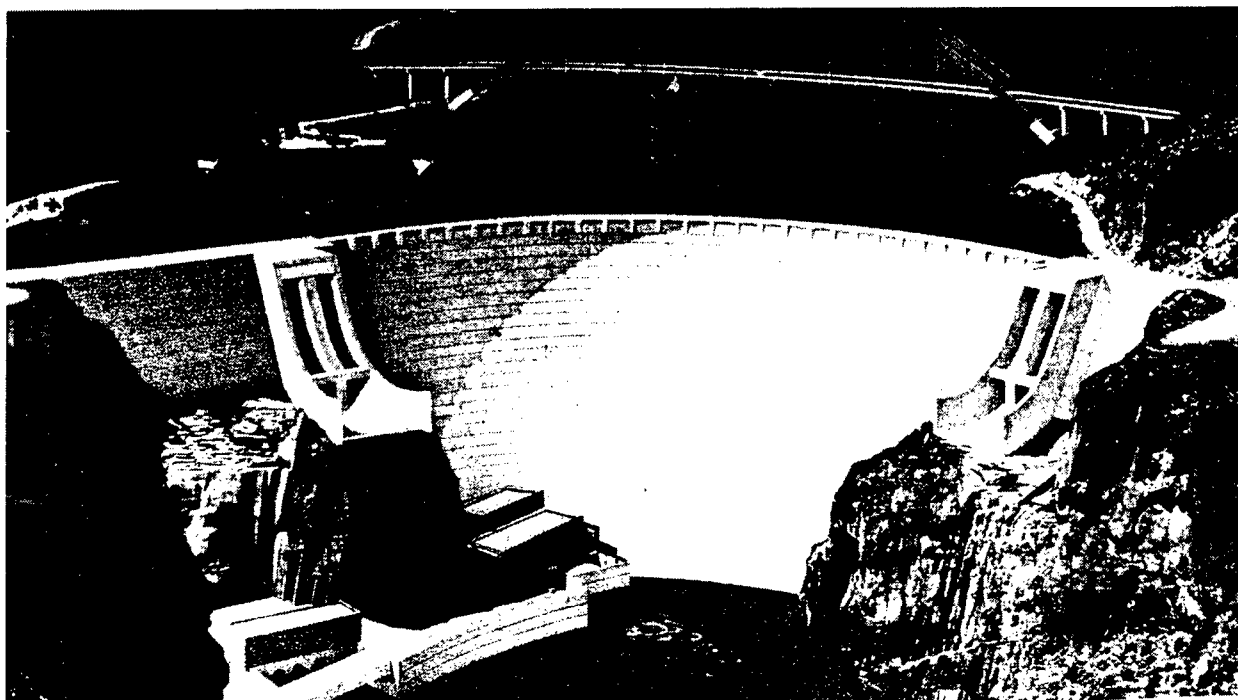
Figure 105. Modifications performed at Theodore Roosevelt Dam

Once the concrete overlay was installed, exposed concrete surfaces were cleaned and stained so they would more closely match the surrounding rock. Figure 105 provides an overall view of the modifications to the structure.

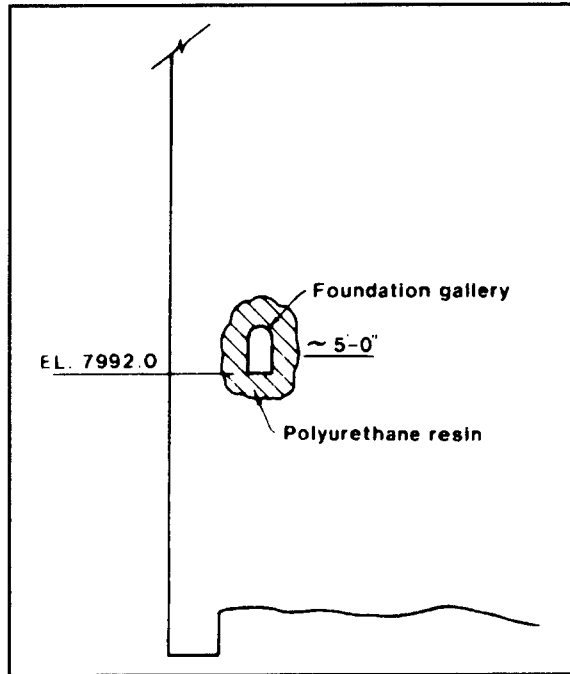
Figure 107. Plan for first injection stage at Upper Stillwater Dam (from Smoak 1991)

Because the reservoir level would change with the seasons, creating the potential for crack movement, a flexible hydrophilic polyurethane resin was selected as the repair material. Another characteristic of this material is that it allows for multiple injections. The injection was accomplished in three stages. Work for the first two stages was executed from the gallery and the downstream face at elevations below the reservoir water level. The first objective of the first stage was to cut off the flow of water into the gallery. A series of 16-mm (5/8-in.) holes were drilled from the gallery walls at an angle to intercept the crack at depths of 0.3 to 0.9 m (1 to 3 ft.) Injector valves ("wall spears") were placed in the holes and opened to relieve the water pressure in the crack. The surface of the crack between wall spears was then sealed with wood wedges, lead wool, or urethane-soaked jute rope or oakum. When the flow of water was controlled, a urethane resin pump system was connected to the injectors, and resin was pressure injected into the crack (Figure 107). If needed, the crack was reinjected.

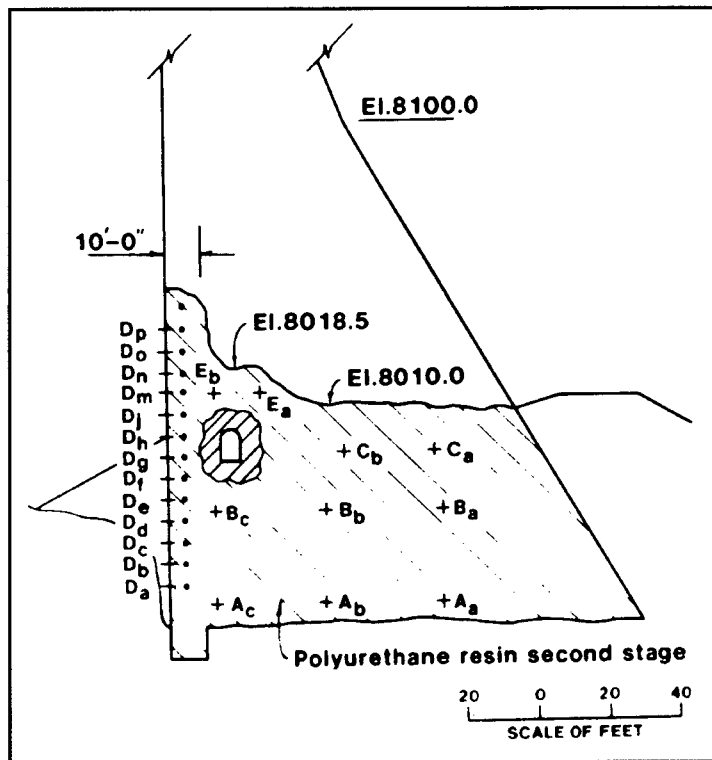
Figure 108. Injection plan for Stage 2 of Upper Stillwater Dam (from Smoak 1991)

The major work in the repair project was performed during the second stage. The first step was to drill 25-mm-(2-in.-) diam holes to intercept the crack at the locations shown in Figure 108. The holes varied in depth from 5.8 to 28 m (19 to 92 ft). When the drill hole intercepted the crack, as evidenced by the drill water loss, a pneumatic packer was set several feet from the hole-crack intercept, and the hole was injected with resin. The D-line of holes was drilled and injected first to reduce water flow during drilling and injection of interior holes. The alphabetical designation of the holes

indicates the sequence of drilling and injection. Water-to-resin ratios varied from 0:1 (neat resin) to 2:1 with most injections done at a 1:1 ratio. Check holes were used to determine whether the crack had been sealed; if not, additional holes were drilled and injected until the crack was adequately sealed.

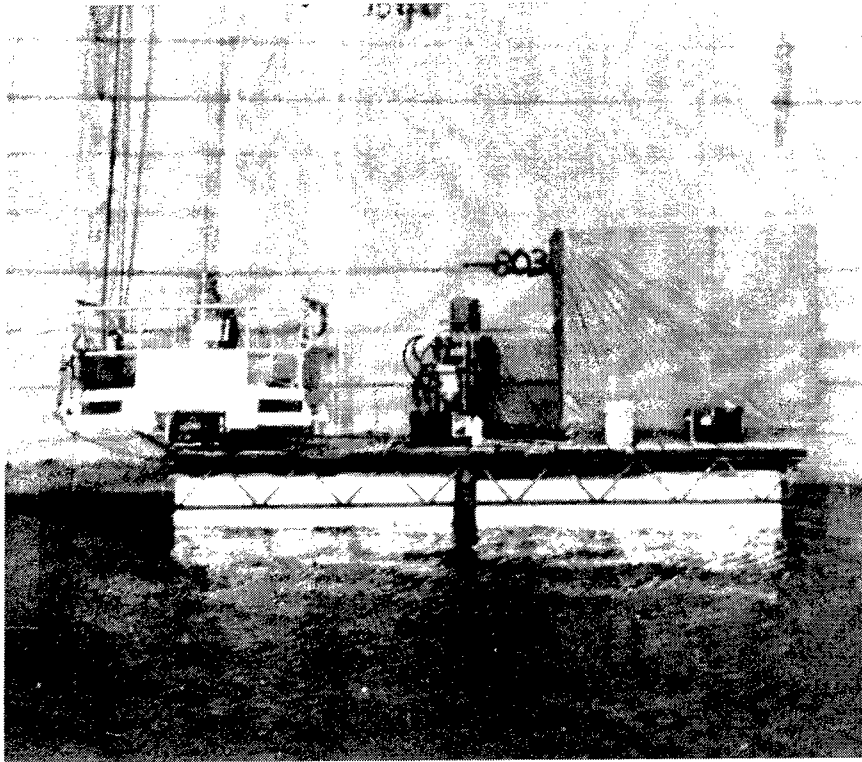
Figure 109. Work platform used at Upper Stillwater Dam (from Smoak 1991)

The third stage of the injection involved sealing the crack on the upstream face of the dam above the drawn-down water level. A floating barge and a spider platform suspended from the top of the dam were used as work platforms during the drilling and injection procedures (Figure 109). Crack intercept holes were drilled 305 to 610 mm (12 to 24 in.) apart on alternate sides of the crack and angled so they would intercept the crack about 0.6 m (2 ft) from the upstream face. Wall spears were installed and then the holes were pressure injected with resin. Workers started at the lowest injection hole and moved up the crack to the top of the dam. Resin volumes were calculated to permit injection of a zone approximately 3 m (10 ft) into the dam; however, in some instances, miscalculations resulted in the resin penetrating the entire section and coming out on the downstream face. A 1:1 water-to-resin ratio was used for the crack at these elevations. Check holes were used to determine whether the crack was sealed.

A similar procedure was used to seal the smaller cracks in the dam. After the repair of the cracks, and at full reservoir, no measurable leakage was detected at any of the smaller cracks. The leakage at the largest crack was reduced from 11,700  $\ell$ pm (3,100 gpm) to less than 3,030  $\ell$ pm (800 gpm).

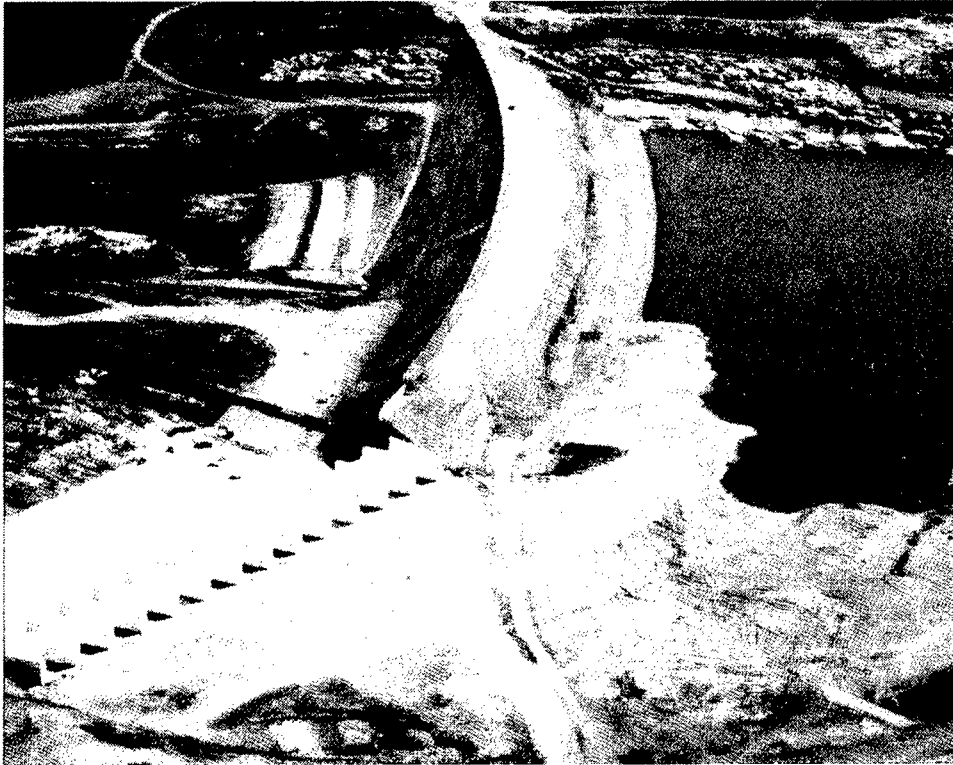
Figure 110. Ute Dam with completed labyrinth spillway (from Parrett 1986)

Discharge flowing over the labyrinth spillway increases in direct proportion to crest length; however, hydraulic model tests show that when hydraulic head increases, discharge efficiency decreases. Piers were placed along the spillway crest at Ute Dam to split the flow and allow air to enter under the flow nappe; the split flow reduces oscillation in atmospheric pressure and noise produced when the spillway is operated under low hydraulic head (Parrett 1986). The completed labyrinth spillway is shown in Figure 110.

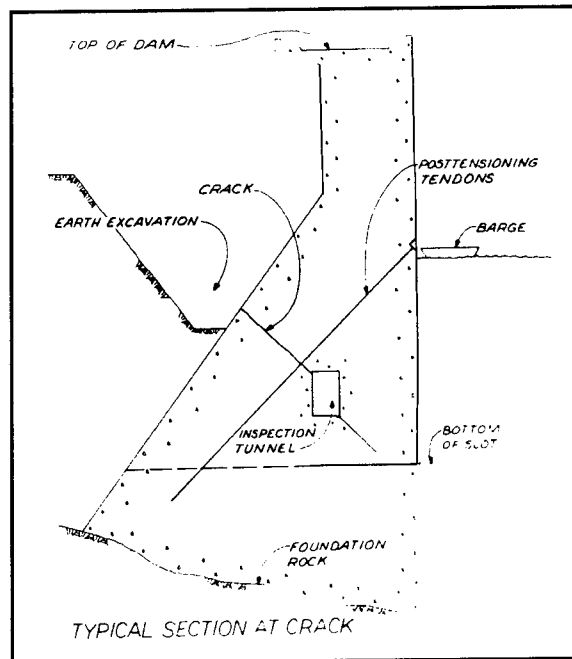
The 6.4-mm (1/4-in.) maximum width crack extended into the adjacent straight block on each side of the blocks comprising the curved portion of the dam and had a 4.8-mm (3/16-in.) maximum upstream offset of the wall face above the crack relative to the face below the crack. The observable cracking indicated an inclined plane intersected the gallery and sloped upward towards the downstream face. The cracking extended from the gallery to the downstream face as well as a short distance upstream of the gallery. Gauges were installed

The downstream face of the dam receives the full force of the afternoon sun. The high temperatures were considered a contributing factor to the cracking, as was indicated by the increasing rate of crack opening during warmer seasons. Temperature data indicated a seasonal temperature fluctuation affecting the exterior 11 m (36 ft) of the mass. Comparison of temperatures measured in 1961 and 1971 indicated a slight average temperature rise may have occurred in the upper portion of the dam during this period. Also, petrographic examinations disclosed small deposits of alkali-silica gel, very fine cracks in a few aggregate particles, and a deficiency in calcium hydroxide in the cement paste.

Figure 111. Crack repair with posttensioning tendons at Fontana Dam (from *TVA Today* 1976)

When the crack was discovered, TVA took action immediately to ensure the integrity of the dam. One of the first measures taken was to "stitch up" or posttension the crack (Figure 111). The work was performed from a barge on the lake face of the dam. Holes were percussion drilled into the dam on a diagonal that crossed the crack and went far enough past it to provide grouted anchorage for the tendons. Hole depths for adjacent tendons were varied to prevent a concentration of anchorage zone loads. The posttensioning cables were inserted in the holes. A total of 25 tendons were used in the three most affected blocks, which included the two curved blocks. Each tendon consisted of 90 wires, each 6.4 mm (1/4-in.) in diam. Initially the tendons were posttensioned to 20 percent of their ultimate strength. The grouting served the dual purpose of restoring shear resistance along the plane of the crack and preventing possible movement of the blocks during cable tensioning. The stitching was completed in September 1973 and will be a part of the permanent repair. However, while the posttensioning was in progress, TVA engineers learned through instrumentation that the crack might still be growing. As an interim measure, they installed a pipe system to spray cold reservoir water onto the downstream face. The beneficial efforts of this spraying were quickly apparent, as the rate of crack opening diminished significantly within a few days after the spraying began.

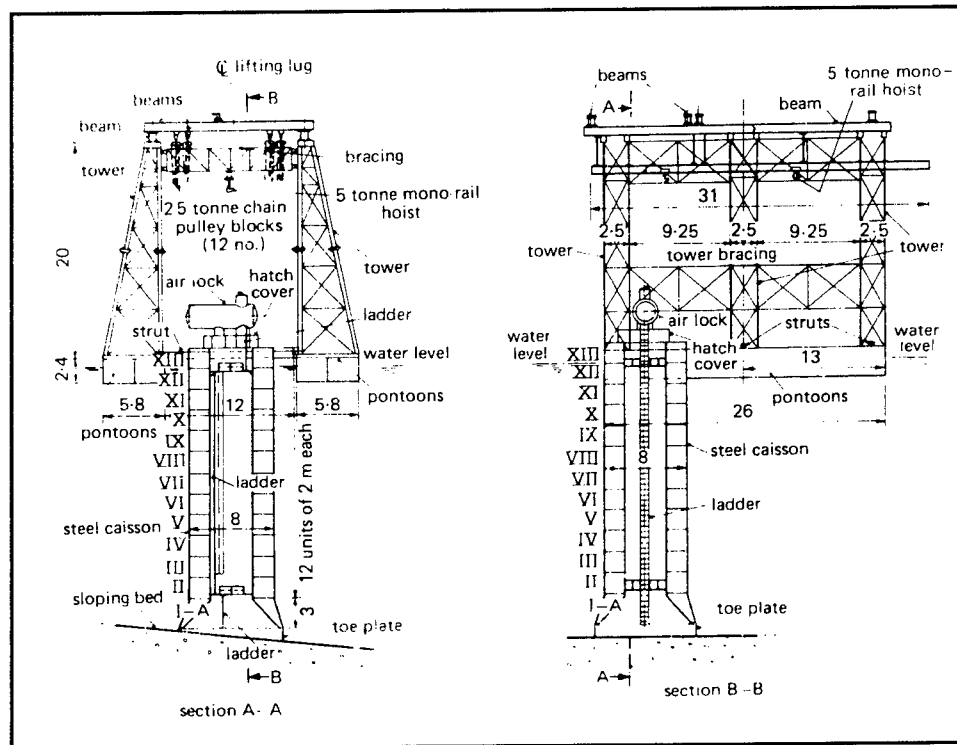
Figure 112. Design of pneumatic caisson and the sinking set used at Bhakra Dam (from Malholtra et al. 1987)

The solution was to construct a 26-m (85-ft-) high steel caisson that could be used to dewater the repair area and then use conventional concrete repair methods in the near-dry area. The square double-walled caisson consisted of 12 upper units and a bottom unit containing two sections. A toe plate on the bottom section maintained the vertical position of the caisson when repairs were made to sloping surfaces. The 4- by 4-m (13.1- by 13.1-ft) center hole had a

double hatch cover for an air lock and was used to regulate the passing of men and materials. The bottom section area was increased to provide a 9.5- by 9.5-m (31-by 31-ft) working area. The air lock consisted of a compression and decompression chamber. The primary air compressor supplied air at a rate of 78 cu m/min (2,750 cu ft/min) and was capable of running continuously for 10 to 15 days. A standby air compressor had a capacity of 21 cu m/min (740 cu ft/min) (Figure 112).

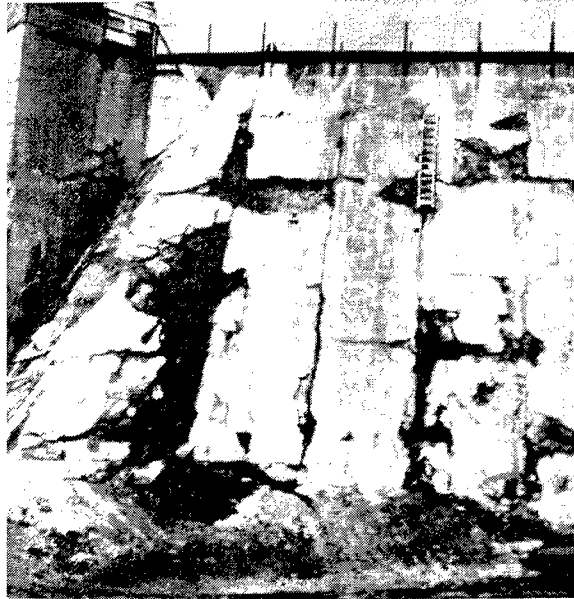
Since its construction, Big Eddy Dam has suffered severe visible deterioration of the concrete and has experienced extensive seepage of water throughout the dam. A variety of repair methods was tried; all failed to halt the concrete deterioration and the seepage. The failure of a shotcrete repair of the downstream face is shown in Figure 114.

In 1974, International Nickel Company, owner of the dam, initiated an investigation to determine the cause of the major problems at the dam. A visual inspection and testing of cores taken from the east wing wall were accomplished. The main causes of deterioration were identified as cycles of freezing and thawing and alkali-aggregate reaction. Further investigation in 1975 indicated a need for a comprehensive study of the dam. Gore and Bickley (1987) reported the investigation and subsequent remedial steps taken. This case history is a summary of their report.

Figure 114. Deteriorated shotcrete repair on the downstream face of Big Eddy Dam (from Gore and Bickley 1987)

Recommended remedial measures in priority order included improvement of the overall stability of the dam, elimination of leakage through the structure, and replacement of deteriorated surface concrete.

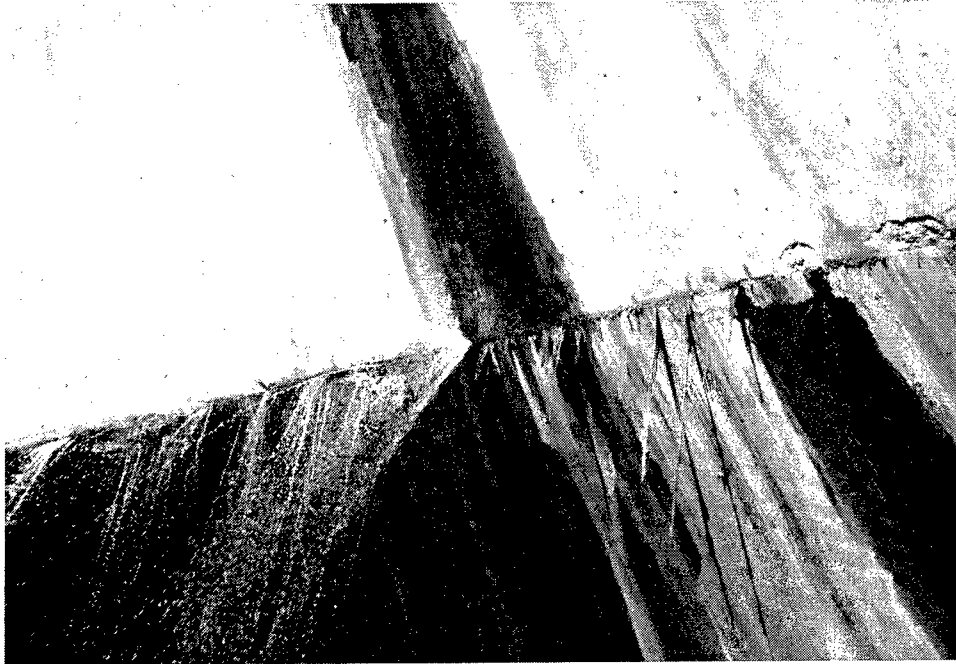
When the lake was impounded, the area between the original and later construction began leaking because of inadequate bond between the older and newer concrete, a result of the interruption in construction (Figure 116).

Figure 116. Joint leakage at Buchanan Dam

The copper-sealed construction joint between the two building phases where the leakage occurred is 9 to 12 m (30 to 40 ft) above the foot of the dam. The first step in the repair process was to install pipes to divert water from the construction joints. Workers used 15.9- by 610-mm (5/8- by 24-in.) bits to drill holes about 305 mm (12 in.) above the seam. The holes were drilled to intersect the joint almost halfway through the arch, which is 0.9 to 1.2 m (3 to 4 ft) thick. Drilling for each hole continued until the joint was intersected and water exited through the hole. A 9.5-mm (3/8-in.) pipe was then inserted into each hole and driven in with a hammer to assure a secure fit. Next, a valve was installed on the pipe and left open so water would flow through the pipe and away from the seam.

Lead wool and oakum were used as a temporary seal. As the seam flow was plugged, the flow of water through the pipes increased. If the increased pressure pushed the lead wool and oakum back out of the seam, more pipes were installed to relieve the water pressure. Once all water was diverted to the pipes, the water-activated foam could be injected into the joint.

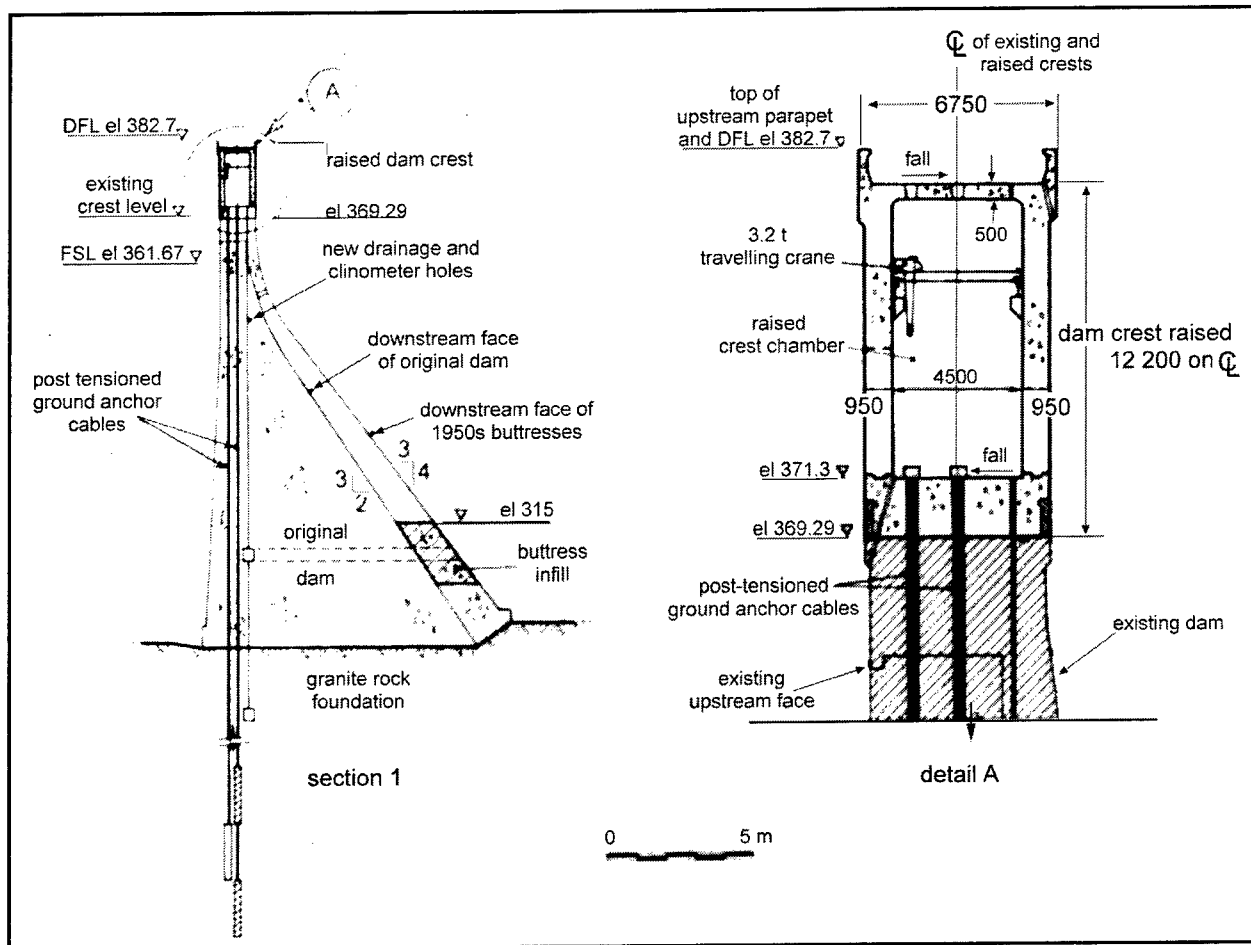
Figure 118. Section through Burrinjuck Dam, showing details of raising height of dam 12.2 m (40 ft)

In 1990, work began on a project to increase the height of the dam by 12.2 m (40 ft). An open reinforced-concrete chamber was constructed at the existing crest level of the dam, and the dam was stabilized with posttensioned ground anchor cables (Figure 118). During high flood levels, the chamber fills with water, thus providing additional stability. Two rows of posttensioned ground anchors provide a stabilizing force of 14,200 kN/m (5,240 tons/ft) for the dam. The anchor cables, each consisting of 63 strands (15.2-mm- (0.6-in-) diam) were placed on 1.5-m (5-ft) centers. To provide corrosion protection, strands were encapsulated in grease-filled polyethylene tubes above the anchorage zone, and cables in the anchorage zone and the free length of cable were installed in a single-stage grouting operation. Type G oil well cement was specified for the grout; it produced a high-strength, low-shrinkage, and low-bleed mixture. Cable load is monitored, and the anchors can be restressed if necessary.

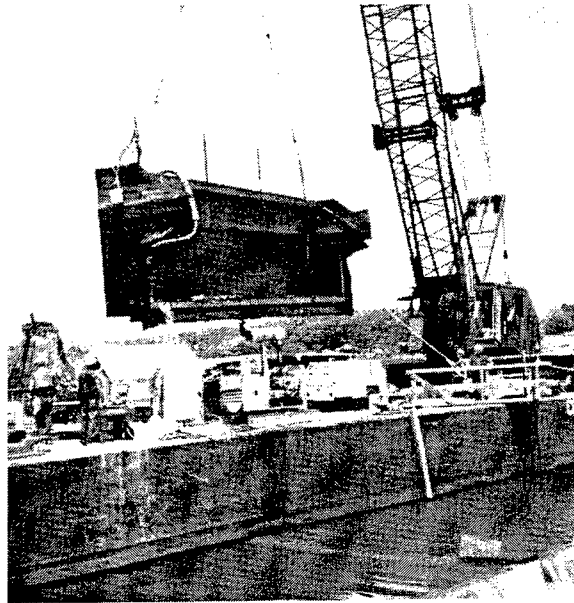
Structural repairs made to the dam faces followed two underwater inspections: the first inspection gave a basis for bidding while the second (an underwater video inspection) aided the contractor in identifying specific areas to be dewatered and repaired. Portable cofferdams were fabricated and assembled onsite to dewater repair areas. On the upstream side of the dam, all repairs were within 1.5 m (5 ft) from the crest. The 1.2-m-wide by 1.7-m-deep (4-ft-wide by 5-1/2-ft-) deep by 90-m- (30-ft-) long cofferdams used in this area were fabricated to match dam contours (Figure 120). Cofferdams used to dewater the downstream toe and apron sections were 7.6 m (25 ft) wide by 4.3 m (14 ft) deep by 9 m (30 ft) long.

Figure 120. Portable cofferdam used upstream at Crescent Dams (from Sumner, Nash, and Haag 1991)

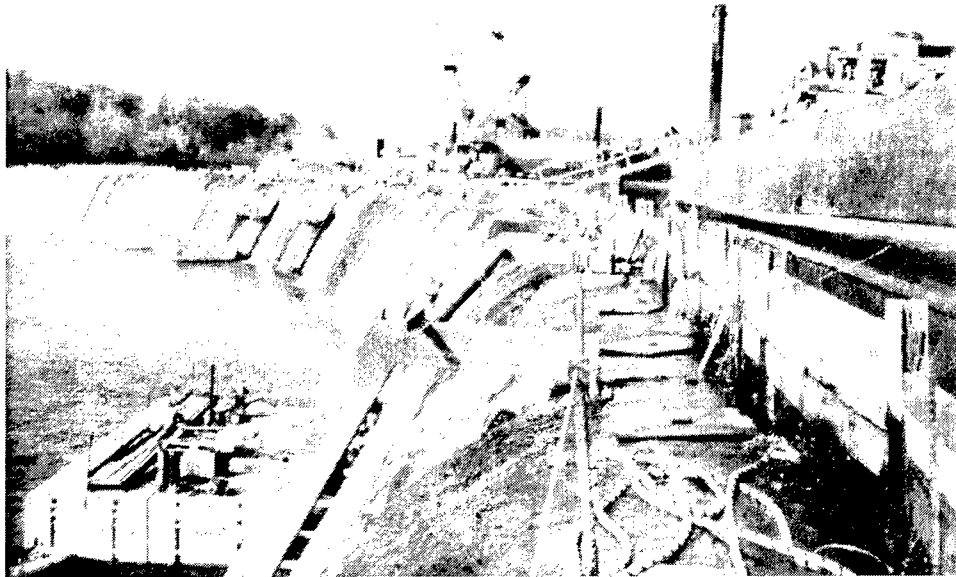
Figure 121. Typical spillway repair in progress at Crescent Dams (from Sumner, Nash, and Haag 1991)

Crane and supply barges and push and utility boats were used to handle materials and equipment during the repair effort. Dewatering allowed for a more detailed inspection of the deteriorated areas. In general, any concrete that had deteriorated to a depth of 127 mm (5 in.) or greater was repaired. Damaged areas were excavated to sound concrete or 102 mm (4 in.) and edges were kept perpendicular to the repair surface. Repairs less than 305 mm (12 in.) deep were reinforced with 6 by 6, W4 by W4 welded wire mesh. Those over 305 mm (12 in.) were reinforced with no. 6 rebar on 305-mm (12-in.) centers. The hooked dowels were epoxy grouted into 0.6-m- (2-ft-) deep holes drilled in the original concrete. If cracking was severe enough to allow leakage, PVC pipe drains were installed to relieve hydrostatic pressure behind a fresh concrete patch and to later serve as urethane grout injection ports (Figure 121).

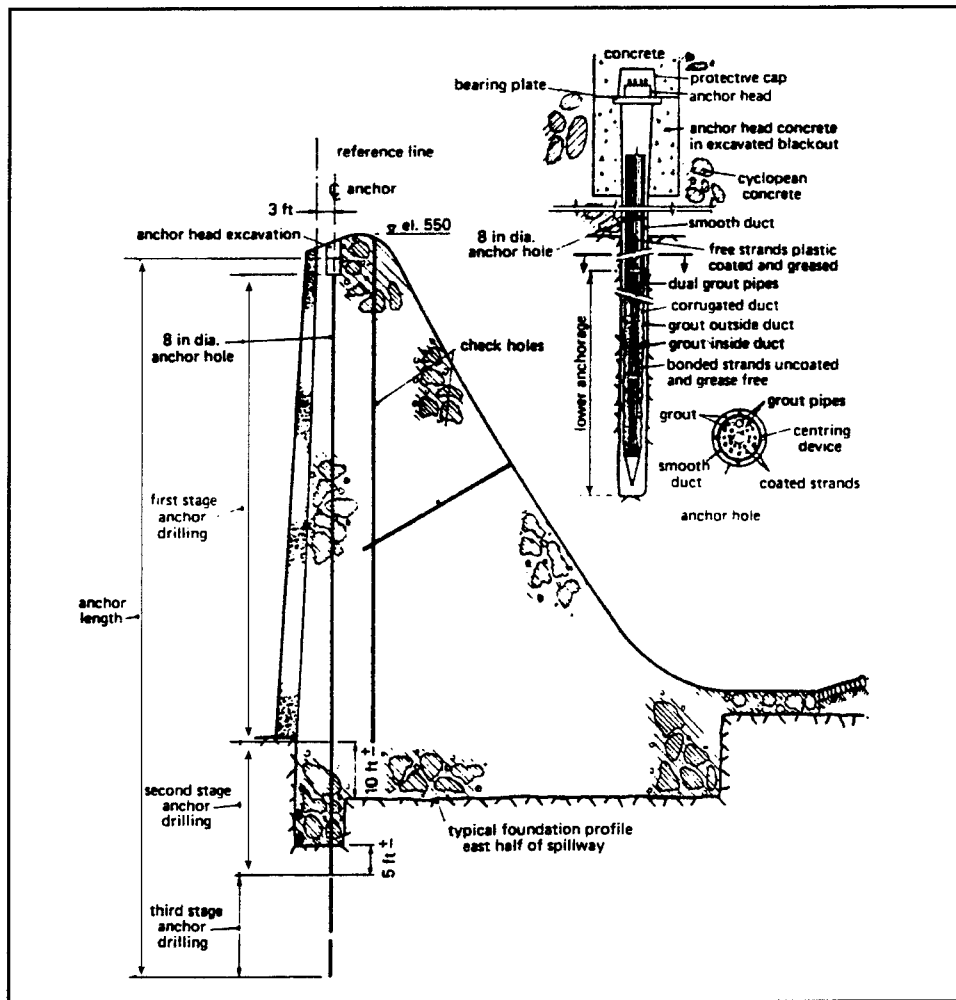
Figure 123. Details for installation of posttensioning anchors at Delta Dam (from Standig 1984)

The system of posttensioned anchors included 93 anchors on 1.8-m (6-ft) centers in the spillway section, where the greatest strengthening was needed, and on 4.6-m (15-ft) centers in the abutment areas. The steel strands specified for the anchors had a guaranteed ultimate tensile strength (GUTS) of 186 kN/sq cm (270 ksi). The design load of each anchor was based on 60 percent GUTS of the material but was actually locked off at 70 percent GUTS to account for losses from creep in the rock and relaxation of the steel strands. Each anchor was stressed to a proof load of 80 percent GUTS during installation to ensure that the lower anchorage could transfer the load to the rock. The strands were installed with double corrosion protection consisting of a plastic duct and grouting. The grouting system included simultaneous tremie-placement of grout both between the strand and casing and the casing and anchor hole. Anchor embedment depth ensured resistance of the lower anchorage to applied upward pull. In the free length of the anchor, the smooth duct and a grease and plastic coating on the strands kept the strands from bonding to the grout. Figure 123 shows the anchor detail.

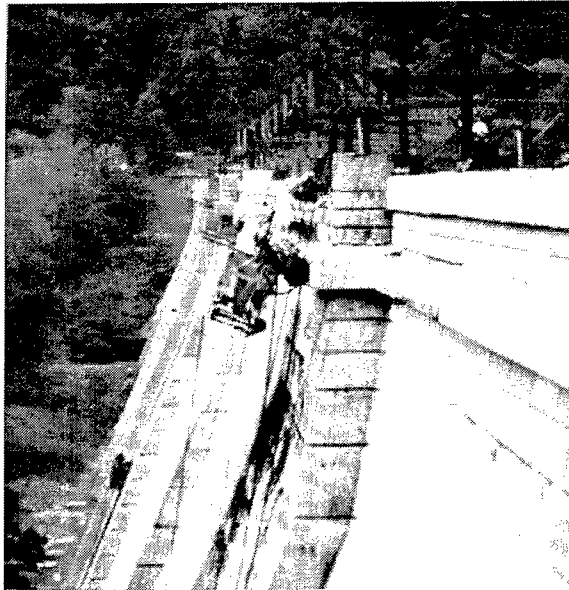
Figure 126. Power-operated cradles used for making repairs to downstream face of Haweswater Dam (from Fosroc Focus 1990)

Work was performed from power-operated cradles (Figure 126). Repair areas were first cleaned with air chisels, high-pressure water jets between 27.6 and 41.4 MPa (4,000 and 6,000 psi), and sand blasting. These methods enabled workers to remove spalling to depths of 100 mm (4 in.). The repair-mortar was mixed with water in a forced-action mixer and applied by
