Technical Report REMR-CS-63  
September 1999

## **Repair and Rehabilitation of Dams: Case Studies**

*by James E. McDonald, Nancy F. Curtis*

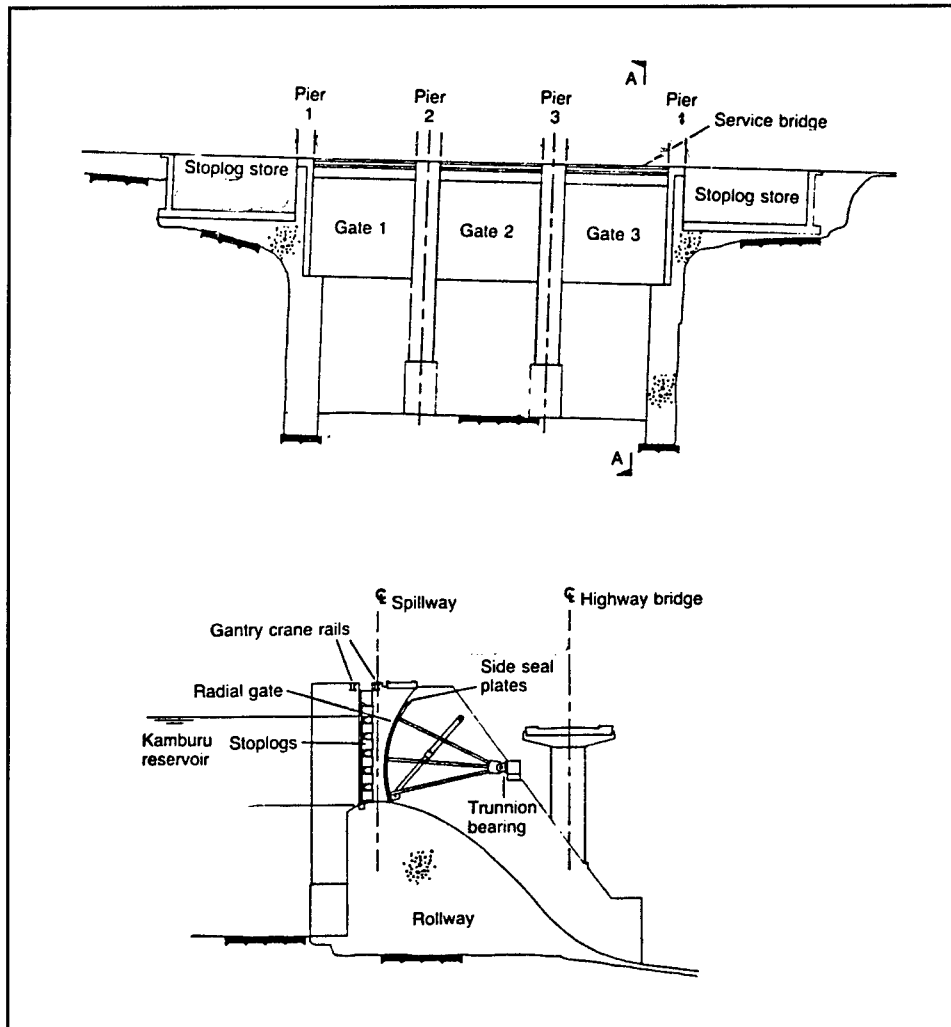
In 1982, eight years after the construction of the spillway, relative movement was observed between Pier 1 and the adjacent stoplog store. This movement was monitored for 3 years until, in 1985, it was found that Pier 1 had deformed into the gate opening to such an extent that gate operation was impossible. An investigation at that time revealed cracks in the concrete on Pier 1 and water seepage through horizontal cracks 20-30 mm wide that were parallel to and adjacent to the tendons securing the gate trunnion. The cracking pattern within

Figure 130. Upstream elevation and typical section of Kamburu Dam Spillway (from Sims and Evans 1988)

the left stoplog store confirmed the that the store was tilting. A study attributed the cracking to drying shrinkage, plastic shrinkage, plastic settlement, and alkali-silica reaction (ASR). This case history is a summary of a report by Sims and Evans (1988).

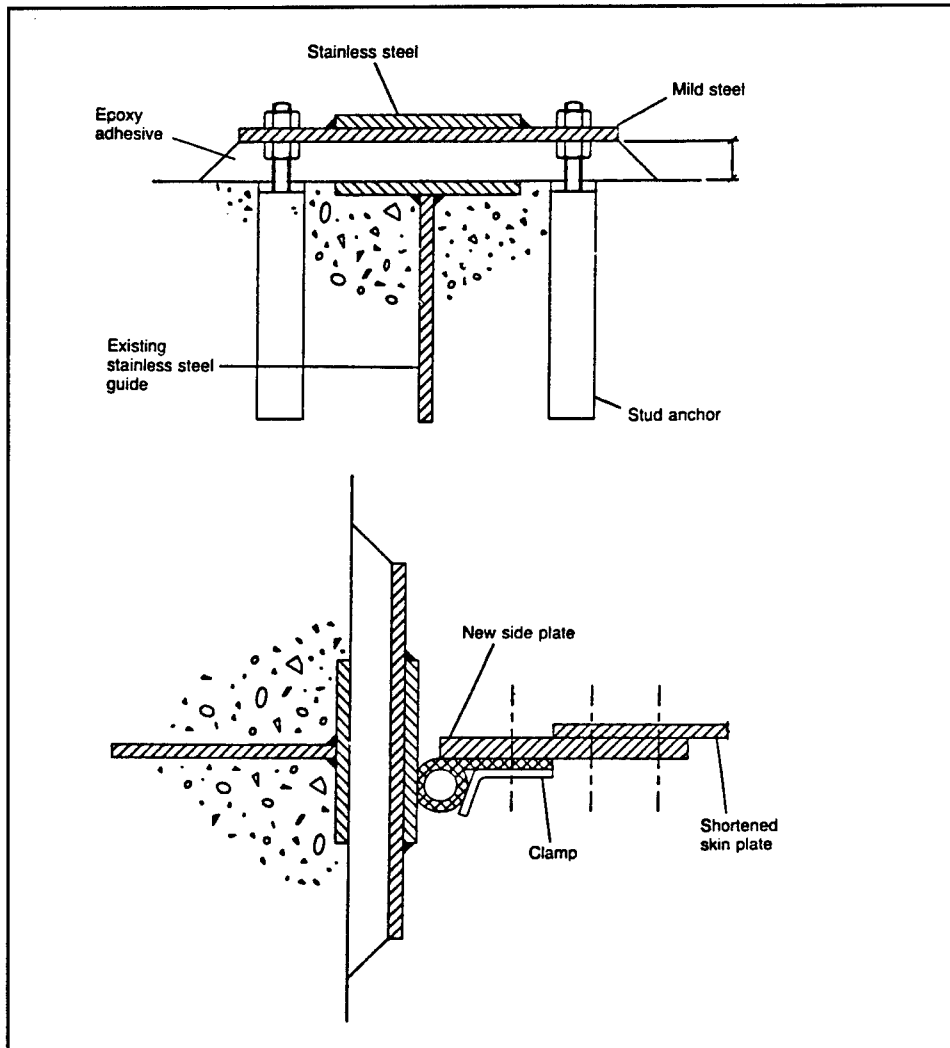
Figure 131. Modifications to radial gate, embedded parts and skin plate, at Kamburu Dam Spillway (from Sims and Evans 1988)

Gate 1 was released by trimming 140 mm (5.5 in.) off the side of the gate adjacent to Pier 1. Figure 131 shows the revised arrangement for the seal and also the new stainless steel sealing face. After the gate was released, the alignment of the gate arms and trunnion bearings were checked, and minor adjustments had to be made to relieve stresses induced by the misalignment of the gate and piers.

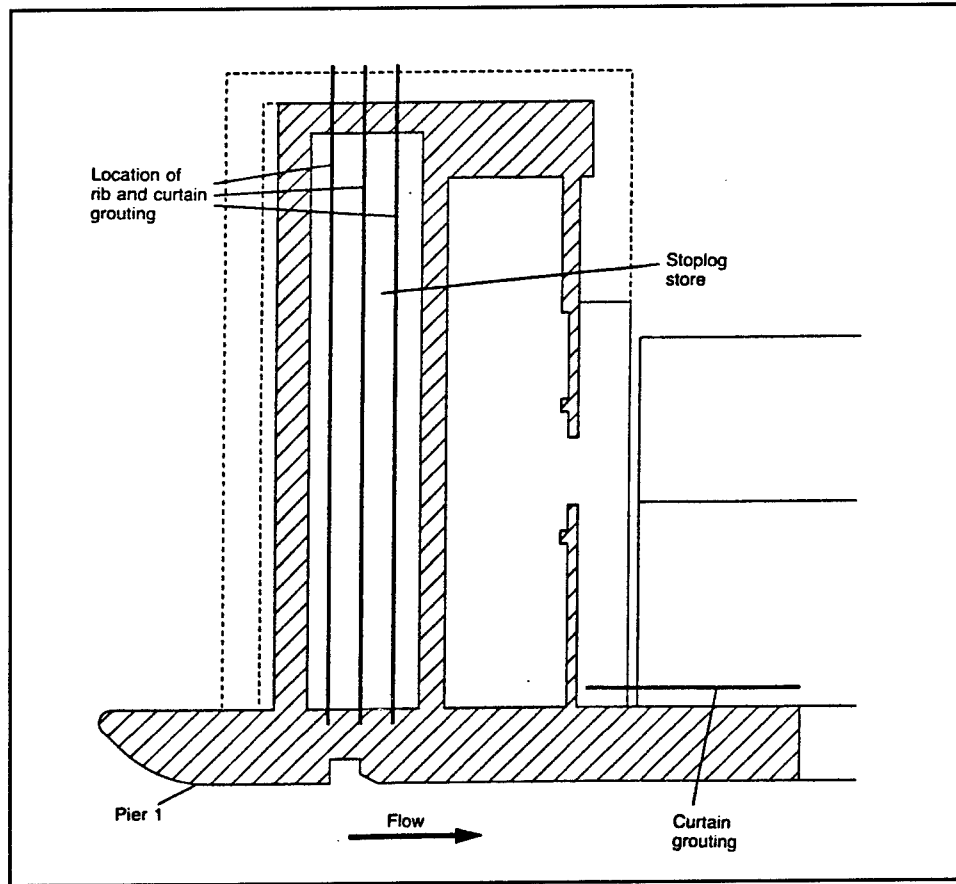
Figure 132. Grout locations on Pier 1 of the spillway at Kamburu Dam (from Sims and Evans 1988)

The measure taken to reduce the water available to the concrete included the following. The existing grout curtain under the stoplog stores was reinforced by placement of both a low-alkali cement grout and resorcinol-formaldehyde resin grout (Figure 132). Immediately under the stoplog store, a combination of curtain grouting and rib grouting was used, the curtain grouting being straight down to the spillway foundation level and the rib grouting inclined at about 1 radian (60 deg) to the vertical to intersect with the rear face of the pier. Both the curtain and rib grouting were carried out in three rows. The two outer rows were grouted first with cement grout. The central row was grouted later, first with cement and subsequently with chemical grout. This grouting reduced the overall permeability of the abutment rock. Additional protection to Piers 1 and 4 was provided by a further curtain of cement grout followed by chemical grout between each pier and the abutment rock.

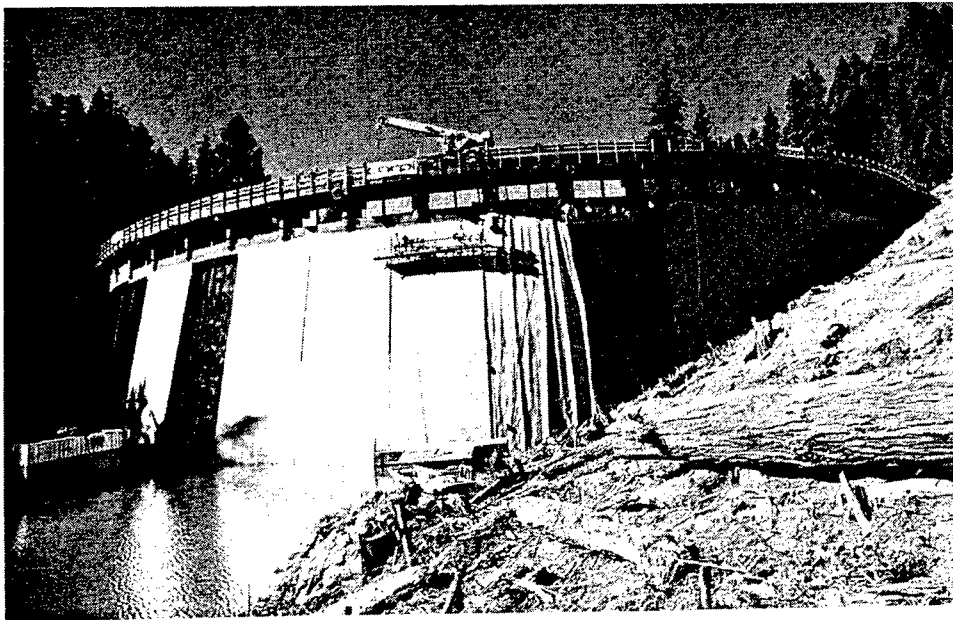
Figure 136. Workers on swing stages install 16 precut geomembrane panels on the upstream face of Lost Creek Dam (from Onken 1998)

To install internal profiles underwater, divers worked from swing platforms that were controlled from a materials barge. They used grid lines as guides to ensure the internal profiles were installed in a perfect vertical line. Gasket material was placed on the installed vertical profiles to provide a watertight seal at the membrane joints. The geomembrane was installed next. Using a crane, workers lifted the top end of each of the 16 panels until it was level with the upper perimeter seal, pulled it to the dam face, and then unrolled the remainder of the panel onto the materials barge and into the water. Divers aligned the panels with the installed internal vertical profiles, making sure the panels overlapped sufficiently (Figure 136). The installation team on the bridge deck used chain falls and winches to make adjustments according to instructions from the divers. Once the panels were aligned, divers secured them to the dam face above the perimeter seal. Another layer of gasket material was placed over the geomembrane, and the external vertical profiles were clamped to the internal vertical profiles, creating tension between the two profiles and pulling the panels toward the face of the dam.

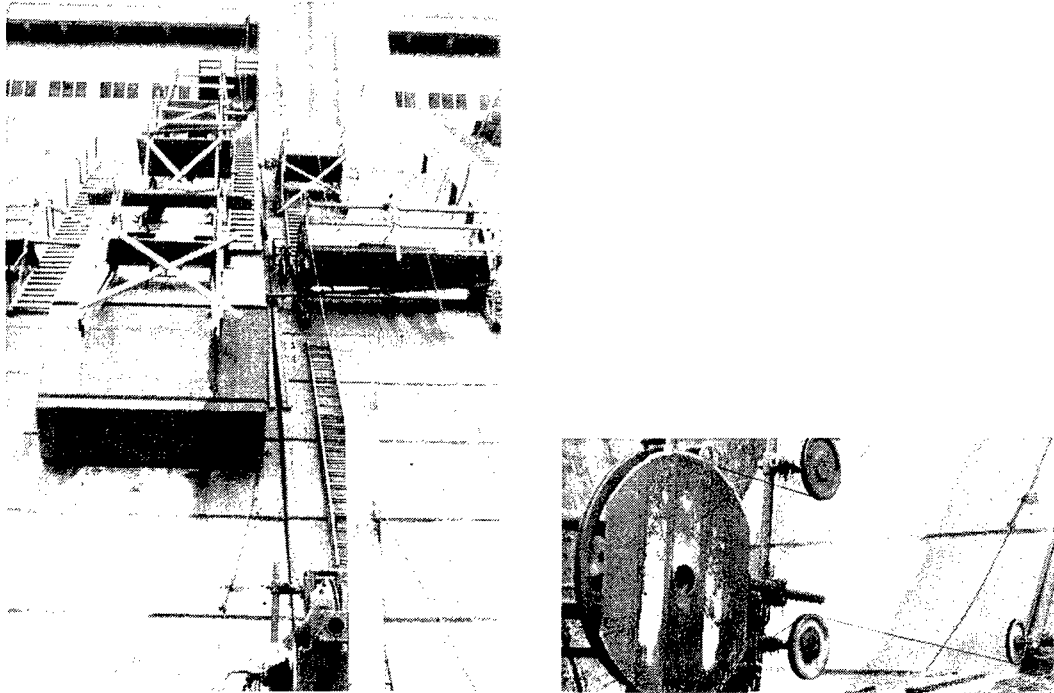
From the time the dam was constructed in the late 1960s, it had been slowly but steadily expanding. As a result, by 1988, a spillway structure pier had moved 30 mm (1-1/4 in.) off-line, there had been some gate obstruction and some cracking in the powerhouse generator floor. The expansion of the concrete

Figure 138. Diamond wire cutting of Mactaquac Dam

As the first cut closed behind the wire saw, the 'load' or pressure caused by the growth was transferred to the top half of the dam. Trentec's crew then moved their equipment to the very top of the dam (Figure 138) to begin the second vertical cut. The 10-mm- (3/8-in.-)wide cut began to close when the diamond wire saw was about 6 m (20 ft) from the top. The second vertical cut intersected the slot of the first cut, completing the project. The second cut relieved pressure on the top half of the dam.

Crews worked around-the-clock for 13 full days to make the two cuts, which covered a 483-sq m- (578-sq yd) cross-sectional area of the concrete structure. The 10-mm (0.4-in.) cut closed almost completely, and any small gaps were grouted and sealed. The leaning spillway pier “rebounded” by about 6 mm (1/4 in.) as the dam moved in and about (5/32 in.) 4 mm on the other side of the cut. The cutting program had “shrunk” the growing dam section about 10 mm (0.4 in.), the exact width of the cuts. This amount was estimated to be the equivalent of 1 year’s growth at the spillway east end pier.

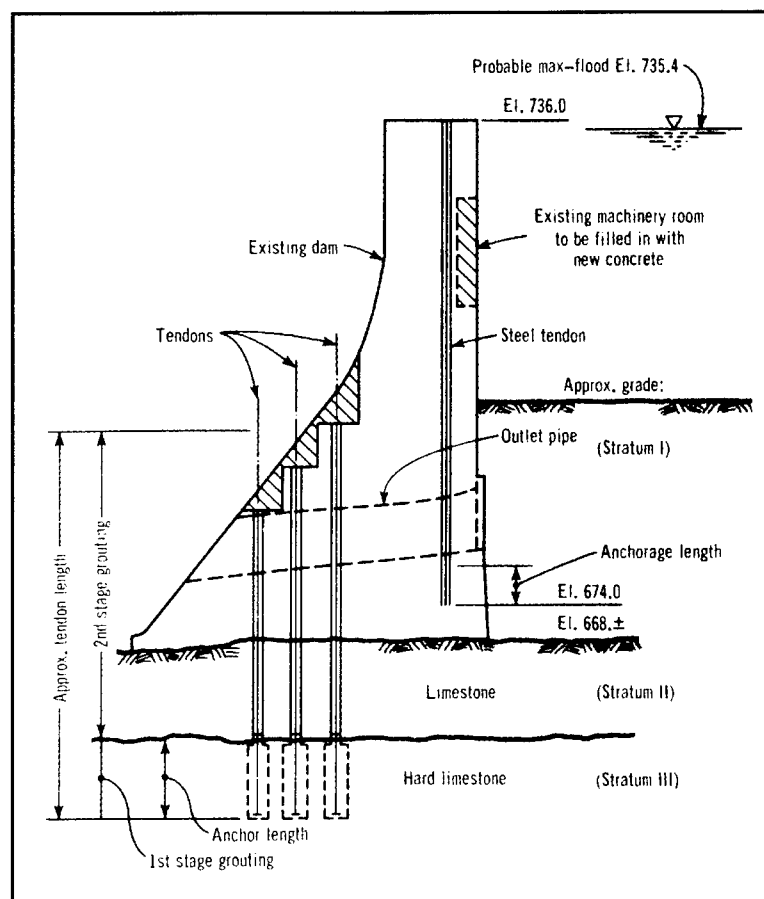
Figure 141. Placement of prestressed reinforcing to strengthen nonoverflow sections at Olmos Dam (from *Civil Engineering* 1982)

The first alternative considered was the placement of mass concrete on the entire downstream face of the dam. This option was rejected because of costs and the modifications to the existing stilling basin and sluice-way discharge at Olmos Creek that it would have required. The alternative selected was to strengthen the two nonoverflow sections with prestressed anchors installed in 2- to 3-m- (7- to 10-ft-) thick, hard limestone 15 m (50 ft) below the base of the dam (Figure 141) and to increase the stability of the spillway with mass concrete (Figure 142).

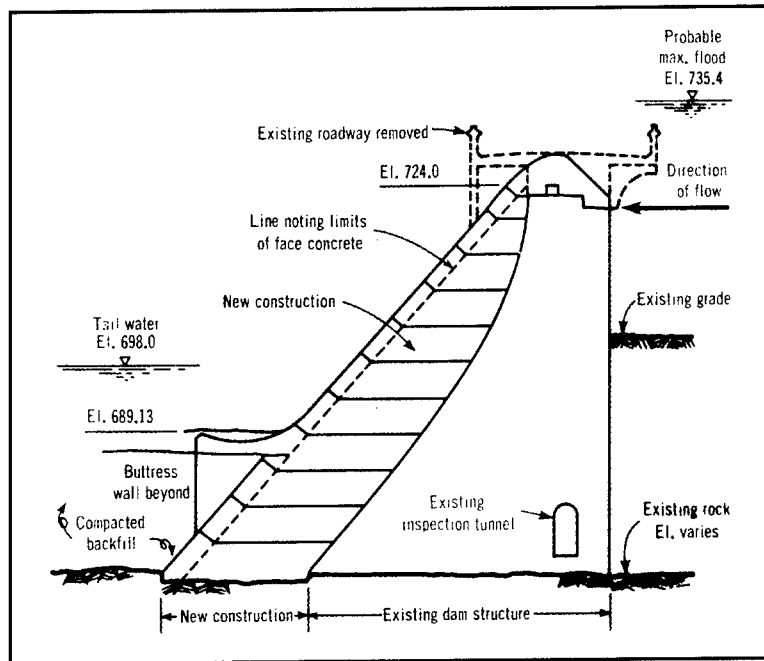
Figure 142. Spillway section strengthened with mass concrete at Olmos Dam (from *Civil Engineering* 1982)

Construction began in 1979 with the first project being the construction of a detour road, which specifications required to be open before Olmos Drive, located on top of the dam, was closed. Two problems that had to be overcome during construction were excessive groundwater in the limestone stratum at the contact plane for the dam and brecciated limestone rock in an area under the spillway. The brecciated limestone rock was grouted.

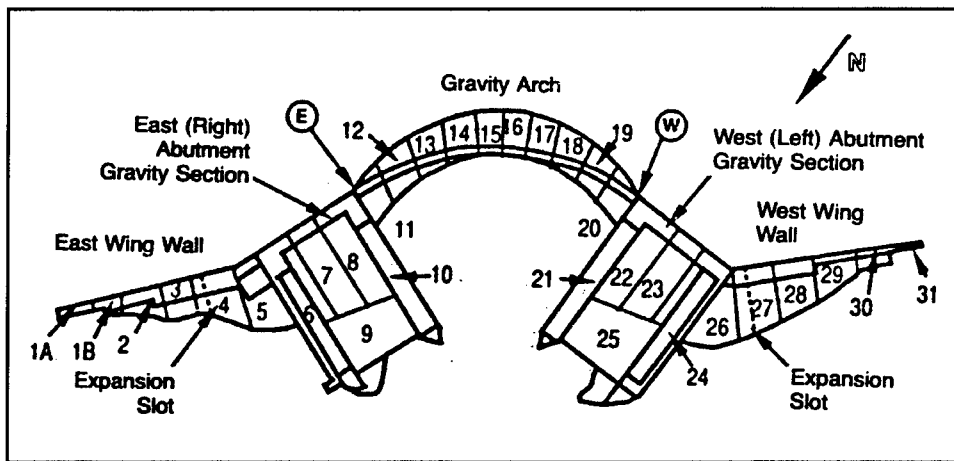
Figure 143. Layout of Shanteetlah Dam (from Bruce and Porcellinis 1991)

Routine measurement of deformation of the dam crest over a period of 25 years indicated that the crest had ratcheted (moved upstream in a cyclically increasing manner) since the 1930 and 1938 modifications, and the seepage volume had increased considerably. By 1987, seepage in the west abutment had reached over 4,000  $\mu\text{m}$  (1,050  $\text{gpm}$ ) and was entering the lower gallery at higher pressures and over larger areas than ever before. In addition, seepage from the downstream side of the gallery was also apparent (Bruce and De Porcellinis 1991).

Old construction records revealed that when repairs were made in 1930 and 1938 no structural connection was used to bond the new concrete to the old, except near the crest. Therefore, engineers attributed the steady ratcheting of the crest to thermal expansion caused by seasonal cycling. Displacements occurred along the interface between the original and new concrete. These upward deformations also caused construction joints to open seasonally, creating the possibility for concrete leaching (Bruce and De Porcellinis 1991).

A decision was made to use epoxy-resin grout to seal the joints and cracks in Santeetlah Dam. A 23-m- (75-ft-) long section in the most critical area was selected for treatment, which was conducted from within the lower gallery. The gallery is located about 3 m (10 ft) above the foundation and 4.5 m (15 ft) back from the upstream face. Cores up to 6 m (20 ft) long were taken from the upstream section of the dam to allow for inspection of the joints (Figure 144). The core holes revealed that water flows were traveling through the joints; the cores indicated the concrete was sound. A number of holes intercepted flows of 400  $\mu$ pm (105 gpm) at full hydrostatic head (Bruce 1989).

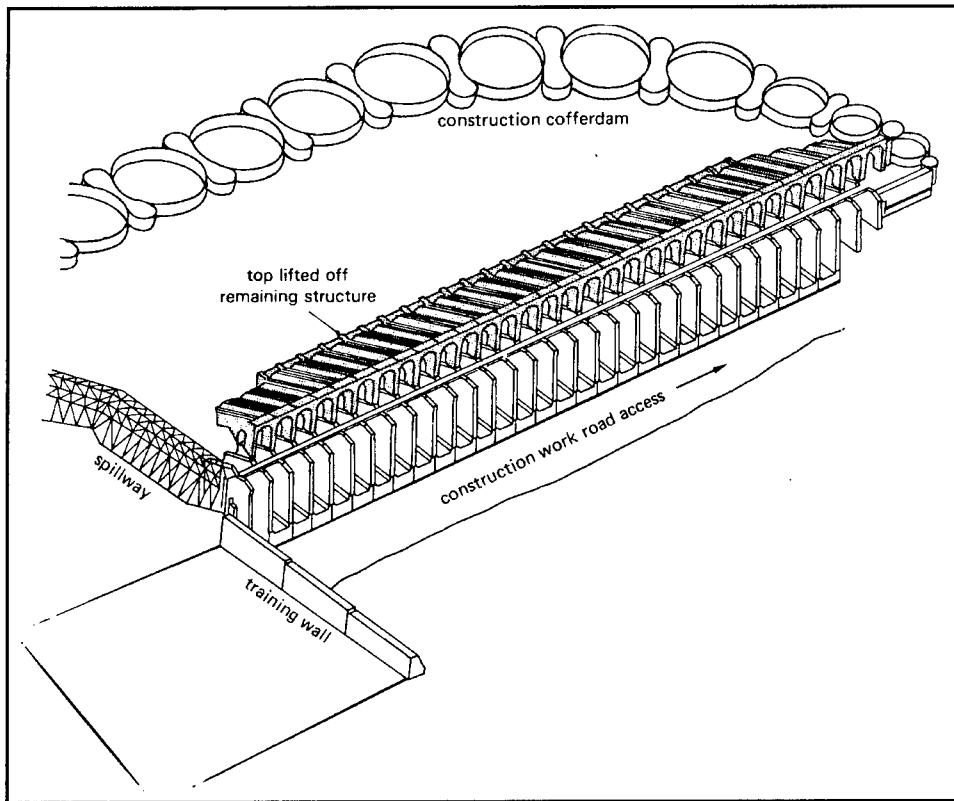
Over time the dam, which is more than 70 years old, suffered concrete damage as a result of chemical reaction and cycles of freezing and thawing. Despite extensive maintenance the deterioration continued to occur. By the mid-1980s, severe cracking in the dam's arches and buttresses was allowing water to penetrate the structure and cause structural damage (*Concrete Construction* 1994). A cellular cofferdam was installed to allow for a careful evaluation of the structure. This evaluation resulted in the decision to conduct a major rehabilitation, including modifying the buttress-arch design of the dam to a flat-slab design.

Figure 145. Overview of Sherman Island Dam rehabilitation project. The arch section of the dam was removed by diamond wire cutting (from Beckman and Hulick 1991)

Next came the demolition work on the dam. The foundation and lower buttress portions of the dam that had not been exposed to weathering were sound and usable; therefore, total concrete demolition was not required (*Concrete Construction* 1994). The entire reinforced concrete arch roof and selected areas of the buttresses would have to be removed (Figure 145). Partial removal of the concrete arches and severing reinforcing steel would affect the stability of the structure and increase the need to restrict heavy vibration. The contractor elected to use diamond wire-cutting technology to remove the concrete at Sherman Island Dam because of its successful use in recent years at large hydro-schemes.

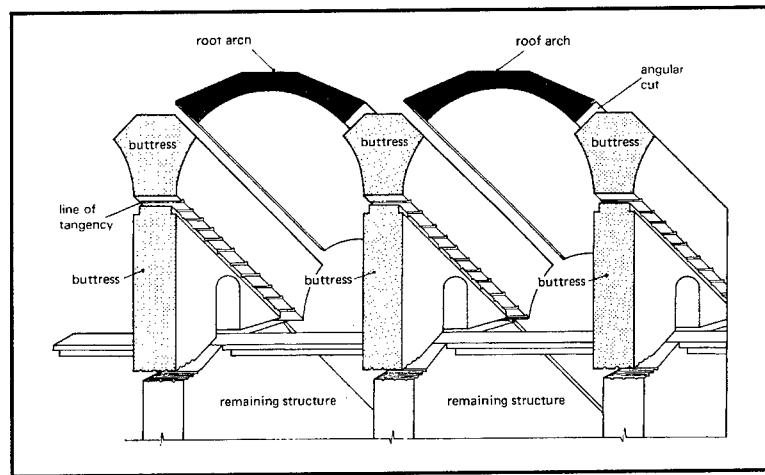
Figure 147. View of two arches prepared for removal at Sherman Island (from Beckman and Hulick 1991)

Work began on the upper arch sections. Two transverse cuts were made between the arches and buttresses in each bay across the 31-m (102-ft) width of the dam (Figure 147), and then three longitudinal cuts were made in steps along the 185-m (600-ft) length of the dam. The cut angle allowed the concrete arch to remain in position, without any additional shoring, until the contractor was ready to remove it. Access holes for the diamond wires, 20 to 40 mm (0.8 to 1.6 in.) in diameter and approximately 700 mm (28 in.) long, were drilled with percussion drills at the points where transverse cuts intersected longitudinal cuts. The wire saws were operated from the ground, from scissor lifts, or on large platforms anchored to the face of the dam. Some cuts required wires up to 80 m (260 ft) long (Beckman and Hulick 1991).

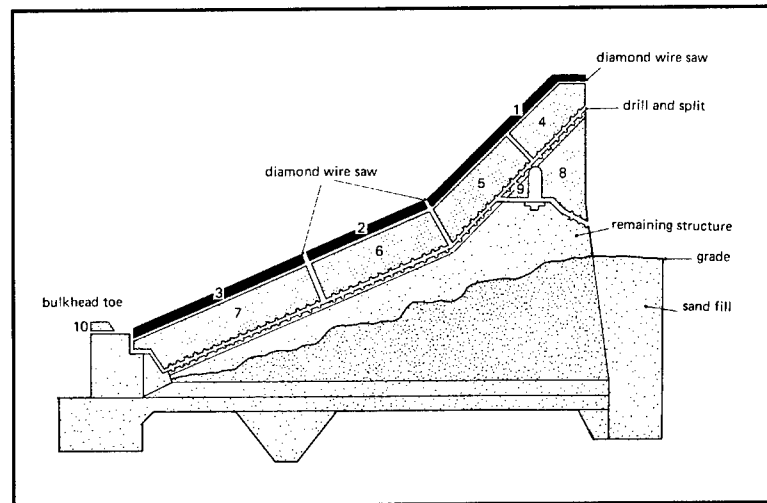
Figure 148. Order of removal of typical transverse section of Sherman Island Dam

Once the arches had been removed, the buttresses were drilled horizontally through the 1-m- (3-ft-) thick section along the line of tangency. Then hydraulic rock splitters separated the buttress along the unreinforced construction joint. Additional buttress sections were removed adjacent to the inspection gallery walkway, along with smaller sections at the bulkhead toe. Finally, bulkhead toe sections and other sections of concrete were removed from the lower upstream edge of the dam (Figure 148). The main scope of the concrete cutting work was completed within the required 16-week schedule (Beckman and Hulick 1991).

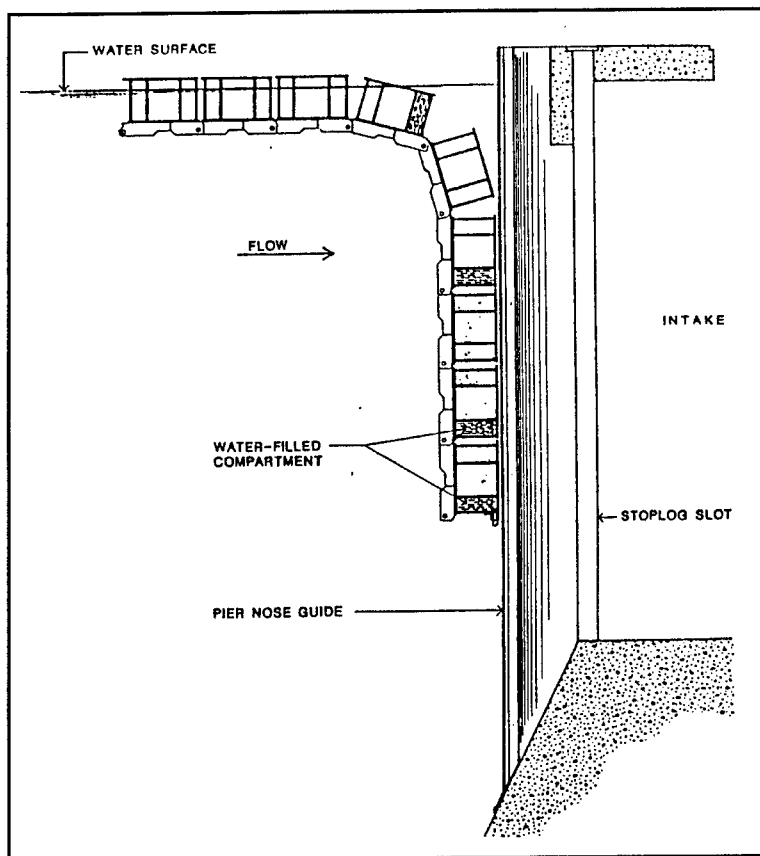
Figure 150. Floating caissons joined to form floating bulkhead at Snake River Dams (from Lux and Regner 1991)

because of its ability to conform to irregular, rough surfaces and its low cost of replacement. Rubber seals are used at steel surfaces. Small leaks through and around the bulkheads are expected; however, construction crews installing the bulkheads have sealed leaks with such materials as cinders and rubber hose.

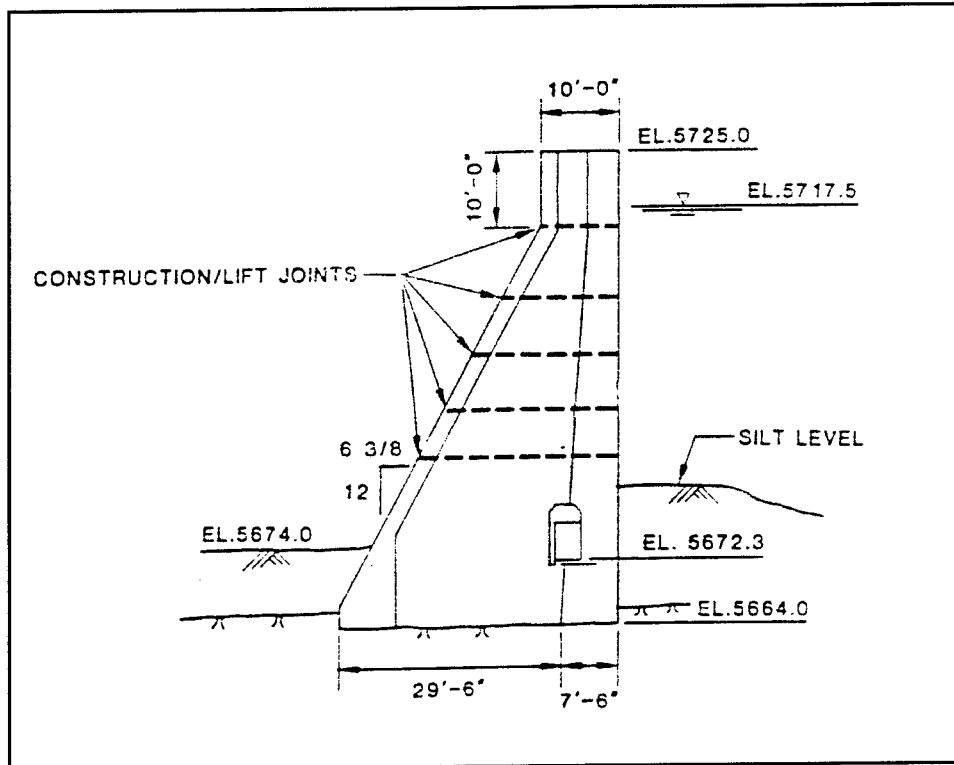
Minor leakage along lift joints has occurred during the life of the project. In the 1950s, a thin layer of shotcrete was placed on the downstream face of the dam in an effort to arrest concrete deterioration. Initially, this layer may have protected the surface from further deterioration, but ultimately, it probably contributed to increasing the rate of deterioration as minor leakage resulted in water being trapped behind the shotcrete. Inspections during 1990 revealed the existing shotcrete layer was delaminating from the underlying surface. This discovery prompted an investigation to determine the extent of deterioration. This case history is a summary of a report on the investigation and repair of Soda Dam by Marold, Koniarski, and Bruen (1992).

Much of the shotcrete layer covering the downstream face was removed to permit an inspection of the surface. Six core holes, ranging from 1.4 to 3.5 m (4.5 to 11.5 ft) deep, were drilled in the downstream face, and two vertical core holes were drilled through the entire height of the structure into the foundation. Samples were retrieved for compressive testing and petrographic analyses. The investigation revealed the following: in the upper 3 m (10 ft) of the structure and on the downstream face, advanced deterioration was found in the outer 0.3 to 0.6 m (1 to 2 ft) of concrete; microcracking with soft, carbonate-like fillings in the surface concrete on the downstream face indicated alkali-aggregate

Figure 151. Nonoverflow gravity dam section at Soda Dam (from Marold, Koniarski, and Bruen 1992) (multiply feet by 0.3048 to obtain metres; inches by 25.4 to obtain millimetres)

reactivity; compressive strengths in the downstream face and upper 3 m (10 ft) of the structure ranged from 10 to 20.7 MPa (1,500 to 3,000 psi), while concrete in the body of the structure had compressive strengths ranging from 20.7 to 27.6 MPa (3,000 to 4,000 psi); reactive aggregates were identified as part of the concrete, especially (rhyolites and other silica-rich aggregates); cracking was attributed to swelling of the calcium-alkali-silica gel by-product of the alkali-aggregate reaction and subsequent cycles of freezing and thawing.

The investigation also revealed that the nonoverflow gravity section was stable, structurally sound, and strong enough to resist overturning or sliding in its present condition for the normal operating loading. However, over time, continued seepage of water through cracks and joints could weaken the structure along horizontal construction joints (Figure 152). Once a large enough area was weakened, a sliding failure or increased leakage could result. A decision was made to eliminate the leakage through the structure. Several remedial techniques were considered. Chemical grouting of construction joints was selected as being the most cost-effective and best technical alternative.

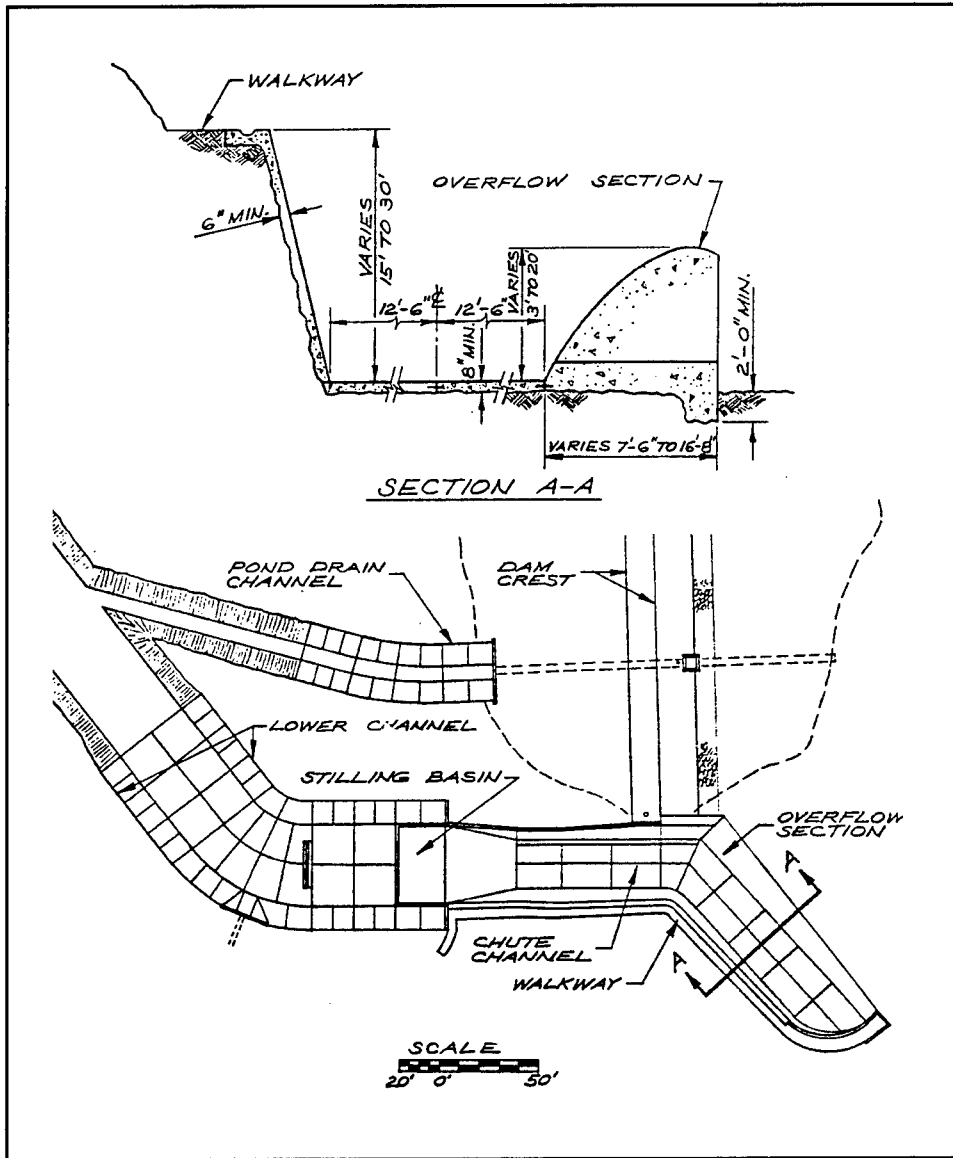
Soon after the dam was completed, progressive concrete deterioration in the spillway was noted. Repairs were made to the spillway wall and floor joints in 1949. A number of floor slabs were replaced, and prepacked aggregate and grout were used to repair the walls in February 1955. The entire floor below the overflow section was replaced in 1964, and additional repairs were made on the walls. The deterioration has been attributed to lack of quality control during construction, the use of tongue and groove joints, inadequate expansion joints, winter construction, and cycles of freezing and thawing.

The concrete continued to deteriorate--cracking, spalling, raveling rock pockets, and efflorescence were evident. By 1977 there was concern about the structural integrity of the structure, so a decision was made to inspect all concrete areas in the spillway and pond drain channels and to make repairs where needed. This case history is a summary of a report by Coghlan and Vanderpoel (1980) on the investigation and repairs made at Vesuvius Dam spillway.

Figure 154. General plan for Vesuvius Dam and spillway (from Coghlan and Vanderpoel 1980) (multiply feet by 0.3048 to obtain metres; inches by 25.4 to obtain millimetres)

The lowest of four bidders was an experienced shotcrete firm from Alabama. Repair work began in May. Chipping hammers were used to remove the deteriorated concrete. Then the exposed surface was washed and sandblasted. Wire mesh reinforcing was installed, and the shotcrete was sprayed on the prepared area to an overdepth. The surface was troweled smooth and brush finished. Because large repair surfaces were noticeably rougher than the original surface, the concrete in these areas was removed and repaired in 0.9-m (3-ft) sections. Plywood forms with chamfer strips served as a straight-line guide and support for finishing longer edge repairs. The repairs were completed in July.

The last step in the contract for repairs was to sandblast the walls of the spillway channel to clean them and then treated the walls with a double coat of linseed oil. The linseed oil was used to improve the weather resistance of the existing concrete as well as to blend the appearance of the old and new concrete. However, the concrete did not absorb the same amount of the oil: old concrete became darker, new concrete remained light colored, and the area around the repairs became very dark, especially where the area was smeared with grout.

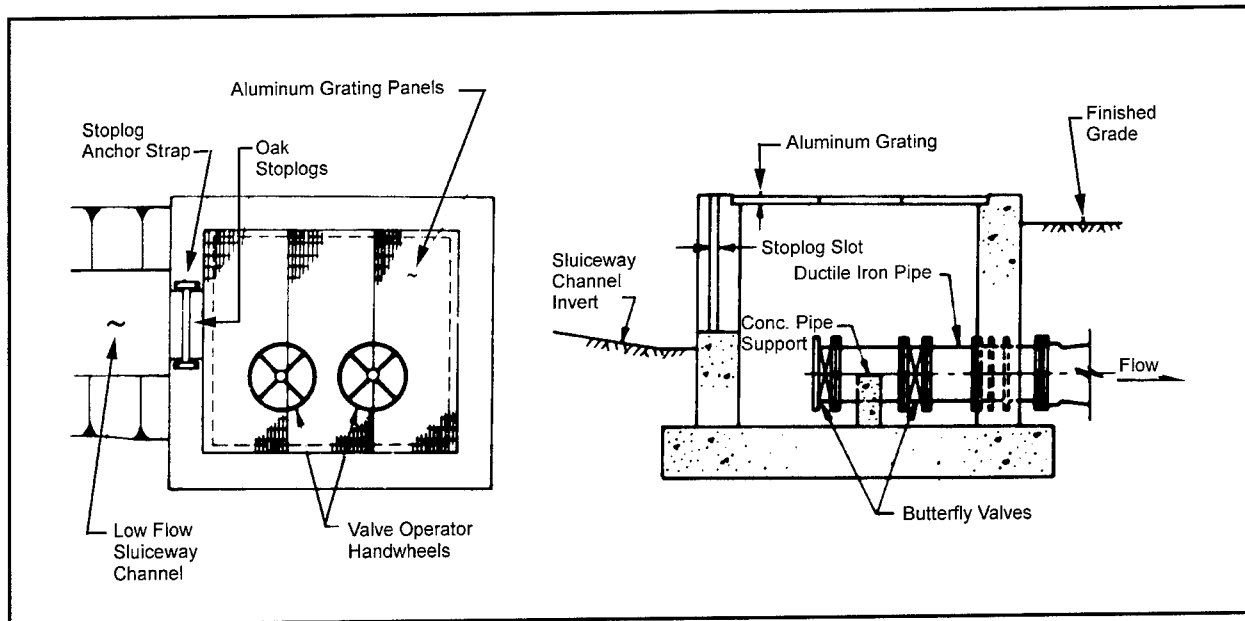
Figure 155. Plan for submerged intake structure at Waste House Dam No. 1 (from Kline 1992)

The submerged intake chamber (Figure 155) allowed for various foundation conditions and diver safety in valve operation. The intakes consist of a cast-in-place concrete chamber housing two valves in series mounted at the upstream end of the outlet pipe. The actuators for the valves were specially fitted with stainless steel parts to resist corrosion. The second valve was a backup for the first valve in case it failed to operate. A flap gate mounted on the pipe entrance would also meet this purpose. Aluminum floor grating placed on the cast-in-place valve housing served as an intake screen and working platform for the operator. In the event of an emergency, a diver could be onsite for valve operation within a day. Downstream valves controlled routine reservoir release.

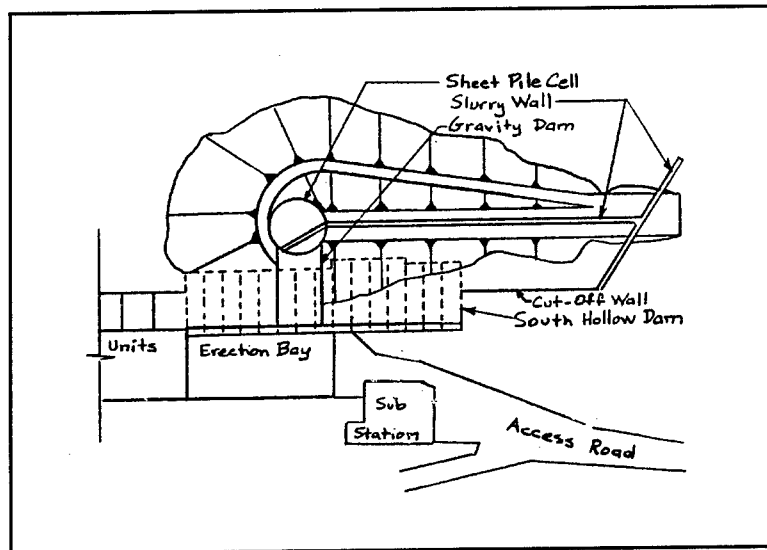
Figure 156. Plan for replacement of South dam at Wissota Hydroelectric Project (from LaMar, Iverson, and Tonke-White 1991)

Two types of replacement dams were considered: a cellular sheet-pile dam or a sand-fill dam with an impervious cutoff. Also, a matter of consideration was how new and rehabilitated structures would be connected. A study indicated a sheet-pile cell would provide the easiest way to connect the two structures. The cell would also provide support for dewatering a small area or for placing tremie concrete. The study also indicated a sand-fill dam would be the most cost effective alternative, but that connecting it to the existing dam would be difficult. The final decision was a combination of the two alternatives (Figure 156).

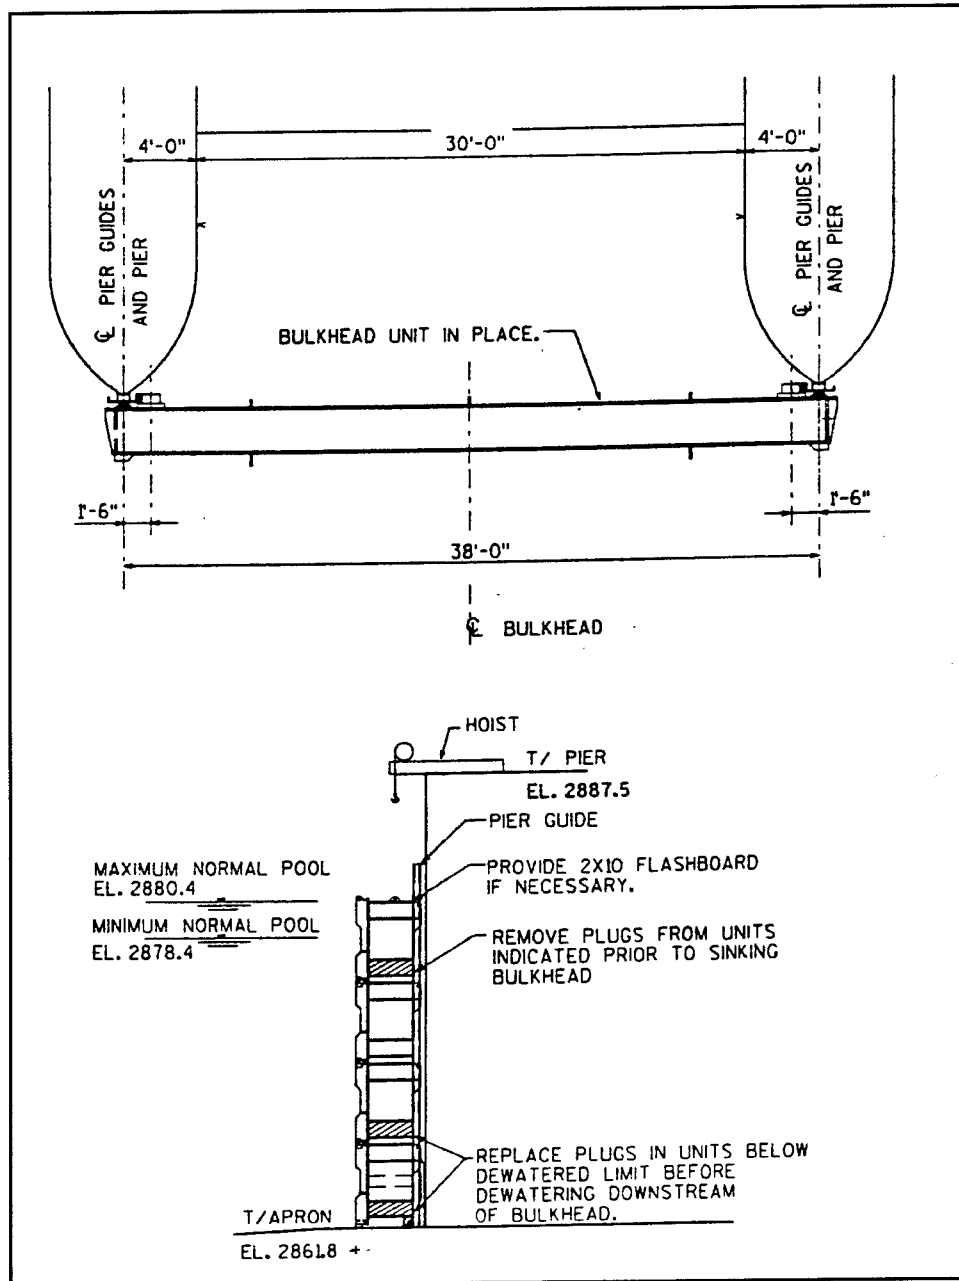
Figure 157. Cross section of design of floating bulkhead, Wissota Hydro Project

To repair head gates, stoplog slots, and trash racks, NSP had to develop a way to seal the entire fore bay of each unit or lower the reservoir to perform the repairs. Work in the head gate area would require a minimum of 4.6-m (15-ft) drawdown of Lake Wissota, which has a normal full-reservoir volume of 69,076,000 cu m (56,000 acre-ft), and the existing stop-log support trusses were too badly deteriorated to be considered. Rather than rent a barge and crane, NSP had an articulated floating bulkhead designed and fabricated for the project. The floating bulkhead was very similar in design to the one used at Snake River Dams. It was installed at the intakes of Lake Wissota hydroplant in 1987 (Figure 157) (Lux and Regner 1991).

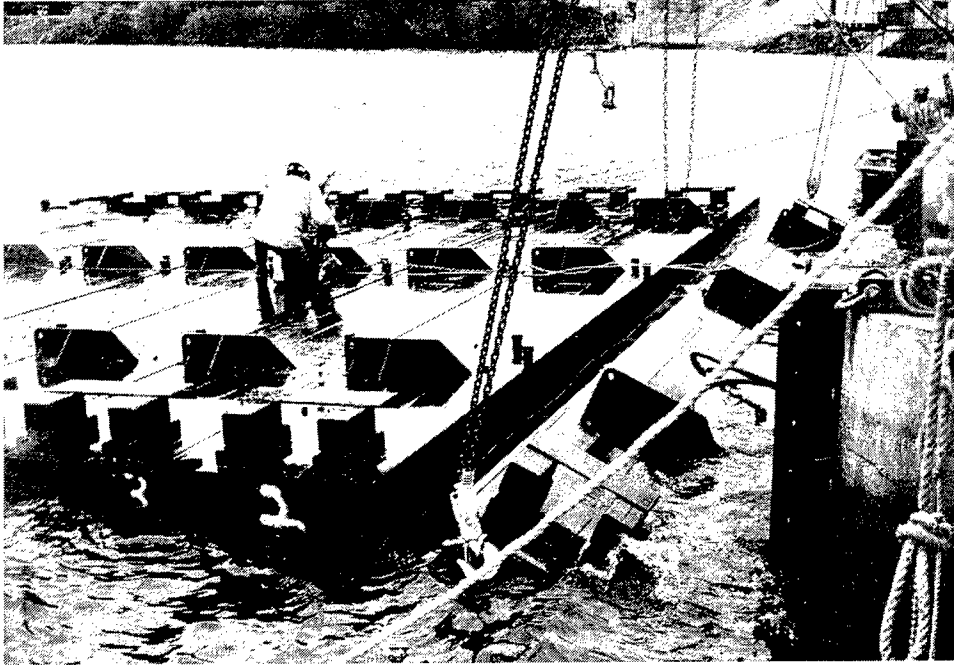
Figure 158. Caissons fill on floating bulkhead, causing bulkhead to sink, Wissota Hydro project

The floating bulkhead is constructed of nine caissons, each comprised of three compartments, which are used to float or sink the unit (Figure 158). The caissons are placed in the water and then linked together to form the bulkhead. The floating bulkhead fabricated for Wissota Hydro Project is 11 m (36 ft) square and 0.7 m (27 in.) thick when fully assembled (Figure 159). Because of its buoyancy, only 1,270 kg (2,800 lb) of the 62-Mg (68-ton) mass of the structure rests on the concrete below the headgate. Steel and wooden vertical guides installed on the pier noses are used to align the bulkhead. To sink the unit, the caissons are selectively filled. Water pressure from the lake seals the bulkhead. When repairs are completed, the water-filled compartments of the caissons are emptied, and the unit rises to the surface. The bulkhead has been installed in less than 2 hr and removed within 30 min. The bulkhead cost about \$130,000 (Lux and Regner 1991).

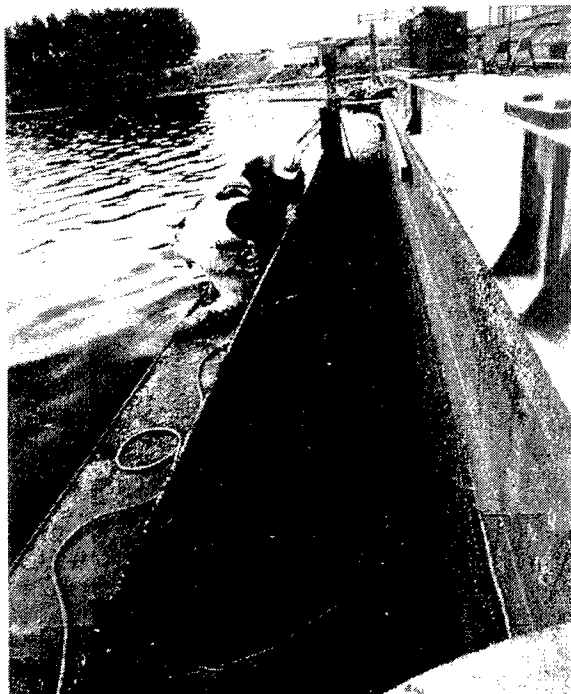
Figure 159. Floating bulkhead used to repair head gates, stop logs, and trash racks at Wissota Hydro Project
