Technical Report GL-99-11  
December 1999

# **A Case History of Embankment Failure: Geological and Geotechnical Aspects of the Celotex Levee Failure, New Orleans, Louisiana**

by Joseph B. Dunbar, Victor H. Torrey III, Lillian D. Wakeley

Geotechnical Laboratory  
U.S. Army Engineer Research and Development Center  
3909 Halls Ferry Road  
Vicksburg, MS 39180-6199

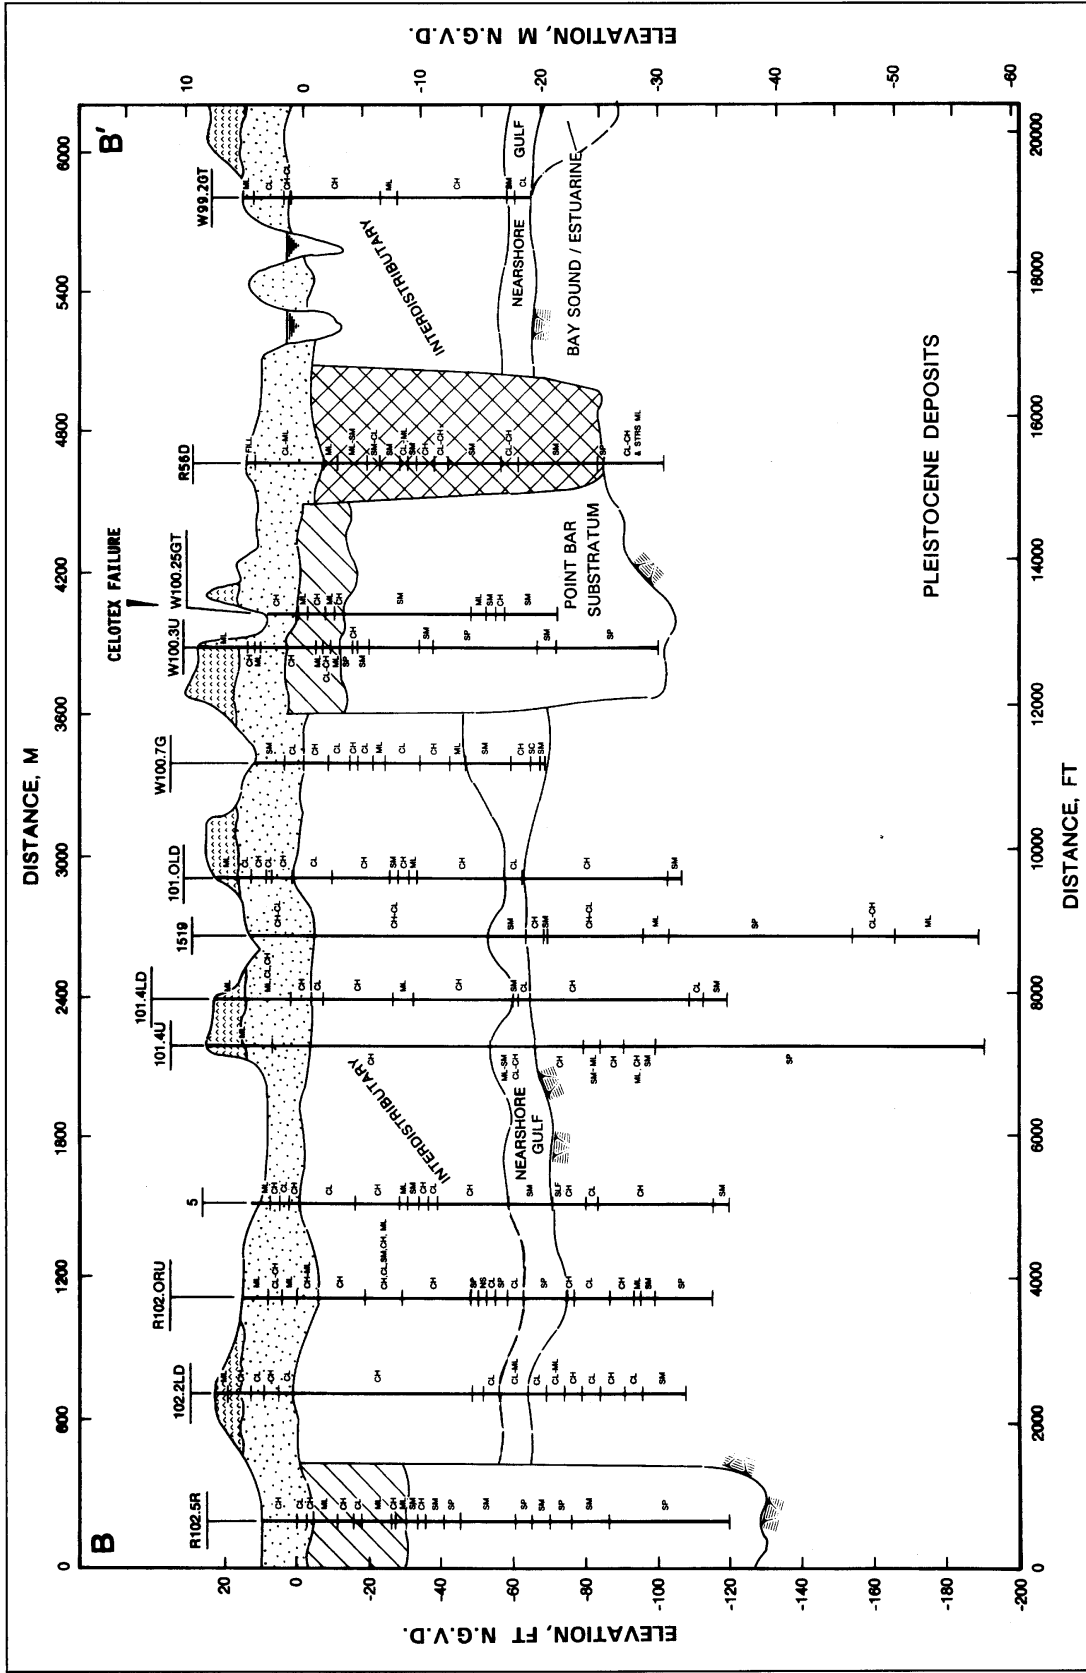
Figure 5c. Geologic cross section B-B' (see Figure 5f for symbol legend)

This riverbank reach extends from river mile 98.3 to 102.0 (158.2 to 164.1 km) on the right descending bank. The subsurface geology of the Celotex failure site is shown by cross sections B-B' (Figure 5c) and F-F' (Figure 5i). The locations of these sections are shown in Figure 4. Areal photography and boring data identify a point bar sequence (Figure 4 and 5c) associated with Bayou des Familles (Figure 5i). This distributary channel was a major course of the Mississippi River during the active St. Bernard delta complex.

The Celotex failure site is located within the Greenville bend scour pool area, along the downstream margin of the zone where maximum movement has occurred. Considering the overall nature of the geology at this site (Figure 5c), the historic channel migration (Figure 8b), and the distribution of thalweg profiles at this location (Figure 9c), the Greenville Bend reach will be an area to monitor because it has indicated instability in the past.

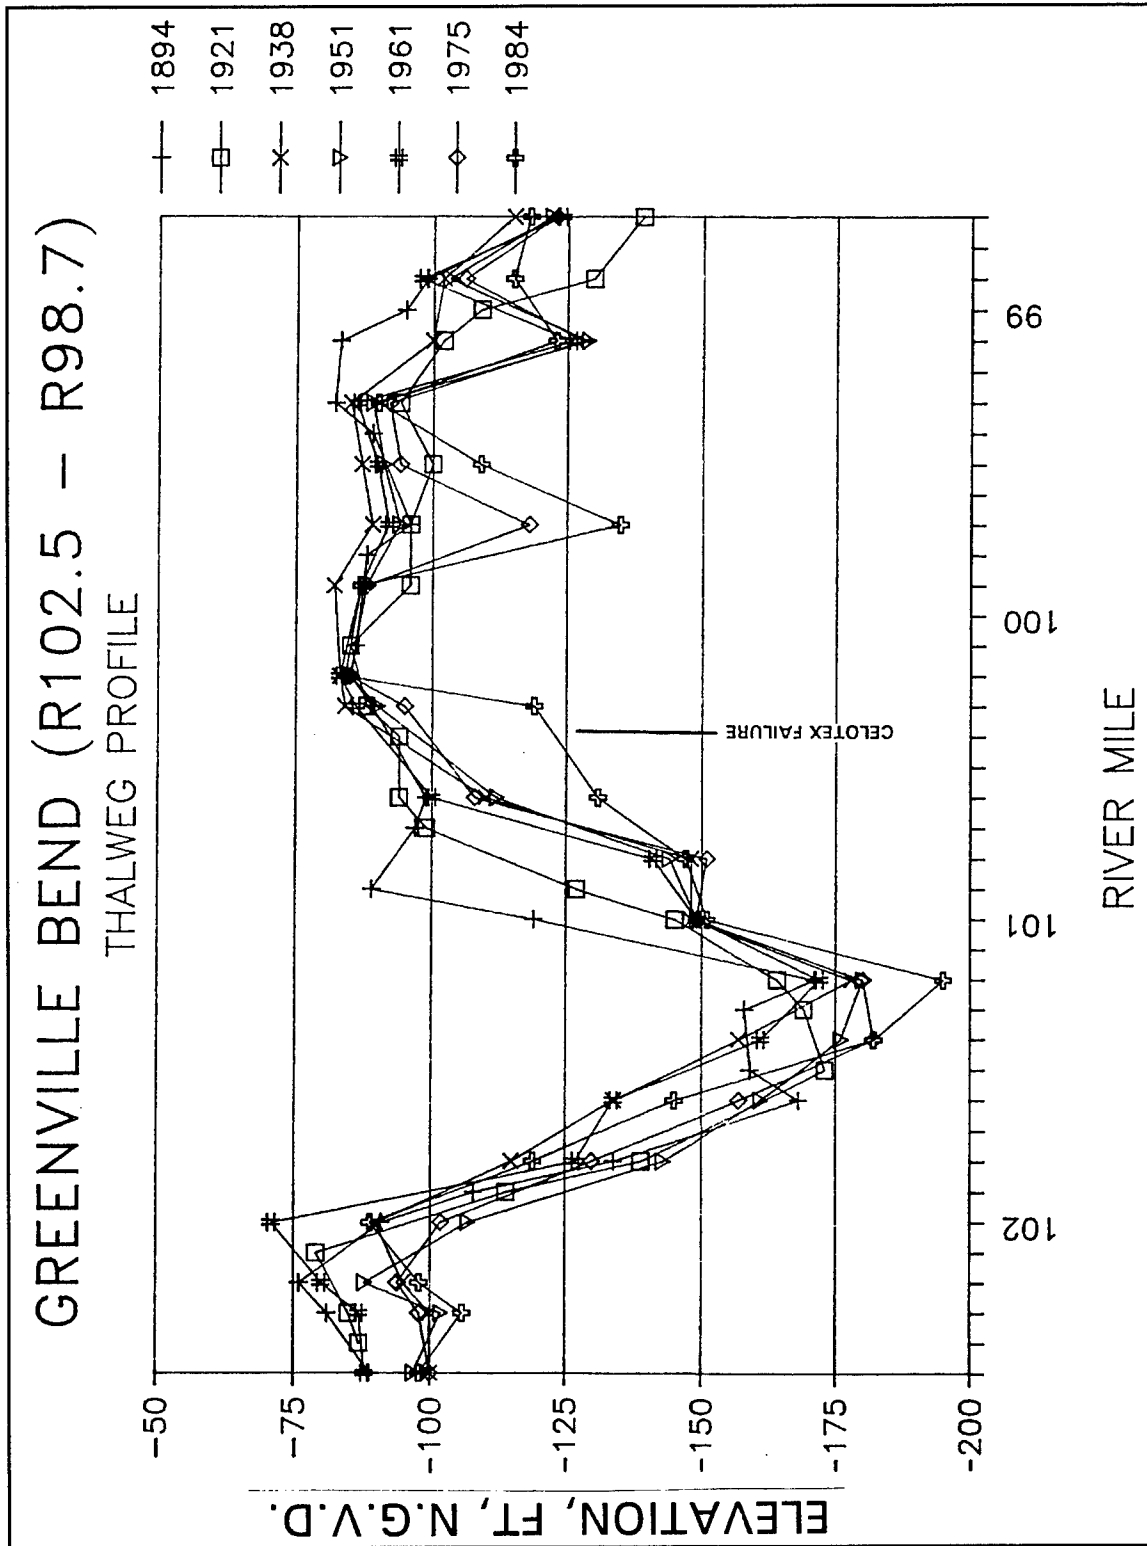
Figure 9c. Thalweg profiles at Greenville Bend

River depth variability and the general historic trend at each scour pool are shown by the thalweg profiles. Examination of Figure 9a shows that in the New Orleans reach there are three major scour pools that are deeper than el -150 ft (-45.7 m) NGVD. The deepest pool in the study reach is at Algiers Point. The maximum depth at Algiers Point was at el -208 ft (-63.4 m) NGVD and occurred during the 1938 survey period. For the most recent survey period, the maximum occurs at Greenville Bend with a scour pool depth near el -200 ft (-61 m) NGVD. The Celotex failure is located along the downstream margin of the Greenville Bend scour pool (Figure 9c).

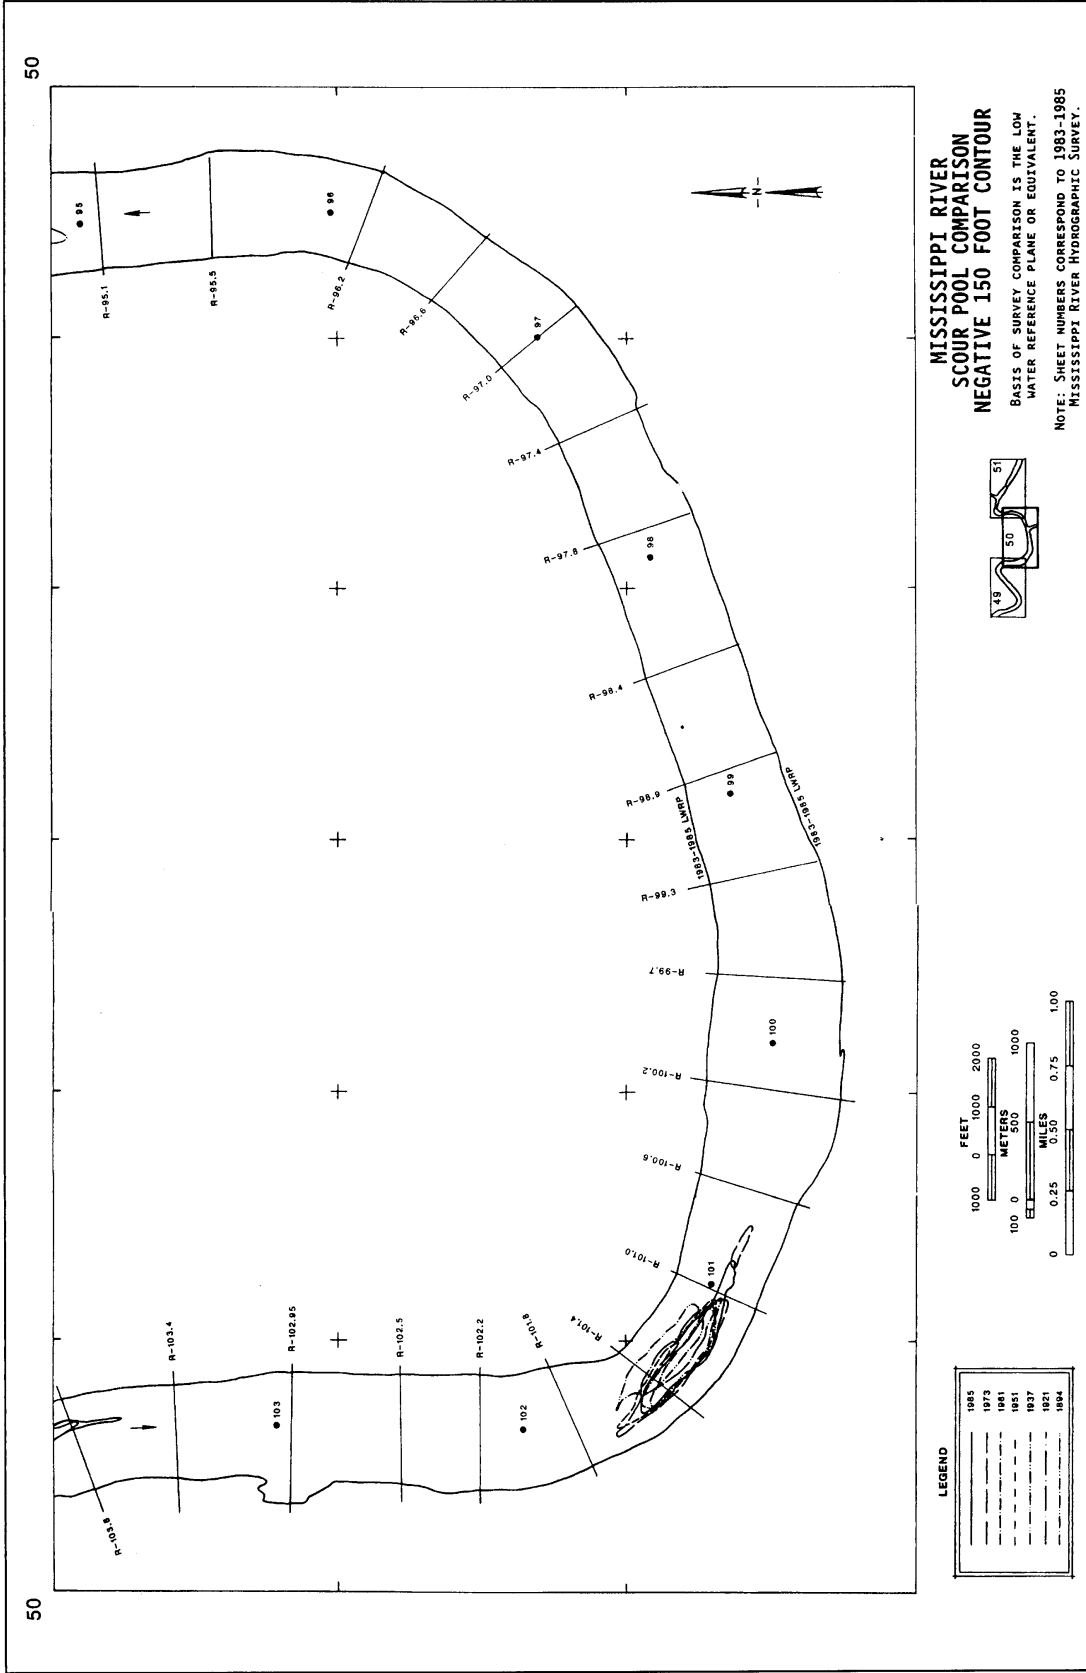
Figure 11b. Scour pool comparisons for the -150-ft (-45.7-m) contour from river mile 103.8 to 95.0

- b. *Greenville Bend*. This pool has experienced the most lateral migration, both bankward and downstream as indicated by the 1984 contour (Figure 11b). The 1984 contour shows that the Greenville Bend scour pool has shifted slightly downstream and become one pool instead of two separate pools as in the 1973 survey.

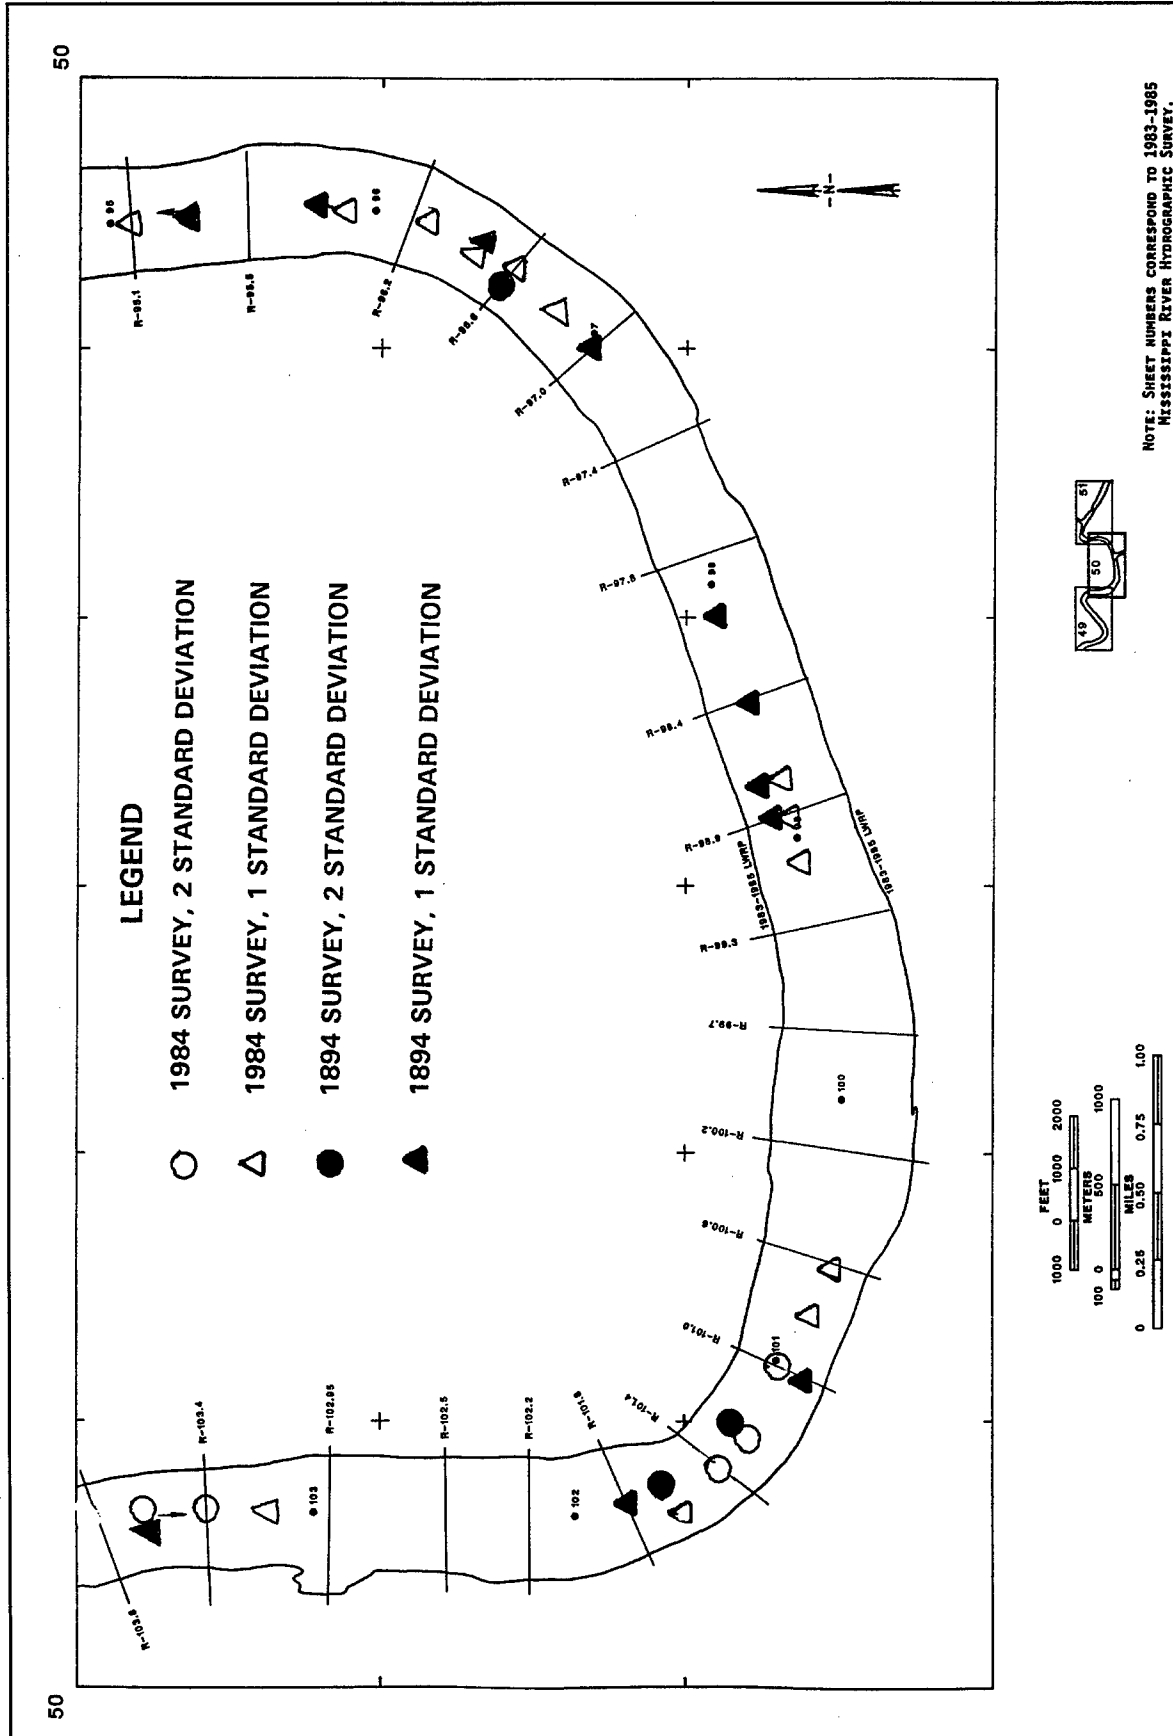
Figure 13b. Locations of W:D ratios for Greenville Bend at 1 and 2 standard deviations below the mean value (Figure 12)

As seen from Figure 13b, the Greenville scour pool has migrated downstream and possibly enlarged according to the low W:D ratios at this location. A similar trend occurs at Carrollton Bend (Figure 13a). At Gretna Bend, the scour pool has shifted upstream between river mile 98 and 99, (157.7 and 159.3 km) and remained nearly constant between river miles 96 and 97 (154.5 and 156.1 km) (Figure 13b). The scour pool at Algiers Point (Figure 13c) has expanded upstream but has not generally moved downstream. Again, W:D data generally indicates that the frequency of locations with W:D ratios below the mean value has increased. Consequently, the general trend has been toward channel deepening with a corresponding reduction in channel width.

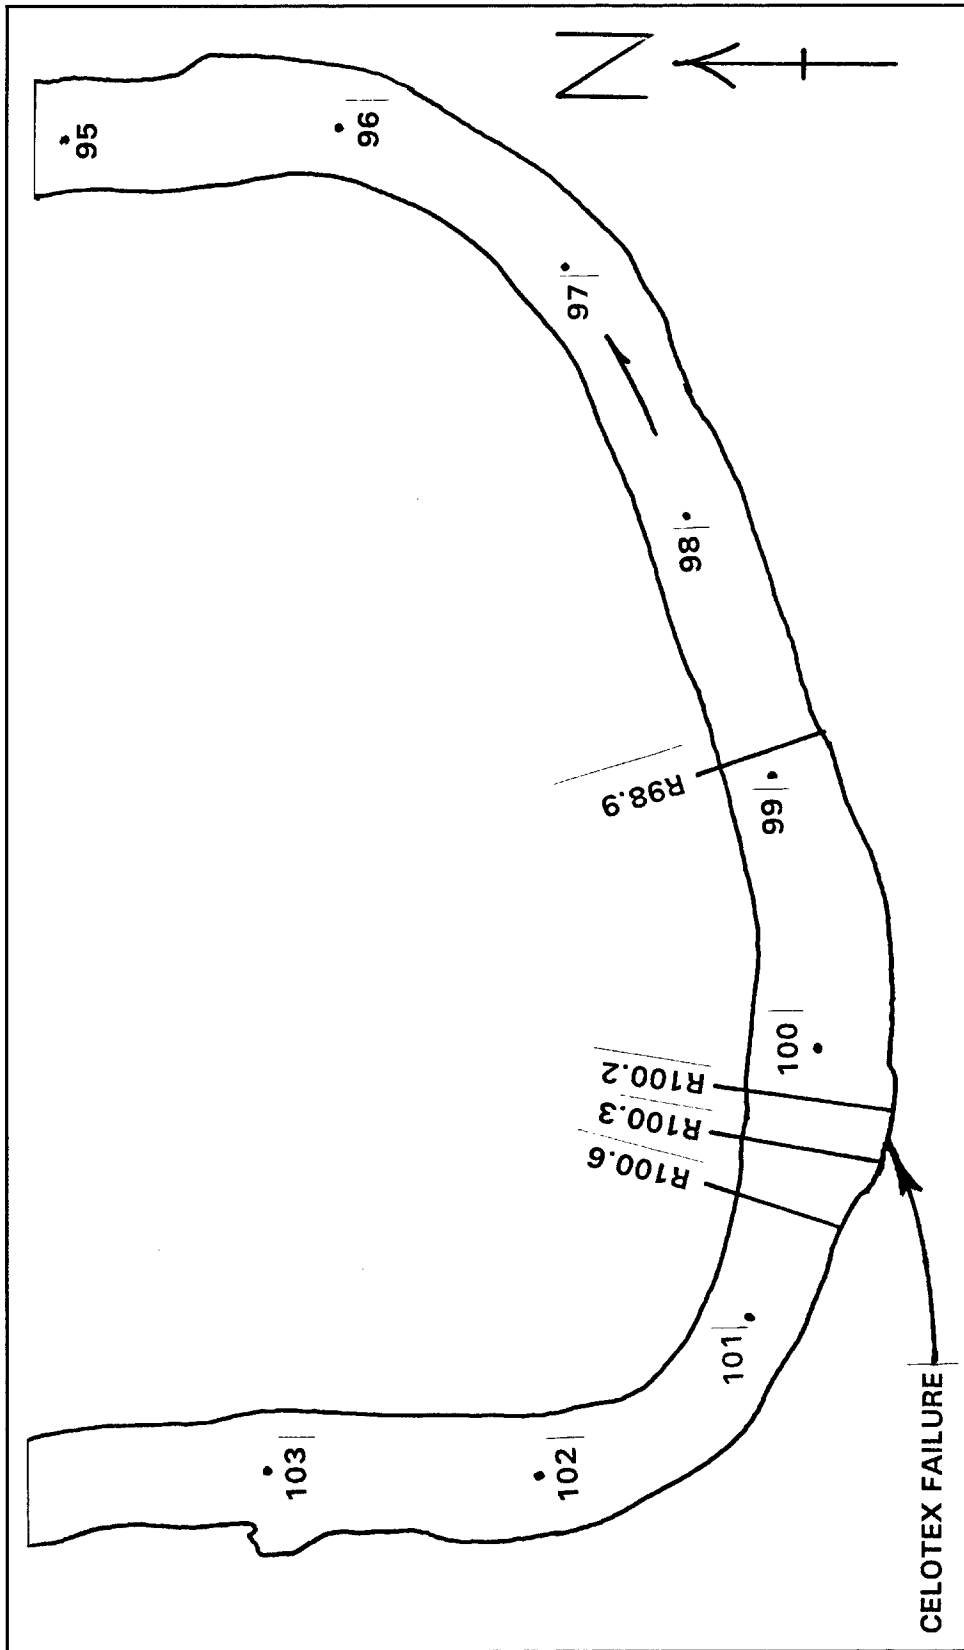
Figure 14a. Map showing locations of river profiles

indicated, there isn't a profile exactly at the failure location. Instead, profiles occur immediately upstream (i.e., R100.3) and downstream (i.e., R100.2) from the failure site as shown by Figure 14a.

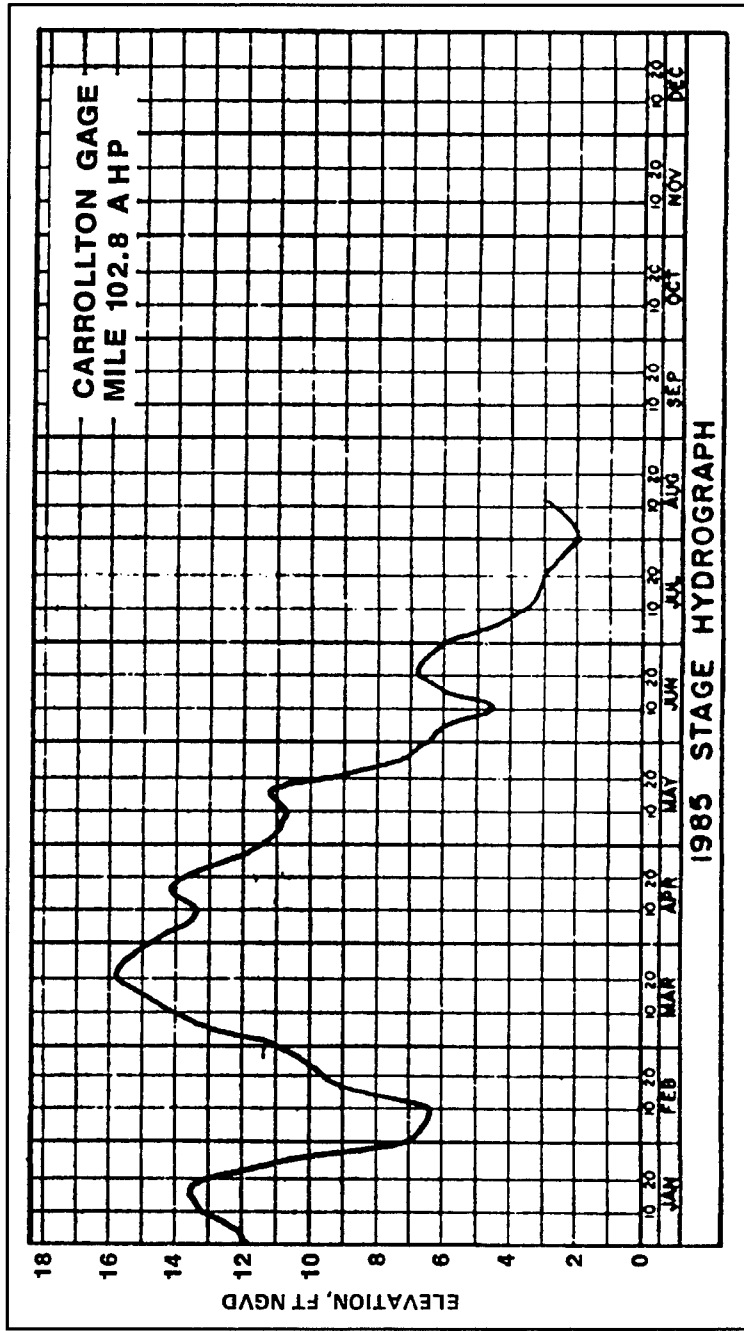
Figure 23. Hydrograph from the Carrollton gage during the period of the Celotex failure

An important consideration in evaluating and understanding the Celotex failure is the Mississippi River stage prior to the failure. A stage hydrograph for the Carrollton gage located about 2.5 river miles (4.0 km) upstream of the failure location is shown in Figure 23. On the day of the failure (i.e., 30 July 1985), the river had reached its lowest level during the year at about elevation 2.0 ft (0.6 m) NGVD. Immediately following the failure, the river began to rise and continued to rise during the repair operations (Figure 23). The river was falling prior to the failure, beginning in late June at an average rate of only about 0.1 ft (3.0 cm) per day. The stage hydrograph in Figure 23 shows that the general trend since mid March was a steady decline from its peak at about el 16 ft (4.9 m) NGVD.
