# WIRE STRIKE REPORT

**WIRE STRIKE MISHAP ANALYSIS REPORT**

Report No. 71-2

**UNITED STATES ARMY BOARD FOR  
AVIATION ACCIDENT RESEARCH  
Fort Rucker, Alabama**

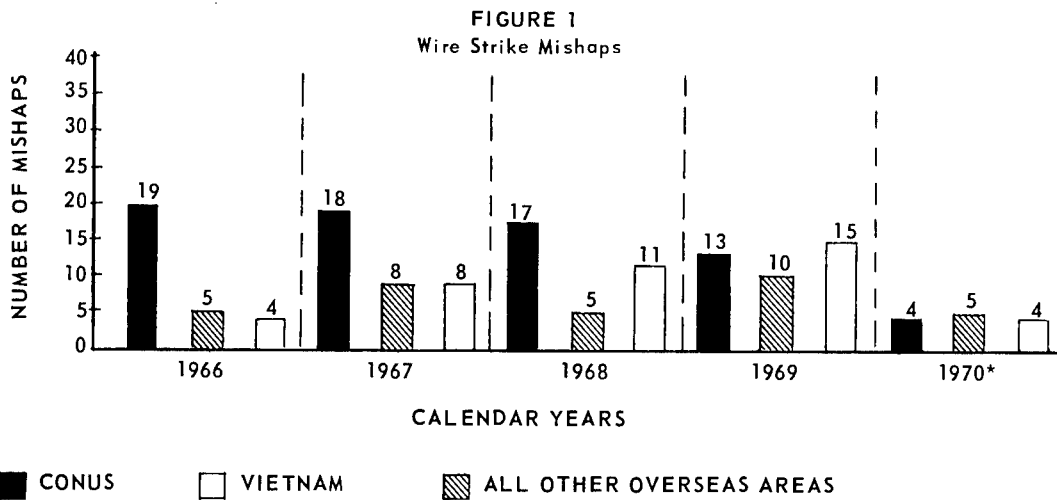
**V. DISCUSSION.** Figure 1 shows fixed and rotary wing wire strike mishaps by calendar years and location. The 4½ years of data reveals that in-flight collision with wires remained fairly constant, with an average of approximately 32 wire strike mishaps per year. Forty-nine percent of the total wire strikes occurred in CONUS. Vietnam accounted for approximately 29% and other overseas areas (USAREUR, Pacific, Alaska, etc.) reported the remaining 22%. CONUS showed a slight decrease in wire strike mishaps, from 19 in 1966 to 13 in 1969. Vietnam, however, indicated an increase from four in 1966 to 15 in 1969. It is believed the increase in Vietnam mishaps was primarily due to the increase in the flying hour program beginning in CY 1967, the low level mission requirements dictated in the Vietnam operation, and the aviator himself.

Even though figure 1 seems to indicate a decreasing trend for CONUS and an increasing trend for Vietnam, the average wire strike encounters per calendar year for both rotary and fixed wing aircraft remain fairly constant.
