US Army Corps of Engineers. Engineer Research and Development Center

Structural Evaluation of Aircraft Hangar 46, Corpus Christi Army Depot

February 2001

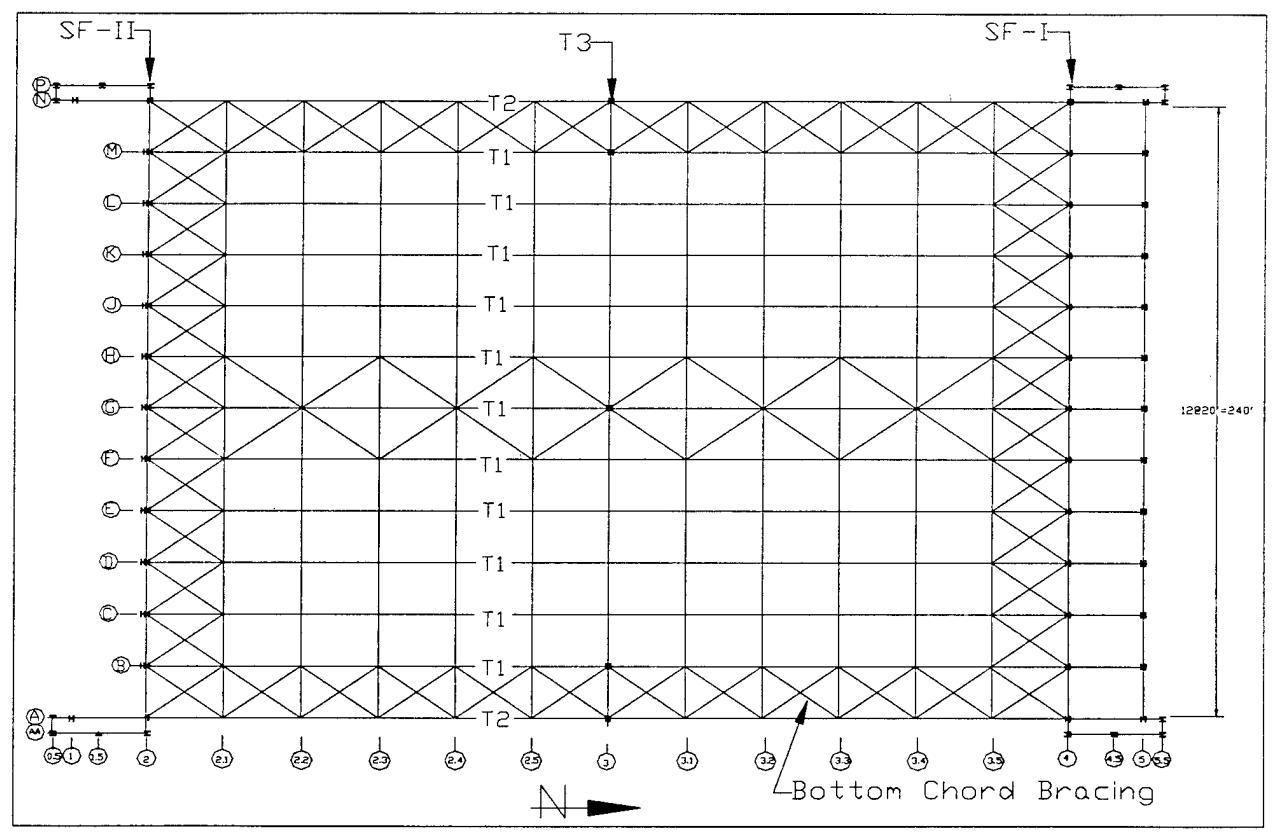
Figure 4-1. Plan view and location of truss types.

There are five different typical trusses in Hangar 46. The locations of the trusses in plan for the hangar were taken from NAVFAC drawing 1353171. There are 11 trusses called T1 in the main interior that run north-south. Two type-SF trusses, one at each end, and one type T3 truss run perpendicular to the T1 type trusses. The T1 trusses span from SF at the north and south ends of the hangar area to the center truss called T3. There are two T2 trusses, again spanning from SF to T3, on the exterior edges above the hangar doors. The north end of T1 and T2 trusses are braced with moment-resisting frames. T3 vertically supports all T1 and T2 trusses at their center and provides lateral bracing. The SF trusses support the T1 and T2 trusses at each end, vertically and laterally in the east-west direction. The T1 and T2 trusses are laterally braced at the bottom chord members by horizontal diagonal bracing and channel sections, as seen in NAVFAC drawing 1353171. There are two types of SF trusses, SF-I and SF-II. Both the loading and structure of each type is distinct. SF-I is found at the north end, where there are braced bays with offices and storerooms; SF-II is found at the south end, where there are no braced bays, just an outside wall. Figure 4-1 shows the plan view of Hangar 46.

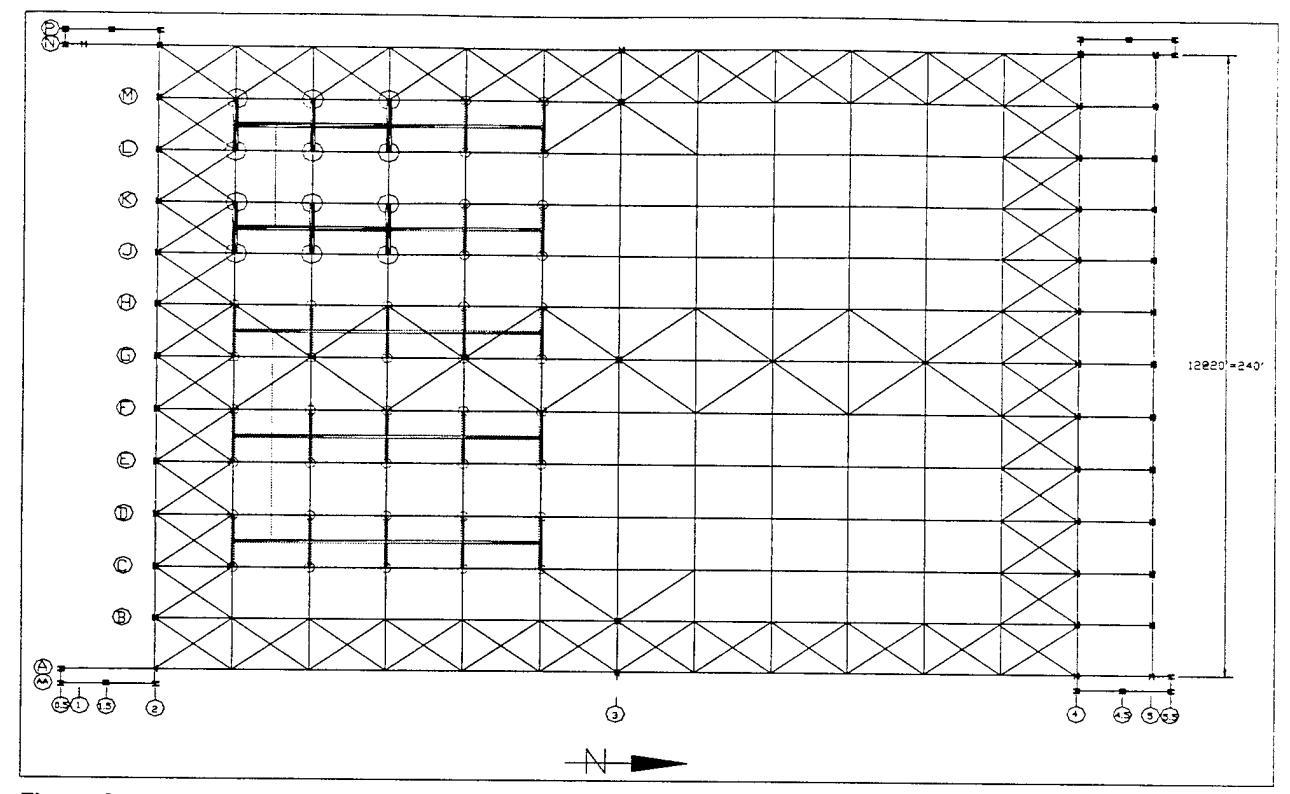
Figure C-1. Location of current and proposed railway crane.

Attached as Appendix C is a memorandum pertaining to the crane installation in Hangar 46, including a diagram of the current and proposed crane locations and a photograph of the current system in Hangar 46. It was submitted by the project team's structural engineer as an initial opinion on the safety of expanding the crane system. The recommendations were based on the assumption that the existing crane system is safe according to current codes. However, after structural analysis it was determined that Hangar 46 requires some structural rehabilitation because the old crane system puts stresses on trusses T1 and T3 that exceed AISC ASD 89 allowable limits. Therefore, retrofit as proposed in Chapter 8 is necessary.
