Damage mechanisms and non-destructive testing in the case of water ingress in CF-18 flight control surfaces

Technical Memorandum

DCIEM TM 2000-098

August 2000

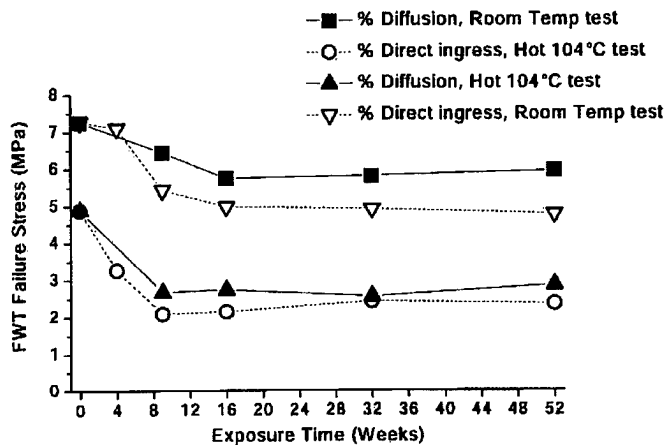
Immersion of aluminum joints in water or exposure to high humidity normally leads to a substantial loss in joint strength, but exposure to moderate humidities for long periods does not normally lead to permanent strength loss [9]. Hence, this effect is relatively unimportant compared with environmentally induced loss of adhesion at, or close to, the metal oxide/adhesive interface due to water ingress. Although the difference between the strength for direct ingress and diffusion ingress specimens is not great when wet/moist (Figure 4), the failure mode is fairly different. After long-term exposure, the diffusion ingress samples show cohesive failure in all cases (i.e., through the adhesive) while direct ingress samples failed at the adhesive to core interface [3].

Figure 4. FWT test results for direct moisture ingress and diffusion moisture ingress tested under room temperature and 104°C test conditions from [3].

This difference in the degradation mechanisms between diffusion and direct ingress cases is supported when considering the dry recovery of the specimens (Table 1). The diffusion specimens recover much of their original properties which indicates that reductions in Flatwise Tension (FWT) strength are due to moisture in the adhesive causing plasticisation and not due to any permanent degradation of the adhesive bond. On the other hand, the direct ingress specimen did not recover their full FWT strength. This loss of strength indicates that some level of permanent adhesive bond degradation has occurred [3].

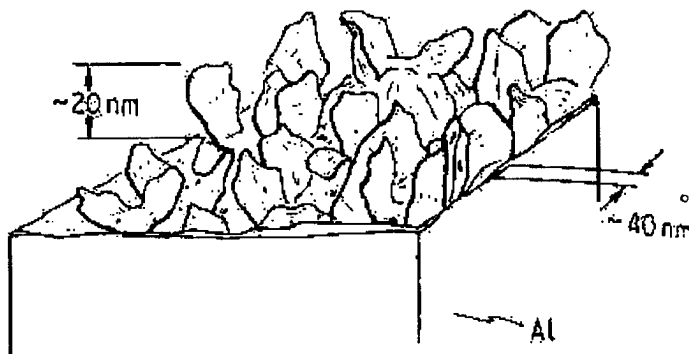
Weakening of the oxide by hydration involves permeation of water through the adhesive, hydration of the oxide and cleavage of the mechanically weak hydrated oxide [11,24,25]. Specifically, water initially passivates the oxide film and protects the metal from attack during an "incubation" period. The intense hydration activity will convert the original oxide to a hydroxide. It is the hydration of aluminum oxide on the adhesive/adherend interface that likely plays an important role in joint failure. Venables [26] found that pseudo-boehmite (Figure 5) may be created by the reaction

Figure 5. Characteristic "cornflake" structure associated with pseudo-boehmite morphology from [9].

The conversion of aluminum oxide to hydroxide is accompanied by a threefold increase in thickness, and the adhesion of the hydroxide to aluminum is sufficiently weak that once the hydroxide forms, it separates from the adherend and leads to bond failure. Experiments [26]
