AIRCRAFT ACCIDENT REPORT

In-flight Breakup Over the Atlantic Ocean
Trans World Airlines Flight 800
Boeing 747-131, N93119
Near East Moriches, New York
July 17, 1996

**NTSB/AAR-00/03
DCA96MA070
PB2000-910403
Notation 6788G
Adopted August 23, 2000**

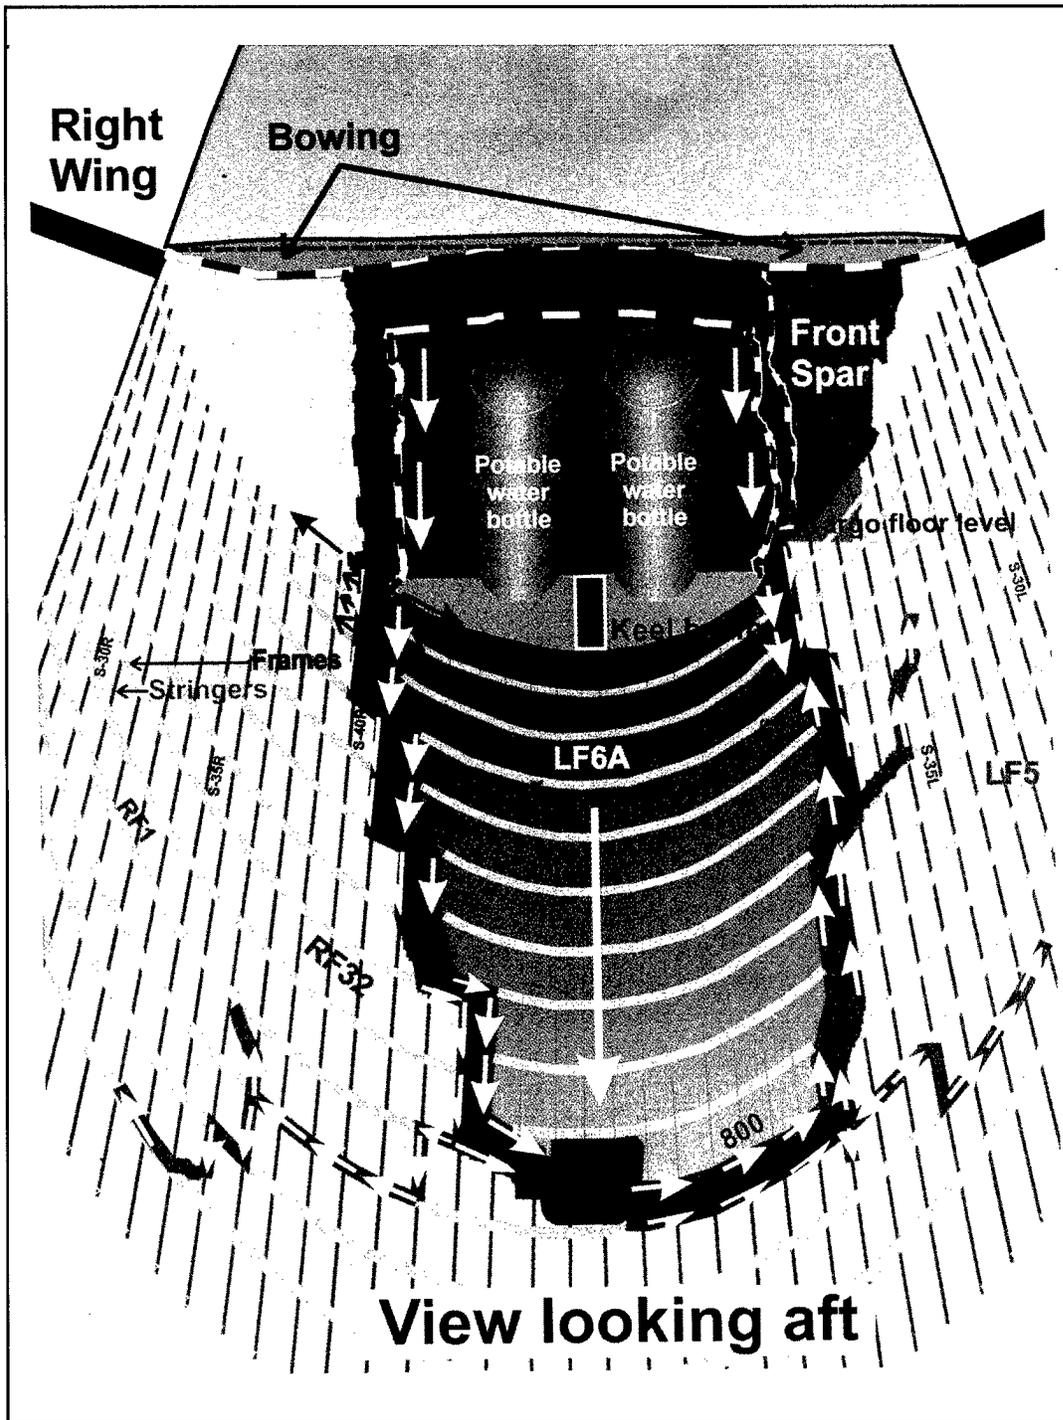
Figure 30. A schematic drawing of the lower portion of the fuselage skin in the area

The detailed examinations of the fuselage red zone pieces are an example of how these examinations were successful in determining an important segment of the breakup sequence. Figure 30 shows a schematic drawing of the lower portion of the fuselage skin in the area forward of the front spar. In this figure, the earlier fuselage skin fractures have been highlighted, and arrows have been added to indicate the direction of cracking in these earlier fractures. Of all of the fuselage fractures examined, only a limited number (all of which were on pieces recovered from the red zone) could be classified as earlier fractures (that is, consistent with in-plane loading). Further detailed examination of the rivet-to-rivet fracture pattern in these earlier fuselage fractures generated information on crack propagation directions and indicated that the earliest fracturing was of the lower fuselage, beginning at the front spar of the WCS. (The methodology used to determine the sequence of fracture in the fuselage red zone pieces was typical of the approach used for the entire airplane structure.)

The Sequencing Group determined that the upper chord of the front spar then completely separated from the WCS upper skin panel, and the overpressure within the CWT forced the WCS lower skin panel and the forward end of the keel beam downward. Stress analysis performed as a part of the sequencing study showed that the continuing downward keel beam motion increased the stresses in the ring chord and fuselage skin adjacent to the front spar. The front spar stiffener at LBL 18 was not bent as far forward as the others, indicating that there was limited forward rotation of the front spar in this area before the ring chord separated at the bottom of the stiffener. Fractures on the right side of the front spar continued into the lower pressure bulkhead,²⁰¹ then continued through the ring chord and into the fuselage skin just in front of the front spar, at stringer 40 right (see figure 30).

On the basis of cracking directions of the fuselage skin, the Sequencing Group determined that the initial fuselage skin cracking (at stringer 40 right just forward of the front spar, about STA 1000) propagated forward and toward the bottom center of the airplane, then continued circumferentially in both directions and back toward the front spar on the lower left side. This fuselage cracking then quickly progressed²⁰² around three sides of a large piece of fuselage belly structure (subsequently identified primarily as piece LF6A). See figure 30 for a diagram of this cracking in the fuselage; piece LF6A is located in the center of this figure.

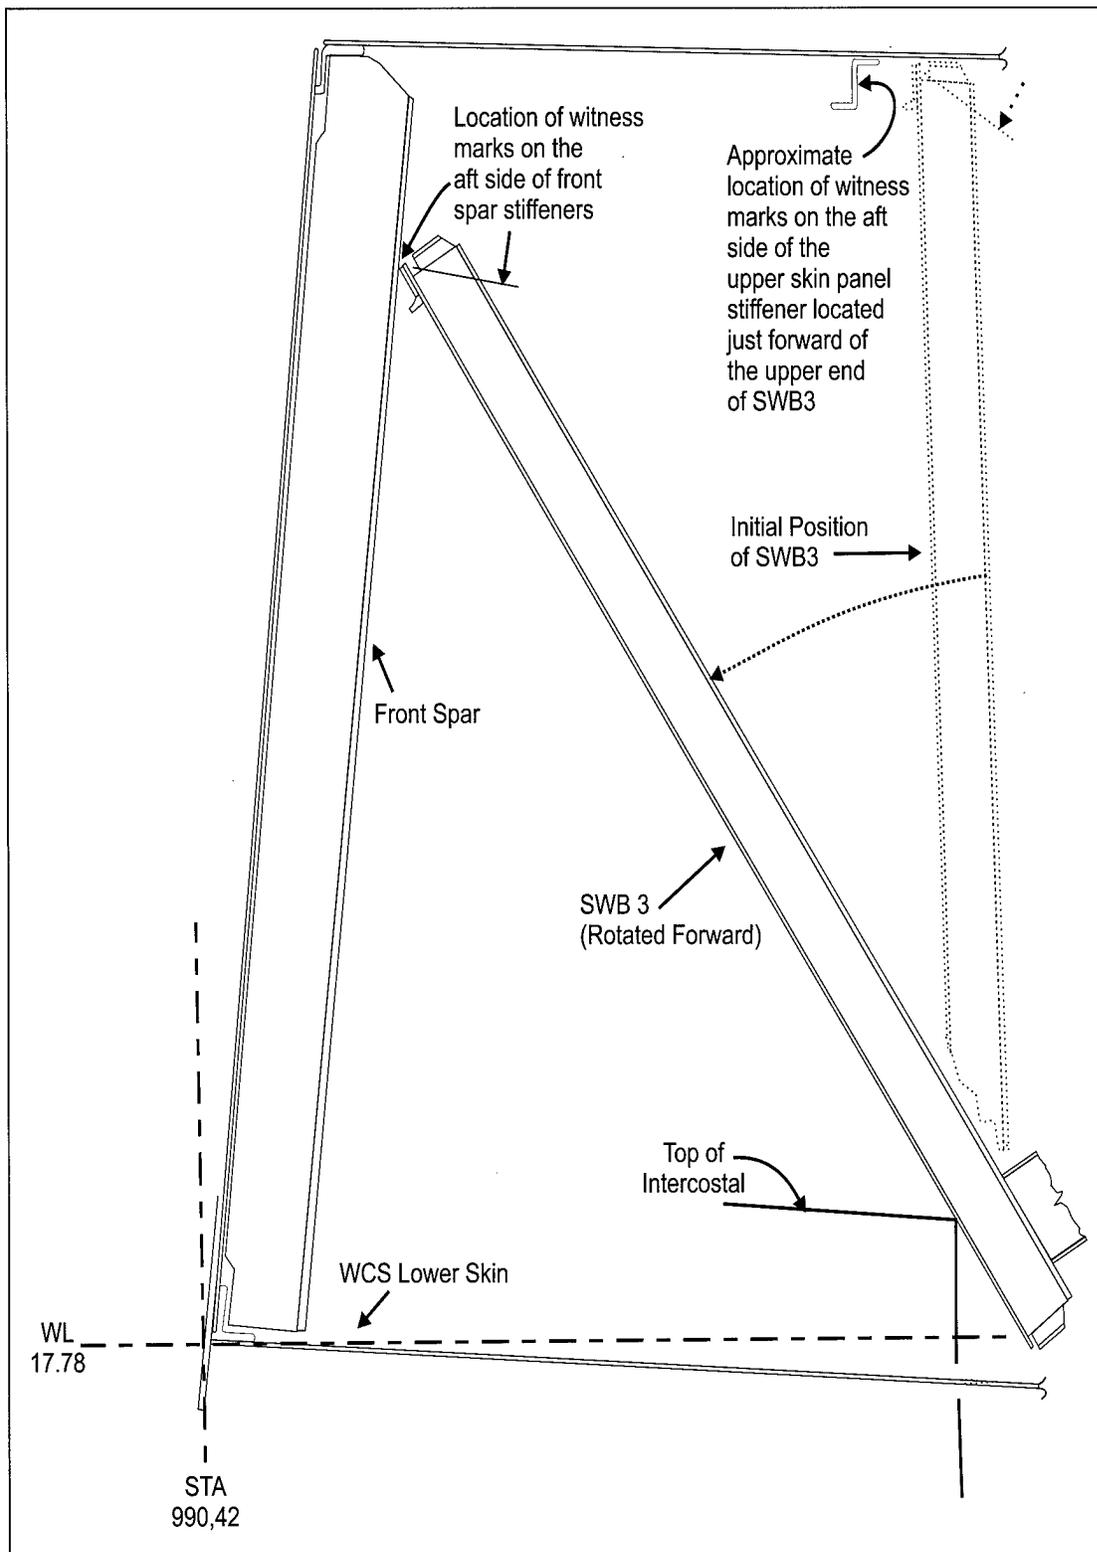
Figure 31. Diagram showing the approximate shape of the upper skin panel stiffener and its location before being struck by SWB3 as the beam rotated forward.

As the upper portion of SWB3 rotated forward, hinging on the still-attached lower chord, the upper chord impacted the aft side of the upper skin panel stiffener immediately forward of SWB3. (Figure 31 shows the approximate shape of this stiffener and its location before being struck by SWB3 as the beam rotated forward.) A geometrical layout of SWB3 and the upper and lower skin panels indicates that the forward rotation of SWB3 about its lower chord would result in an impact on the vertical flange of the stringer about 1.8 inches above the lower edge of the stringer (assuming no relative motion between the upper skin panel and SWB3). However, in the center of this stiffener, a witness mark was

noted at a distance of only 0.9 inch above the lower edge of the stringer. The difference between these values represents an upward vertical displacement of 0.9 inch between the upper and lower skin panels along the airplane's centerline when SWB3 impacted the stringer. The distance of the witness mark from the bottom of the stringer's vertical flange gradually increased at positions further outboard, indicating lesser amounts of upward vertical displacement outboard of the centerline. According to the sequencing study, the location of the marks left on the stiffener by SWB3 indicate that the upper skin of the CWT was likely bowed upward, apparently also as a result of an overpressure event within the CWT.

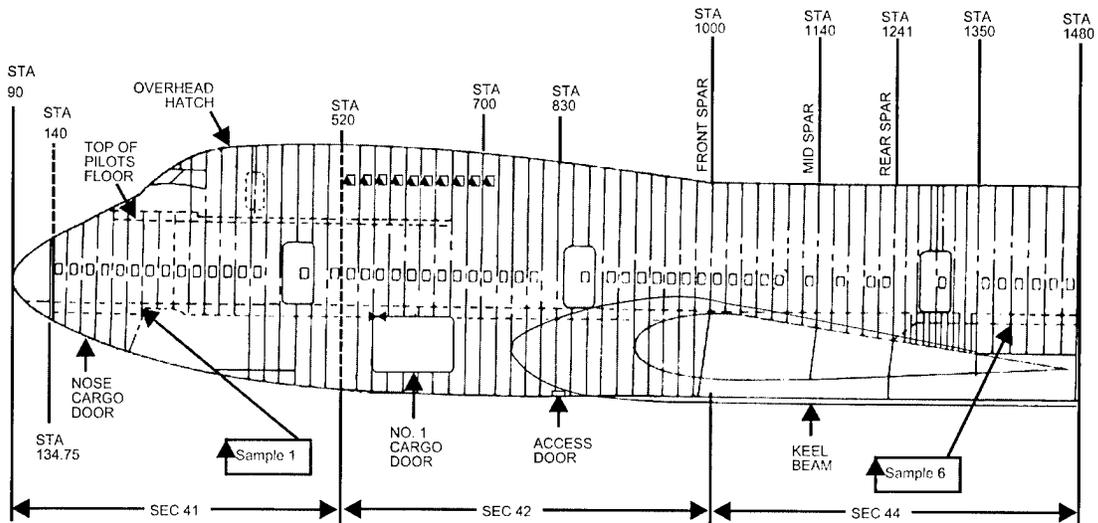
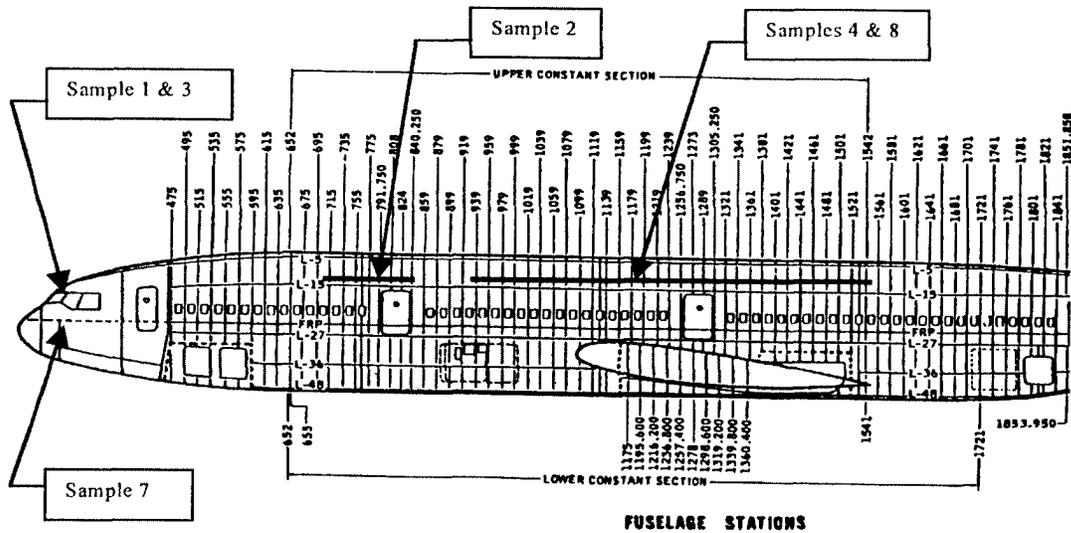
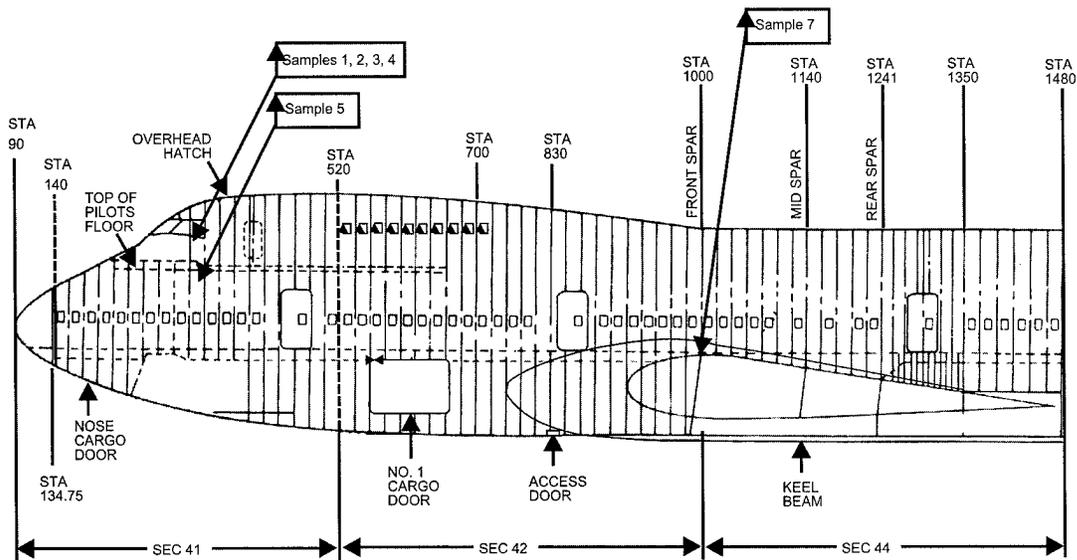
4. The weak point in this wire type appears to be the lack of ability to maintain physical and electrical integrity during extended elevated thermal exposure with mechanical stress. As the wire ages, there is an increased risk of dielectric problems [breakdown of wire insulation integrity], mechanical damage and loss of electrical integrity.
5. No wire was submitted that was exposed to high levels of environmental exposure (such as wires from wheel wells, wing leading edges, etc.). Wire from these areas, would be expected to perform worse than the wire submitted. [See figures 35a, 35b, and 35c for sample locations.]

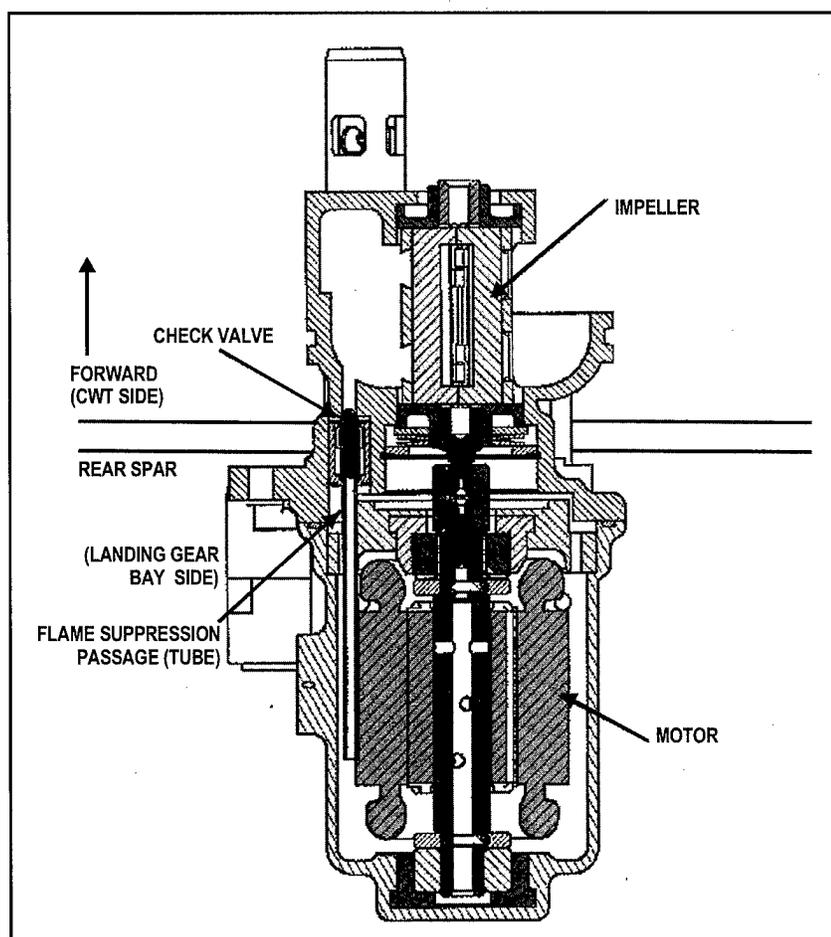
Figure 37. A diagram of a scavenge pump.

contained multiple explosions that were intentionally ignited within the pump motor cavity, preventing the ignition from transferring to the fuel tank. (Figure 37 is a diagram of a scavenge pump.) Because the Board became aware of instances in which the flame arrestor tube was broken or missing, investigators also conducted a series of tests to determine whether the scavenge pump motor housing would contain explosions with only one of the flame suppression system components (either the flame arrestor tube or the check valve) functioning. In all tests, the scavenge pump housing contained the explosions, and the explosive atmosphere surrounding the test pump did not ignite.

During its postaccident examination of other transport-category airplanes, the Safety Board observed that components in the electrical connector on a scavenge pump in a retired 747 were deteriorated. (Boeing ASBs 747-28A2194 and 747-28A0043, both dated January 18, 1996, "encouraged" operators to inspect for degradation in connectors.) Investigators observed that several scavenge pump electrical connectors had been manufactured of a material that degraded with long-term exposure to fuel. Boeing provided the Board with a service history for the 747 scavenge pump for the 10 years preceding the accident. When queried about the brevity of this history, Boeing indicated that most operators did not return the scavenge pumps to the manufacturer for overhaul.

As a result of these findings, Boeing issued ASB 747-28A2206, dated September 25, 1997, and AD 97-25-06, effective December 16, 1997. AD 97-25-06 contained the following summary:

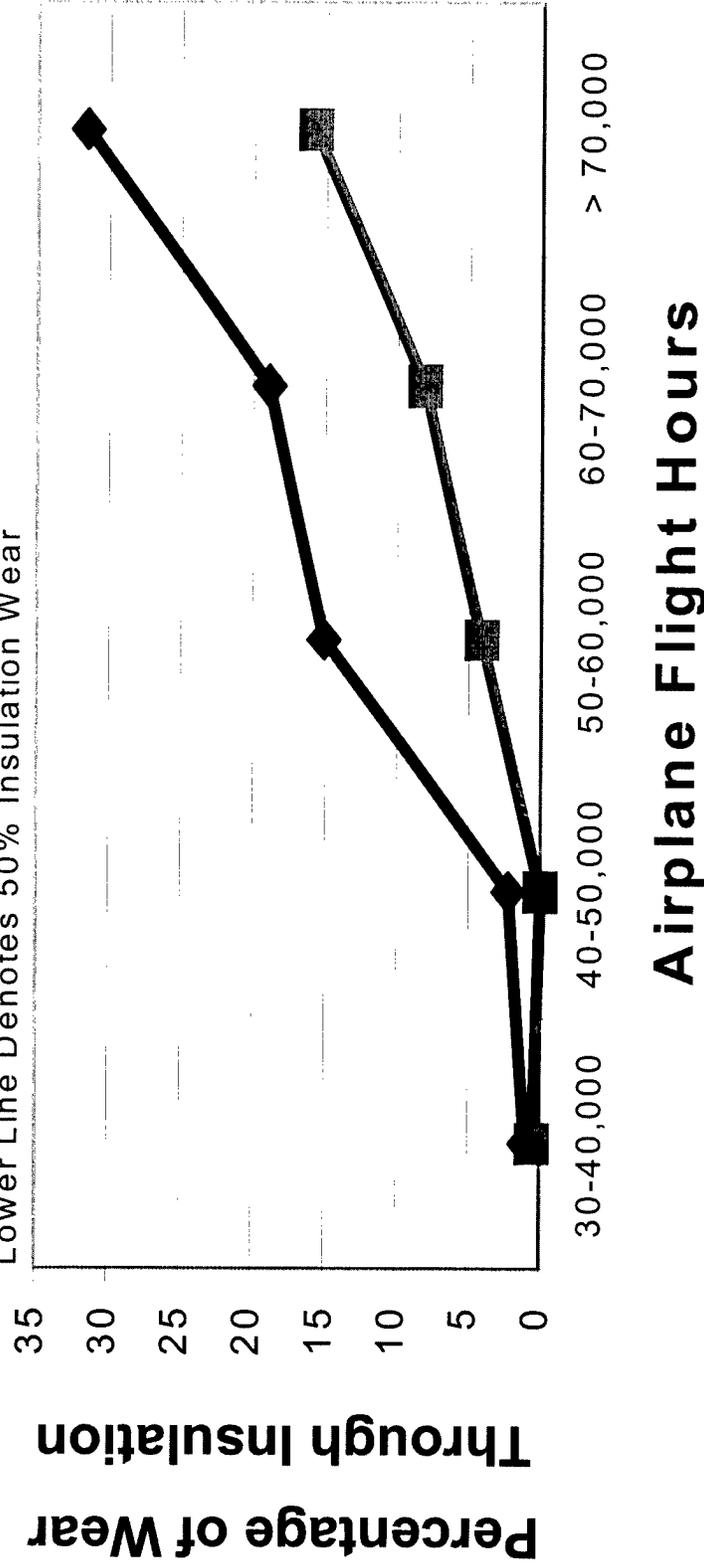
Figure 39. A chart showing the 737 fuel pump conduit wear rate that was identified by the FAA during representative 500 wire inspections.
