ok
**(OPERATION OF A FORCED CIRCULATION,
HAYNES ALLOY NO. 25, MERCURY LOOP
TO STUDY CORROSION PRODUCT
SEPARATION TECHNIQUES)**

by David B. Cooper

Prepared under Contract No. NAS 5-462 by
THOMPSON RAMO WOOLDRIDGE, INC.
Cleveland, Ohio

NATIONAL AERONAUTICS AND SPACE ADMINISTRATION • WASHINGTON, D. C. • JULY 1965

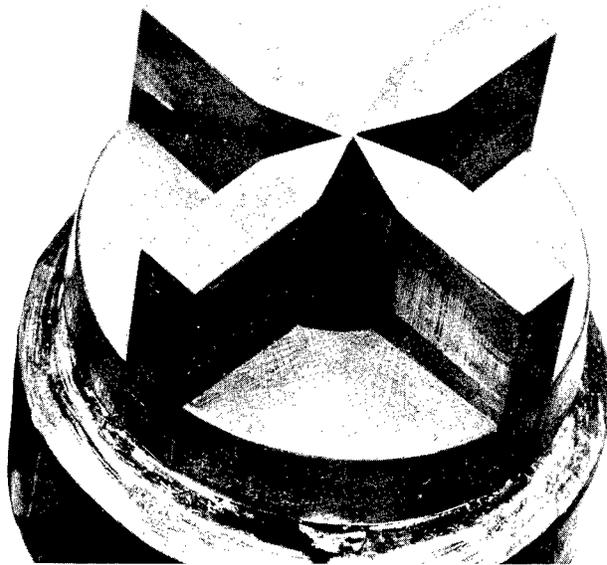
a) Inlet

The nozzle was also observed to contain a deposit, as shown in Figure 17. Although there was a small amount of deposition on the inlet side, the majority of the deposit was found on the outlet.

Figure 17. Deposit Found in Loop Nozzle.

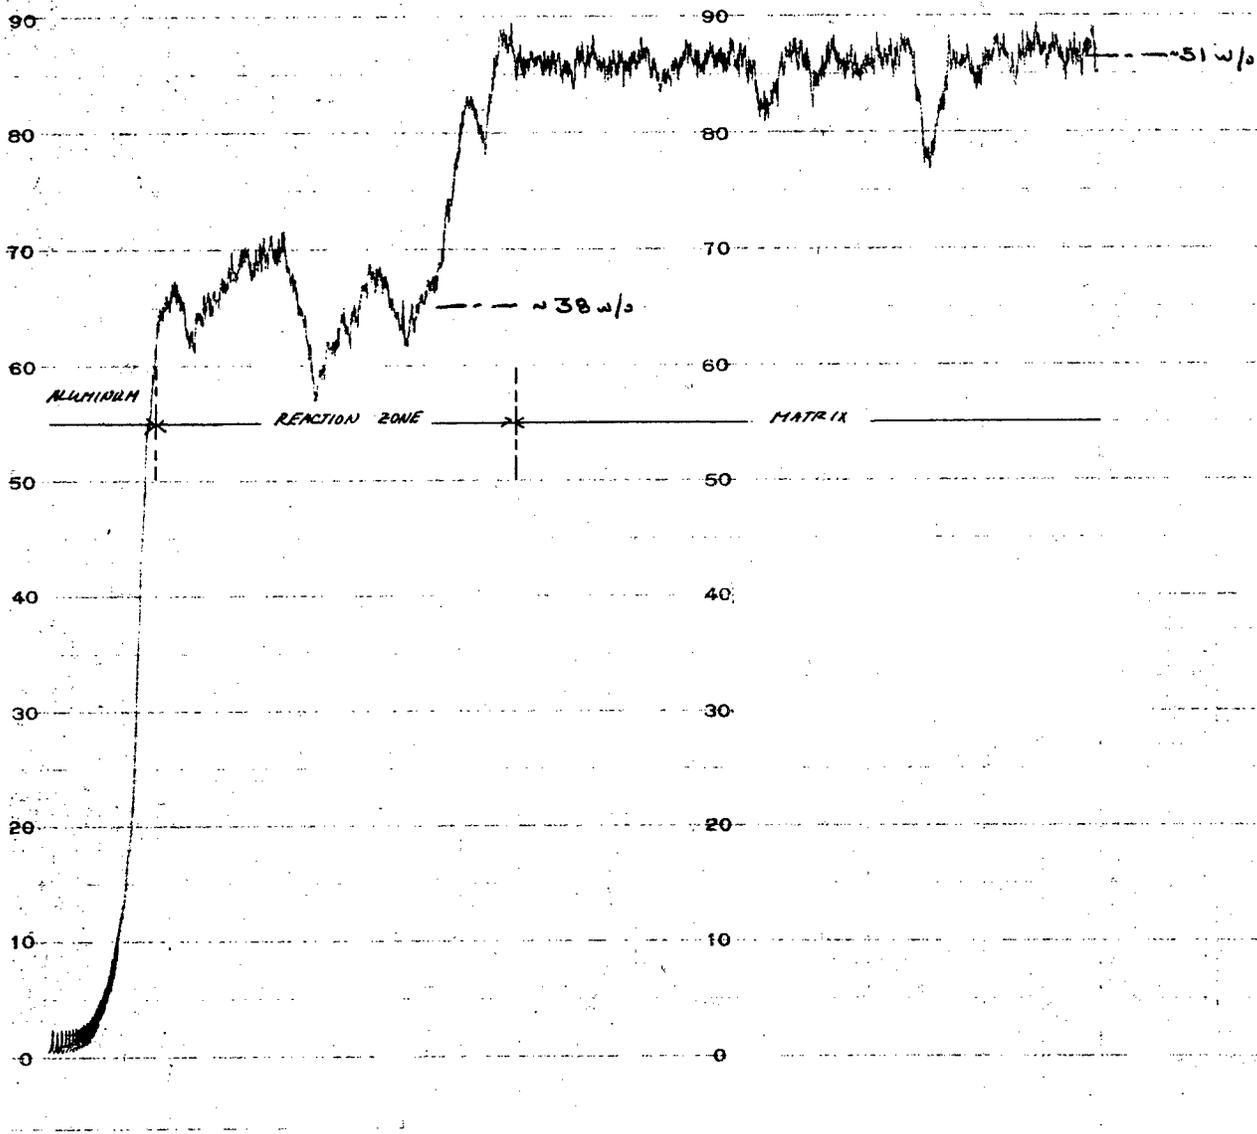
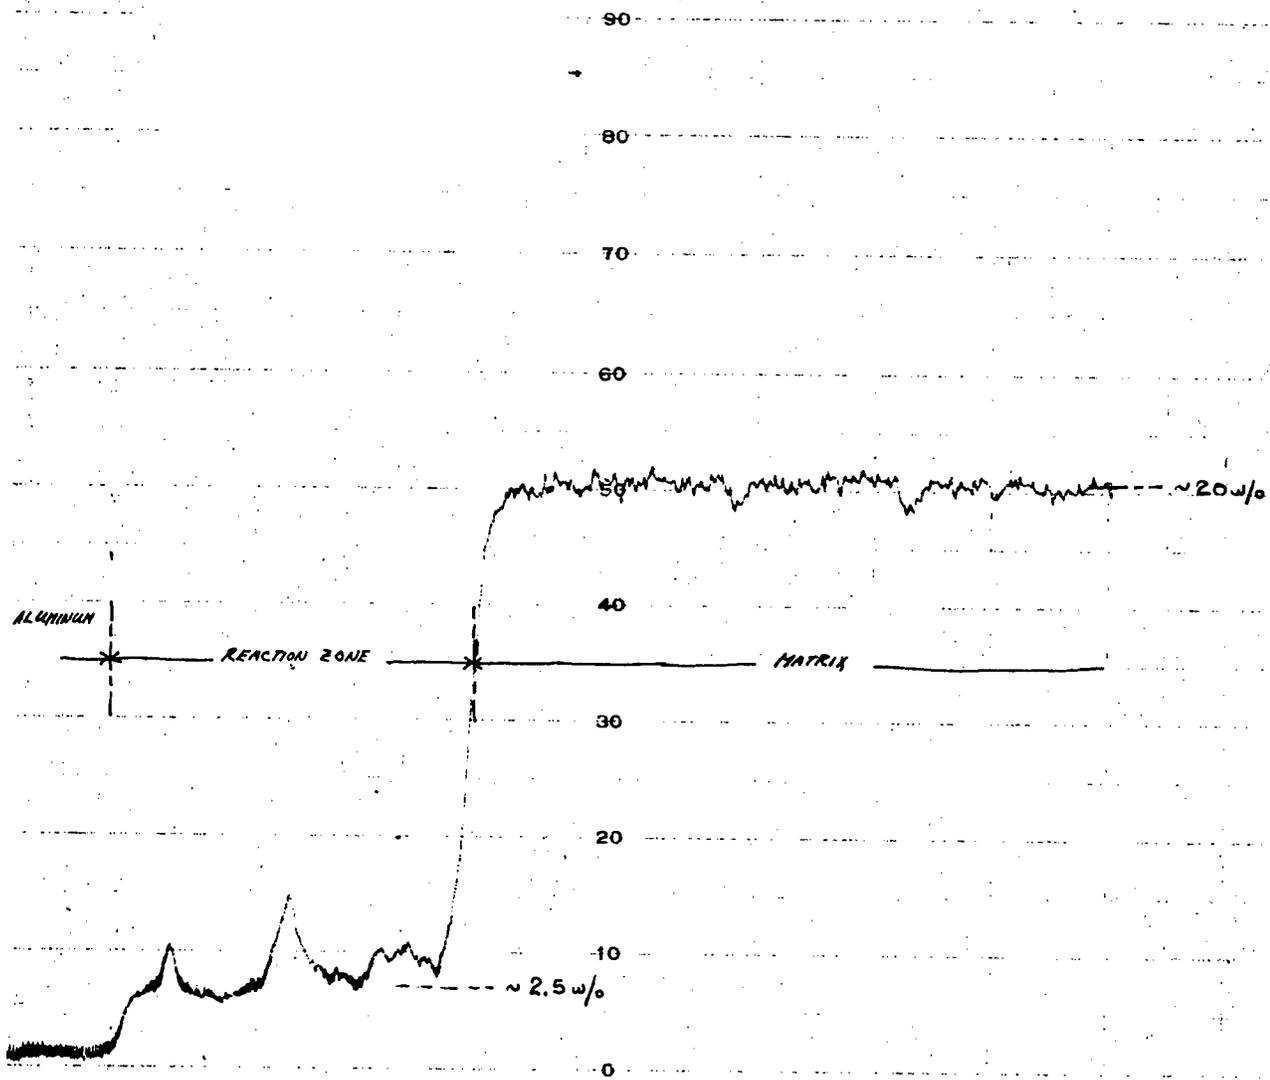
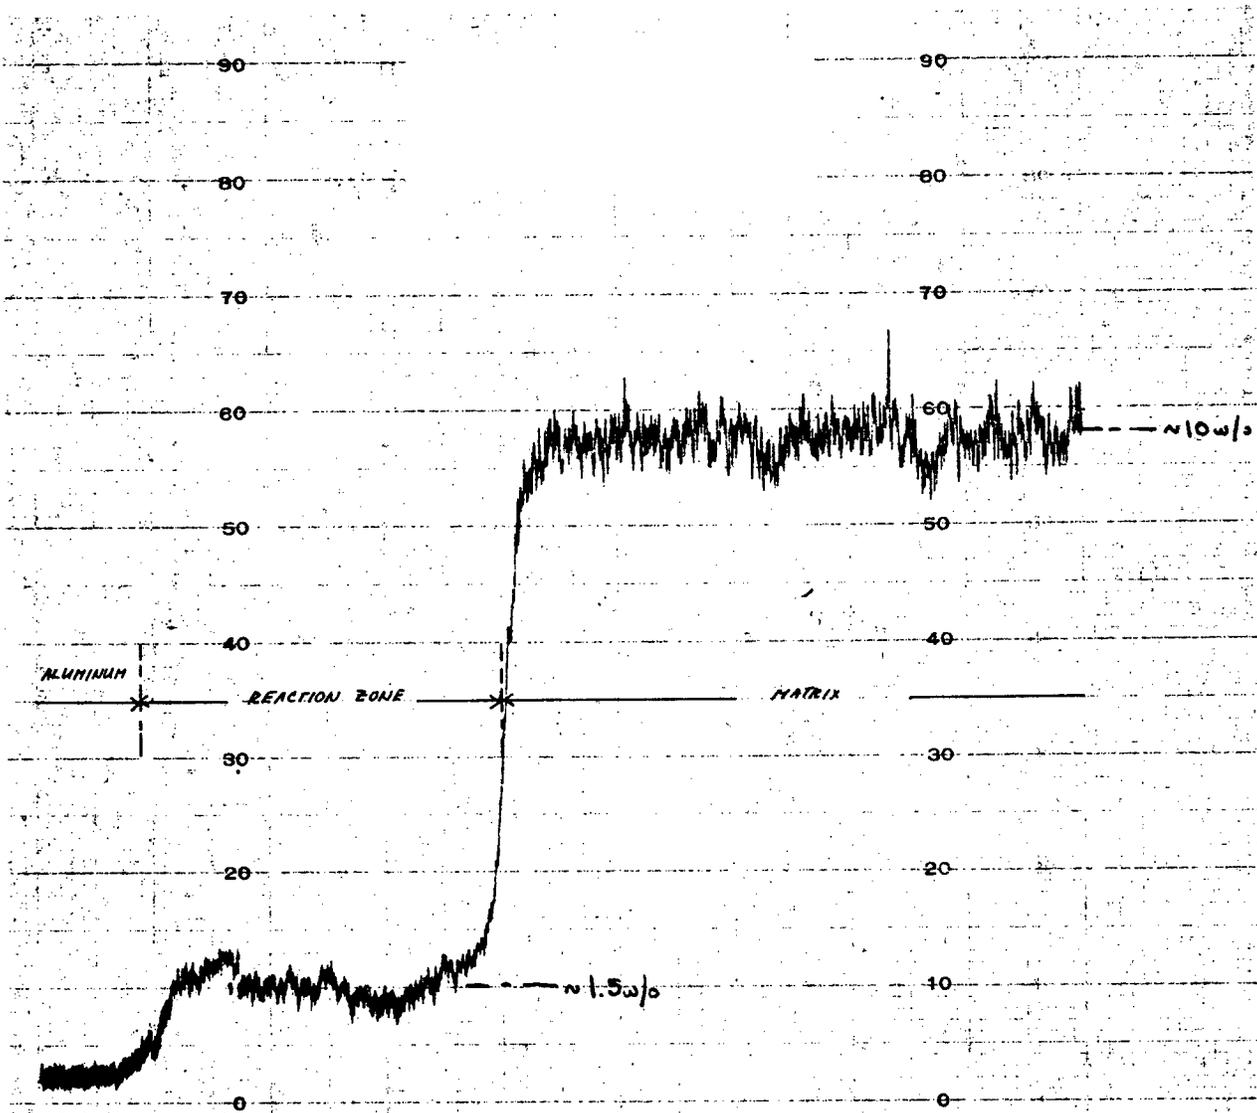
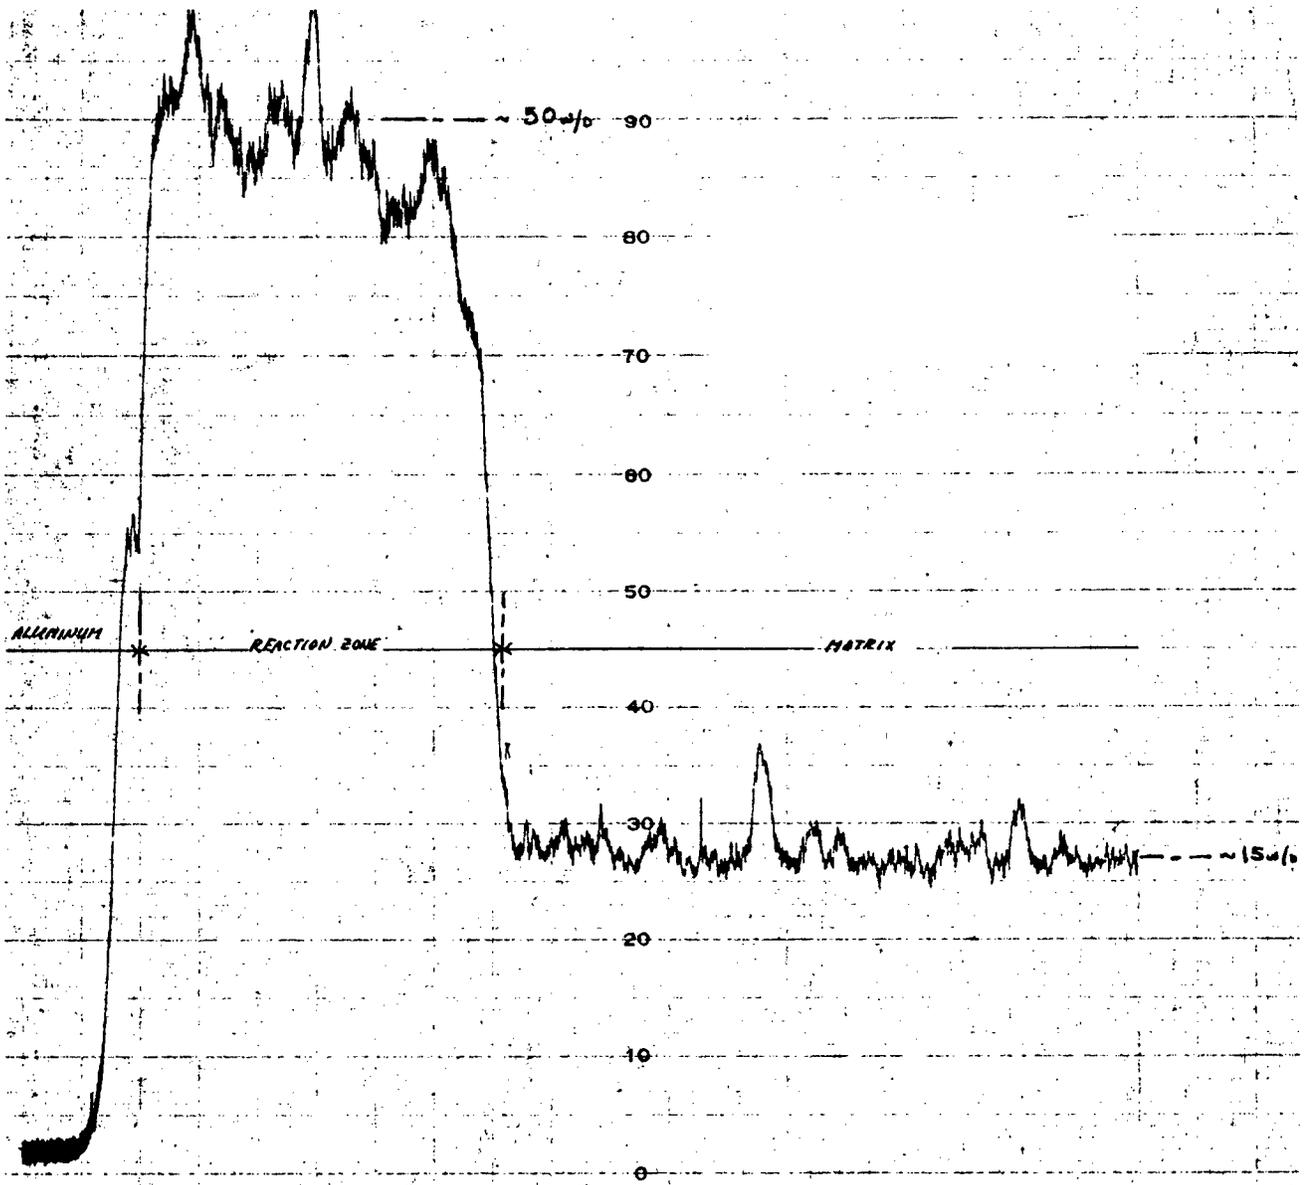
As seen in Figures 31 through 34, the electron beam microanalysis on the pre-heater outlet specimen (see Figure 20b) revealed a leached layer with an abrupt concentration discontinuity approximately 40 to 45 microns from the surface. The corrosion layer was found to be enriched in tungsten and depleted in nickel, chromium, and cobalt. Zirconium was found in the matrix as tungsten-zirconium carbides and comprised less than 0.05 percent. The zirconium concentration rose to 0.05 to 0.08 percent in the corrosion layer; however, the background intensity also rose as a result of the increased tungsten content. The titanium and columbium concentrations were consistently less than 0.05 percent.

Figure 31. Distribution of Cobalt in the Pre-Heater Outlet Specimen.

Figure 32. Distribution of Chromium in the Pre-Heater Outlet Specimen.

Figure 33. Distribution of Nickel in the Pre-Heater Outlet Specimen.

Figure 34. Distribution of Tungsten in the Pre-Heater Outlet Specimen.

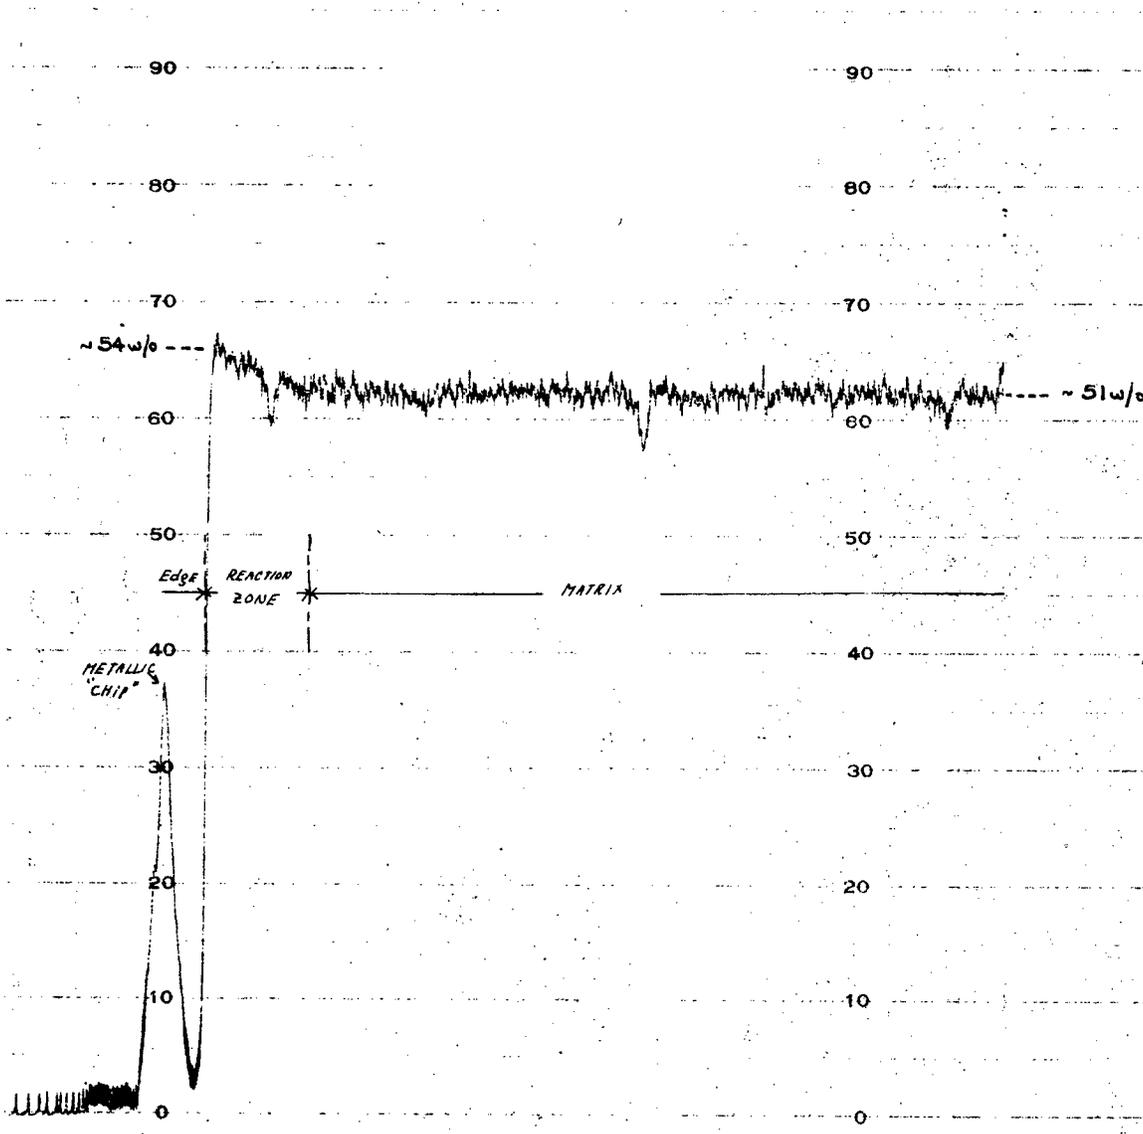
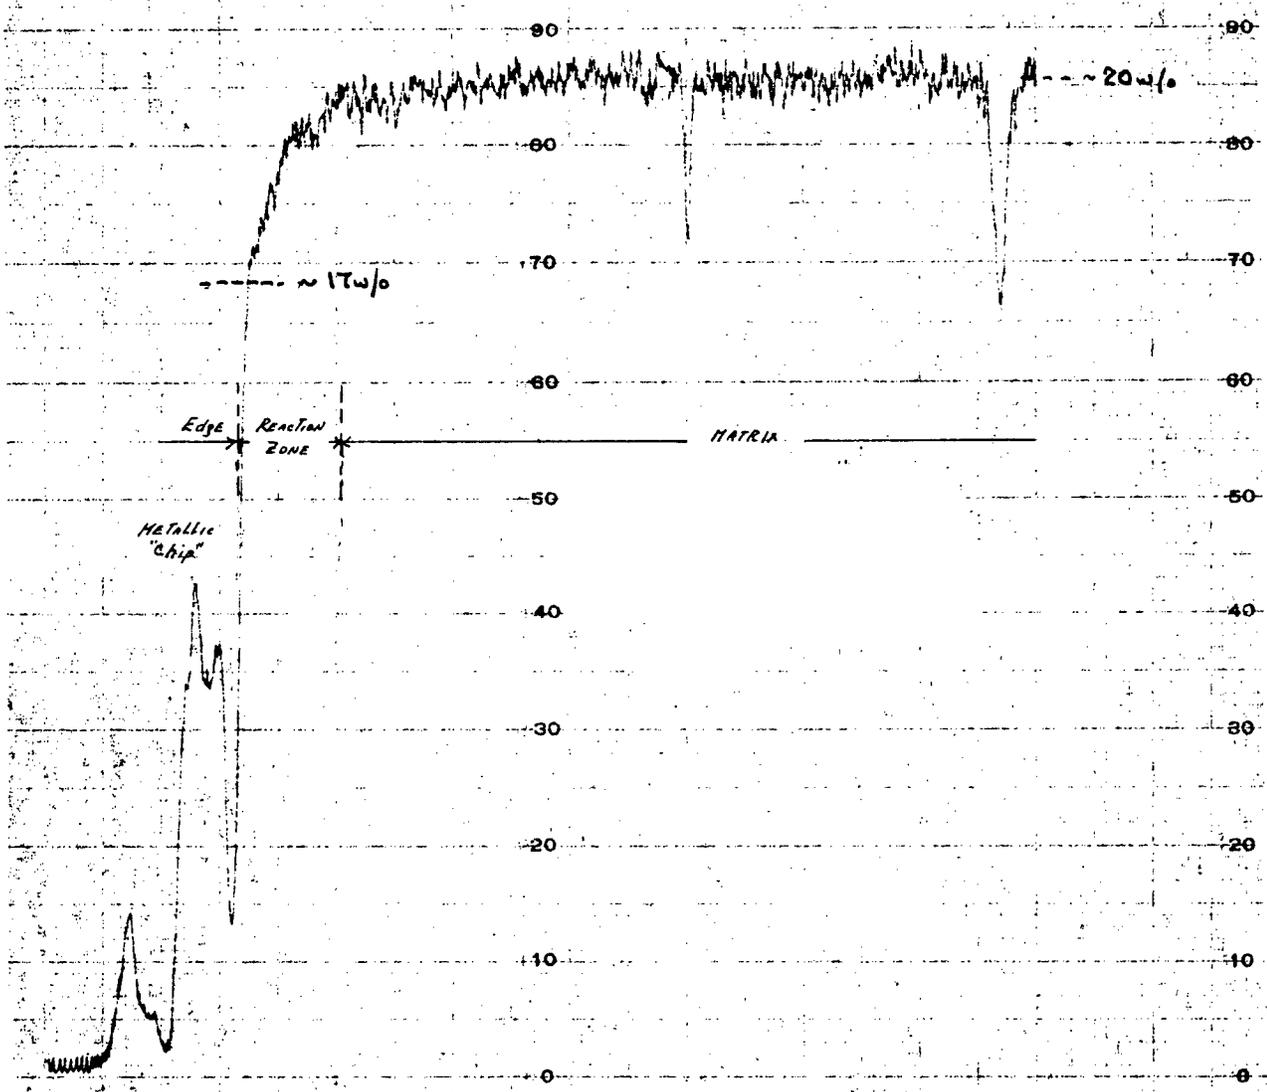
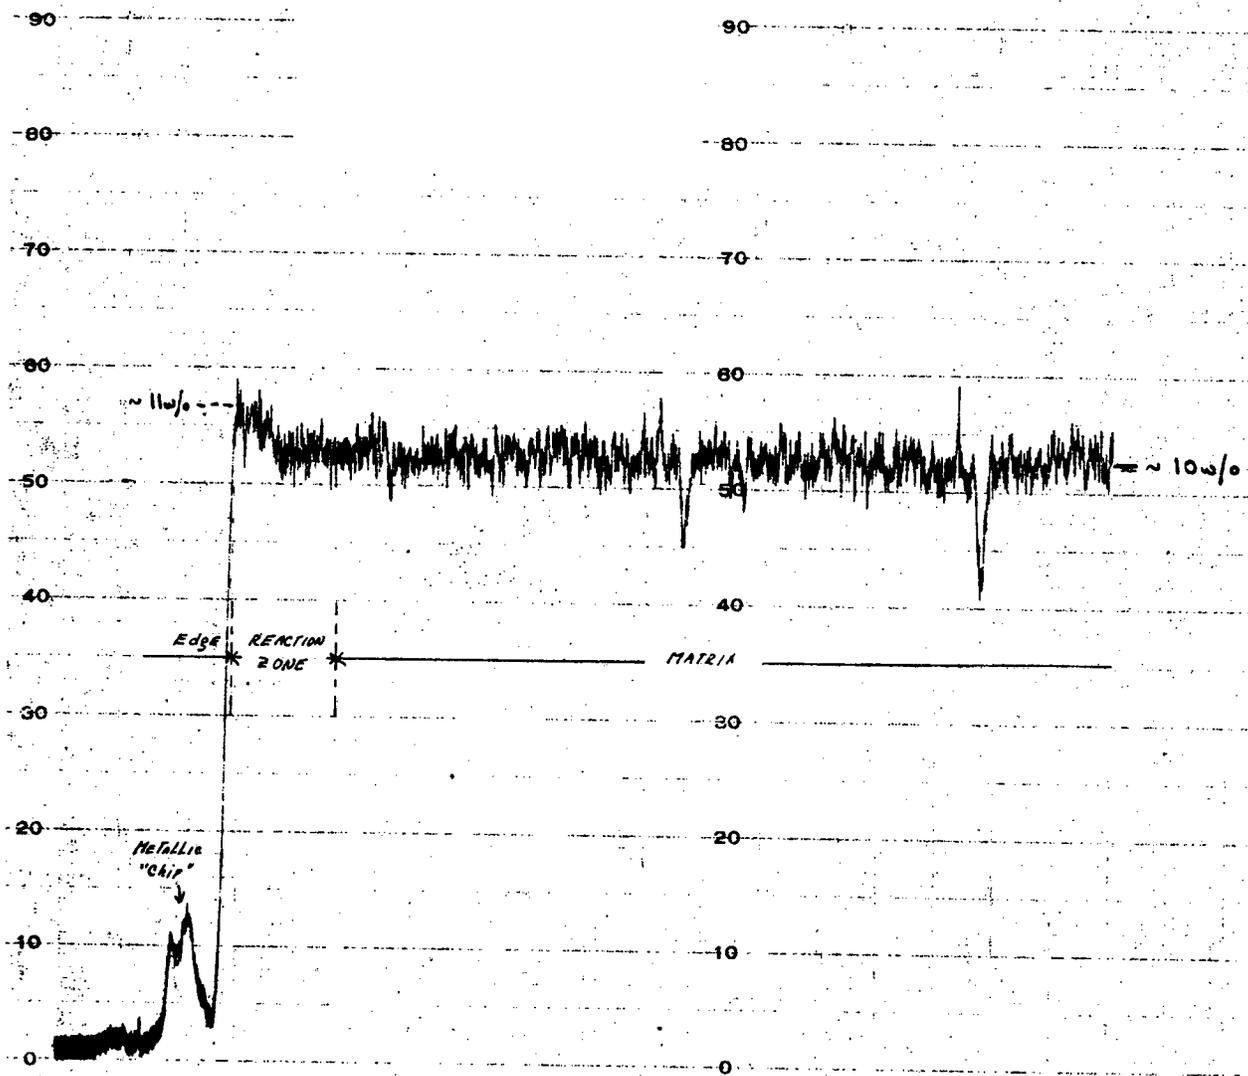
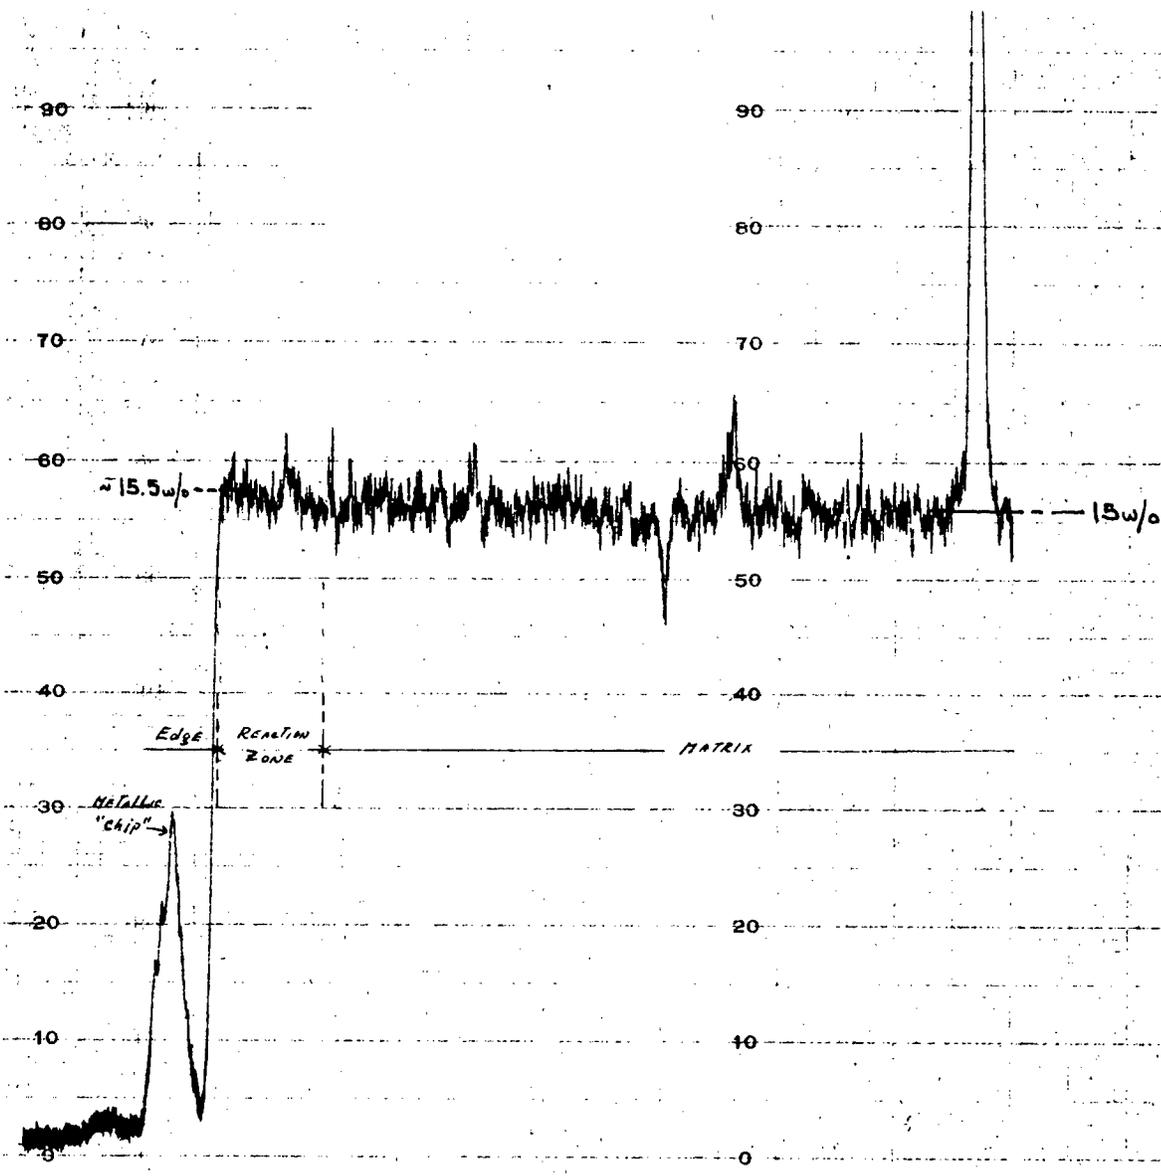
The condenser outlet specimen (see Figure 22d) revealed no visible evidence of a surface chemistry change. However, the concentration distributions (Figures 35 through 38) showed the presence of a slowly varying gradient to a depth of 25 to 30 microns. Cobalt, nickel, and tungsten showed an increase at the I.D. surface of the specimen, while chromium was found to be depleted. A small metallic chip, partially buried in the mount material, was included in the traverse. This chip was the only one noted in the area selected for analysis and is considered insignificant. Except for some zirconium in the matrix tungsten-zirconium carbides, the zirconium, titanium, and columbium concentrations were consistently less than 0.05 percent.

Figure 35. Distribution of Cobalt in the Condenser Outlet Specimen.

Figure 36. Distribution of Chromium in the Condenser Outlet Specimen.

Figure 37. Distribution of Nickel in the Condenser Outlet Specimen.

Figure 38. Distribution of Tungsten in the Condenser Outlet Specimen.

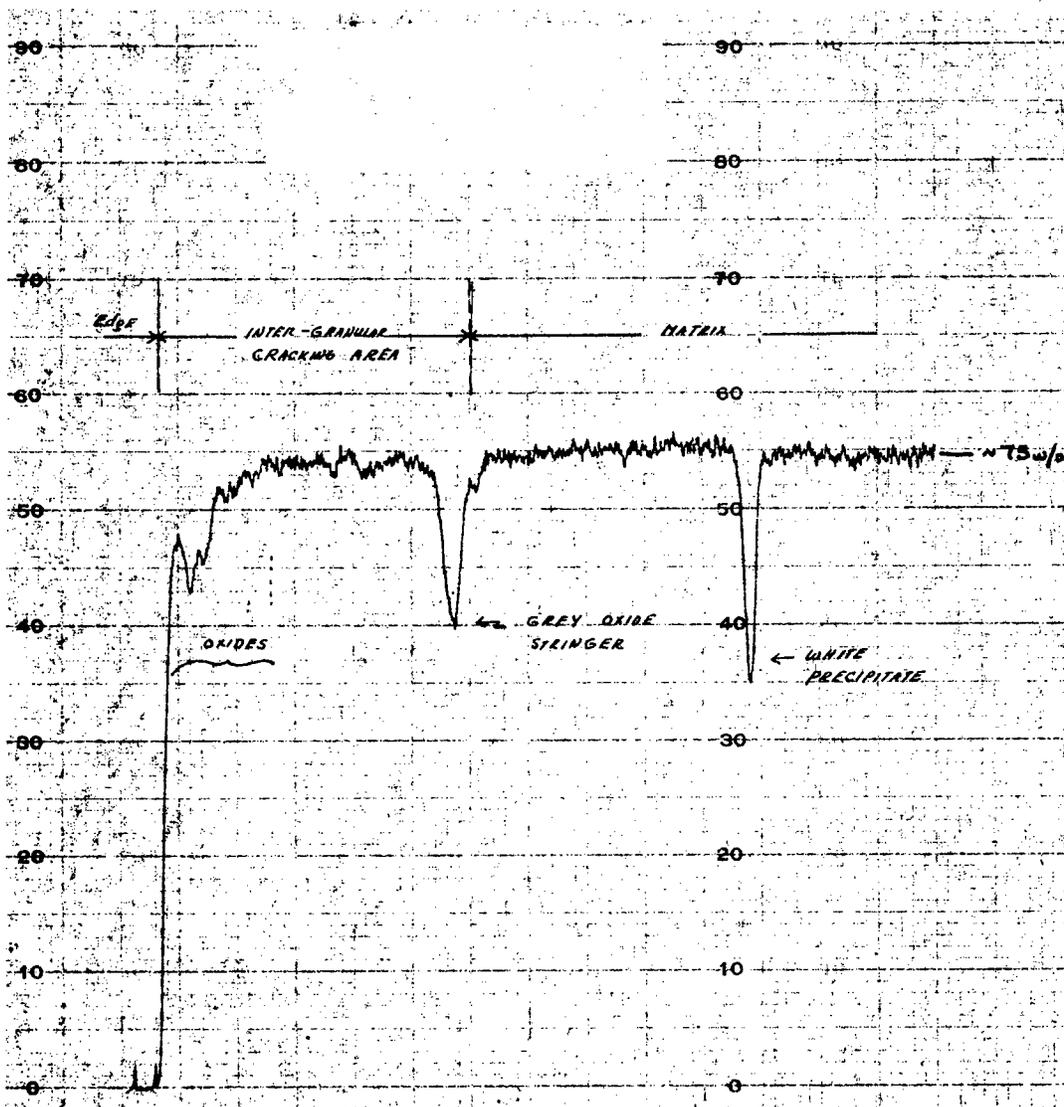
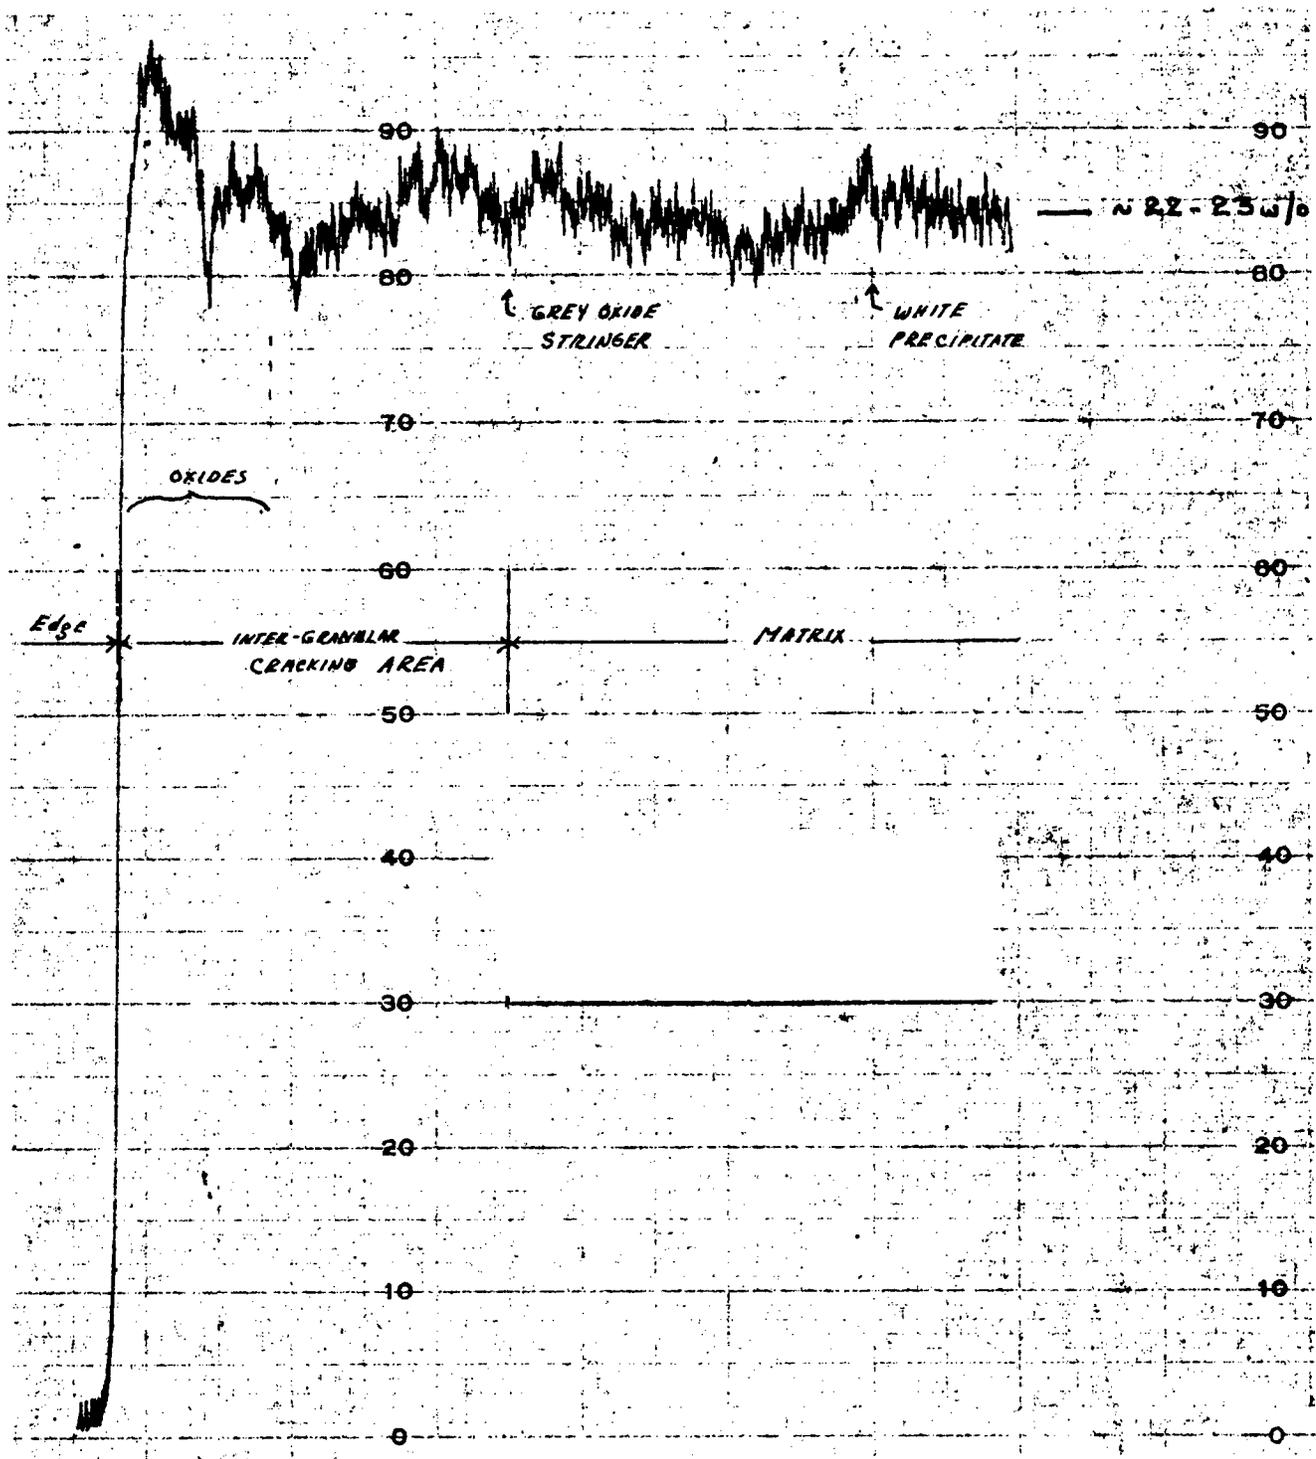
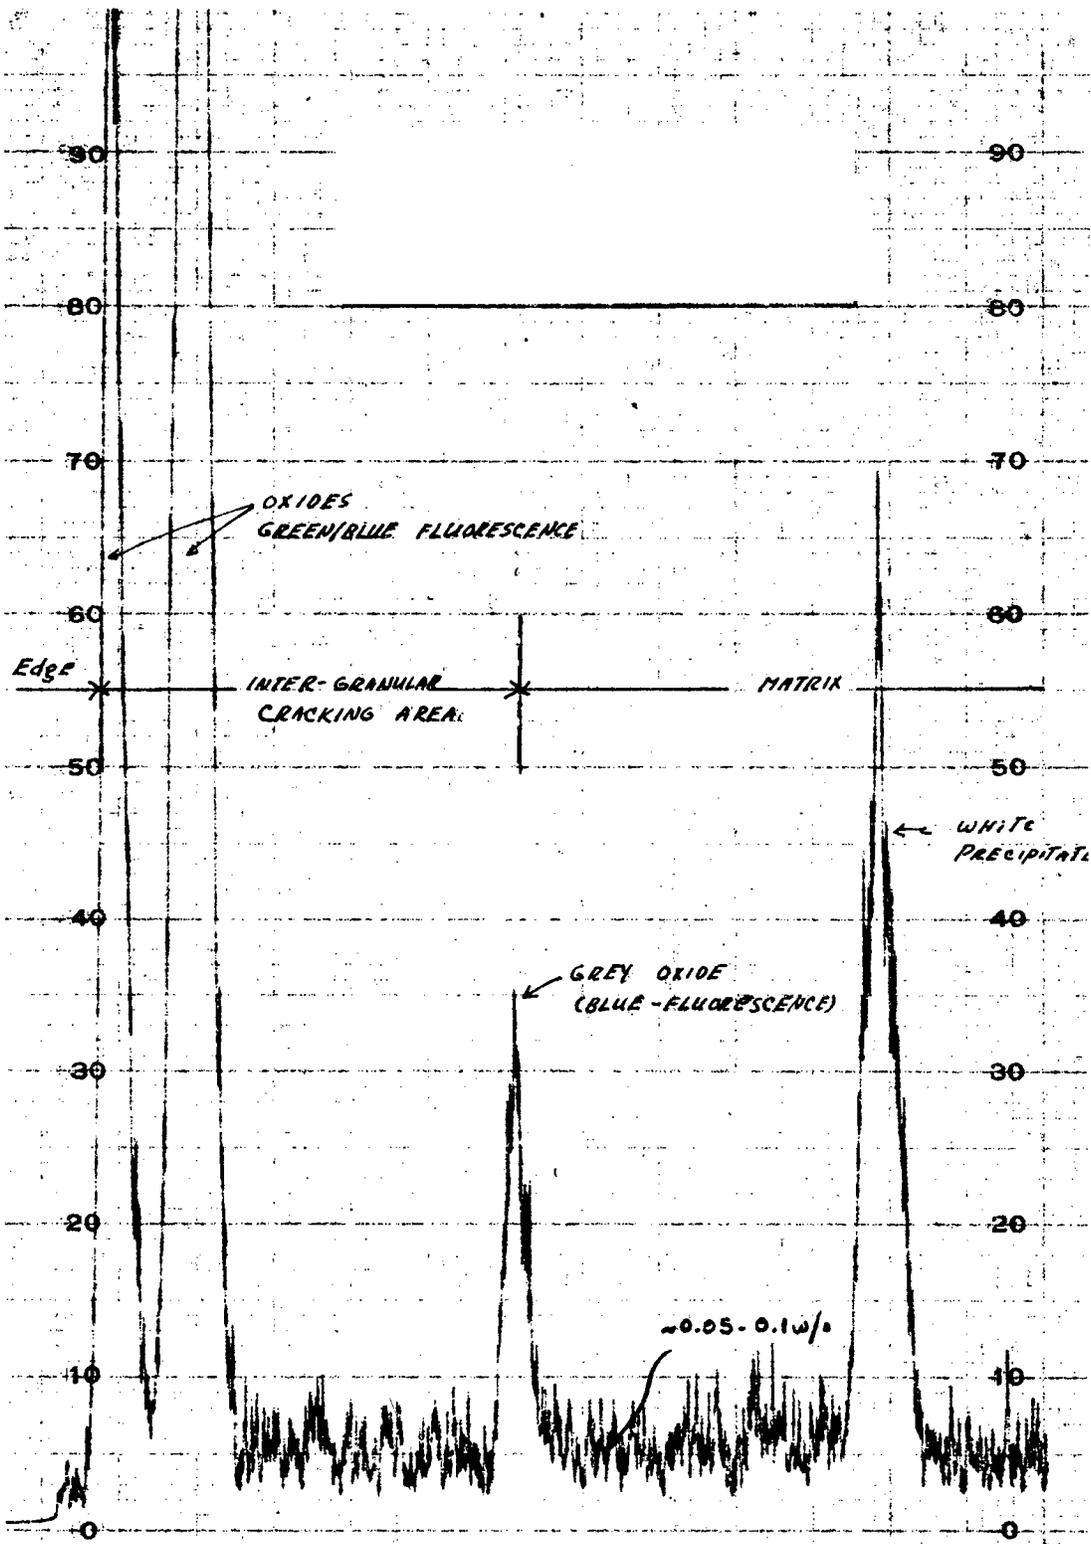
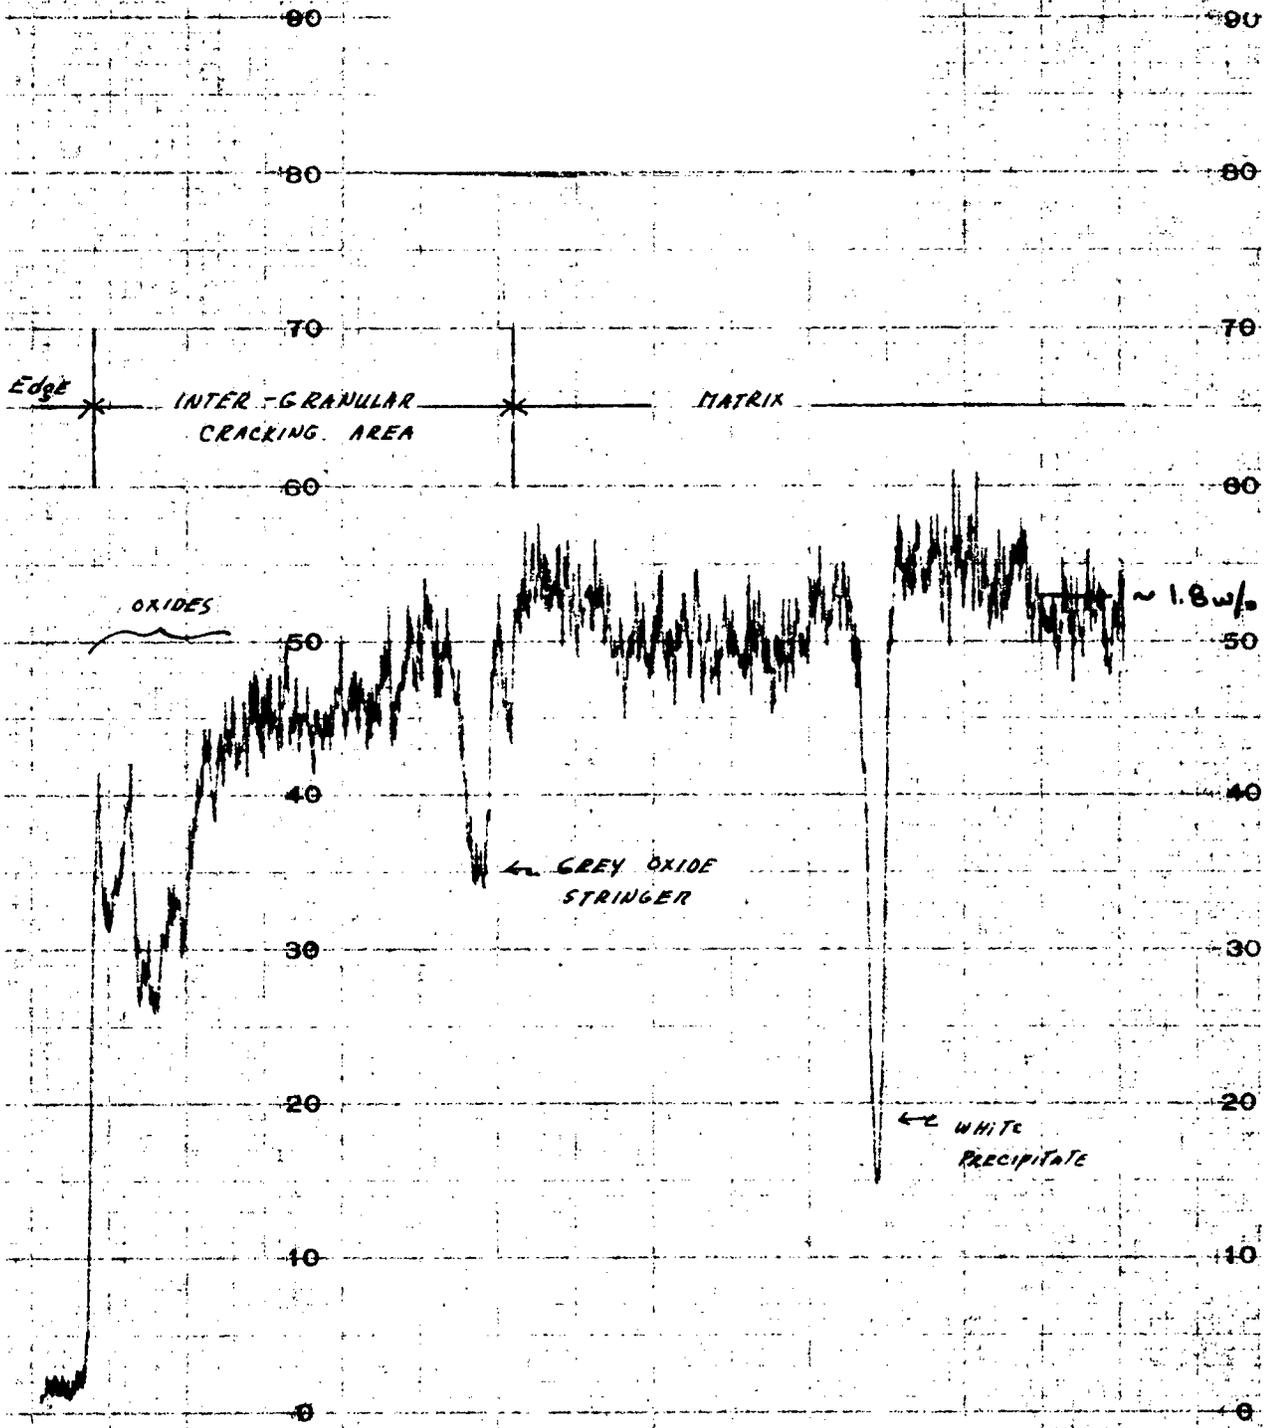
Examination of the nozzle throat specimen (see Figure 27b) revealed a surface zone of intergranular precipitation extending to a depth of approximately 70 microns. A series of large gray precipitates near the base metal-end of the surface zone were also noted. The gray phases and oxides were found to be zirconium oxides that appeared to also contain some nickel in solution. These phases were identified as oxides since they yielded a visible fluorescence when struck by the electron beam. This fluorescence is typical of the presence of combined oxygen. The composition of the metal matrix surrounding the oxides was found to be essentially the same as the base metal. The concentration distributions for chromium and tungsten were consistent at less than 0.05 percent.

Figure 39. Distribution of Cobalt in the Nozzle Throat Specimen.

Figure 40. Distribution of Nickel in the Nozzle Throat Specimen.

Figure 41. Distribution of Zirconium in the Nozzle Throat Specimen.

Figure 42. Distribution of Titanium in the Nozzle Throat Specimen.
