Archaeological Site and Reservoir Shoreline Stabilization Using Wetland Plants and Bioengineering, Rice Reservoir, Wisconsin

by Cathy J. Wendt and Hollis H. Allen

PURPOSE. This technical note describes a case study in which wetland plants and bioengineering treatments were used to protect an archeological site on an eroded reservoir shoreline and to stabilize the shoreline from further erosion. The site is called the Robinson Site and is located on Rice Reservoir in northern Wisconsin, about 26 km (16 miles) southeast of Rhinelander.

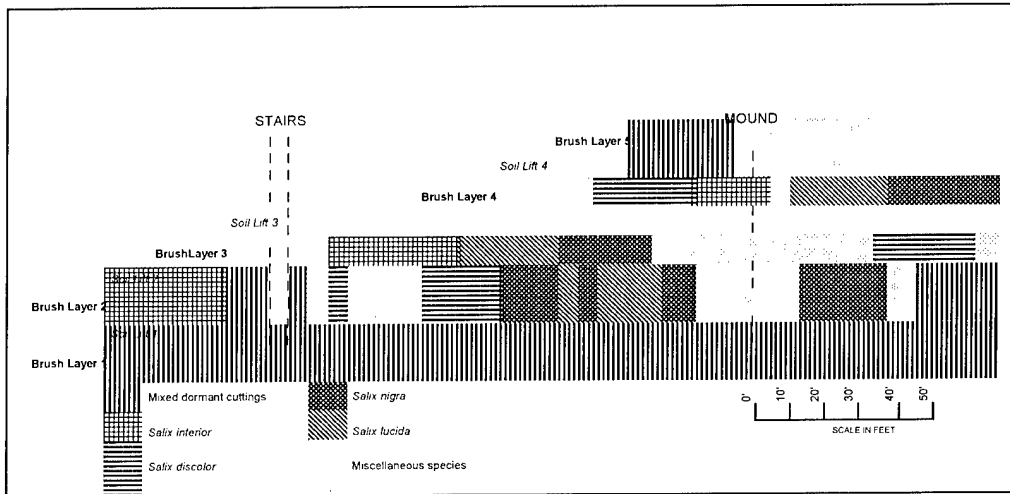
Figure 11. Diagram of brush locations in the geogrid

The transect method determined the survivability of the woody species by measuring 100 percent of the brush layers along transects. Survivability was determined by dividing the living stem occupation along the transect by the linear distance of materials originally planted. Each of the five layers was mapped (Figure 11) according to the species originally planted in the geogrid. Planting dates and harvesting dates were recorded. Portions of each brush layer consisted of different species (some were pre-grown in brush layer mats and some were installed as dormant cuttings). The species pre-grown in the brush layer mats were carefully monitored so valid comparisons between species could be made. The dormant cuttings were not differentiated by species but were intentionally mixed to increase the brush layer's chance of survival. Five

species of willow and one dogwood, *Cornus stolonifera*, were harvested locally and used in both variations in approximately the same proportions. This provided a means to compare the two planting techniques. Comparing only these six species, the pre-grown brush layer mats resulted in a 41.5-percent overall survival rate, slightly less than the 47-percent survival rate for the same species planted as dormant cuttings.

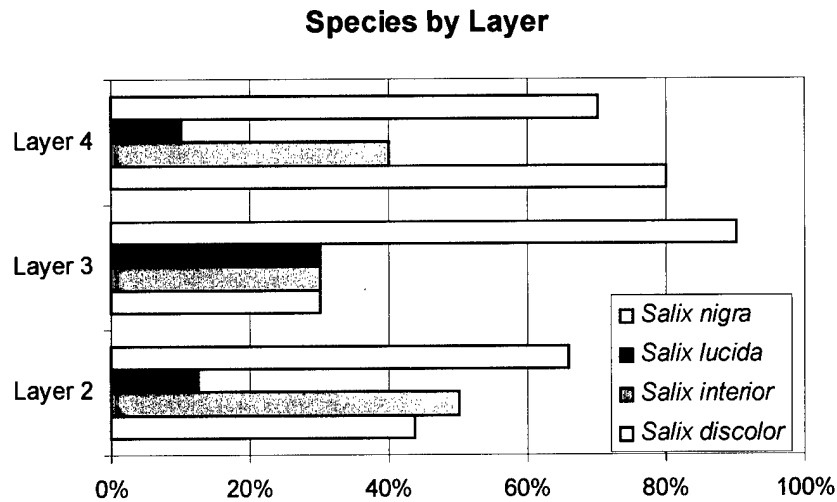
Figure 12. Plant survival by vegetative-geogrid height location by layer

Of the 85 pre-grown brush layer mats, 73 contained the six native species. The placement of the mats on the bank was designed to test survivability of these species (Figure 12) under differing conditions within the site. *Cornus stolonifera* was not included in the comparison since an adequate amount of material could not be located. One native willow species, *Salix rigida*, performed poorly in the greenhouse and was also eliminated from the comparison. The 19 mats containing these two species plus 12 mats containing USFS stock are designated as miscellaneous species on the layout map (Figure 11) and were used to fill in the remaining areas among the four species being tested. The remaining four species demonstrated no apparent advantage or disadvantage to placement on the bank.

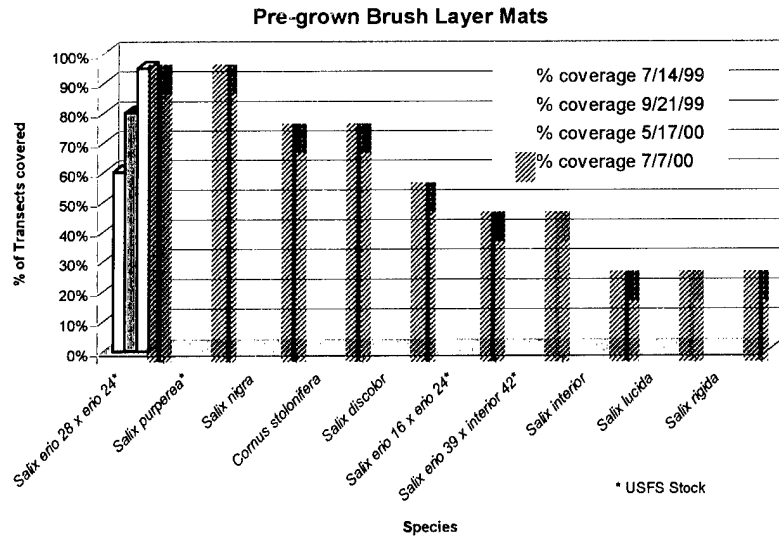
Figure 13. Performance (percent coverage) of brush layer mats by species

The transect method revealed a steady increase in the coverage for each pre-grown mat during the four testing periods from July 14, 1999 to July 7, 2000, with the exception of three mats (Figure 13). For one mat (*Cornus stolonifera*), coverage dropped by 20 percent between May 17, 2000 and July 7, 2000. The other mats were *Salix rigida*, which were already doing poorly in the greenhouse. Some mats showed increases as high as 60-80 percent, with an average increase of 23-percent coverage between July 14, 1999 and July 7, 2000. The species with the highest survival percentages were *Salix eriocephala* (90.0 percent) and *Salix purpurea* (90.1 percent) both from USFS stock. The native locally harvested species with the highest percentages were *Cornus stolonifera* (72.8 percent) and *Salix nigra* (72.7 percent). *Salix lucida* and *Salix rigida* had the lowest survival (17.7 and 16.5 percent, respectively). The overall survival rate of all pre-grown brush layer mats was 46.2 percent.

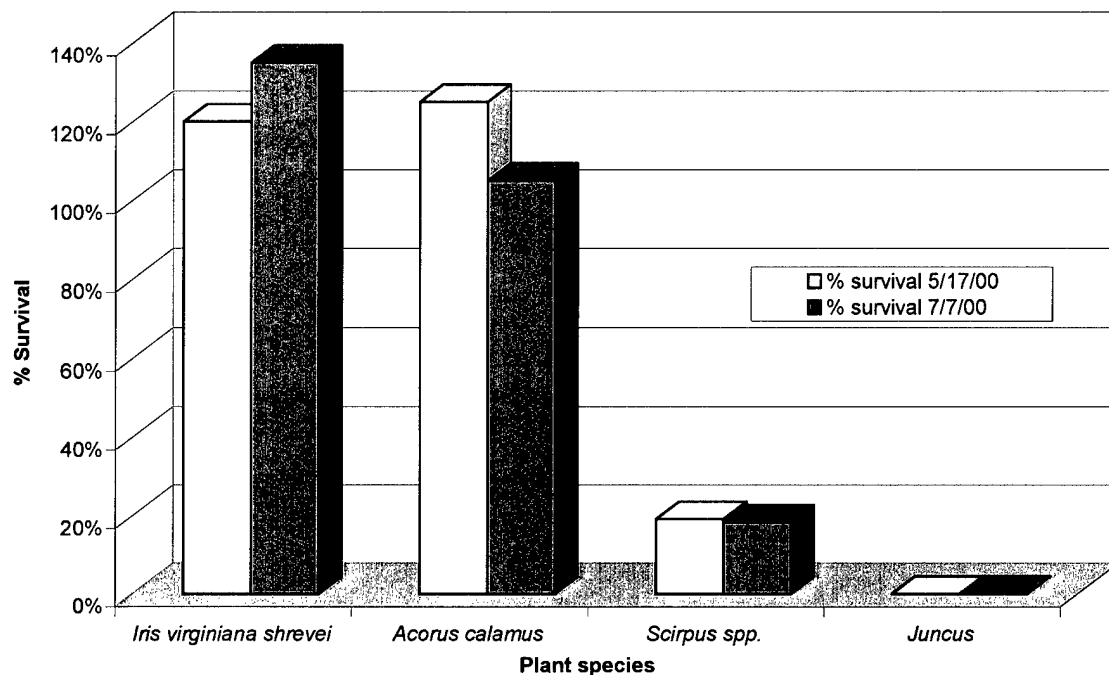
Figure 15. Survival of plants behind the branchbox breakwater

It appears that the area between the branchbox and shore may have suffered from either or both of two effects created by the branchbox's proximity to the bank. First, the protected area is shaded by existing trees on the steep bank for half of the day, then is shaded by the branchbox breakwater for much of the remainder of the day. This lack of sunlight may be responsible for an observed 0.76-m- (2-1/2-ft-) wide area directly behind the branchbox that is unvegetated (Figure 14). Second, sand has deposited behind the branchbox to a height approximately 6 in. higher than directly in front of the branchbox. This sand appeared to be enough to cover small plants as they began to grow. Between this 0.76-m- (2-1/2-ft-) wide void and the original bank, however, there is vegetation. Quadrats were used twice to assess the vegetation of the entire area behind the branchbox breakwater, once on May 17, 2000 and again on July 7, 2000. The entire area was covered with 28 quadrats or partial quadrats. Numbers of *Juncus effusus*, *Scirpus spp.*,

Of the planted species, *Iris versicolor* and *Acorus calamus* had the highest survival percentages when measured on July 7, 2000 (135 percent and 105 percent, respectively) indicating they have already regenerated. *Scirpus spp.* have not fared as well, having a combined survival percentage on July 7, 2000 of 18 percent. Of the 60 *Juncus* that were planted, none survived (Figure 15).
