Little Goose Dam Radial Gate Inspection and Testing

US Army Corps of Engineers, Walla Walla District

13. ABSTRACT (Maximum 200 words) This report is an evaluation of the overall condition of the spillway tainter gates at Little Goose Lock and Dam, Snake River Washington.

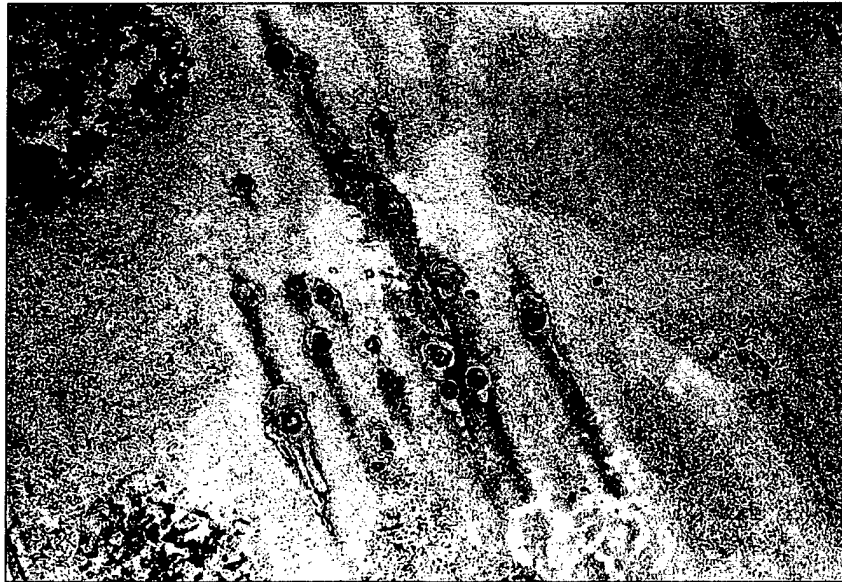
the 1/2-inch thick portion. See Figure 2, and photos 4 and 5. There is moderate to heavy, scattered pitting on the 3/4-inch wear plates on most of the gates. There is pitting present in excess of 1/2-inch deep at some locations, see Photo. 6. At many locations the pitting on both the skin plate and wear plates appears to be associated with scratches or dings in the plates original protective coating, see Photo. 5 and Photo 7. Based on the hemispherical shape of the pitting, the corrosion appears to be microbially influenced. It is likely that increased acid levels due to microbial activity have created a concentration cell within the pits and accelerated the corrosion.

Photo. 5: Skin plate pitting, typical.

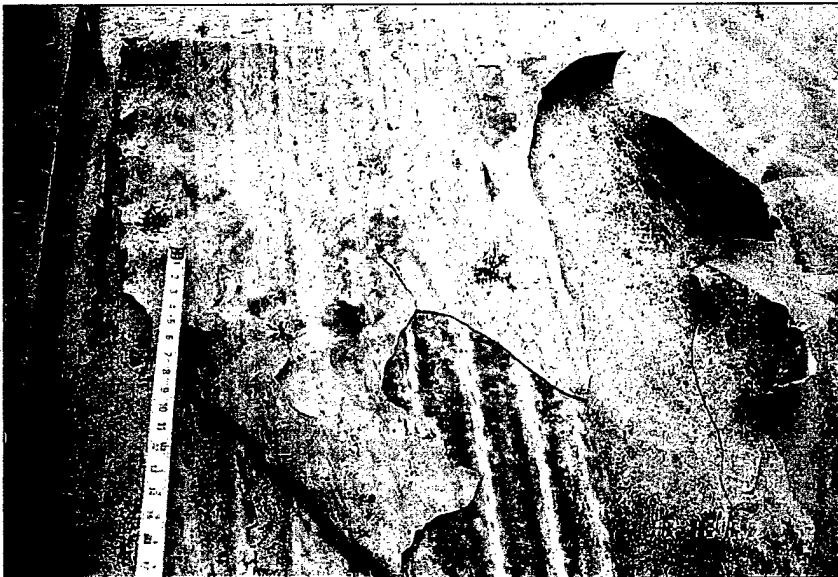
There is significant delamination of the vinyl coating on the wear plate at Gates 2 and 6 with smaller spots of delamination at other gates. See Photo. 8.

Photo. 8: Delamination of vinyl coating on wear plate, typical Gates 2 and 6.

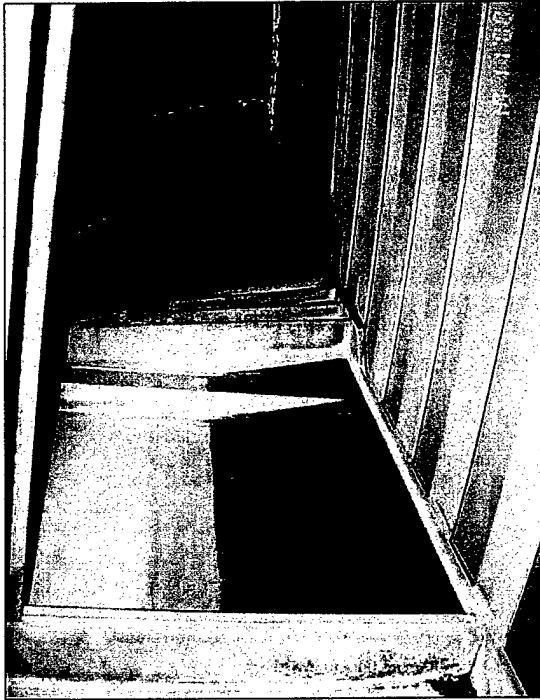
Photo. 12: Standing water or debris lines between stiffeners at ends of bottom horizontal girder, typical.

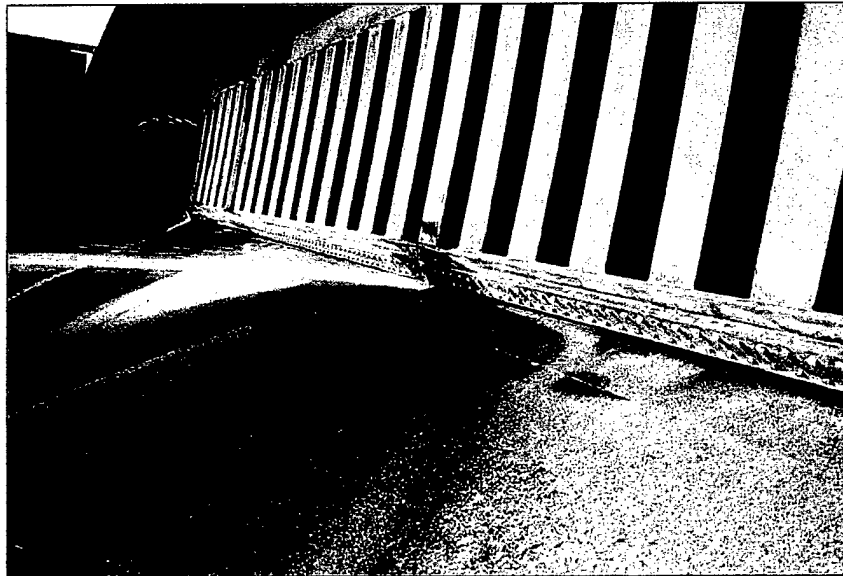
The side and bottom seals are in generally good condition. Small side and bottom seal leaks are visible on many of the gates, although no major leaks were observed. There is a leak at the bottom seal, at the spillway monolith construction joint at nearly every gate, see Photo. 17. There is light to moderate corrosion on the downstream side of the skin plate at the side seals and side seal bolts, see Photo 19.

Photo. 17: Leak at spillway monolith construction joint, typical.

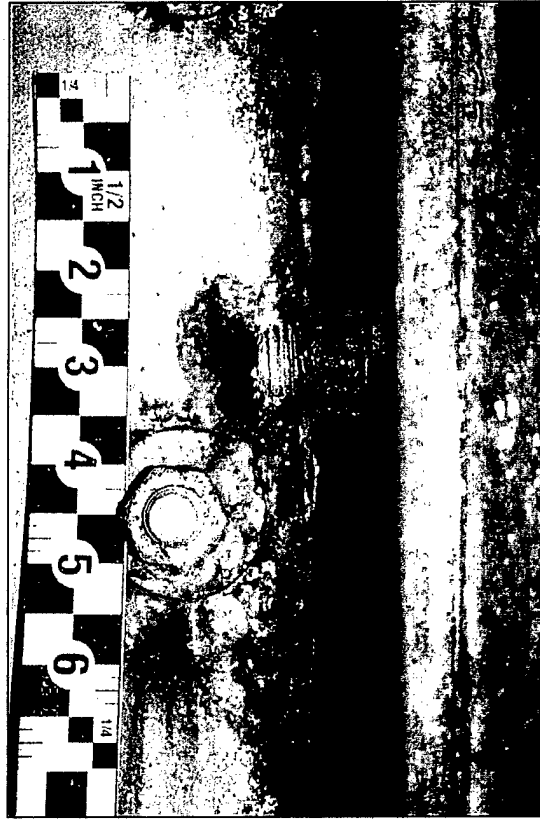
Photo. 18: Side seal from downstream side, light to moderate corrosion on skin plate, seal angles, nuts and bolts, typical condition.

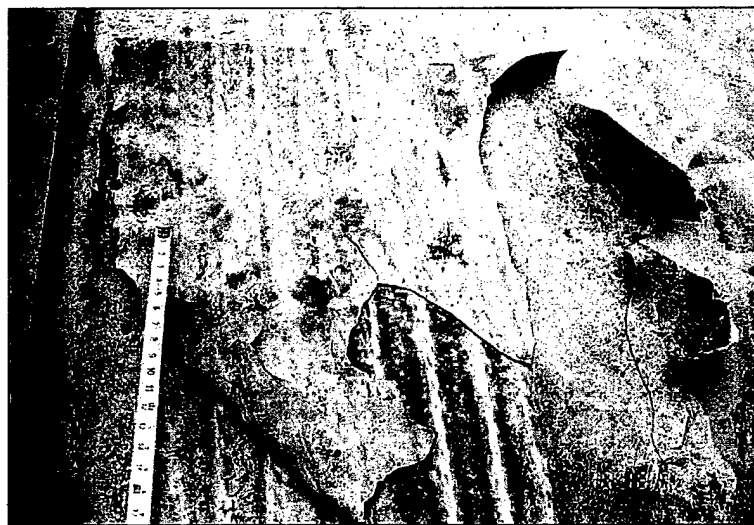
- On the downstream side of the skin plate, along the wear plate, there is delamination of the vinyl coating on the plate. Large sheets of vinyl are peeling off of the wear plate and hanging loosely on the gate face.

Photo. 28: Delaminated vinyl coating on wear plate, left side of Gate 6.

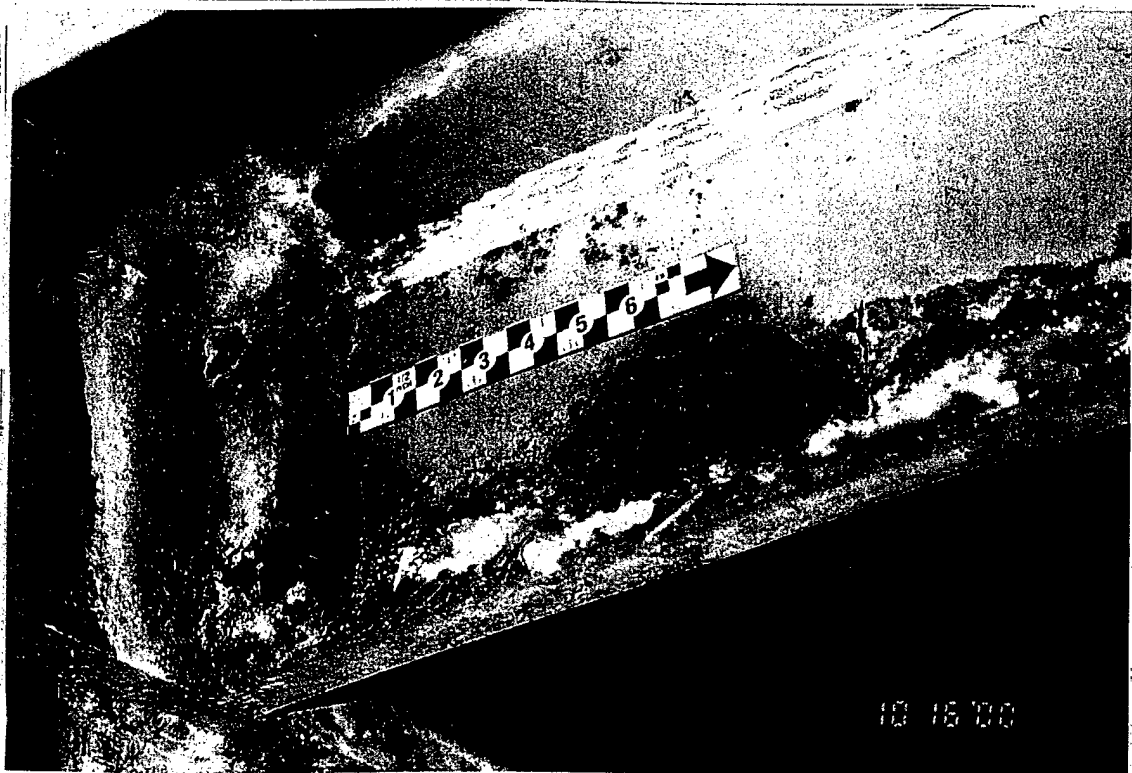
Little Goose Dam	Gate 1 Bottom of bottom horizontal girder at stiffeners for bottom left radial strut. Light to moderate corrosion due to horiz. girder drain hole above.
10/16/00	
1-20

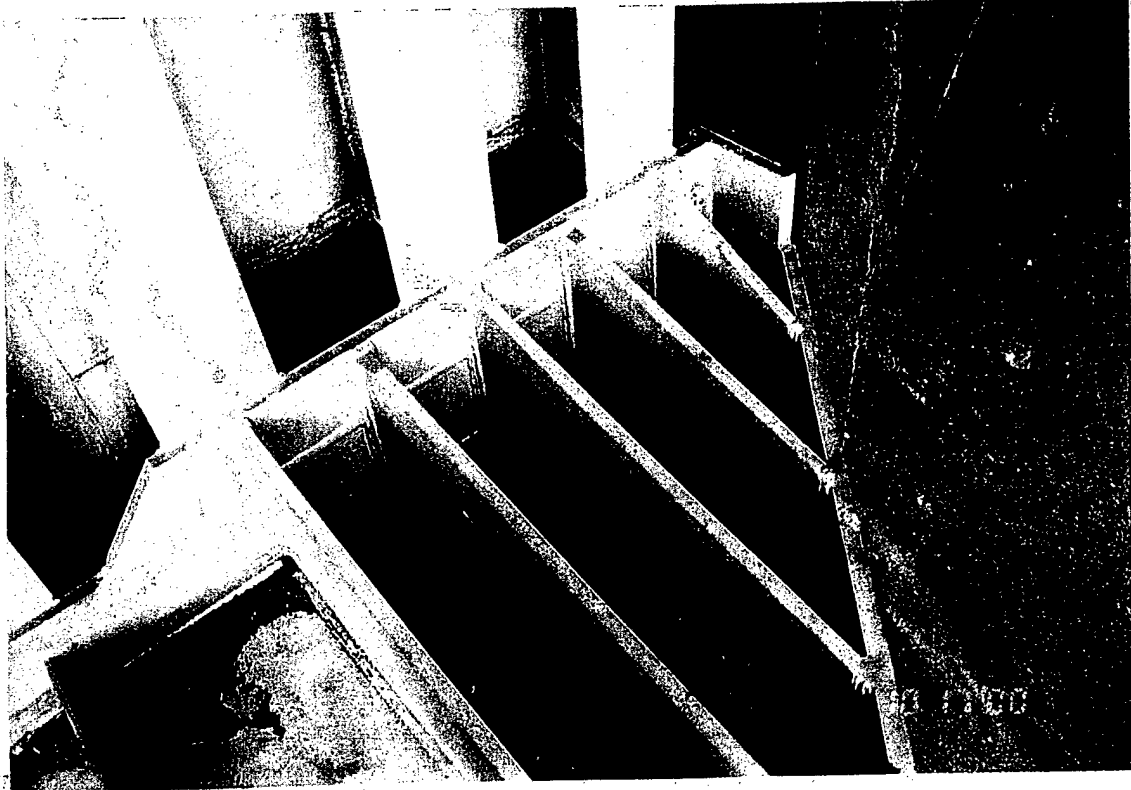
Little
Goose
Dam
10/17/00
2-11

Gate 2
Bottom horizontal girder, left end.
Standing water, no drainage between
multiple stiffeners, typical.

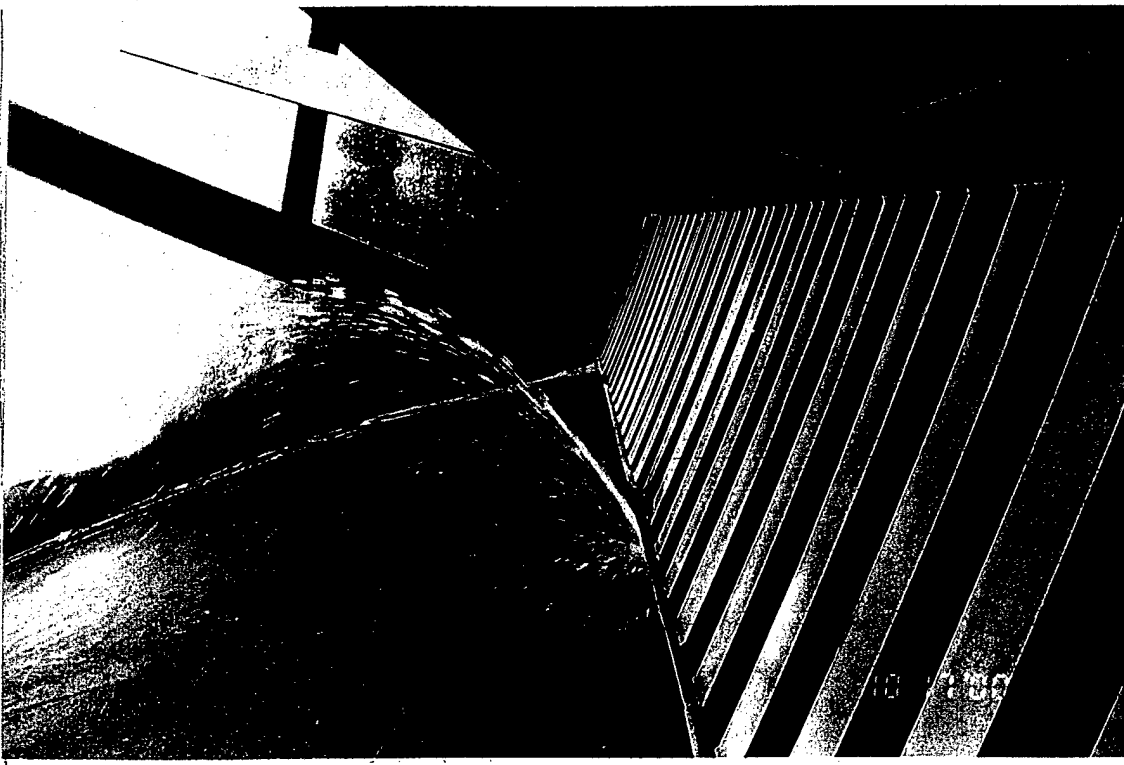
Little Goose Dam	Gate 2 Leak at center construction joint in spillway monolith.
10/17/00	
2-15

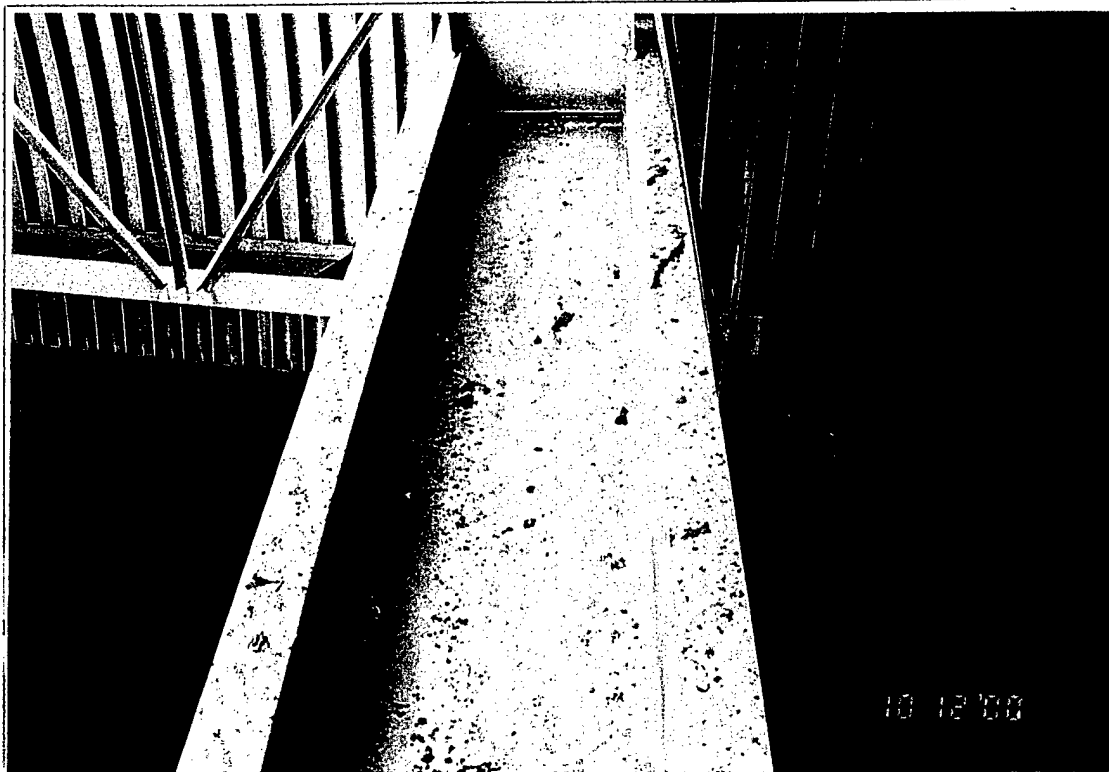
3-2

Gate 3
Left frame, middle radial strut,
typical.

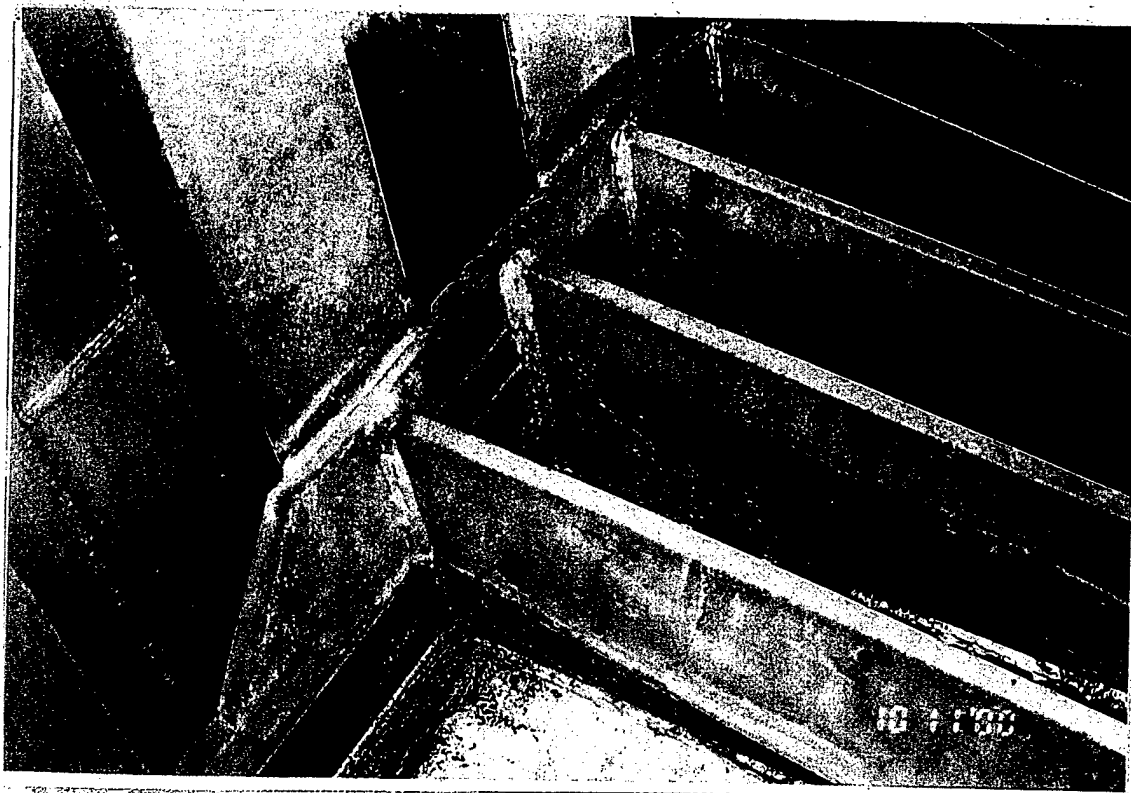
Little Goose Dam	Gate 7 Bottom horizontal girder, left end. Standing water, no drainage between multiple stiffeners, typical.
10/11/00	
7-12
