<b>13. ABSTRACT (Maximum 200 words)</b> This report is an evaluation of the overall condition of the spillway tainter gates at Lower Granite Lock and Dam, Snake River Washington.				
<b>14. SUBJECT TERMS</b> Spillway tainter gates inspection testing			<b>15. NUMBER OF PAGES</b> 250	
			<b>16. PRICE CODE</b>	
<b>17. SECURITY CLASSIFICATION OF REPORT</b> Unclassified	<b>18. SECURITY CLASSIFICATION OF THIS PAGE</b> Unclassified	<b>19. SECURITY CLASSIFICATION OF ABSTRACT</b> Unclassified	<b>20. LIMITATION OF ABSTRACT</b> UL

February 2001

# Lower Granite Dam Radial Gate Inspection and Testing

US Army Corps of Engineers, Walla Walla District

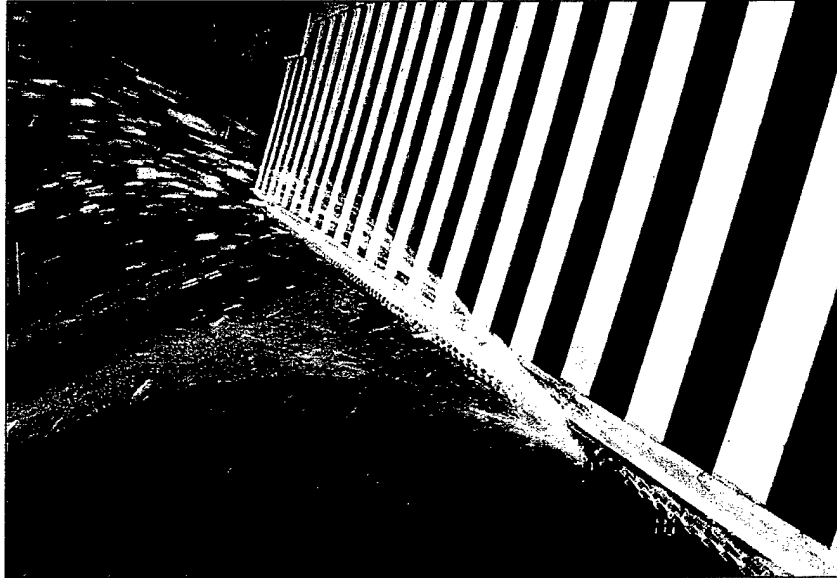
The side and bottom seals are in generally good condition. Small side and bottom seal leaks are visible on many of the gates, although no major leaks were observed. There is a leak at the bottom seal, at the spillway monolith construction joint at nearly every gate. Photo. 15. The

**Photo. 15: Leak at spillway monolith construction joint, typical.**

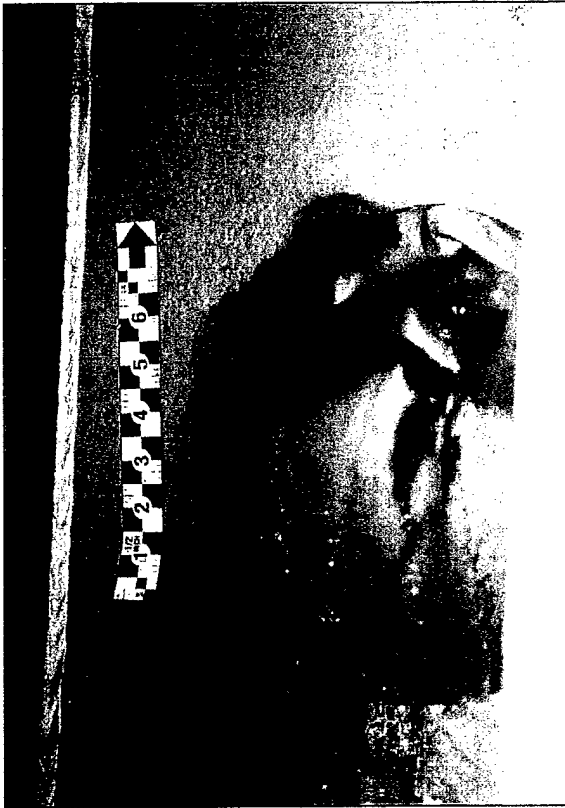
- Prior to the inspection of the upstream face of the gate and waterblasting, an approximately 10-inch diameter paint blister was observed on the downstream side of the skin plate. The blister was located between the middle and top horizontal girders, approximately 7-feet from the left side of the gate (looking downstream) and approximately 6-feet above the transition between the 1/2-inch and 3/8-inch skin plate. The blister did not appear to be leaking water at the time, however, rust stains were observed on and beneath the blister. After waterblasting the upstream surface of the gate, the blister developed several leaks, see Photo. 24 and Photo 25. During the downstream inspection of the gate the blistered paint was removed to expose the hole in the skin plate, see Photo 26. The actual hole through the skin plate was roughly oblong and approximately 1/4-inch wide and 1/8-inch tall.

*Photo. 25: Skin plate leak  
prior to removal of  
paint.*

- The leak was patched by Gus Hernandez, USACE, on October 17th using META-LOX™ Industrial-Grade Metallic Patching Compound, a 2-part epoxy and resin compound.

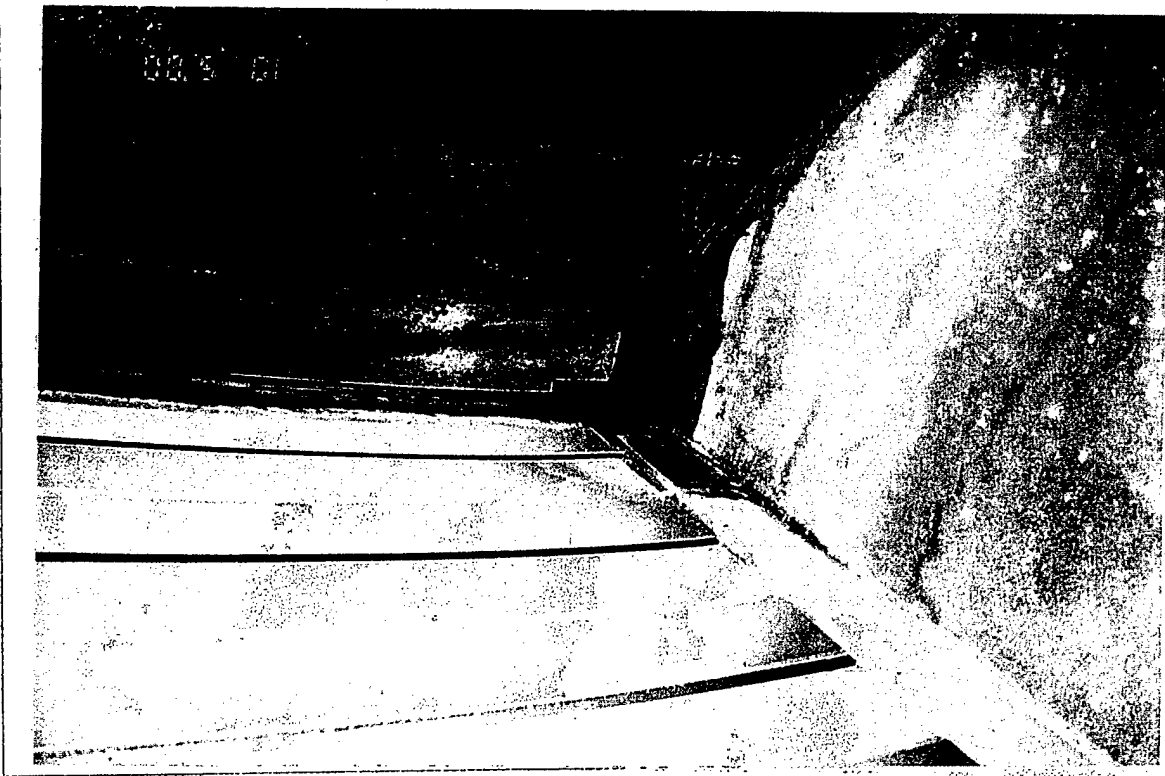
**Gate 2**  
Left end, middle horizontal girder.  
Peeling paint on purlins, light  
corrosion.

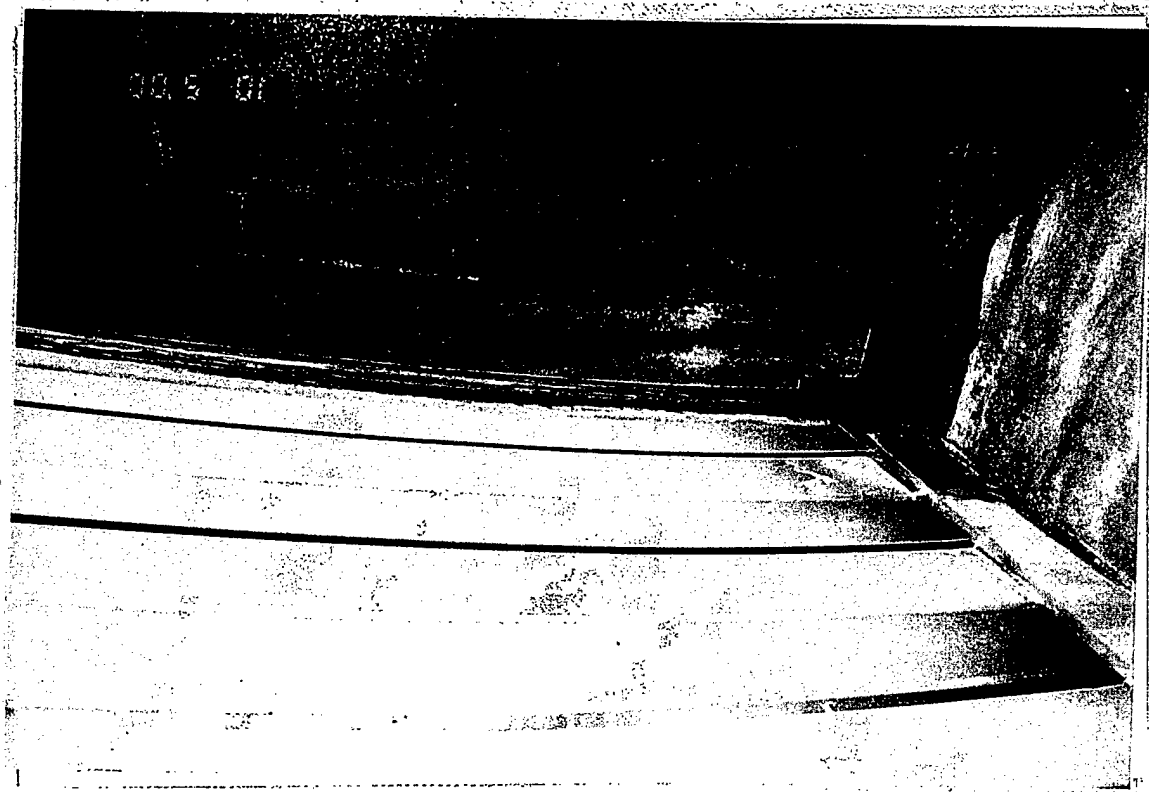
**Gate 2**  
Left end, middle horizontal girder.  
Peeling paint on purlins, light  
corrosion.

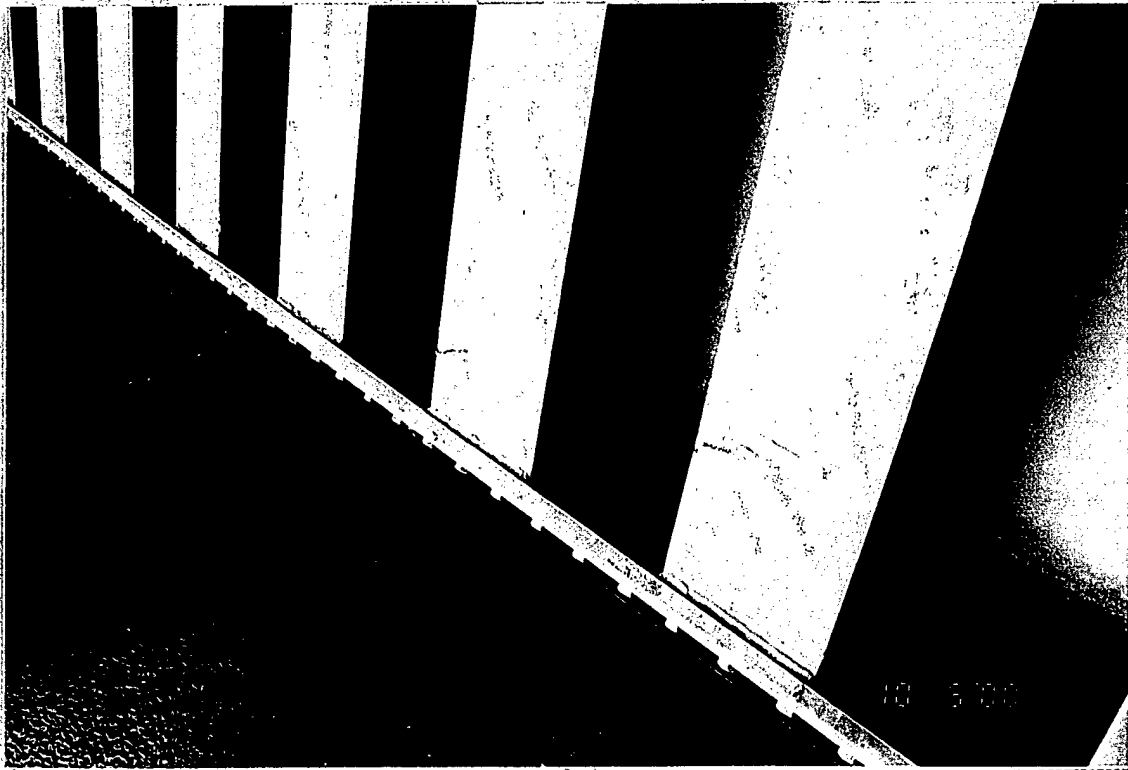
2-11

Lower Granite Dam Gate 2 Bottom seal closure plate looking upstream. Standing water between closure plate, purlin webs and skinplate. Typical.

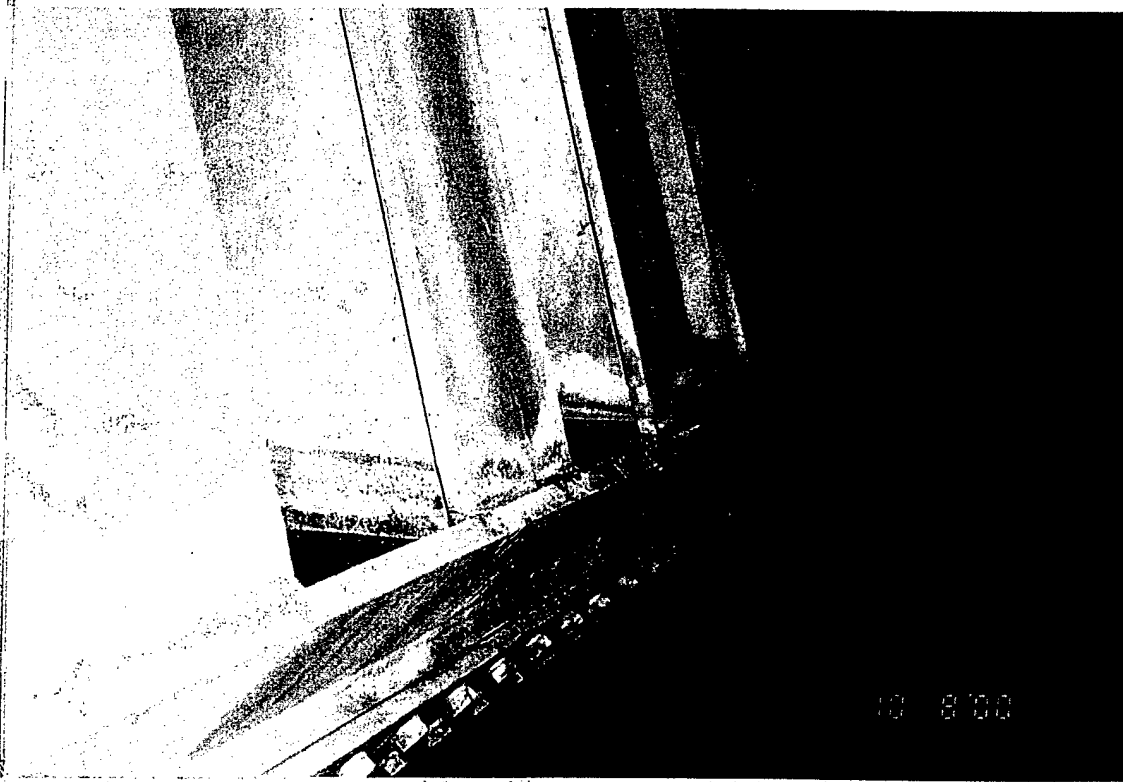
**Gate 3**  
Downstream side of bottom seal and  
keeper plate looking upstream.

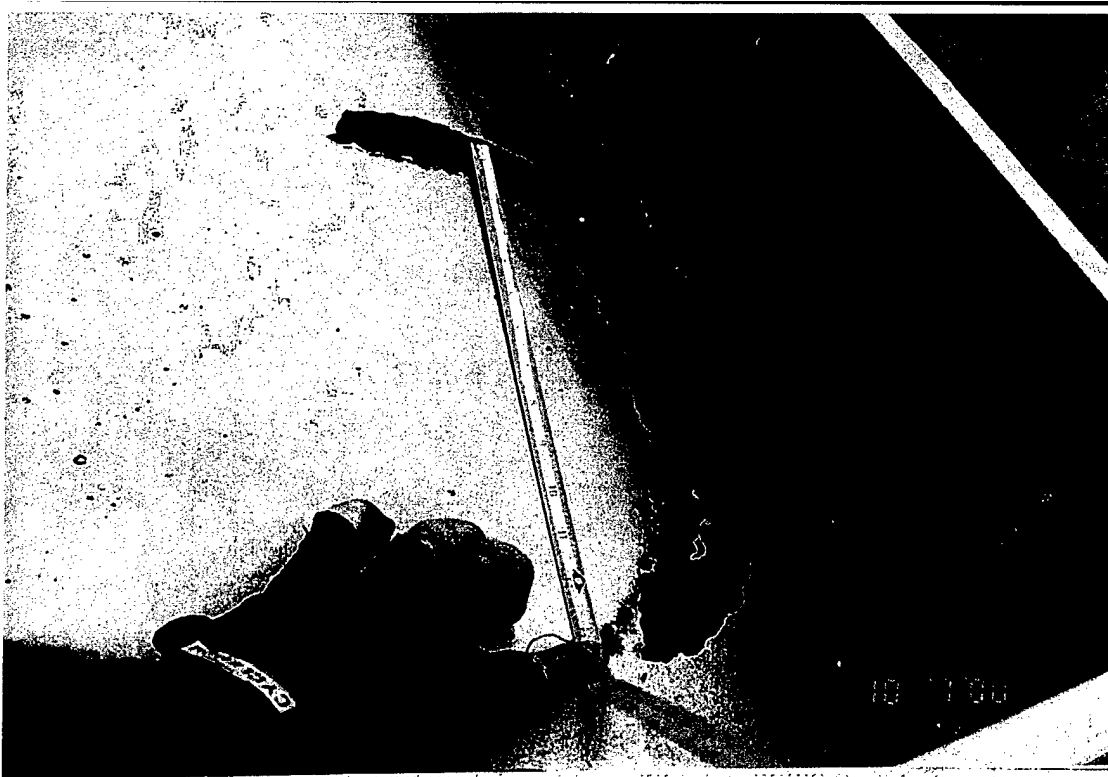
7-7

Gate 7  
Top horizontal girder near right radial  
strut connection. Light corrosion
