A Proposed Highly Damped Repair for the Aft Fuselage of the F/A-18

DSTO-TR-1374

Air Vehicles Division
Platforms Sciences Laboratory

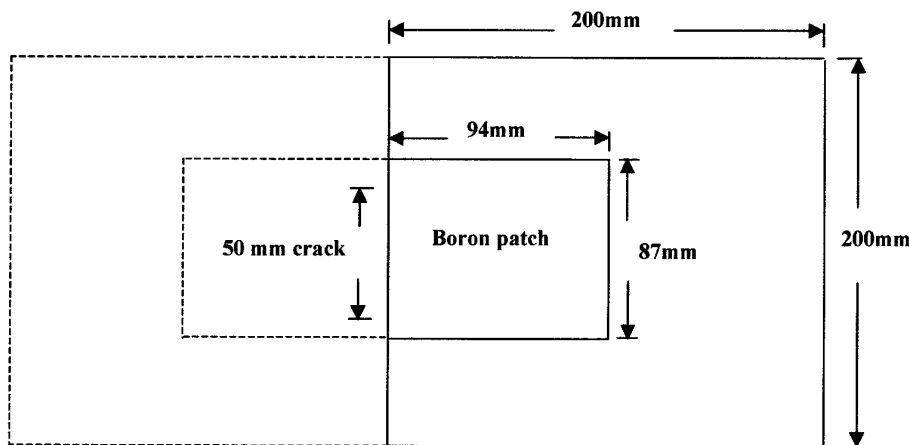
Figure 4. Dimensions of repair, plan view

In order to study the cracking mechanisms of the cracked and repaired/cracked aft skin cases, a simplified model has been developed in which the skin is considered to be a flat rectangle. Most of the skin panels in which cracking occurs have a chemical milled step in which the panel is reduced in thickness to 0.91mm. While the width and height dimensions of each panel vary, the F.E. model has representative dimensions as shown in Fig. 4. Also shown in Fig. 4 the local uni-directional patch extends partially across the panel, but since the crack lies near the boundary the repair will continue across the adjacent panel as shown in the dotted outline. In order to accurately represent the bending of the panel, 2 layers 20 noded brick elements have been used through the thickness. The F.E. mesh is shown in Fig. 5. The local boron/epoxy repair [O₃] has been applied to make up for material lost as a result of the crack. The highly damped section of the repair covers the entire panel including the local boron patch. This section consists of two viscoelastic layers with two boron/epoxy [0/90] constraining layers as shown in Fig. 6. The viscoelastic layers and adhesive have been modelled using 3D elements as are the constraining layers. The total structure consists of 7000, 20 noded brick, elements and 29000 nodes.

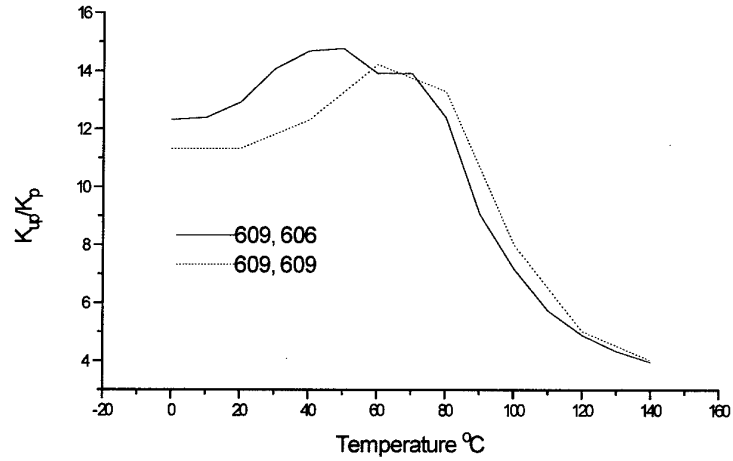
Figure 15. Plot of K_u/K_p versus temperature for configurations using 609 and 606.

In Fig. 15 a plot is shown of the variation in the ratio of stress intensity factor, for the cracked unpatched plate (K_{up}) to the stress intensity of the repaired plate (K_p), with increasing operating temperature for a patch incorporating both 606 and 609 (viscoelastic material) VEM and two layers of Dyad 609 VEM. The stress intensity factor (SIF) was calculated using the F.E. model described in section 5 and the analysis includes the thermal residual stress contribution and softening effect of the adhesive. A significant reduction of K is shown over the complete temperature range. Results using two layers of 609 are also shown in Fig. 15.

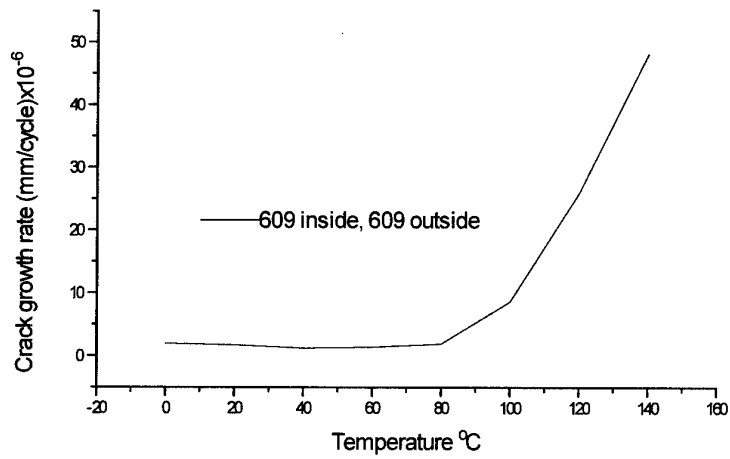
Figure 16 Crack growth rate for highly damped repair.

Fig. 16 shows the crack growth rate for 7075-T6 cracked plate incorporating a patch with two layers of Dyad 609 over the temperature range of interest. In this figure, equ(6) is used to obtain the crack growth rates, with relevant coefficients, including both thermal residual stresses estimated from a closed form solution and adhesive softening. The crack growth rate is relatively low for temperatures of 80°C, beyond this the crack growth increases significantly. In comparison Fig. 17 shows that the crack growth rate for the cracked unrepaired panel compared to the repaired panel is approximately 2700 time greater for temperatures around 40°C. Even at 140°C the crack growth rate of the cracked unrepaired panel is 70 times then that for the repaired panel.

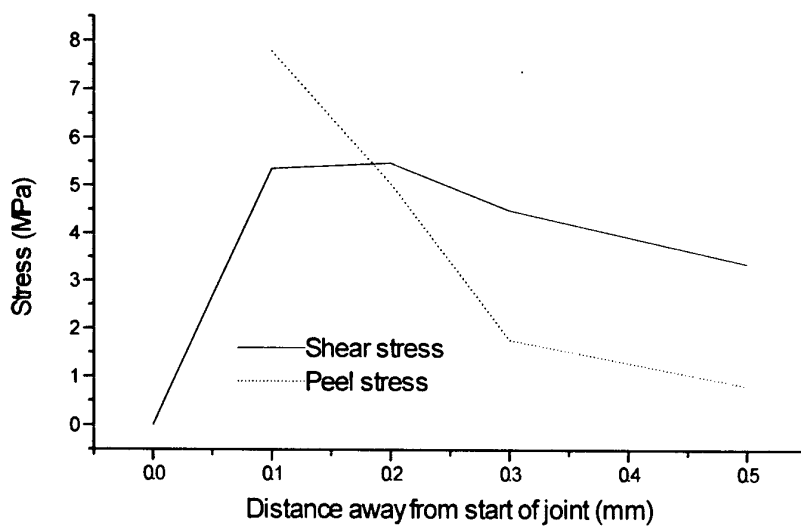
Figure 18. Adhesive stresses bonding boron to aluminium at room temperature.

The adhesive shear and peel stresses in the adhesive layer of the boron repair the are shown in Fig. 18 for the room temperature case. At this particular SPL the stresses are relatively low and no yielding will occur under peel or shear.

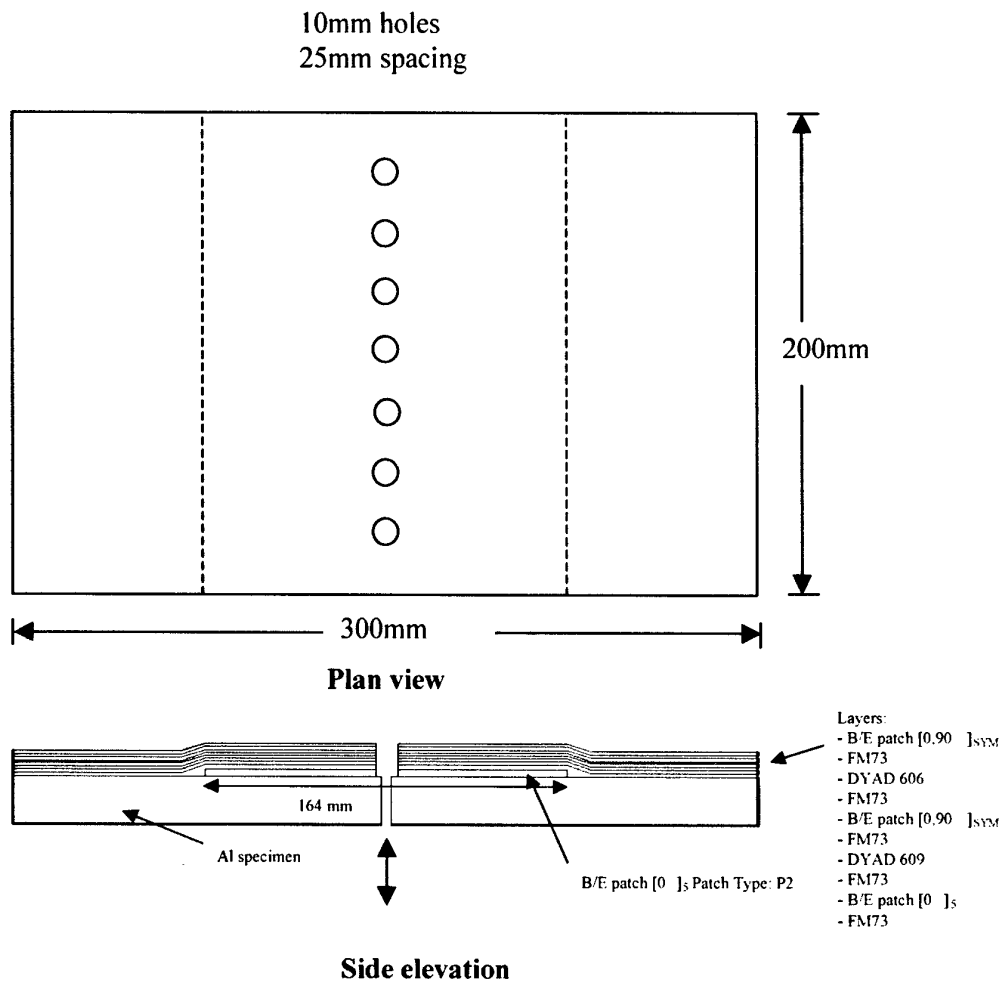
Figure 20. Highly damped repair configuration, from ref(19)

Limited experimental work has been carried out in [19,20,21] in support of the analytical work. While differences exist between the aft fuselage geometry and specimens, similar experimental trends are expected. This work covers testing butterfly specimens which involve the flexing or bending motion shown in Fig. 19, provided by a shaker, in order to simulate the acoustic excitation. The geometry of the specimen is shown in Fig. 20. These specimens consist of bare aluminium specimens with boron/epoxy patches and Dyad 609 and 606 damping layers with $[0,90]_s$ constraining layers. The highly damped repair was applied using room temperature curing adhesive Hysol EA9320. All panels were pre-cracked with a crack length of 25mm. In each case the maximum force applied to the specimen by the shaker was 90N. This forcing level achieved a nominal *rms* strain of about $1000 \mu\epsilon$ ahead of the crack. Comparative results are shown in Fig. 21. In the case of bare aluminium specimens approximately 100,000 cycles were obtained before the resonant frequency of the specimen dropped by 15%. A 15% drop in resonant frequency was used as a criteria to indicate extensive crack growth. For boron/epoxy repairs approximately 1,000,000 cycles were obtained before the resonant frequency of the specimen dropped by 15%. In the case of the highly damped repair the first test with a shaker force of 90N gave no reduction in resonant frequency at 10,000,000 cycles, as shown by the dotted line. A second run was made with the shaker force increased to 180N. The results for this run are shown in Fig. 21. At approximately 10,000,000 cycles a 15% reduction of resonant frequency has occurred. The highly damped repair tested is slightly different to in that analysed above in section 5 in that the constraining layers of $[0/90]_s$ are used in the experimental test rather than the $[0/90]$ plies in the aft fuselage F.E. model. However the experimental results indicate that highly damped repairs are very effective in reducing the crack growth rate.
