**Metallurgical Examination of a Failed AH-64D Pilot  
Cyclic Stick (Part Number 7-511512001-3)**

**by Victor Champagne and Scott Grendahl**

**ARL-TR-3272**

**August 2004**

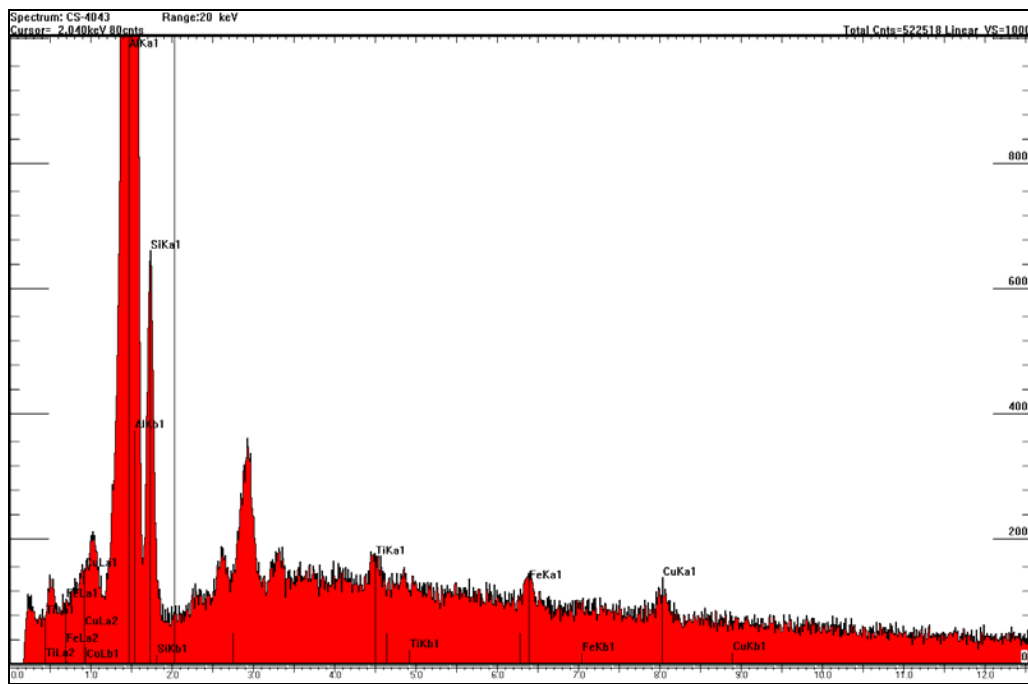
The chemical composition of the weld bead was initially determined by quantitative energy dispersing spectroscopy (EDS), within the scanning electron microscope. This method was chosen to obtain relative chemical composition quickly in lieu of wet chemistry techniques to verify the weld rod material. It was not meant to provide absolute values of chemical composition. The differences in the silicon and copper content between the two welding rods were the distinguishing elements used as a basis for comparison. The small concentrations of manganese, magnesium, and zinc did not yield an appreciable peak and therefore did not factor into the overall weight-percentage calculation. Samples of the two possible weld rod materials, AMS 4190 (ER4043) and AMS 4189 (ER4643), were obtained and analyzed to calibrate the EDS system. The spectra obtained are shown in figures 20 and 21. A section of the weld bead on the elbow fitting was polished with 15- $\mu\text{m}$  diamond paste, to remove surface contamination, in preparation for EDS analysis. The spectrum of the weld bead compared favorably to that of ER4643, as figure 22 reveals. Table 5 lists the corresponding numerical values of these EDS analyses.

Figure 20. EDS spectrum for the 4043 welding filler rod.

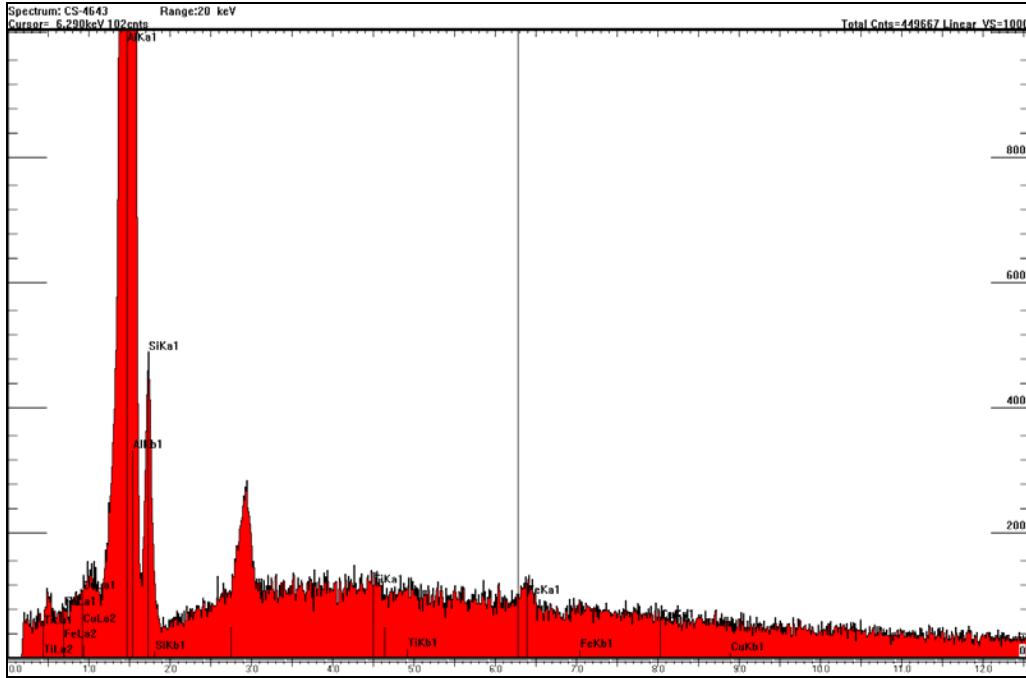
Because it appeared from the hardness data that the pilot stick assembly was not heat-treated, and heat-treatable 4643 weld filler rod was used, a small amount of filler material was painstakingly removed for wet chemical analysis. DC plasma emission spectroscopy (DCP) was used, and the major constituents compared favorably with 4643 filler rod (silicon, copper, and magnesium), confirming the initial analysis. These data are presented in table 6.

Figure 21. EDS spectrum for the 4643 welding filler rod.
