Australian Government
Department of Defence
Defence Science and
Technology Organisation

A Review of Australian and New Zealand Investigations on Aeronautical Fatigue During the Period April 2003 to March 2005

DSTO-TN-0624

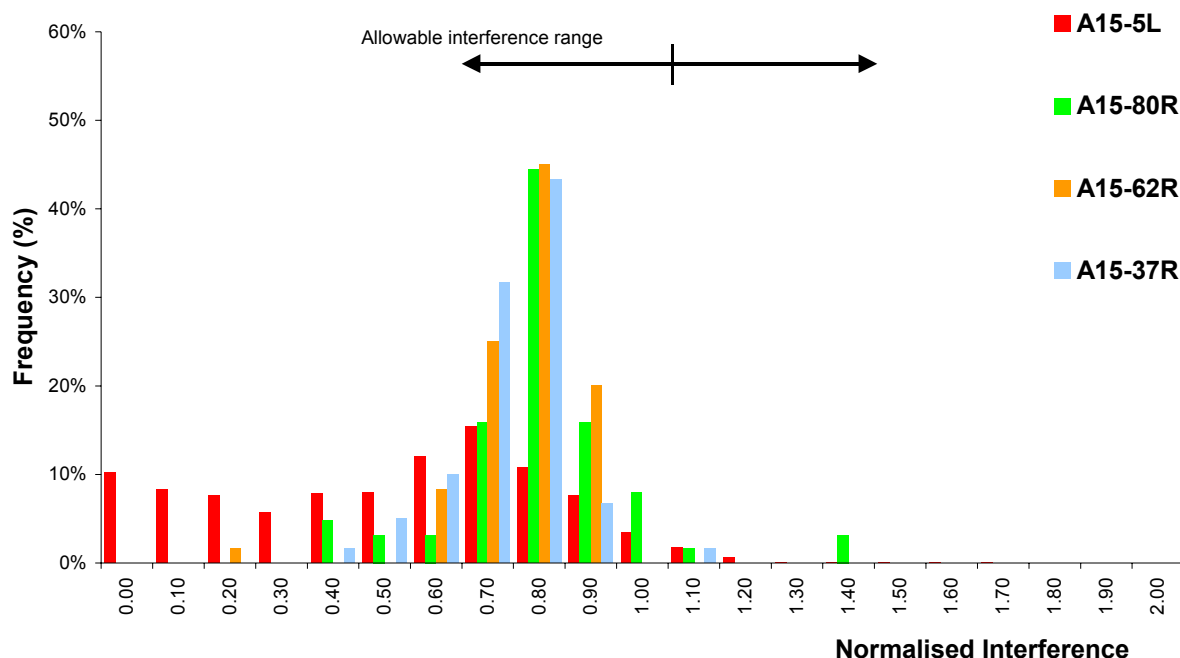
The build quality of the test wing A15-5L was confirmed to be very poor. For A15-5L, 47% of fasteners sampled had below-specification interference and 7% of fasteners sampled were loose in the hole (zero interference), see Figure 1. In addition, 34% of fastener holes sampled were measured to have above-specification surface roughness in the hole bore. The data from the F-111F and F-111D wings showed that, on average, the build quality of these wings was significantly better than the test wing A15-5L. However, there was also a statistically significant variation in measured build quality between the F and D wings sampled. In addition, a number of significant manufacturing defects were detected in the F and D model wings during the build quality survey. A statistical analysis was performed to examine the probability that an F or D wing might have a build quality as poor as the failed test wing A15-5L. Unfortunately, it was not possible to conclude, with a high level of statistical confidence, that this probability was negligible, primarily due to the statistically significant variation in measured build quality between the F and D wings sampled.

Figure 1 Frequency distribution of fastener interference for the failed F-111C fatigue-test wing A15-5L compared to three F-111F wings (A15-80R, A15-62R and A15-37R). Interference values are normalised by dividing by the nominal interference level, so that a normalised interference of 1 corresponds to the nominal (blue-print) interference level. The allowable range of normalised interference is from 0.6 to 1.4.

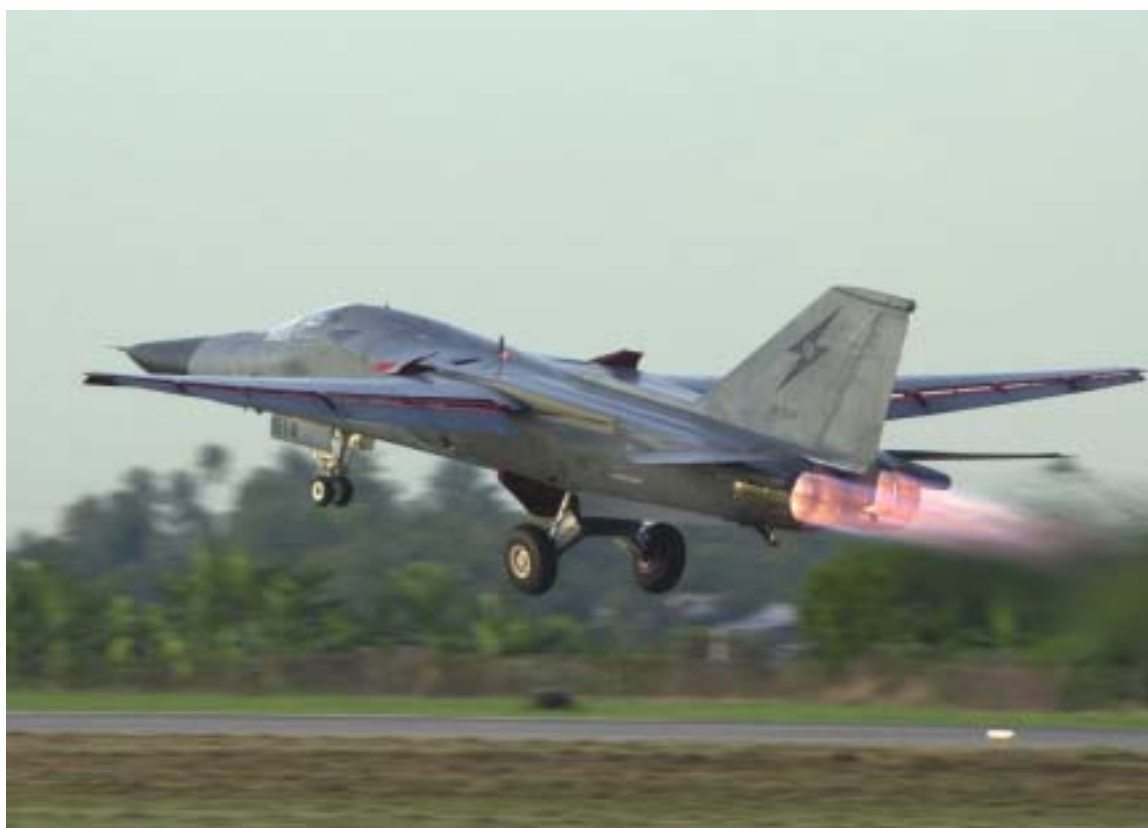
Figure 1 shows position of the strake – the fin on bottom side of rear fuselage. Figure 2 shows a failed strake next to a good one. Figure 3 shows two failures - failure occurred by fatigue of the aluminium mounting plate member, from the front working backwards. Note the similarity of the two failures about 18 inches in a total length of 24 inches was cracked, although there were smaller fatigue cracks in the "overload" region, around the side of the section. Figure 4 shows visual detail of typical fatigue region near front - fatigue cracks start on the upper radius and work there way down the length and through the section thickness. Figure 5, SEM striations on fracture surface - vibrational loading with occasional large load (i.e. high G turn). Unfortunately, there is no information on the time frame of G turns so it is difficult to obtain the rate of growth - although we can conclude that the 18 inch cracks have probably been growing since new (after an "incubation" period). Figure 6 shows a smaller fatigue crack in "overload" zone at rear.

Figure 1: Position of strake - fin on bottom side of rear fuselage

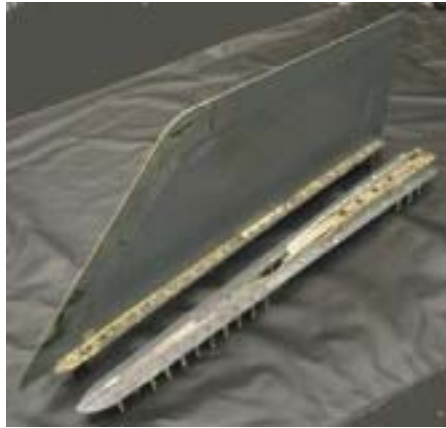
Figure 2: Failed strake next to a good one.

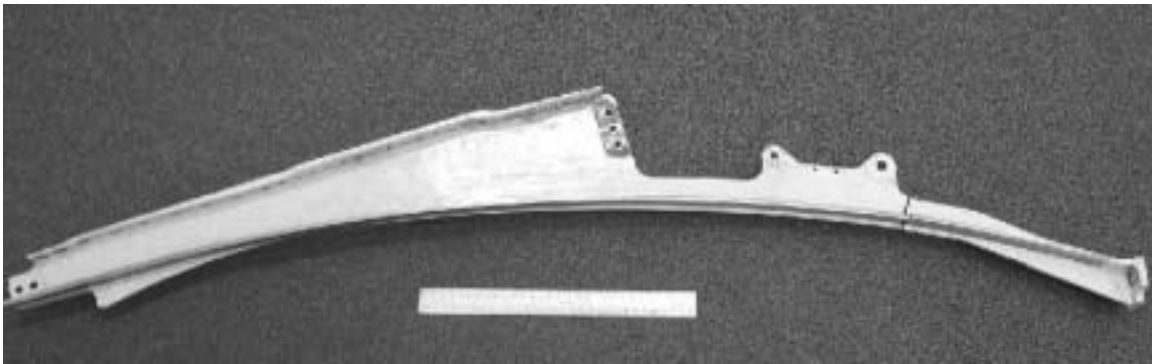
Figure 3:

The immediate concern with the Hawaii incident was - was this hydrogen embrittlement after all? Figure 3 shows where the cracking is on the track and Figure 4 the detail. The fracture certainly looked very brittle. Figure 4 however was sent later on from Hawaii and the very smooth front during crack propagation suggested that it might be fatigue and not hydrogen embrittlement.

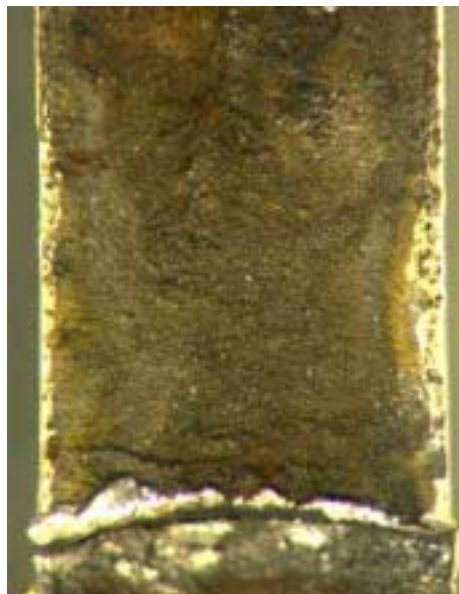
Figure 7:

On getting the fracture into the lab, it was found that it was not fatigue either (a least most of it), but stress corrosion cracking (Figure 5). There was a little bit of fatigue before final overload (Figure 6 upper and lower lugs). The smooth transition on the surface was due to two periods of SCC. That the track had SCC present at the last overhaul was evident from cadmium and paint on the sides of the fracture face (Figure 7). Metallography confirmed that the mechanism was SCC (Figure 8).

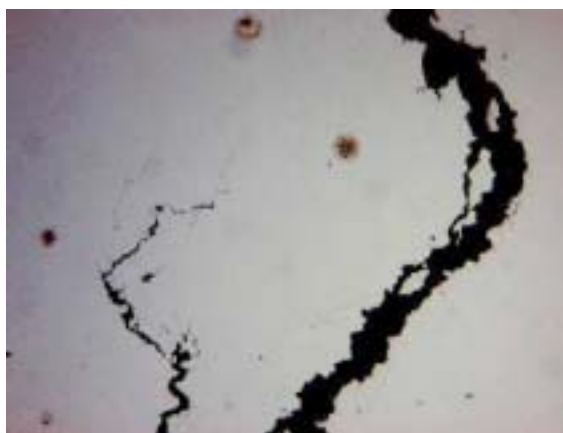
Figure 8: Metallographic section, showing SCC nature of cracking.

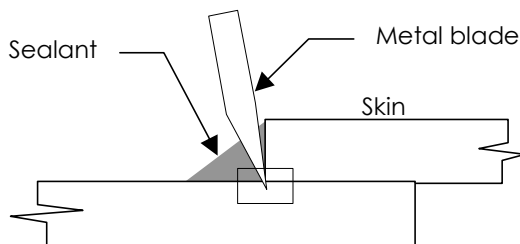
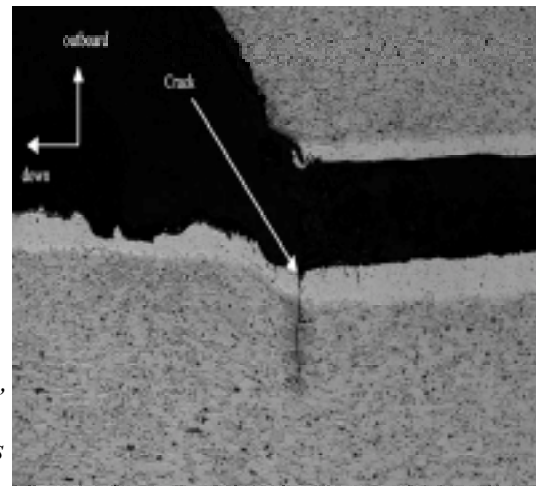
Figure A. Skin scratches and cracks.

It could have failed because of a common maintenance error. See Figure A. The current evidence suggests half the world's airliners (and not just Boeings) could be scratched to varying degrees. Some could be unaffected by it. Some could be unsafe. Some could be unrepairable.

Figure A: To save time, some painters improperly use a metal blade instead of a plastic scraper to remove sealant from skin joints. The scratch cracks, as shown at right. The Australian 747 was an extreme case; someone penetrated half the thickness with some kind of power tool.

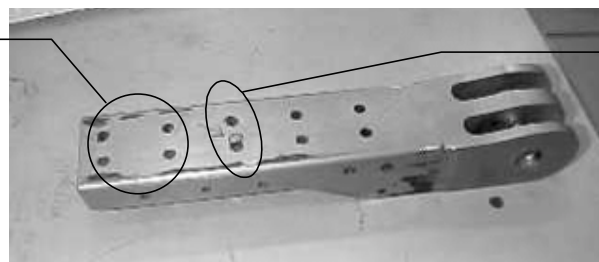
Figure C: This fitting held the wings on a small airliner. It wouldn’t have for much longer!

The damage-tolerance-based maintenance program said to inspect these holes (using eddy currents).

Luckily, the inspector went further and found a crack in one of these holes!

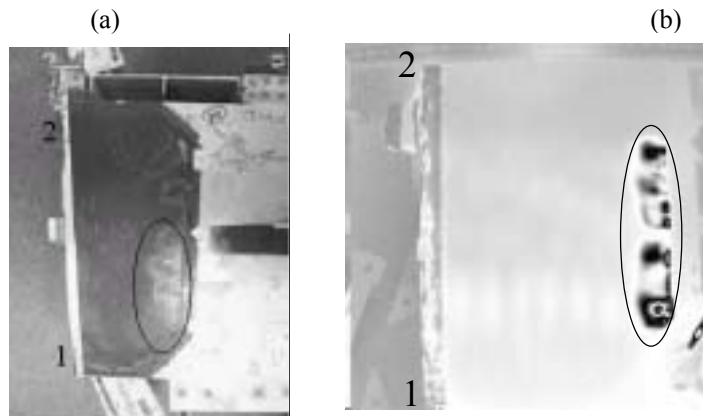
Figure 1 (a) Photograph of the LWS section, indicating region of interest. (b) Raw sonic thermograph showing darkened regions indicating elevated heat production and possible disbands.

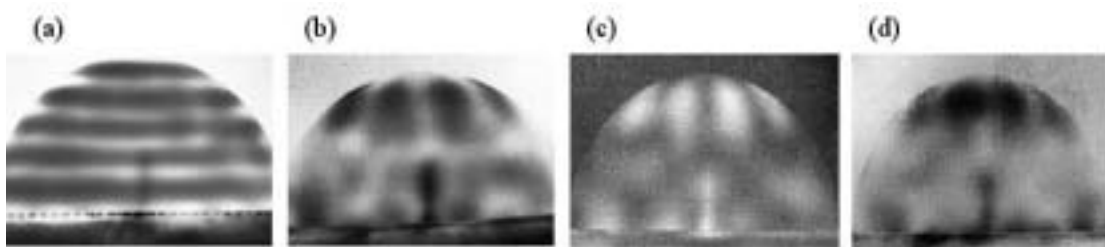
Figure 3. Sonic thermographs of boron epoxy patched honeycomb panel insonified at four locations (a, b, c and d) corresponding to Figure 2. The vertical indication corresponds to the crack in the Al 2024-T3 panel beneath the composite patch.

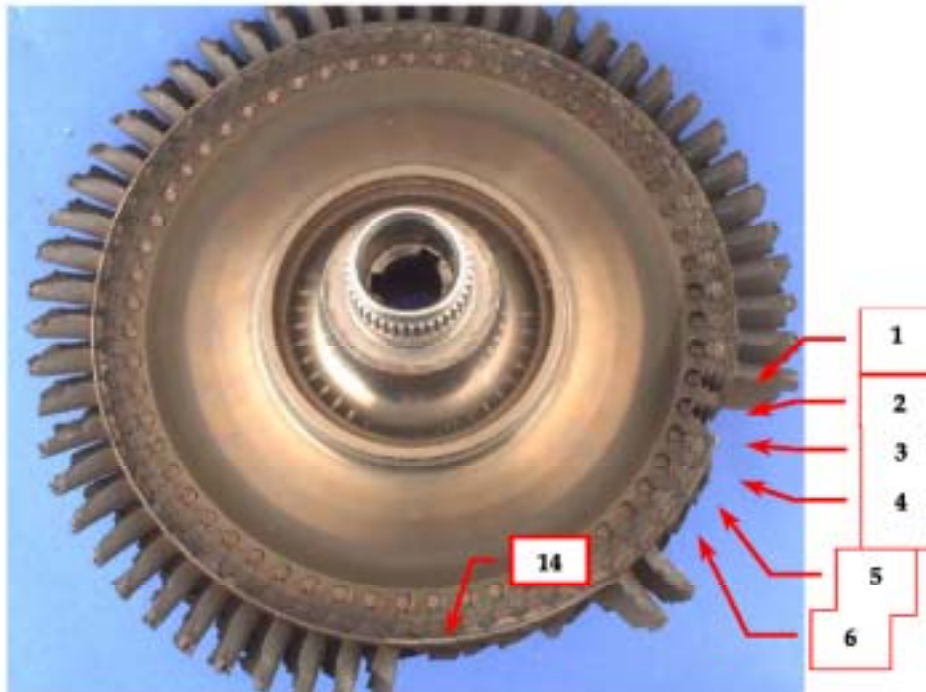
While the pilot of an RAAF PC-9A aircraft was carrying out touch and go manoeuvres, a loud bang accompanied by flames emanating from the exhaust stubs occurred on take-off after the fifth touch and go at approximately 20 feet off the ground. The flight was aborted and the aircraft landed without further incident. The investigation by the DSTO found that a perforated airfoil of a Compressor Turbine (CT) vane resulted in a CT blade being hit by vane material during the break-up of the perforated airfoil resulting in crack initiation leading to fatigue cracking and subsequent failure of the blade. The damage to the CT vane was consistent with rapid oxidation due to overheating of the vane. In addition, deleterious phases were observed which most likely formed as a result of prolonged exposure at elevated temperatures. The investigation revealed external cracking and both thinning and cracking of the internal surfaces of other vanes. While the external cracking was most likely caused by thermal cycles (i.e. thermal fatigue), the internal cracking was mostly due to preferential grain boundary oxidation and possibly thermal fatigue. The fatigue cracking associated with the blade propagated to approximately 51% of the blade cross-sectional area over numerous flights. Vibration analysis on ex-service CT blades found that it was unlikely that the blades were in a resonant mode as a consequence of the pulse of air emanating from the perforated airfoil. Furthermore, it was also considered unlikely that a fatigue crack driven by a forced aerodynamic excitation (i.e. once per revolution) due to disruption of the gas flow passing through the perforated airfoil would take multiple flights to reach a critical crack size. Whilst it was possible that the CT blade may have been mistuned, dimensionally and/or through fitment, mistuning induced cracking would have affected any mistuned blade and was not the result of a once per revolution frequency excitation. No evidence was found to indicate that a defect(s) in the microstructure, or weakness in the casting, led to the initiation of the cracking in the CT blade. However, the origin of the crack (i.e. suction side and two-thirds from the leading corner) was not at a location that was usually expected from cracking from a blade fir tree, i.e. at the corners. It was considered likely that the blade may have been hit by vane material during the break-up of the perforated airfoil consequently resulting in crack initiation and subsequent failure of the blade.

Figure 1. Photograph of the CT turbine disk assembly as received. Blade 1 (containing the primary fracture surface) and Blade 2 were removed by P&WC. DSTO labelled the blades from 1 to 59 in the clockwise direction

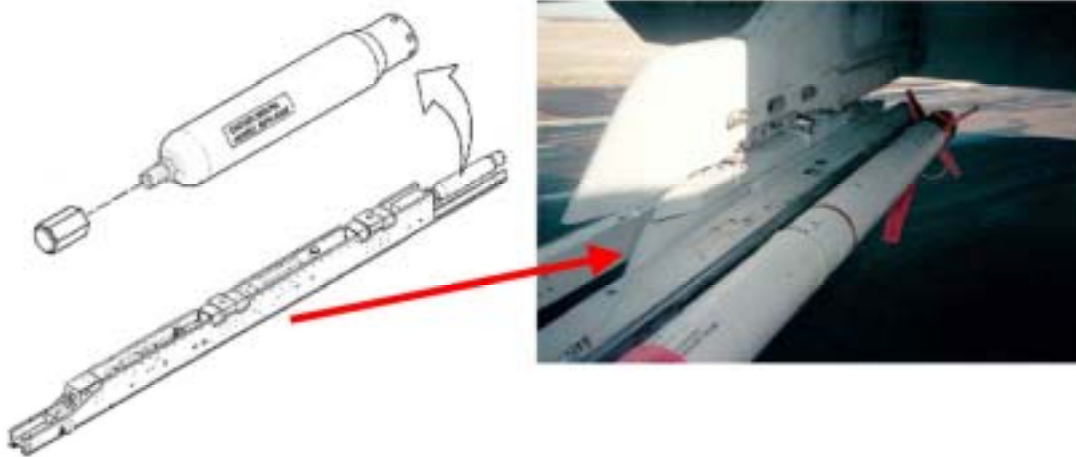
DSTO investigated the cause of corrosion found during an acceptance inspection/service of the cylinders, on the internal and external surfaces of two new LAU-127 Guided Missile Launcher Nitrogen Receivers. The investigation found that a manufacturing defect, which resulted in the formation of deleterious phases (i.e. pearlite layer) on both the internal and external surfaces of the material comprising the cylinders was the main contributing factor for the formation of the corrosion and cracking. These deleterious phases resulted in a material surface layer with lower strength, lower corrosion resistance and passivity, which consequently led to corrosion and cracking when the cylinders were exposed to an otherwise mild corrosive environment. The investigation concluded that the cylinders failed to satisfy the requirements specified by the Original Equipment manufacturer regarding corrosion resistance and surface condition (e.g. cracks or corrosion free surfaces), and that the presence of these defects might have compromised the structural integrity of the cylinders.
