September 1, 2004

Final Report

SERDP Pollution Prevention Project 1137

Non-Destructive Testing of Corrosion Under Coatings

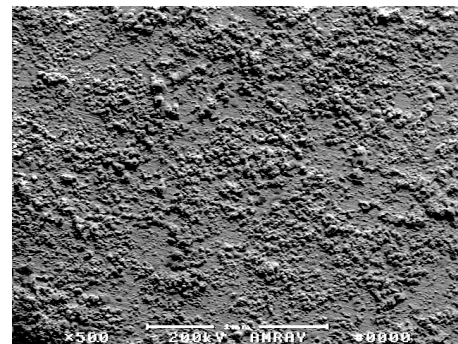
Figure 25 shows a comparison of the two as prepared surfaces (SAA and CCC, with the DHR of a bare salt fog corroded 2024 aluminum coupon. The corrosion products, shown in the scanning electron microscope (SEM) image in Figure 26, appear as a white patina on the surface. Analyzed by electron microprobe (EDAX), the corrosion products are essentially aluminum oxide (Al_2O_3) with excess oxygen and some trace amounts of sodium, magnesium, and chlorine from the salt fog. There is a similarity in all three reflectance spectrums. This is especially so in the 3400 cm^{-1} region. This is the absorption band from hydroxyl groups, which are found bound to oxides. As the oxide layer increases due to weathering, this hydroxyl absorption increases.

Figure 26 Scanning electron micrograph of a salt fog corroded bare aluminum coupon. Oxide is primarily Al_2O_3 .

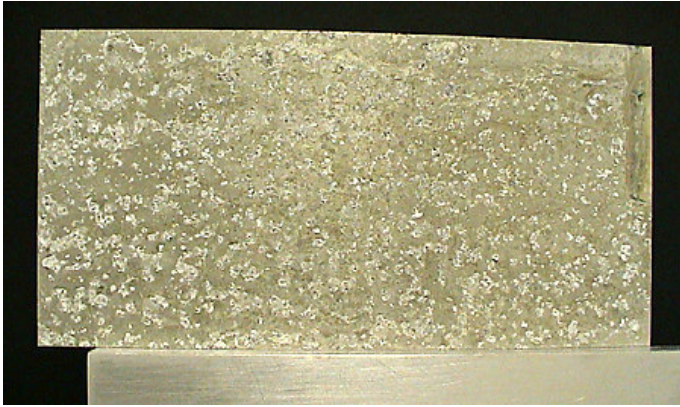
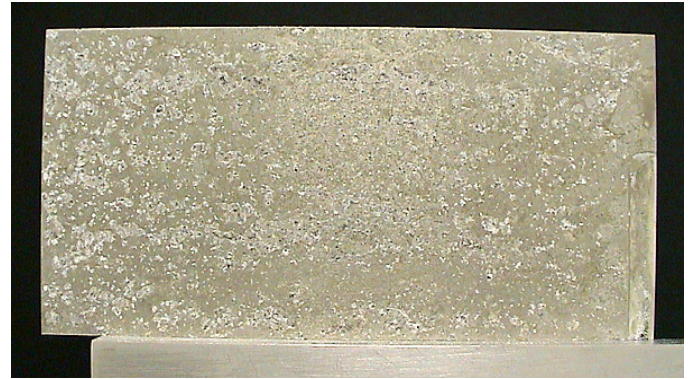
Figure 40 shows two examples of visual photographs of unpainted salt fog exposed coupons. The whole coupon was exposed. In addition to superficial corrosion, there is pitting also in the aluminum surface. This is in contrast to the lighter surface corrosion in the original set of standards.

Figure 40 2024 aluminum coupon exposed to salt fog. Visual image of corrosion before painting.

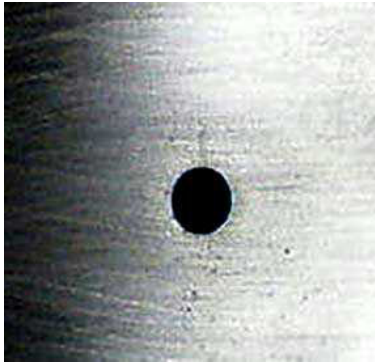
Figure 41 Visual micrograph of a 0.250" fatigue crack propagating from a hole in a 2025 aluminum bar.

shows an example of a real fatigue crack in a 2024 aluminum bar. A hole was drilled into the bar and a small notch was made in its interior. The bar was subjected to cyclic fatigue so that a crack of a given length was generated. The hole was then drilled out only leaving the crack. Crack length standards from 0.250" to below 0.030" were generated. These cracks were extremely difficult to see optically under normal illumination.

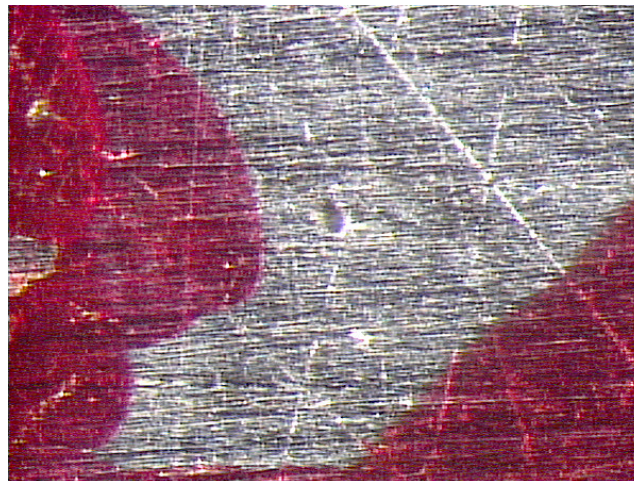
Electrical discharge machined holes were made in 2024 aluminum to simulate pits of various depths and diameters. Diameters ranged from 0.001" to 0.008" and depths from 0.001" to 0.008" inch. Figure 42 shows a visual image of a 0.001" diameter EDM pit in the center of an aluminum coupon.

Figure 42 Visual micrograph of a 0.001" diameter pit EDM machined into a 2024 aluminum bar.

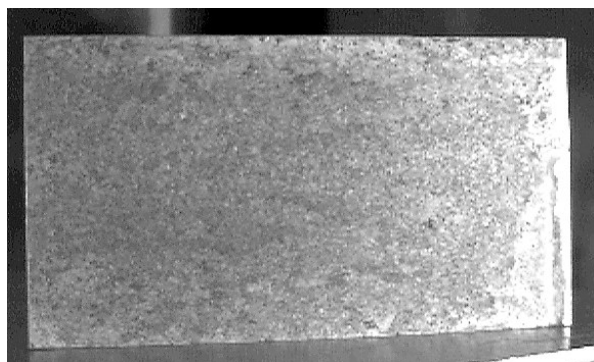
The corrosion coupons shown previously in Figure 40 were coated with various thicknesses of paint and IR images taken. Figure 48 shows an IR image of the corrosion and pits on an unpainted coupon.

**Figure 48 IR image of an unpainted corroded 2024 aluminum coupon.
The corrosion products and pits are apparent.**

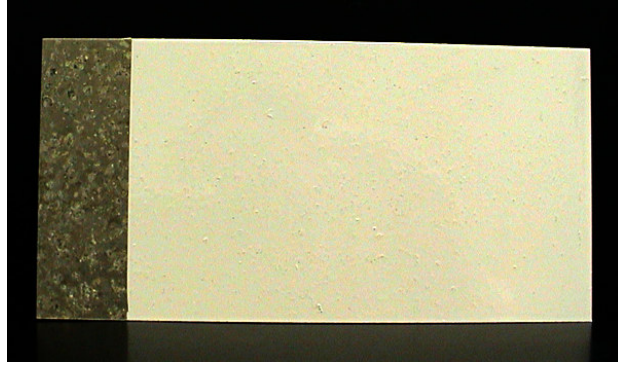
Figure 49 shows a visual image of an un-corroded coupon coated with 3.0 mil primer and topcoat. Figure 50 shows a corroded coupon with a total of 3.0 mil primer and topcoat. Due to coupon roughness, some of the surface morphology comes through the paint. These coupons were imaged in the IR with multiple coats of primer and topcoat.

Figure 50 Visual image of 3.0 mil primer and topcoat on corroded 2024 aluminum coupon.

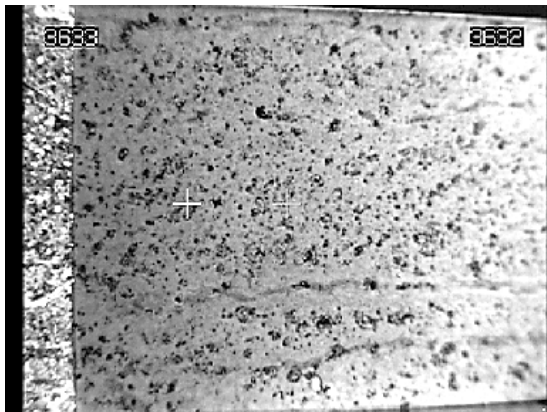
Figure 51 shows the baseline IR image of 3 mil coating on a corroded coupon. The corrosion and pits are readily apparent as observed under IR illumination.

Figure 51 3 mil coating on corroded aluminum. The narrow strip on the left is unpainted

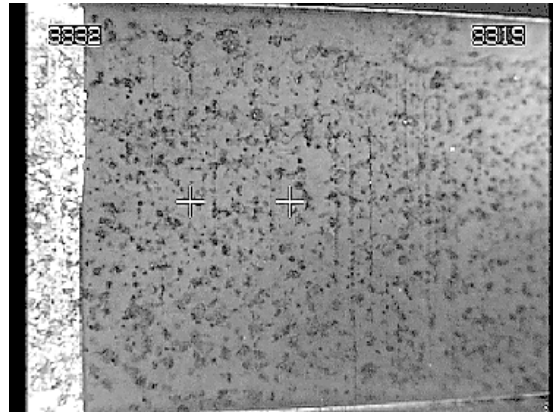
Figure 52 6 mil coating on corroded aluminum. The narrow strip on the left is unpainted

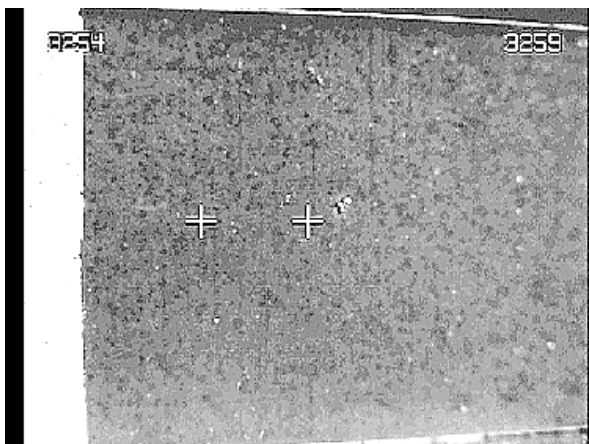
Figure 53 9 mil coating on corroded aluminum.

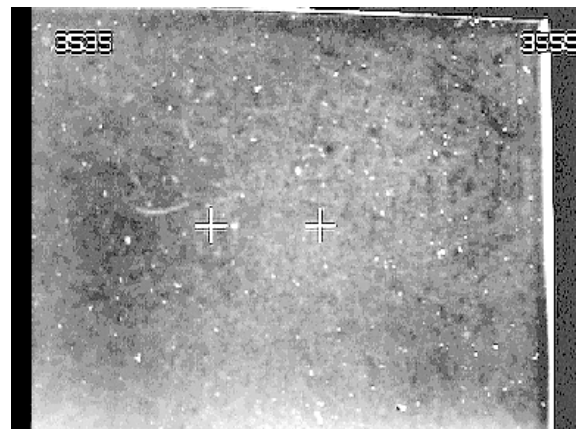
Figure 54 12 mil coating on corroded aluminum

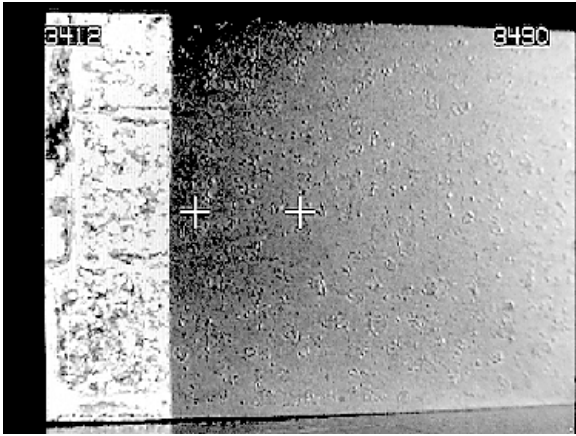
Figure 55 3 mil Dark Camo Grey topcoat on corroded aluminum. The narrow strip on the left is unpainted.

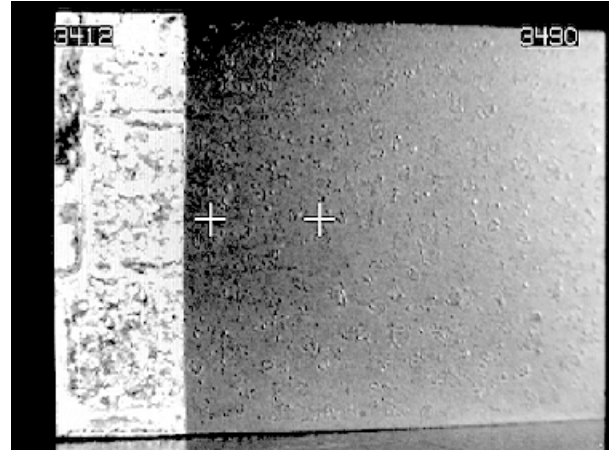
Figure 56 3 mil Dark Camo Grey with Low IR primer on corroded aluminum. The narrow strip on the left is unpainted.

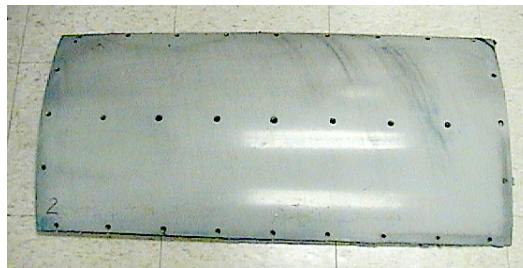
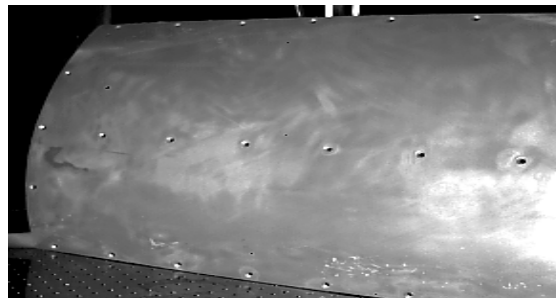
A variety of corroded and un-corroded painted real aircraft parts were imaged both in the lab and in the field in daylight. Parts came from a variety of Northrop Grumman aircraft, including the E-2C, EA-6B, F-14, and Joint STARS (707). Figure 57 shows an E-2C access panel imaged visually under normal illumination and with the IR camera system. The metal surface morphology come through quite clearly. This includes scratches, blemishes, and metal rework (corrosion removal) not visible from the painted surface.

Figure 57 Comparison of visible and IR image of an E-2C access panel
a) visible image of paint surface only, b) IR image through the paint to metal surface underneath.

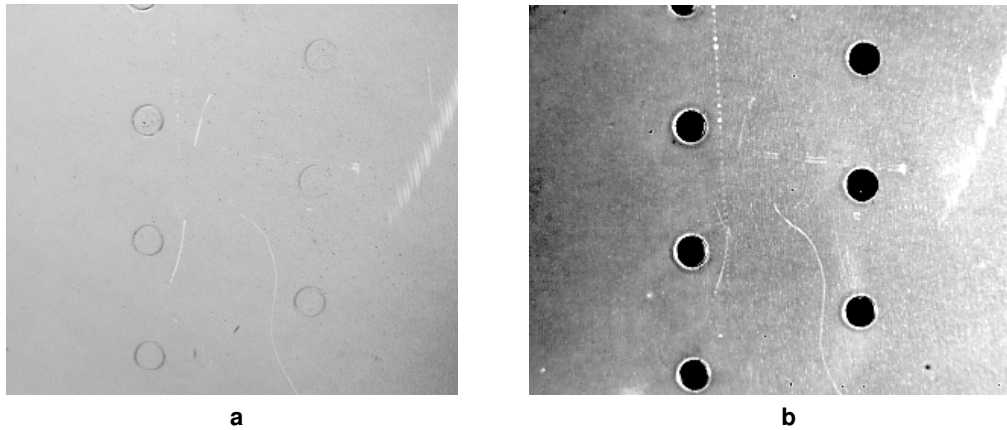
Figure 58 shows a comparison of a visual image of a portion of a JSTARS 707 wing and an IR image revealing corrosion on the fastener heads under the paint. Dark fastener heads indicate cadmium plate missing.

Figure 58 A visual (a) photo and an IR image (b) of corroded fasteners under paint in a Joint STARS 707 wing section.

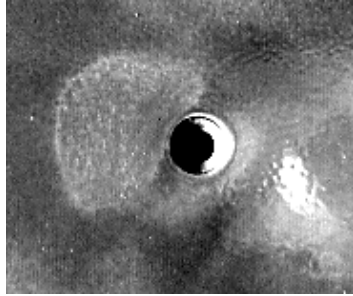
Metal Rework

Figure 60 Additional IR images of metal surface conditions through paint on aircraft parts.

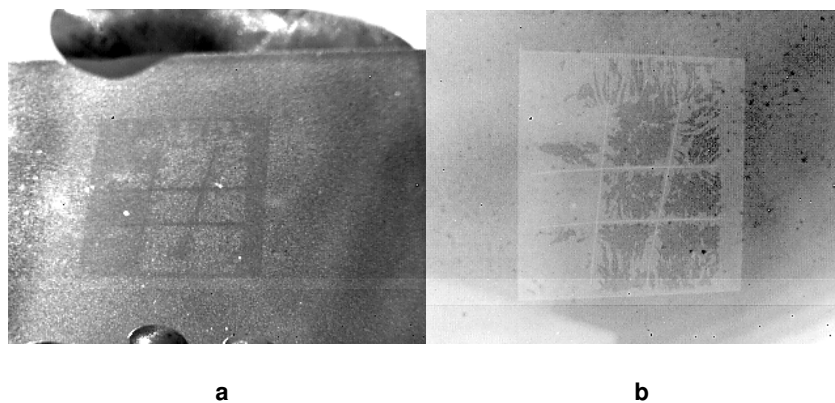
Figure 60 shows a collection of IR images of additional aircraft parts. Figures 61 and 62 shows IR images taken on a painted corroded coupon outdoor in daylight (cloudless day - summer). In Figure 61a, the first image is taken with indirect sunlight (shaded) with no artificial IR illumination. The corrosion pattern clearly comes through. The second image (Figure 61b) was taken with direct sunlight after the coupon was allowed to heat up. Although the corrosion image is still there, its contrast is reversed from the “cold” image. A similar situation

Figure 61 Outdoor imaging of painted test coupon a) in shade, b) in sun with heating (summer).

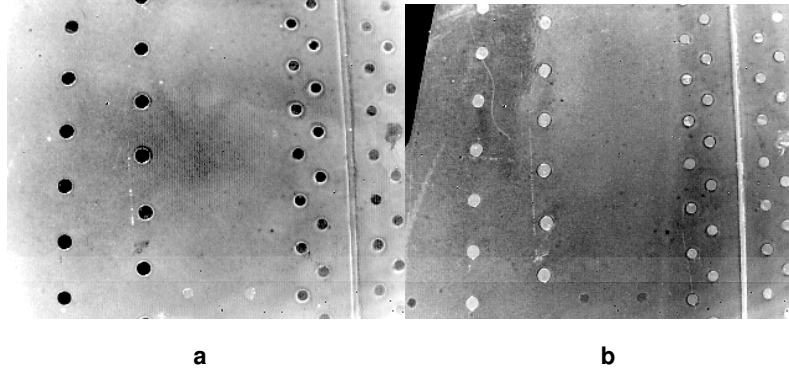
holes for the Joint STARS 707 wing panel in Figure 62. The wide area IR imaging technique relies on differences in surface reflectance's using an external IR illumination source. This is essentially ordinary photography in the IR. However, as the part heats up in the sun, the part starts to radiate thermal energy on its own independent of external illumination. Since high emissivity regions (low reflectance) of the part will appear brighter when emitting IR radiation, there is a contrast reversal in the image. Essentially, the conditions have changed from IR reflectography to IR thermography. This is a complication that must be accounted for in any outdoor or flight line application of wide area imaging through paint.

**Figure 62 Outdoor imaging of painted wing section fastener corrosion
a) in shade, b) in sun after heating (summer).**

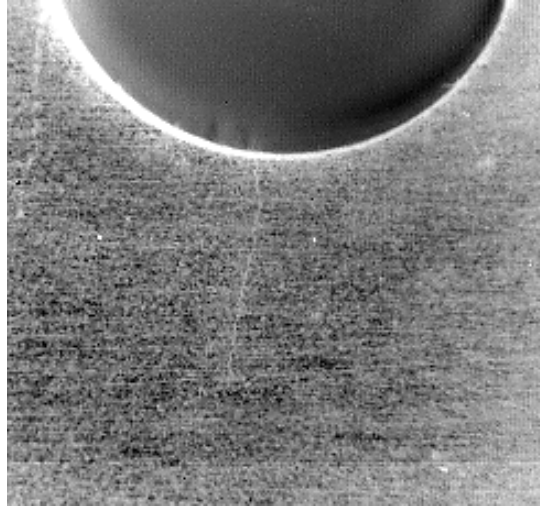
Figure 64 0.120" fatigue crack in 2024 aluminum bar imaged through 3.5 mil primer and topcoat.

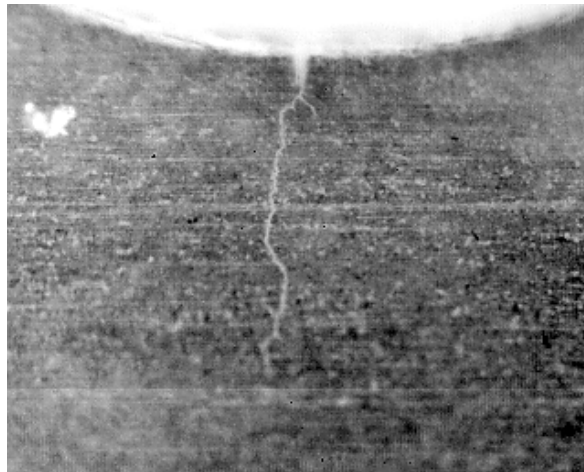
Figure 65 0.060" fatigue crack in 2024 aluminum bar imaged through 3.5 mil primer and topcoat.

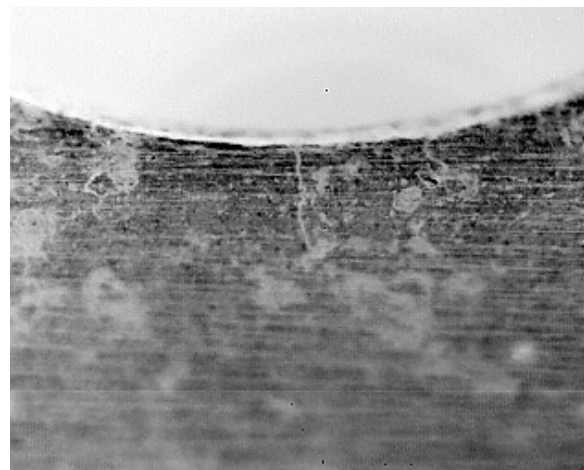
Fatigue cracks could be detected down to 0.030" in real time using the 25 mm lens. Better images could be obtained with 1x and 4x IR magnification lenses. See Figure 63. Figures 64 through 66 show wide area detailed images of fatigue cracks under paint.

Figure 66 0.030" fatigue crack in 2024 aluminum bar imaged through 3.5 mil primer and topcoat.

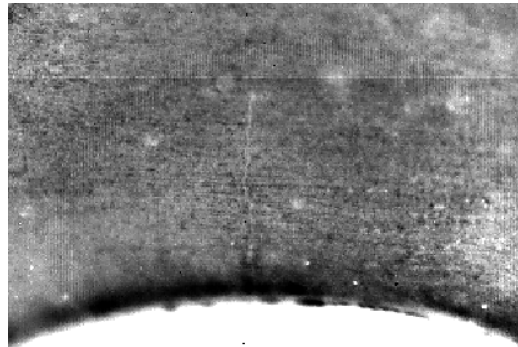
In addition to clean fatigue cracks, we imaged corroded fatigue cracks as well. Figure 67 shows a drilled aluminum plate with a fatigue crack exposed to salt fog, corroded, and painted. The crack is still clearly visible through the paint.

Figure 67 0.060" fatigue crack corroded, painted, and imaged with the IR system.

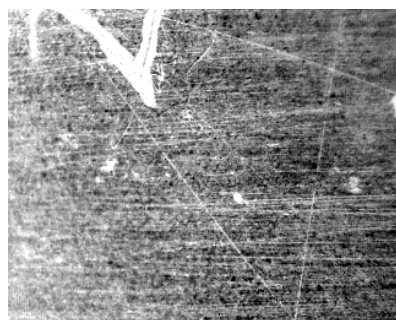
1.3 mil diameter
1.2 mil depth

Figure 68 EDM simulated pits in 2024 aluminum imaged through 3.5 mil primer and topcoat.

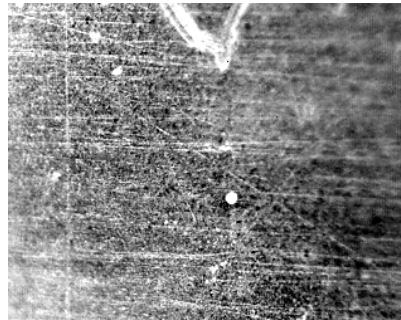
2.4 mil diameter
2.1 mil depth

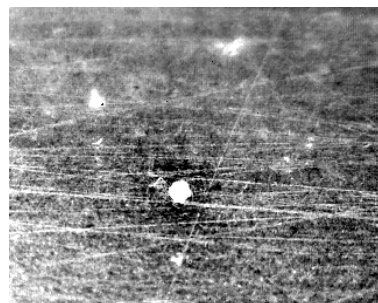
4.4 mil diameter
4.1 mil depth

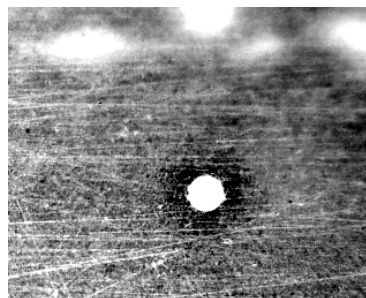
8.4 mil diameter
8.2 mil depth

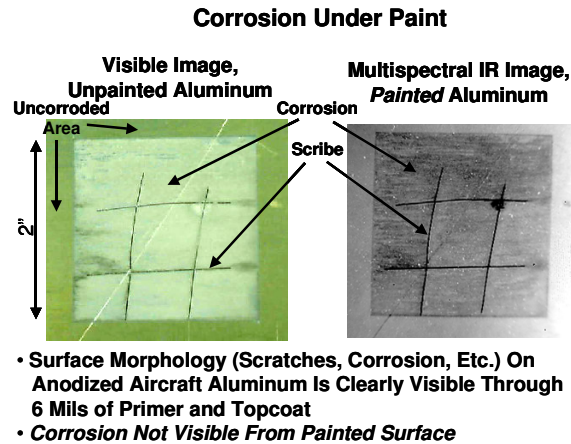
Studies to detect corrosion and other defects under coatings as a function of thickness were on going during 2002. Figures 73 and 74 show what a panel looks like before painting/coating and after painting under IR illumination. Note: The painted panels were completely covered with paint and the corrosion was not visible except under IR imaging. Figure 73 shows high clarity under 6 mils of paint, while Figure 74 exhibits clarity under 8 mils of primer and top coating, when viewed in the IR.

Figure 73 Corrosion on an unpainted panel on the left and the same corrosion under 6 mils (.006”) of paint once the panel was painted.

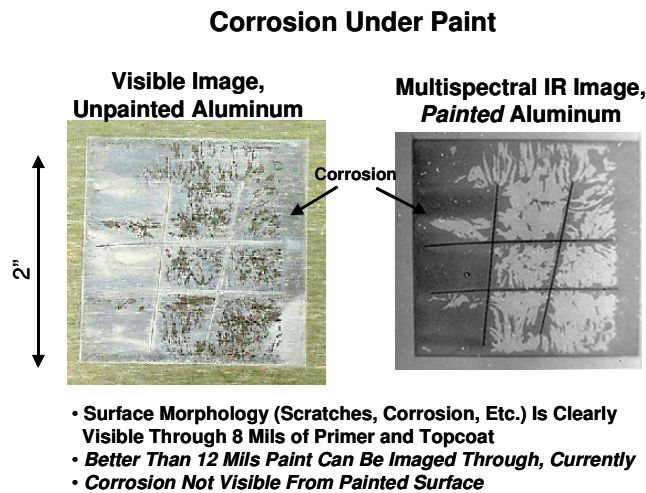
Figure 74 Corrosion on the surface of an unpainted panel on the left and the same corrosion under 8 mils (.008”) of paint once the panel was painted.

These studies indicate that field produced corrosion should be detectable up to at least 8 mils of Mil-PRF-23377, epoxy primer and Mil-PFR-85582 TYI, polyurethane topcoat. This is important as many field aircraft have additional multiple coatings applied and in some cases far beyond specification requirements/limits.

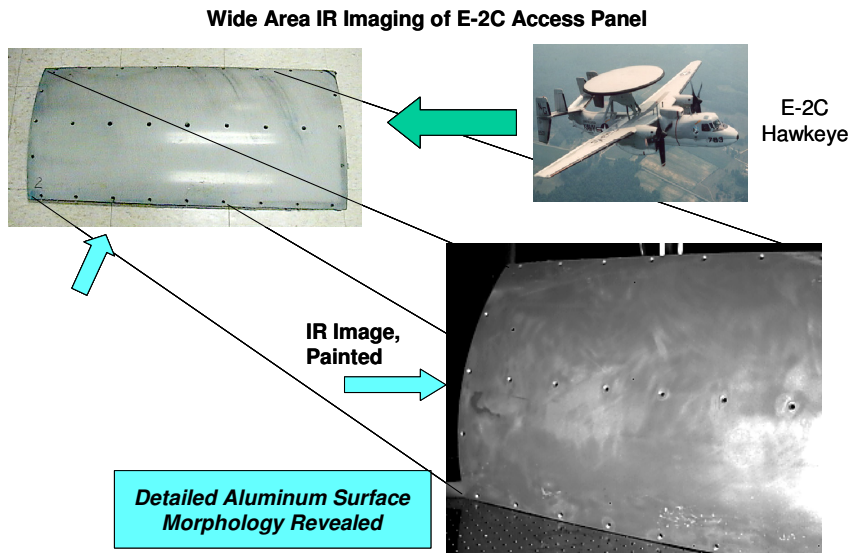
An E-2C production access panel was examined for corrosion and other defects. A general part survey was made first, as shown in Figure 76. As can be seen in Figure 76 potentially defective and/or discrepant areas can be seen by demarcations. These areas are denoted by un-uniform color and outlines in the IR Image. This was initially thought to be all corrosion related, however, it was later determined that upon close microscopic examination of the actual organic coating porosity was the problem. This can be seen in the second photograph of Figure 77.

Figure 76 Photographs of the overall panels as taken from an E-2C. The first photo shows the painted panel; the second is a picture of an E-2C; the third photo shows the panel image taken under IR.

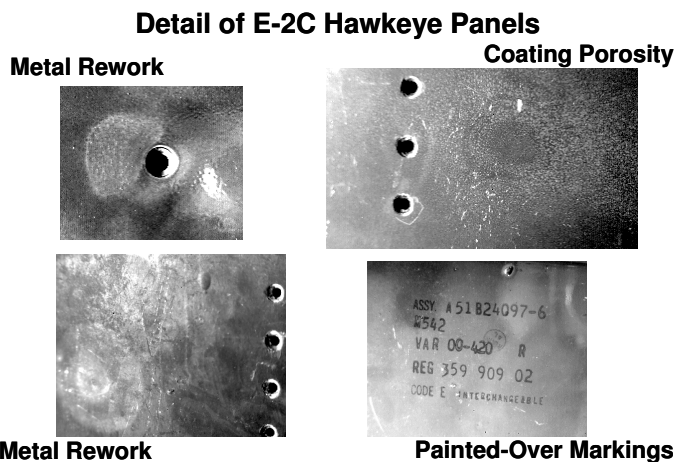
Figure 77 shows a more detailed and up close survey of the panel depicted by Figure 76. Metal rework can be seen in the first photograph. This rework is most likely the result of previous corrosion that was at least partially cleaned up by sanding or abrading. The second photograph illustrates what coating porosity looks like under IR. This is not a surface effect on the aluminum substrate and hence IR may also be a good tool to investigate coating quality as it relates to spray techniques and flow prior to setting up. The third photograph in Figure 77 shows another area where rework has taken place. The fourth and last photograph was an old part

marking under the top coat. The assembly number and even the individual inspector's stamp can be clearly seen. This capability could well help in a future failure investigation. Normally this information is virtually impossible to obtain under a painted part by other economical means.

Figure 77 Details of an E2C Panel in various locations around fastener holes plus a hidden ink stamp part number and an inspection stamp marking.

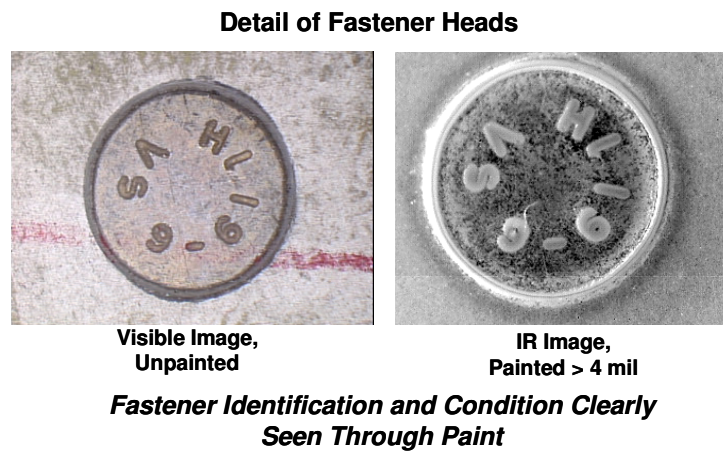
Figure 78 shows a standard aircraft Hi-LoK® Part Number HL19-6 manufactured by Fairchild Industries, as indicated by the VS on the fastener head. As can be seen the IR Image, which was taken under 4 mils (.004") of paint clearly shows the applicable part number and manufacture designation.

Figure 78 Hi-Lok® fastener head under visible light and under IR looking though 4 mils (.004") of paint. The part number can be clearly seen under the organic coating under IR illumination.

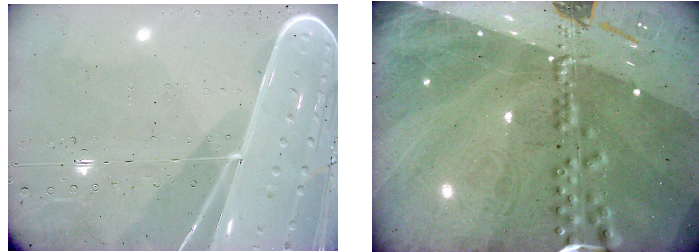
Visible Images
of Painted Wing
Sections

Corrosion Not
Apparent in Many
Areas

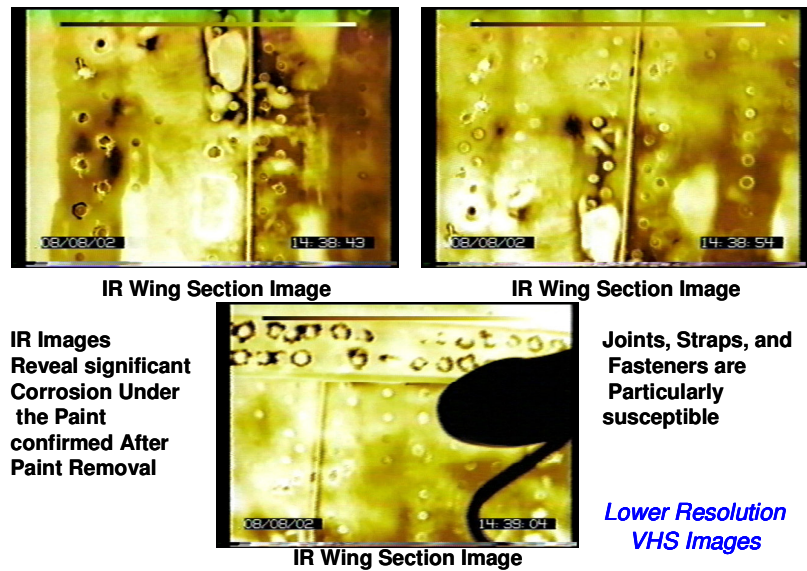
Figure 98 shows some of the painted locations that were surveyed for corrosion under the coatings by the IR camera system. As can be seen in the above photographs very little corrosion can be observed on the painted surface, which is usually indicated by corrosion deposits and peeling paint. The photographs in Figure 99 on the show what the corroded metallic surface looks like below the surface of the paint.

It must be noted that this aircraft is no longer in service and was decommissioned due to corrosion around fasteners and other locations on the wing. Early detection could have saved this aircraft, which is now a complete loss to the Air Force inventory.

Figure 99 Corrosion is indicated by dark areas around fasteners. Lines of sealant can be seen in all photographs.

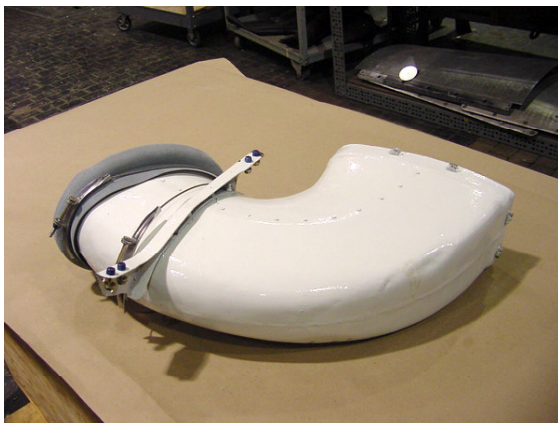
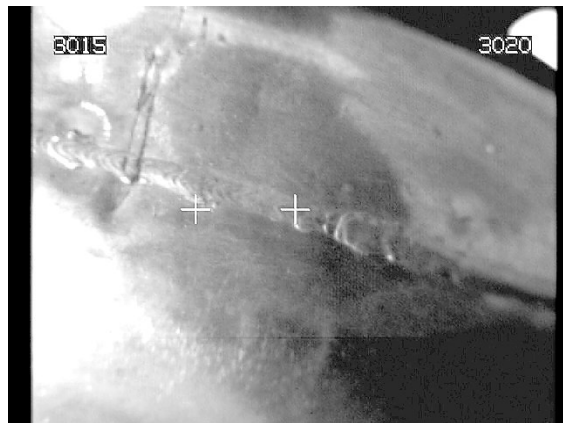
Figure 102 Welded duct from Bearcat. Photograph No. 1 shows white paint and photograph No. 2 shows weld area and corrosion that was reworked/abraded under the painted surface

The photographs in Figure 102 show a typical Bearcat environmental control system (ESC) duct that has been welded in at least two locations, as shown by the lower photograph. As can be seen from the top figure, the duct has been painted and the coating is most likely a coating of primer, MIL-PRF-23377 TYI and a top coated with MIL-PRF-85285TYI Gloss Insignia White Color No.17925. The lower photograph shows the aluminum surface of the ECS duct, which has been most likely abraded, prior to painting. The abraded area is located in the center of the photograph and is a little darker than the surrounding area. These figures were snap shots taken digitally from a movie that was made during the real time corrosion survey. Note: Two movies were made. One of the movies was output from the IR camera feed into the camcorder and the other movie was just the standard illumination feed into the camcorder much the same way a home movie is made.

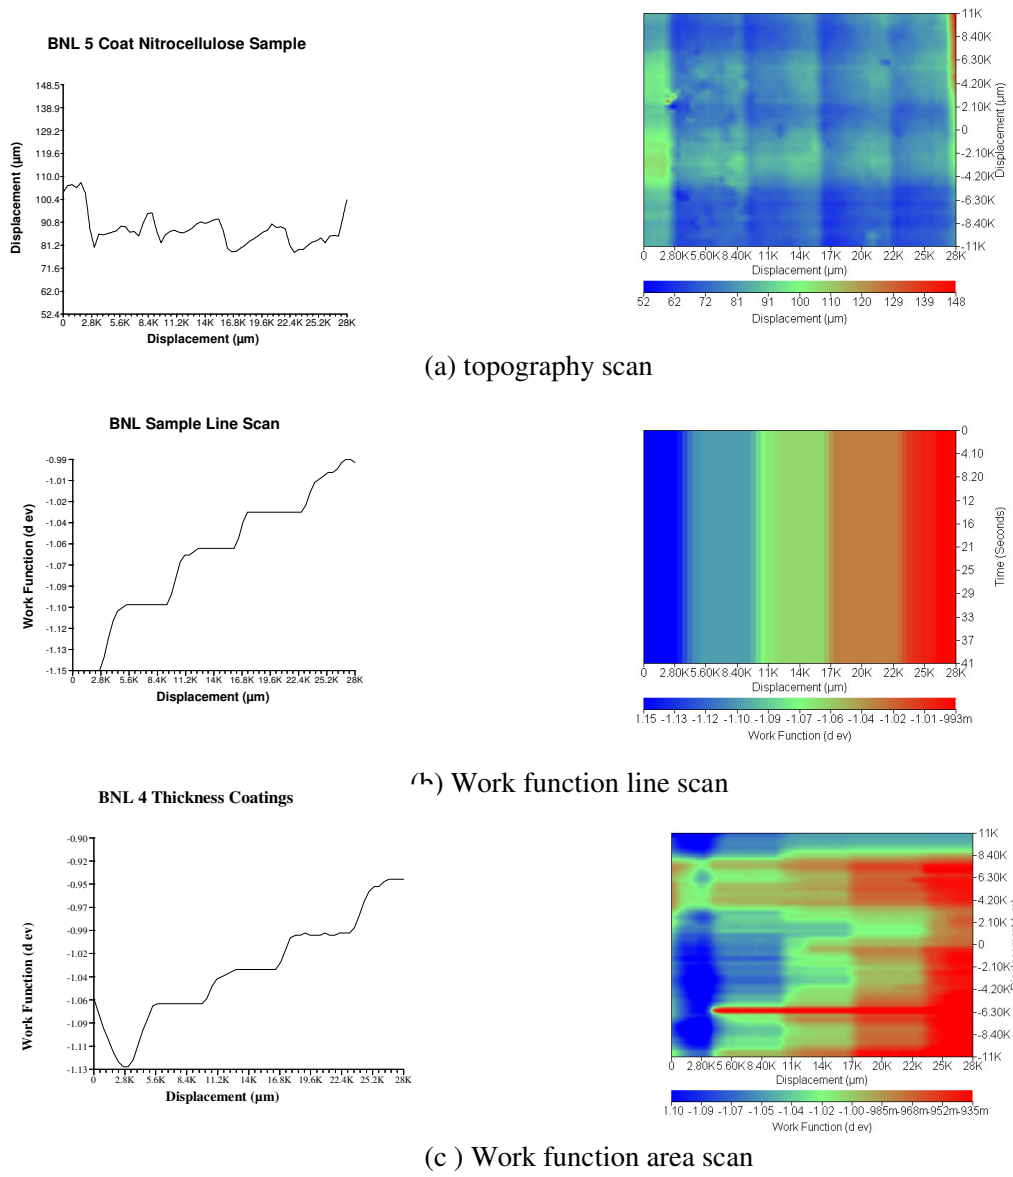
Figure 130 shows the effect of paint thickness on the Volta potential, for a AA 2024 specimen. Four different thicknesses of nitrocellulose paint were applied in strips over an abraded sample. The thickness of paint was nominally 0, 1, 2, 3, and 4 mil. The topography of the painted surface, leveled parallel with the scanning head, is shown in Figure 130a. The topography scan indicated a difference in the paint layers of about 15 μm or about 0.6 mil. Volta potential changes are shown in Figure 130b where five distinct steps were observed with increased thickness of paint. The total potential difference was approximately 360 mV or about 80 mV/mil. A Volta potential scans over an area of about 20 x 20 mm is shown in Figure 130c. Each line scan again showed the difference in Volta potential between bare metal and each of the four layers of pant but the background potential varied. Causes of this change in background potential are being investigated. It may be due to instrumental causes, or variations in potential of the reference probe. The results nevertheless demonstrated that the Volta potential measurements respond to the differences in the thickness of the paint. However, the magnitude of the changes, due to paint thickness is smaller than the change of over 0.6 V between corroded and non-corroded areas.

Fig. 130 Volta potential measurements of Al alloy AA2024 covered with four different thickness of nitrocellulose paint.

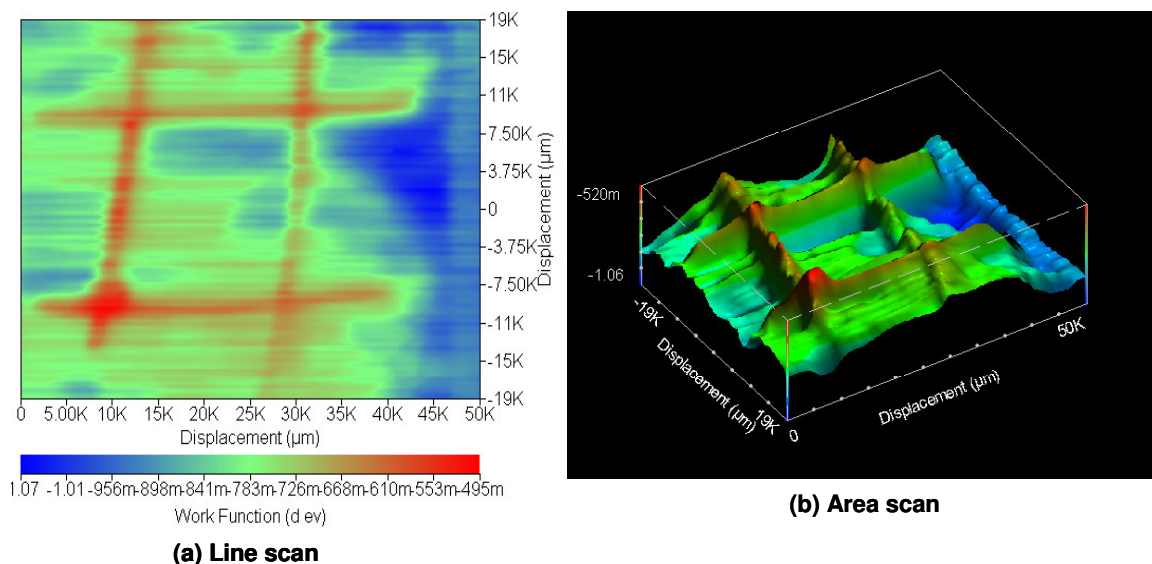
the overall thickness of paint was 5.6 mil. In Figure 131 the Volta potential scanned area is presented in the form of 2D and 3D maps. The exposed area and the scribe marks were also detected by the SKP. The difference in Volta potentials, between the corroded scribe and surrounding area was approximately 580 mV. Differences in the potential between the exposed and unexposed areas were much smaller, about 20mV. While it is recognized that there are differences in the chemistry of the coatings involved, the observed difference in Volta potential for the scribe marks is primarily due to the presence of corrosion products within the scribe mark and not due to the

“filling in” of the scribe marks with coating resulting in a thicker coating layer immediately above the scribe marks.

Figure 131 SKP Volta potential measurements of corroded clad Al alloy AA2024 covered with several layers of paint. The overall thickness of the paint is 5.6 mil.

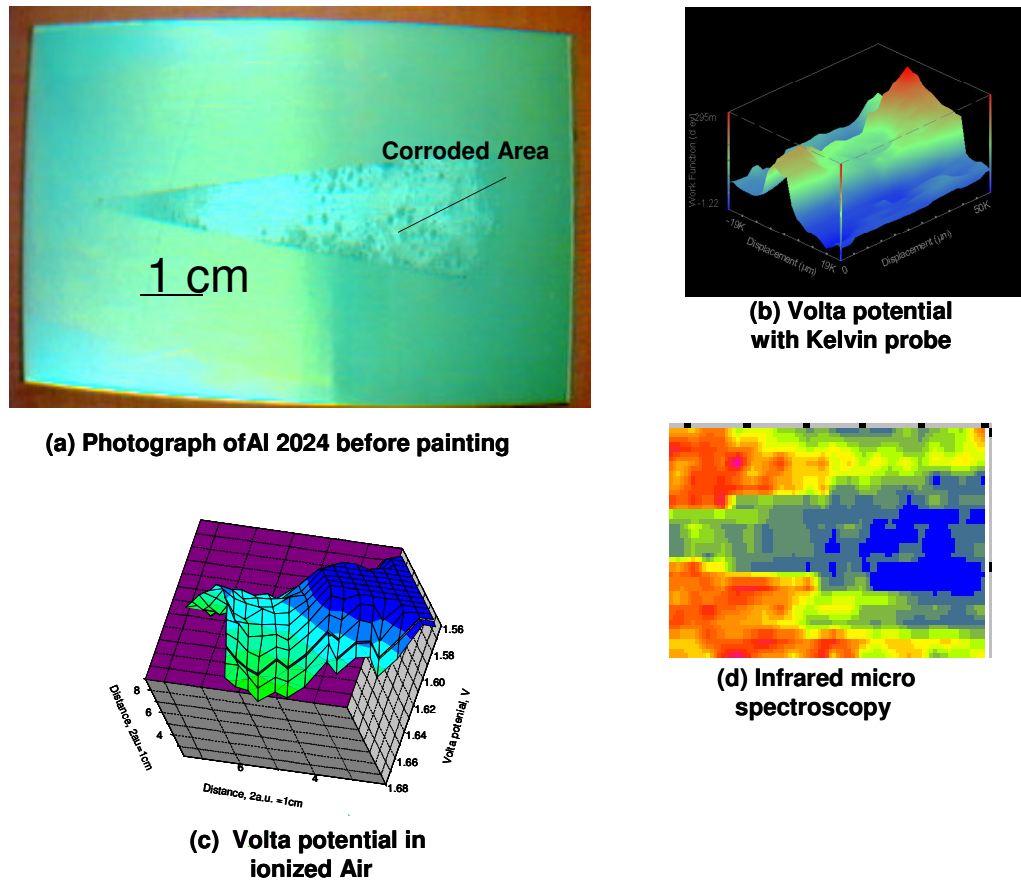
A comparison of the two Volta potential methods and the infrared microspectroscopy (IMS) method for detection of corrosion under a film of a defect-free paint is given in Figure 132. The first image shows a photograph of an AA 2024 sample with a visible corroded area, prior to being painted. The sample had been chromate conversion coated. The sample was masked leaving a wedge shaped area exposed. The sample was first covering with 0.1 M HCl and then placed in a humid atmosphere for two weeks. The masking was then removed, the sample washed and dried, and the surface painted. The photograph of the sample Figure 132a, shows the area that was scanned using the three different techniques.

The SKP results are shown in Figure 132b. The map of the scanned surface obtained by Volta potential measurements in ionized air is shown in Figure 132c. The 3D map of Volta potential shows the difference between the corroded and non-corroded areas. The last image in Figure 4d represents the results obtained by infrared microscopy. The intensities of the peaks at 1042 and 2086 cm^{-1} were used to generate the 2D plot. It exhibits the same locations of corrosion, as the two Volta potential techniques. All three techniques can therefore be used to detect of corrosion under paint.

Fig. 132 Detection of corrosion under 3.6 mil paint layer using three different scanning techniques.

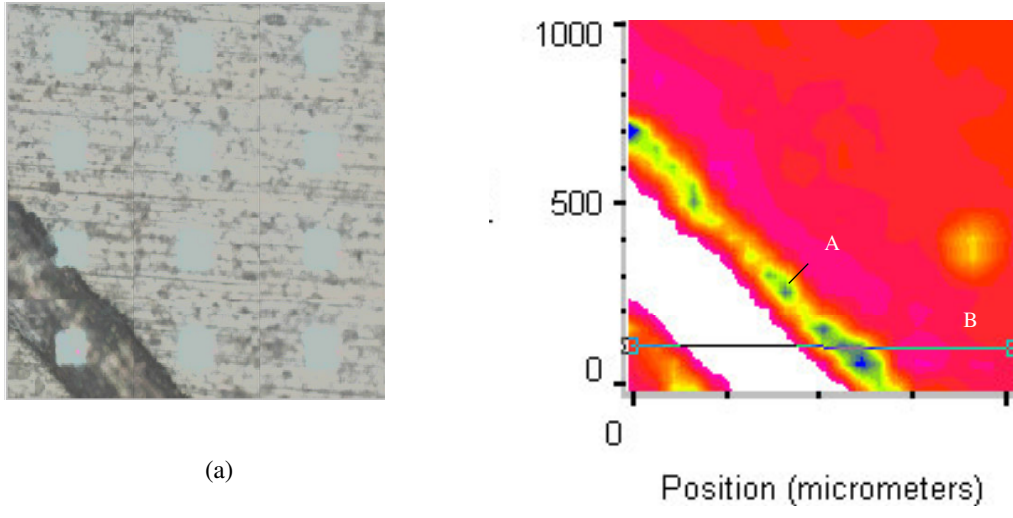
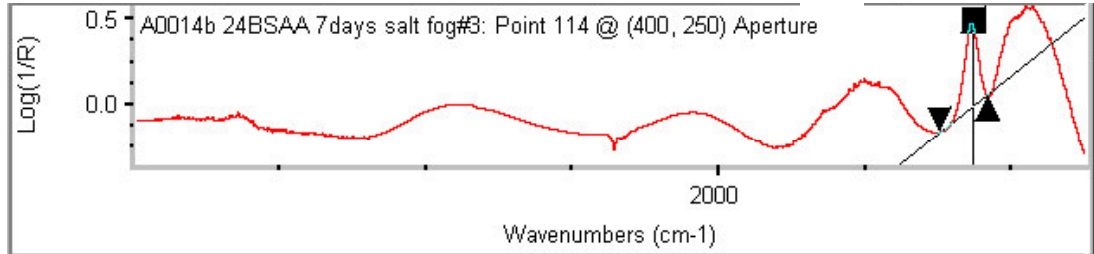
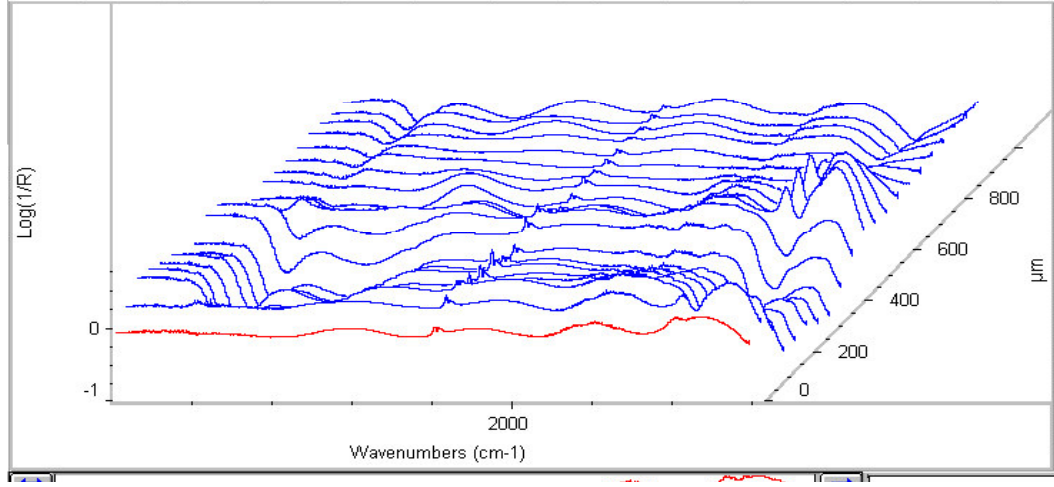
IMS Investigation of AA 2024 – IMS mapping of an unpainted corroded AA 2024 surfaces identified a species similar to sulfate or bisulfate as can be seen in Figure 133 along scribes after corrosion. The sample was originally sulfuric acid anodized, scribed, exposed to salt fog for 1 week, masked, covering with 0.1 M HCl,

exposed for 12 weeks to a humid atmosphere, washed, and dried. Figure 133a shows a photograph of the scanned area that correlated with generated 2D map in Figure 133b showing the variations in intensity a peak at 1149 cm^{-1} . This data was generated with an aperture size of $100 \times 100\ \mu\text{m}$, and a step size of $0.1\ \text{mm}$. The presence of this peak is shown in the spectrum in Figure 133c. The presence of this peak was observed close to the edge of the scribes as it can be seen for spectra (shown in Figure 133d) taken along the line B in Figure 133d.

Figure 133 IMS of corroded sulfuric acid anodized AA 2024: (a) photograph of the scanned area; (b) map for the variation of the peak height at 1149cm-1; (c) spectrum in point A shown in (b); (d) spectra along the line B shown in (b).

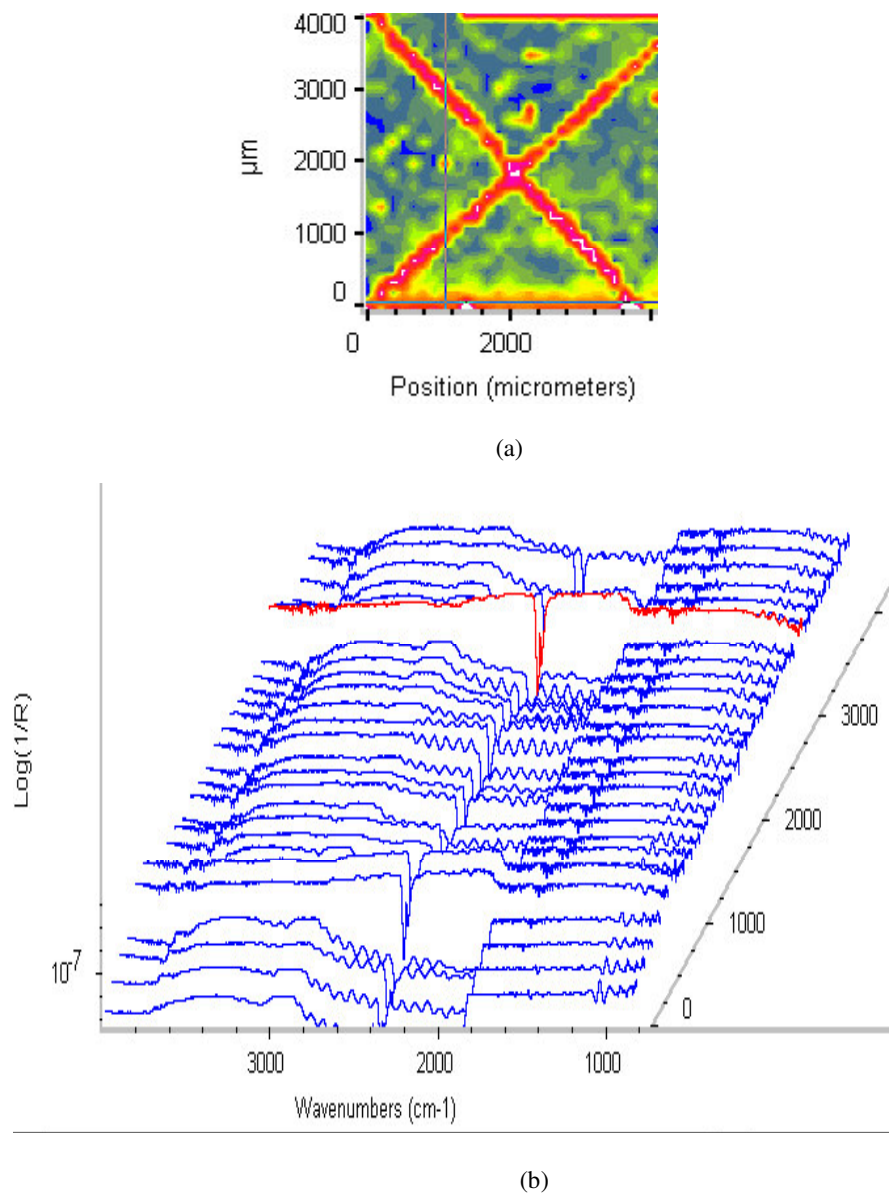
An example of the detection of corrosion under a paint layer using IMS is given in Figure 134. The sample was a scribed, chromate conversion coated AA2024, which was then exposed 3 days to humidity, masked, exposed two weeks in a humid atmosphere after covering with $0.1\ \text{M HCl}$, washed, dried, and finally painted with a $3.5\ \text{mil}$ thick paint layer. The spectrum for a corroded area showed a typical window between 1850 and $2850\ \text{cm}^{-1}$ which makes it possible to see through the paint (Figure 134b). The 2D map (Figure 134a) was derived from the overall intensities of the absorbance. This mode of plotting clearly identified the areas of corrosion. The differences were greatest at heavily corroded sites that can be seen in Figure 134b for the 5th and 6th and the 22nd and 23rd spectra which were recorded over the scribes taken along the line in Figure 134a

Fig. 134 IMS of painted AA2024 scribed before corrosion. (a) Map for the overall intensities of absorbance spectra; (b) absorbance spectra along the line shown in (a).

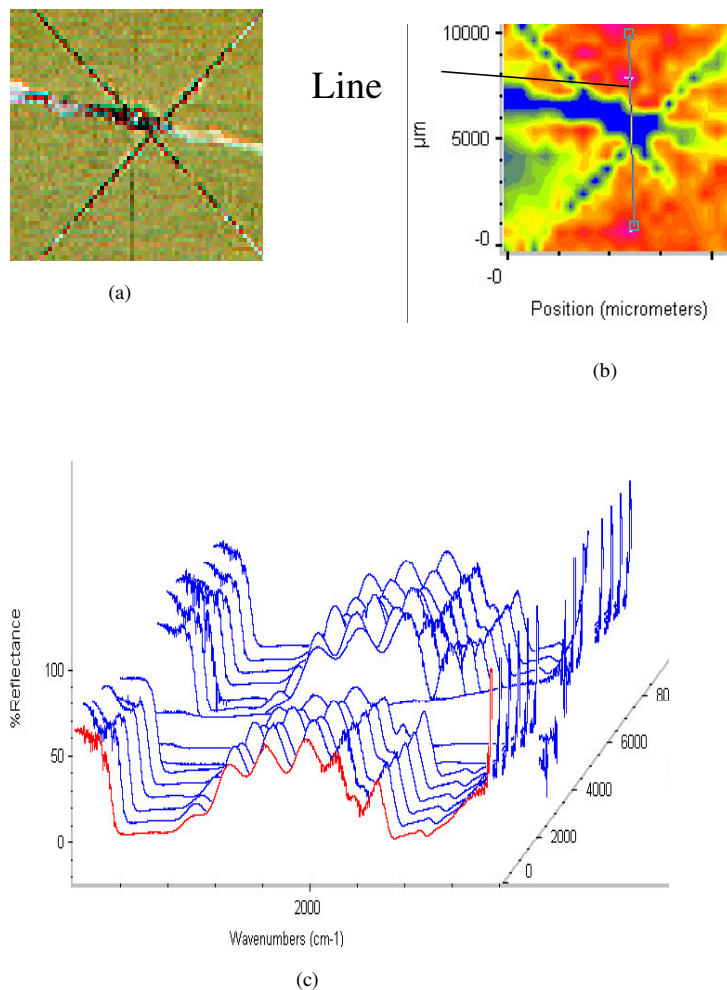
Figure 135 shows the photograph of crevice corrosion under tape at the crossing of scribes for AA 7075. The sample was previously anodized in sulfuric acid, scribed, exposed to salt fog for 1 week, partially taped covering where the scribes intersected, corroded in $0.1\ \text{M HCl}$ for 12 weeks, washed, and dried. IMS was used for mapping the image shown in Figure 135a. The 2D plot and corresponding line spectra are shown in the same figure. The first 6 spectral lines, over non-corroded parts of the surface, were typical for anodized coating. The following three spectral lines were over corroded areas.

Figure 135 IMS of AA 7075 anodized in sulfuric acid after crevice corrosion under masking. (a) Photograph of the scanned area; (b) variations of the reflectance intensities for the region 1560 – 1670 cm⁻¹; (c) reflectance IR spectra along the line shown in (b).

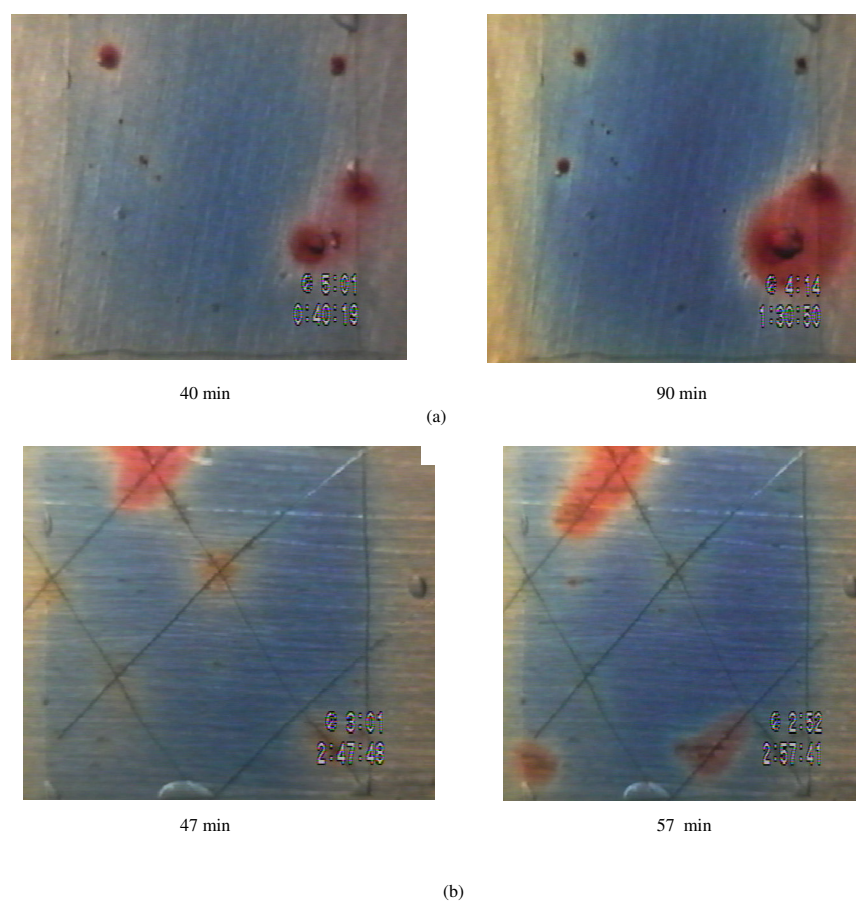
A gel technique [3] was used to visualize corrosion process on two different alloys. Surfaces were covered with an agar gel containing NaCl and a wide range pH indicator. Figure 136 demonstrates the differences in behavior of the two alloys in $1\ \text{M NaCl}$ Agar gel. Both samples had been abraded. AA7075 was additionally scribed to verify the spreading of corrosion laterally along the grooves as it was found that corrosion appeared to spread along scratches. The samples were masked with tape and then covered with gel. The red color due to a low pH marks the spots where corrosion of the alloy takes place. A blue color indicates a high pH due to the oxygen

reduction reaction. Corrosion of AA2024 occurs mainly by a pitting mechanism. Some pits repassivate, others continue to corrode as may be seen from Figure 136a. The early stage of corrosion of AA7075 does take place mainly along the scribes but eventually general corrosion takes place.

Figure 136 Video images of the corrosion in 1M NaCl Agar gel: (a) Al alloy AA2024; (b) Al alloy AA7075.

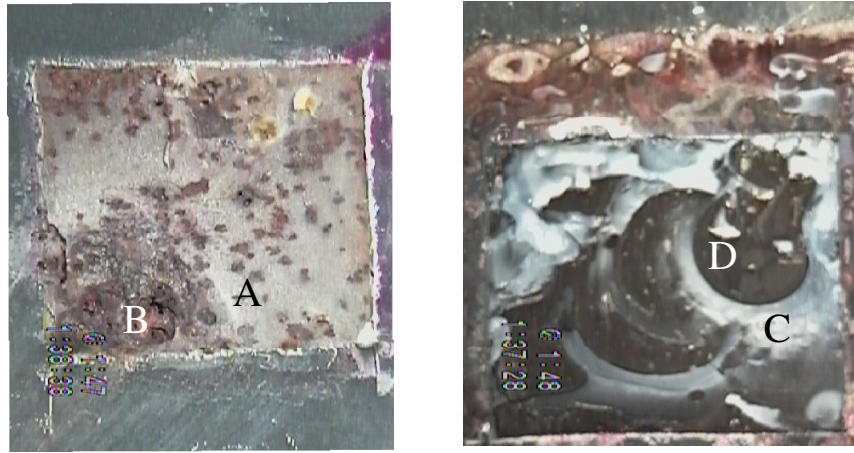
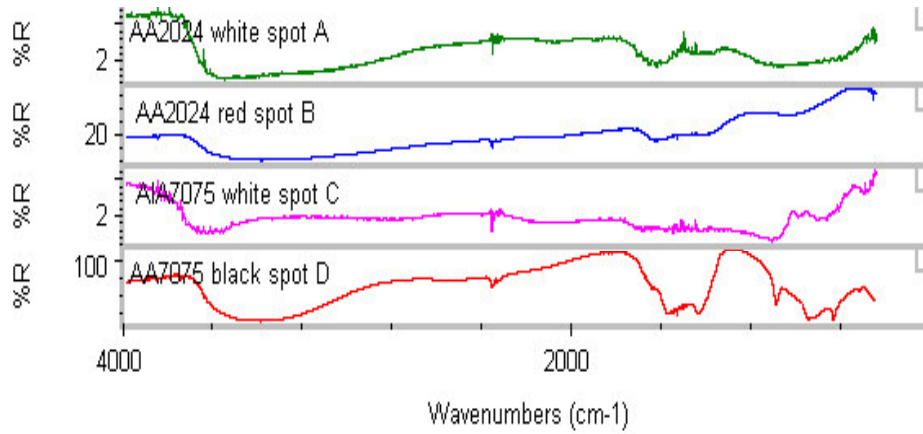
The appearances of the samples after removal of the gel are shown in Figure 137a and b, respectively after 12 weeks of corrosion in a humid environment covered with gel. The appearance was quite different for the two alloys. In both cases the pH indicator disappeared. The alloy AA7075 produces a cloudy white corrosion product.

The gel over AA2024 was clear. Heavy pitting occurred on Al 2024 with red spots in the pits that blackened with

time when exposed to air. The AA7075 had quite a different appearance, showing white and black areas on the surface. Corrosion had also spread into crevices under the tape, and had a similar red coloration seen in the AA2024 pits and also turned black with time.

Figure 137c shows IMS spectra taken over different spots on the corroded alloys. There is a marked difference in the spectra between the black and the white spots for the alloy AA7075, while for the AA2024 the difference is due to intensity variations of the reflectance spectra. Preliminary analysis of AA70 75 ascribes the peaks at 1400 to 600 cm⁻¹ to a zinc aluminum carbonate [2]. A broad absorption region at 3400 cm⁻¹ corresponds to an OH⁻ starching group that can be seen in all the spectra.

Figure 137 IMS on the corroded Al alloys AA2024 and AA7075. Video images of the samples after 12 weeks corrosion in gel: (a) AA2024; (b) AA7075 and corresponding reflectance spectra (c).
