September 1, 2004

Final Report

SERDP Pollution Prevention Project 1137

Non-Destructive Testing of Corrosion Under Coatings

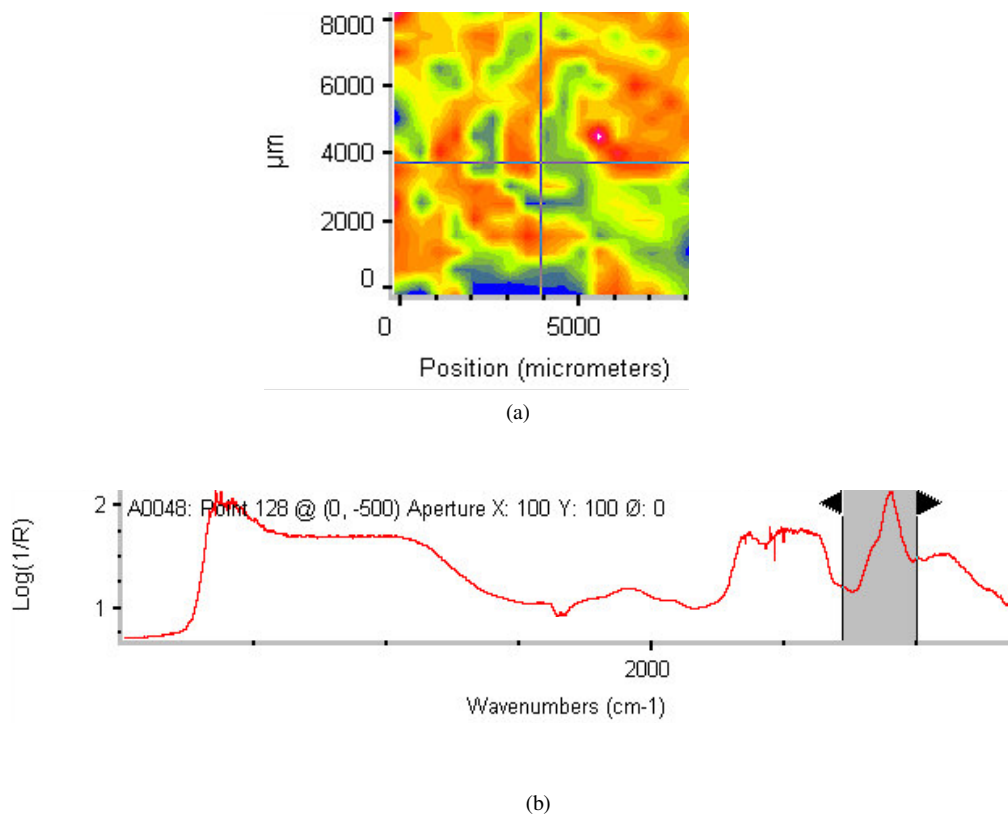
IMS mapping of the corroded AA7075 surface is shown in Figure 138a. The map was generated from the variations in intensity of the absorbance peak highlighted in the spectrum shown in Figure 138b. The spectrum was taken from the center of the area shown in Figure 138a. It can be seen that the black and with areas of the corroded sample in Figure 137b corresponds to the differences in the corrosion products

Figure 138 IMS on Al alloy AA7075 (shown in Fig. 9b) after 12 weeks of corrosion in gel: (a) Map of the surface for the variation of the highlighted peak; (b) absorbance spectrum at the cross point shown in (a).

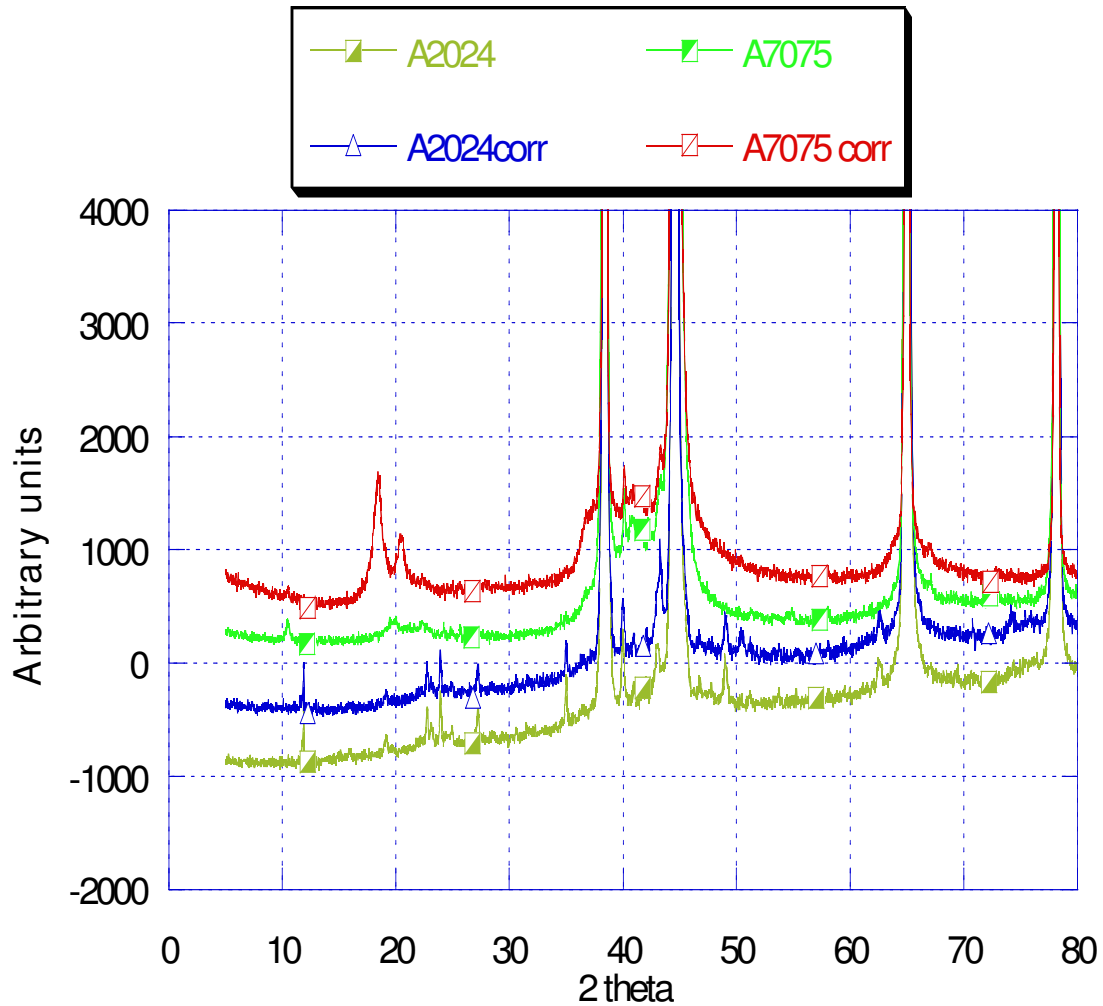
Figure 139 shows XRD data for corroded and uncorroded alloys AA2024 and AA7075. All patterns show strong peaks for Al, and smaller peaks for intermetallics. Distinct peaks for 2θ of 18.429° and 20.523° were observed when the corrosion product on AA7075 was present. The product can be ascribed to aluminum hydroxide (Gibbsite) $\text{Al}(\text{OH})_3$. However, the carbonate that was indicated from the IMS data and has been observed [3] with Zn-Al alloys could not be seen probably because of the small quantities present.

Figure 139 XRD patterns for AL alloys AA2024 and AA7075 corroded in 1M NaCl gel and for the corresponding non corroded alloys.

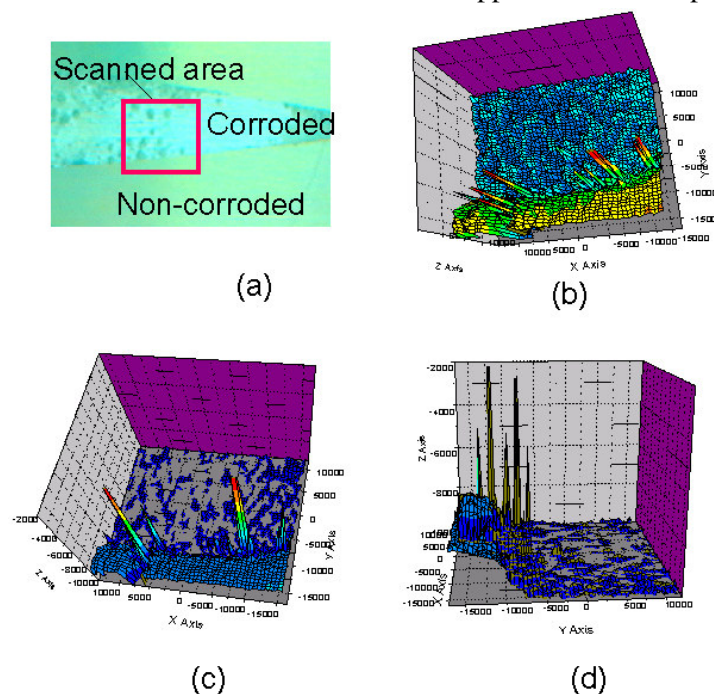
Results – Figure 148 shows the impedance scanning probe measurements over partially corroded painted Al alloy 2024. The sample was originally conversion coated A wedge shaped area was masked off and corroded, and then the sample was coated with 3.6mil thick White military paint. Figure 148a shows the photo of the sample before painting, indicating the scanned area. The generated images of the scanned surface are obtained by plotting the change in impedance. Measurements at 1000 Hz are shown in different three-dimensional projections (Figures 148b-d). The spikes on the edge between corroded and non-corroded area are probably due to the particles in the paint. The areas with the heaviest corrosion were apparent in the 3D plots.

Figure 148 Scanning impedance probe measurements on painted Al alloy 2024:
(a) Photo of the sample; (b), (c), (d) Three-dimensional plot of impedance change over the scanned area.

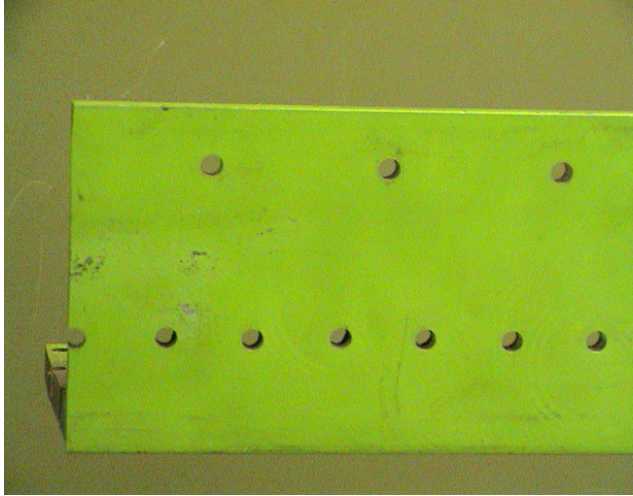
*J-STARS Part Showing
Green Primer Surface*

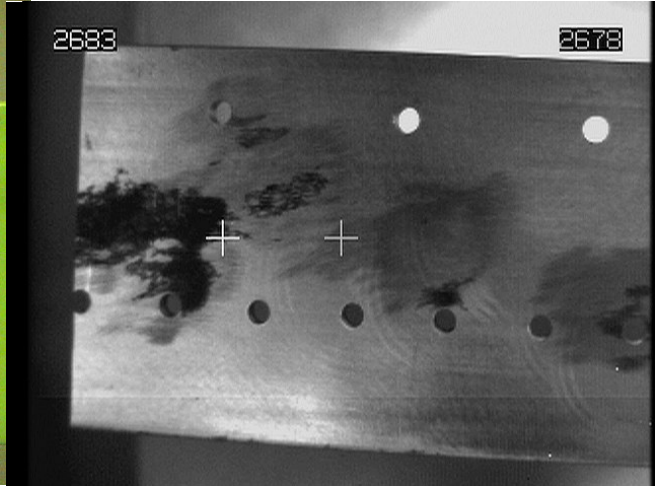
Special Note: A video was created of the corrosion survey and played at the 2002 IPR. Corrosion was clearly seen around pasteworks and splice plates on the E-8 wing.

*Same J-STARS Part Showing
Corrosion Under Primer Surface Using
IR Reflectance Technology*

Example paint taken from E-8 aircraft above shows clear evidence of corrosion under the primer coating (BMS 10-11).

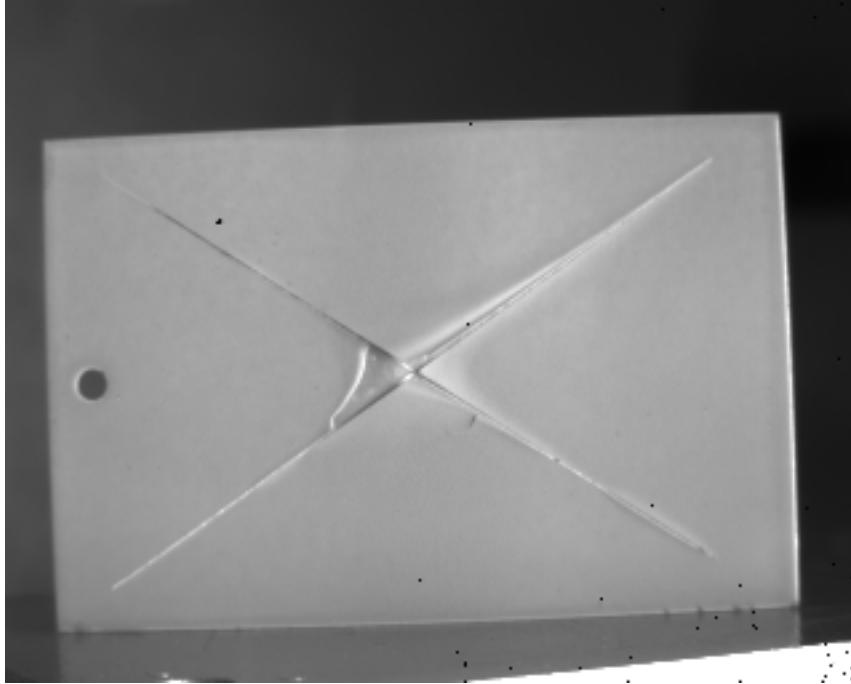
21 C4

IR Photograph

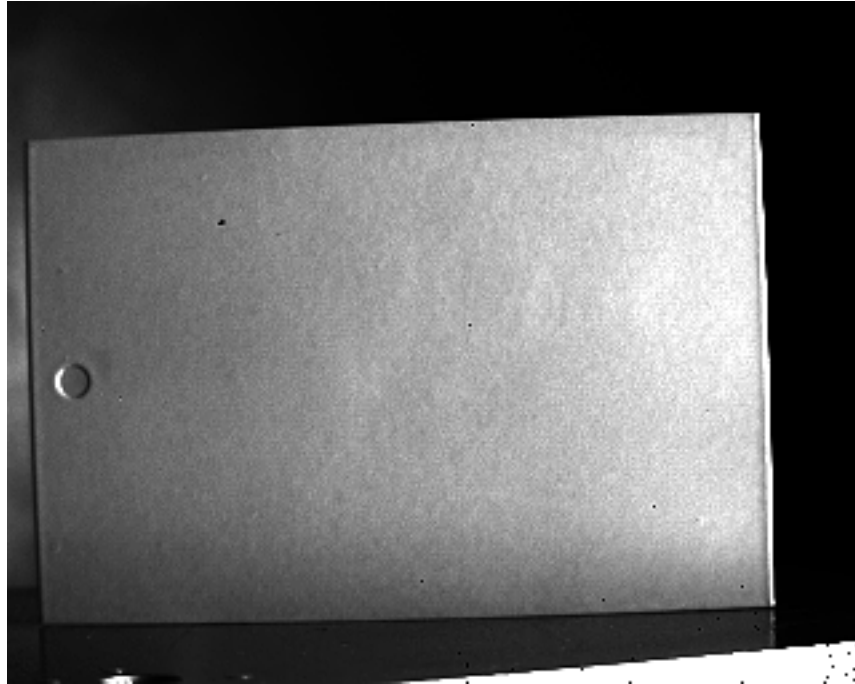
31 C2

IR Photograph does not indicate the presence of corrosion.

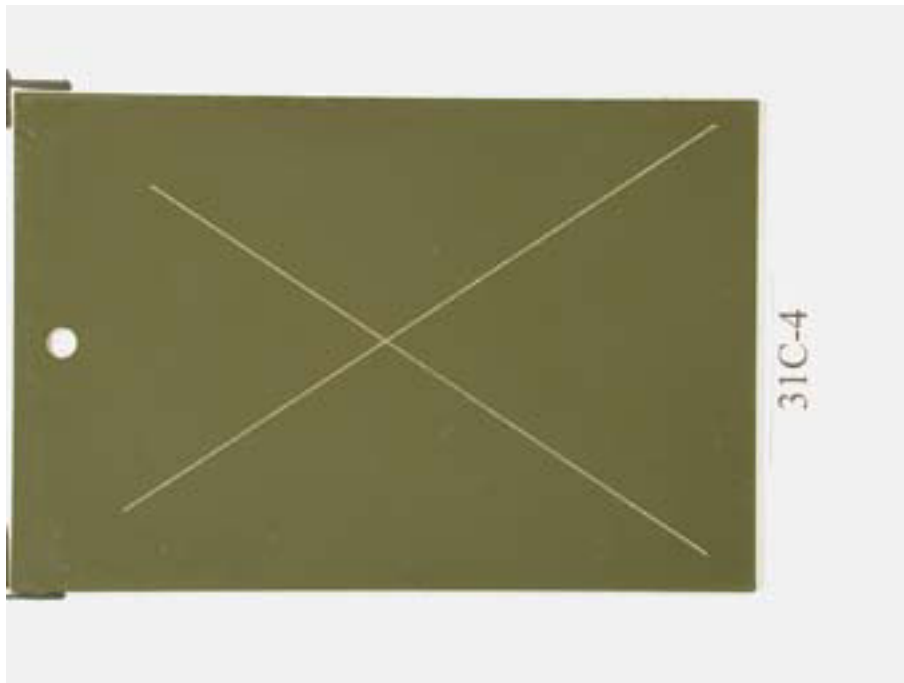
31 C4

IR Photograph indicates minor corrosion in scribed zone.

Standard Illumination Photograph

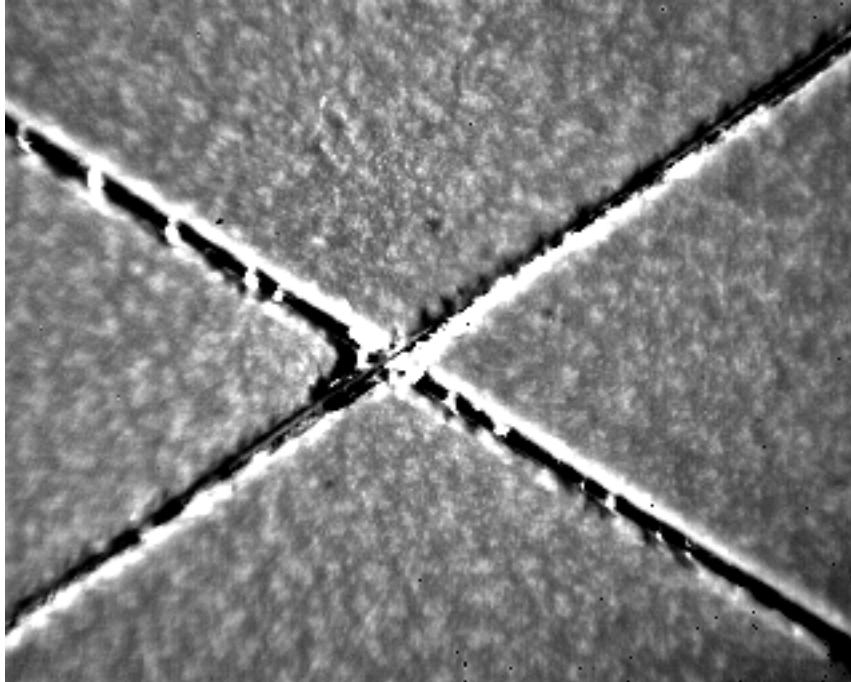
31 C4 (1XMAG.)

Corrosion present in scribed area and possible corrosion under coating to be confirmed after coating removal.

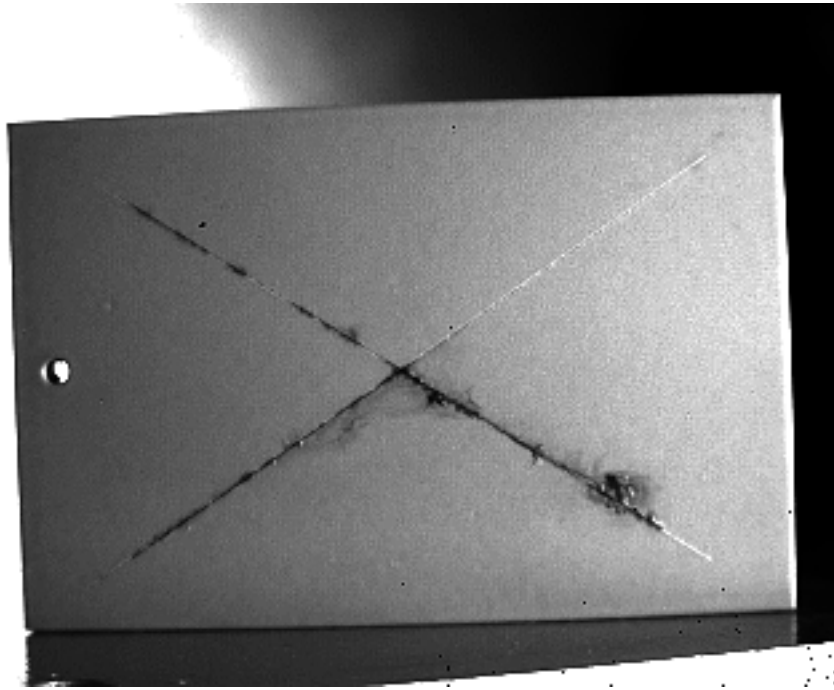
47 c5

Extensive corrosion under coatings in some areas adjacent to scribed areas.

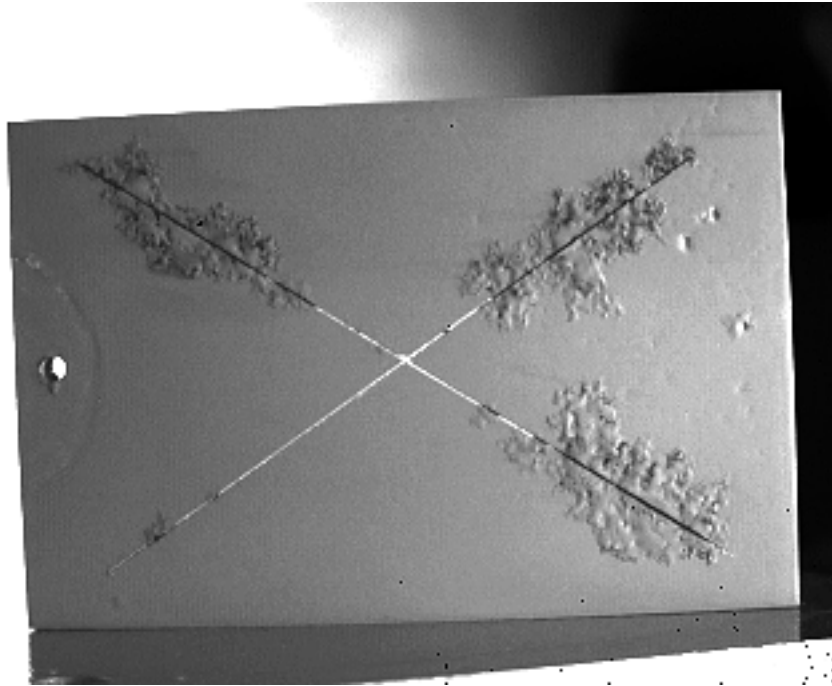
47 e1

Extensive corrosion observed under the coating in the local areas around the scribe.

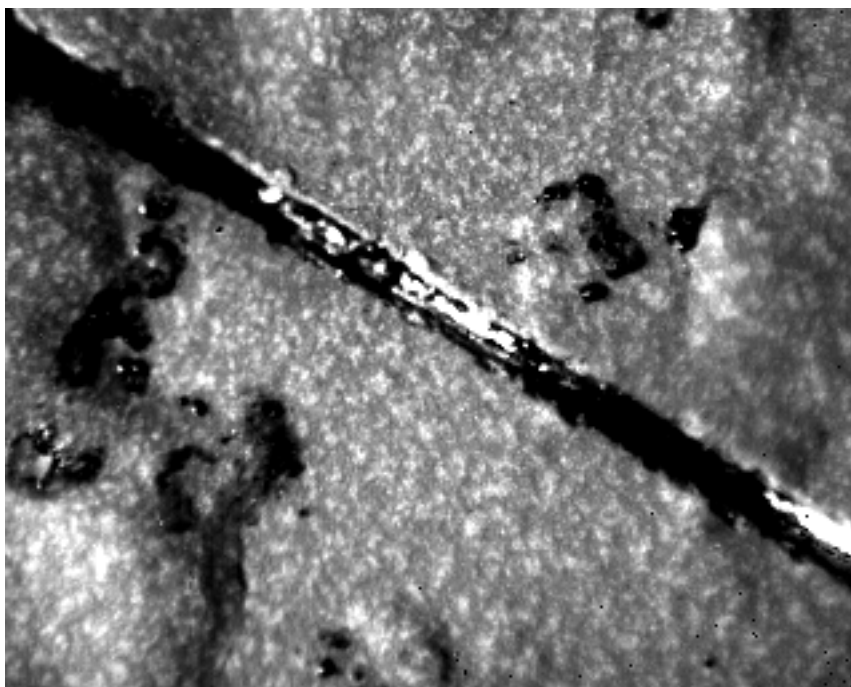
47 e1 (1XMag)

Photo indicates corrosion in scribe as well as some corrosion away from scribe.

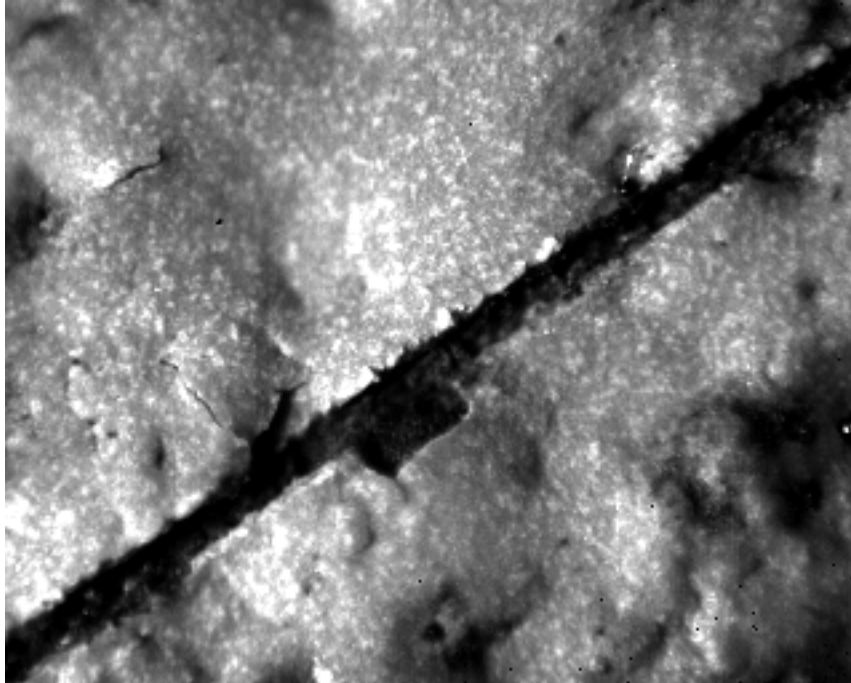
47 e1 (1X Mag)2

Same as 47 e1, except indications of cracks in coating around scribed area.

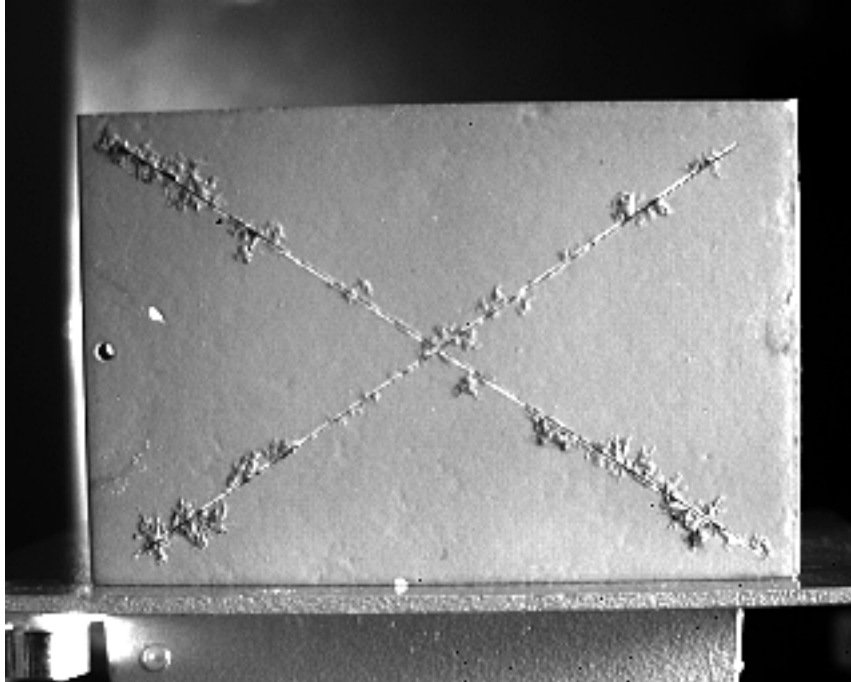
47 e3

Indicates corrosion under coating adjacent to scribed area that is corroded

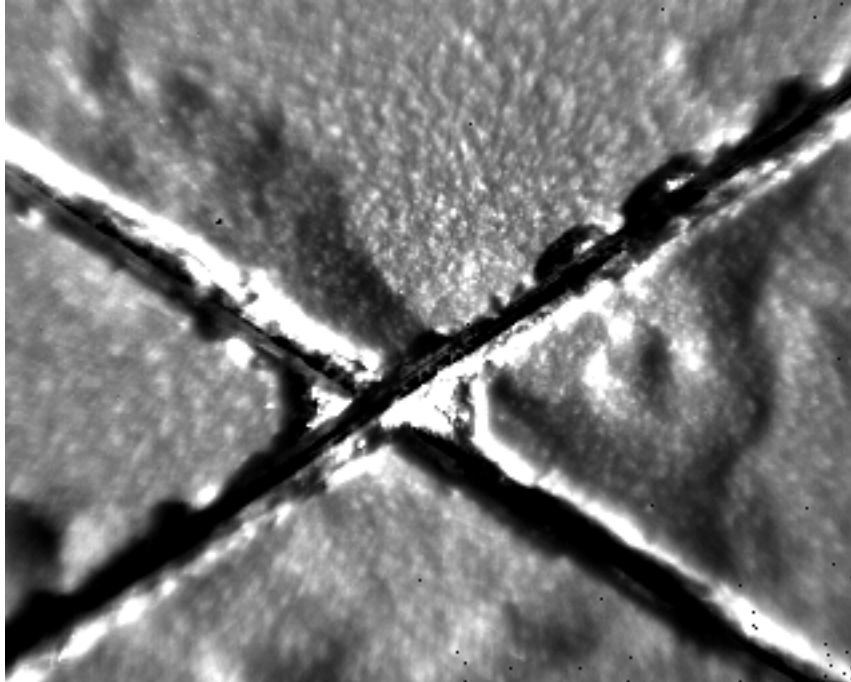
47 e3 (1 x Mag.)

Indicates corrosion in scribe as well as corrosion under coating.

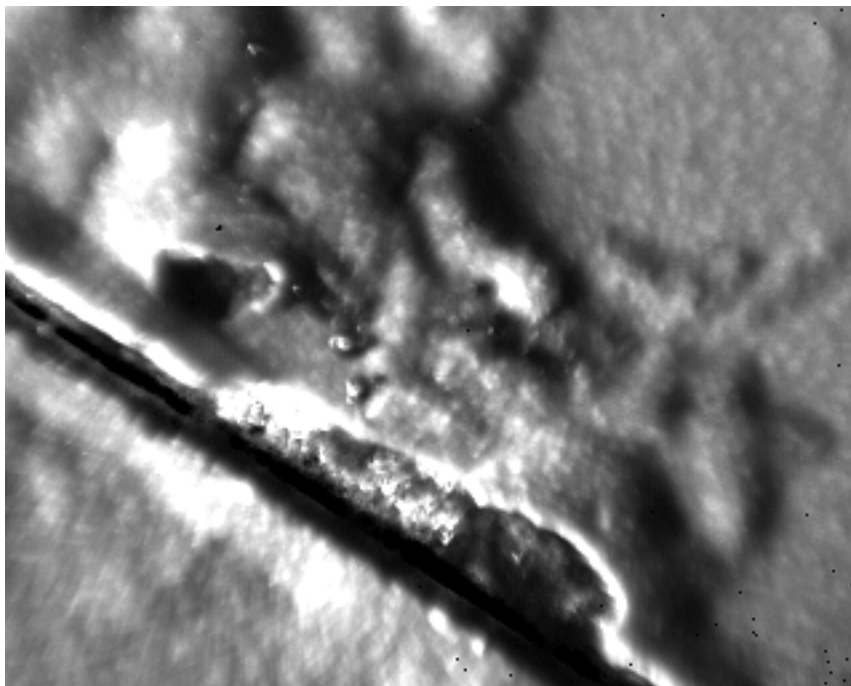
47 e3 (1 X Mag.2)

Comments same as 47 e3 (1XMag.)

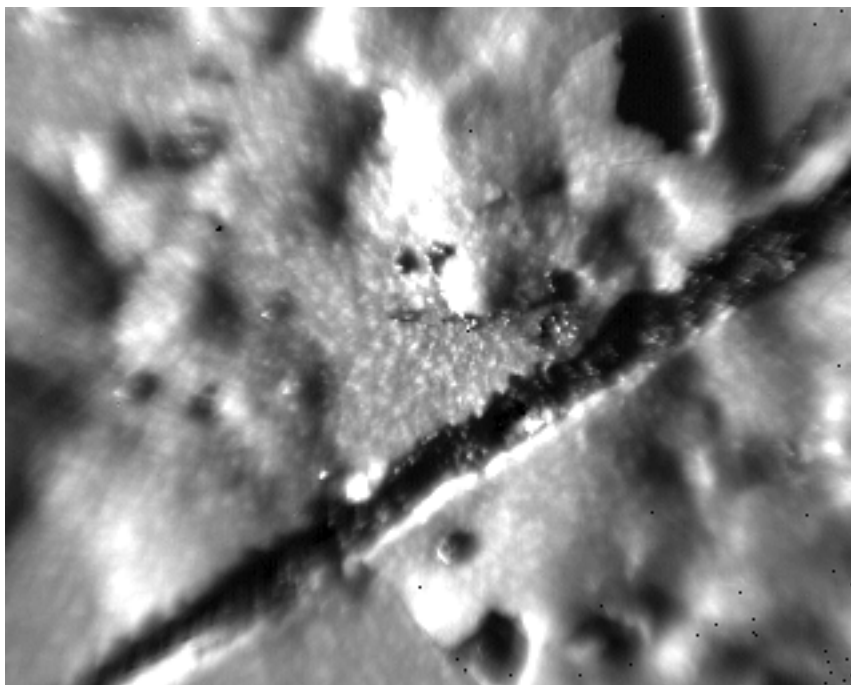
47 e3 (1 X Mag.3)
IR Photograph

Comments same as 47 e3 (1XMag.2)

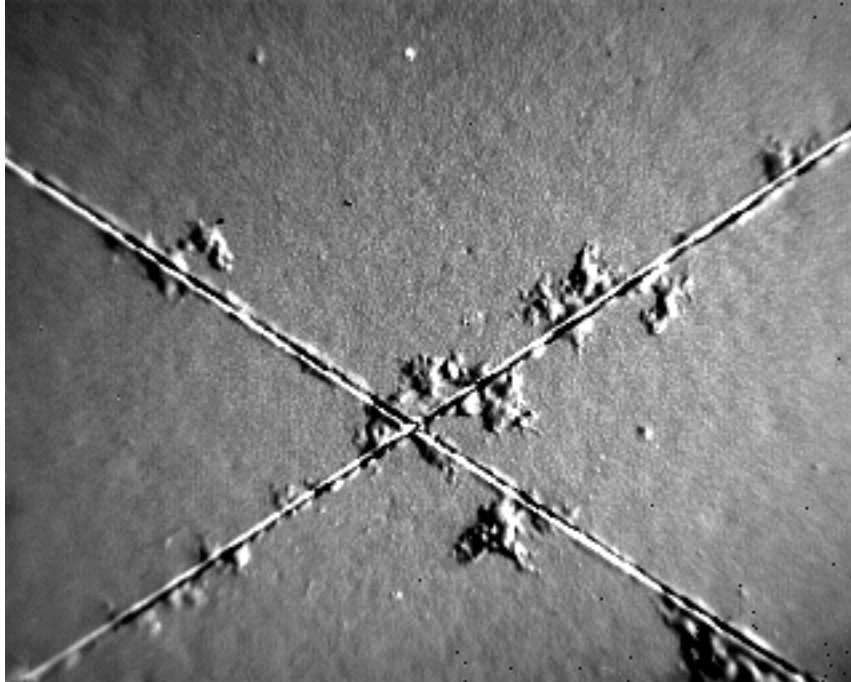
47 e3 Close

Filiform like corrosion under coatings as seen on Photograph

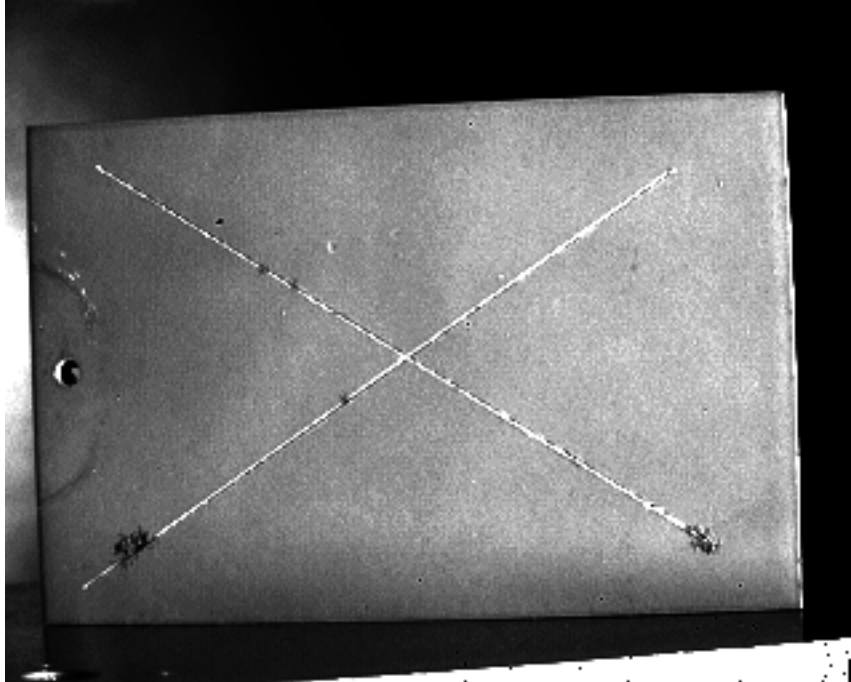
47 e4

Minor corrosion seen at end of each scribe is observable. Corrosion under coating is apparent at the end of each scribe.

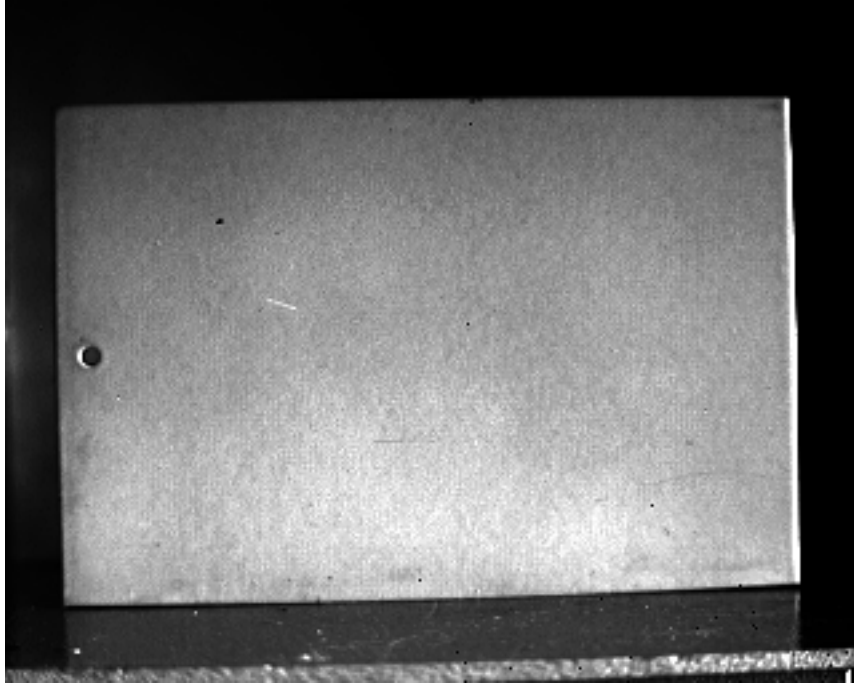
47 j1

No corrosion apparent or detectable under the coating.

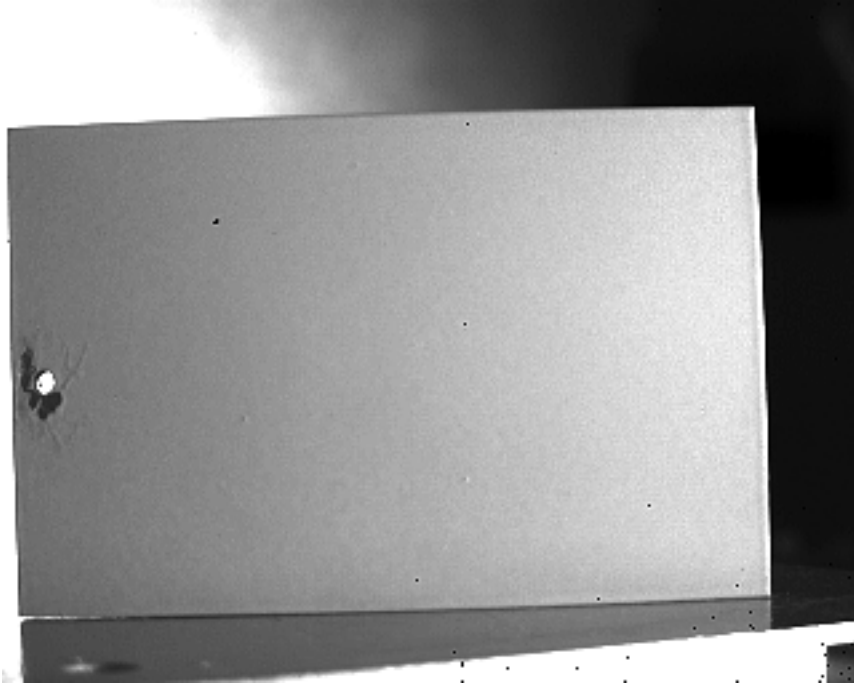
55 c3

Corrosion under coating is detectable by the hole in the panel.

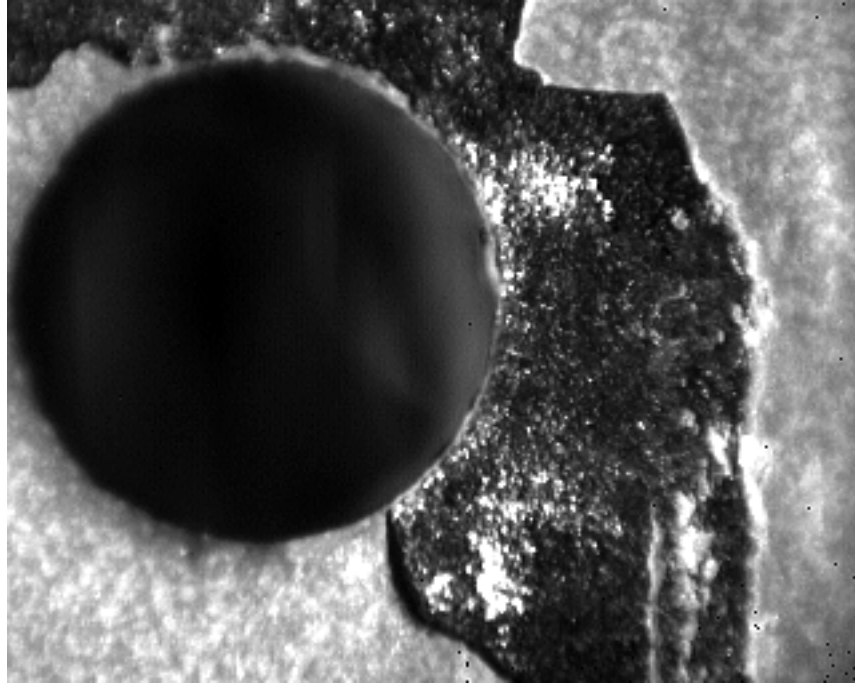
55 c3 (1XMag.)
IR Photograph

Corrosion quite apparent under coating next to hole in panel.

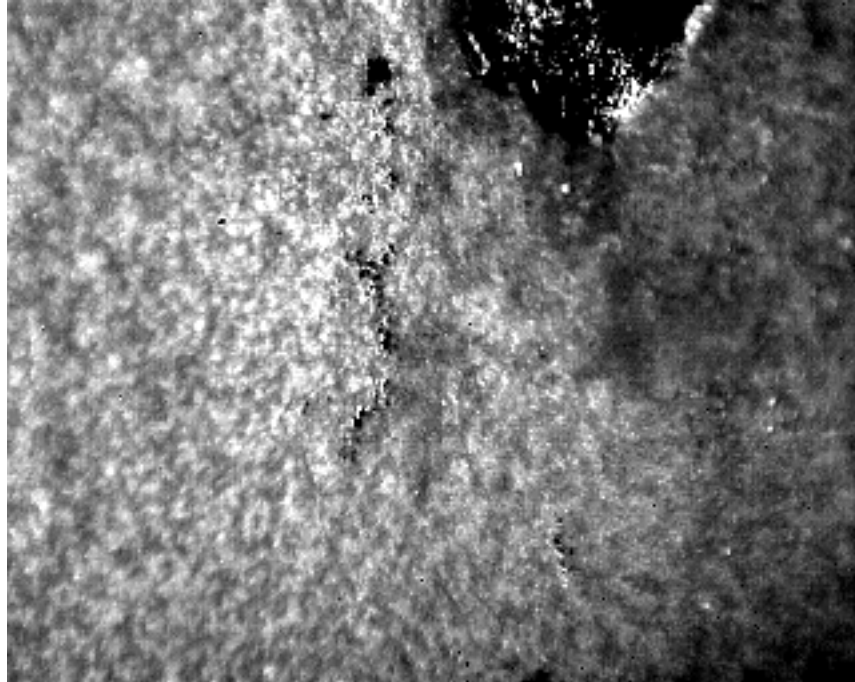
55 c3 (1Xmag.2)

Corrosion under coating detectable next to hole in panel.

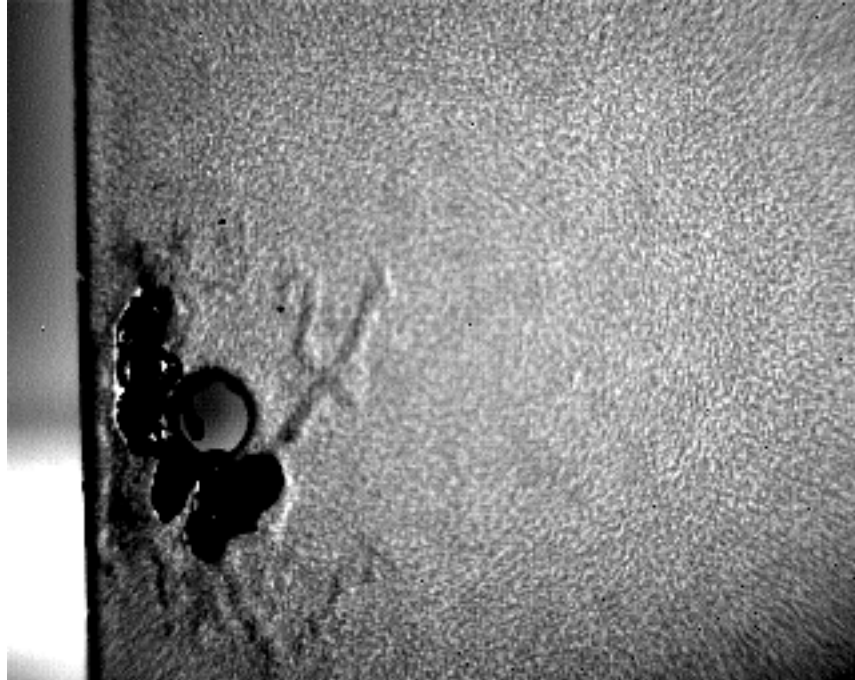
55 c 3 Close

Corrosion detected near hole, as well as under coating.

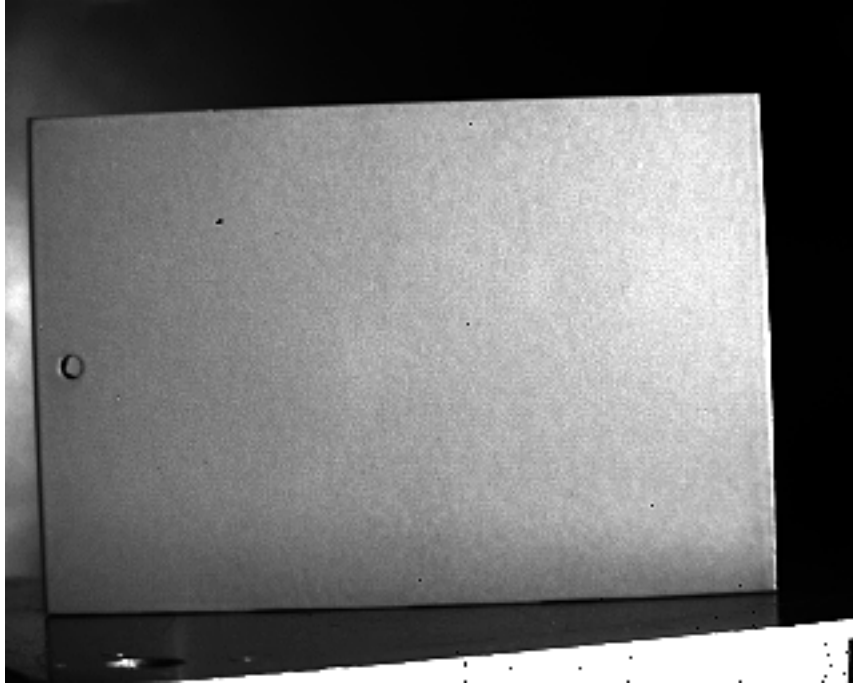
55 j1

No corrosion apparent or detectable under coating.

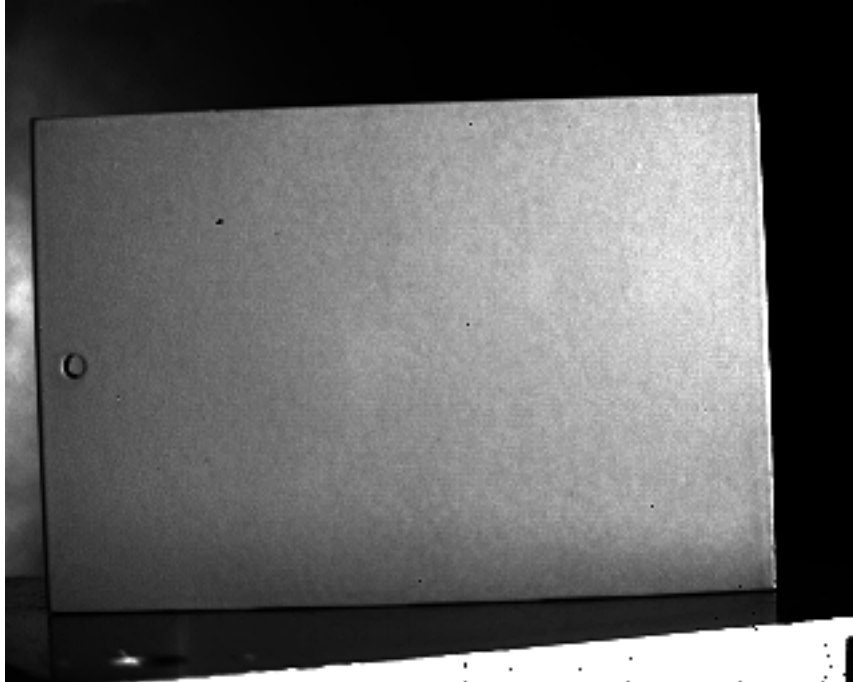
55 j1b

No corrosion apparent or detectable under coating.

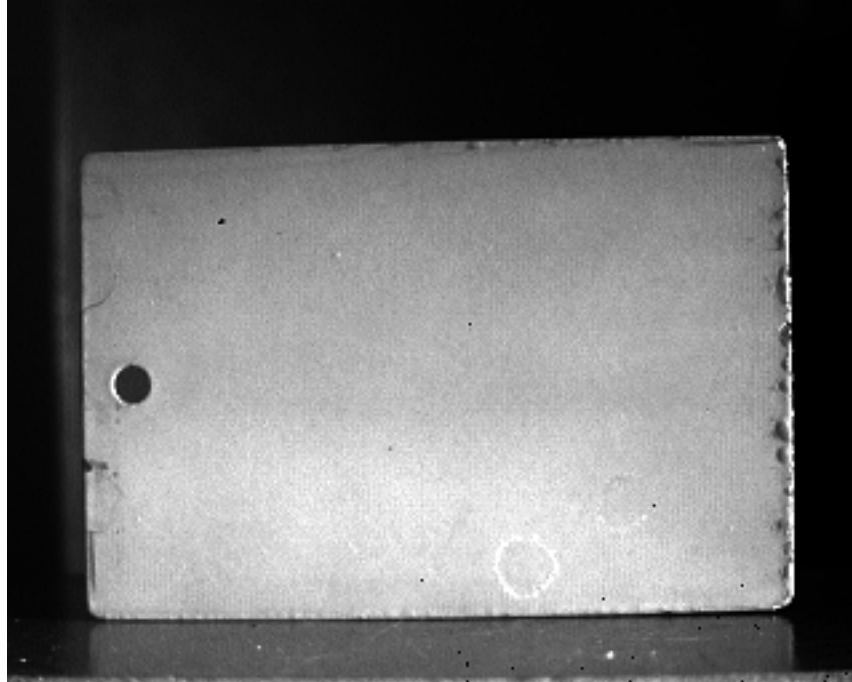
7 c2a (Front Side)

Corrosion Detected on Edge of panel Right Side.

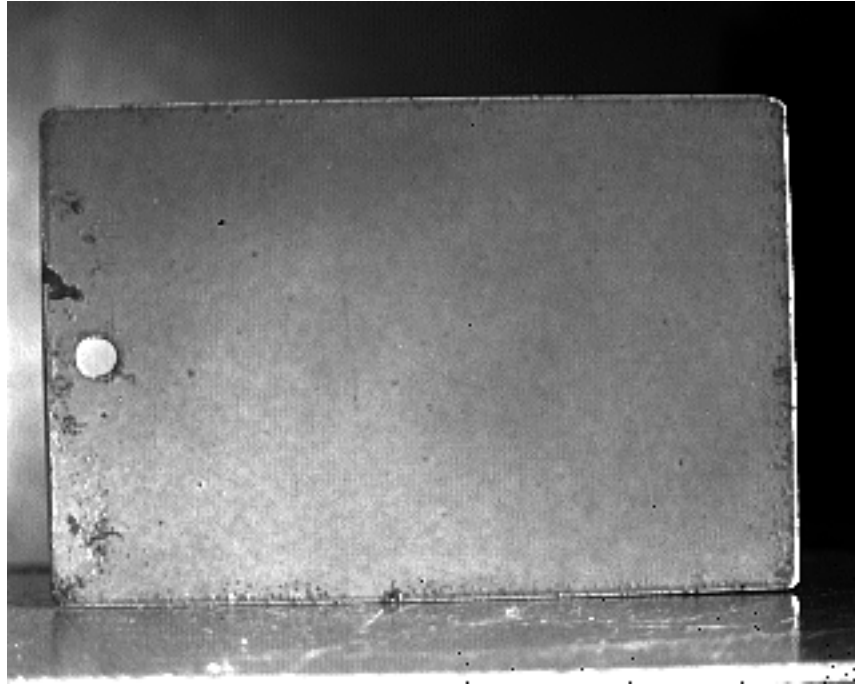
7 c2b (Back Side)

Panel appears to have a contamination or indication of corrosion near edge by hole.

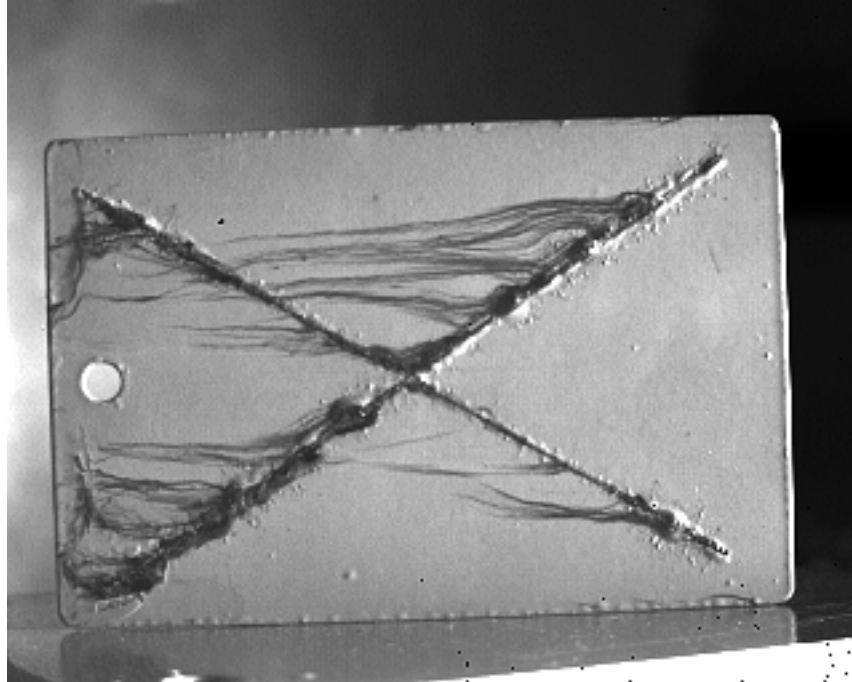
7 c 5

Photograph indicates corrosion in scribe area and under coating.
Corrosion Product on top of coating.

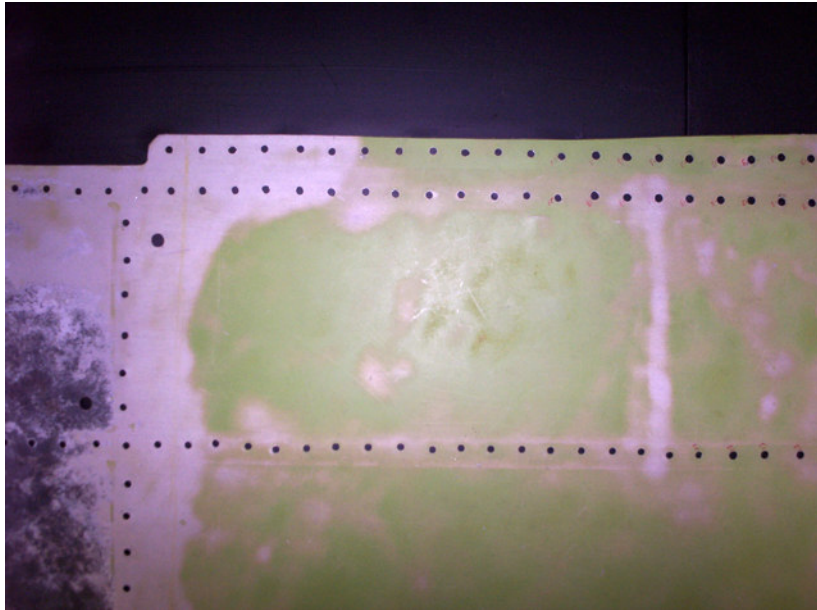
Visible and IR images of belly skin. One side is corroded, the other side has primer on surface.

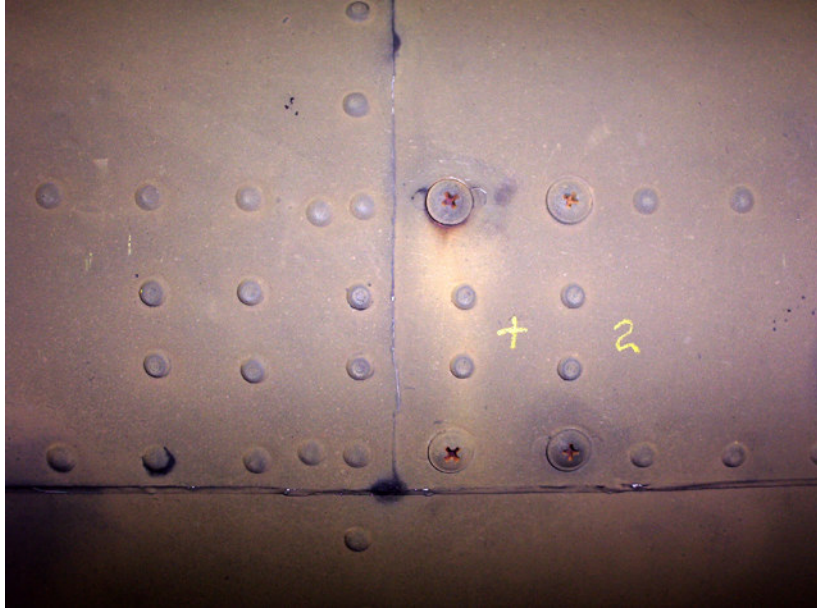
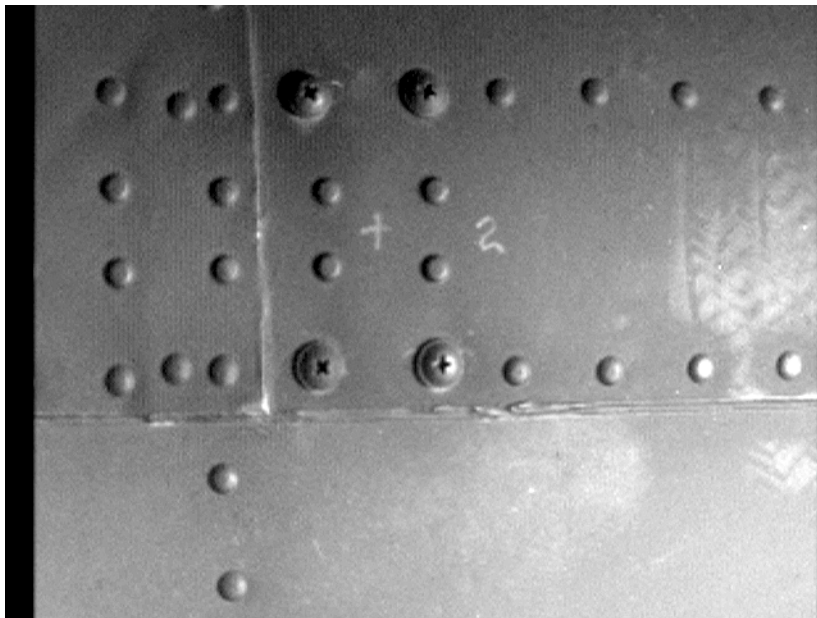
Visible and IR images of Boom Position 2. Note the "footprint" in the IR image.

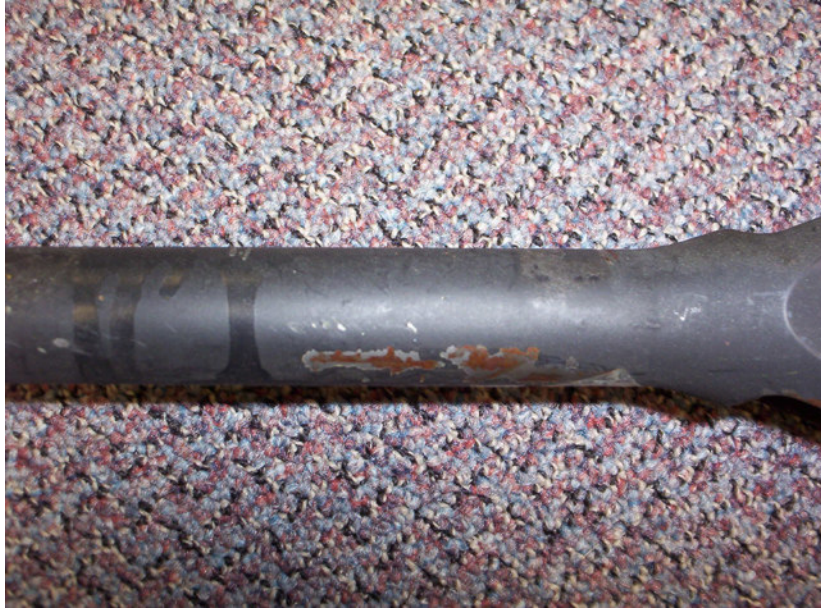
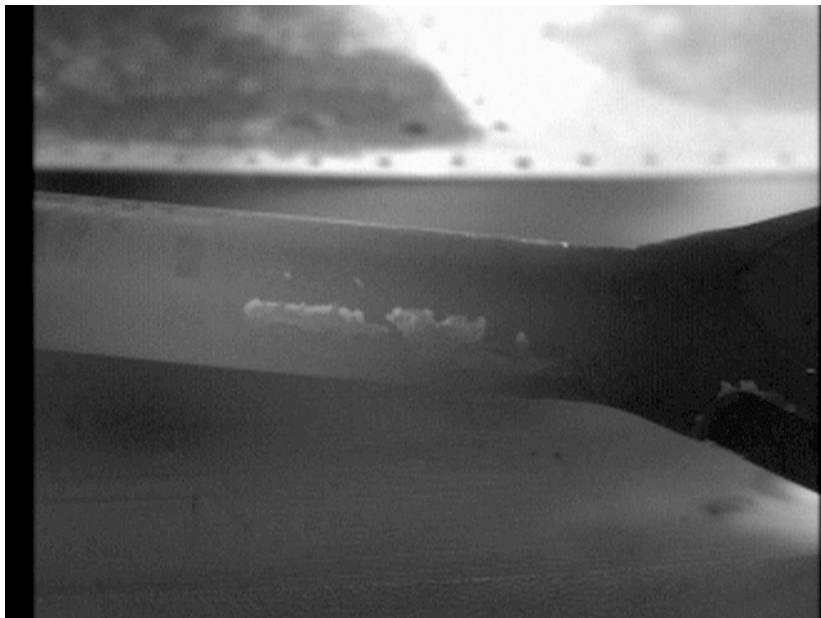
Visible and IR images of Dog Bone part

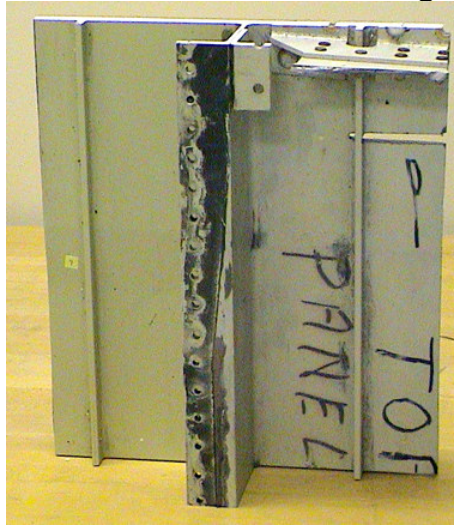
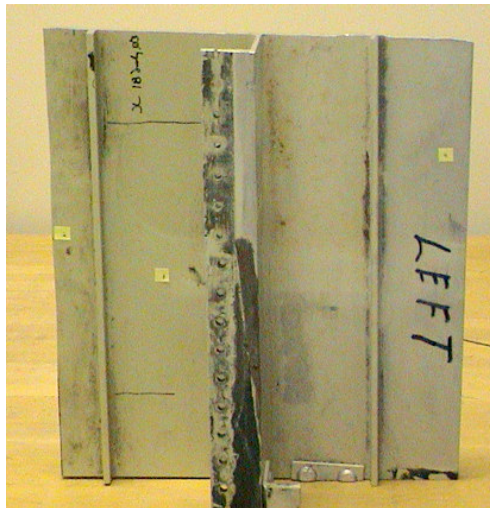
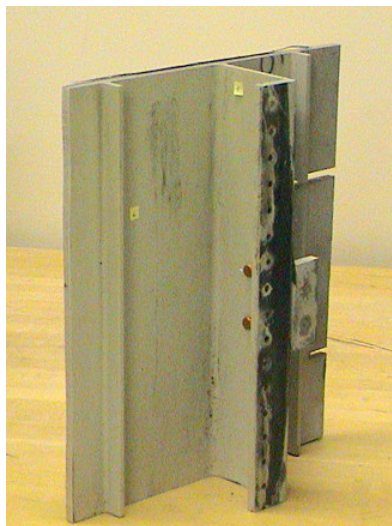
Visible image of B-52 parts.

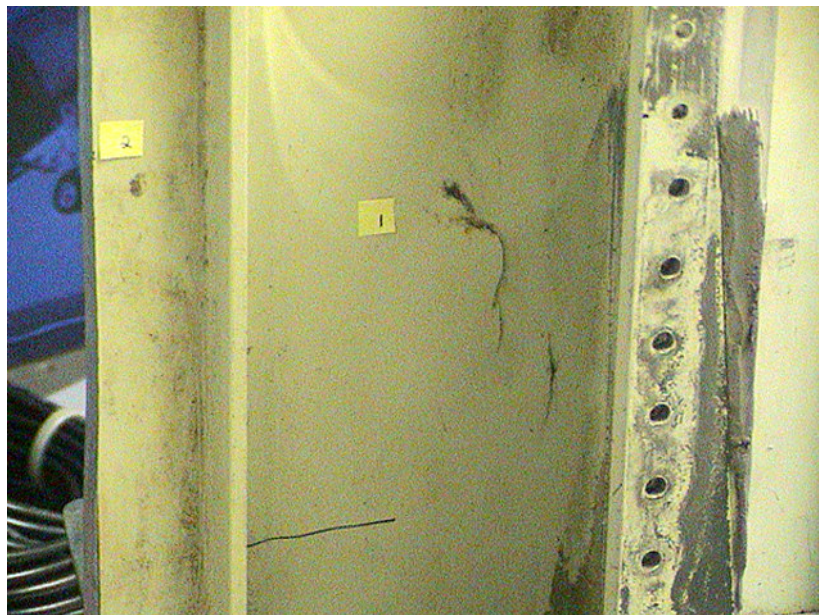
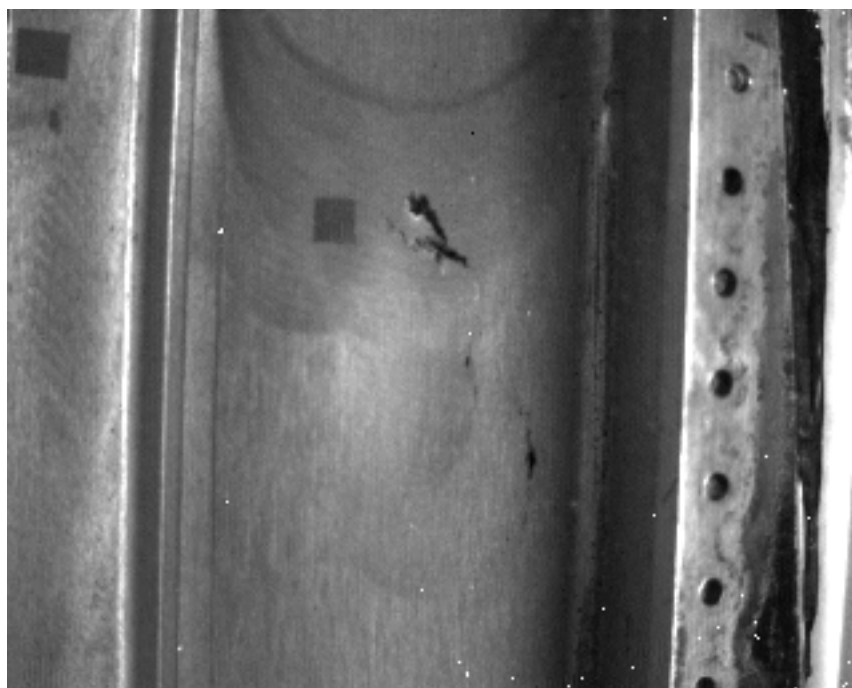
Visible and IR reflectance images of spot 1 and 2. The IR image shows the metal grain structure underneath the paint. Rework and corrosion can be seen in the IR.
