September 1, 2004

Final Report

SERDP Pollution Prevention Project 1137

Non-Destructive Testing of Corrosion Under Coatings

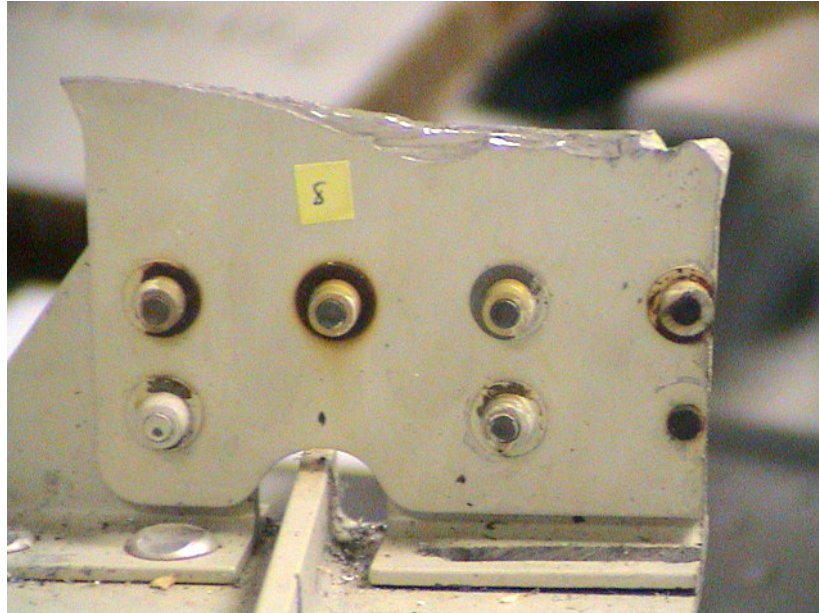
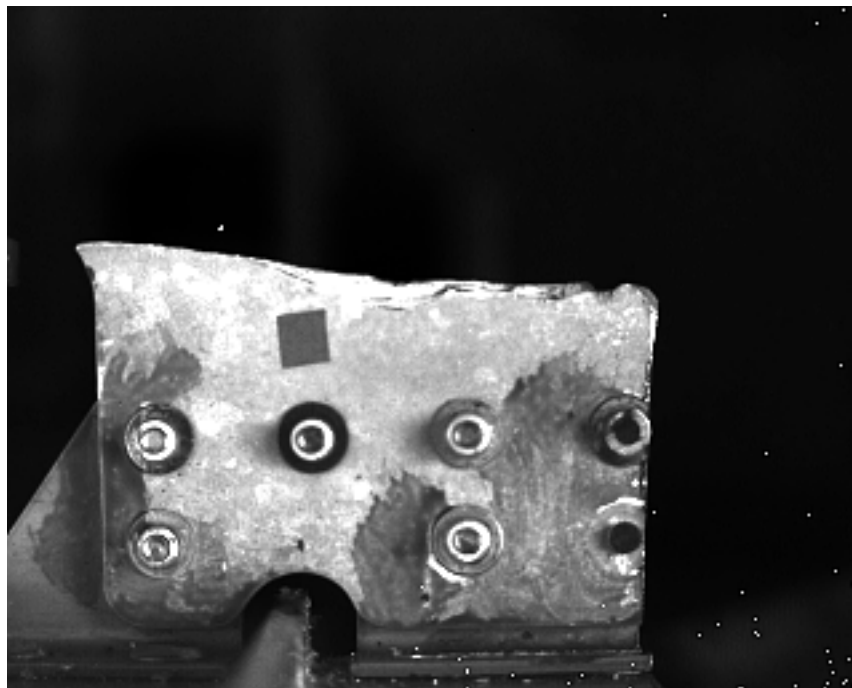
Visible and IR reflectance images of spot 8. The IR image shows the possible rework underneath the paint. The IR image reveals features not seen in the visible image.

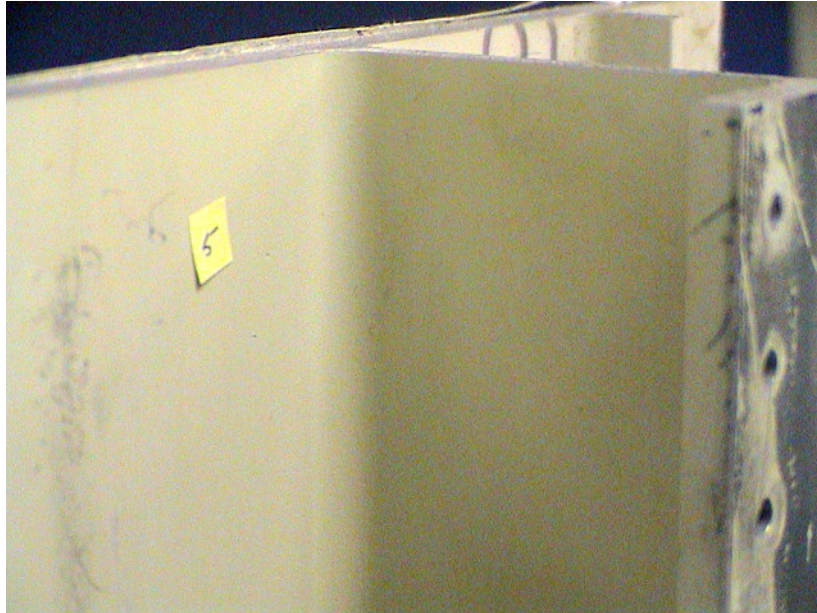
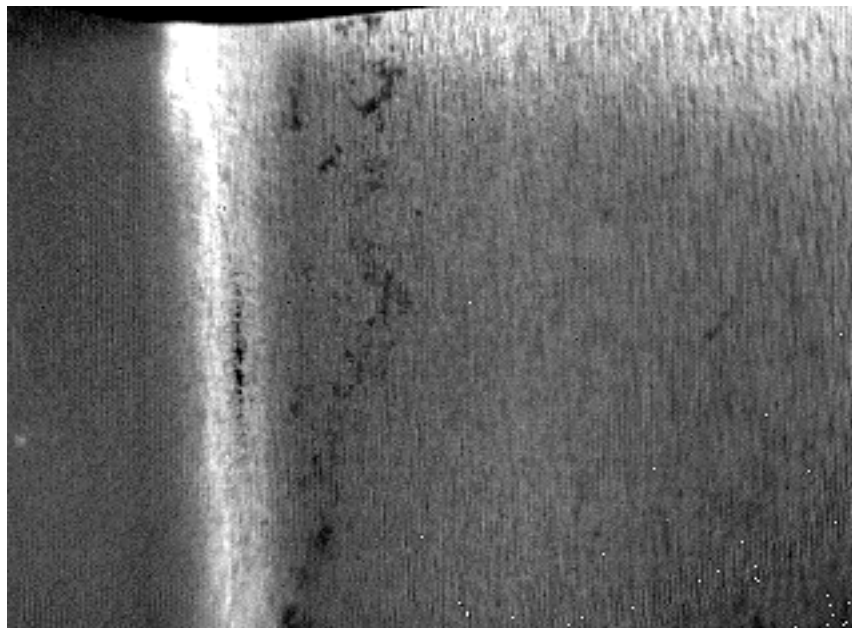
Visible and IR reflectance images of spot 5. After cleaning area with Naphtha, corrosion is clearly seen underneath the paint in the IR mode.

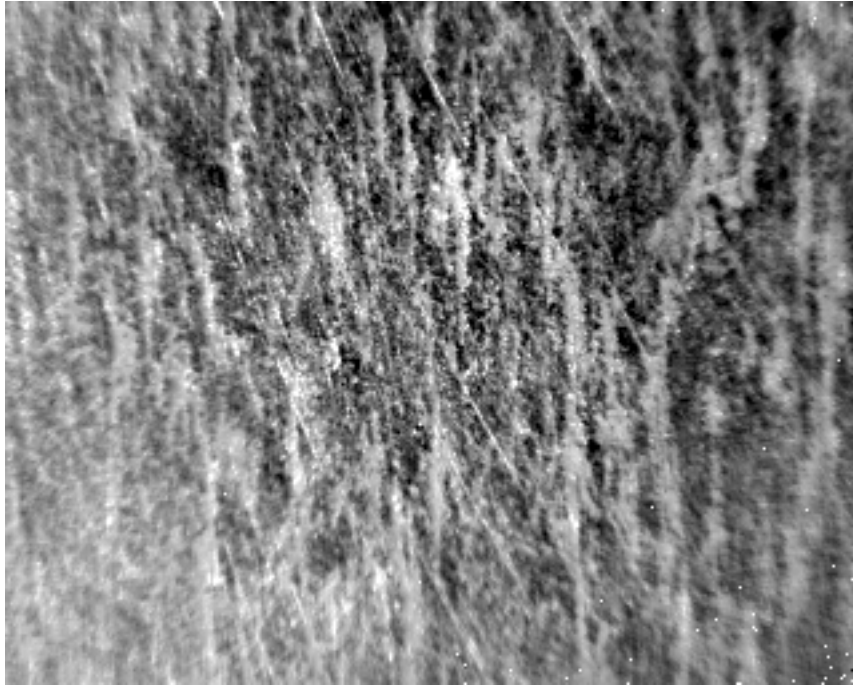
IR reflectance image of spot 1. This is a 1x mag. IR image. The metal surface is clearly seen. Dark areas may be sites of corrosion.

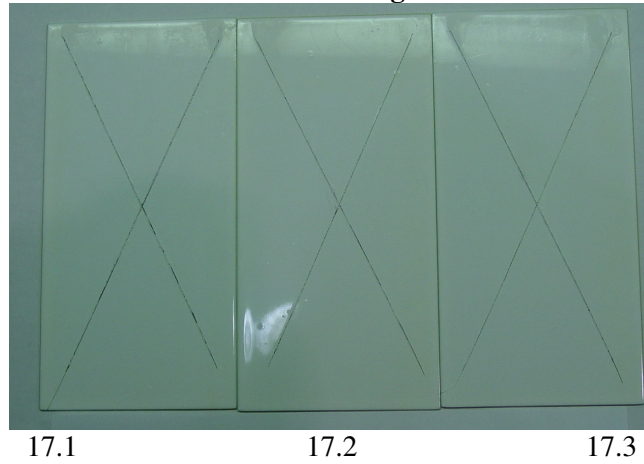
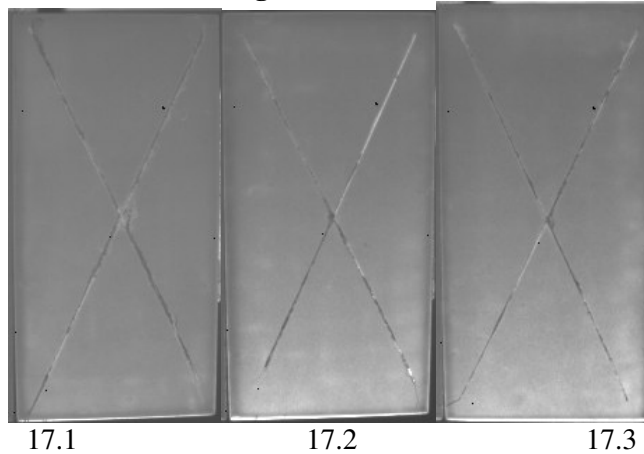
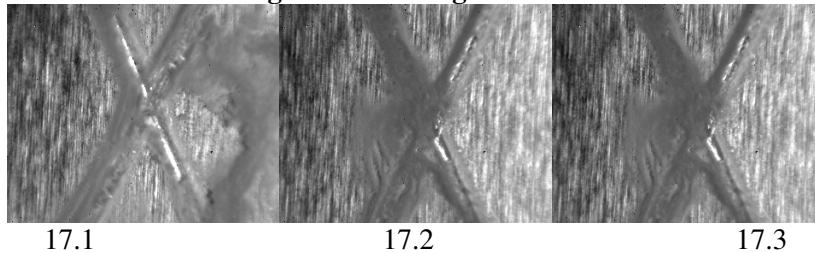
Visible and IR reflectance images of panels 17.1, 17.2, and 17.3. Panels 17.1, 17.2, and 17.3 all consist of the same paint scheme. These panels all have a Deft 44-GN-098, non-chromated primer (candidate for specification MIL-PRF-85582D Type 1, Class N), and topcoat MIL-PRF-85285 Type 1, Gloss 17925 ELT). The panels were exposed to ASTM B117 Salt Fog for 2000 Hours. Note: Aluminum grain structure on IR images (17.1, 17.2, and 17.3) indicates the candidate primer and gloss topcoat system are compatible with the IR Detection System.

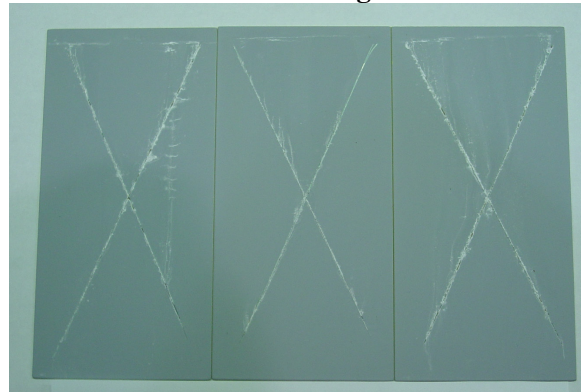
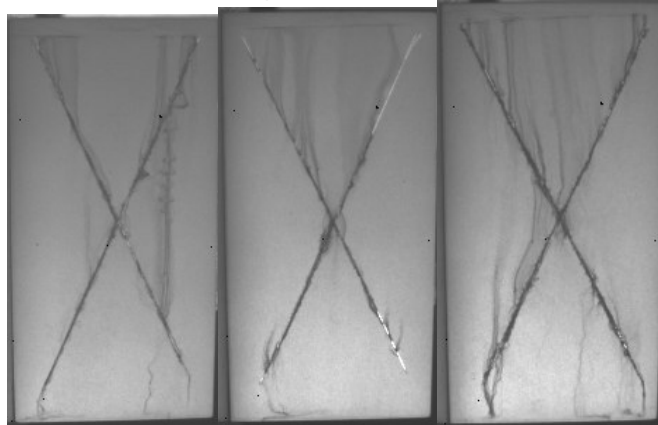
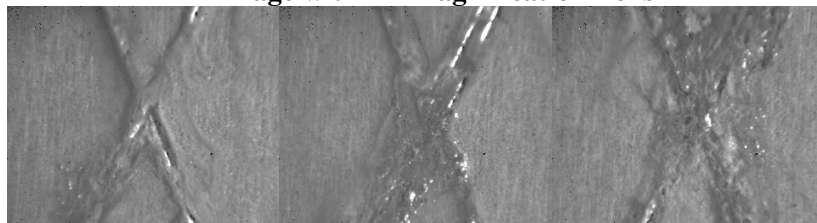
Visible and IR reflectance images of panels 18.1, 18.2, and 18.3. Panels 18.1, 18.2, and 18.3 all consist of the same paint scheme. These panels all have a Deft 44-GN-098, non-chromated primer (candidate for specification MIL-PRF-85582D Type 1, Class N), and topcoat MIL-PRF-85285 Type 1, Camouflage 36375 ELT). The panels were exposed to ASTM B117 Salt Fog for 2000 Hours. Note: Aluminum grain structure on IR Images (18.1, 18.2, and 18.3) indicate primer and camouflage topcoat system are compatible with IR Detection System.

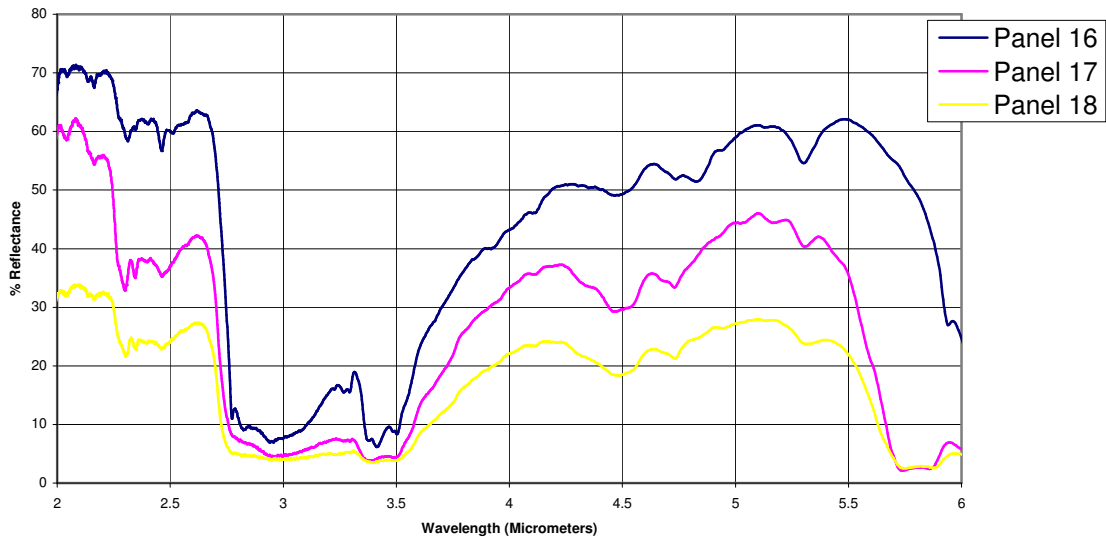
The above chart is the IR Reflectance spectra of panels 16, 17, and 18. Panels 16, 17, and 18 each consisted of 3 panels, the spectra was then averaged. The panels were exposed to ASTM B117 Salt Fog for 2000 Hours. The IR Reflectance measurements were not taken on the scribe line, where corrosion and salt residue appear most often.

The above chart indicates coating/substrate reflectance in the 2 to 6 micron wavelength range. The current production Merlin™ Camera has a 3 to 5 micron window. However, the chart also indicates that if the filter was moved to the 3.5 to 5.5 micron window, an enhanced IR flux intensity may improve contrast of the corroded areas vs the non-corroded areas.

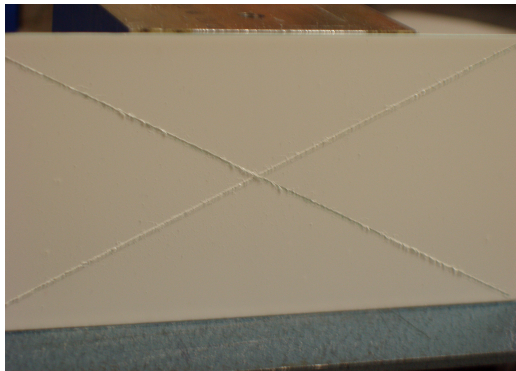
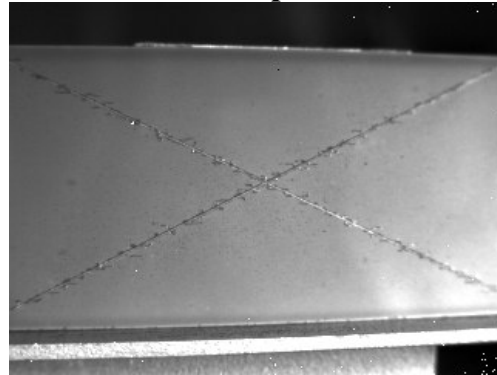
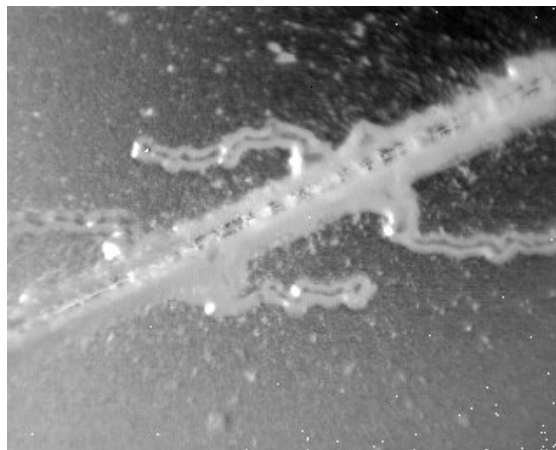
Panel 19.1 Gloss Topcoat: 2000 Hours Filiform Exposure

**IR Images enhance the ability to see filiform corrosion through gloss topcoat. Note:
Filiform corrosion exposure protocol was conducted in accordance with MIL-PRF-85582.**

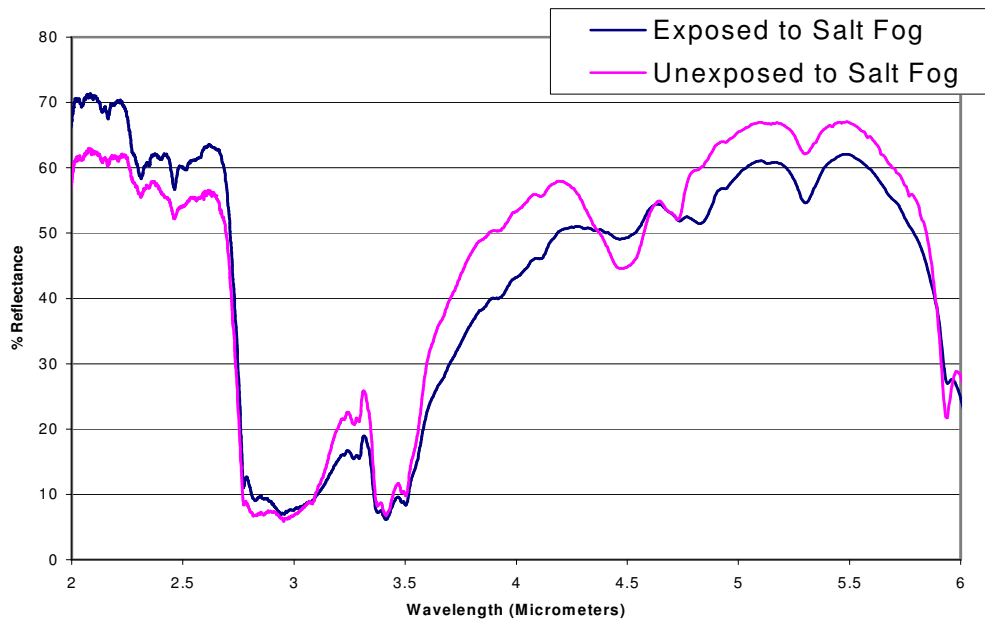
Deft 44-GN-098: Degradation of Coating w/Exposure to Salt Fog

The above chart is the IR Reflectance spectra of panels that were painted with a Deft 44-GN-098 non-chromated primer (candidate for specification MIL-PRF-85582TYCLN). The line marked “Exposed to Salt Fog” represents a panel with non-chromated primer that was exposed to ASTM B117 Salt Fog for 2000 Hours (panel 16.1). The line marked “Unexposed to Salt Fog” represents a panel with non-chromated primer that was not exposed and tested as new (panel 42.1). This chart shows the potential degradation of the non-chromated primer with the addition of increased salt fog exposure. Both the exposed and the unexposed panels with this non-chromated primer prove to transmit in the 3-5 micrometer wavelength region, this is evident in the above spectra. It is also apparent that an improved IR signal may be obtained in the 3.5 to 5.5 micron range.
