Evaluation of New Surface Preparation and Coating Repair Techniques in Ballast Tanks - Phase III

**THE NATIONAL
SHIPBUILDING
RESEARCH
PROGRAM**

**NEW SURFACE PREPARATION &
COATING REPAIR TECHNIQUES IN
BALLAST TANKS**

EVALUATION OF
NEW SURFACE PREPARATION AND COATING REPAIR
TECHNIQUES IN BALLAST TANKS-PHASE III

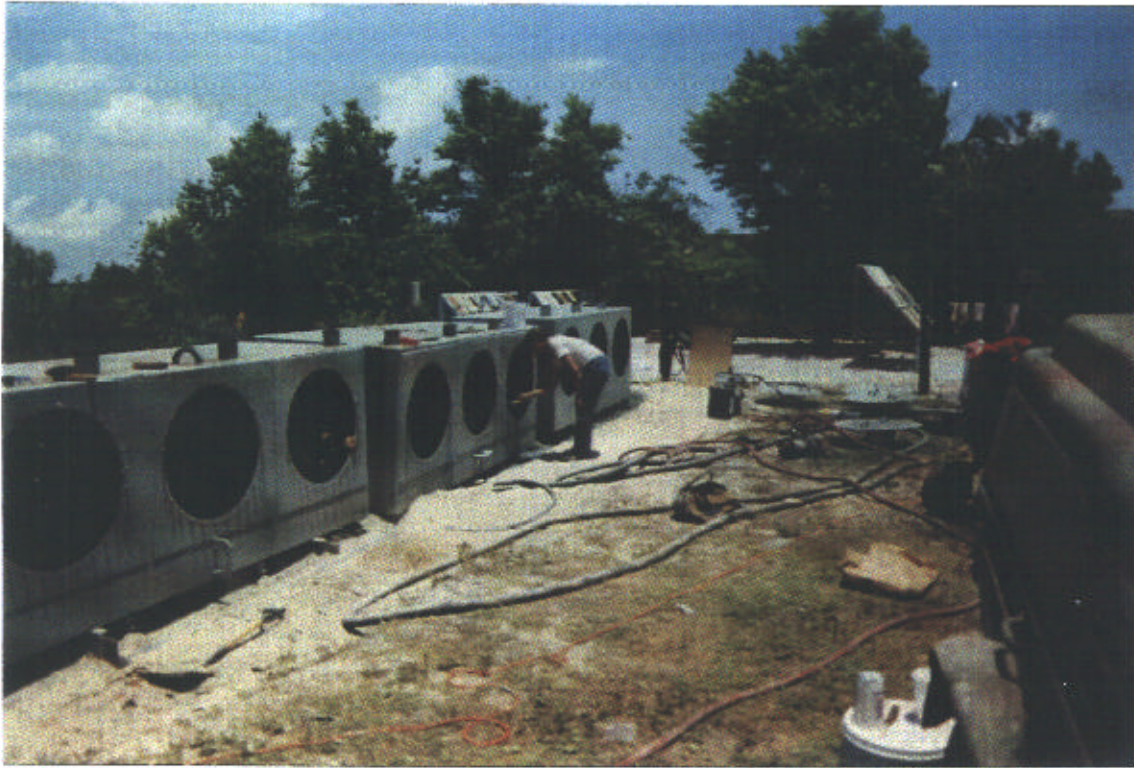
The dimensions of each tank assembly is twelve feet long by four feet wide and four feet high. Each tank assembly is divided into three separate test cells for a total of nine test tanks. Each tank assembly is constructed to simulate the internal geometry of an actual ballast tank to include angles, built up frames, T bars, and wide flanges. One side of each tank has bolted construction to facilitate access for coating application and inspection. See Photograph 1.

PHOTOGRAPH 1-TEST TANK ASSEMBLIES

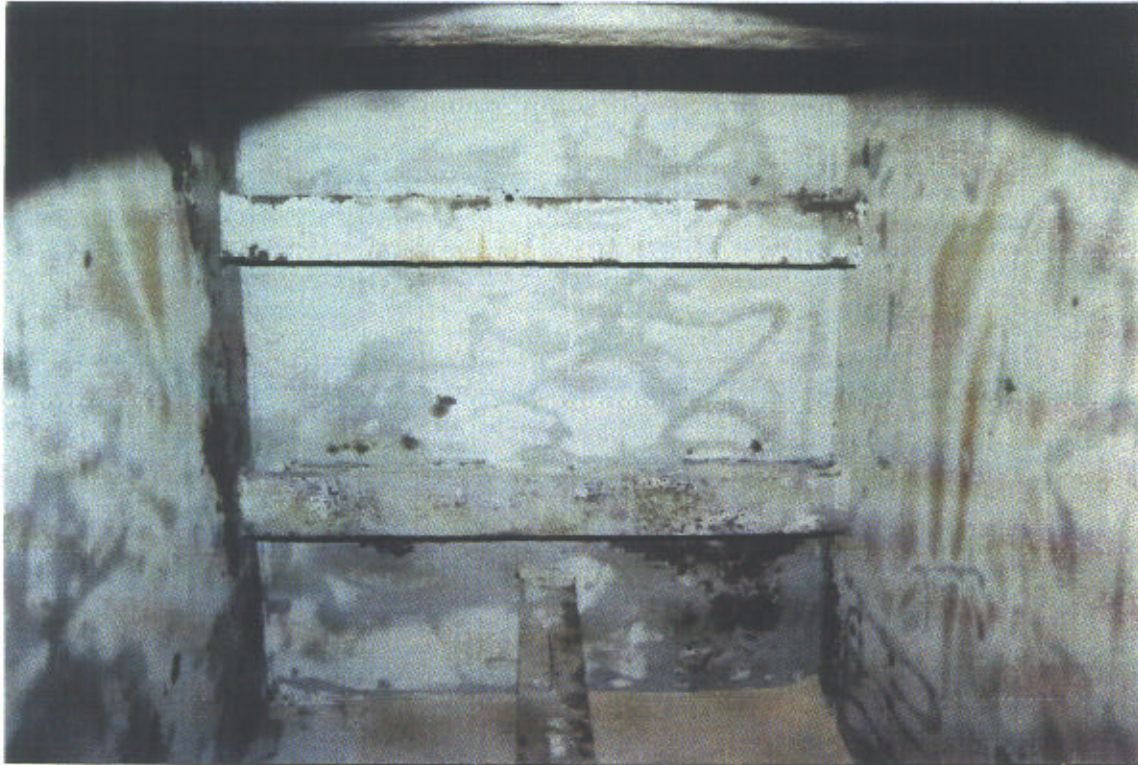
The chloride contamination of the Sweep Blast Cleaned (SP 7) surface was measured as being 8 milligrams per square meter. The results of the Sweep Blast Cleaned surfaces is shown in Photograph 3.

PHOTOGRAPH 3-SWEEP BLAST CLEANED SURFACE PRIOR TO COATING

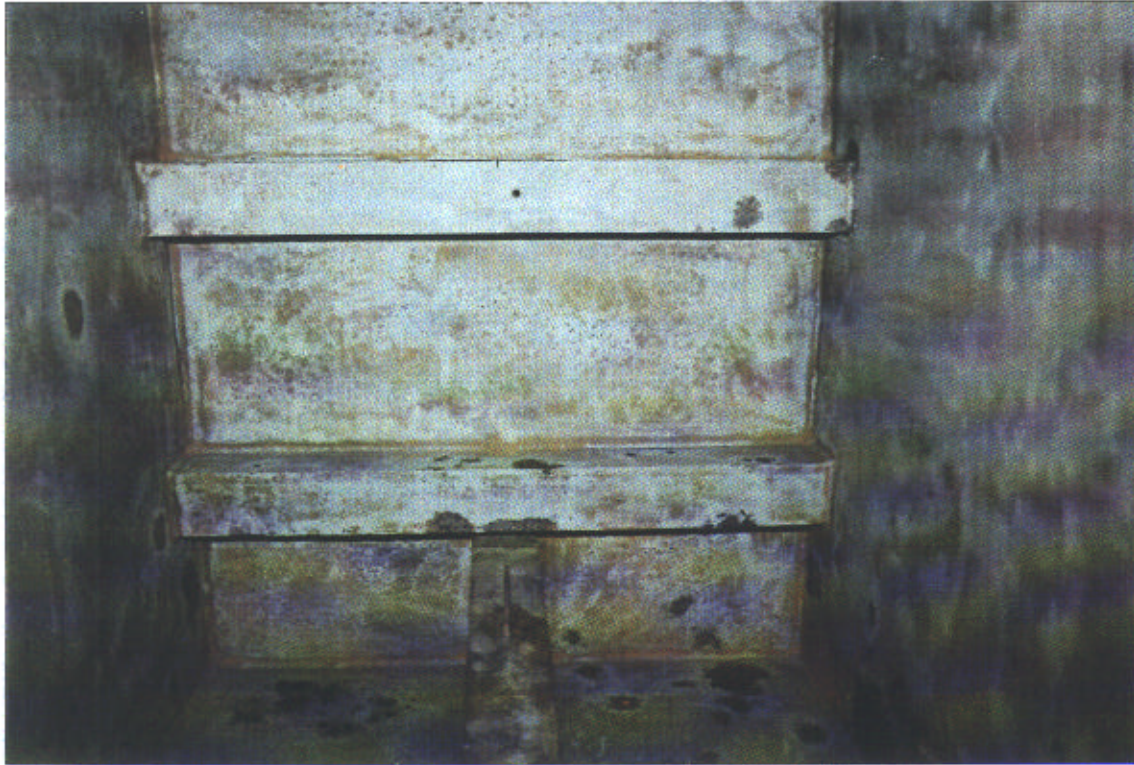
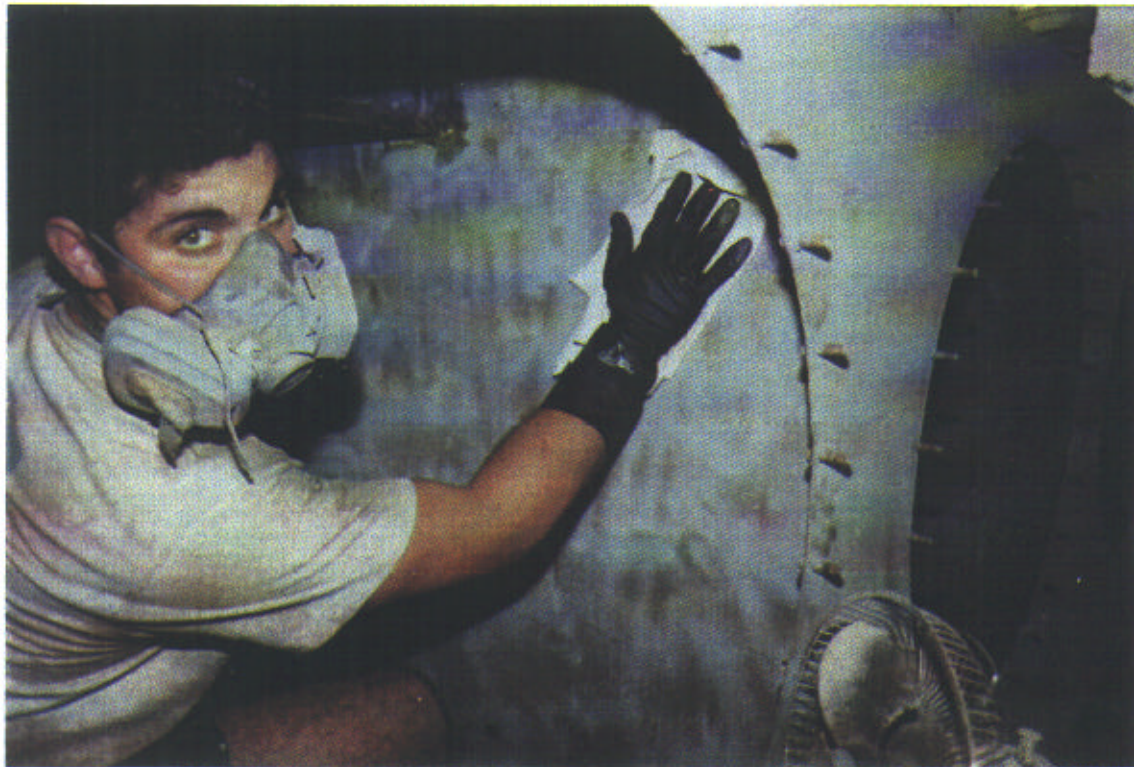
PHOTOGRAPH 5-SURFACE PREPARATION OF INTACT MIL-P-24441

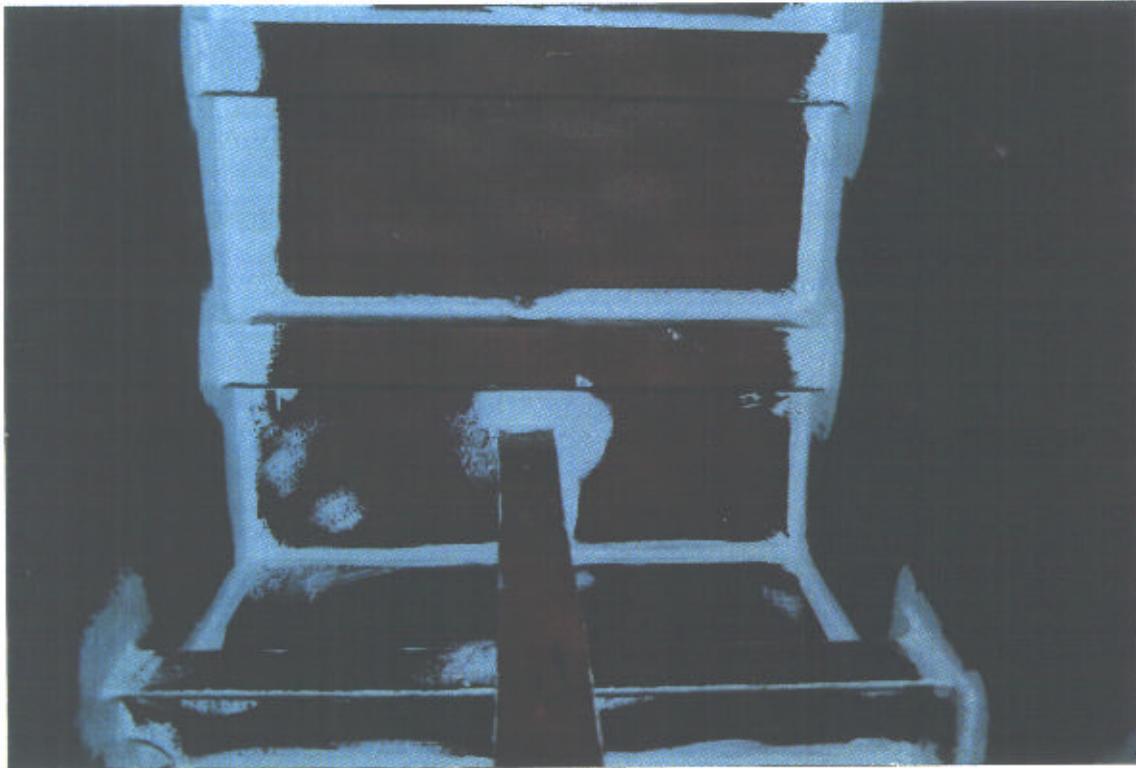
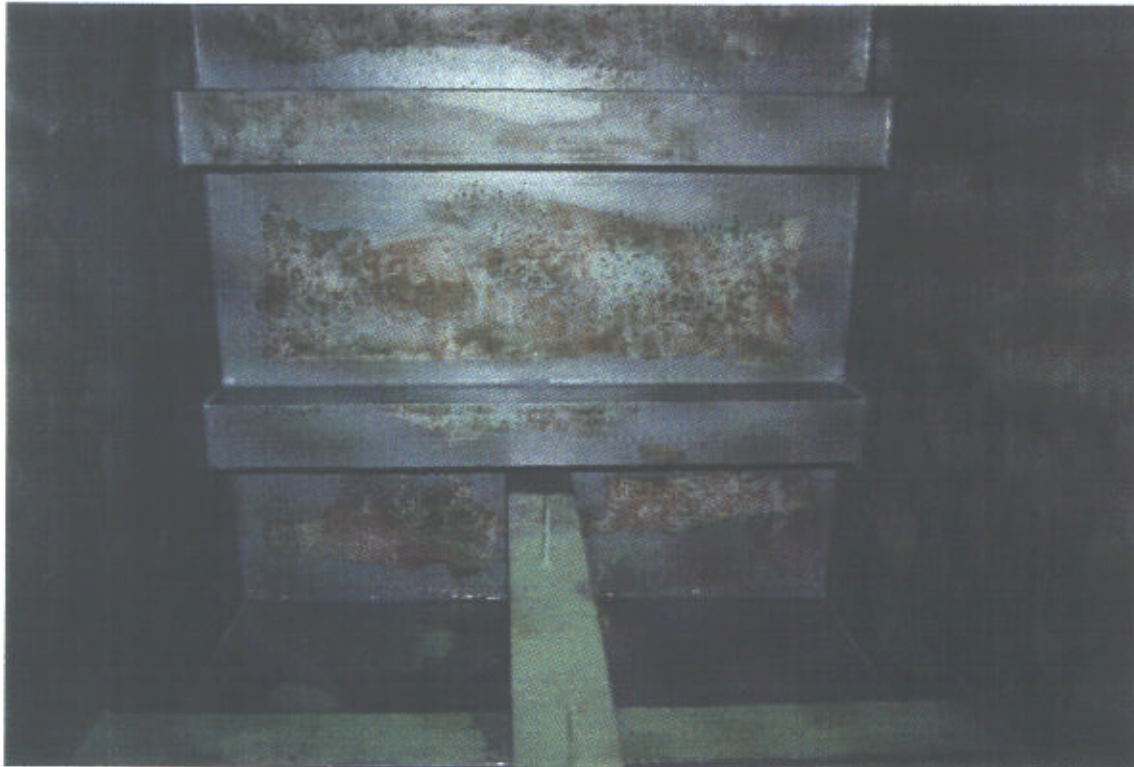
All coatings were applied with conventional pressure pots and spray guns. All welds and sharp edges were stripe coated before the application of the first coat and between coats. See Photograph 6. Sharp edges were not rounded.

PHOTOGRAPH 6-STRIPE COATING BETWEEN COATS

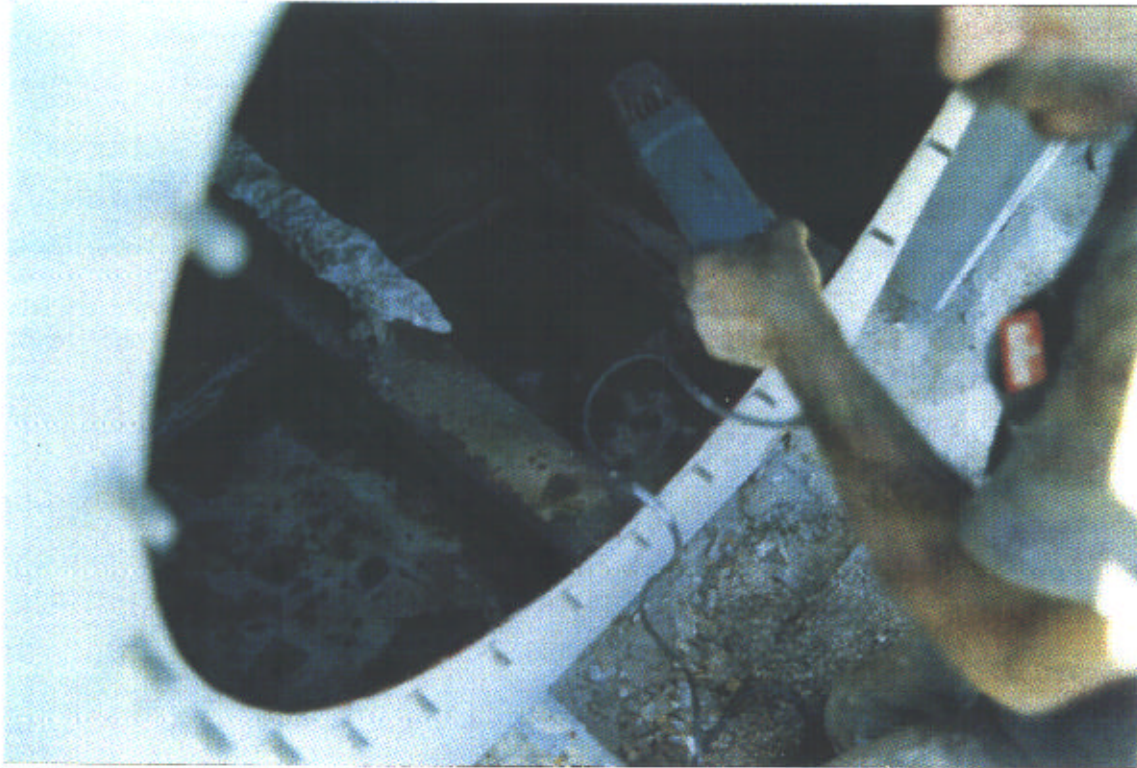
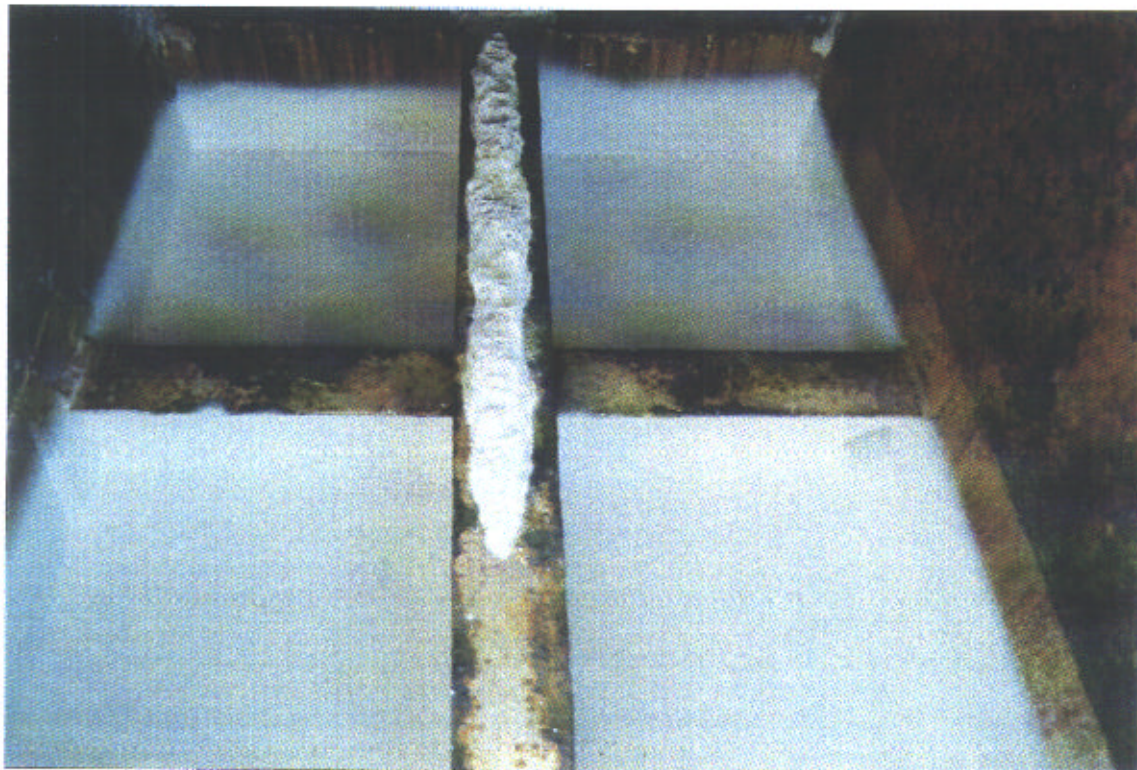
PHOTOGRAPH 7-REPAIRED BOTTOM OF PARTIALLY COATED TANK WITH CP
