NASA TM X-1194

INVESTIGATION OF HYDROTEST FAILURE OF THIOKOL CHEMICAL CORPORATION it : 260-INCH-DIAMETER SL-1 MOTOR CASE

NATIONAL AERONAUTICS AND SPACE ADMINISTRATION • WASHINGTON, D. C. • JANUARY 1966

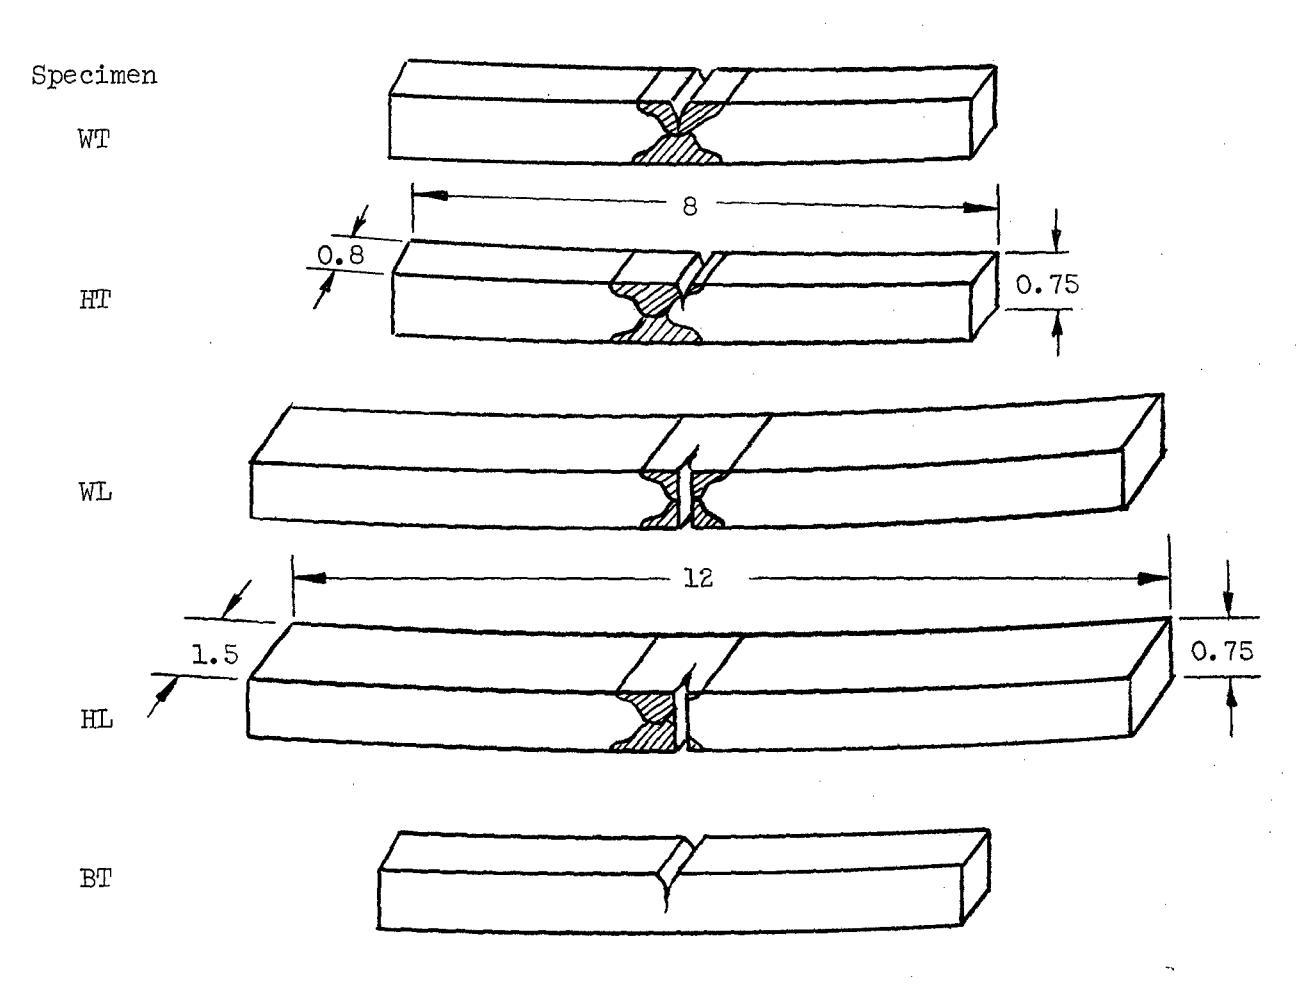
Figure 16. - Types of specimens used for $\rm K_{Ic}$ bend tests. Widths and thicknesses shown are nominal.

The K_{Ic} values listed in table I for the specimens of types WT, WL, and HL, in which the cracks propagated wholly or partly through the subarc weld material, are considerably lower than those for the heat-affected zone, type HT, and base plate, type BT, specimens. If these weld material K_{Ic} values are to be compared with the K_{I} value for the black origin, it must be remembered that only part of the narrow limb of the origin is located in the W7/302 weld deposit (fig. 12). As stated previously, the lower bound K_{I} value of 25 000 psi \sqrt{in} . is probably a good estimate of the correct value for this part of the origin at 542 psi pressure. This K_{I} value is considerably lower than any of the K_{Ic} values reported in table I. On the other hand, the corresponding K_{I} value for the hydrotest proof pressure of 960 psi is 45 000 psi \sqrt{in} , which is higher than the K_{Ic} values for the WL specimens in table I. There is, therefore, a distinct possibility that premature failure would have started at the black origin if the clean origin had not been present.

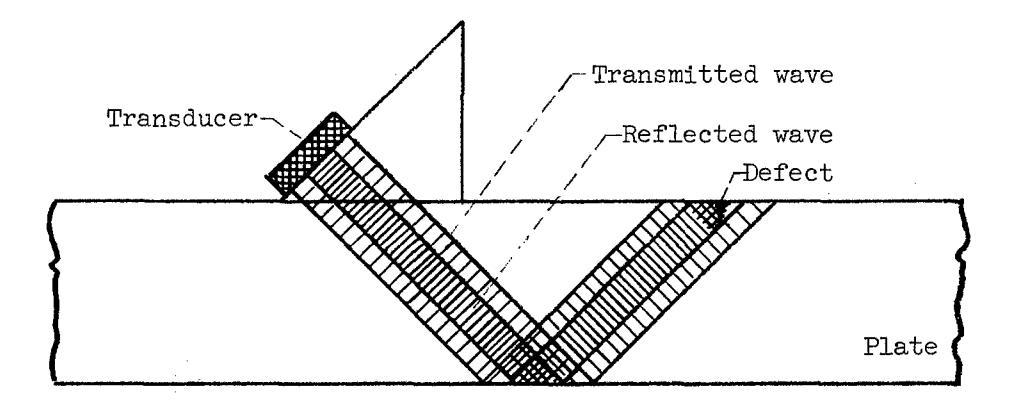
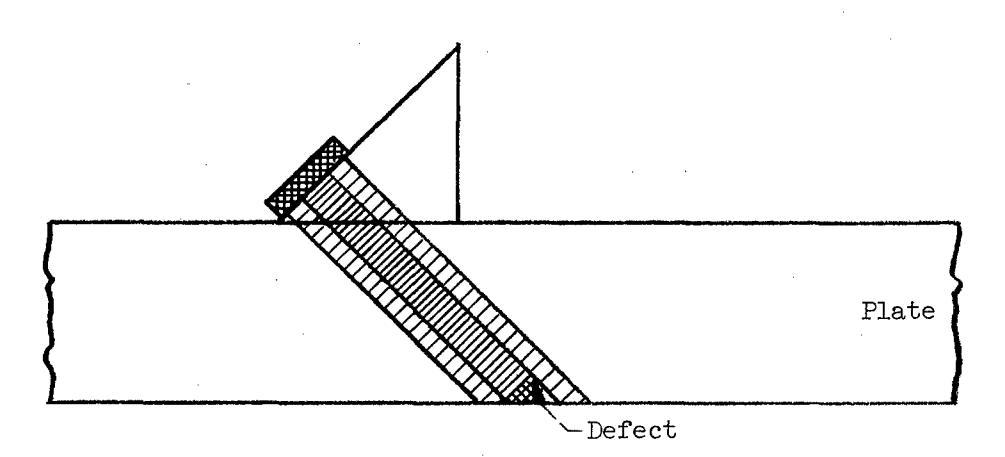
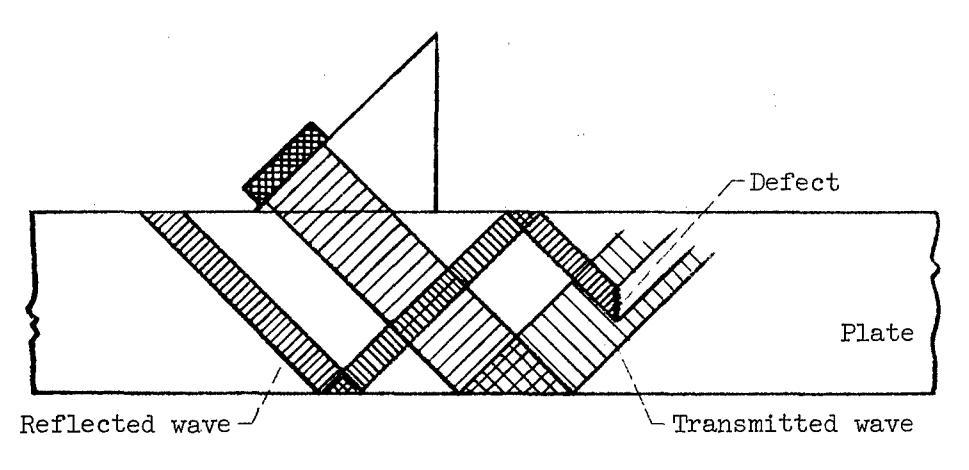
Figure 17. - Effect of defect location on detectability by ultrasonic techniques.

Cracks that are approximately normal to the surface are detected by UT by transmission of pulsed waves of acoustic energy into the plate at an oblique angle, as illustrated rather idealistically in figure 17. When the transmitted wave intersects a defect, the wave is reflected. If this reflected wave returns to the transducer, the reflected signal can be observed on an oscilloscope. Figures 17(a) and (b) show that defects near the surface readily reflect the energy waves back to the transmitter. It is possible, however, for reflected waves from submerged defects to miss the transducer as illustrated in figure 17(c) so that the defect may not be detected. Reflections generally scatter much more than illustrated in figure 17, but the use of single transducers may not permit detection of all submerged defects in relatively thick plate. It appears that the defect in the W7/101 weld may have been missed for this reason. In addition, very tight cracks may not be detectable in all cases by UT. It has been determined that when accurately machined gage blocks are held closely together, the signal obtained from UT that indicates the discontinuity between the blocks is quite low. Very tight cracks are not detectable by RT either. It therefore appears possible to have submerged cracks of a type similar to the clean origin that may not be detectable by presently available nondestructive testing techniques.

(a) Defect on same surface as transducer.

(b) Defect on surface opposite to transducer.

(c) Defect submerged within plate.

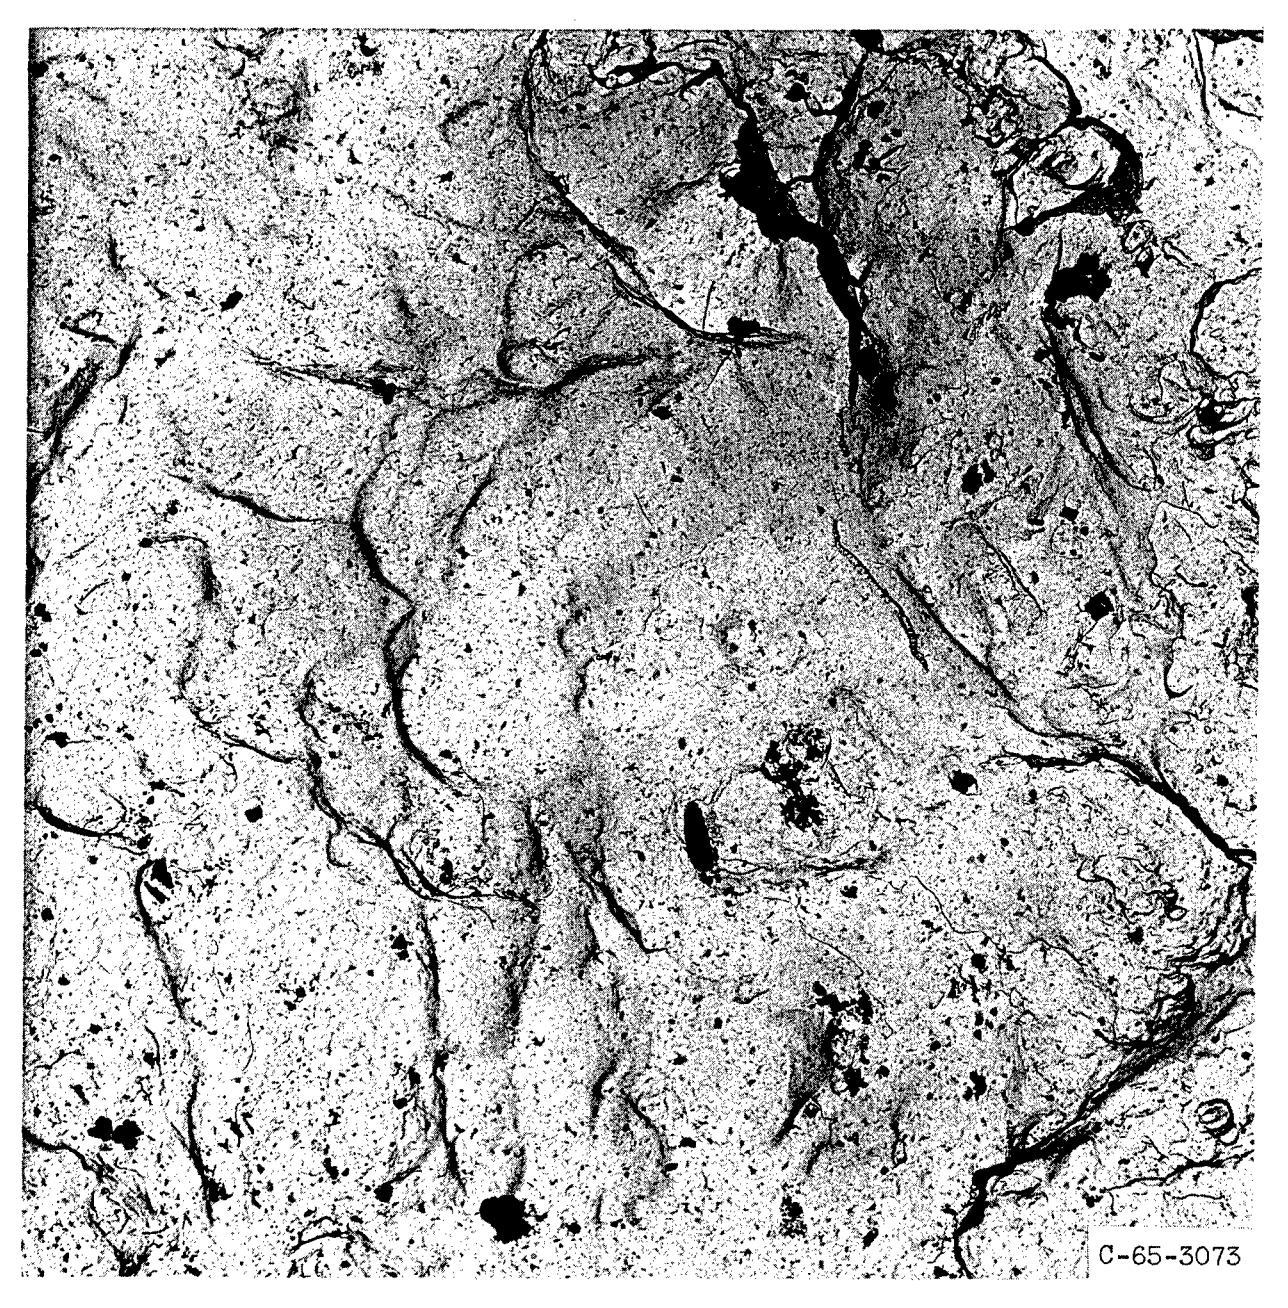
(b) Weld metal - area 2 of figure 20(b). Figure 22. - Continued.

Fractographic results confirmed the light microscopy observations. Figure 22(a) shows predominantly grain-boundary fracture in the region of the clean defect. Away from the clean defect, the fracture appears to be interdendritic through the subarc weld metal (fig. 22(b)) and shows a more ductile, "dimpled" type failure in the finer grained re-austenitized region of the HAZ of the base plate (fig. 22(c)).

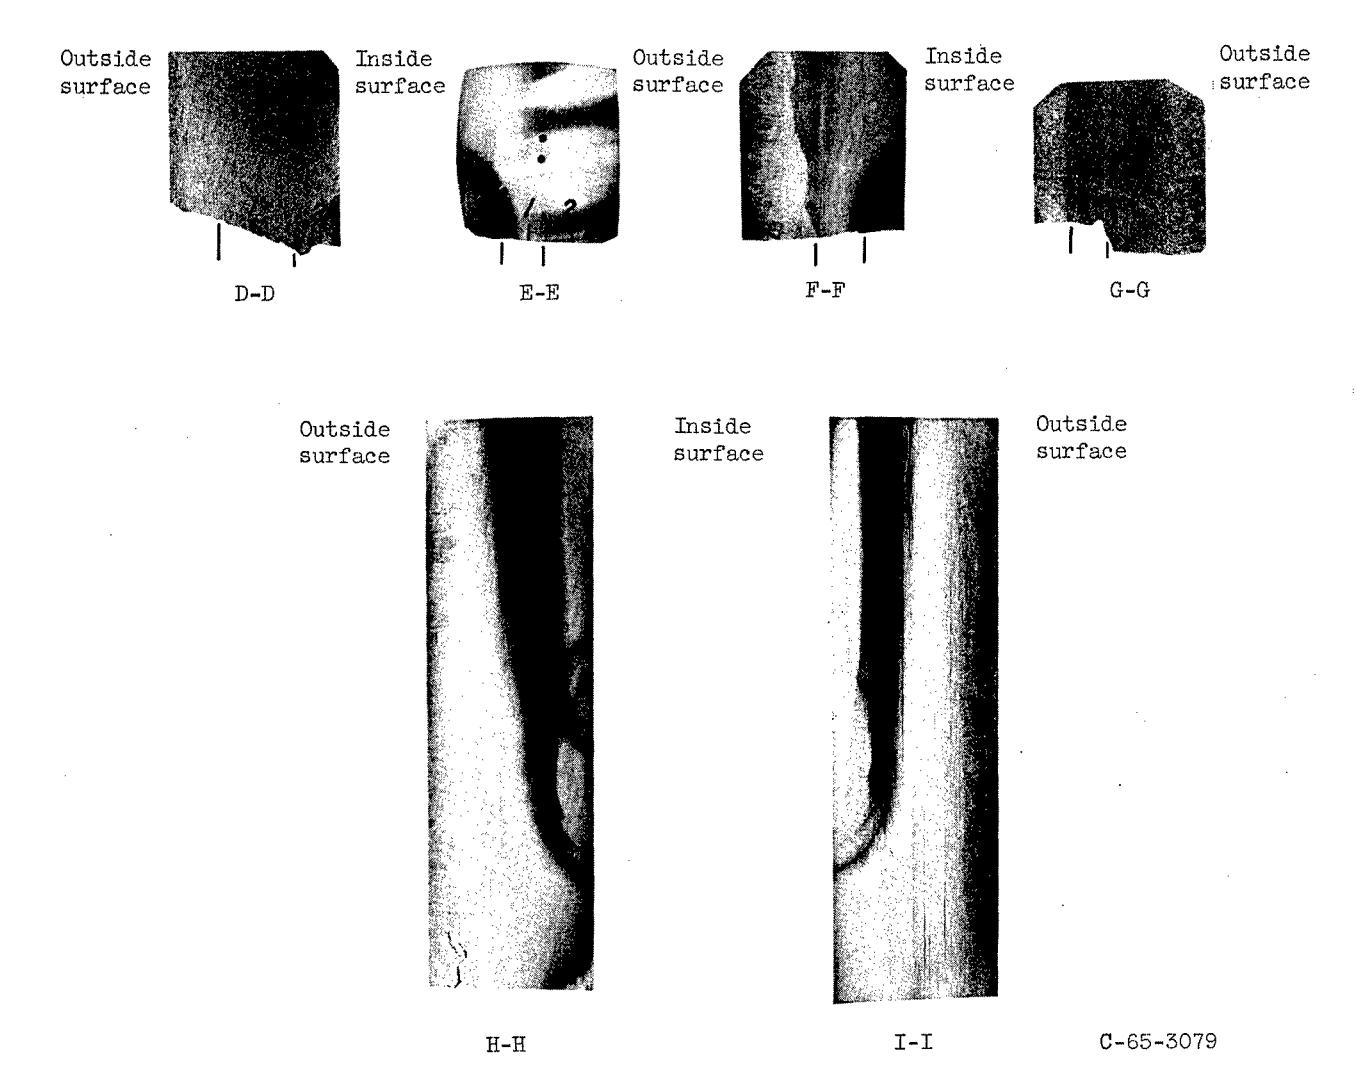
Figure 27. - Cross-sectional views through black defect region (see fig. 25). ×1.5. (Reduced 17 percent in printing.)

The black defect consists of a region covered with a black film, with fracture lines radiating from it. The defect has an L-shape, and at one point extends to the outer surface of the motor case through a region of the base plate adjacent to the dark etching band of the subarc weld HAZ. The blackened region extends from one side of the subarc weld completely across the weld metal to the base metal on the other side. The markings of the columnar solidification pattern of the subarc weld metal are clearly visible in the blackdefect area of the fracture surface. Various sections transverse to the black defect and parallel to the main fracture path are shown in figure 27. The transverse sections (D-D to G-G) show that the entire length of the black defect (the boundaries of which are indicated by the black marks) is located immediately below the dark etching band of the TIG repair. The crack in section G-G can also be seen in the surface macrograph (fig. 25) and was probably generated during the case failure. The parallel sections H-H and I-I show that no flaw similar to the black defect exists at the aft end of the TIG repairs.
