# Feasibility Investigation into Strengthening of Timber Bridge Stringers

Anthony J. Lamanna, Arda Akbiyik, James C. Ray,  
and Gerardo I. Velázquez

May 2007

Final report

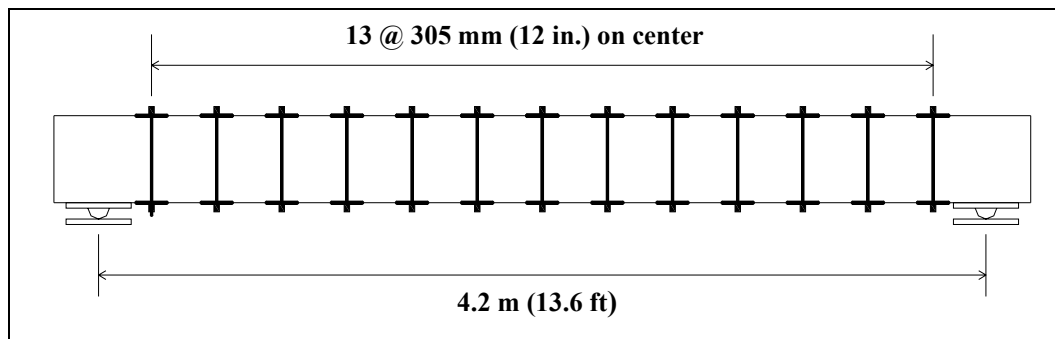
Figure 44. Schematic of hex bolt layout for specimen C5-R.

Specimen C5-R was repaired using a total of 13 hex bolts with steel plates and washers, as seen in Figures 42 and 43. The hex bolts were 508 mm (20 in.) long and 12.7 mm (1/2 in.) diameter and were spaced 305 mm (1 ft) on centers, as shown schematically in Figure 44. The steel plates were 102 mm (4 in.) square and 6.4 mm (1/4 in.) thick. The plates were used in addition to the bolts, and were located between the bolt head or nut and the timber stringer, both on top and underneath the stringer at each bolt. Since the hex bolts and steel plates were tightened into place with nuts, epoxy was not used. Steel washers were used both at the top and bottom between the bolt head or nut and the steel plate. The plates were

intended to introduce a compression force in the transverse direction to control several splinter and horizontal cracks which developed during testing of specimen C5.

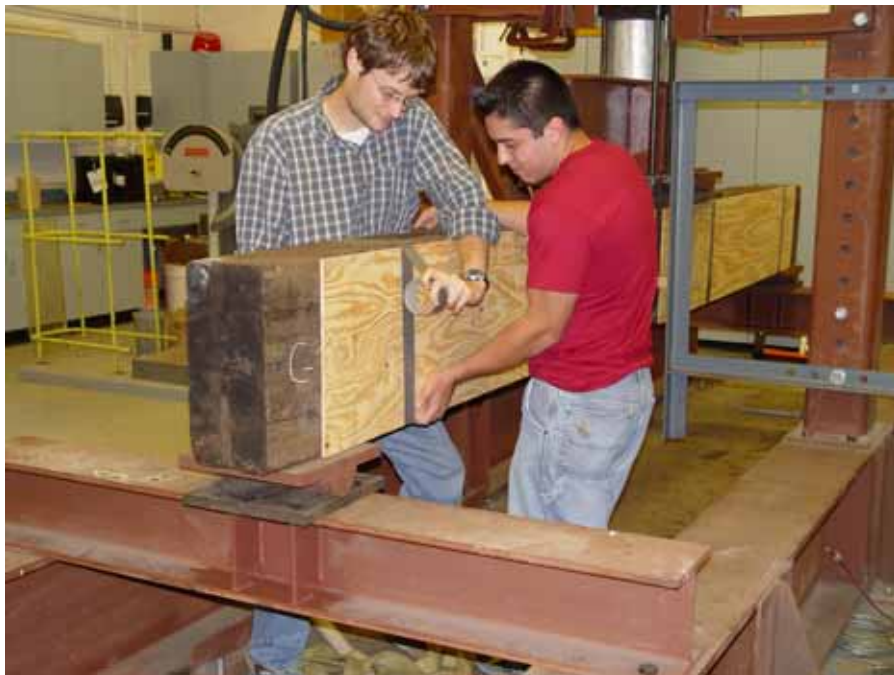
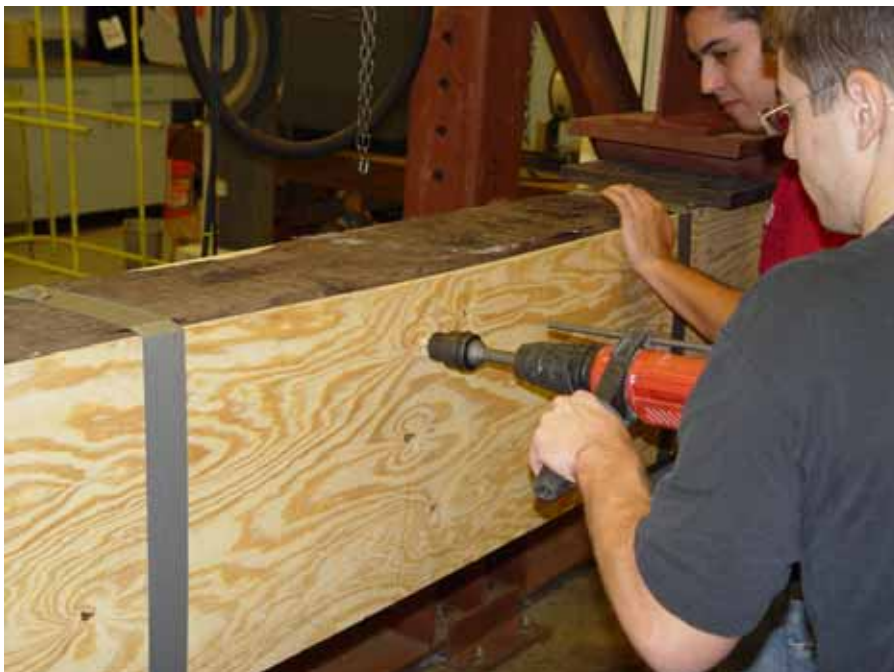
Figure 50. Lag screws being installed to specimen C13-R.

Figure 51. Lag screws being installed.

Four plywood side plates were attached to the sides of stringer C13-R. The plywood was first cut into 406 mm by 2,057 mm (16 in. by 81 in.) plates. The plates were then duct taped to the sides of stringer C13, and 76 mm (3 in.) long lag screws were used to attach the side plates to the stringer

using a TE 35 drill, as shown in Figures 50 and 51. Schematic of the plywood side plate layout is shown in Figure 52. A total of 14 lag screws were used to attach each plywood plate to the sides of the stringer. The plywood plates were not used over the entire length to prevent buckling in the midspan, as shown in Figure 53.

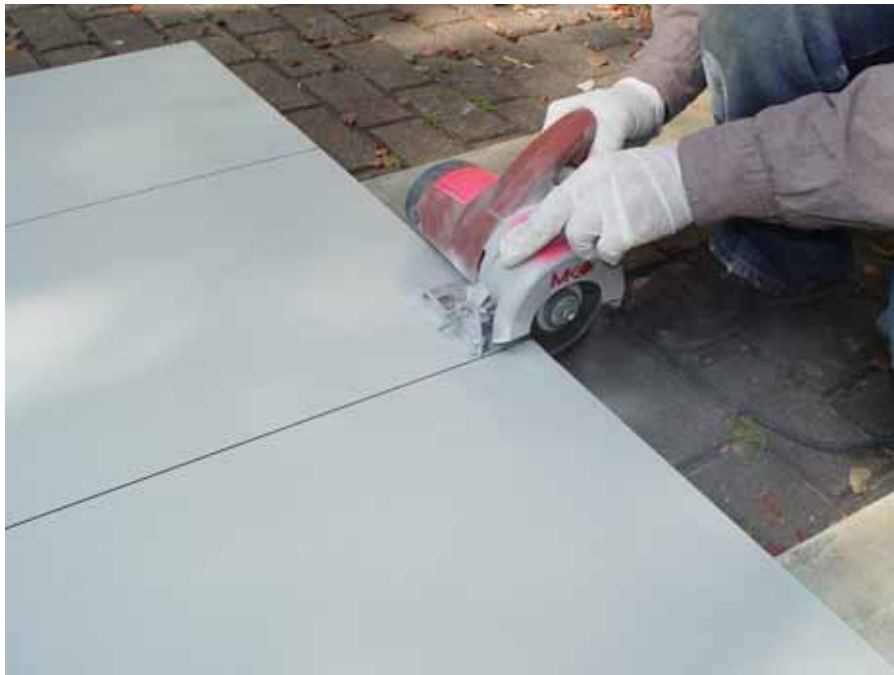
Figure 54. FRP plates being cut to size.

Specimens C14-R and C16-R were repaired with four FRP plates attached to the sides of the stringers. The FRP plates were first cut into 406 mm by 1,829 mm (16 in. by 72 in.) plates, as shown in Figures 54.

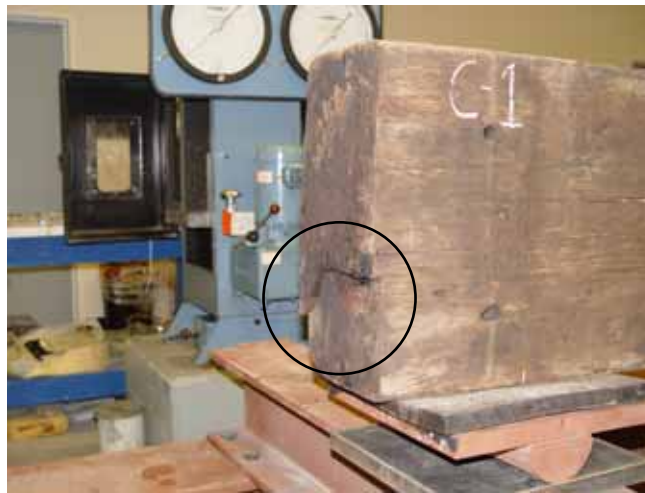
This first stringer was tested as a control specimen without repair. The load-deflection curve of stringer C1 was relatively linear until the failure, as shown in Figure 67. The maximum midspan load resisted by the stringer was 191 kN (43 kips) at a displacement of 27 mm (1.06 in.). As the load reached 178 kN (40 kips), cracking noises were heard. The stringer suddenly failed in shear, parallel to grain, and the load dropped to 93 kN (21 kips) which was the unstrengthened postfailure capacity. Horizontal sliding was observed at the support faces following the horizontal shear failure, as seen in Figure 68.

Figure 68. Horizontal sliding on support face after shear failure of stringer C1.

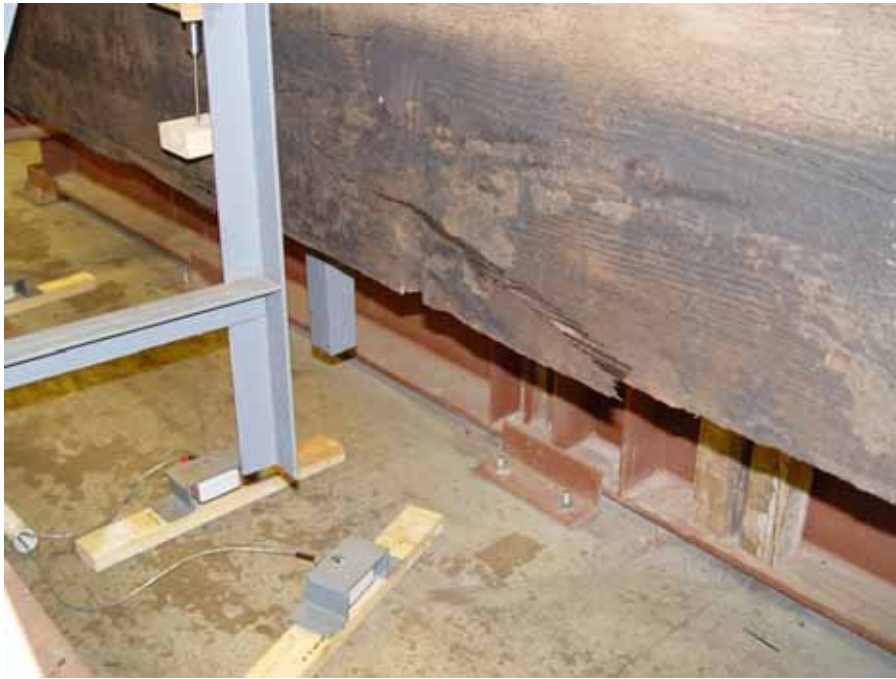
The load-deflection relationship for stringer C3 was linear until the timber cracked in the tension zone at a load of 98 kN (22 kips), as seen in the load-deflection curve in Figure 70. The supported load dropped to 76 kN (17 kips) after tensile cracking. The stringer then gained a load capacity up to 138 kN (31 kips) where crushing occurred, and then the timber cracked again in tension at the midspan. A close-up of the second tension failure is shown in Figure 71. The stringer then continued to gain load until, the stringer failed in horizontal shear. This was the ultimate load of 142 kN (32 kips), and a midspan deflection was 36 mm (1.40 in.). After the horizontal shear failure, the unstrengthened postfailure capacity was 102 kN (23 kips).

Figure 71. Splinter at the midspan on stringer C3.

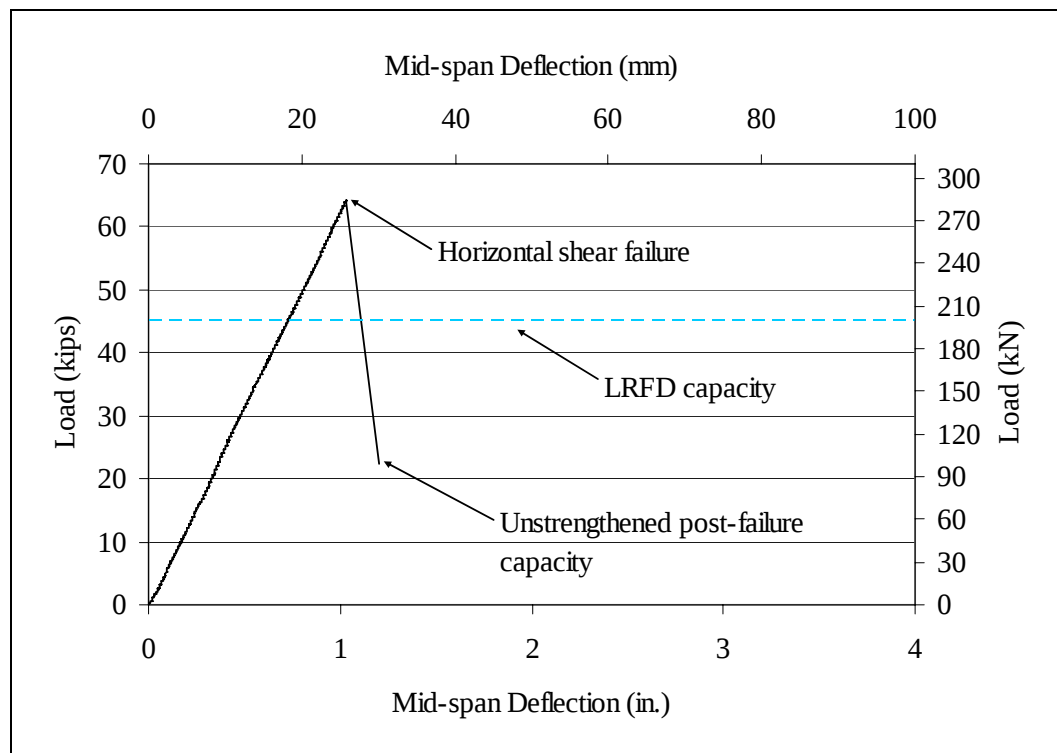
Figure 85. Load-deflection curve for stringer C10.

The stringer behaved linearly up until it reached the ultimate load, as seen in load-deflection curve shown in Figure 85. Stringer C10 failed in horizontal shear, and horizontal sliding was observed at the support face. The ultimate load at failure was 285 kN (64 kips) at a displacement of 26 mm (1.03 in.). The unstrengthened postfailure capacity was 98 kN (22 kips).

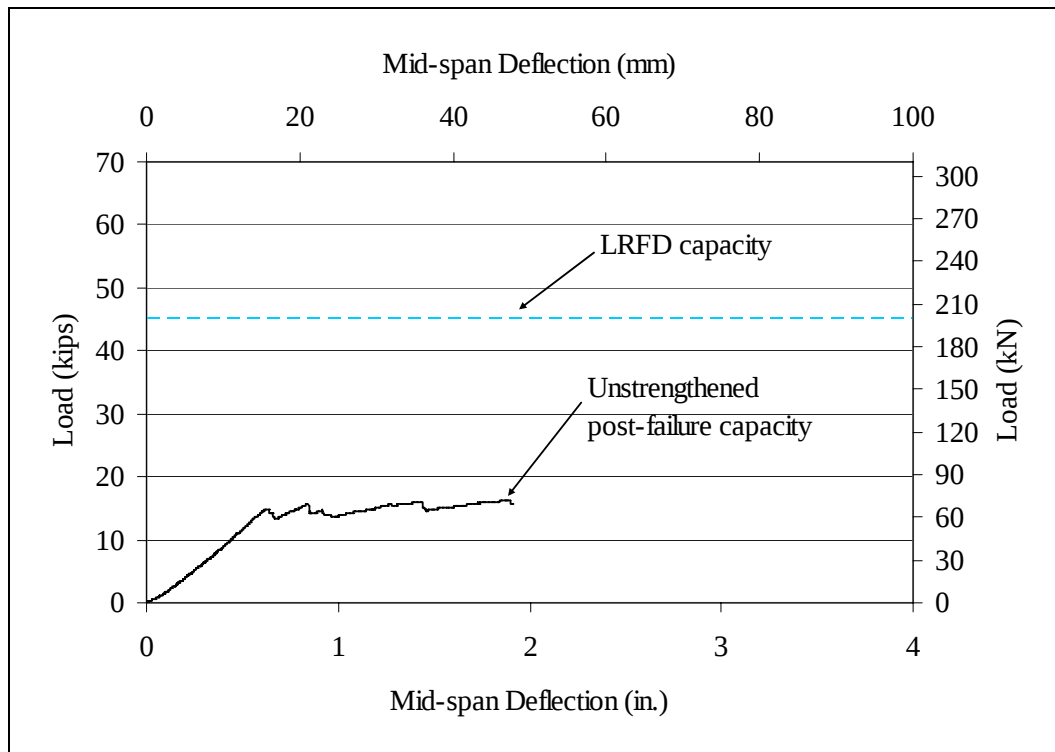
Figure 86. Load-deflection curve for stringer C11.

Horizontal sliding was observed at the support faces of stringer C11 as the load increased. There were existing horizontal end splitting before testing. The initial portion of the load-deflection curve, shown in Figure 86, was linear until the timber cracked again in horizontal shear at 67 kN (15 kips), causing a drop in the supported load to 58 kN (13 kips). The stringer underwent additional deflection with the increased load carrying capacity until postfailure capacity was reached. This large deflection was caused by the two pieces sliding over one another. Several horizontal cracks were observed as a result of excessive deformation. The unstrengthened

postfailure capacity was 76 kN (17 kips) at a deflection of 48 mm (1.90 in.). The experiment was terminated at the postfailure capacity.

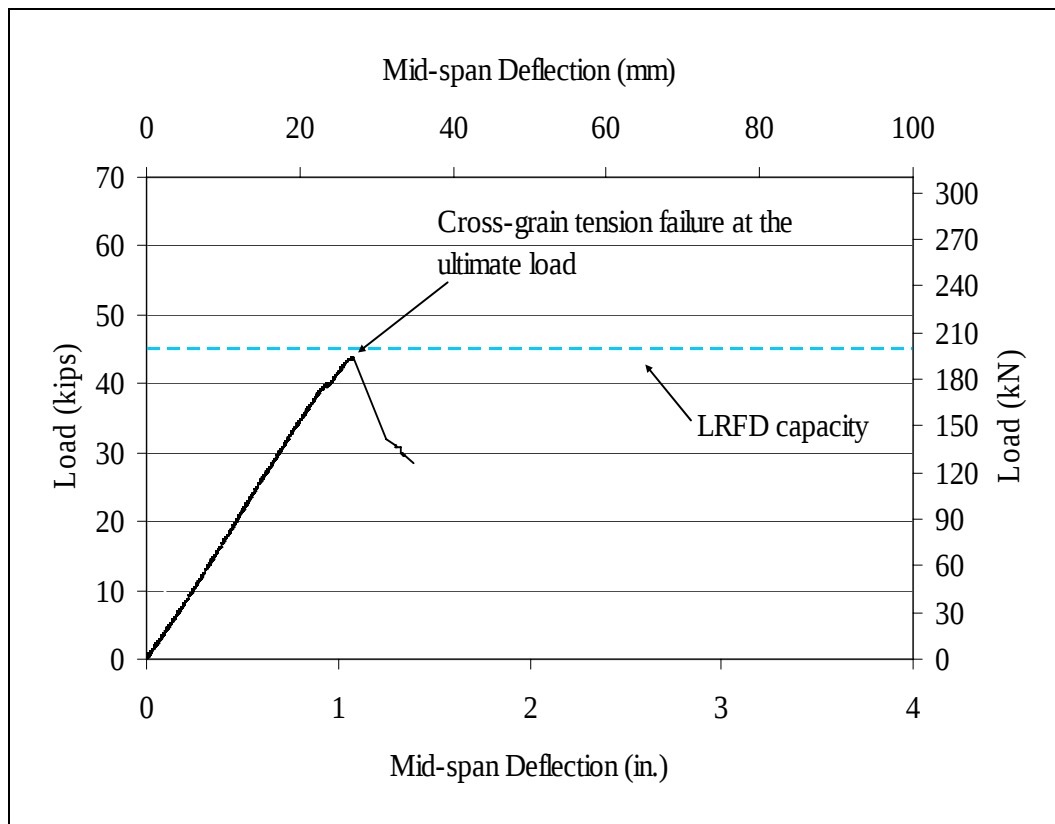
Figure 87. Load-deflection curve for stringer C12.

The initial slope of the load-deflection curve for stringer C12, shown in Figure 87, was linear until the stringer cracked in the tension zone causing the capacity to drop. The stringer had a cross-grain tension failure, as shown in Figure 88. The ultimate load resisted by the stringer was 196 kN (44 kips) at a displacement of 27 mm (1.07 in.). After the tension failure, the unstrengthened postfailure capacity was 129 kN (29 kips).

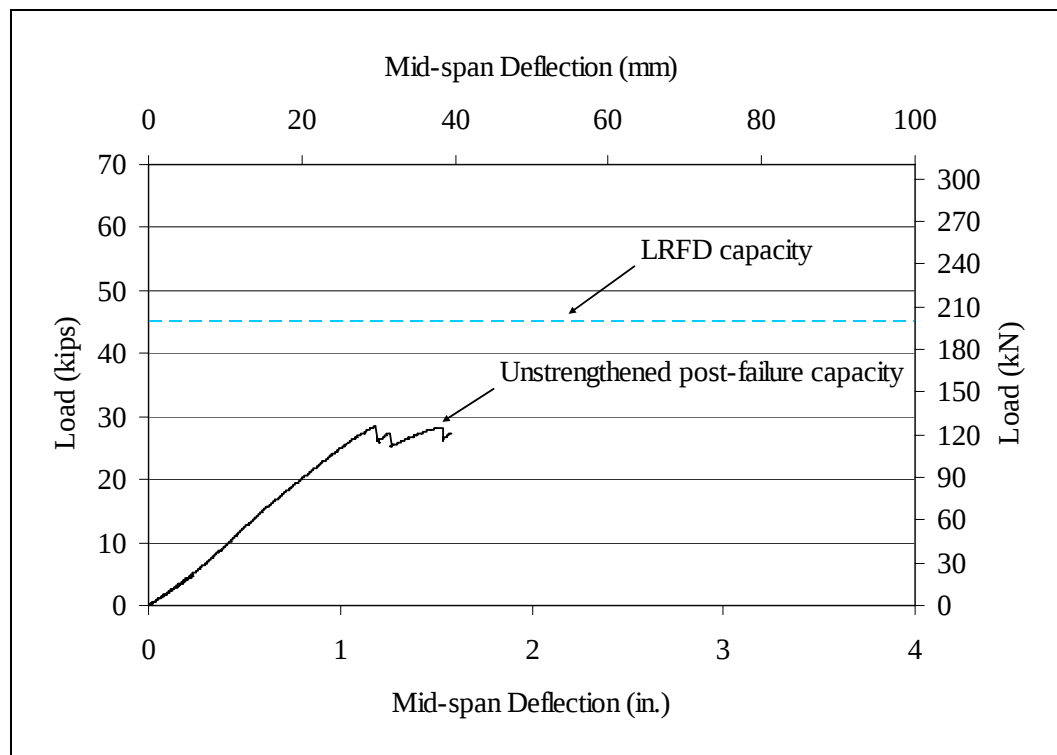
Figure 89. Load-deflection curve for stringer C13.

Stringer C13 had end splitting prior to testing. The stringer showed horizontal sliding on the support face as the load increased. The load-deflection curve of the stringer, shown in Figure 89, was linear until the stringer reached the unstrengthened postfailure capacity of 125 kN (28 kips) at a deflection of 39 mm (1.53 in.). With a decreased stiffness, the load increased further. The stringer underwent additional deflection while developing tension cracks.

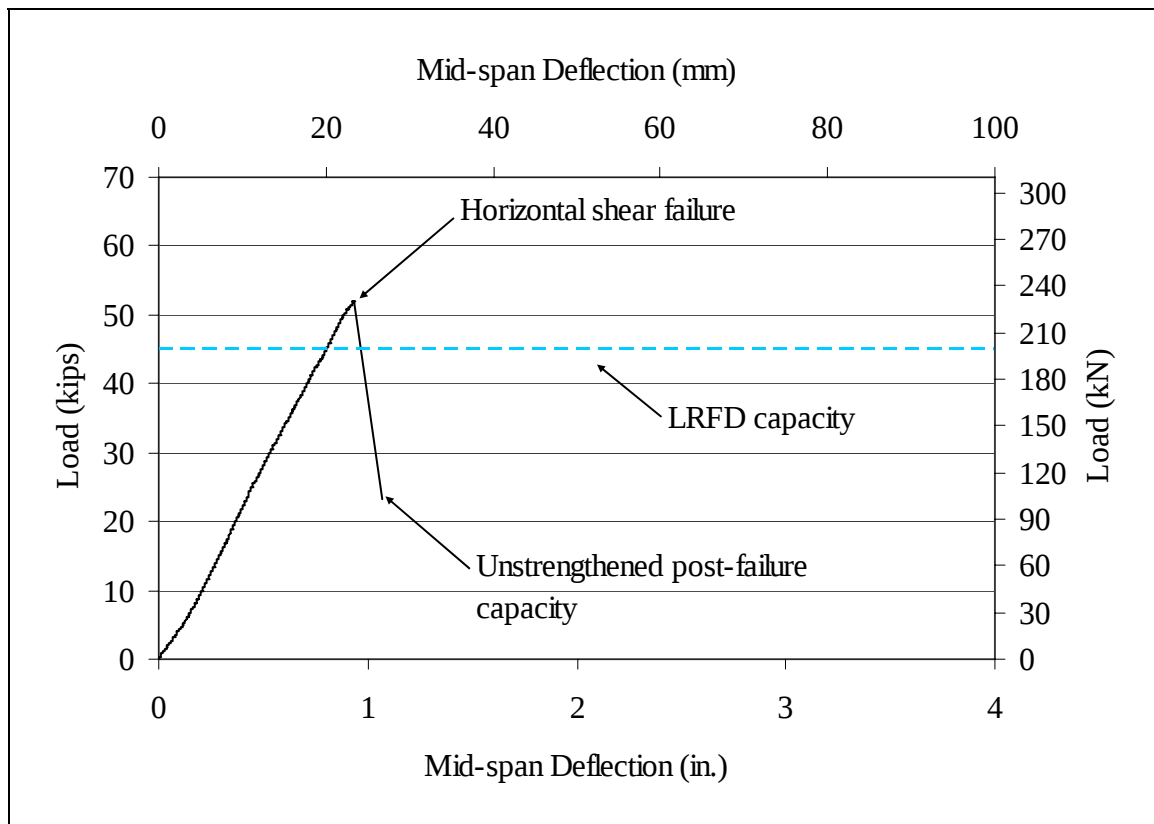
Figure 90. Load-deflection curve for stringer C14.

Stringer C14 had signs of heart checks prior to testing. The stringer behaved linearly until it reached its ultimate load capacity, as seen in the load-deflection curve shown in Figure 90. The stringer failed in horizontal shear. The ultimate load was 231 kN (52 kips) at a displacement of 24 mm (0.94 in.). The unstrengthened postfailure capacity was 102 kN (23 kips). Horizontal sliding was observed on the cross section after the horizontal shear failure, as shown in Figure 91. Horizontal splitting occurred at the center of the cross section where shear stresses reached their maximum value.

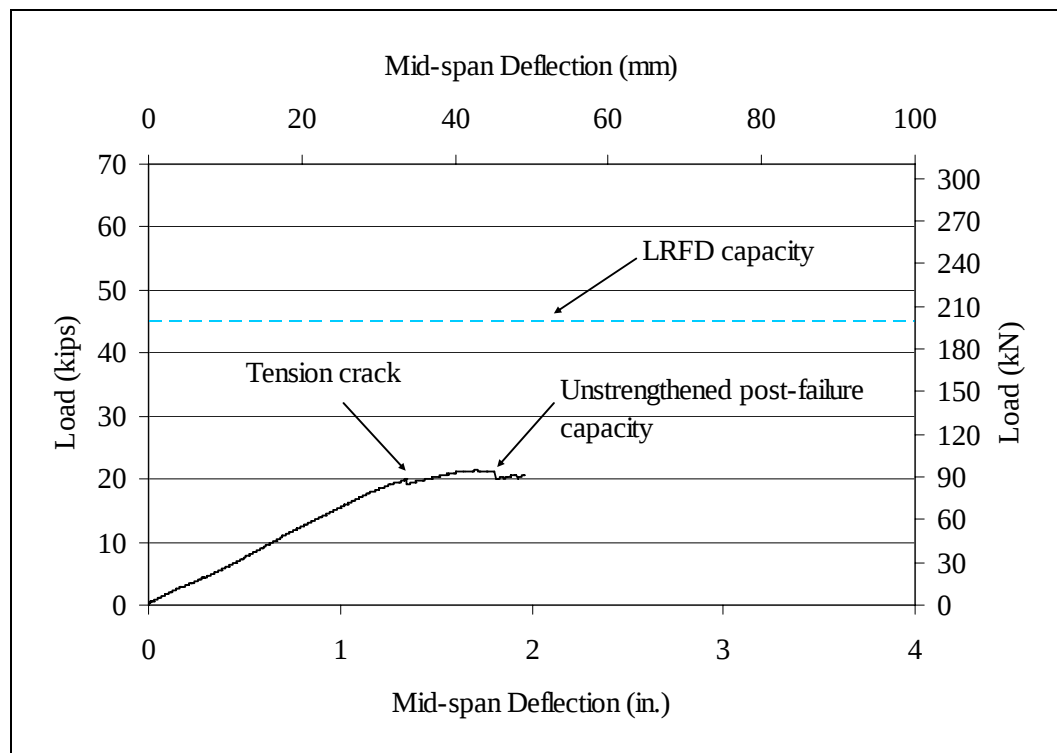
Figure 92. Load-deflection curve for stringer C15.

Horizontal sliding was observed at the support faces of stringer C15 as the load increased due to horizontal end splitting. The initial slope of the load-deflection curve for stringer C15, shown in Figure 92, was linear until the timber cracked in the tension zone at a load of 89 kN (20 kips). This caused a small drop in the supported load to 85 kN (19 kips). The stringer then underwent additional deflection of 13 mm (0.5 in.) with increasing load. Several additional horizontal cracks were formed because of the excessive deformation in the stringer. The unstrengthened postfailure capacity was 93 kN (21 kips). The experiment was terminated at the postfailure capacity in order to prevent the formation of additional tension cracks.

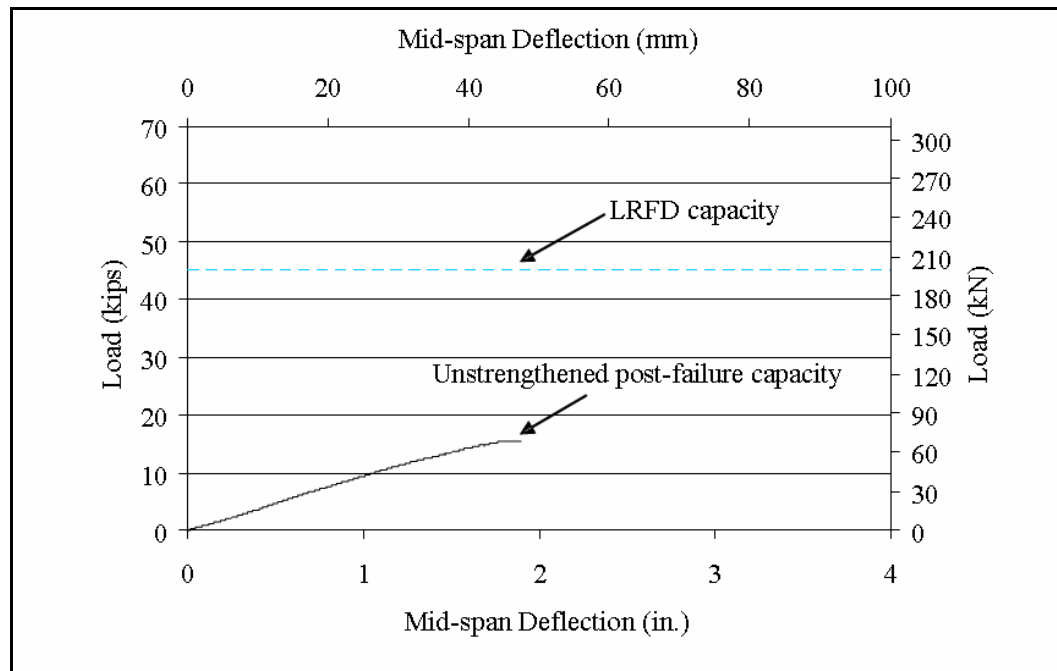
Figure 93. Load-deflection curve for stringer C16.

Stringer C16 exhibited end splitting prior to testing. The stringer behaved linearly until the unstrengthened postfailure capacity, as seen in the load-deflection curve given in Figure 93. Horizontal sliding on the support face was observed as the load increased throughout the test. The unstrengthened postfailure capacity was 67 kN (15 kips). The experiment was

terminated to prevent the formation of tension cracks after the postfailure capacity was reached.

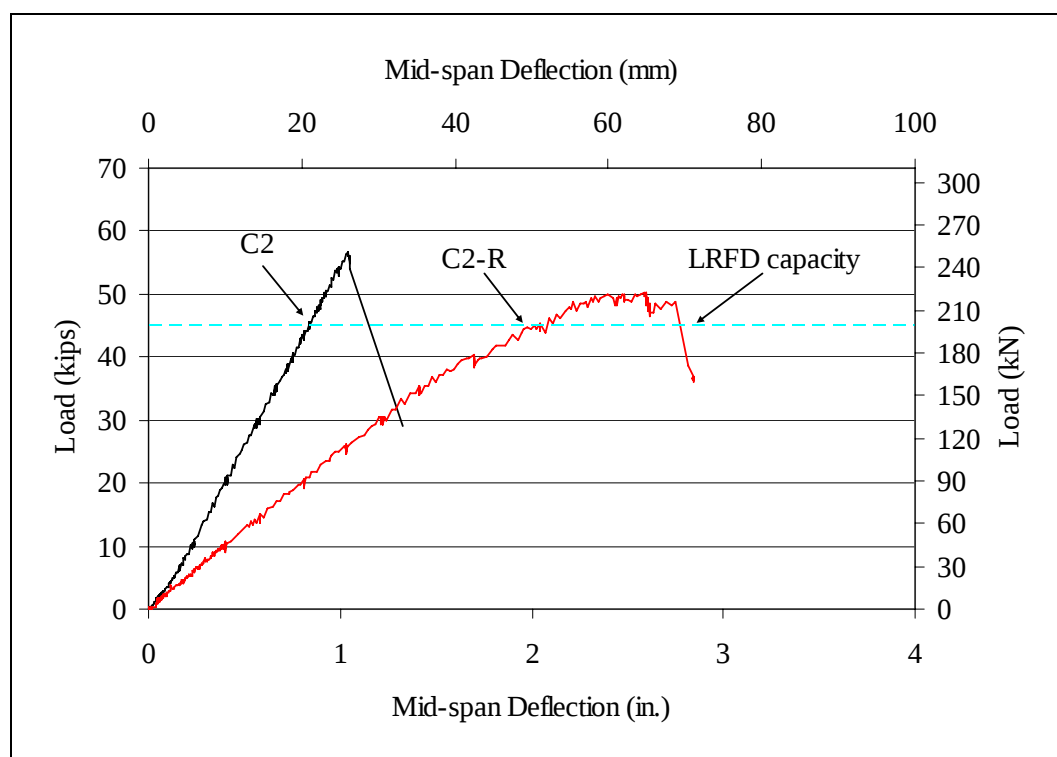
Figure 97. Load-deflection curves for stringers C2 and C2-R.

The load-deflection curve for stringer C2-R, shown in Figure 97, was linear until the stringer C2-R cracked in the tension zone which caused a drop in its load capacity. Cracking noise was heard and horizontal sliding was observed at the support face as the load increased to failure. Stringer C2-R had tension cracks and tension splinters at the midspan at the repaired ultimate load, as shown in Figure 98. The repaired ultimate load was 222 kN (50 kips) at a displacement of 66 mm (2.6 in.).

The increase in the repaired ultimate load over the unstrengthened postfailure capacity was 72.4 and 30.4% for repaired stringers C2-R and C3-R, respectively. These stringers were repaired using hex bolts at every 610 mm (2 ft) with epoxy. The epoxy used on the surface of the hex bolts improved the load transfer between the timber and the hex bolts. Since stringers C2 and C3 developed horizontal shear cracks prior to the repair, the repair method was effective. The original and repaired ultimate loads were 254 kN (57 kips) and 222 kN (50 kips) for stringers C2 and C2-R, respectively. This represents 88% recovery of ultimate load for stringer C2-R, and the increase in the unstrengthened postfailure capacity was 72.4%. The repair method was effective because the initial failure of stringer C2 was only in horizontal shear and; therefore, effectiveness of the shear repair method was maximized for stringer C2-R.

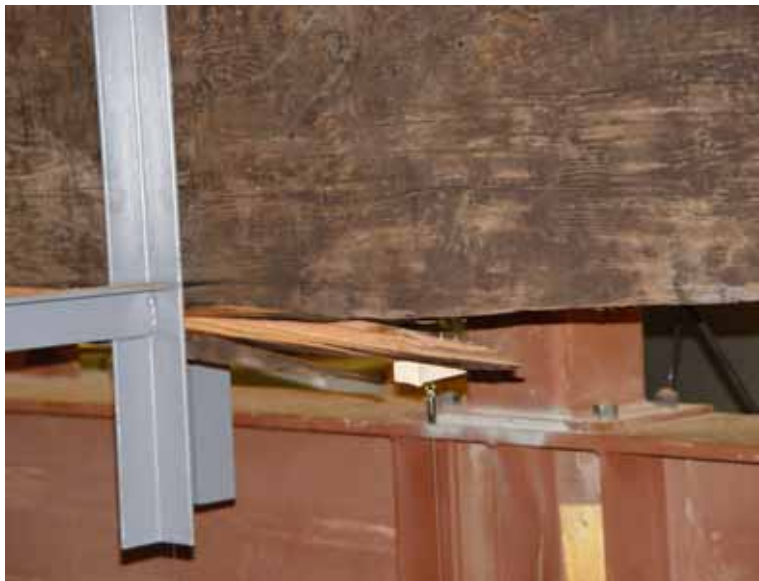
Figure 98. Tension cracks at the failure on stringer C2-R.

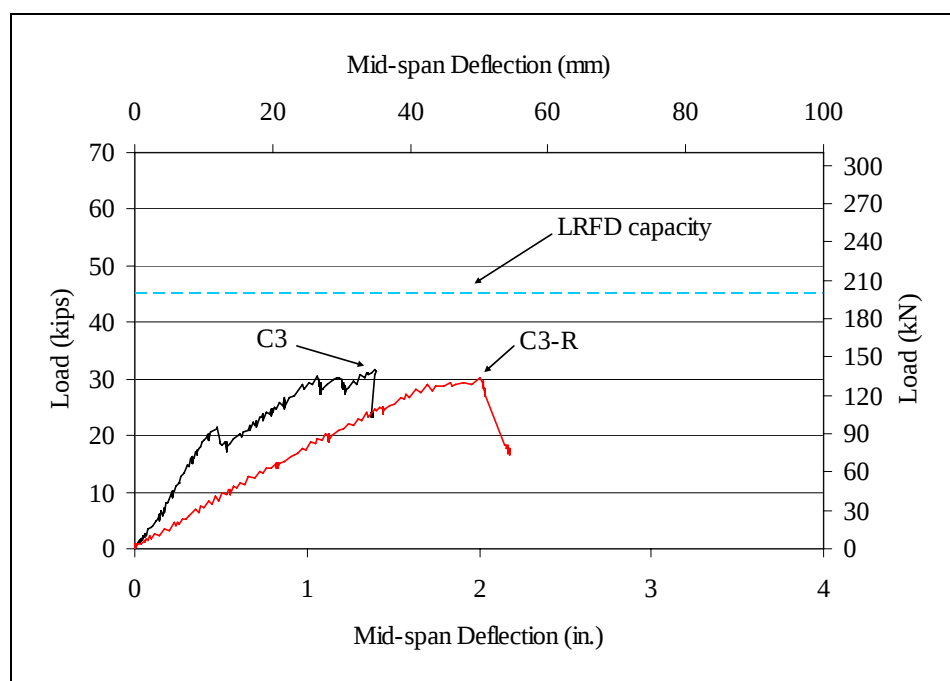
Figure 99. Load-deflection curves for stringers C3 and C3-R.

Stringer C3-R behaved linearly until it reached the repaired ultimate load, as seen in the load-deflection curve shown in Figure 99. The stringer failed in horizontal shear, which caused a drop in its load capacity. Horizontal sliding was observed at the support faces, as the load increased to failure. The repaired ultimate load was 133 kN (30 kips) at a displacement of 51 mm (2 in.).

The original and repaired ultimate loads were 142 kN (32 kips) and 133 kN (30 kips) for stringers C3 and C3-R, respectively. Stringer C3-R with hex bolts and epoxy recovered 94% of ultimate load of stringer C3. Effectiveness of stringer C3-R was lower than stringer C2-R because of the tension cracks that developed during testing of stringer C3, as explained in Chapter 5, "Test results and discussion, Test results of original stringers, Specimen C3." Two tension cracks occurred in stringer C3 as the load increased to failure to 93 kN (21 kips) and 133 kN (30 kips). At failure, a horizontal shear crack was visible in this stringer. Using hex bolts with epoxy did not restore the stiffness of stringers C2-R and C3-R to their original unsplit stiffness.

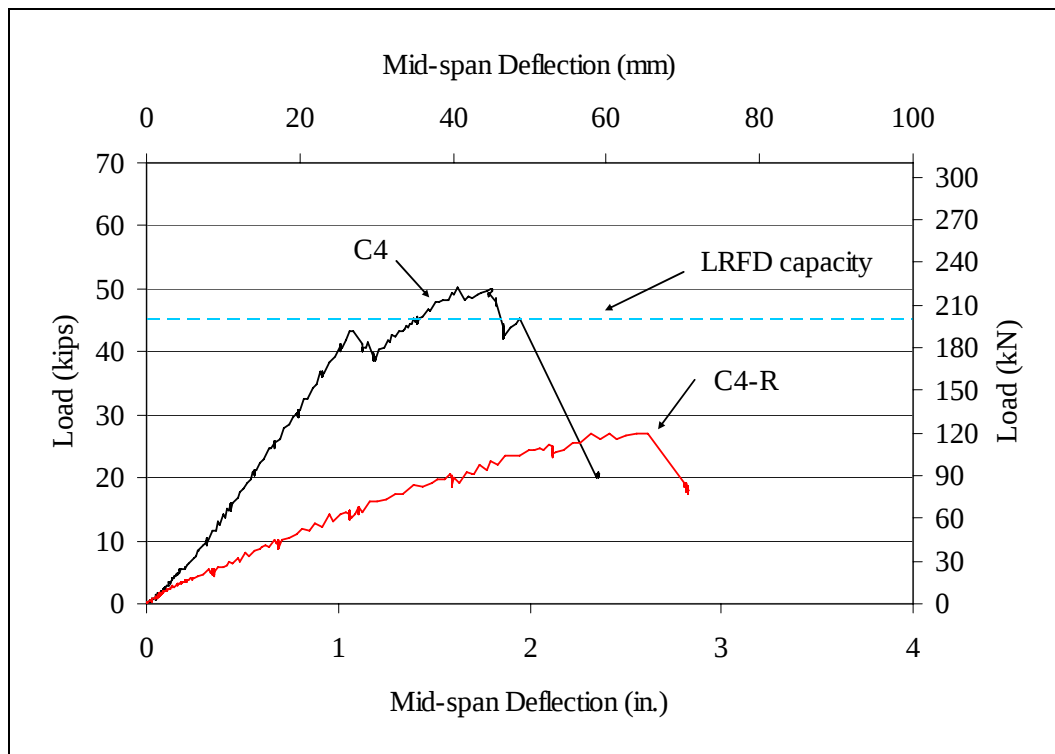
Figure 100. Load-deflection curves for stringers C4 and C4-R.

The load-deflection curve for stringer C4-R, shown in Figure 100, was linear until the stringer cracked in the tension zone. Cracking noise was heard and horizontal sliding was observed at the support face as the load increased to failure. The stringer had cross-grain tension cracks and tension splinters near the midspan at failure, as shown in Figure 101. The repaired ultimate load was 120 kN (27 kips) at a displacement of 67 mm (2.63 in.).

The increase in the repaired ultimate load over the unstrengthened post-failure capacity was 35% for repaired stringer C4-R. This value was near the percent increase observed for timber stringer C3-R which was 30.4%. Stringer C4-R was repaired with hex bolts and epoxy at every 305 mm (1 ft). Decreasing the spacing from 605 mm (2 ft) to 305 mm (1 ft) did not significantly improve the repaired ultimate load of the timber stringers. The original and repaired ultimate loads were 222 kN (50 kips) and 121 kN (27 kips) for stringers C4 and C4-R, respectively. This represents 54% recovery in the ultimate load capacity of stringer C4-R. The increase in the unstrengthened postfailure capacity and recovery of the ultimate load was low because of the cross-grain tension cracks that developed in stringer C4 and affected the repair method as compared to the repaired stringer C2-R. Cross-grain tension failure in stringer C4 reduced the recovery of the repair ultimate load on the stringer C4-R, although the unstrengthened postfailure capacity increased by 35% from 89 kN (20 kips) to 121 kN (27 kips). Recovery of the ultimate load with respect to stringer C4 was low for stringer C4-R, and the stiffness of stringer C4-R was not enhanced compared with stringer C4.

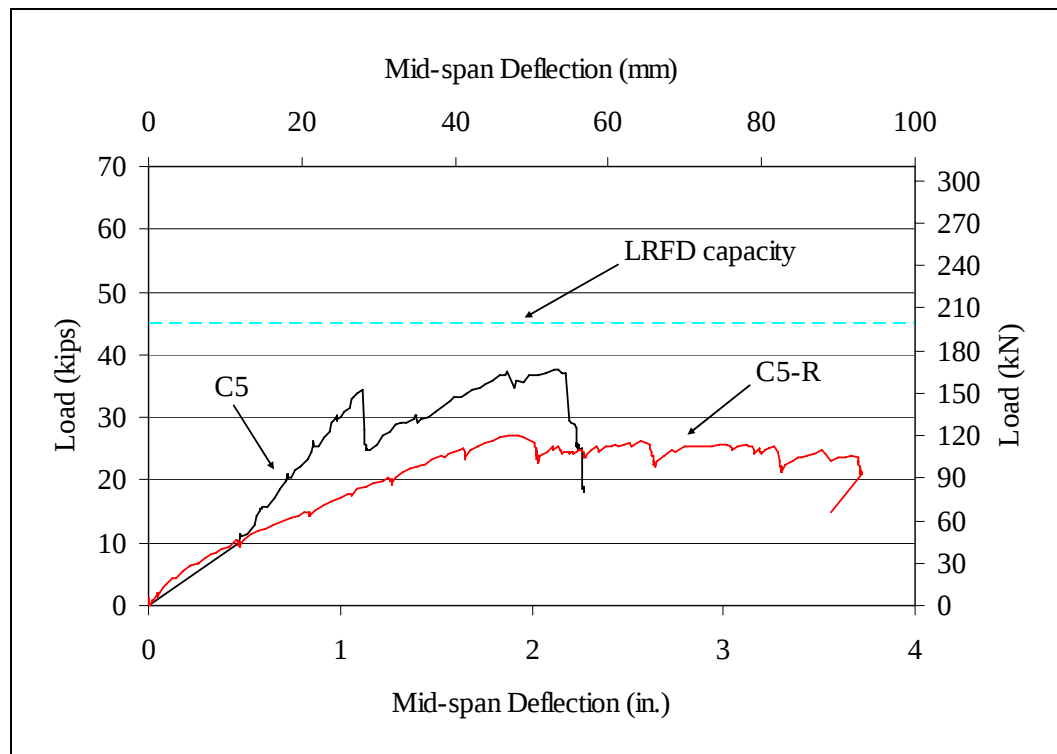
Figure 102. Load-deflection curves for stringers C5 and C5-R.

The load-deflection curve for stringer C5-R, shown in Figure 102, was linear until the stringer cracked in the tension zone at the midspan. The repaired ultimate load was 120 kN (27 kips) at a displacement of 49 mm (1.93 in.). Horizontal sliding was observed at the support face during this period of deflection.

The increase in the repaired ultimate load over the unstrengthened postfailure capacity was 50% for the repaired stringer C5-R. This increase was greater than that observed in timber stringers C3-R and C4-R and lower than for stringer C2-R. Timber stringer C5 developed horizontal and tension cracks as explained in Chapter 5, “Test results and discussion, Test results of original stringers, Specimen C5.” Stringer C5 was repaired using hex bolts with steel plates. A compression force in the transverse direction was applied using the steel plates at the top and bottom of the stringer which increased the stiffness at the beginning of load-deflection curve until the load reached 45 kN (10 kips). Above 45 kN (10 kips), stiffness of stringer C5-R was again lower than that of stringer C5. The original and repaired ultimate loads were 169 kN (38 kips) and 121 kN (27 kips) for stringers C5 and C5-R, respectively. This was 71% recovery in the ultimate load of stringer C5-R with respect to stringer C5.

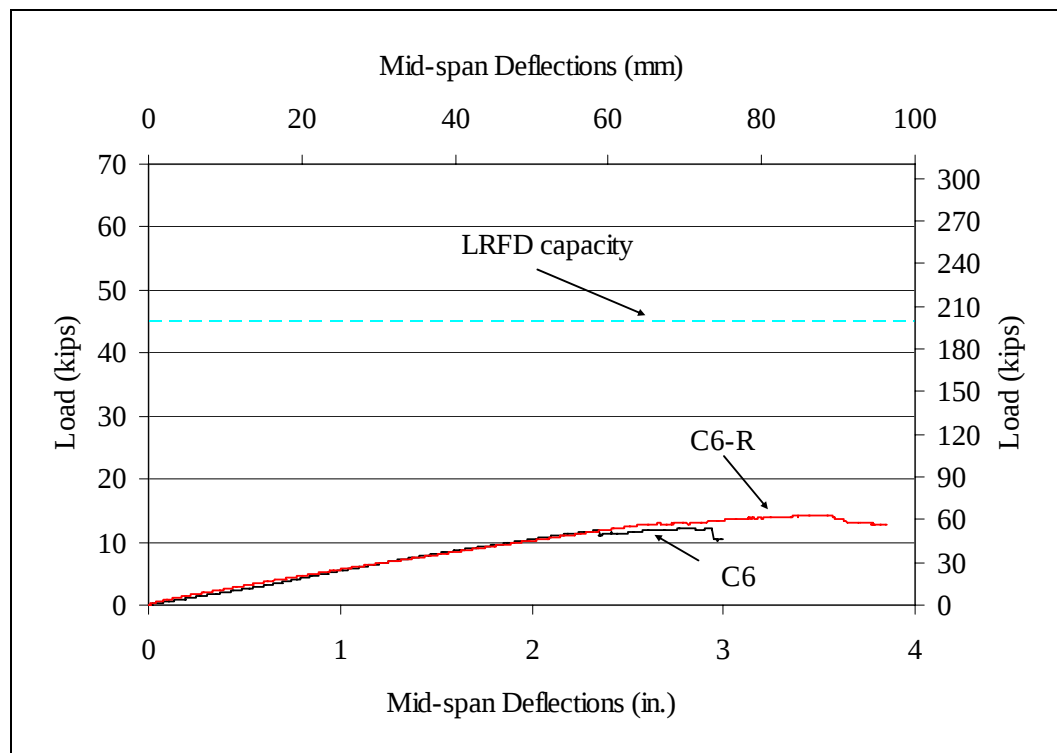
Figure 103. Load-deflection curves for stringers C6 and C6-R.

The load-deflection curve for stringer C6-R, shown in Figure 103, was linear until the stringer cracked in the tension zone. Several tension cracks and tension splinters near the midspan were visible, which were caused by excessive deformation. The repaired ultimate load carried by the stringer was 62 kN (14 kips) at a displacement of 90 mm (3.56 in.). As the load increased to failure, horizontal sliding occurred at the support faces. A lag screw spacing of 305 mm (1 ft) was used for stringer C6-R, which resulted in a strength increase over the unstrengthened postfailure capacity of 16.7%. This was a lower increase than the timber stringers repaired with hex bolts and lag screws because of the preexisting end splitting on timber stringer C6. The tension cracks that developed in the tension zone of stringer C6 affected the repair method, as discussed in Chapter 5, “Test results and discussion, Test results of original stringers, Specimen C6.” There was no increase in the slope of the load-deflection curve of timber stringer C6-R. As for stringer C5-R, steel plates could have been utilized on stringer C6-R to apply compressive pressure to close the end splitting gap and to increase the stiffness of split timber stringers.

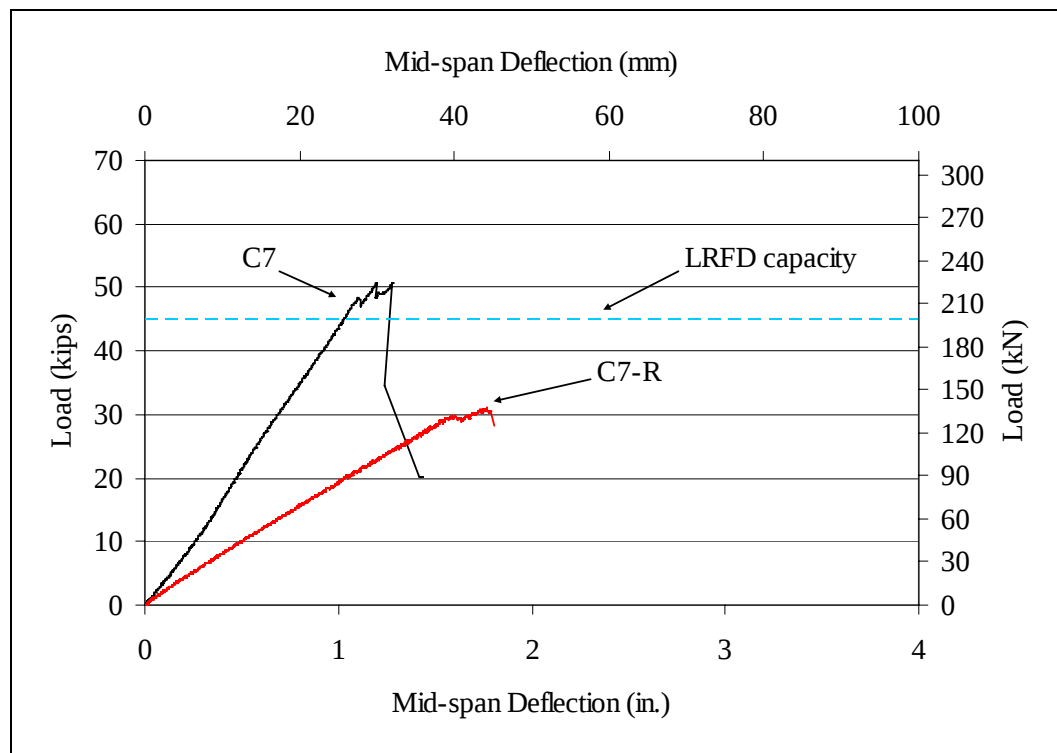
Figure 104. Load-deflection curves for stringers C7 and C7-R.

The load-deflection curve for stringer C7-R, seen in Figure 104, was linear until the stringer failed in the tension zone with several tension splinters, which caused a drop in the supported load. The repaired ultimate load at the failure was 138 kN (31 kips) at a displacement of 45 mm (1.77 in.). Horizontal sliding occurred at the support faces as the load approached failure. Stringer C10-R behaved linearly until it reached the ultimate load, as seen in the load-deflection curve shown in Figure 105. As the load increased to failure, horizontal sliding occurred at the support face. The repaired ultimate load resisted by the stringer was 196 kN (44 kips) at a displacement of 51 mm (2.02 in.). The stringer failed in simple tension at 187 kN (42 kips) at a displacement of 58 mm (2.3 in.).

The increase in the repaired ultimate load over the unstrengthened postfailure capacity was 55% and 100% for stringers C7-R and C10-R, respectively. These stringers were repaired using lag screws making a 45° angle with the transverse direction. Stringers C7 and C10 developed horizontal shear cracks before the repair which made the repair scheme effective. The original and repaired ultimate loads were 227 kN (51 kips) and 138 kN (31 kips) for stringers C7 and C7-R, respectively. This represents a 61% recovery for stringer C7-R, although the increase in unstrengthened postfailure capacity was 55%. The lag screws layout used in stringer C10-R; therefore, produced a more effective repair than the layout used in stringer C7-R.

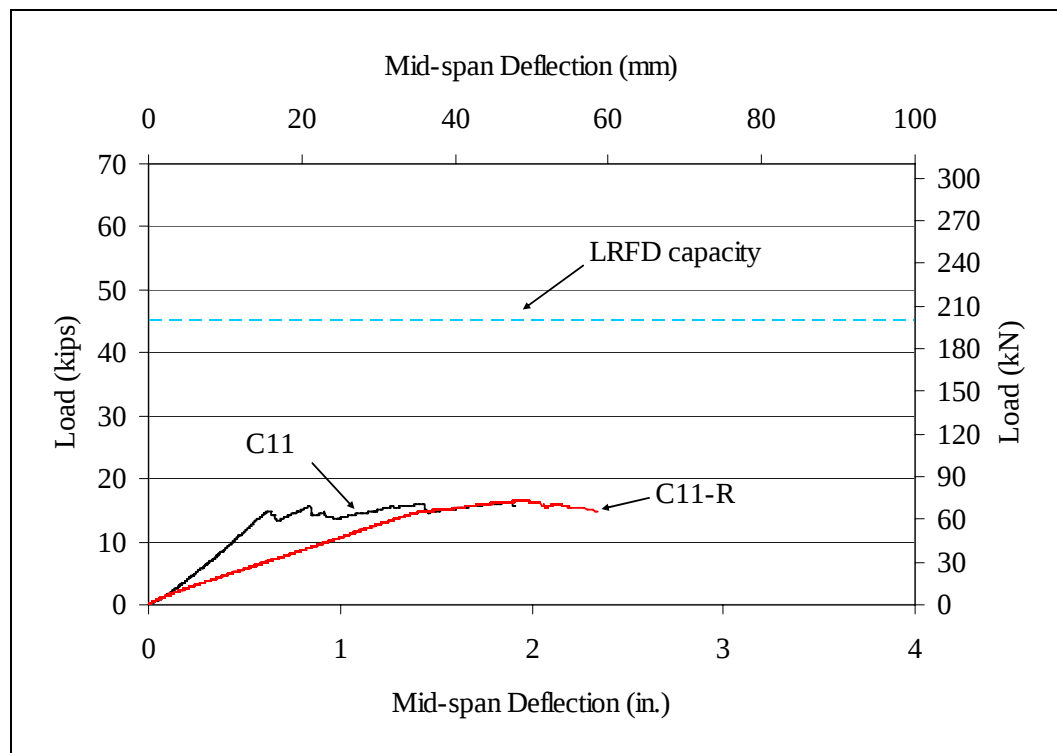
Figure 106. Load-deflection curves for stringers C11 and C11-R.

Stringer C11-R behaved linearly up to the repaired ultimate load, as seen in the load-deflection curve shown in Figure 106. The stringer developed tension cracks near the midspan at the repaired ultimate load. The repaired ultimate load carried by the stringer was 71 kN (16 kips) at a displacement of 52 mm (2.05 in.). Horizontal sliding occurred at the support faces as the load approached failure.

A lag screw spacing of 610 mm (2 ft) was used to repair stringers C11-R and C15-R. The increase in the repaired ultimate load over the unstrengthened postfailure capacity was 6.3% and 4.8%, which were the lowest values among all of the repaired timber stringers. Stringer C11 was severely deteriorated at one end support before testing, as explained in Chapter 3, “Repair systems for stringers, Timber specimens, Specimen C11,” which caused this lower percent increase in strength for the repaired stringer C11-R. These stringers also had lower stiffness than the original stringers with end split.

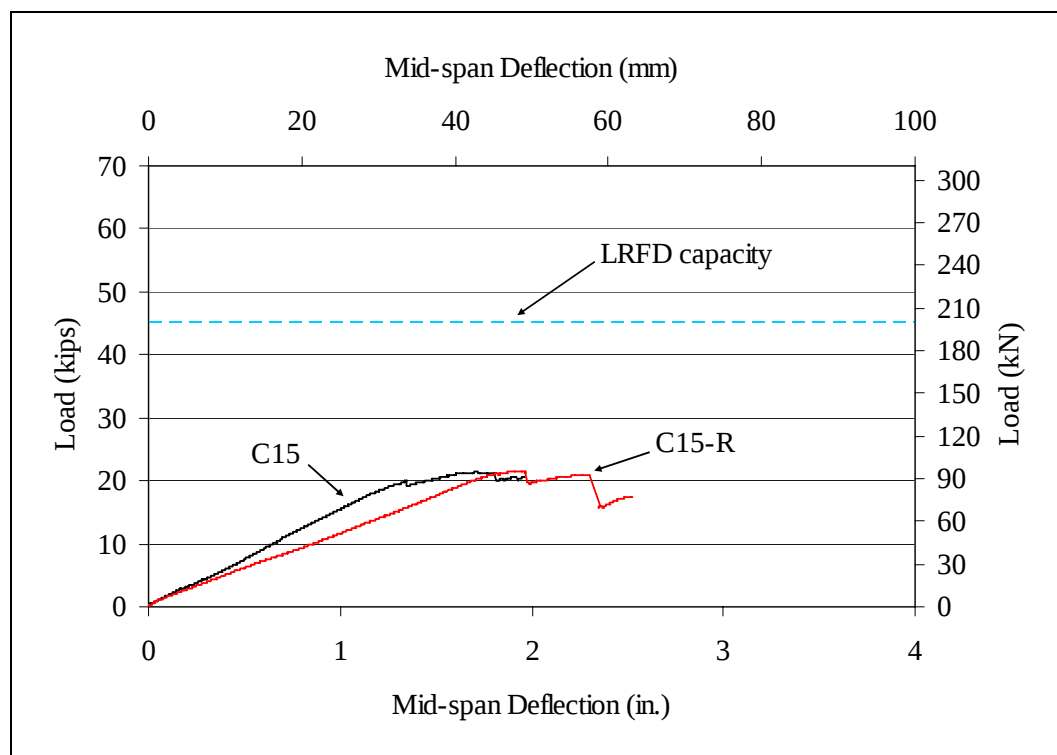
Figure 107. Load-deflection curves for stringers C15 and C15-R.

Stringer C15-R behaved linearly until it reached a load of 93 kN (21 kips), as seen in the load-deflection curve shown in Figure 107. The stringer then cracked in the tension zone causing a small drop in the supported load. The stringer then gained load capacity up to 98 kN (22 kips) where crushing started and the timber cracked again in tension. The stringer failed in tension and developed several cracks and tension splinters at the midspan. The repaired ultimate load was 98 kN (22 kips) at a displacement of 50 mm (1.96 in.).

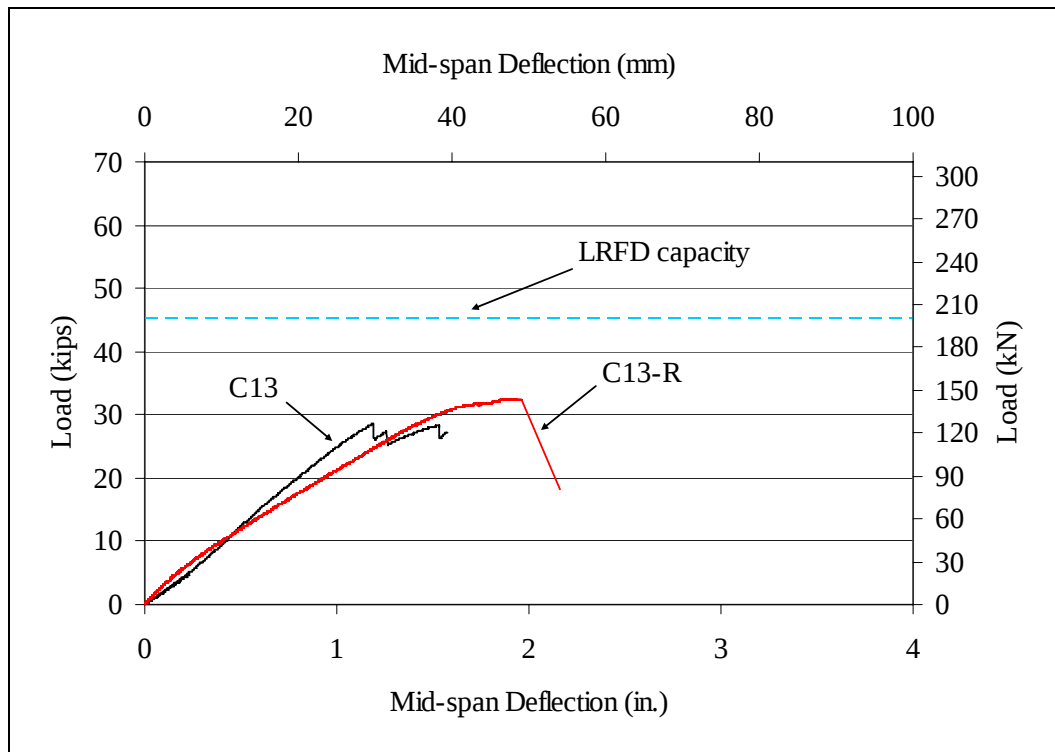
Figure 108. Load-deflection curves for stringers C13 and C13-R.

Stringer C13-R behaved linearly until it reached its repaired ultimate load, as seen in the load-deflection curve shown in Figure 108. As the load approached failure, buckling and horizontal cracks occurred in one of the side repair plates, as seen in Figure 109. There was no other damage observed in the plywood side plates. The stringers then failed in the tension zone causing a drop in the supported load. The repaired ultimate load was 142 kN (32 kips) at a displacement of 50 mm (1.95 in.). Tension cracks and splinters occurred at the midspan at failure. Following the test, the plywood side plates were removed and inspected for additional

Plywood side plates were used to repair stringer C13-R which had severe end splitting prior to testing. The increase in the repaired ultimate load over the unstrengthened postfailure capacity of the stringer was 14.3%, which was higher than the stringers repaired with lag screws. The stiffness of the repaired stringer was higher than that of stringer C13 up to a load of 45 kN (10 kips), as shown in Figure 108. The plywood plates developed bearing damage at the holes where they were attached, horizontal cracks along the length of the plywood plates, and several horizontal surface cracks along their lengths.

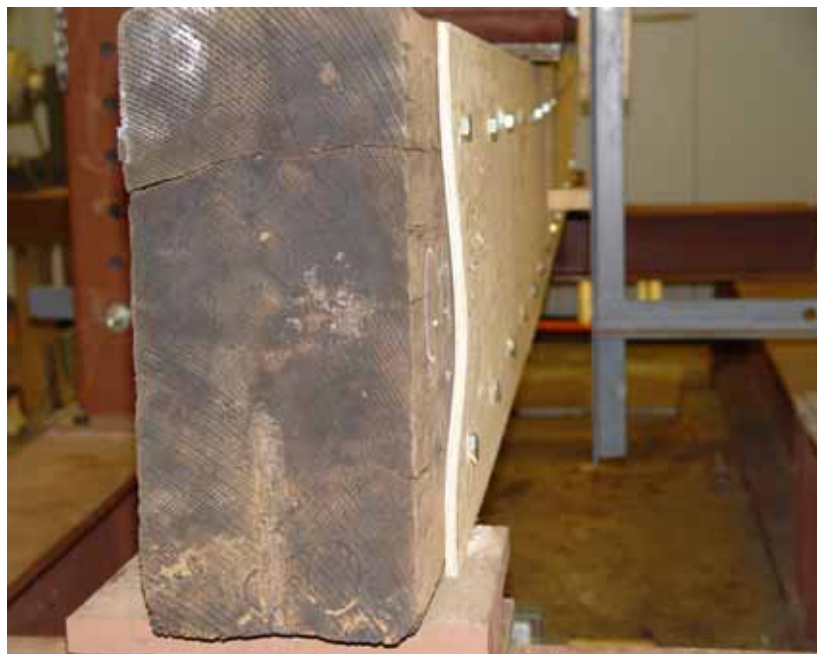
damage. There was bearing damage at the holes where they were attached and horizontal cracks along the length of the plates.

Figure 109. Buckling of the side plate on stringer C13-R.
