# Feasibility Investigation into Strengthening of Timber Bridge Stringers

Anthony J. Lamanna, Arda Akbiyik, James C. Ray,  
and Gerardo I. Velázquez

May 2007

Final report

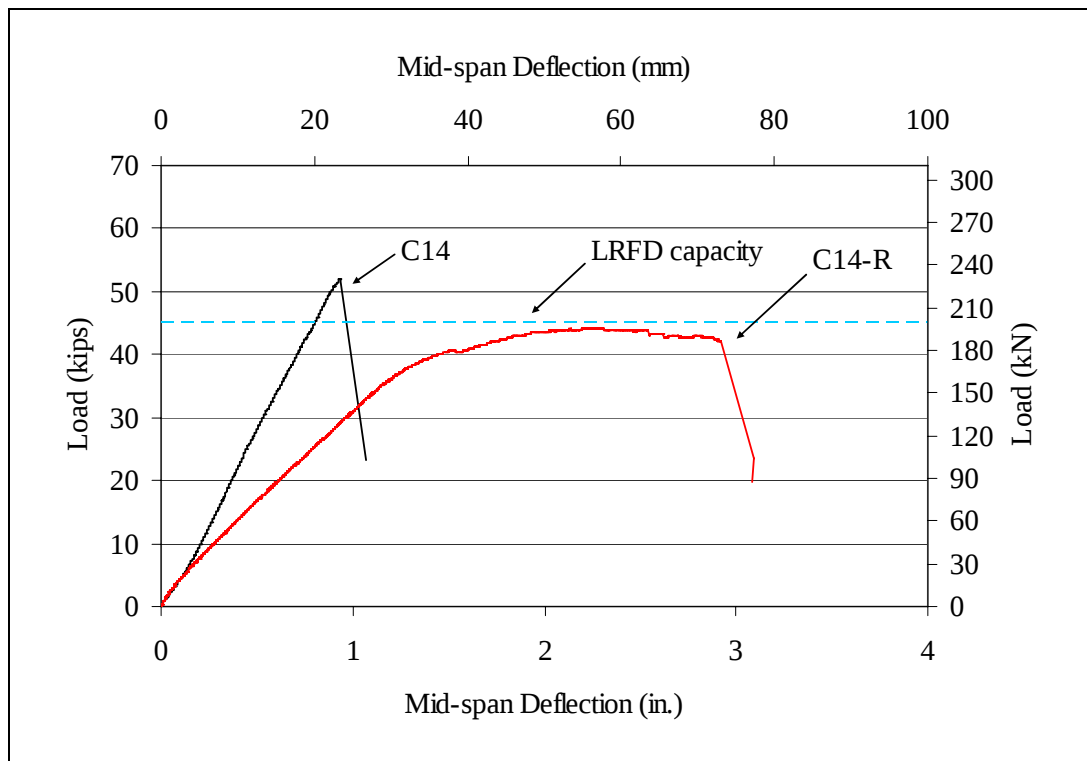
Figure 110. Load-deflection curves for stringers C14 and C14-R.

The load-deflection curve for stringer C14-R, shown in Figure 110, was linear until the stringer reached a load of 182 kN (41 kips). As the load approached ultimate failure load, horizontal sliding occurred at the support face. The repaired ultimate load was 196 kN (44 kips) at a displacement of 57 mm (2.24 in.). The stringer underwent a deflection of 23 mm (0.9 in.) without any increase in load capacity after the stringer reached the repaired ultimate load. The stringer developed tension cracks and compression failure at a load of 187 kN (42 kips) and a displacement of 74 mm (2.92 in.) causing a drop in the load capacity. The compression failure is shown in Figure 111. The experiment was terminated at this point due to excessive deformation. The side plates had minor bearing damage at the holes where they were attached, as seen in Figure 112.

Timber stringer C14-R was repaired using FRP side plates. The increase in the repaired ultimate load over the unstrengthened postfailure capacity was 91%. This repair method was more effective. It yielded 18.6% higher strength than stringer C2-R repaired with hex bolts, but 9% lower strength than stringer C10-R repaired with lag screws. Stringer C14 developed a horizontal shear crack at failure, as explained in Chapter 5, “Test results and discussion, Test results of original stringers, Specimen C14.” Stiffness of the repaired stringer C14-R, shown in Figure 110, was also below the stiffness of stringer C14, as the other repaired stringers.

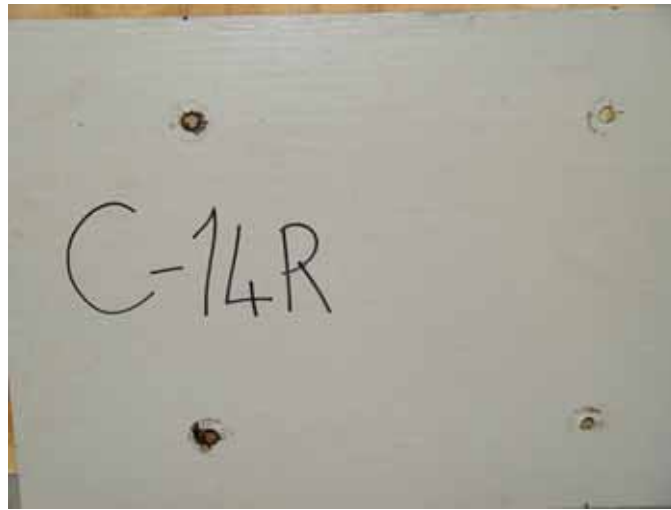
Figure 112. Minor bearing damages at the holes on FRP plates.

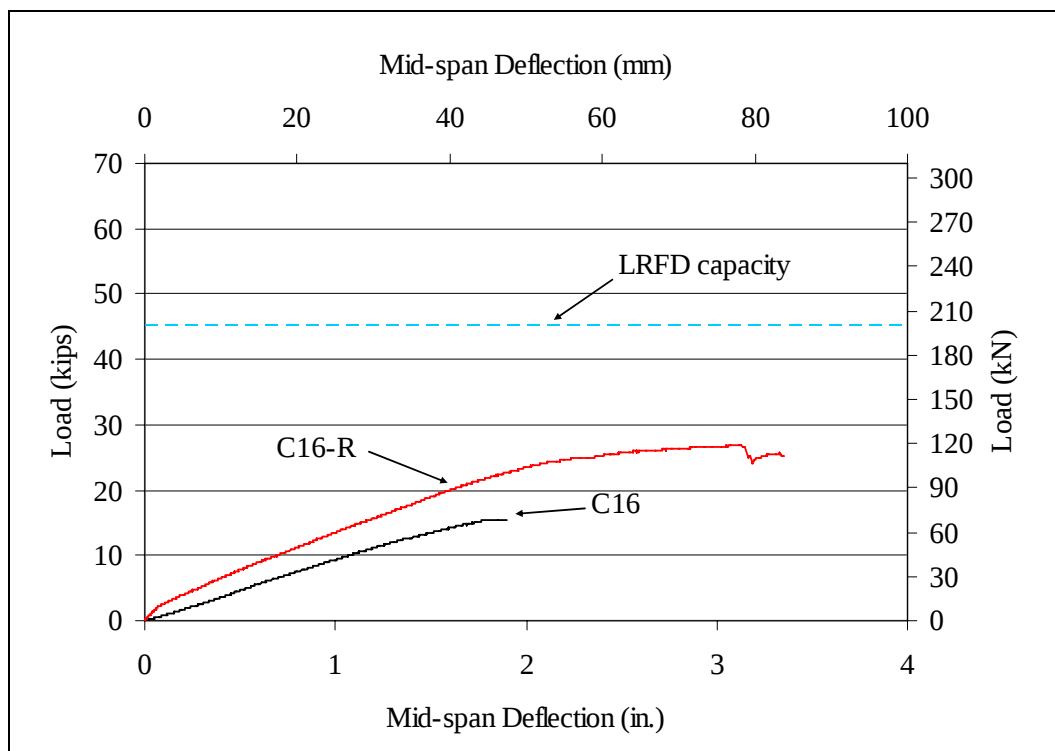
The load-deflection curve for stringer C16-R, shown in Figure 113, was up to a load of 111 kN (25 kips). The stringer developed tension cracks and splinters within the tension zone at failure. The repaired ultimate load was 120 kN (27 kips) at a displacement of 80 mm (3.15 in.). Horizontal sliding occurred at the support faces as the load approached failure. There was no visible damage on the FRP side plates, except for minor local buckling problems.

Figure 113. Load-deflection curves for stringers C16 and C16-R.

Timber stringer C16-R had existing end splitting before testing, and it was repaired using FRP side plates. The increase in the repaired ultimate load over the unstrengthened postfailure capacity was 80%, and a higher stiffness was provided by the repair, as shown in Figure 113. The FRP plates provided higher increase in the repaired ultimate load and stiffness. Therefore, it was feasible to use FRP side plates to enhance the load behavior of the timber stringers with end splitting when compared with repairing with hex bolts or lag screws. The FRP side plates also did not develop major damage except minor bearing damage where lag screws were installed.

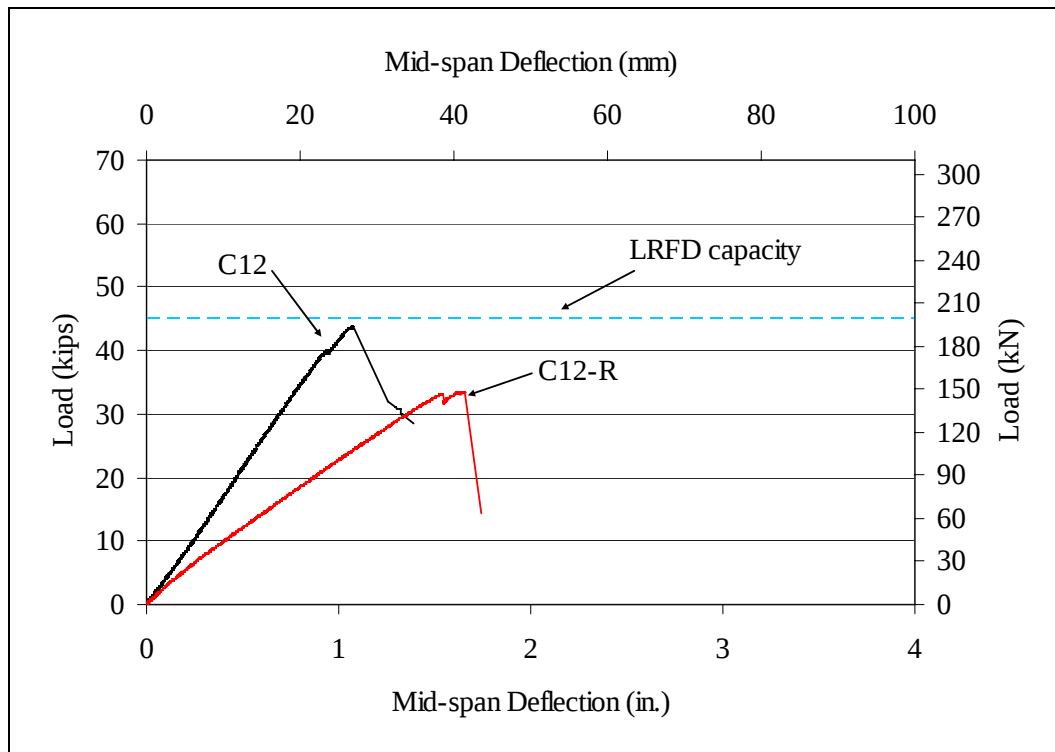
The load-deflection curve for stringer C12-R, shown in Figure 111, was linear until a small drop occurred in the load carrying capacity at 147 kN (33 kips). There were no visible cracks at this point. The load increased further until the stringer failed in horizontal shear, causing a drop in the load carrying capacity. The repaired ultimate load was 151 kN (34 kips) at a displacement of 42 mm (1.66 in.).

Stringer C12-R had an FRP strip attached to the tension zone using lag screws. Flexural reinforcement was used along with the lag screws because stringer C12 developed a cross-grain tension failure. The increase in the repaired ultimate load over the unstrengthened postfailure capacity for the repaired stringer was 17.2%. The original and repaired ultimate loads were 196 kN (44 kips) and 151 kN (34 kips) for stringers C12 and C12-R, respectively. This represents a 77% recovery in the ultimate load of stringer C12-R. The stiffness of the timber stringer was lower than that of stringer C12-R, as seen Figure 114. The repaired stringer had a horizontal

Figure 114. Load-deflection curves for stringers C12 and C12-R.
