Operational Evaluation Test Report on Beaver Micro-Vegetation Cutter

April 2005

Institute for Defense Analyses
4850 Mark Center Drive
Alexandria, VA 22311-1882

**Operational Evaluation Test Report
on
Micro-Vegetation Cutter**

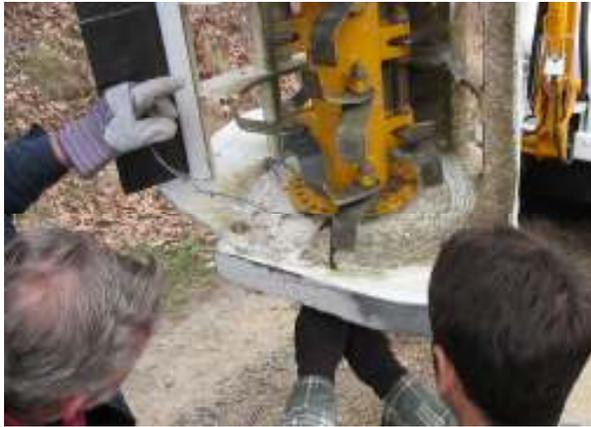
Figure 3: Pre-Test Cutters

- **Vegetation Cutter:** The vegetation cutter was designed and fabricated in the Humanitarian Demining Program’s fabrication shop at Ft. Belvoir. A second hydraulic pump is mounted in the Beaver to power the cutter. As a result of the high failure rate of the commercially procured cutting blades used during the pre-evaluation test, new cutters were designed and manufactured in the fabrication shop and used throughout the operational evaluation test. Figures 3 and 4 show the damage sustained by the two-piece cutters used during the pre-evaluation test (wt. = 434 grams); Figure 5 shows the pre-test cutters (left) and the T-1 steel machined cutter (right) used during the

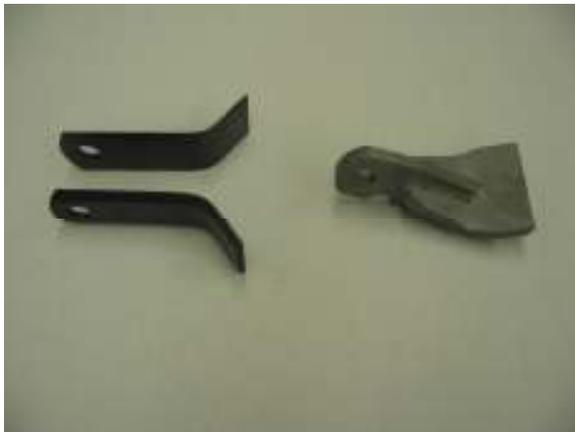
Figure 5: Pre-Test & Operational Evaluation Cutters

operational evaluation test (wt. = 634 grams); and Figure 6 shows the machined cutter (left) and the 4130 heat-treated cast alloy cutter (right) that will be used on future fabricated vegetation cutters (wt. = 756 grams). The weights and materials are shown for each of the cutters as an indicator of each cutter's strength and durability.
