Technical Findings, Lessons Learned, and Recommendations Resulting from the Helios Prototype Vehicle Mishap

NASA Langley Research Center
Hampton, VA 23681
USA

The Helios Prototype was originally planned to be two separate vehicles, but because of resource limitations only one vehicle was developed to demonstrate two missions. The vehicle consisted of two configurations, one for each mission. One configuration, designated HP01, was designed to operate at extremely high altitudes using batteries and high-efficiency solar cells spread across the upper surface of its 247-foot wingspan. On August 13, 2001, the HP01 configuration reached an altitude of 96,863 feet, a world record for sustained horizontal flight by a winged aircraft. The other configuration, designated HP03, was designed for long-duration flight. The plan was to use the solar cells to power the vehicle's electric motors and subsystems during the day and to use a modified commercial hydrogen-air fuel cell system for use during the night. The aircraft design used wing dihedral, engine power, elevator control surfaces, and a stability augmentation and control system to provide aerodynamic stability and control. At about 30

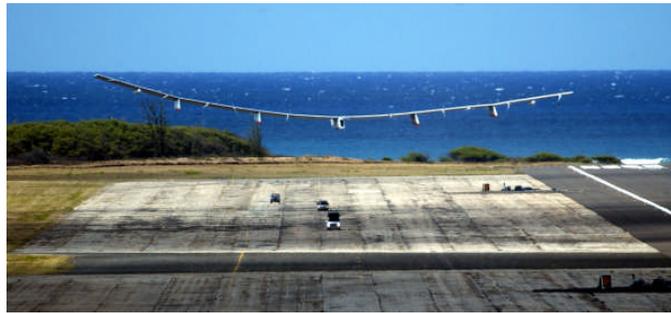
On June 26, 2003 at 10:06am local time, HP03-2 vehicle took off from the PMRF under the guidance of the Mobil Pilot (MP) located in the front vehicle shown in Figure 4. At that time the wind conditions were within an acceptable envelope, and consisted of a wind shadow over and offshore from PMRF, bounded to the north, south, and above by zones of wind shear and turbulence separating this region from the ambient easterly trade-wind flow.

Figure 4: HP03-2 on takeoff

At 10:19am, the Stationary Pilot (SP), located in a trailer near the runway, noted that instrumentation and the aircraft were behaving as though it was in turbulence (noted later as the 1st encounter with turbulence). At 10:22am and again at 10:24am the aircraft again encounter some turbulence. The aircraft's wing dihedral became larger than normal and mild pitch oscillations occurred; the wing dihedral during both events returned to normal without any pilot inputs, and the oscillation damped out. These events both occurred during the time when the Stationary and Mobil crews were focused on the handoff procedure. Neither crew was aware of the high wing dihedral or the pitch oscillations. At 10:35am, at approximately 2,800 feet altitude, the aircraft began experiencing airspeed excursions of around ± 2 ft/sec. The persistent high wing dihedral (Figure 5) and the subsequent loss of pitch control, the aircraft became very unstable in a highly divergent pitch mode in which the airspeed excursions from the nominal flight speed about doubled every cycle of the oscillation. During the final nose down dive (approaching 90°) the aircraft exceeded the maximum allowable speed by over a factor of two. The resulting high dynamic pressures caused progressive failure of the wing leading edge secondary structure on the outer wing panels. Soon thereafter, the solar cells and skin on the upper surface of the wing began to rip off. These failures destroyed the aircraft's ability to generate lift and sustain flight; as a result, the aircraft fell into the ocean (Figure 6). The aircraft impacted the ocean within the confines of the PMRF test range and was destroyed.
