**FUEL SYSTEM DURABILITY—
U.S. COAST GUARD**

**INTERIM REPORT
TFLRF No. 393**

**U.S. Army TARDEC Fuels and Lubricants Research Facility
Southwest Research Institute® (SwRI®)
San Antonio, TX**

May 2008

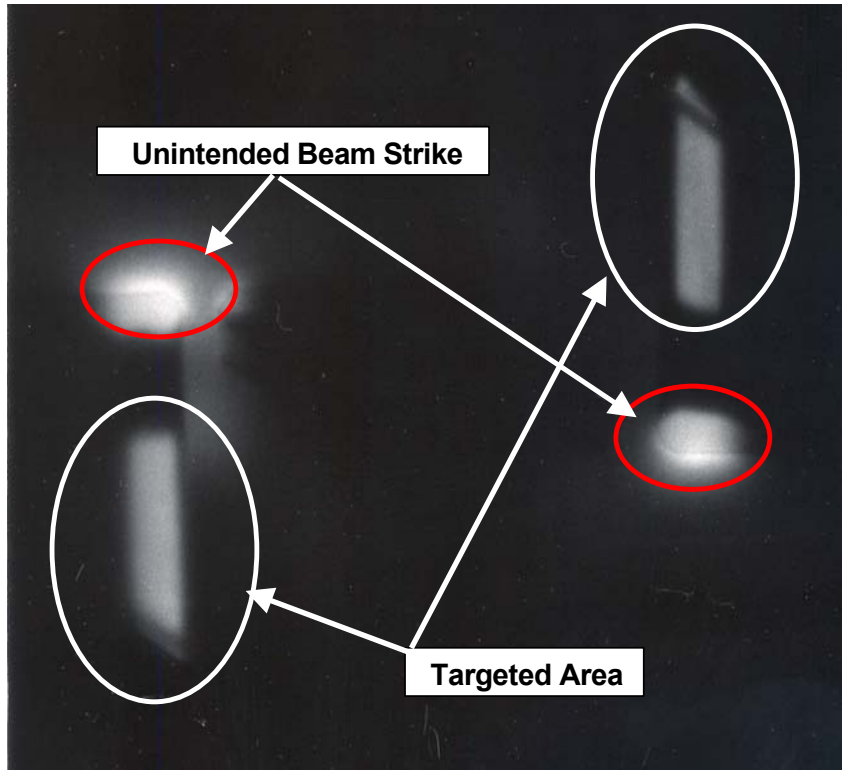
Figure 11. Radiograph Showing Target Area and Unintentional Activation

Examination of the radiograph indicates the activity is high because the beam struck an unmasked vertical edge of the plunger. It is likely most of the activity measured is on the vertical surface, normal to any wear surface. Figure 11 does show activity in the target area, but SwRI cannot separate the activity from that area with the detectors. Furthermore, the activity depth profile is unknown due to the beam strikes on the different surfaces. It appears the mask was not extended far enough along the length of the plunger to block the beam from an unintentional strike (9). The subcontractor acknowledged their error, and will activate another plunger at no cost.

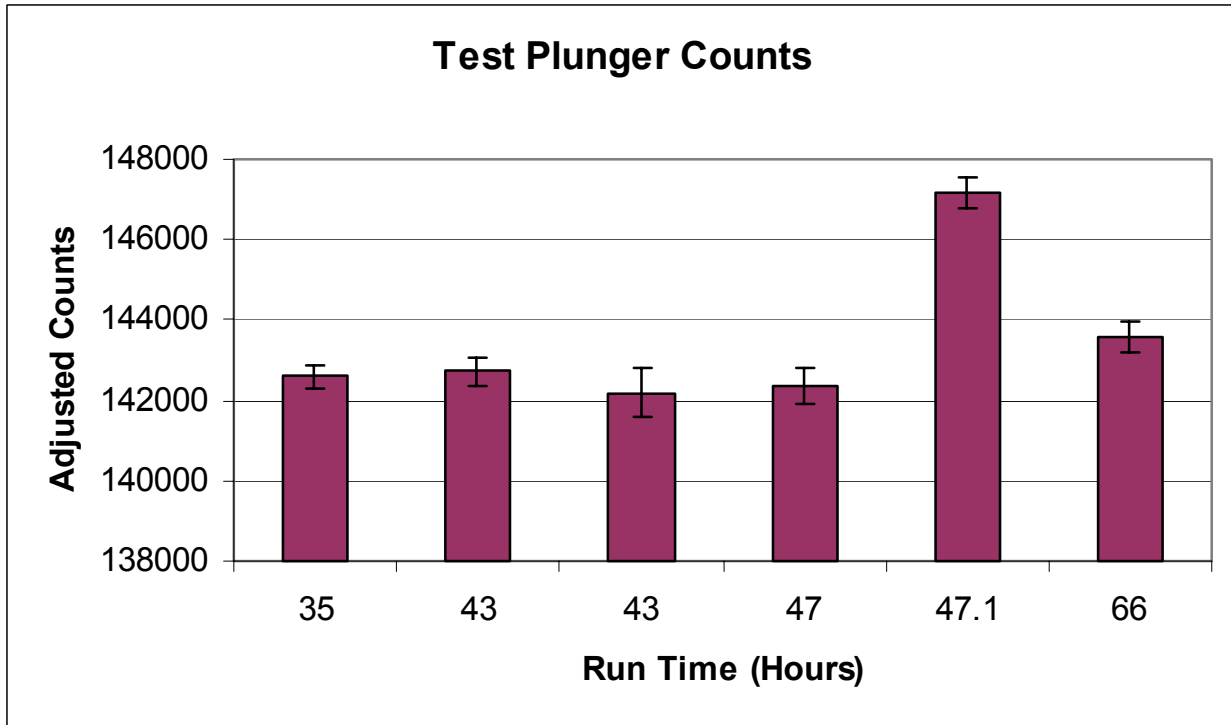
possible, this was an indication that SwRI was still experiencing a detector stability problem. A decrease in activity was recorded between running hours 47 and 66 on the plunger, however due to detector instability, this data is not statistically reliable. This data is shown in Figure 15, with counts adjusted for isotope half-life.

Figure 15. Plunger Activity Adjusted for Half-Life

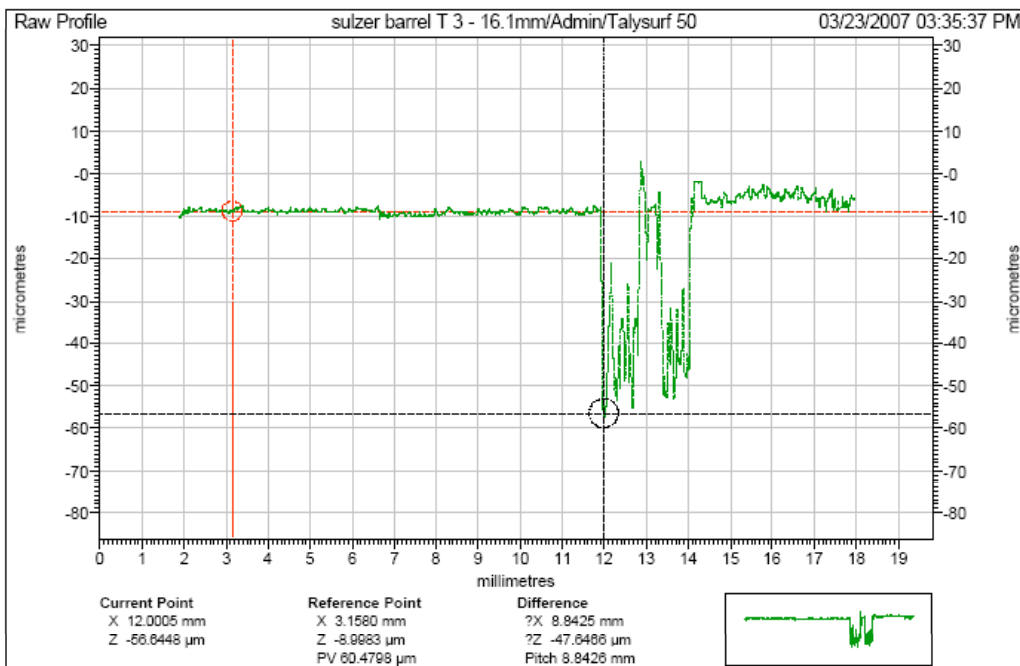
The Talysurf surface profilometer trace shown in Figure 23 is across one of the major pits of the injection pump barrel showing a scar depth of 47-microns. Of interest is the ploughing of

Figure 23. Surface Profilometer Trace across Pit from Injection Pump Barrel

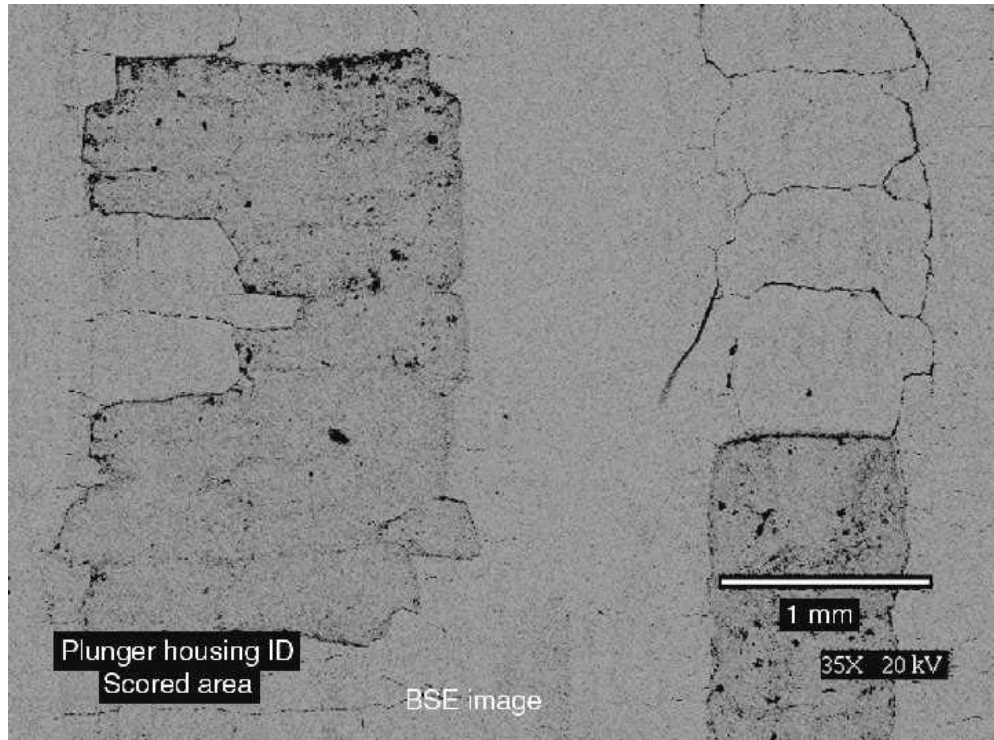
Figure 28. Back Scatter Scanning Electron Image of Scored Barrel

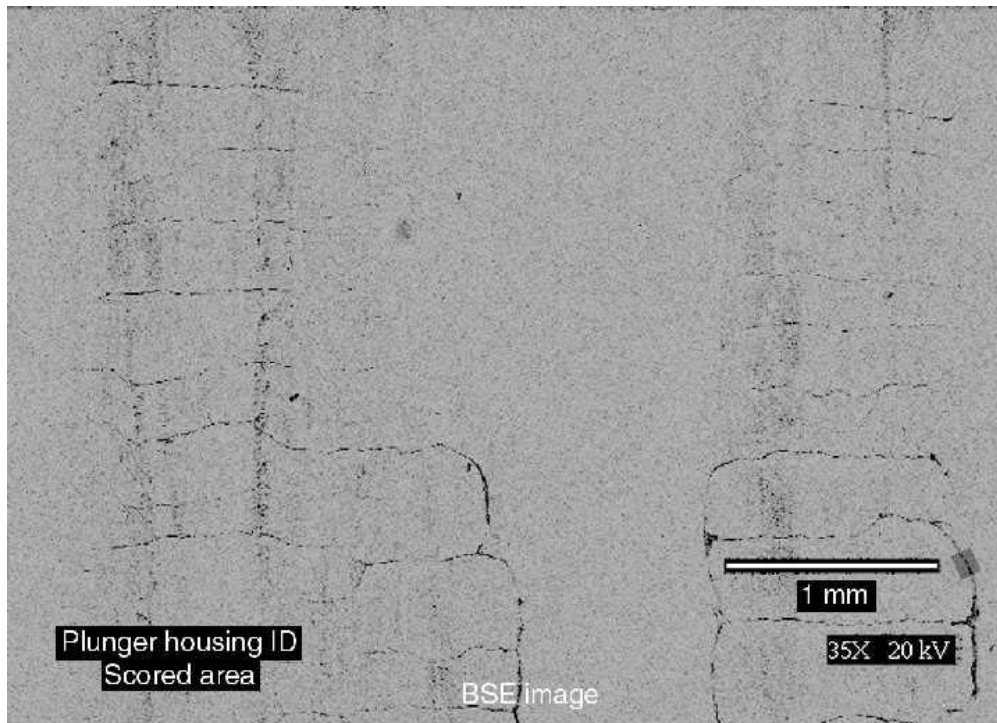
Figure 29. Back Scatter Image of a Different Scored Area of the Barrel

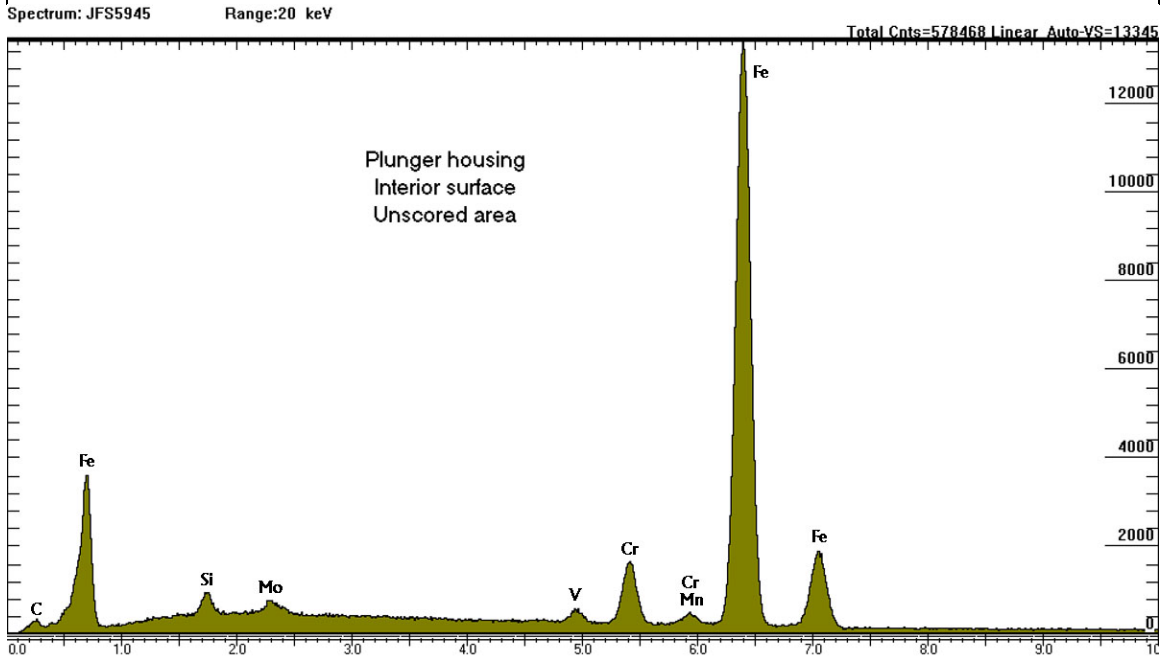
An elemental analysis was performed on an area of the barrel that did not reveal wear and on one of the scored areas. The un-scored area elemental results matched closely with the base metal elemental results. Figure 30 details the elemental analysis of the scored area and Figure 31 details the elements found in a scored area of the barrel. An element that shows up in the scored area is aluminum, which does not show up in the base metal or un-scored area elemental scans. The quantity of aluminum is small, thus alloying elements of are not seen so it is not certain if the aluminum is from an alloy or from an abrasive such as aluminum oxide.

Figure 30. Elemental Scan Results for Unscored Area of Barrel

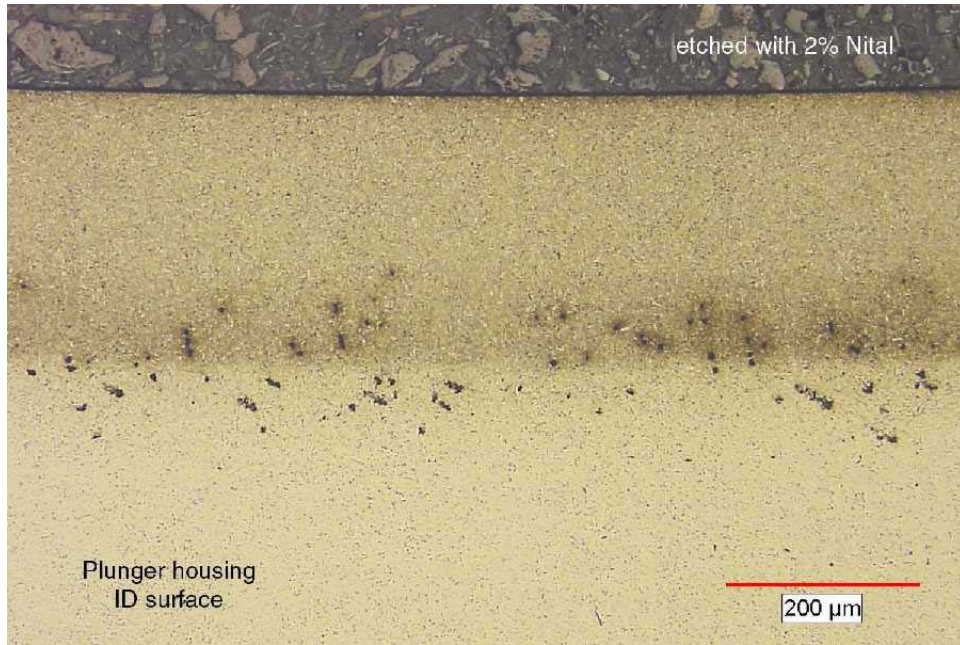
The heat treatment case depth was checked for the barrel. Figure 32 shows the etched barrel section with the depth of the case hardening around 300-microns.

Figure 32. Barrel Etched to Determine Case Hardness Depth

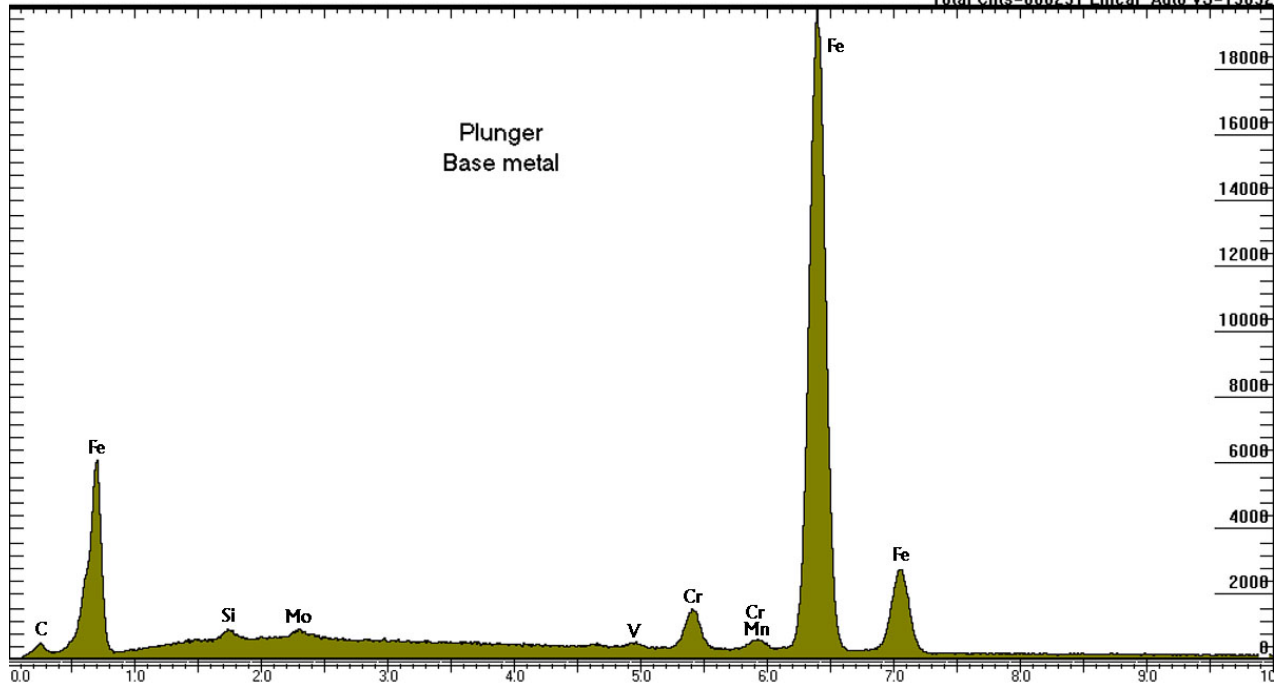
Elemental scans were performed on the base material and on a damaged section of the plunger to determine if foreign materials were present in the wear scars. As seen with the barrel, the plunger revealed a small aluminum peak in the damaged areas as shown in Figure 40. The undamaged area did not show an aluminum peak as seen in Figure 41.

Figure 41. Elemental Scan of Plunger Base Material

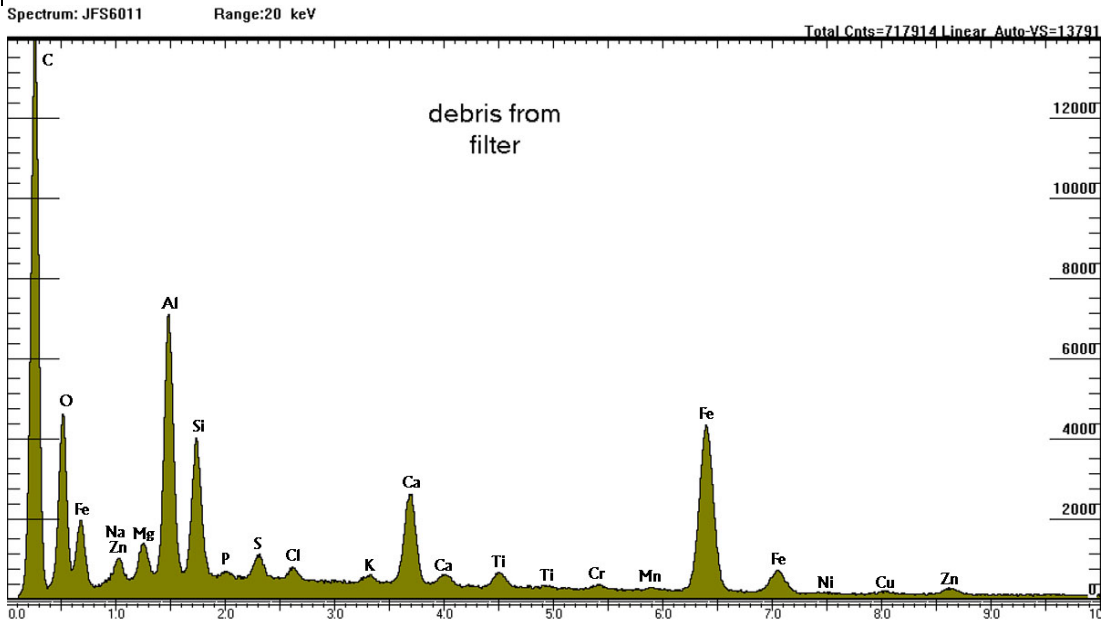
The system fuel filter was washed with a solvent, then the solvent was filtered through a Millipore filter, then the filter was dried. The remaining debris was analyzed for elemental composition and the results are shown in Figure 42. Particles of iron and aluminum alloy were found in the filter debris as shown in Figure 43. The aluminum may have come from the threads of the filter element holder when it was tightened after the filter was changed. The iron could be wear debris that is recirculating through the fuel injection system. It is known that particulate can be pumped through filter media due to pressure pulsations. The pressure pulsations for the single pumping element system were quite severe.

Figure 42. Fuel Filter Debris Elemental Analysis

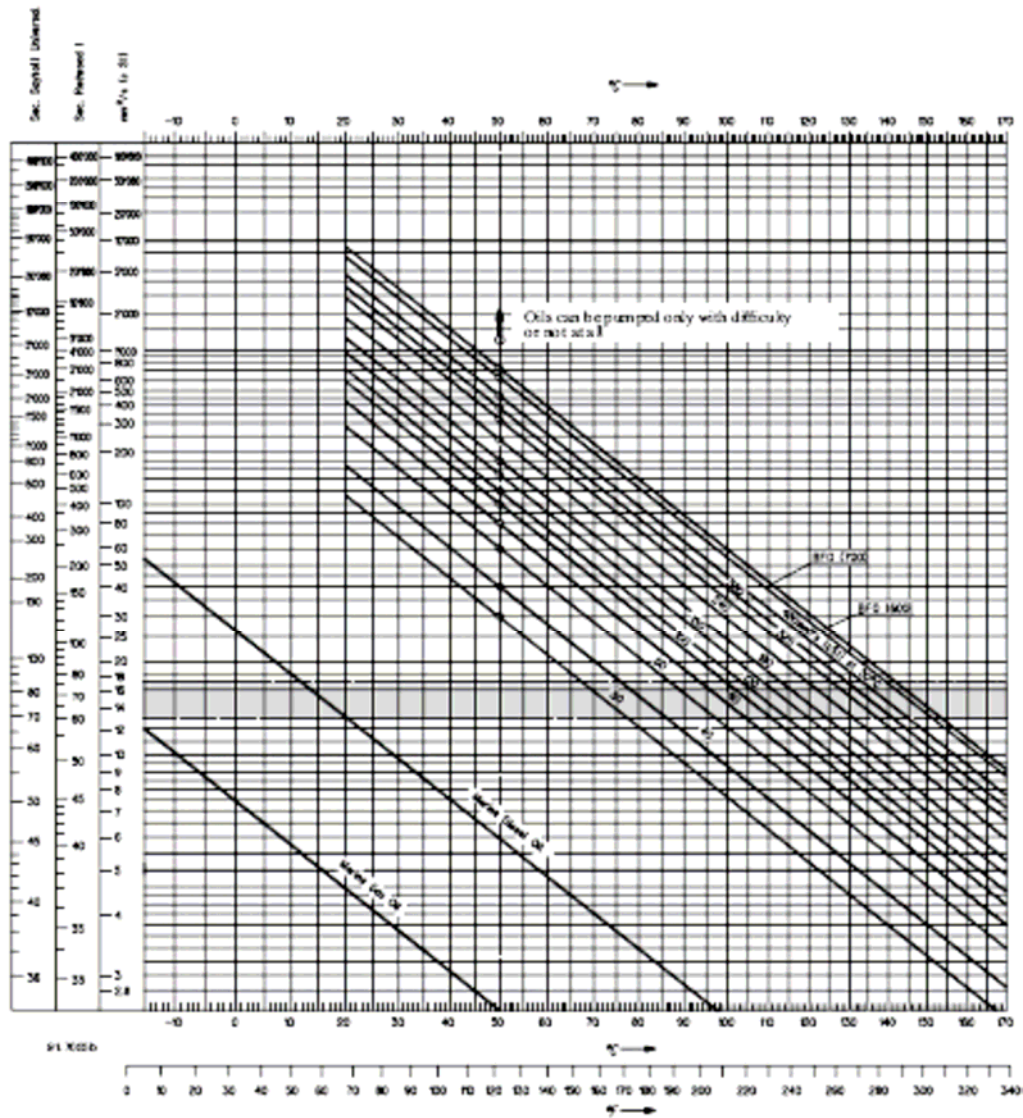
fluctuating pressure waves. It should be noted the viscosity of JP-5 is nominally 1.5 cSt at 40°C, versus nominally 3.0 cSt at 40°C for DFM. The recommended viscosity range for the 12ZAV40S engine is shown in Figure 45, and is recommended to be 13–17 cSt at the fuel injection pump inlet temperature. It is probably safe to assume the design and durability prototype of the fuel injection pump was performed with fuels in the aforementioned viscosity range. Thus fuels in the 1.5 to 3.0 cSt range could vary the cavitation sensitivity of the fuel injection system due to reduce dissipation. At this time it has yet to be determined if the increased operating speed utilized later in the test program may have contributed to the likelihood of the occurrence of cavitation, although the increased speed would have altered the turbulence of the fuel flow in the fuel injection pump body.

Figure 45. Fuel Viscosity Recommendations

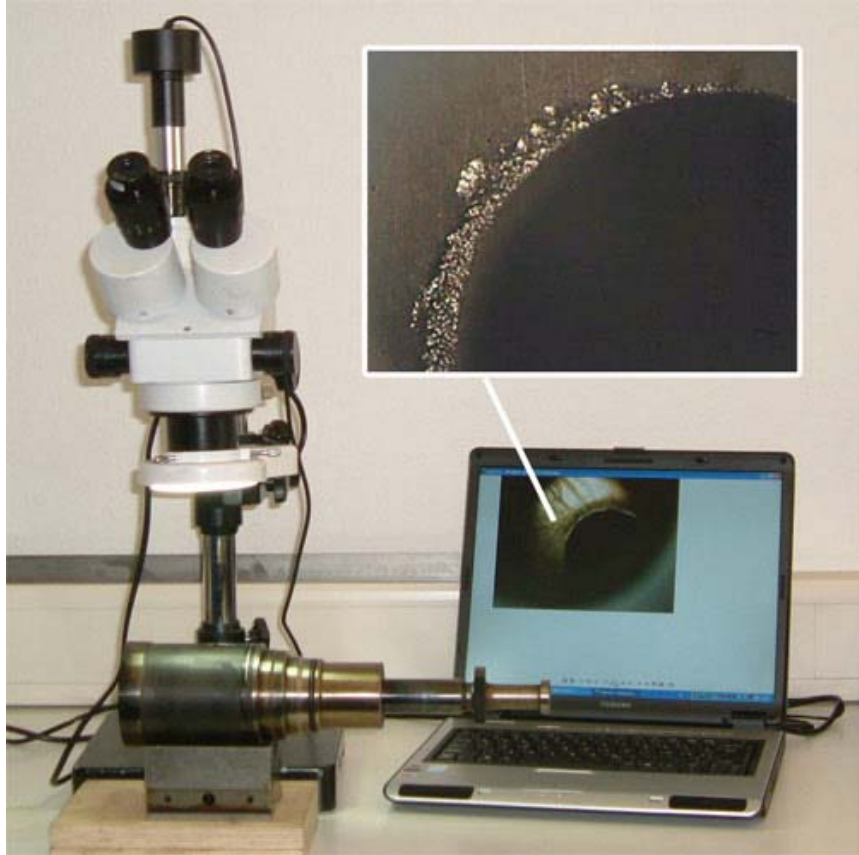
The image in Figure 46 from a commercial maritime fuel injection service company shows evidence of cavitation in a large engine barrel and plunger assembly, with the cavitation erosion being evident around one of the ports in the barrel. This image can be compared to Figure 47 that was taken after the barrel from the JP-5 fuels testing was sectioned. The erosion pattern around the port appears quite similar to the case documented in Figure 46, suggesting some cavitation occurred during testing. What has not been documented is whether the debris eroded due to cavitation can cause the scuffing seen during the JP-5 test program.

Figure 46. Documented Cavitation from Commercial Diesel Service Company
