Naval Submarine Medical Research Laboratory

NSMRL/TR--2007-1252

March 28, 2007

Results of Inspections of MK-10 Submarine Escape and Immersion Equipment Life Rafts Following Leeway Testing

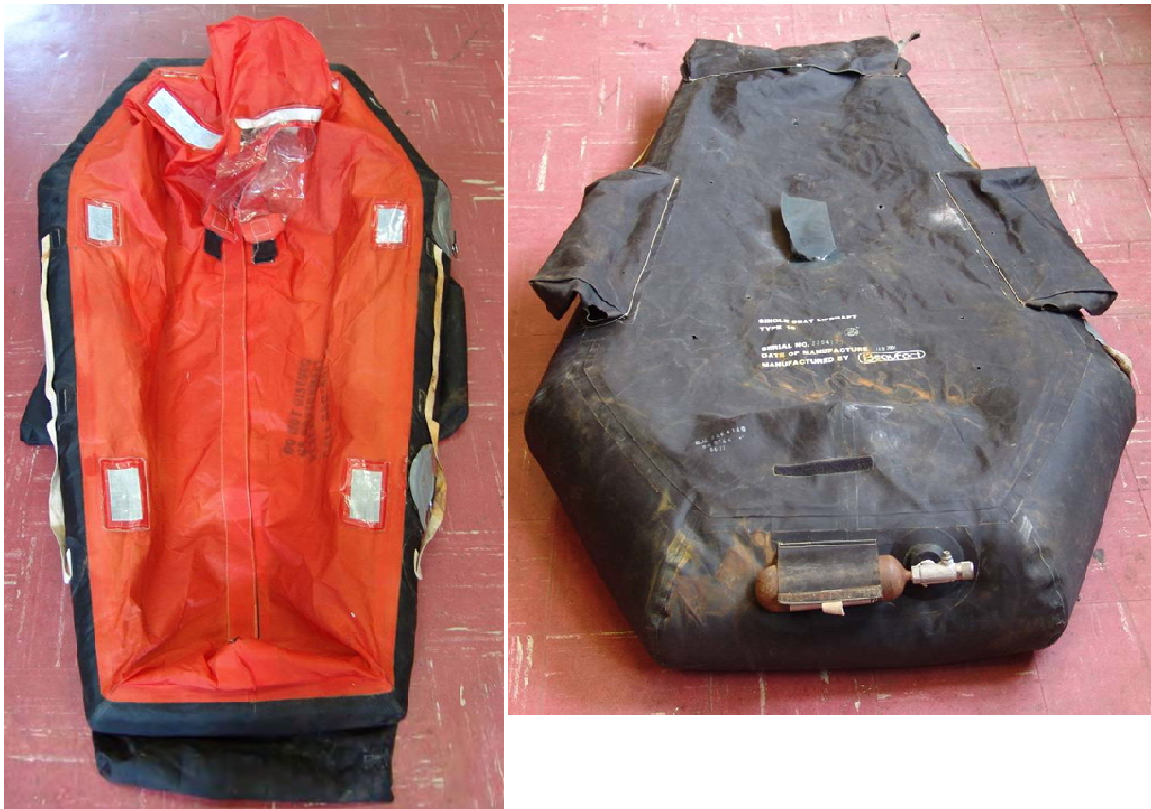
Figure 26: Raft Serial Number 2204171 Top View (Left) and Bottom View (Right)

- Two D-rings were added on left side. No grommets added to canopy.
- Forward Stability pocket left side seam (As seen from top.) was ripped open for entire length.
