INSPECTION AND ANALYSIS OF FAILED TRANSMISSIONS

**INTERIM REPORT
TFLRF No. 399**

**U.S. Army TARDEC Fuels and Lubricants Research Facility
Southwest Research Institute® (SwRI®)
San Antonio, TX**

June 2009

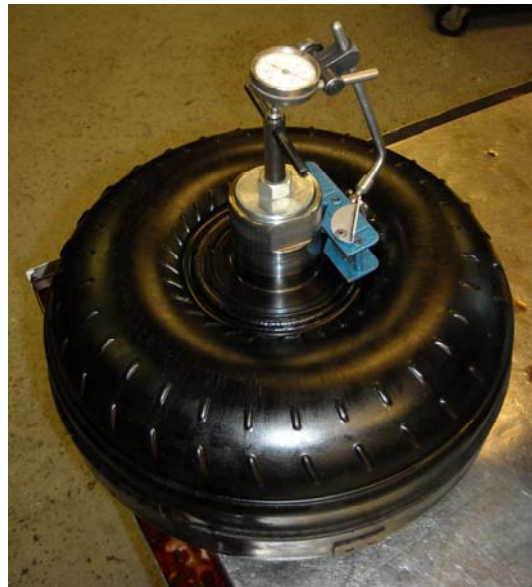
Figure 7 - Torque Converter Endplay Measurement Apparatus

During initial transmission disassembly, the endplay of the each converter was measured in an effort to determine the cause of failure. The measurement apparatus can be seen below in Figure 7.
