October 2009

WARFIGHTER SUPPORT

Independent Expert Assessment of Army Body Armor Test Results and Procedures Needed Before Fielding

Highlights of [GAO-10-119](#), a report to congressional requesters

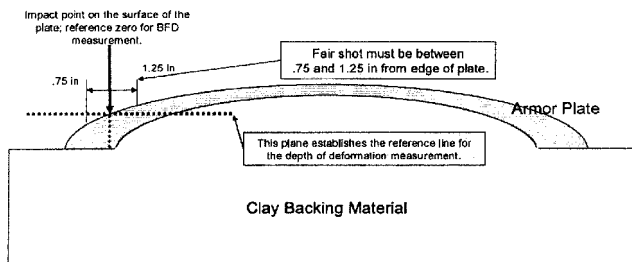
Figure 1. Test setup before test shot.

Assertion 5 – Army tester's incorrectly measured the amount of force absorbed by the designs tested by measuring back-face deformation at the point of aim rather than at the deepest point of depression. (Page 5 of 48, paragraph 1; and, Page 21-23 of 48.)

Response: Though ATC deviated from the test protocol in the Purchase Description regarding measuring BFD at the lowest deformation, Army leadership after a deliberative internal process and in consultation with DOT&E, decided to use the BFD point-of-aim measurement as it was determined to be an accurate and repeatable process that did not bias any vendor's design. The following information highlights the rationale for this decision. For clarity and reference, Figures 1 and 2 depict the geometry associated with this issue. Further discussion follows the figures.

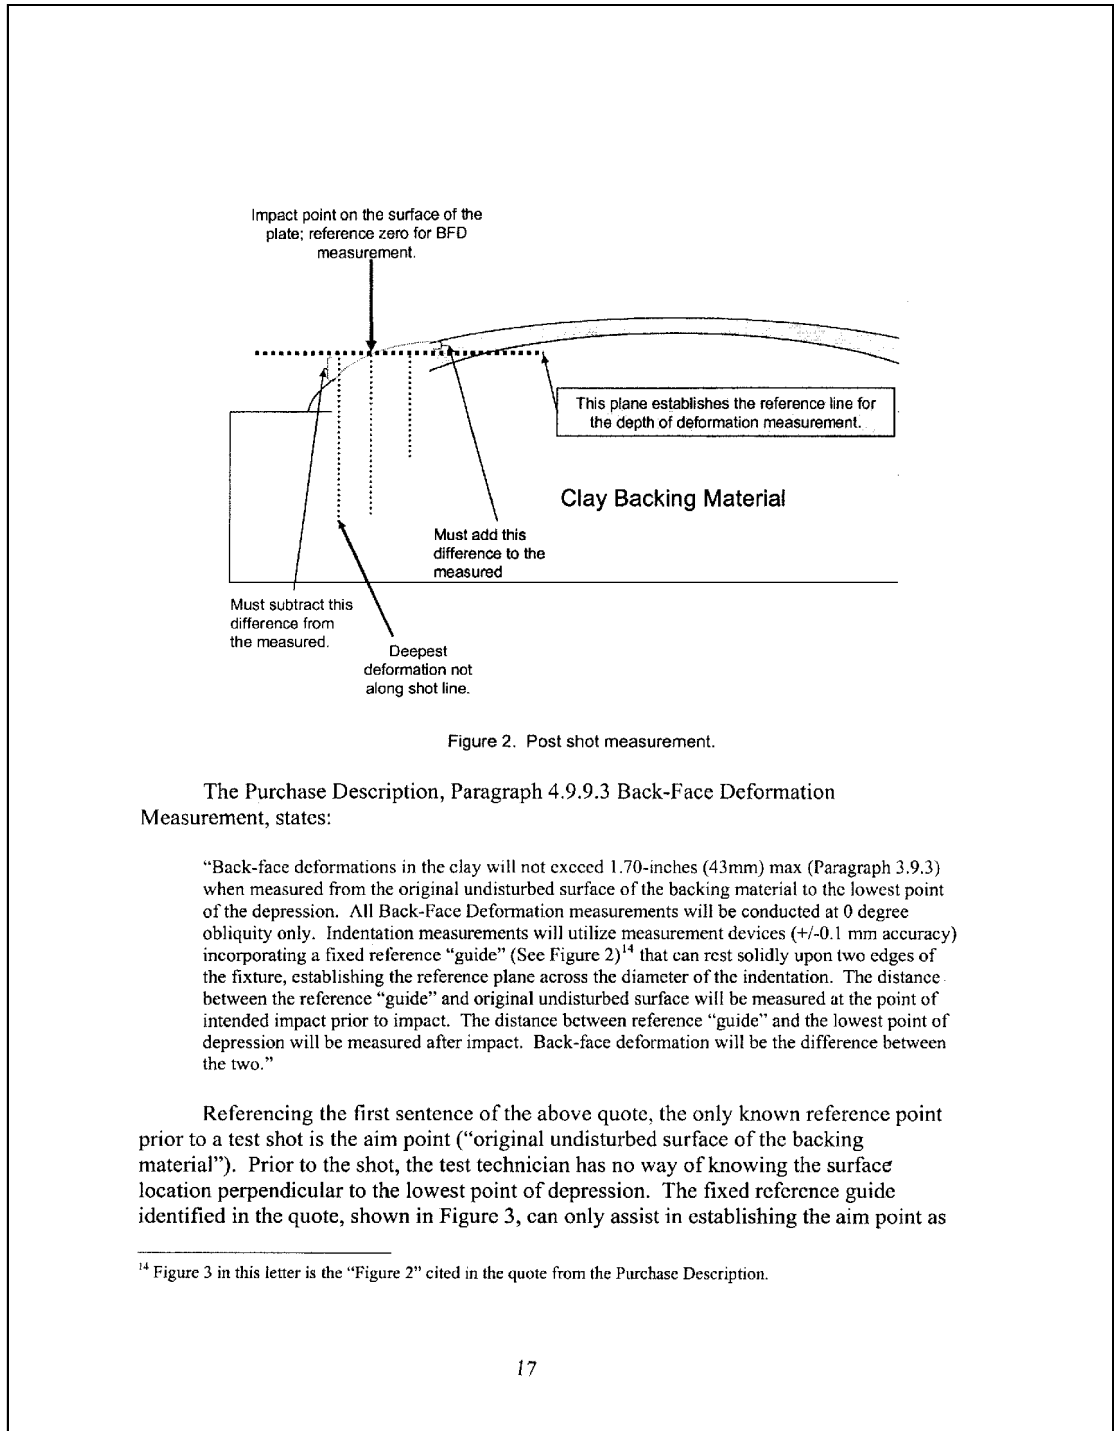
Figure 2. Post shot measurement.

Referencing the first sentence of the above quote, the only known reference point prior to a test shot is the aim point (“original undisturbed surface of the backing material”). Prior to the shot, the test technician has no way of knowing the surface location perpendicular to the lowest point of depression. The fixed reference guide identified in the quote, shown in Figure 3, can only assist in establishing the aim point as

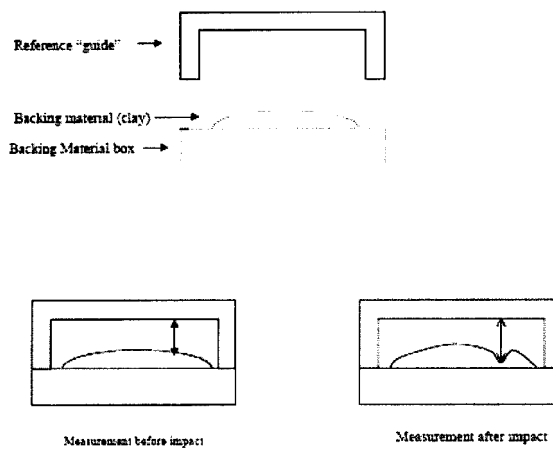
Figure 3. BFD Measurement Reference Guide from Purchase Description.

There are two important considerations pertaining to the guidance in the Purchase Description: First, the lowest point of depression must be subjectively selected by a test technician, and second, measuring perpendicular from the point selected as the lowest point of depression to the reference guide provides the distance between that point and the original undisturbed surface at the aim point, not the original undisturbed surface perpendicular to the lowest point of depression, which is what is required to obtain an accurate measurement. Using the technique described, an accurate measurement can only be made if the measurement is made on a flat surface with a uniform original undisturbed reference surface. However, since the plates are curved and the radius varies between vendor plates and even within vendors for same plate sizes, as shown in Figure 4, the only point at which an accurate measurement can be made with the described measuring device is the aim point.

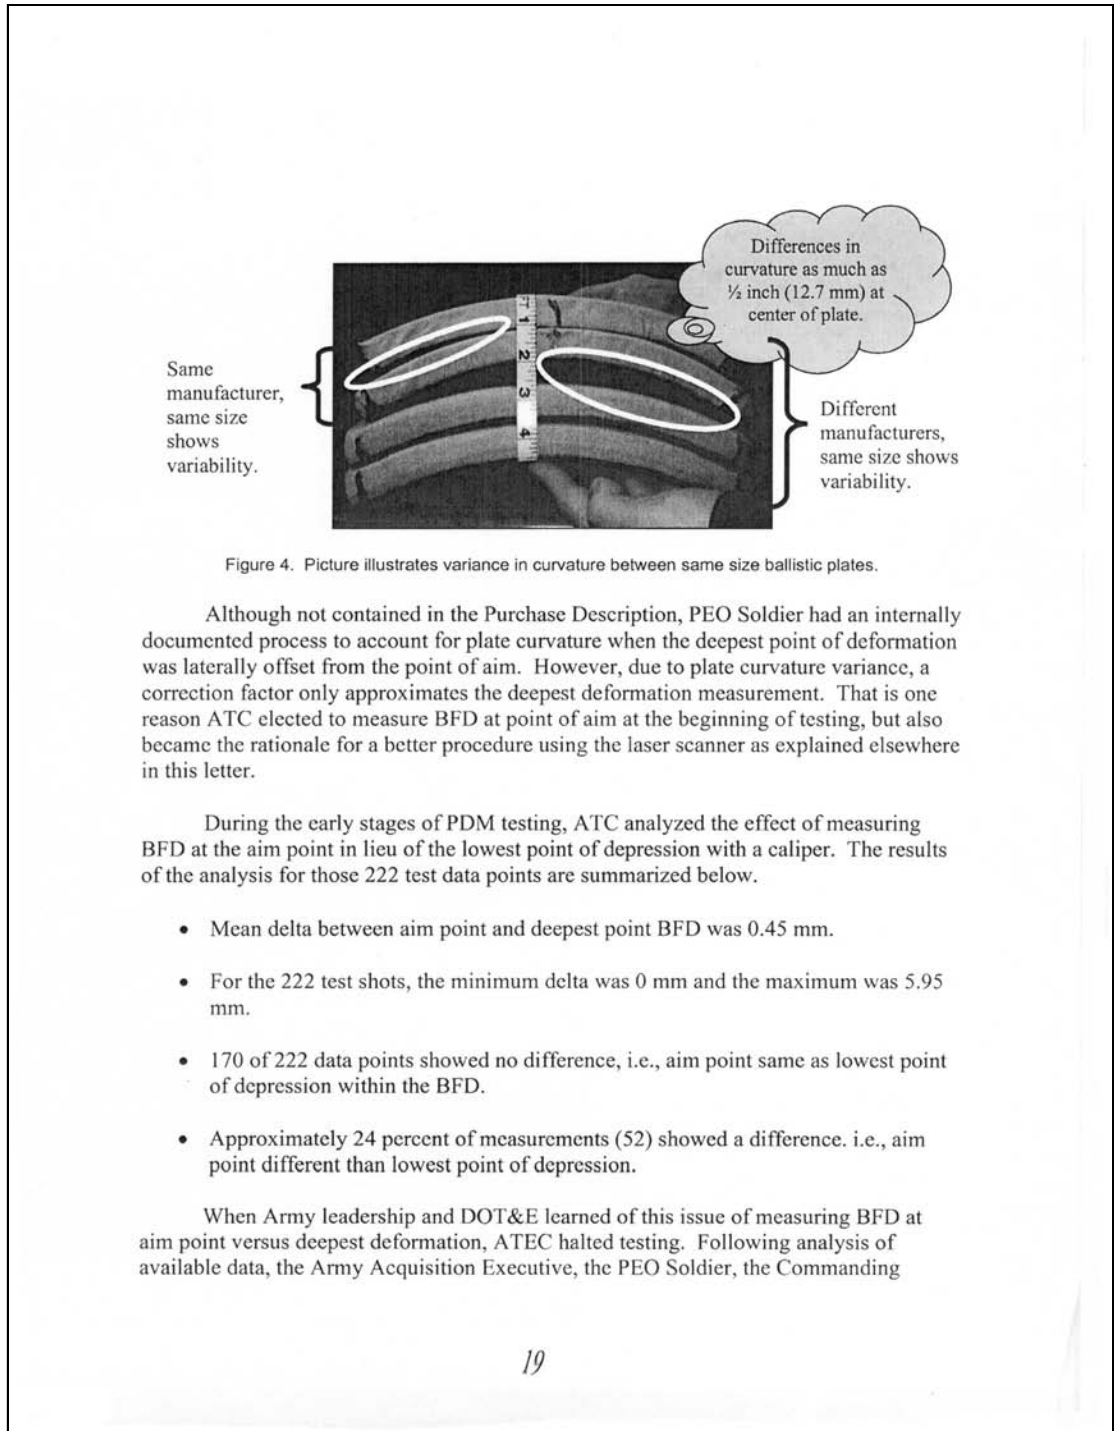
Although not contained in the Purchase Description, PEO Soldier had an internally documented process to account for plate curvature when the deepest point of deformation was laterally offset from the point of aim. However, due to plate curvature variance, a correction factor only approximates the deepest deformation measurement. That is one reason ATC elected to measure BFD at point of aim at the beginning of testing, but also became the rationale for a better procedure using the laser scanner as explained elsewhere in this letter.
